Go & See RESULT

Go & See Summary Report: 2008 M/Y Tundra Accelerator Pedal Stuck

Go & Study Report

Subject: Vehicle Go&Study: Accelerator pedal Stuck on TMMF Yaris

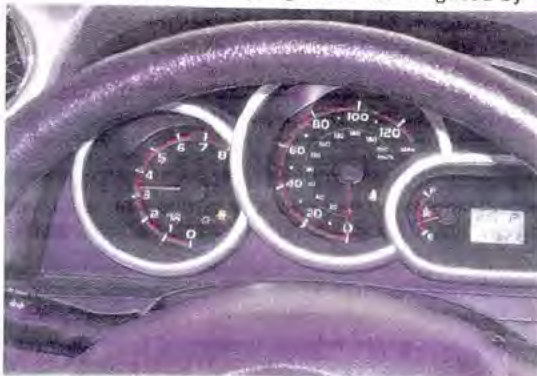
アクセル引っ掛かり時のメーター表示
Display on the meter when the pedal was sticking.

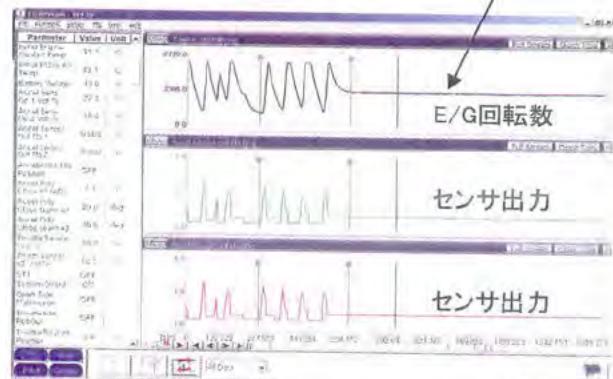
テックストリームデータ表示
Tech stream data

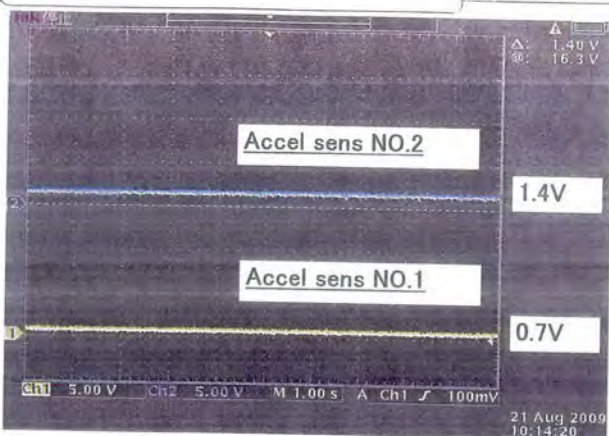
アクセルセンサ出力値(全閉位置)
Output value of the accel. sensor
(when the accel. pedal was fully closed)

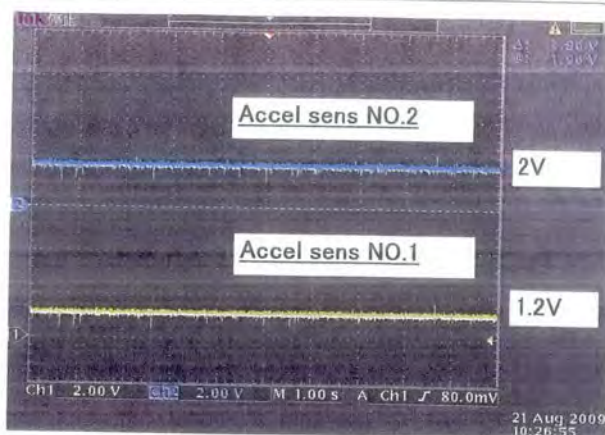
結論: メカ的要因(応力等)によるアクセルペダル引っ掛かりと思われる。

Conclusion: The mechanical problem (ex.stress) may cause the pedal sticking.

アクセルセンサ出力値(引っ掛かり時)
Output value of the accel. sensor
(when the accel. pedal was sticking)

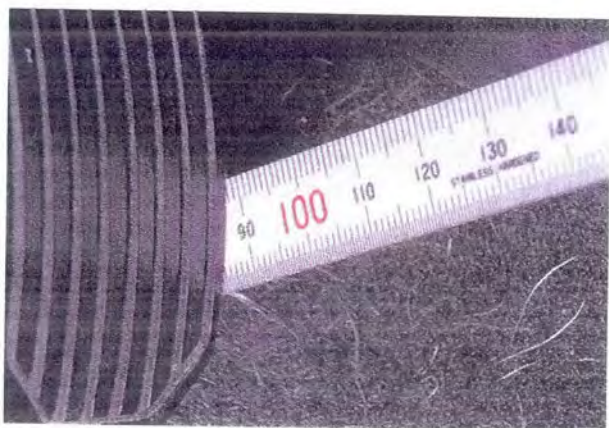
アクセルペダル全閉位置
The position of the pedal fully closed

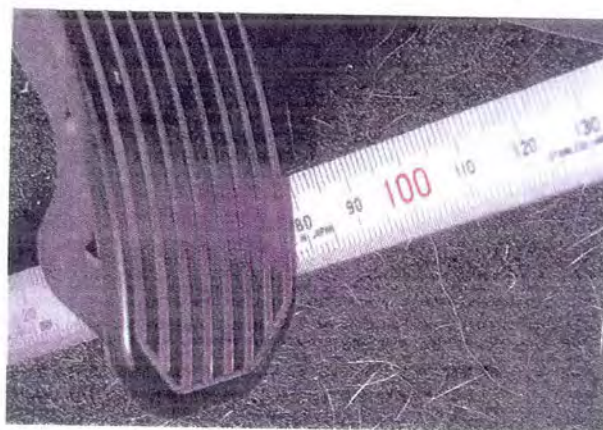
1. E/G-ON プレンジ
E/G-ON P-range
2. 手押しにてアクセルをスロットル開状態へ押し込む
Push the accelerator pedal down by hand and make the throttle opened
3. その後、ゆっくりスロットル閉状態へ戻す
Return the throttle to be closed slowly
4. 所々、引っ掛かりが感じられ再現(約3300rpm、スロットル開度22%)
The sticking was partly felt and the concern was duplicated.(approximately 3300rpm, throttle 22% opened)
5. アクセルペダルを手で全閉方向へ軽く引っ張ると"コツ"音と共に全閉に復帰
After pulling the accelerator pedal up by hand, it came to normal with the sound.
* 現品回収のため取り外したところ引っ掛かりがなくなった
There was no pedal sticking when it was removed from the vehicle.

アクセルペダル引っ掛かり時
The position of the pedal sticking

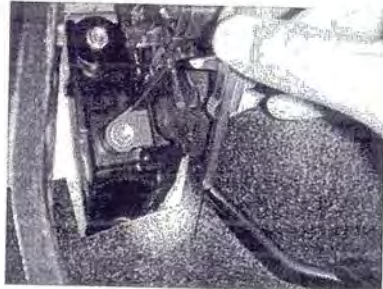
- 'Accelerator Pedal Stuck condition' not duplicated
- No interference between Floormat and panel confirmed by static measurements
- Engine data should be further analysed by TMC design
- No evidence of condensation or water entry

Pic. 1: Pedal Stroke Measurement

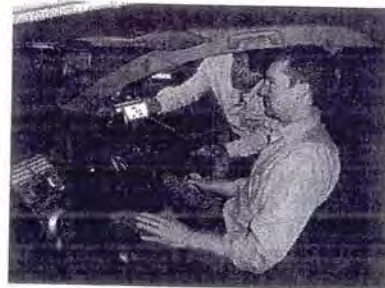
- Vehicle was driven in actual condition and with recovered parts installed for 20min each
→ No duplication

Pic. 2: Duplication trial with dealer's technician

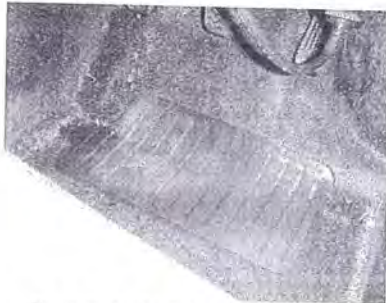
- Floormat, windshield, doors, roof were checked
→ No mark of water entry neither condensation could be confirmed

Pic. 3: Body check for condensation
