TQCN DOC# FTR-80N129671	Affiliate TMS	Dept. QA-Vehicle and	Source FTS	Location TMS-GST	Ref 43351-1	Date 10/24/2007
Problem Area PPO/DIO	Primary Model Tacoma	Model Year 2006	Production Date 01-Aug-2006	Odometer 7176 mi	VIN (confirm 17 characters): 5TEKU72N06Z [REDACTED]	
Condition Title FLOOR MAT ALL WEATHER - REF# 58525

Condition Description

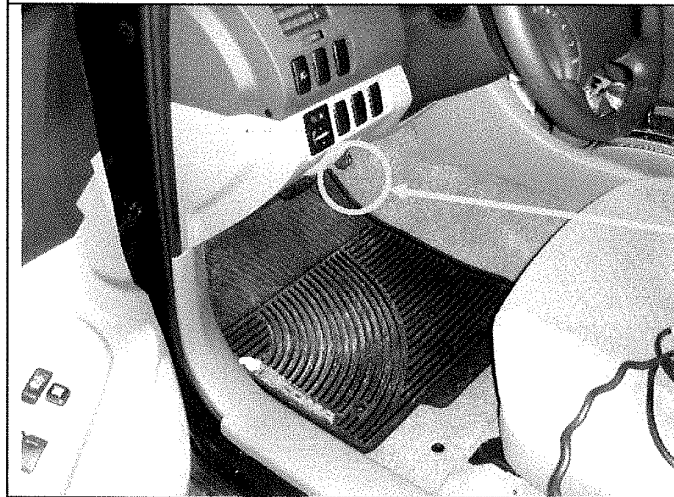
Left front all weather floor mat interferes with the proper operation of the accelerator pedal when the mat is not properly installed.

1. Road test vehicle and verified the interference between the accelerator pedal and the all weather floor mat.
2. Next removed the all weather floor mat and road tested the vehicle and found that the operation of the accelerator pedal was normal.

Improper installation of all- weather floor mat.

Photo showing location of the accelerator pedal interference with floor mat.

Cut flashing off of the rear portion of the mat and reinstalled into the vehicle with the retainer clips installed and the interference with the accelerator pedal was no longer evident.
