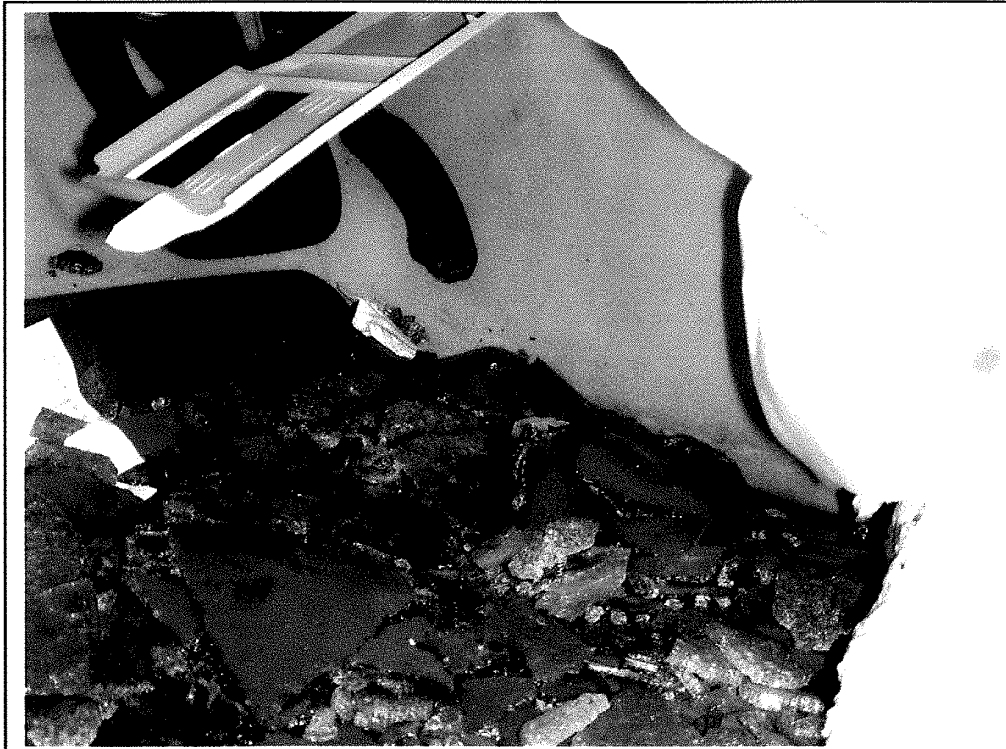
Photo 11: Driver side floor board as inspected, all weather mat installed

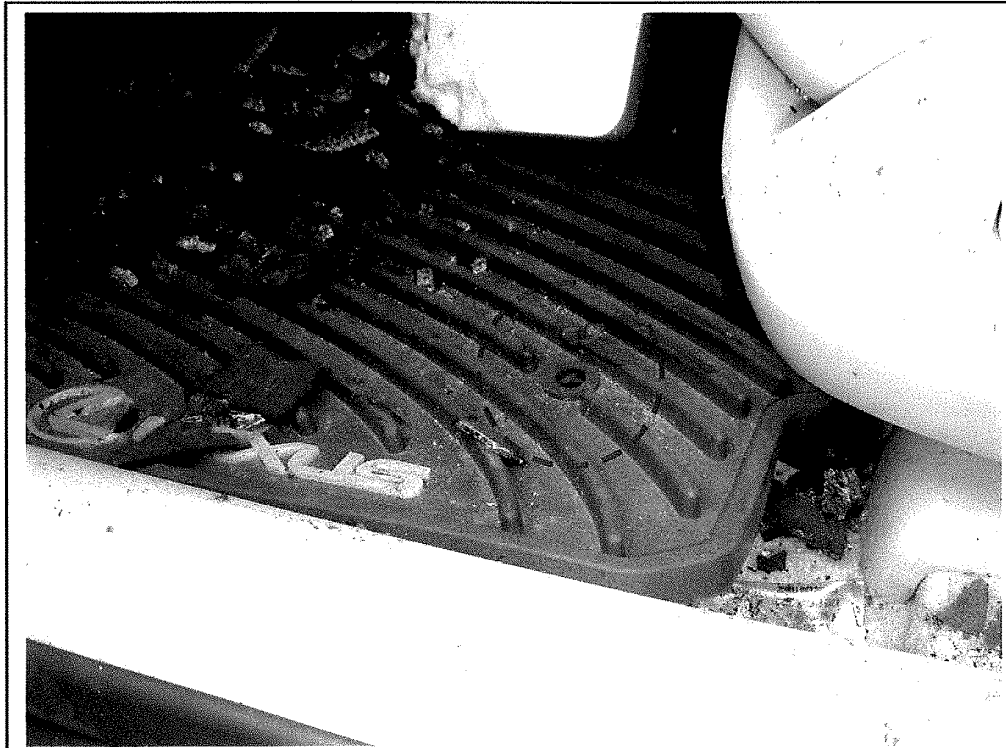
Photo 12: Drivers outboard mat retention hole without retaining hook engaged
