# Investigation Report for Tacoma vehicle

Oct 25, 2007

North America CQE-LA center

## 1. Vehicle Outline

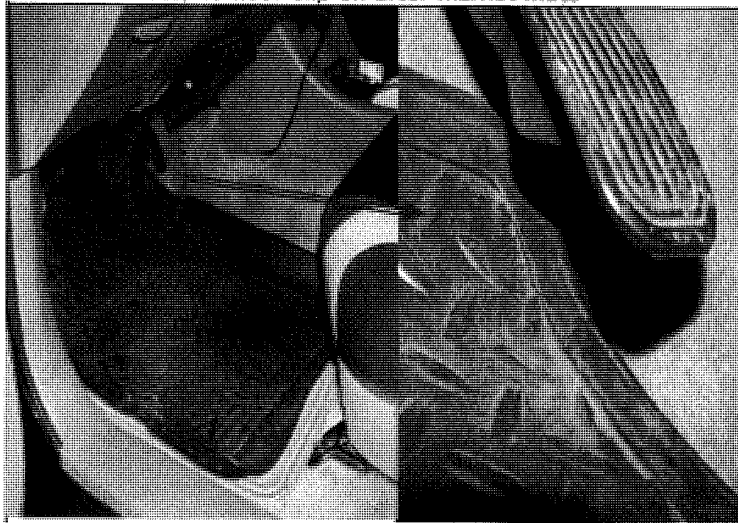
**(2) Photographs****1. Double mats, no floor clip on after market mats**

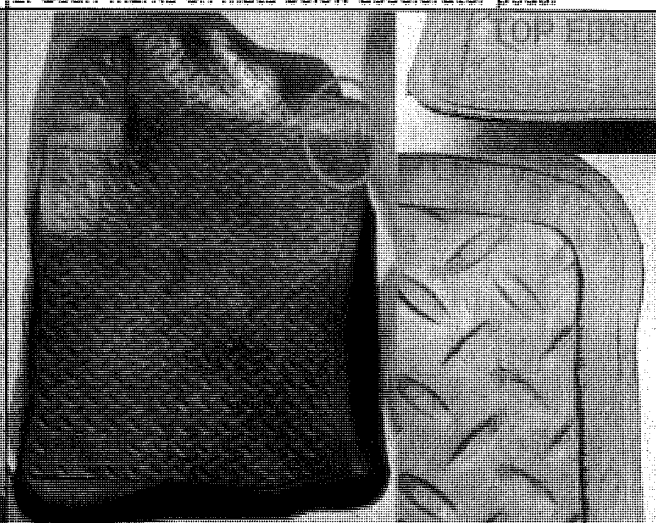
Abnormal position. Deformation (fully opened) : None	
		Contact of movement range : Bottom of Husky mat	
		Abnormal pedal force, Contact with other component : Bottom/top of mat	
		Return spring : Good	
Throttle Body	Foreign body adhesion from air cleaner to surge tank : None

**2. Scuff marks on mats below accelerator pedal**

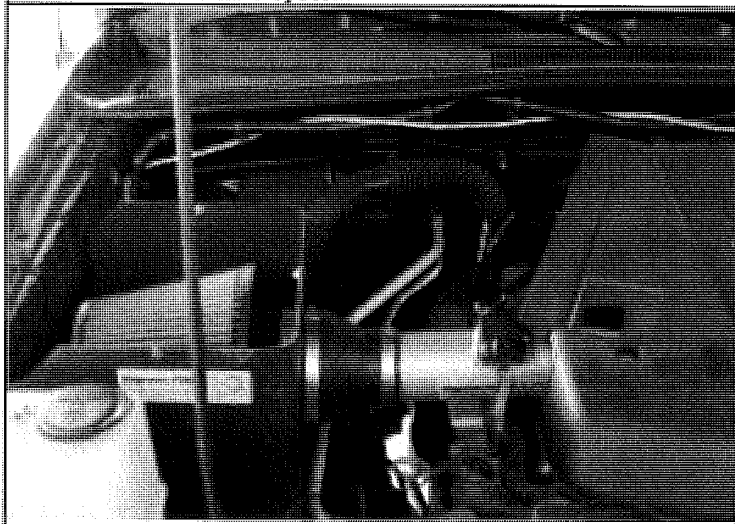
**3. After Market Intake system**

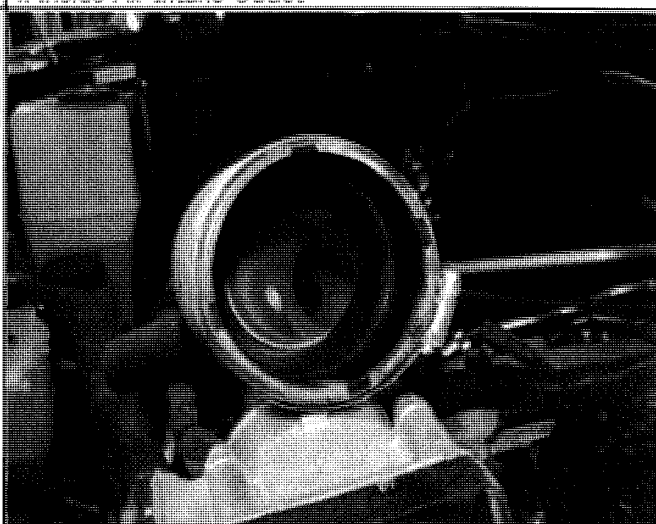
**4. Inside Air Intake Outlet**

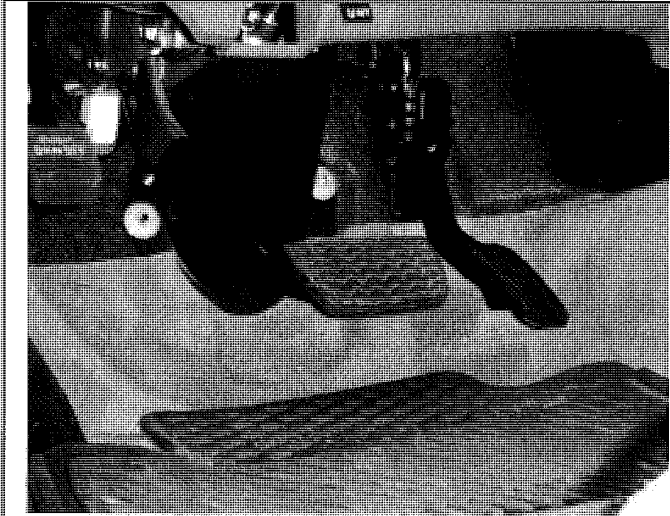
Intake System	Accelerator Pedal	Abnormal position.Deformation (fully closed):None Abnormal position.Deformation (fully opened):None Contact of movement range : None Abnormal pedal force, Contact with other component : Pedal stuck the floor mat at full position when floor mat was moved. Return spring : Good

There were 2 floor mats. Upper mat was not fixed and moved easily.

1. Around pedals Part1

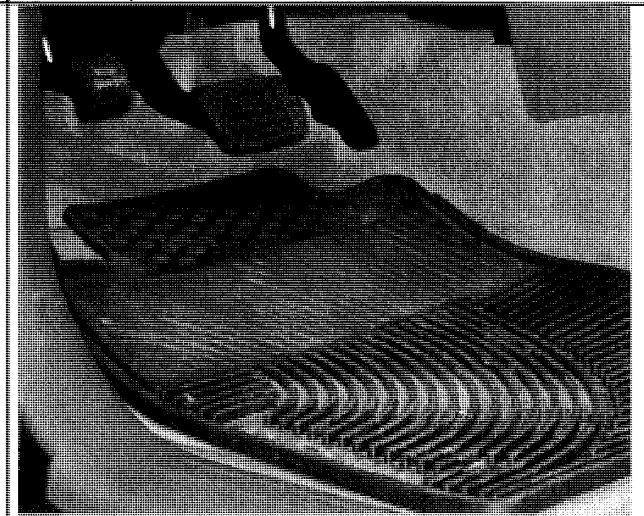
The right side of brake pedal was a little bit dirty.

2. Around pedals Part2

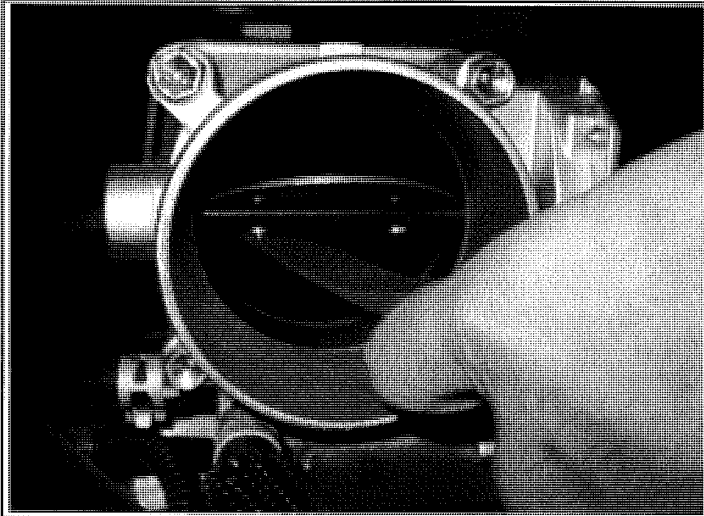
Throttle Body	Foreign body adhesion from air cleaner to surge tank : None Valve movement : Good Valve damage : None Range of deposit adhesion : Good Resistance value of throttle motor : Good

3. Inside of throttle body

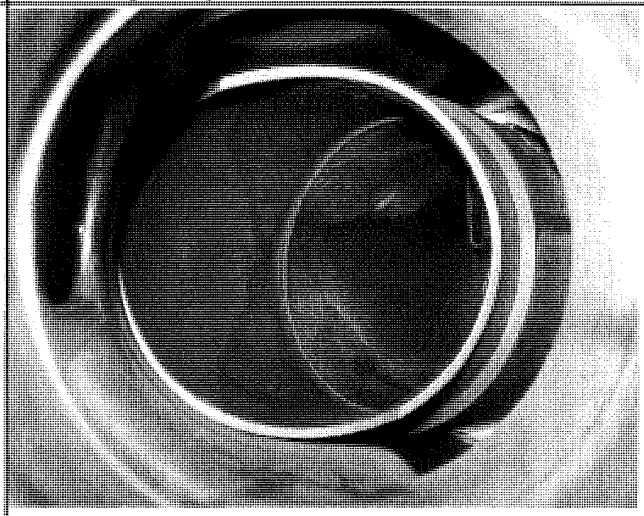
4. Intake system part (Intake side of air cleaner case)

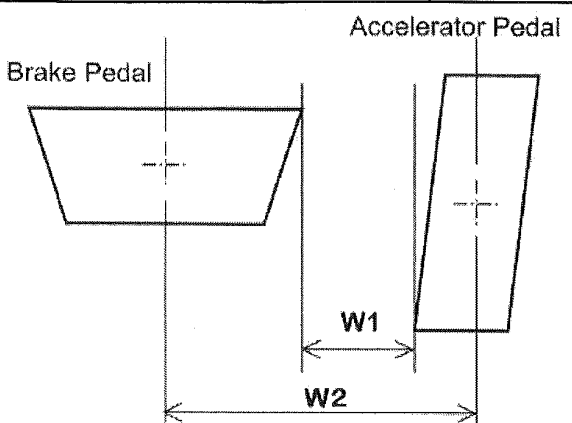
1. Distance between each pedal		2. Distance between each pedal height	
W 1 : Minimum gap of each pedal	81mm	D : Difference between each pedal height	33mm
W 2 : Minimum gap of each pedal	146mm
