Subject: Safety Recall – 90L
Certain 2007 – 2010 Model Year Camry and Camry Hybrid Vehicles
Potential Floor Mat Interference with Accelerator Pedal (January, 2010)
Phase 1 – Vehicles Equipped with Accelerator Pedals manufactured by Denso Corporation

TECHNICAL INSTRUCTIONS
FOR
SAFETY RECALL 90L
DENSO ACCELERATOR PEDAL MODIFICATION
2007 – 2010 MODEL YEAR CAMRY

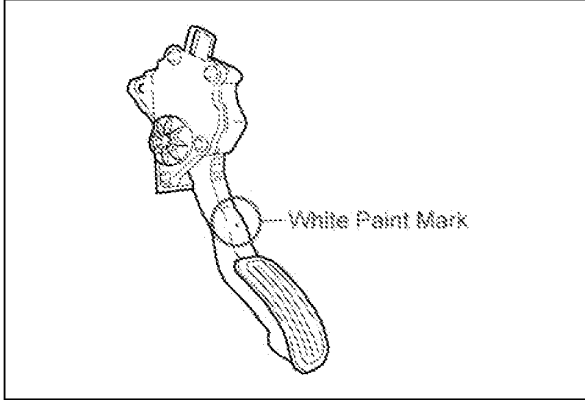
1. INSPECT THE ACCELERATOR PEDAL ASSEMBLY

- a) Verify if the accelerator pedal assembly has a white paint mark in the location shown.

- The accelerator pedal requires modification. Make sure to perform the modification process during the Work Procedure.
