To: All Toyota Dealer Principals, Service Managers, Parts Managers

Subject: Safety Recall – 90L
Certain 2007 – 2010 Model Year Camry and Camry Hybrid Vehicles
Potential Floor Mat Interference with Accelerator Pedal (January, 2010)
Phase 1 – Vehicles Equipped with Accelerator Pedals manufactured by Denso Corporation

TECHNICAL INSTRUCTIONS
FOR
SAFETY RECALL 90L
DENSO ACCELERATOR PEDAL MODIFICATION
2007 – 2010 MODEL YEAR CAMRY

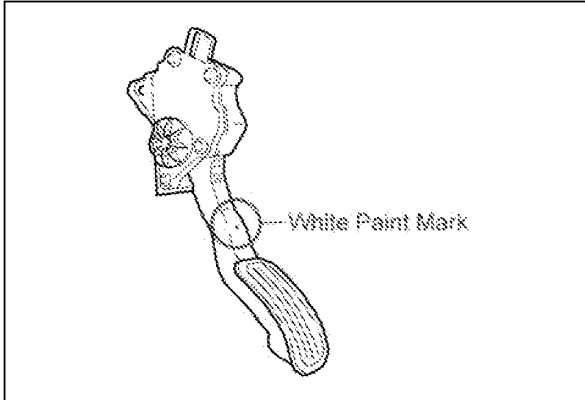
1. INSPECT THE ACCELERATOR PEDAL ASSEMBLY

- Verify if the accelerator pedal assembly has a white paint mark in the location shown.

- The accelerator pedal requires modification. Make sure to perform the modification process during the Work Procedure.

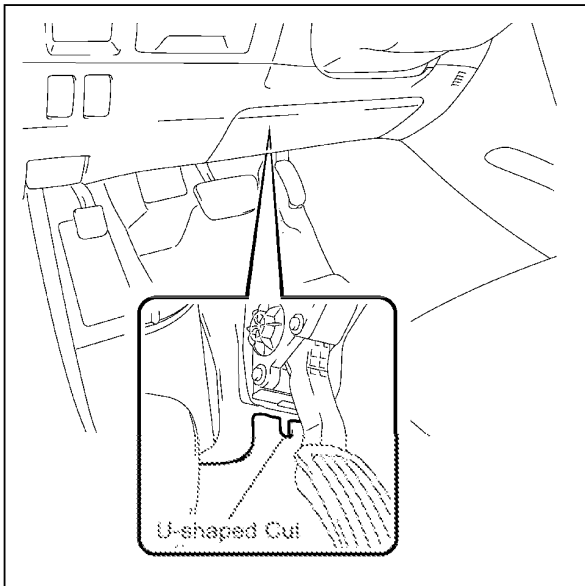
2. INSPECT THE FLOOR CARPET

- Verify if the floor carpet has a “U” shaped cut in the location shown.

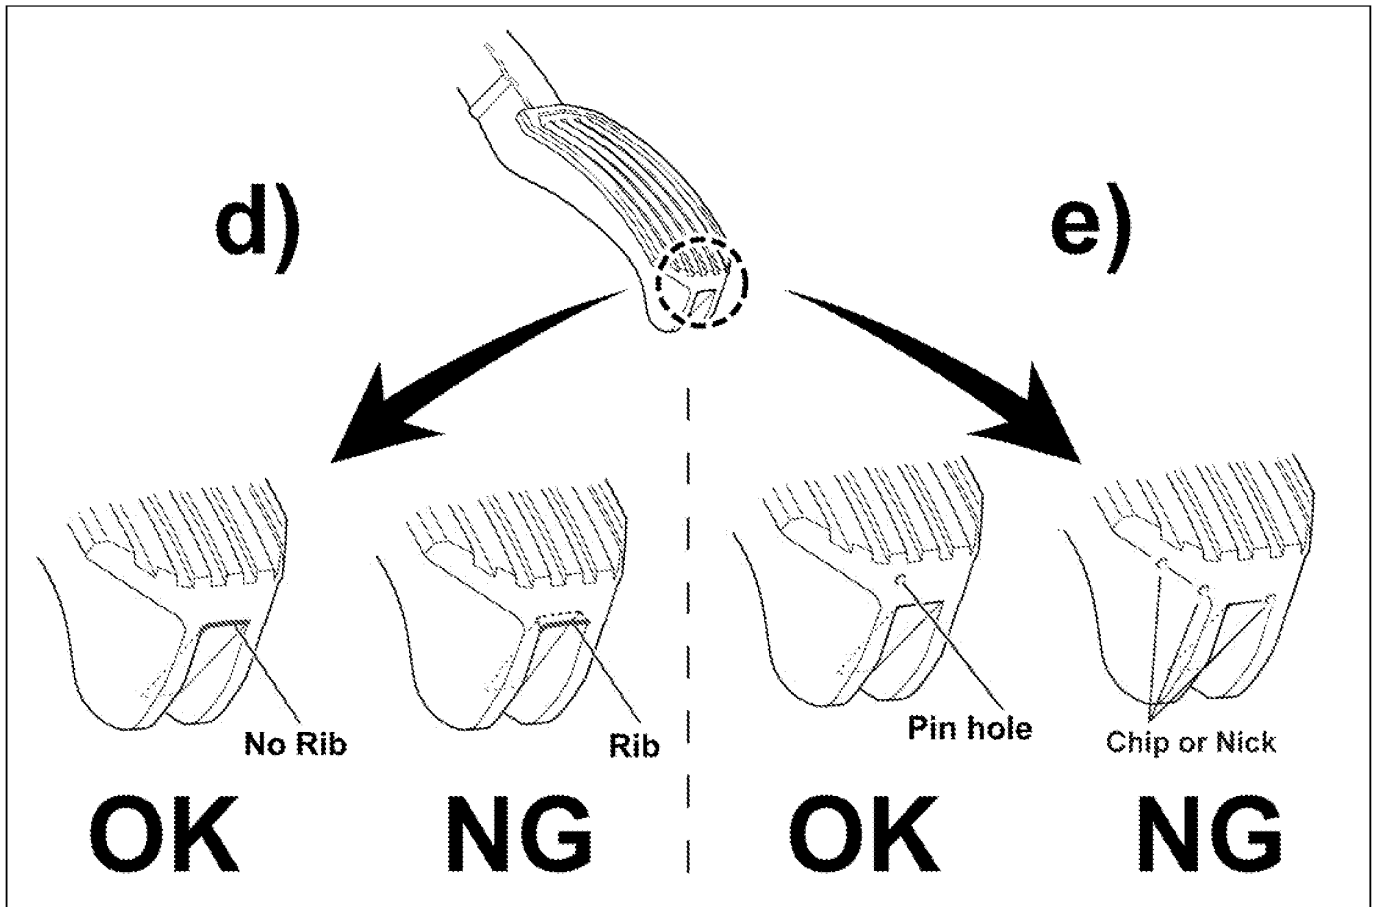
d) Check for a rib as shown. If there is a rib, file it until it is gone.

e) Check for any chips or nicks on the finished surface edge. If there are any chips or nicks, file the edge to make them smooth.

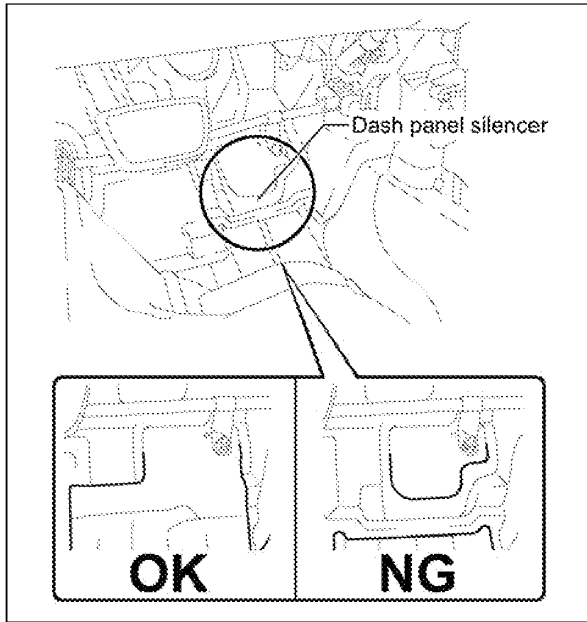
3. INSPECT THE LOWER PORTION OF THE FABRIC FLOOR SILENCING MATERIAL

- a) Inspect the lower portion of the fabric floor silencing material.
 - If OK, proceed to step 4 "RUBBER PAD APPLICATION" below.
 - If NG, please refer to APPENDIX "B" for "CUT THE FLOOR SILENCING MATERIAL"

The fabric floor silencing material is a soft, gray, paper-like material beneath the carpet.

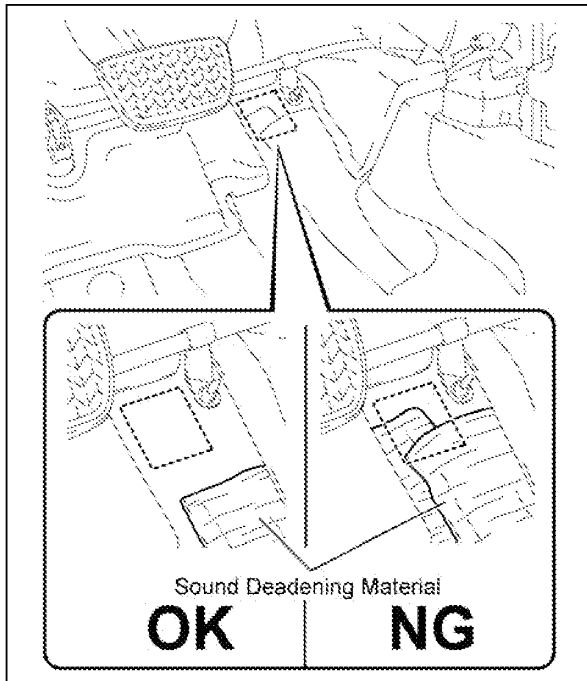
4. RUBBER PAD APPLICATION

- a) Inspect the rubber pad application area for sound deadening material.
 - If OK (no sound deadening material in pad application area), proceed to step "b" below.
 - If NG (sound deadening material found in application area), please refer to APPENDIX "C" for "REMOVE THE SOUND DEADENING MATERIAL".

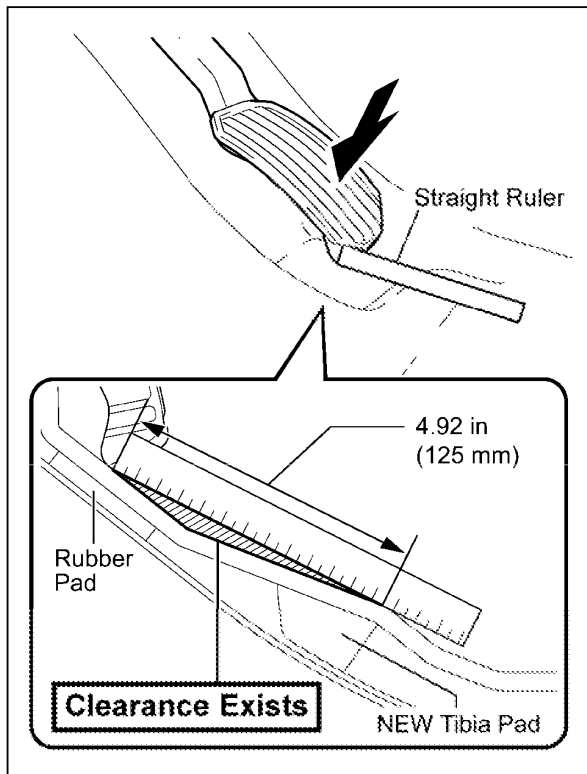
2. INSPECT THE FLOOR CARPET

- With the accelerator pedal fully depressed, confirm clearance exists between the floor carpet and the straight ruler as shown.
- If no clearance exists, reshape the carpet again.
- Confirm the claw and all fasteners of the floor carpet are securely attached.
