TECHNICAL INSTRUCTIONS

SPECIAL SERVICE CAMPAIGN 7LB (SAFETY RECALL)

2007 AND EARLY 2008 MODEL YEAR
LEXUS ES 350 ALL WEATHER FLOOR MAT

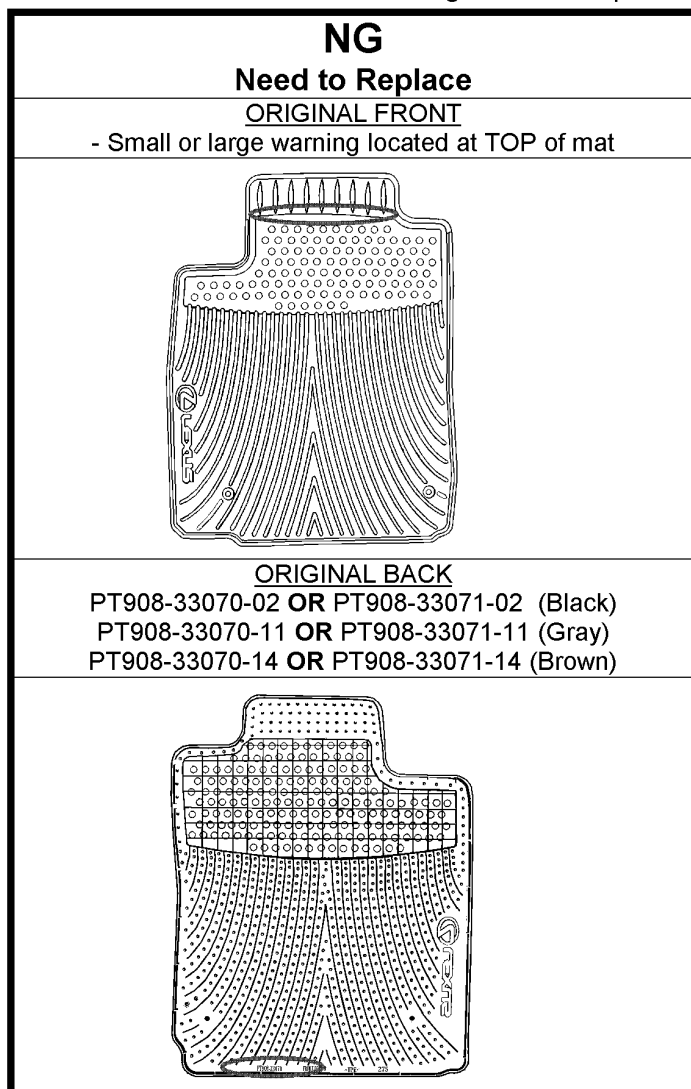
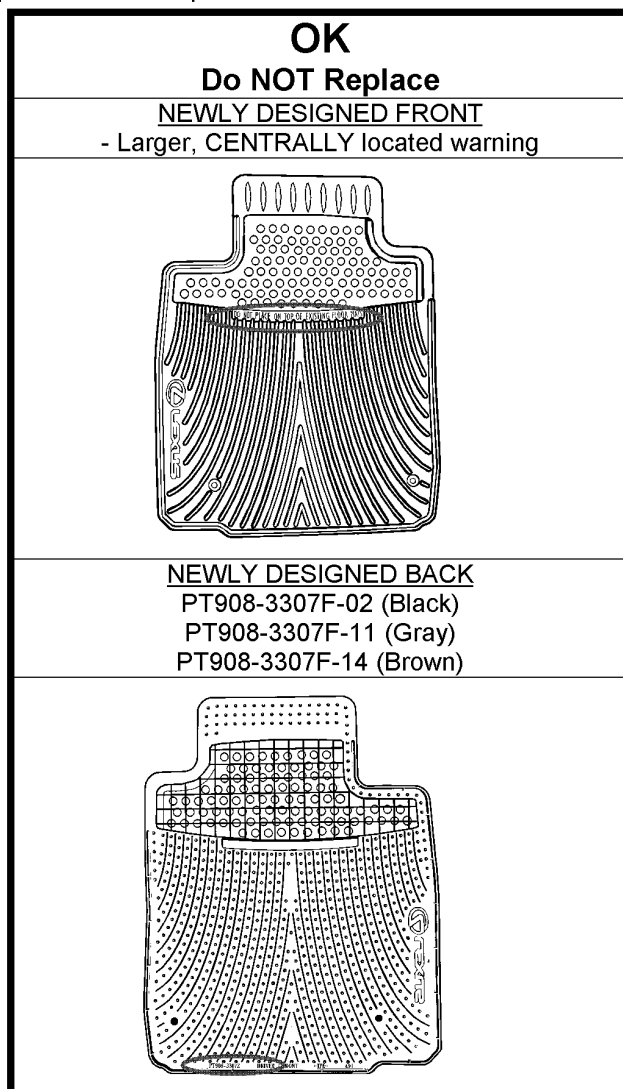
Confirm if the **original** driver side All Weather Floor Mat (see the diagram below for key areas to aid in identification of the original vs. the newly designed mat) is present in the vehicle.

- If the original mat is NOT present, no action is necessary. You do not need to file any claims.
- If the original mat IS present, proceed to step B.

B. REPLACE THE AFFECTED DRIVER SIDE ALL WEATHER FLOOR MAT WITH THE NEWLY DESIGNED ONE

- MAKE SURE THE RETAINING HOOKS (CLIPS) ARE PROPERLY INSTALLED TO THE VEHICLE'S CARPET AND SECURE THE ALL WEATHER FLOOR MAT.
- MORE THAN ONE FLOOR MAT SHOULD NEVER BE USED IN THE DRIVER'S SEATING POSITION, AS THE RETAINING HOOKS (CLIPS) ARE DESIGNED TO ACCOMMODATE ONLY ONE FLOOR MAT AT A TIME.
