NHTSA Investigation

NHTSA Concerns

Toyota Action Plan

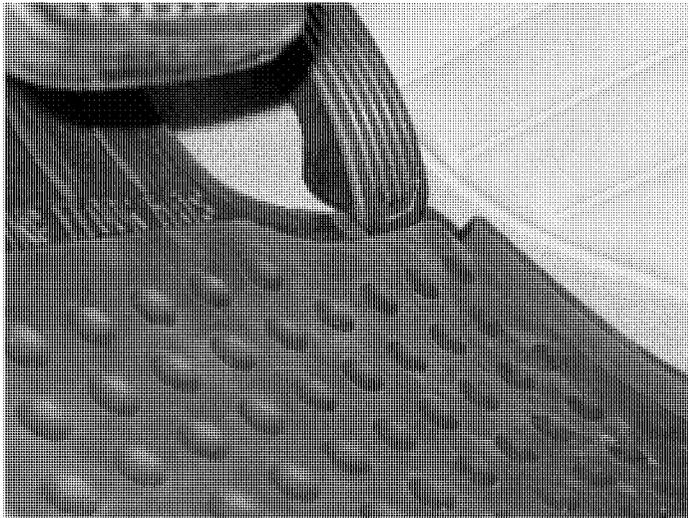
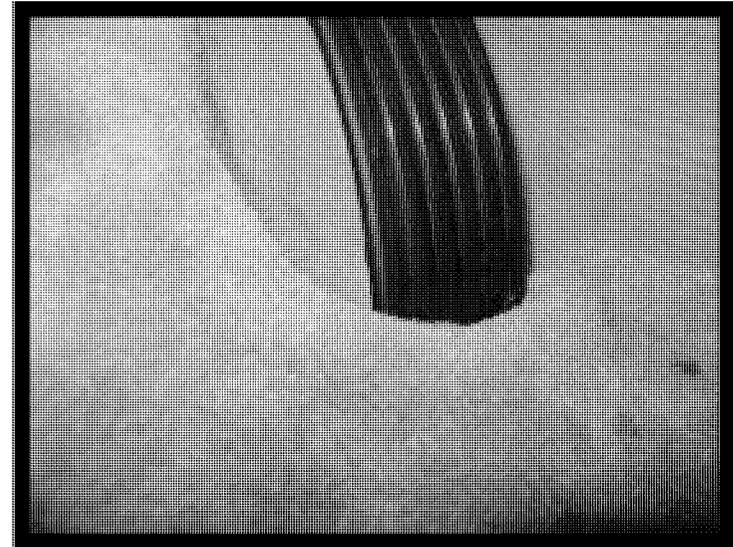
- What is the prevalent failure mode?
 - Double stacked AWM
 - AWM: Pedal trapped in ridge
 - CFM: Pedal trapped under mat edge

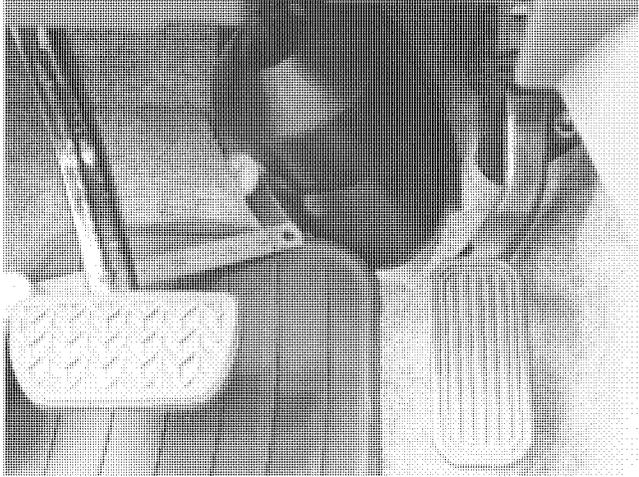
Prius

- Leading edge of mat interferes with steering column
- Cannot experience same condition as ES350
- 1 in scope VOQ
