Lexus ES 350
All Weather Floor Mat

September 13, 2007

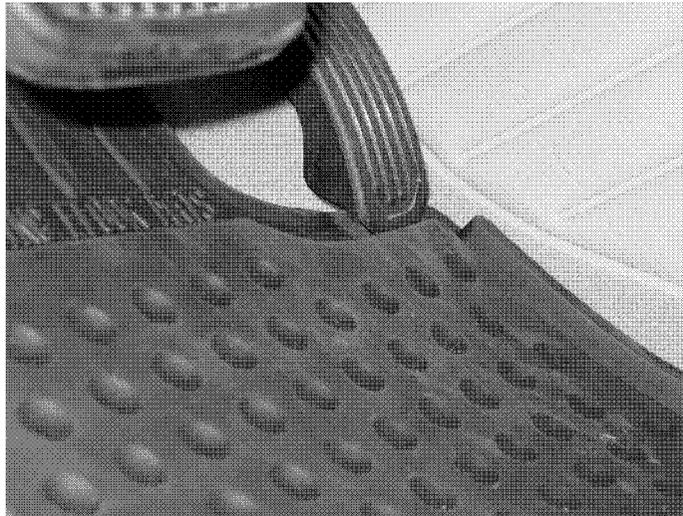
- What is the prevalent failure mode?
 - Double stacked AWM
 - AWM: Pedal trapped in ridge

Note: AWM cannot interfere with accelerator pedal if properly secured with the retention clips

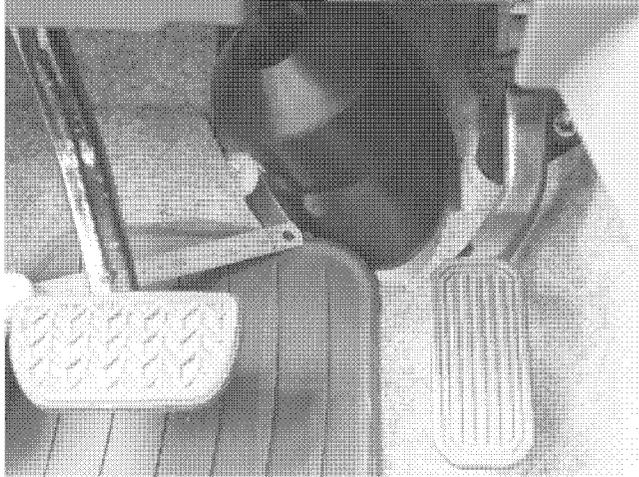
Prius

- Leading edge of mat interferes with steering column cover
- Cannot experience same condition as ES350
- 1 in scope VOQ

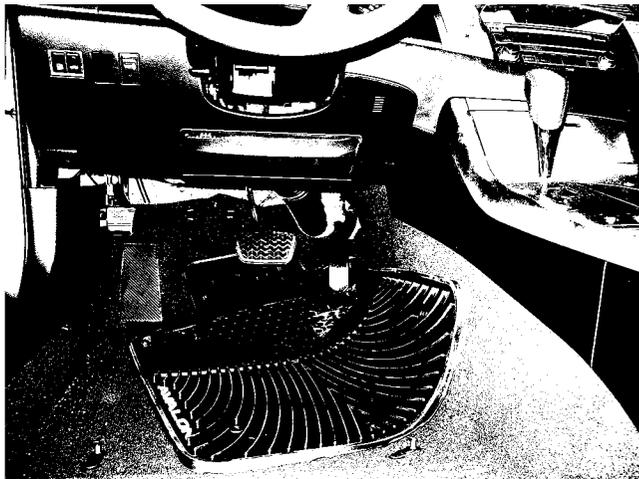
Avalon

- No ridge on AWM
- Footwell may impede forward movement of AWM
- Tunnel design reduces the possibility of occurrence
- 1 in scope VOQ
