**FIELD TECHNICAL REPORT**

TQCN DOC# TQCN_FTR-082340025	Affiliate TMS	Dept. Vehicle & A	Source FTS	Location AREA-CENTRAL	Ref 82473575	Date 09/03/2008
Problem Area PPO/DIO-TMS	Primary Model IS F	Model Year 2008	Production Date 2008-02-08	Odometer 3723	VIN (confirm 17 characters): JTHBP262885 [REDACTED]	
Condition Title Gas pedal gets stuck on winter floor mat

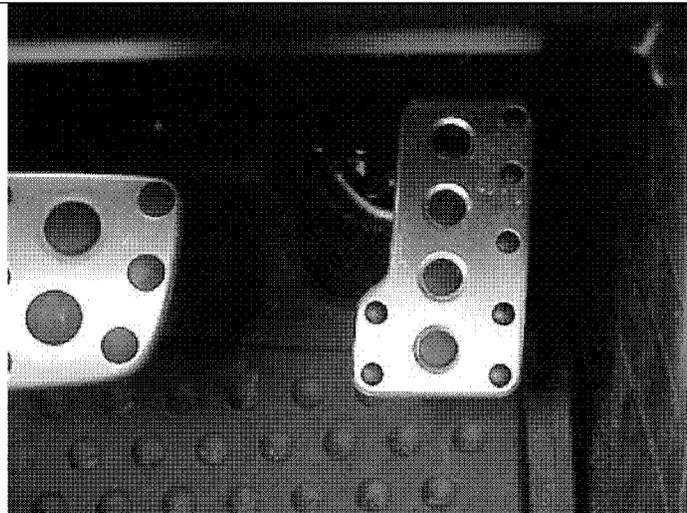
Pedal is in the up position

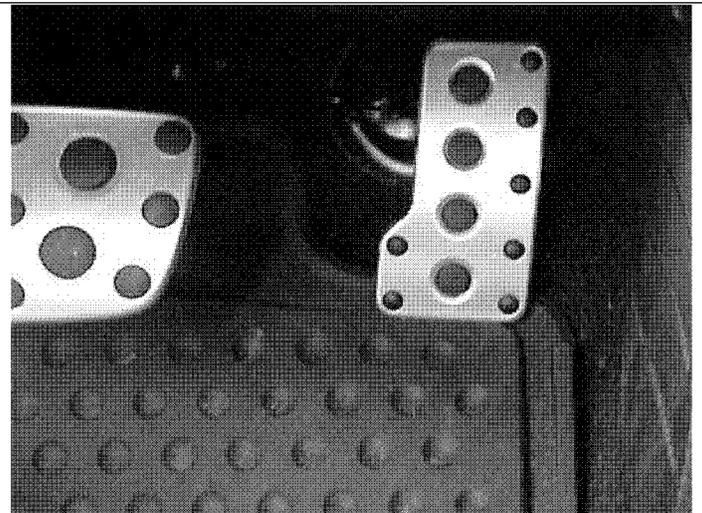
The technician confirmed that the gas pedal got caught by the floor mat on hard acceleration. **The winter floor mat was not attached to the hold down clips.**

The winter floor mat was not clipped in position and so physically interfered with the pedals arc of return.

The pedal is held down by the out of position winter floor mat.

The technician repositioned and clipped the mat down with the factory hold down clips.
