U.S. Department
of Transportation
**National Highway
Traffic Safety
Administration**

DOT HS 812 112

Crashworthiness Research of Prototype Hydrogen Fuel Cell Vehicles: Task Order 7 Project Report

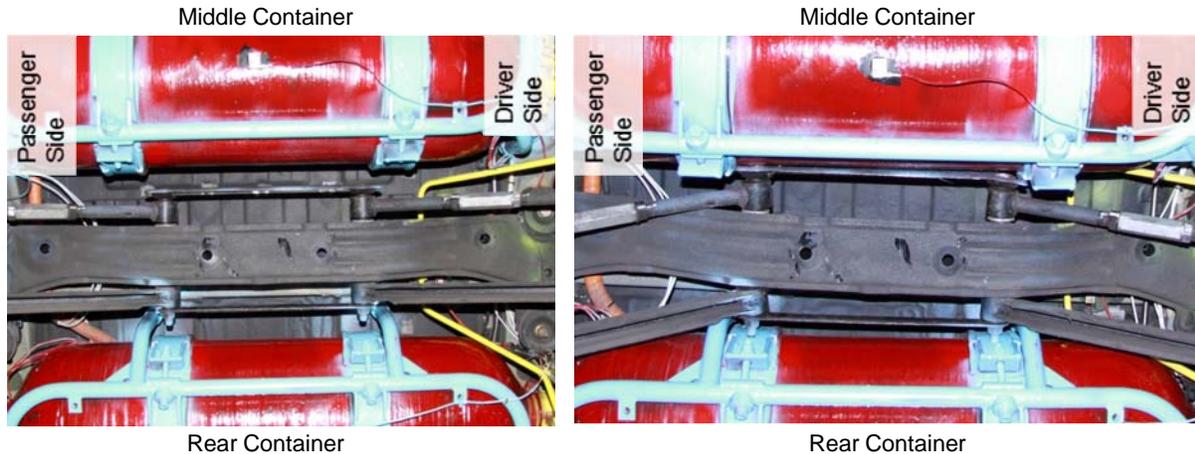
The billboard barrier pushed the rear bumper into the vehicle. The rear container moved forward within the vehicle, pushing a suspension cross member into the middle container. This sequence of events is visible in the high-speed video from the photo pit, and it is consistent with the recorded signals. The permanent deformation is visible in the pre- and post-crash photos in Figure 3-1. The string potentiometers show the rear container beginning to move with respect to the vehicle about 25 ms after impact, and the two forward containers begin to move 50 ms after impact. Most of the vehicle-mounted accelerometers recorded a peak forward acceleration on the order of 20 g, which is typical for a crash test. The rear container experienced a peak forward acceleration closer to 80 g, indicating it was struck more directly by the barrier through the bumper. The middle container's peak forward acceleration exceeded 120 g, which is consistent with the rear container's impact on the middle container, through the rear suspension bushings.

Figure 3-1. The gaps between the containers and the suspension are visible in the pre-crash photo on the left, which is looking up at the underside of the vehicle. The post-crash photo on the right shows that the gaps have closed. The straps for the rear container (painted blue) have been pushed forward into the suspension bolts, which in turn have moved into the side of the middle container. These are close-ups of Figures A-29 and A-30 in Appendix A.

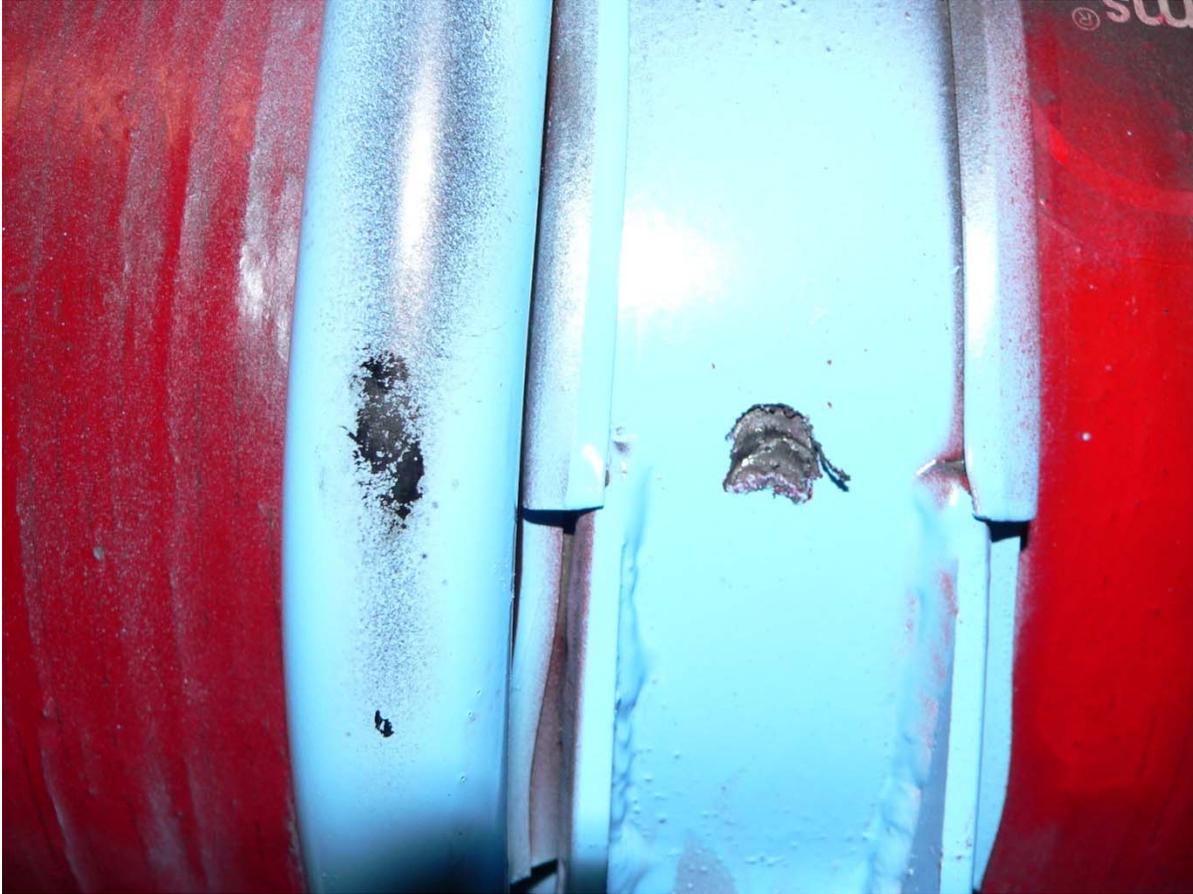
The two steel straps that hold the rear container in its mounting frame were directly in line with two exposed bolt ends from the suspension. As the container was displaced forward in the rear crash, the steel straps contacted the bolts, leaving a mark in the paint on the passenger side strap (Figure 3-2). As a result of the bolts impacting the straps, the suspension cross member was pushed forward enough to contact the middle container. As was visible in Figure 3-1, the swing arm bolts align with the straps of the rear container, but were pushed directly into the middle container itself. Figure 3-3 shows the damage that the bolt caused to the wall of the middle container. Forward motion of the rear container caused forward displacement of the middle and front containers. Figure 3-4 shows a gouge of approximately 10 mm length where the front container was pushed into the underbody of the vehicle.

Figure 3-2. The suspension bolt caused this damage to the mounting strap for the rear container. The strap protected the surface of the container from abrasion and distributed the load of the bolt.

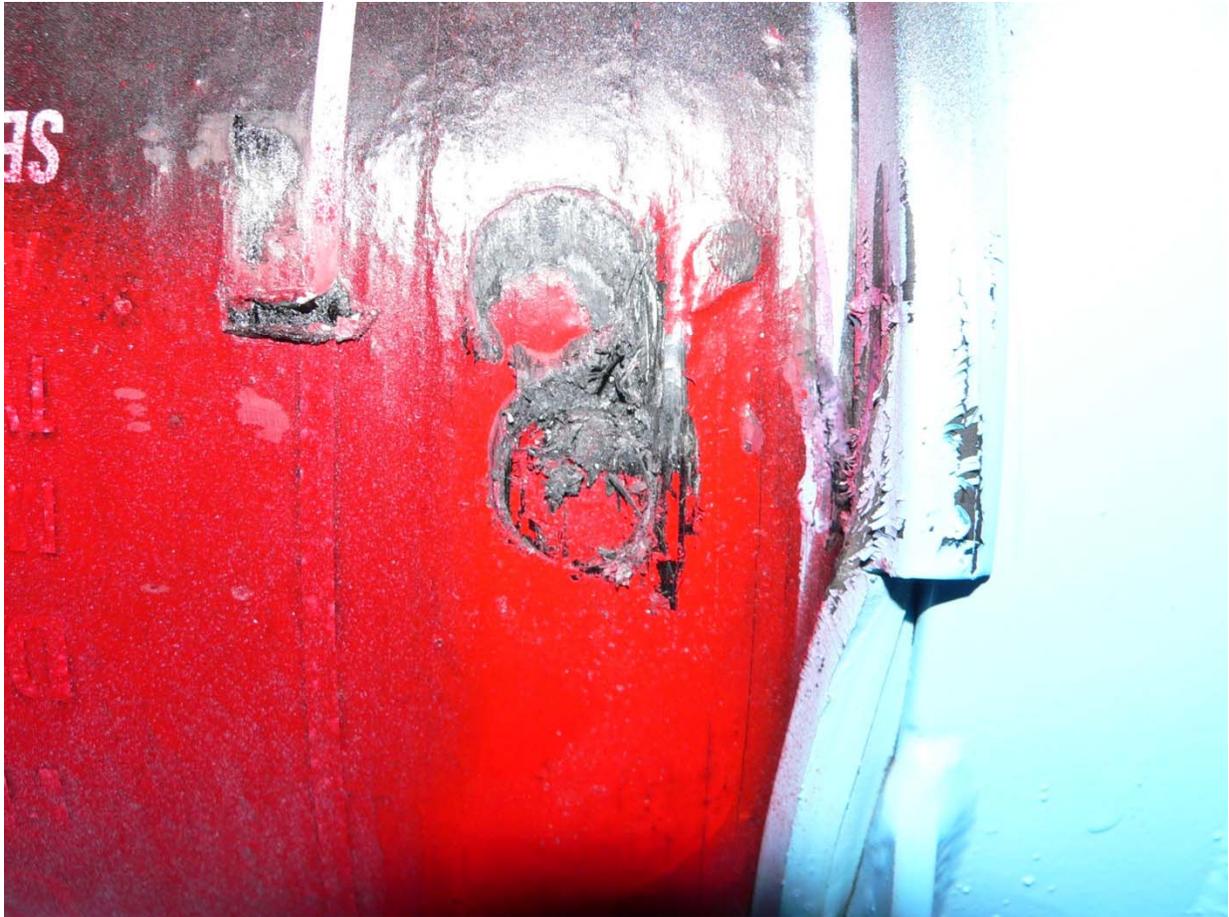
Figure 3-3. The impact drove the suspension bolt into the rear surface of the middle container. Two imprints of the bolt face are visible, indicating a rebound and second impact. Paint from the container was visible on the end of the bolt.

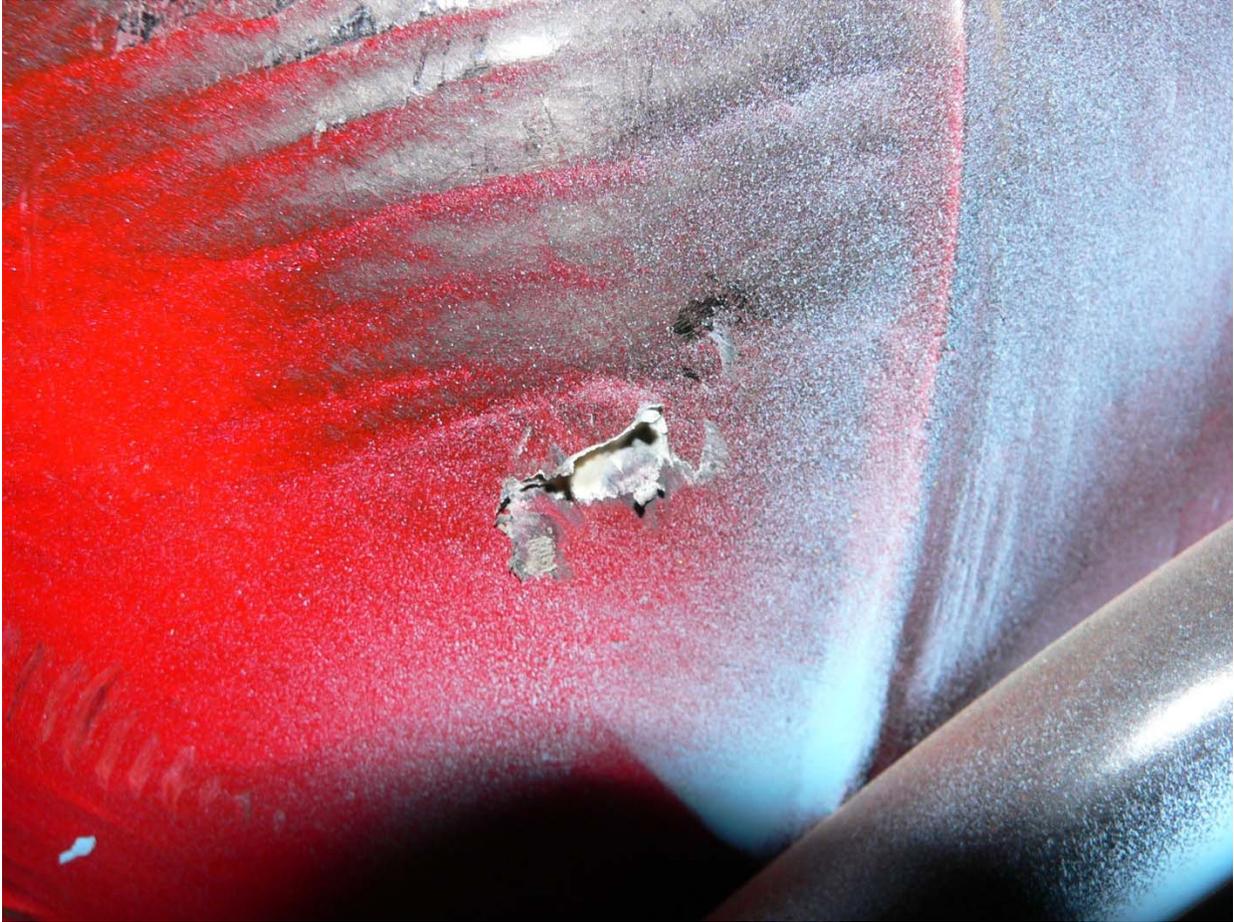
Figure 3-4. This gouge on the front surface of the forward container was caused by its contact with the underbody of the vehicle.

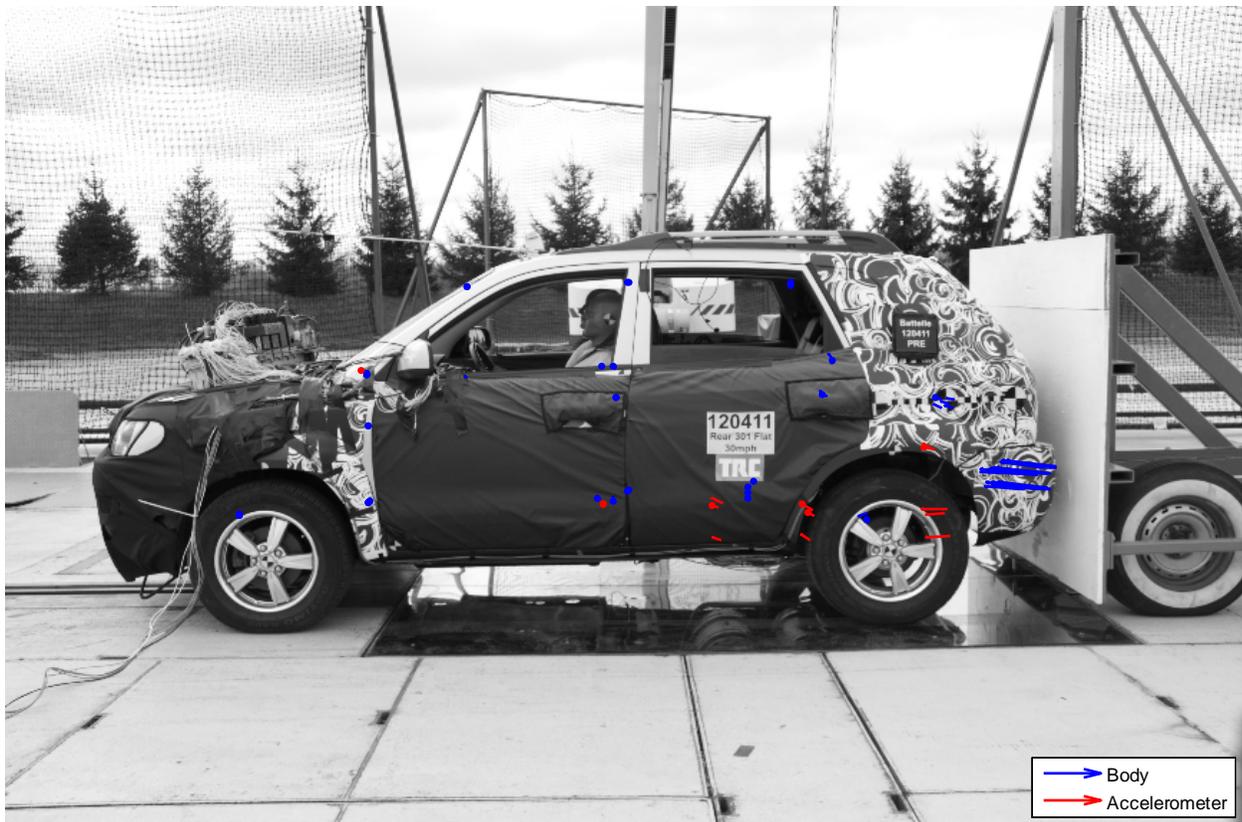
Before and after the crash Faro Arm data was collected so that comparisons could be made between the original and deformed structures. In the rear crash it can be seen below that the rear bumper deflected a significant amount, while the rest of the vehicle remained relatively unchanged. Figure 3-5 and Figure 3-6 depict the vector displacement of the Faro Arm measurement locations on the vehicle body panels (blue) and the accelerometer locations (red).

Figure 3-5. Displacement vectors overlaid on a pre-test side view of the rear-crash vehicle.

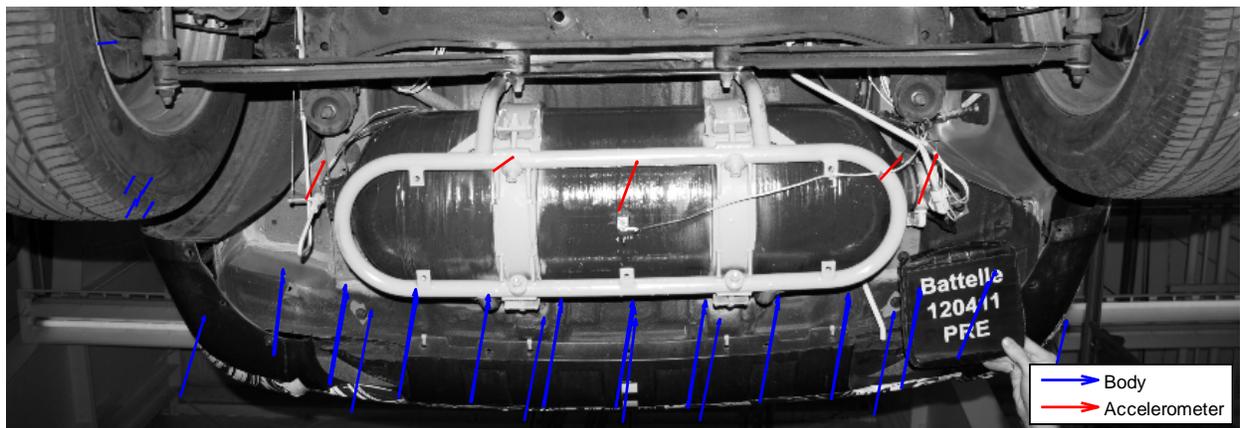
Figure 3-6. Displacement vectors overlaid on a pre-test bottom view of the rear-crash vehicle.

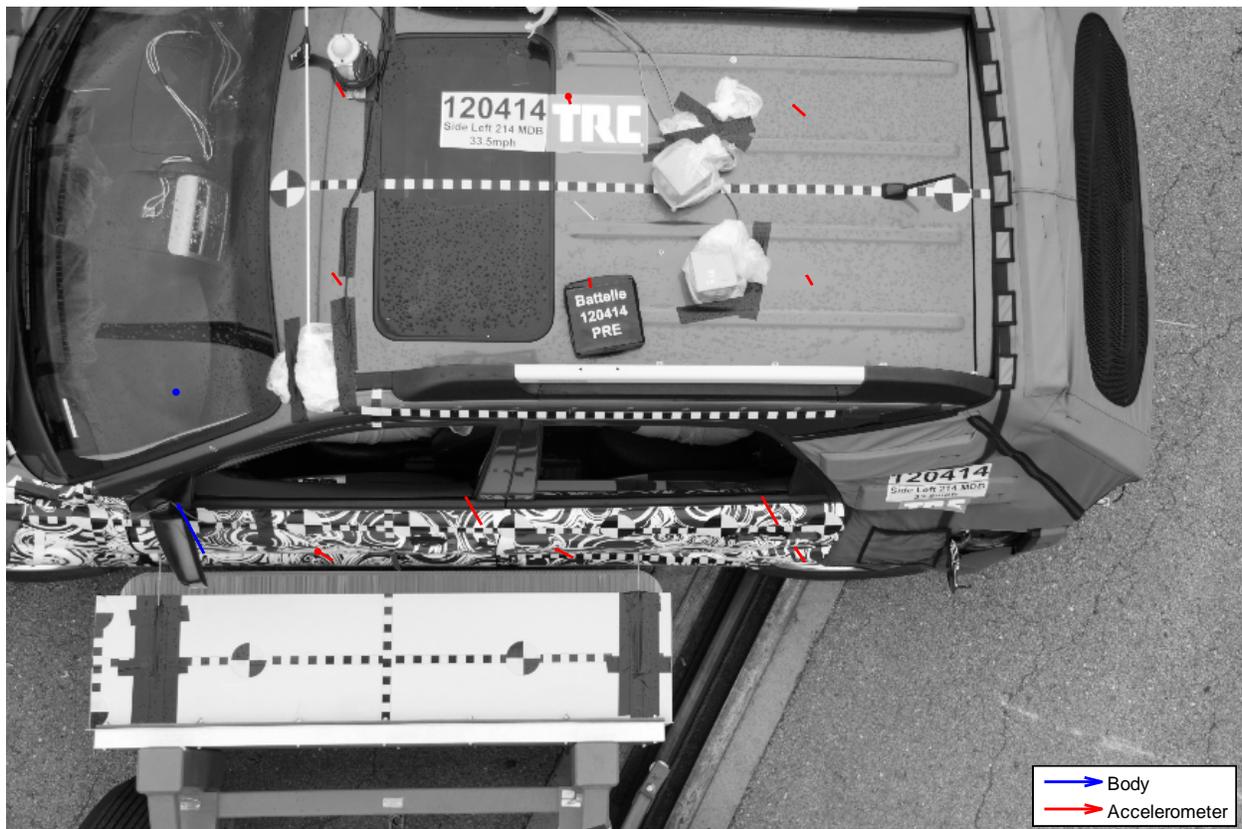
Similar to the rear crash, it can be seen from the vector data overlaid on the pre-test pictures that the vehicle used in the side crash deformed more where it was impacted by the moving barrier (Figure 3-7 and Figure 3-8). There was little overall deflection at any point. One important aspect to notice is the trend for arrows in the side view to be pointing downwards; this is likely due to the flat front driver side tire at the end of the test.

Figure 3-7. Displacement vectors overlaid on a pre-test top view of the side-crash vehicle.

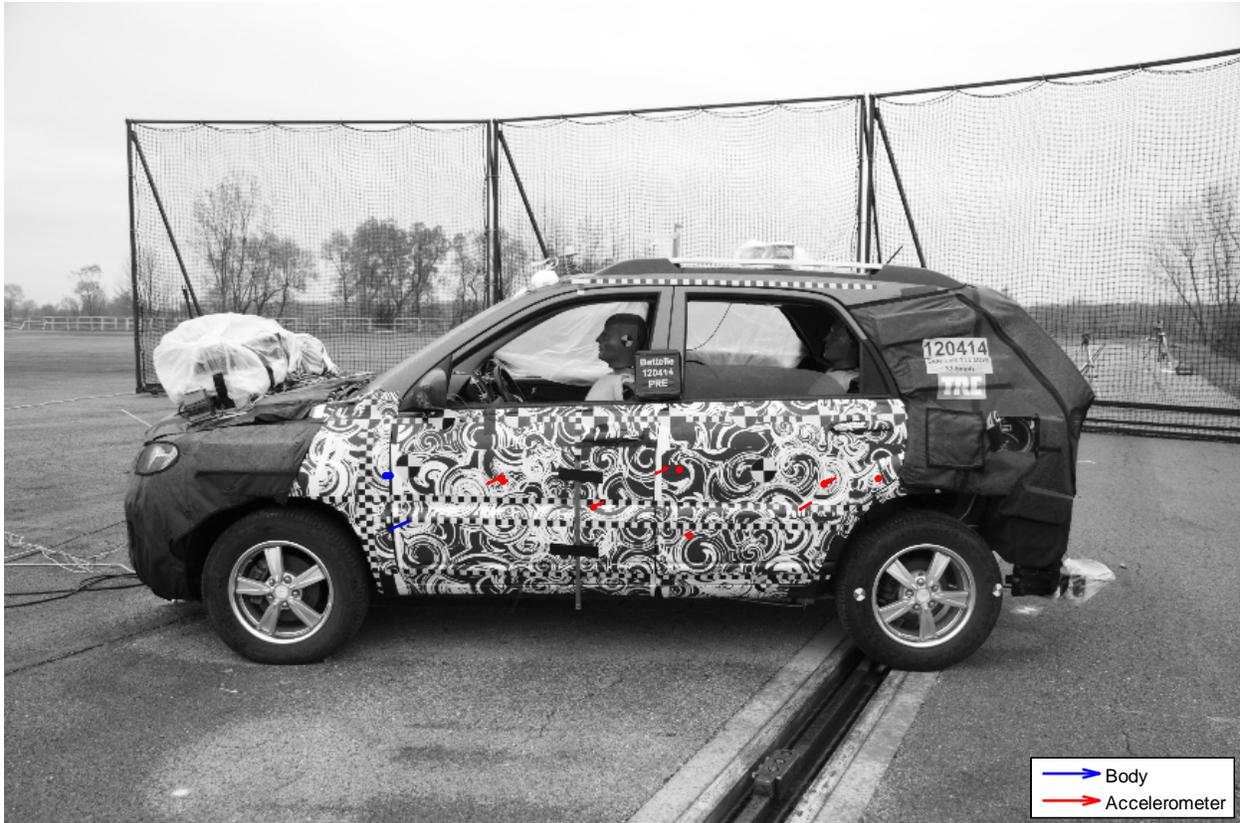
Figure 3-8. Displacement vectors overlaid on a pre-test side view of the side-crash vehicle.

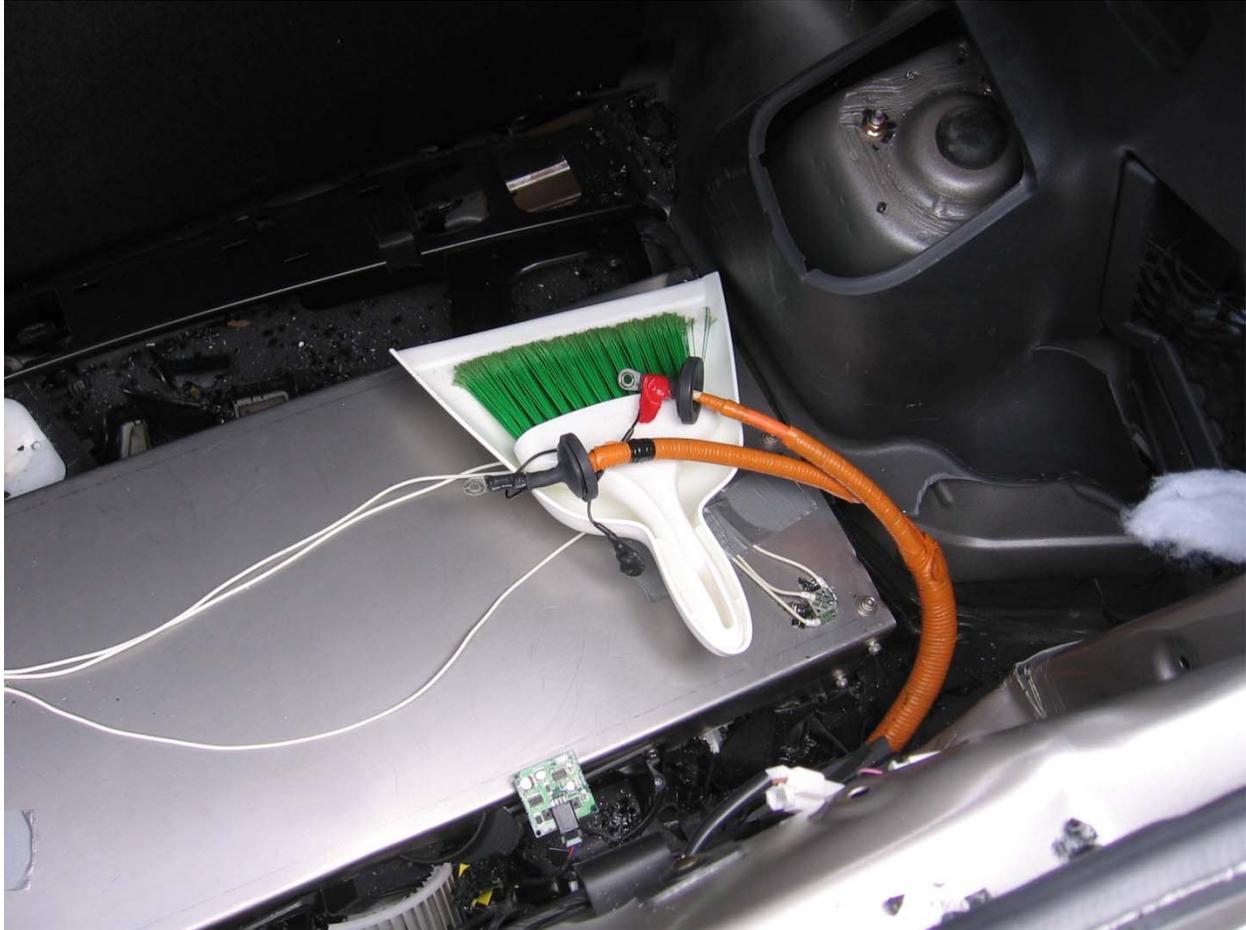
Figure 3-12 shows the remains of the fan assembly following the rear crash. The accelerometers on the passenger side of the compartment recorded a direct impact, which is consistent with the fan assembly being crushed into the battery housing. The original battery housing had vent holes by the fan, but its internal components could easily have been arranged so that cells were unlikely to be punctured by fragments from the fan. The battery housing itself was intact. The resultant acceleration, shown in Figure 3-14, on the driver side of the battery housing was sustained above 20 g for a 50 ms crash pulse and reached a peak of 76 g. The rear crash battery resultant acceleration is much higher than the side crash battery resultant. This is due to the impact from the fan being crushed against the housing in the rear crash.

Figure 3-12. The high-voltage battery housing was intact following the rear crash, but the fan assembly was crushed between the rear door and the battery compartment. The white fan itself is visible in the lower left. (The photo was taken during the electrical isolation measurements. The terminals of the battery cable are on a plastic pan to isolate them from the battery housing.)

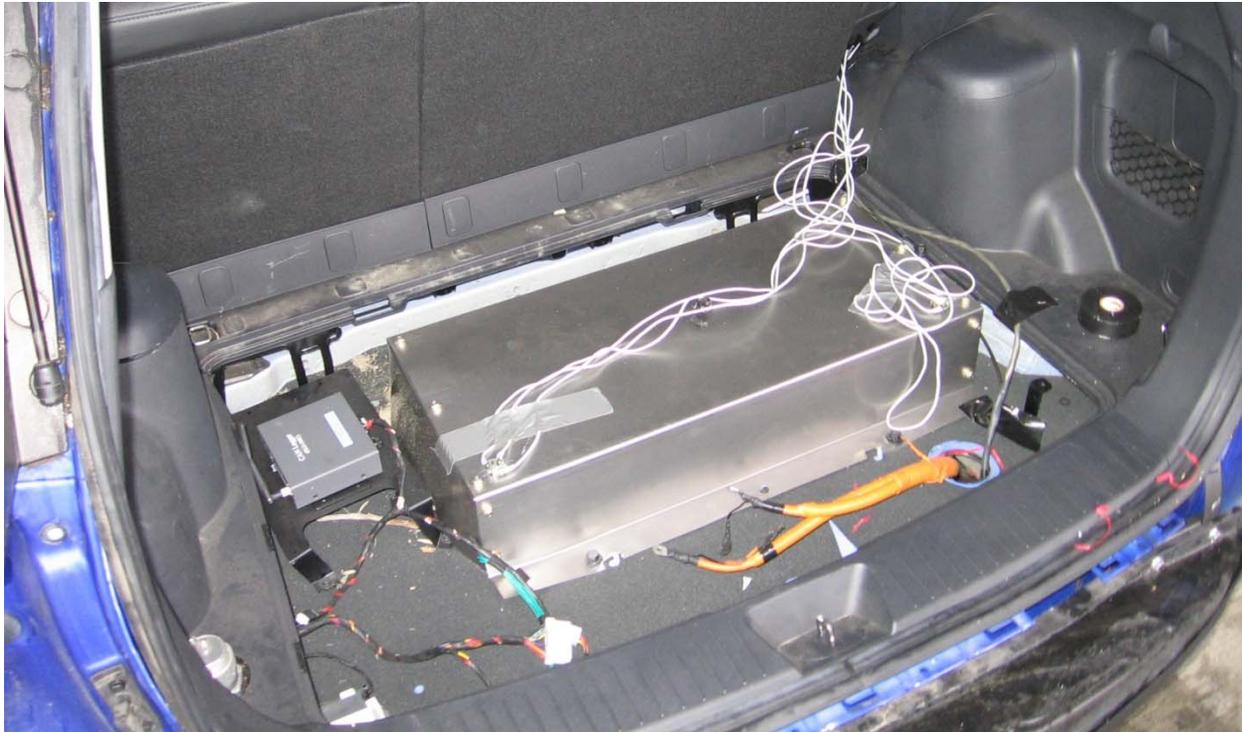
During the side crash, the resultant acceleration on the driver side of the battery housing was sustained at 15 to 20 g for a duration of 50 ms. The acceleration on the passenger side was sustained for 70 ms and then showed a 60-g impact 100 ms after the crash. Figure 3-13 is a photograph of the replacement battery housing during the post-crash electrical isolation measurements. The mounting platform for a wireless CANLogger was deformed, but the battery housing is essentially intact.

Figure 3-13. The replacement battery housing for the high-voltage battery, shown after the side crash.
