SID IIs DUMMY DURABILITY

SAE Government/Industry Meeting

May 2002

***US Department of Transportation
National Highway Traffic Safety Administration
Vehicle Research and Test Center***

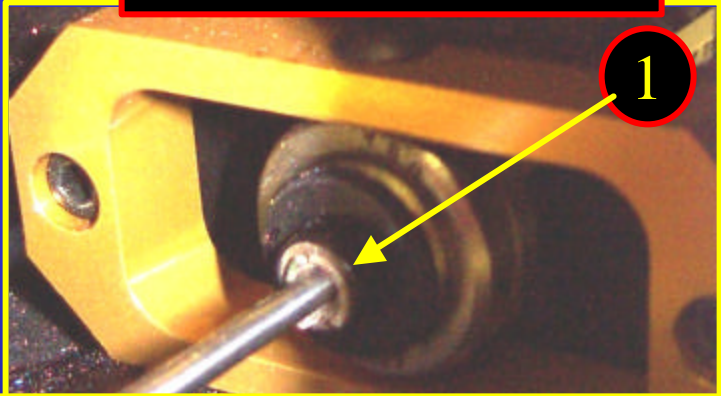
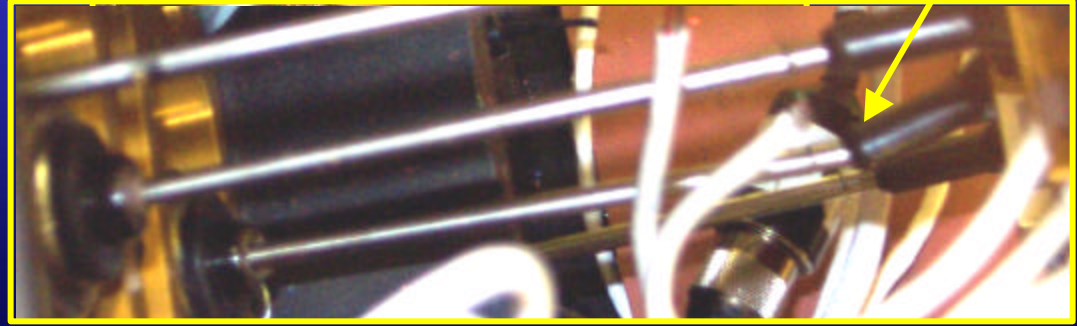
Damages

- 1. Pot housing crushed
- 2. Pot shaft bent

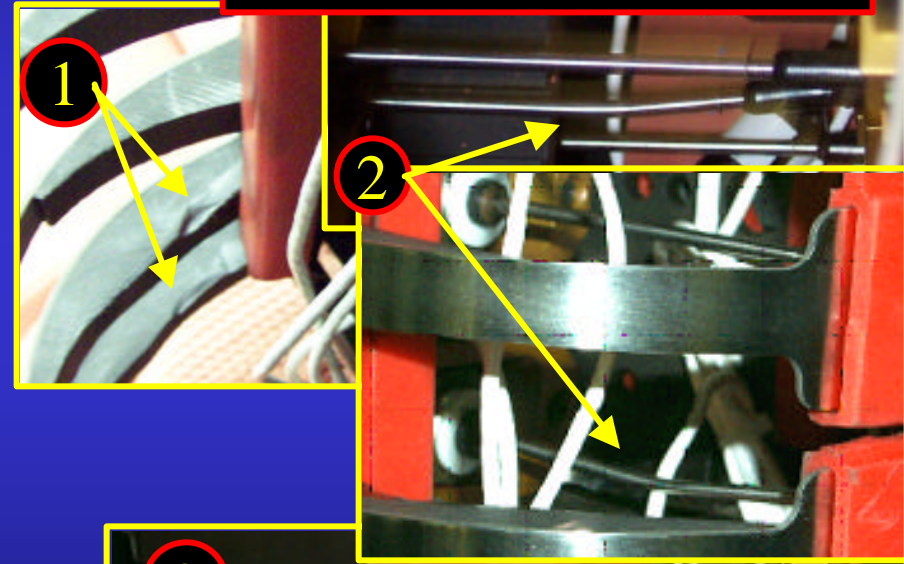
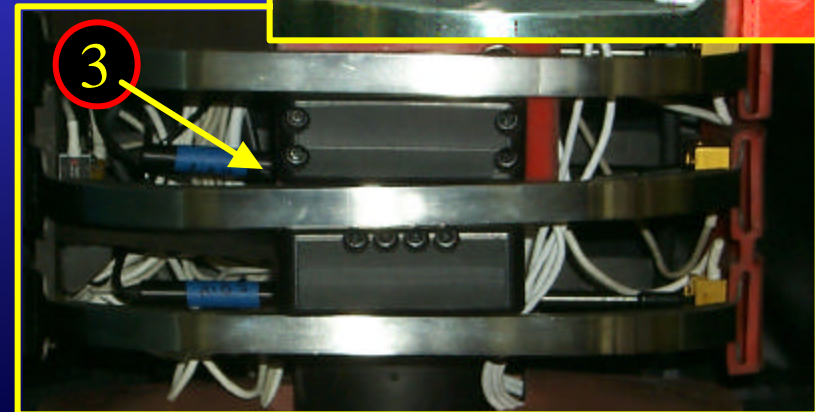
Damages

1. Gouges in damping material
2. Pot shaft bent
3. Ribs deformed

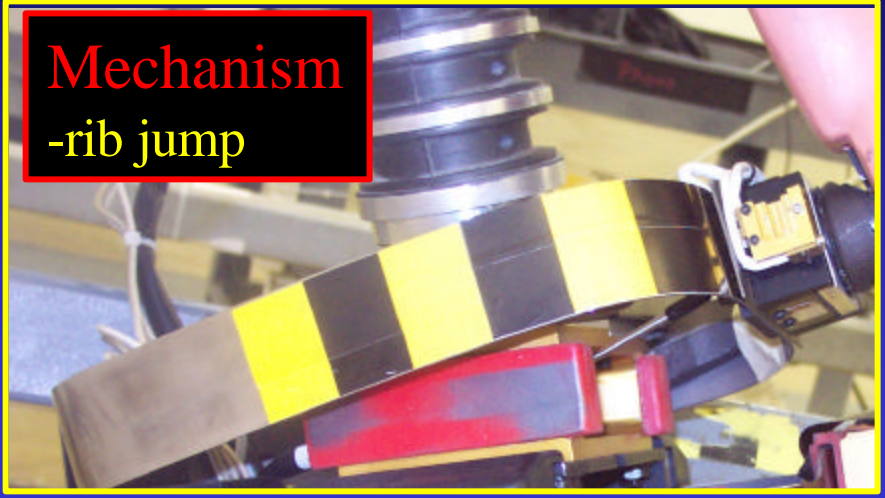
Shoulder Rib Jump

Mechanism
-rib jump

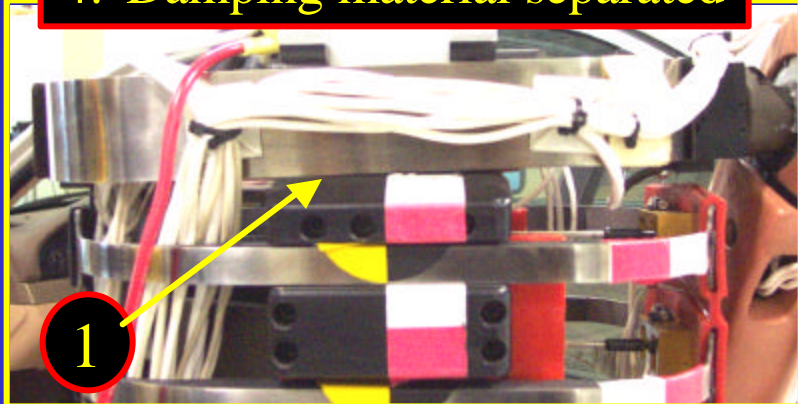
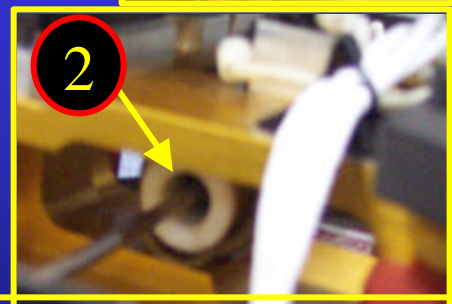
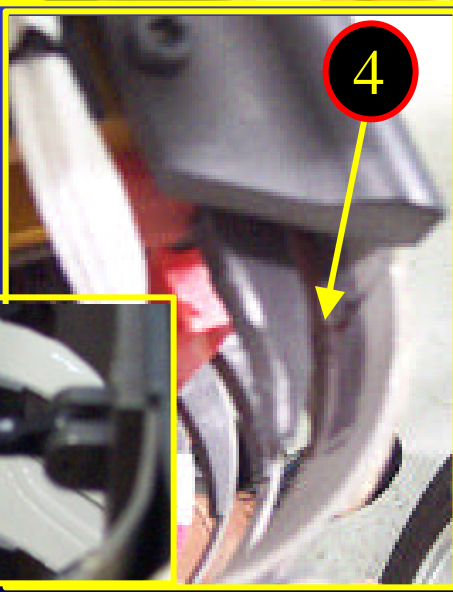
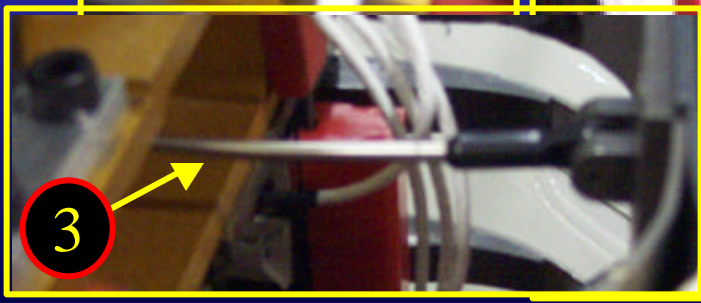
Damages

1. Rib deformation
2. Pot housing inset
3. Pot shaft bent
4. Damping material separated
