U.S. Department
of Transportation

National Highway
Traffic Safety
Administration

NHTSA Toyota Pre-Crash EDR Field Inspections
During March – August 2010

February 2011

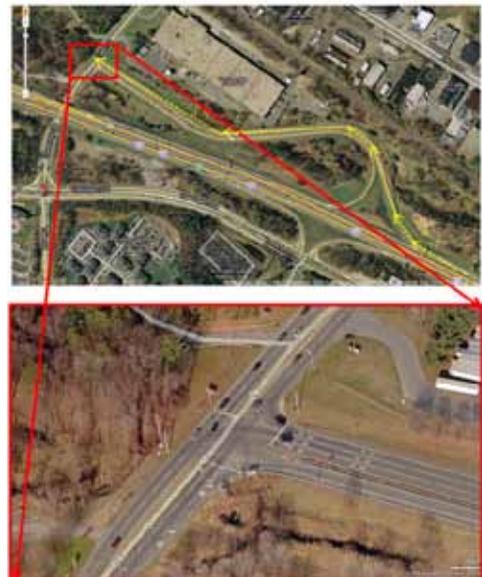
Figure 1: Case 15 Scene Overview

One incident (Case 15) turned out to be entrapment of an accelerator pedal by an all weather floor mat. This case was reported to NHTSA by an insurance company and involved a 2007 Lexus ES350 that was on an interstate highway approaching a long exit ramp (Figure 1). According to the driver, some jockeying for position was necessary that included a passing maneuver (accelerator application). The driver further indicated that after releasing the accelerator at the end of the passing

maneuver, he applied his brakes to slow the vehicle, using both feet at one point. He additionally maneuvered the vehicle against a guardrail in an unsuccessful effort to bring it to a stop. At the end of the exit ramp, the vehicle traversed a traffic light- controlled T intersection, left the roadway, struck a curb (deflating the right front tire), and landed in a marsh. The vehicle sustained significant frontal, undercarriage, and right side bodywork damage, and the driver experienced minor injuries. None of the airbags deployed.

Pre-crash data retrieved from the subject vehicle EDR shows the vehicle traveling at high speeds with a relatively high unchanging accelerator pedal voltage and consistent brake light switch status of “ON”. Engine rpm were very high initially, descending somewhat at 4 seconds from final impact (Latest Bank). This corresponded with a reduction in vehicle speed that remained essentially unchanged for the remainder of the incident. Of note, the latest bank of data showed a dramatic¹² reduction of indicated vehicle speed at 1 second from final impact and then a similar rebound at AE (impact). This fluctuation corresponded with the initial impact (curb strike) and was likely the result of a momentary confinement of one of the front wheels.

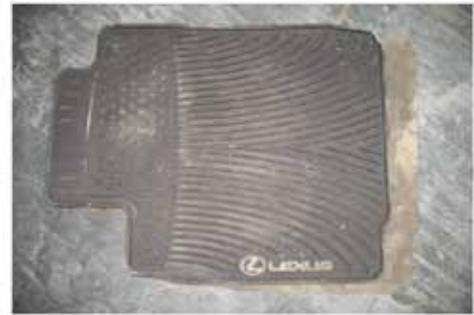
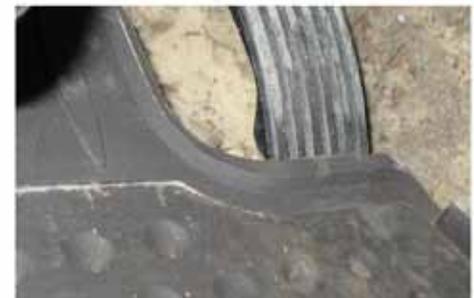
Figure 2: Case 15 Floor Mats

Field inspection of the incident vehicle identified three intact tires, a deflated right front tire, and significant lower frontal impact damage. This damage pattern coincides with the terrain and two indicated impacts. Examination of the vehicle interior uncovered evidence that an OE Lexus all weather floor mat had constrained the accelerator pedal after the driver released it at the onset of the incident. When inspected, the subject vehicle's all weather mats were found in the rear seating area. Its OE carpeted floor mats were found secured properly in the footwells. Dirt patterns on the driver's carpeted mat indicated that the all weather mat was typically laid atop it in an (inappropriate) double stack configuration. Using the dirt patterns as a guide (Figure 2), it was possible to recreate the confined accelerator pedal.

Examination of the vehicle showed no other indications of accelerator pedal, throttle body restriction or malfunction. Electronic outputs from the brake light switch and accelerator pedal were verified as within range.

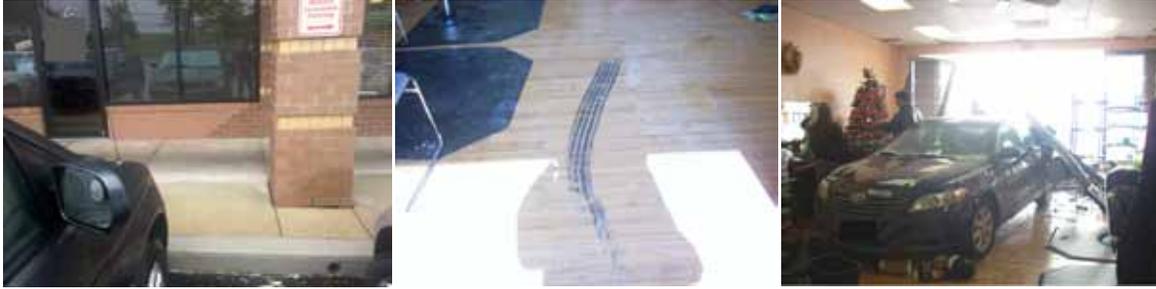
Figure 3: Case 33 Incident Scene

Case 33, which involved a 2009 Camry operated by a male driver in his mid- thirties intruded into a hair salon during daylight hours in late 2009 typifies the majority of UA crashes examined by ODI¹⁸. The driver had turned to enter the parking space from the lane of traffic and was about to come to a rest facing a shopping plaza storefront at the time of the incident. The driver reported having his foot on the brakes when the vehicle unexpectedly lunged forward, traversed the sidewalk, and intruded into a hair salon. After penetrating the brick and window façade, the subject vehicle traversed the waiting room area and came to a rest against the reception desk. The subject vehicle driver’s left front tire deposited a streak of rubber on the floor and the driver reported that the engine was roaring even as his foot was on the brake. The incident was ended by the driver shifting the transmission into Park and shutting the engine off after the vehicle came to rest. The impact was insufficient to deploy the frontal airbags and the vehicle suffered minor damage,

The vehicle had received normal maintenance throughout its service life and had accumulated approximately 14,000 miles at the time of the incident. Neither the driver nor the vehicle's service history indicated prior engine control or brake concerns with the vehicle and it did not appear to have been involved in any prior crashes. Physical examination of the vehicle shortly after the incident showed no apparent concerns with the brakes, throttle, or accelerator pedal.

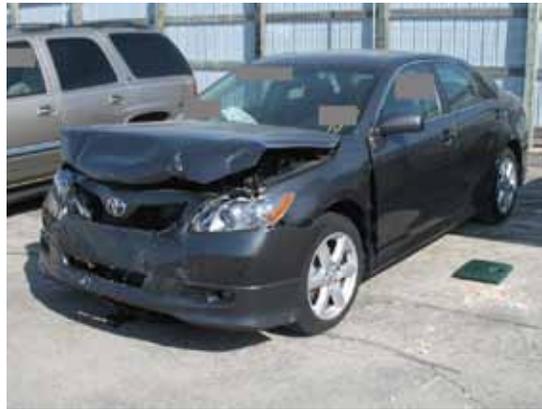
Figure 4: Case 30 Subject Vehicle

Case 30 involved a 2007 Camry operated by a female in her fifties striking vehicles stopped in traffic ahead of her during the first half of 2010. The incident took place during daylight hours on a local road with a posted speed limit of 25 mph and on an ascending grade. The driver reported depressing the brake to decelerate and feeling the vehicle accelerate. She reported pressing the pedal harder, causing the Camry to accelerate harder and then strike vehicles stopped ahead of her. The impact was strong enough to deploy both frontal airbags in the Camry and caused injuries to its (restrained) driver as well as an occupant of one of the struck vehicles.

A Carfax report did not indicate any prior collisions. The vehicle, which had accumulated approximately 25,000 miles of service at the time of the incident, had received recall remedies to address sticky pedal and accelerator pedal entrapment.
