# Takata Inflator Rupture Root Cause Summary Report

Submitted by:  
**Orbital ATK for the Independent Testing Coalition**

Submitted to:  
**National Highway Traffic Safety Administration**

**September 2016**

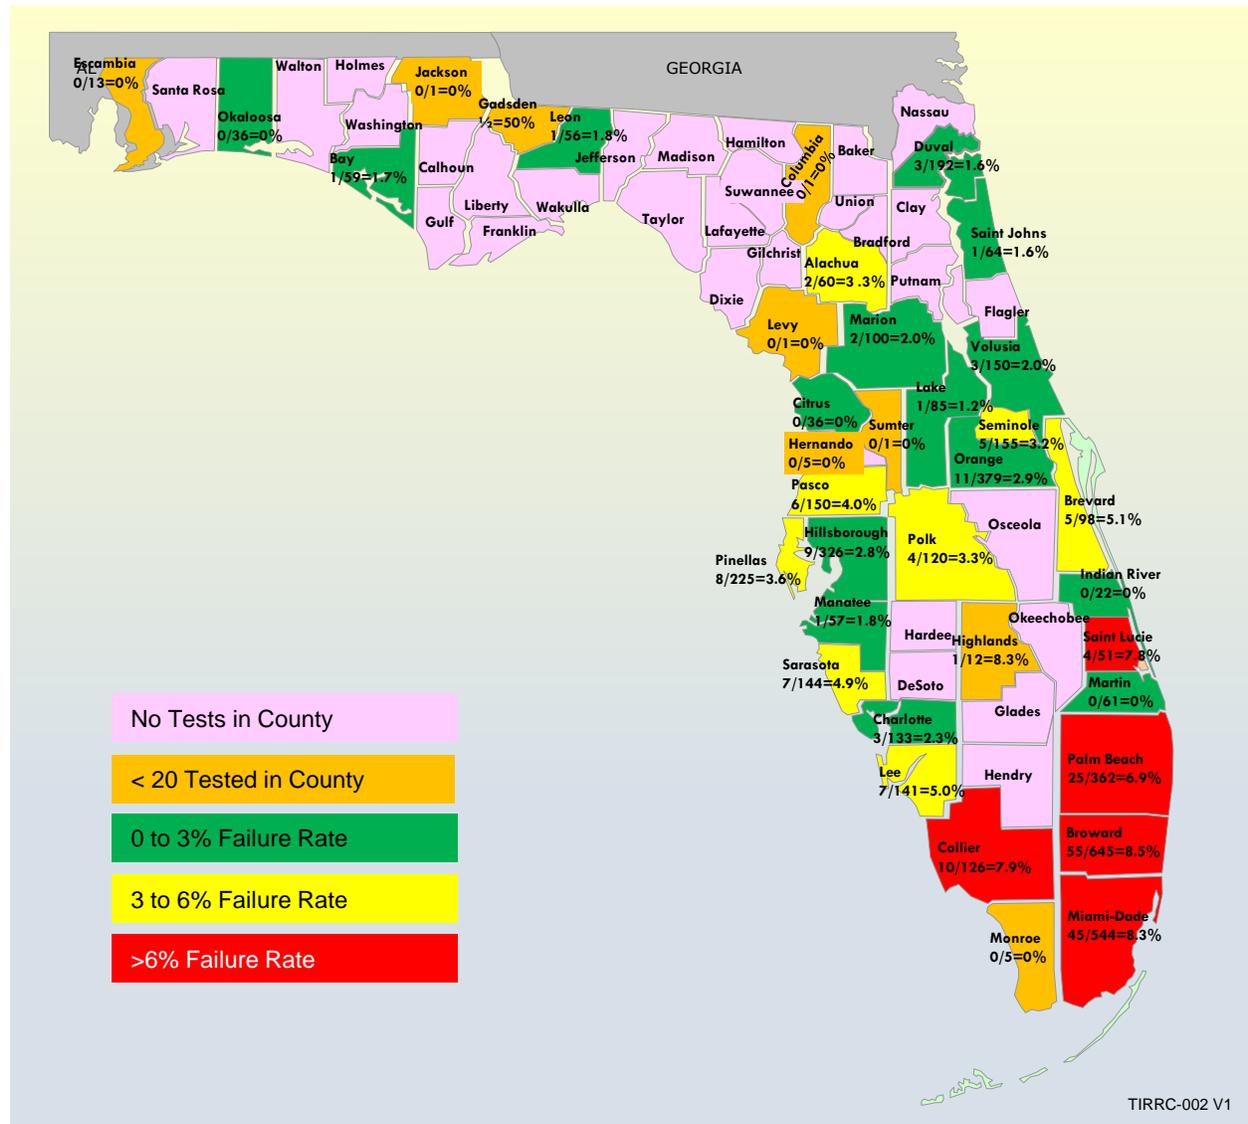
Figure 2. Failure Rates in PSPI-L for a Single Vehicle Model in Florida.

The significant difference of failure rates even within Florida is striking.

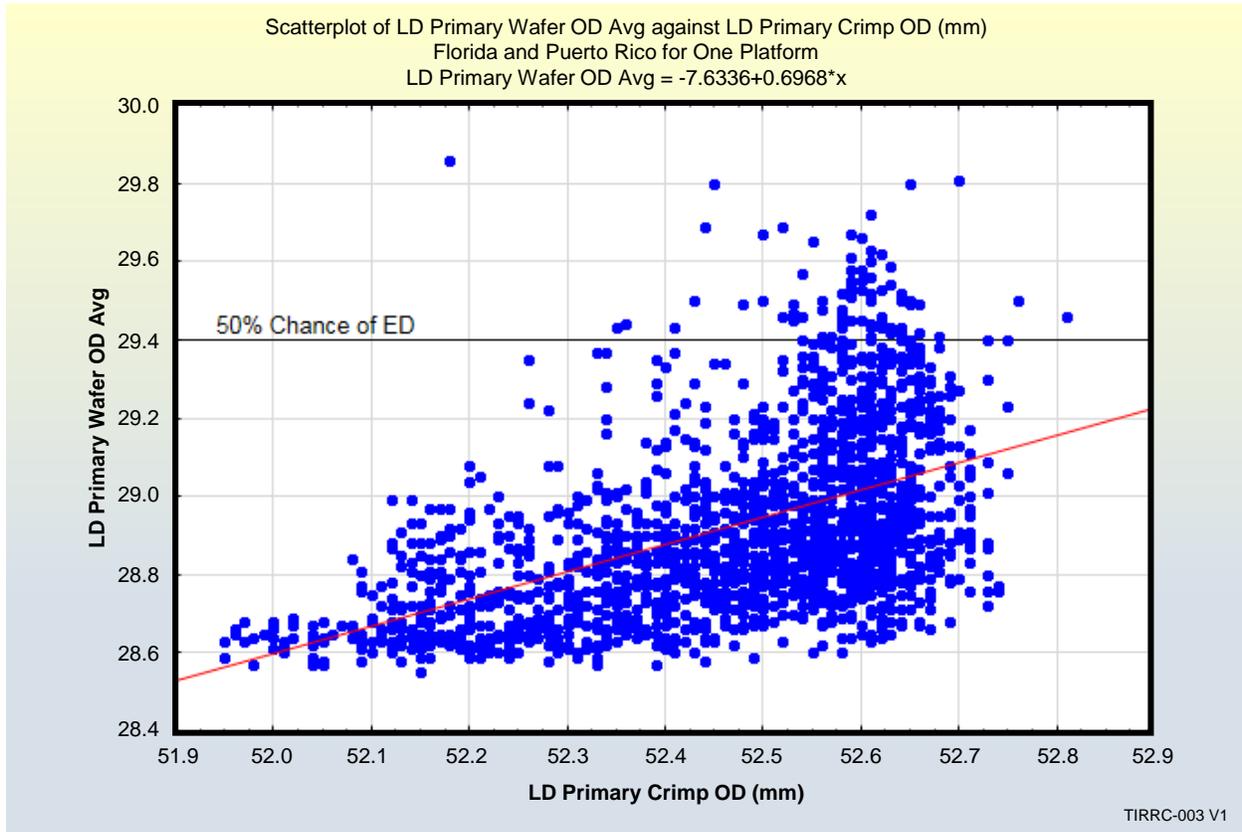
**Figure 3. Wafer Outer Diameter, Crimp (case) Outer Diameter and Failure Probability for PSPI-L for a Single Vehicle Model.**

*The amount of data scatter seen here is typical of many of the statistical relationships but shows a trend.*

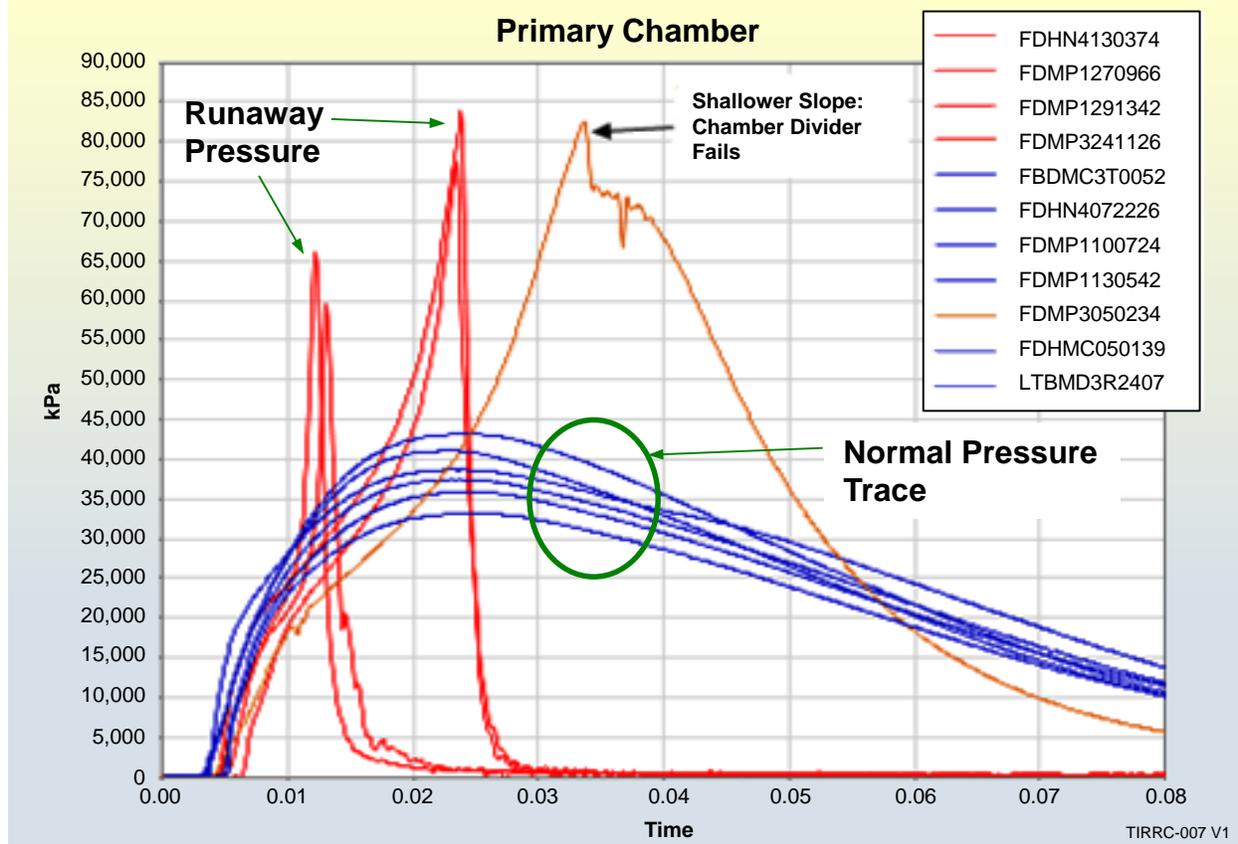
**Figure 6. Typical Ballistic Traces.**

Although we have no evidence of structural failure at normal pressure, there is data showing ED events are associated with runaway ballistics (Figure 6). While some of the failure traces indicate failure below design capability, a separate analysis showed this is likely due to the capability of the data acquisition system.

Shown here are typical pressure-time traces for nominal operation and runaway pressure of an ED. The rounded, “haystack” of the nominal operation is indicative of regression normal to the propellant surfaces. The unique shape of the ED trace provides information regarding what ballistic effects could lead to this shape of trace.

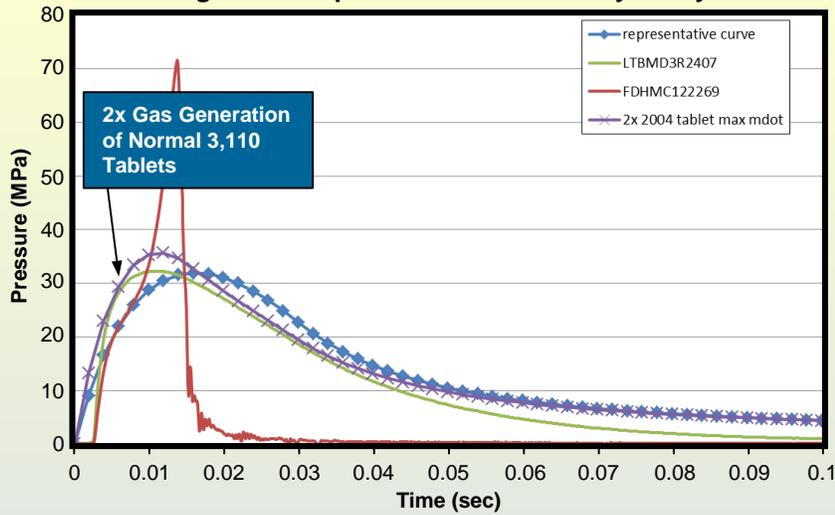
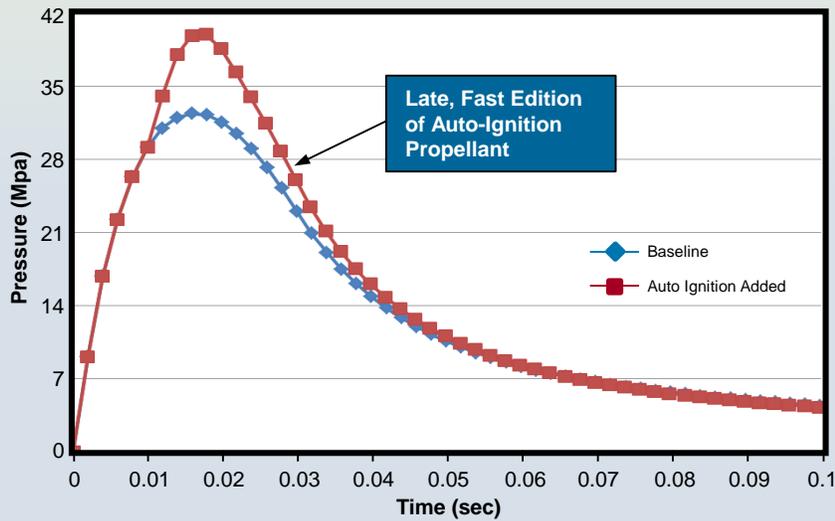
**Figure 9. Potential of Ignition and Auto Ignition Propellants to Cause an ED.**

We examined the potential of the ignition propellants to cause ED. Specifically, we looked at the PSPI-L secondary chamber because of the relatively high ratio of ignition propellant weight to 2004 wafer weight (Figure 9a). We found that 1) we could double the ignition propellant mass flow rate without a significant change in peak pressure, and 2) if we added all the auto ignition propellant at peak pressure we could not increase pressure enough to cause ED (Figure 9b). This important finding helped focus our propellant investigation on the 2004 main propellant.

*These two figures show data from gas or pressure generation studies (Mdot, gas generation rate) on the potential of the igniter closure 3110 propellant (top) or the auto ignition propellant (bottom) to cause an ED. Even under extreme cases, these propellants cannot of themselves cause an ED. This focused our studies on the main 2004 propellant.*

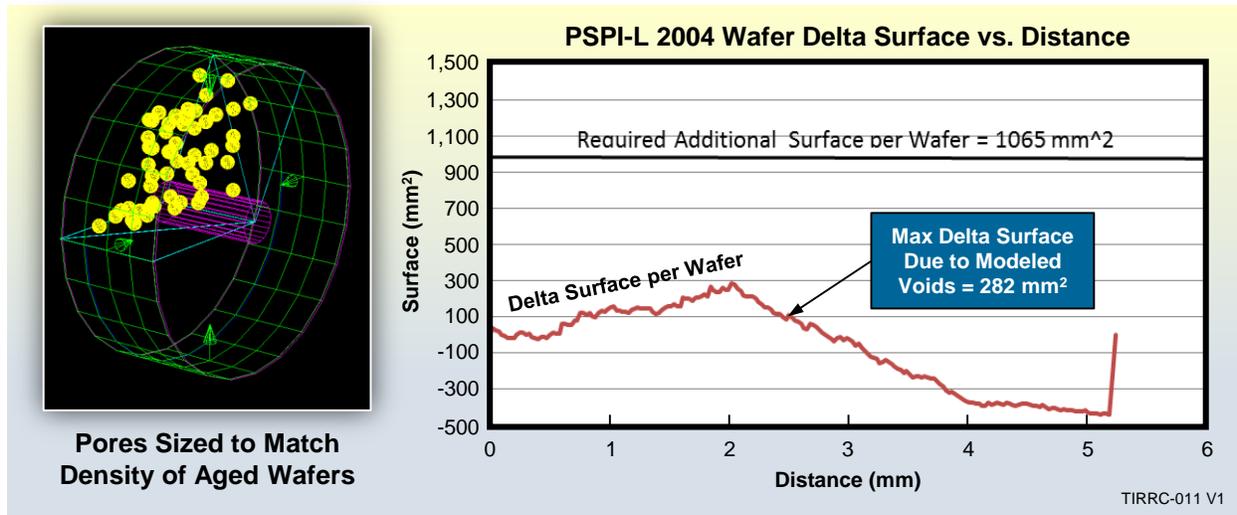
**Figure 10. Closed Pore Impact on Burning Surface.**

*Calculations were done matching the lowest wafer density from field returns by adding closed pores to otherwise nominal wafers. With this matched density, closed pores are insufficient to explain the surface area increase needed to result in an ED event. It may contribute, however. This analysis does not apply to connected pores where there are potential gas paths as discussed below.*

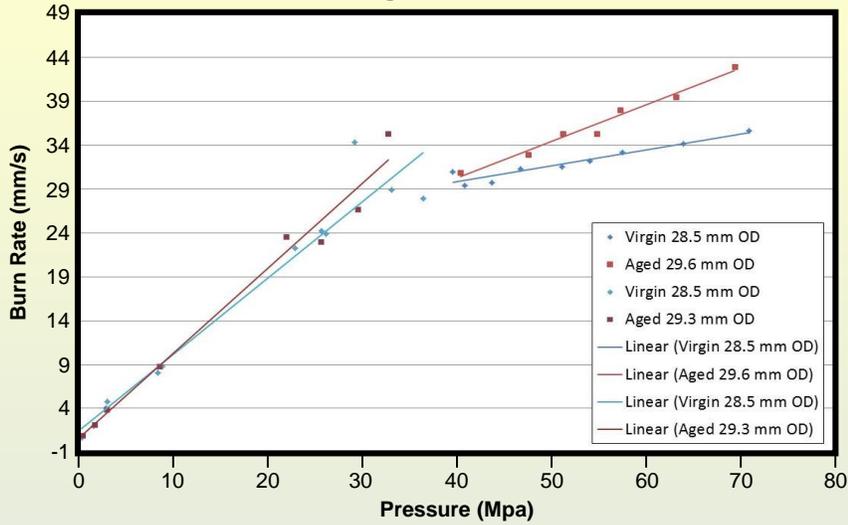
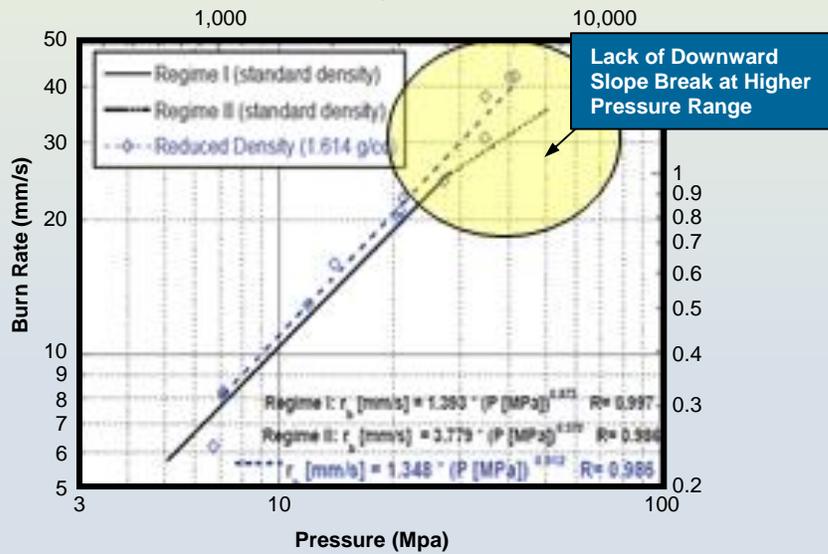
**Figure 11. Change in High Pressure Regime Slope.**

Orbital ATK and Penn State data<sup>2</sup> showed the potential for low-density 2004 propellant to have a slope increase at high pressure compared to the normal slope at high pressure (Figure 11). Modeling the effect of slope change shows that increasing slope from the baseline value of 0.5 to 0.8 is enough to reach ED pressure levels. This ballistic change most likely is caused by the permeable and porous burning noted below.

Data at several locations have shown similar data as depicted here from Orbital ATK (top) and Penn State (bottom). This change in apparent slope at higher pressure is consistent although graphically represented several different ways. Several phenomena can result in this apparent slope change as noted below.

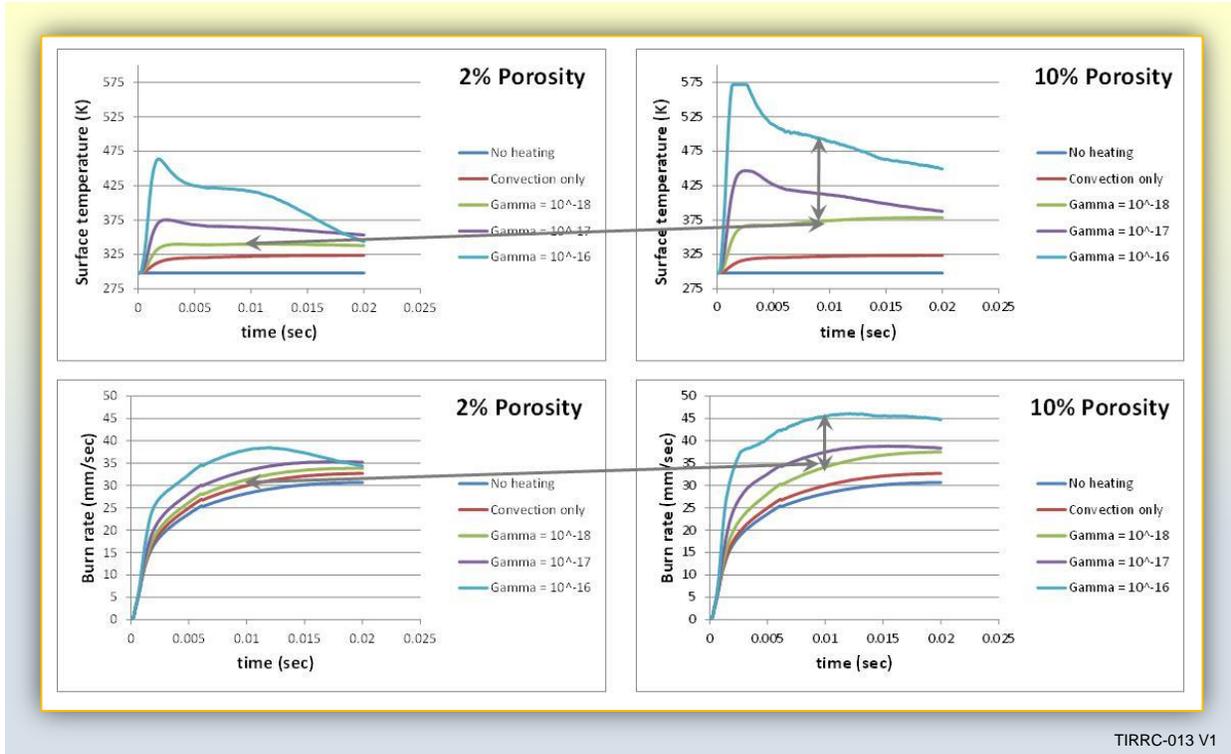
**Figure 12. Impact of Porosity and Permeability.**

Permeable burning is a mechanism that can increase burn rate by preheating the propellant. 2004 propellant burn rate increases with temperature until the auto-ignition temperature is reached. If the propellant is porous (volume is available for hot gas to fill) and permeable (hot gases can flow to the free volume), then hot gas has the potential to preheat the propellant to the depth the permeability extends (Figure 12). This can express itself in what appears to be “in-depth” burning as the hot gases ignite more surface area of the propellant below the normal advancing surface. In a parametric studies completed to test this phenomenon, 2% porosity is typical of virgin propellant, and 10% porosity is similar to aged propellant. For the study, three values for the permeability constant, Gamma, were chosen that span the range likely for this material and to model the potential impact from a change in permeability. This example showed the potential for a 50% burn rate increase due to changes in porosity and permeability. This theoretical underpinning may serve to explain the empirically measured “Integrated Burning Rate” data reported by Takata. Understanding the mechanism will allow validation of appropriate aging models.

*These four figures graphically depict the dramatic effect on in-depth heating and burning rate with increasing porosity and permeability to hot gases. Each graph shows data for no heating and for increasing levels of permeability (gamma). This in-depth heating along gas paths is consistent with the real time radiography, pycnometry data and ED event ballistic traces.*

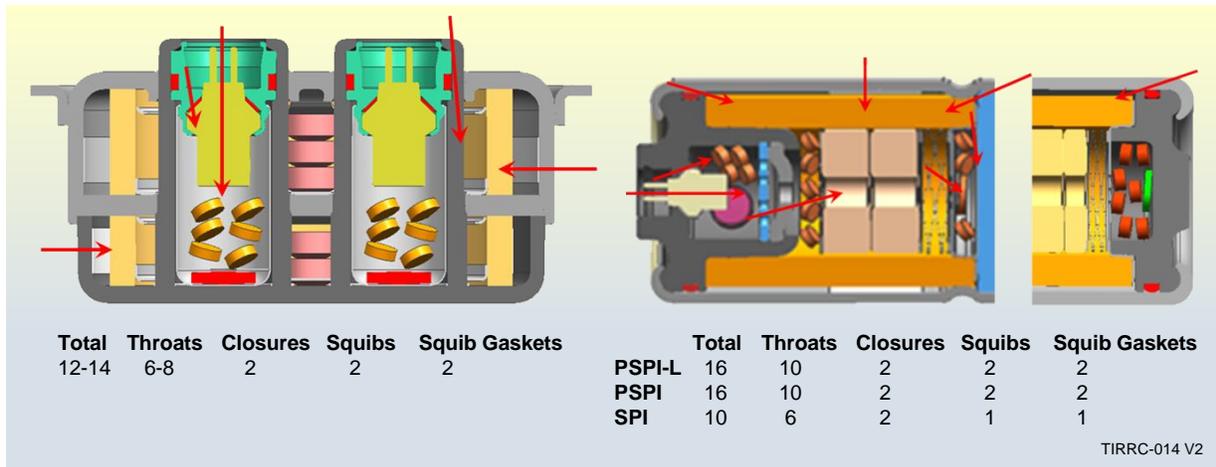
**Figure 13. Potential Leak Paths in Takata Inflators.**

Analysis of the seal systems showed that each driver and passenger inflator has multiple potential leak paths (Figure 13). The leak path of greatest concern is the passenger closure O-ring seal (Figure 14). Based on nominal dimensions for the closure, O-ring and case (away from the crimp zone), O-ring squeeze is excellent. Unfortunately, the closure crimp footprint overlays the O-ring sealing footprint. This design/manufacturing feature allows the possibility of no O-ring squeeze at the maximum engineering-allowed crimp outer diameter (OD) of 52.65 mm. In addition, many inflators were built with crimp ODs that exceed the allowed value. These paths result in greater moisture movement in and out of inflators than what would be calculated based on diffusion through a rubber O-ring and is consistent with reports from Takata, Fraunhofer ICT and original equipment manufacturers (OEM) of higher moisture levels in field return inflators. This moisture movement is critical to generate the observed growth in wafer diameter.

Several different seals are present in both passenger and driver inflators (marked by red arrows). While a great deal of emphasis has been placed on the passenger crimp and O-ring, every seal is a potential path for moisture to enter the inflator and must be considered in any valid moisture transport model.

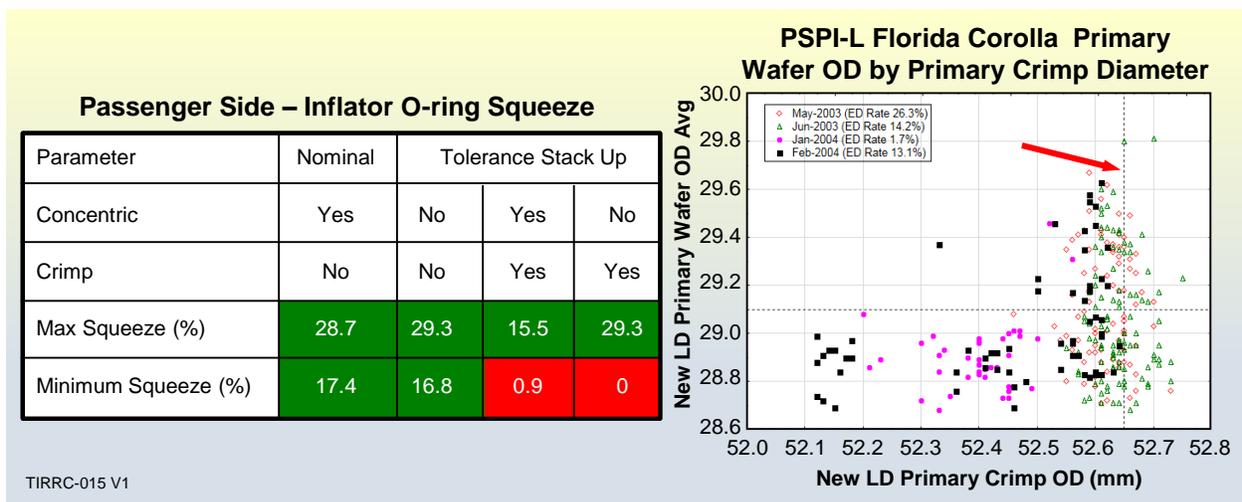
**Figure 14. Passenger Inflator Primary Crimp Data.**

The table on the left presents results from analysis using a proprietary tool developed by Orbital ATK to be a more accurate measure of O-ring squeeze. The tool was developed due to the criticality of O-ring seals in rocket motors. The data on the right show that manufacturing in the time frame of interest for these recalls (2003 and 2004 shown here), that a measurable percentage of all primary crimp diameters exceeded the engineering allowed maximum of 52.65 mm (marked by the red arrow).

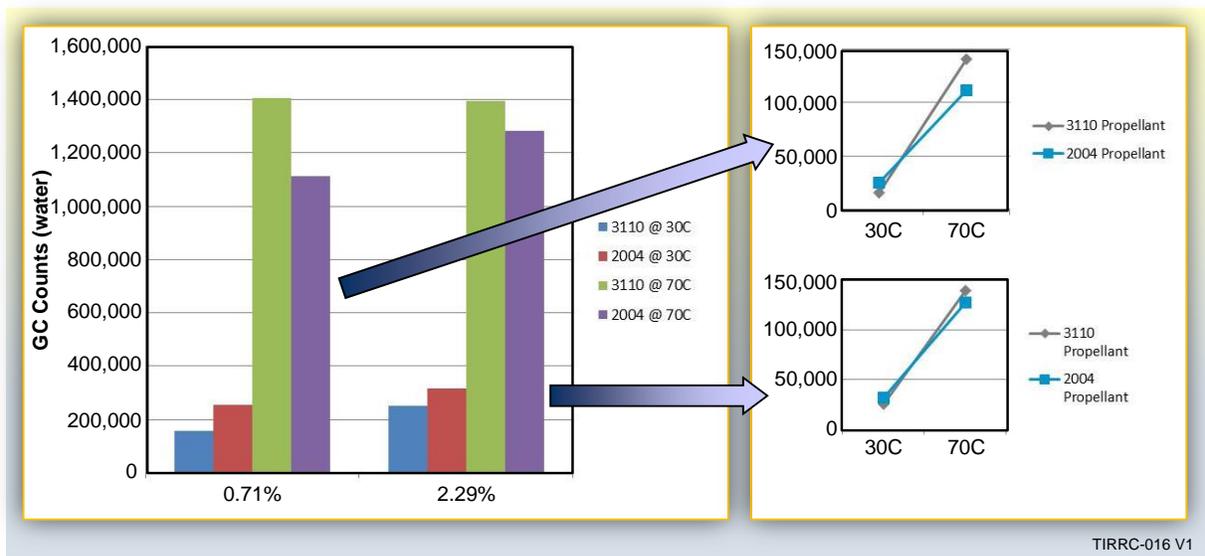
**Figure 15. Headspace Moisture Above 2004 and 3110 Propellants with Moisture Added as a Function of Temperature.**

*In each case, the change in the amount of water that is available is dramatic when transitioning from 30°C to 70°C. This suggests transport is much more likely at the higher end of the range. The 3110 propellant shows a modest increase in propensity to give up moisture compared to 2004. This variability gives rise to the “x-graph” when suitably drawn although the effect is not as dramatic as suggested in some depictions.*

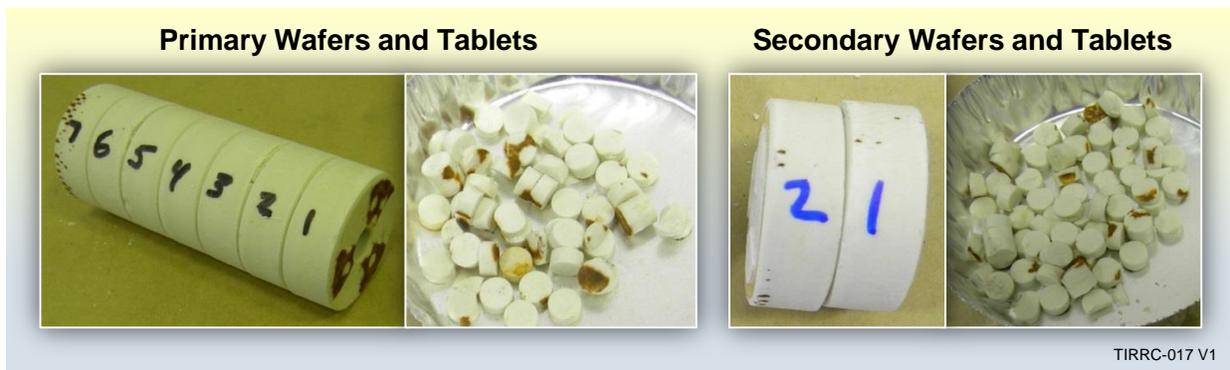
**Figure 16. Examples of Fused Wafers and Tablets.**

Both tablets and wafers are often fused in inflators where there has been significant diameter growth in the wafer consistent with a process similar to Ostwald ripening. The kinetics of such processes are relevant to any aging models.

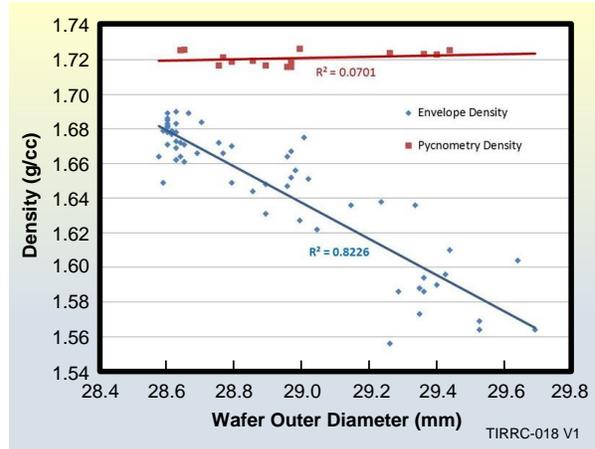
**Figure 17. Density Measurements for 2004 Propellant Wafers.**

*Shown here are measurements of a large number of propellant wafers with increasing OD. Outer diameter has been correlated with likelihood of an overpressure event. These data show two different density measurement techniques. The envelope density method gives an overall geometrical density while the pycnometry density method allows gas penetration, yielding a result that remains constant due to accessibility to gas to the majority of low-density spaces or voids in the propellant. These data show that the low-density voids generally allow gas to pass from one to the next, suggesting connected or communicating voids.*

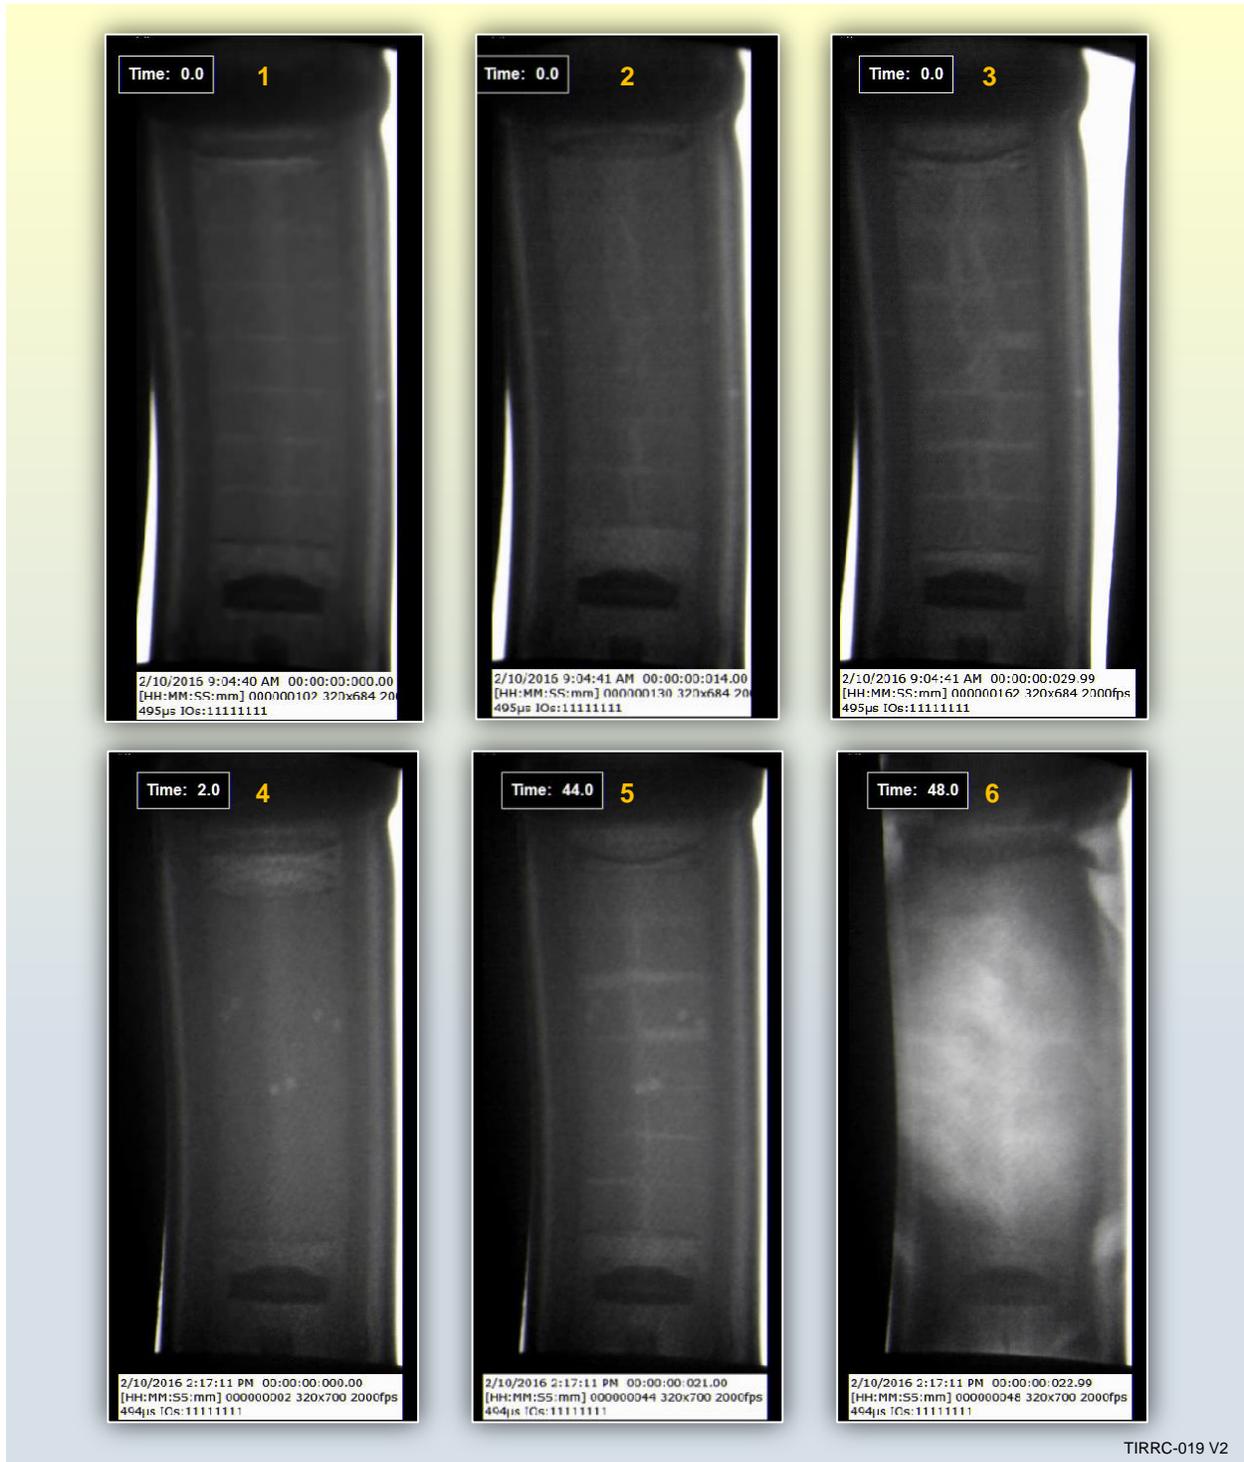
**Figure 18. Real Time Radiography Still Images.**

Real time radiography (RTR) provided remarkable insight into the processes involved in both a nominal burn and during over-pressure events. This technique showed the typical fracture of wafers during ignition. In a nominal deployment, the regular burning normal to all surfaces is apparent. However, in an ED, the initial state shows less distinct wafers, consistent with wafers expanding into direct contact with each other. Fracture occurs on ignition, although perhaps less pronounced than in a nominal deployment. Initial burning is followed by a transition to a much higher mass consumption, consistent with ballistic traces and penetration of combustion gases through void spaces resulting in increased surface area (Figure 18).

Shown above are individual frames from two RTR experiments with PSPI-L FD inflators showing the primary chamber. Stills 1-3 are from test #98553, which was a nominal firing. Stills 4-6 are from test #95179, which was an ED. The time sequence is from left to right. In the first pictures (1 and 4), differences can be seen with the distinct individual wafers with space between wafers in #1 and less distinct boundaries in #4 reflecting the wafer growth in #4. In pictures 2 and 5, the ignition has occurred and flame spread has begun. The typical fracturing of wafers is visible. Space between wafers from flame intrusion is now clear, which is not seen in the baseline (picture 4) for test #95179. In #3 and #6, radical differences are clear. In #3, regression of the surfaces, reducing wafer size but maintaining integrity, is observed. In #6, combustion at a much higher rate and in depth in the wafers is visible although some integrity remains as would be expected. Rupture occurred shortly thereafter attributed to excessive chamber pressure.
