**UNITED STATES DEPARTMENT OF TRANSPORTATION
NATIONAL HIGHWAY TRAFFIC SAFETY ADMINISTRATION**
1200 New Jersey Avenue SE
Washington, D.C. 20590

EA15-001
Air Bag Inflator Rupture

**REPORT OF TK HOLDINGS INC. PURSUANT TO PARAGRAPH 33.a
OF THE NOVEMBER 3, 2015 CONSENT ORDER**

June 30, 2016

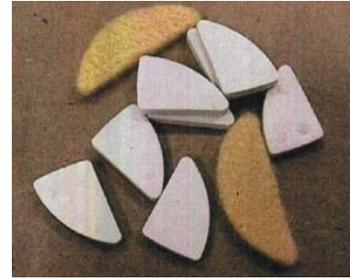
Information indicates that in October 1999, during module DV testing conducted at the vehicle manufacturer's facilities, a rupture occurred of the PSDI inflator. Takata and the vehicle manufacturer reviewed the issue, and Takata advised that the cause of the rupture was believed to be improper welding, which Takata committed to address.

Shark fin wafers (white) of the kind used in PSDI DV

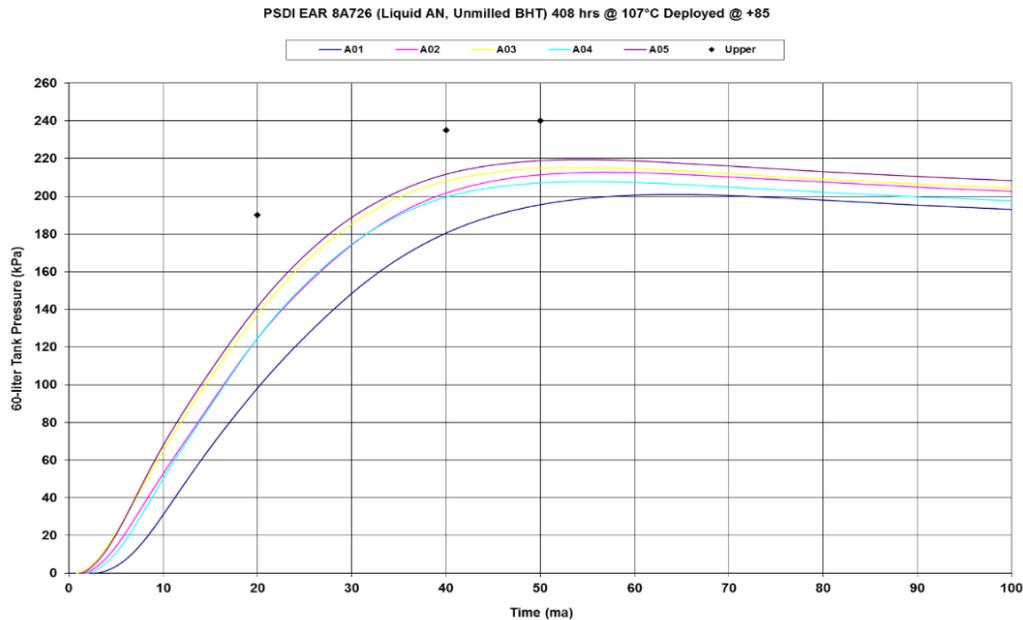
Passing High Temperature Aging test performed on a PSDI inflator with unmilled BHT October-November 2000.

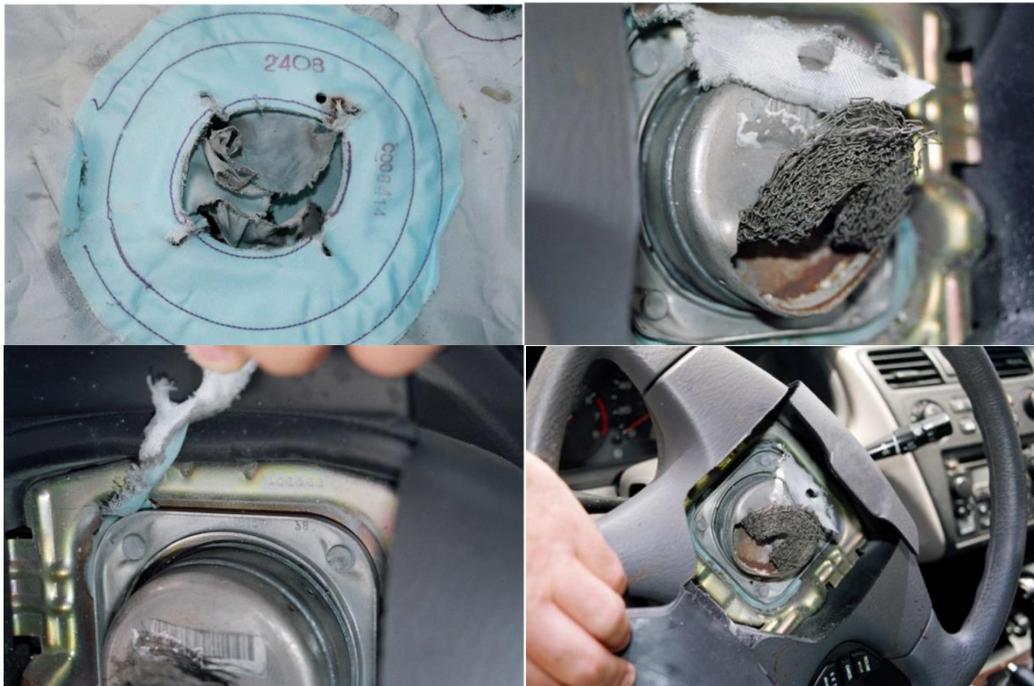
Pictures of Event 0 Received May 6, 2005

On Monday, June 13, 2005, a U.S. engineer in the inflator production group summarized his opinion of Event 0 based on very limited data. The engineer concluded that:

- the anomaly probably initiated in the secondary chamber in the cap material in the region of the booster tubes;
- the anomaly appeared to be due to high pressure, not low material strength;
- rust in the interior is localized and deep which may have indicated that it existed prior to the deployment due to a high interior moisture; and
- rust appeared next to the crack surface, but not on the crack surface, supporting the theory that the interior rust likely existed prior to the event.

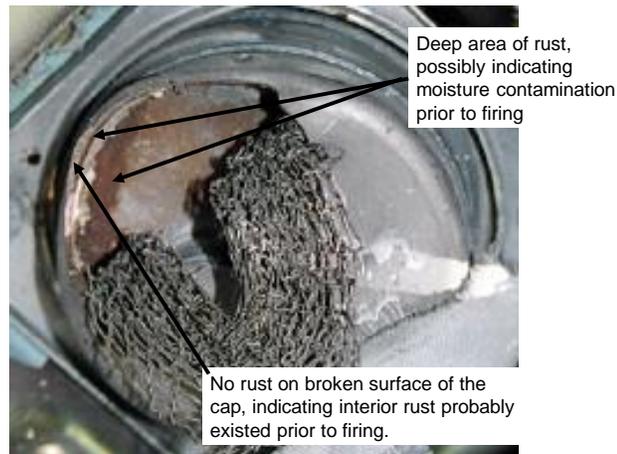
Picture from a U.S. Engineer's June 13, 2005 Analysis

Assuming the rust existed prior to deployment, the engineer concluded that the event could be explained by interior moisture that could cause the suspected over-pressurization by degrading the propellant's physical properties, resulting in excessive wafer break-up, high surface area, and subsequent high pressures. Under this hypothesis, the engineer explained that the interior moisture was either: (i) manufactured into the product (wet filter, wet propellant, etc.) or (ii) leaked into the inflator through a compromised seal. In addition to the possibility of moisture intrusion, the engineer identified other factors that also may have caused the observed over-pressurization: (i) excess main propellant (*i.e.*, too many batwings) or (ii) excess booster propellant in the igniter assembly.¹⁷ The engineer noted that no further effort could be conducted because the subject inflator had not been returned for analysis.

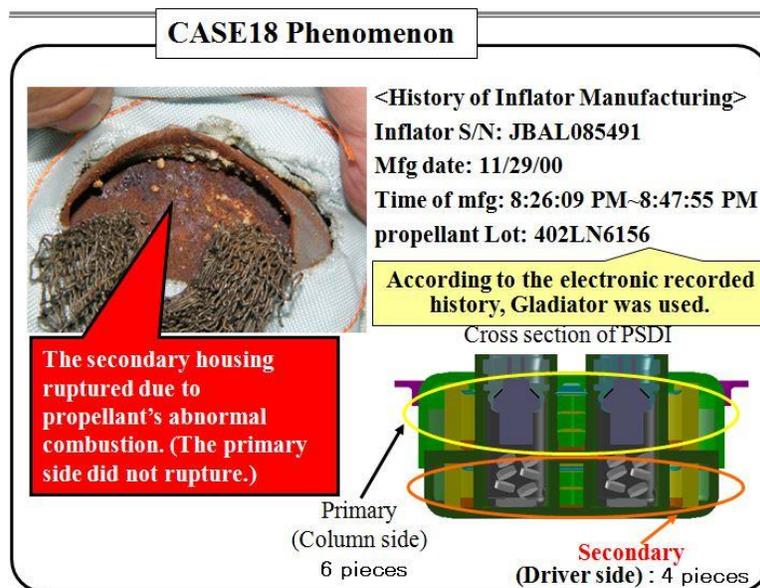
On August 1, 2011, a PSDI inflator ruptured in a vehicle in Pompano Beach, Florida (“Case 18”). Takata’s records indicated that the Case 18 inflator was manufactured using propellant from the Gladiator 1 press. Notably, only the secondary chamber of the inflator ruptured (see explanation and images, below).

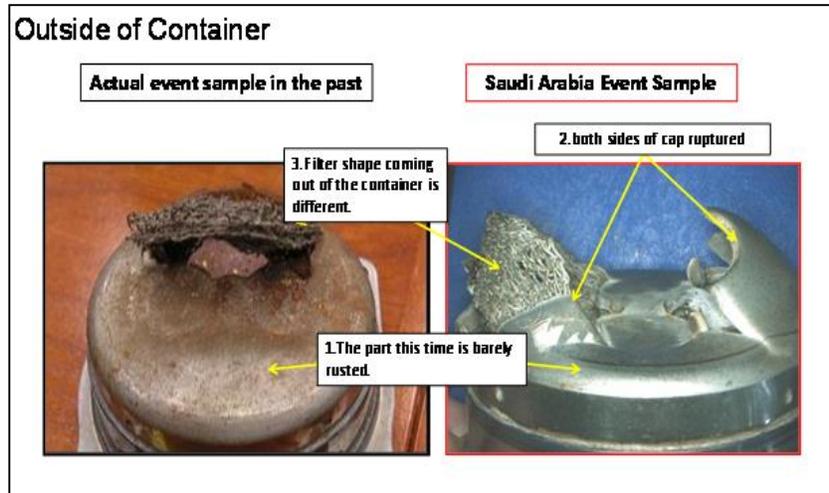
In a meeting with the vehicle manufacturer in April 2012, Takata presented the results of its initial analysis of the Saudi Arabia event sample and its manufacturing inspection records. Takata underscored that there were several differences between the appearance of the Saudi Arabia event and a sample from a past PSDI event, including a lack of rust, a rupture of both sides of the inflator cap, and a difference in the appearance of the exposed filter (pictured below).

Through inspection of the Saudi Arabia event inflator, Takata found no deficiencies in assembly, no deformation on the booster cap, and no ruptures on crimps or welding. Takata thus ruled out as root causes (i) an insufficiently strong inflator housing, (ii) an overly aggressive ignition, and (iii) an insufficient gas outlet area. Through manufacturing records for the event inflator, Takata also confirmed that the press compaction load, density, moisture level, and propellant chemistry met specification.

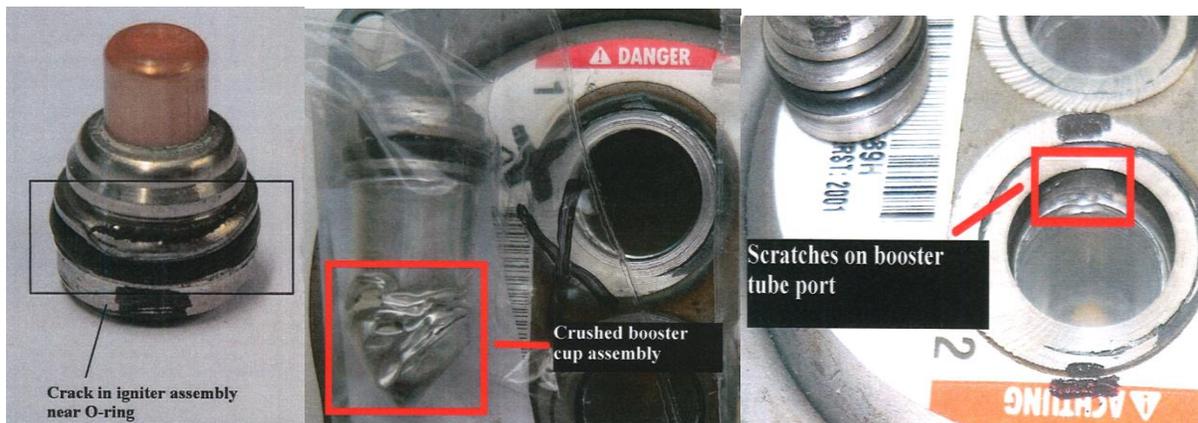
In total, 18 of 60 PSDI inflators (30 percent) examined by Fraunhofer had suffered some physical damage (categories 1-4, above) during manufacturing, and 6 of 60 (10 percent) had severe damage.

Fraunhofer hypothesized that welding heat, along with other potential manufacturing processes, caused the imprecise fitting of the component parts and resulting damage. The cracks in the igniter assemblies, as well as the other abrasions and dents, could promote moisture intrusion, which could worsen over time. In addition, the crushed booster cup assembly caused broken 3110 tablets, which could make the booster propellant more energetic and could adversely affect ballistics during ignition. Because these inflators had been dissected, no ballistic tests could be performed to determine the possible effects upon the performance of these inflators.

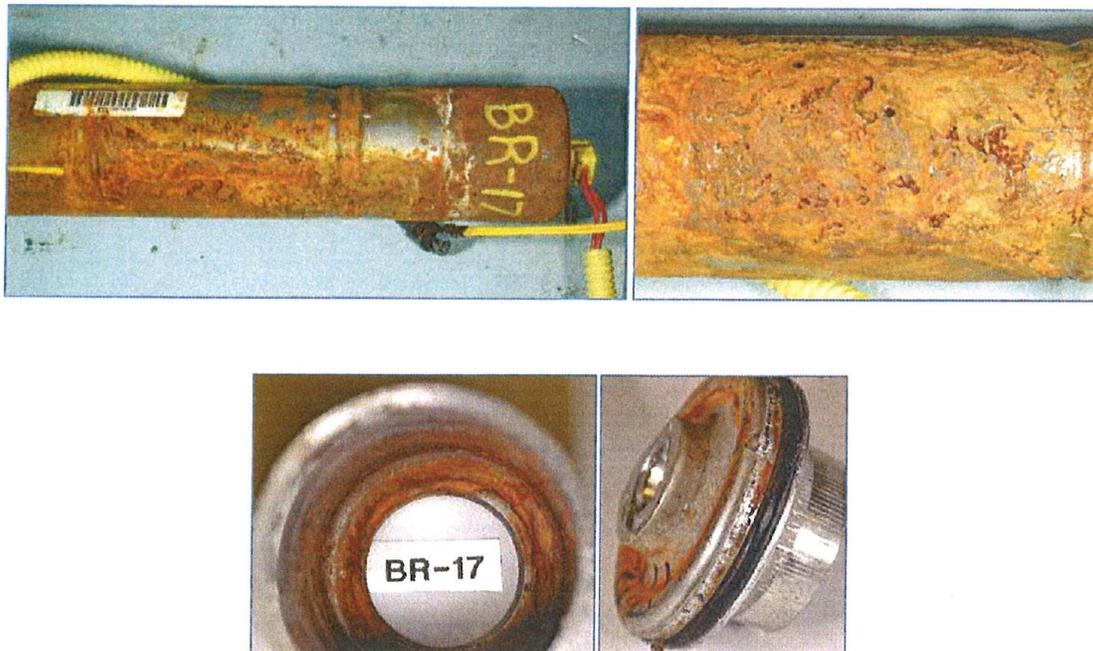
The dissection of 19 PSPI inflators from high temperature and high humidity areas of Puerto Rico, Florida, Texas and Alabama, however, resulted in (i) evidence of moisture intrusion into the inflators (as well as external rust, severe on about 25 percent of the inflators) (see photos, below), and (ii) a scientific explanation for the possible ability of moisture to permeate through rubber and plastic materials in certain warm and humid climates (see section XIII.G).

Figure 4. PSPI-L Disassembly showing Moisture Intrusion through the End Crimp

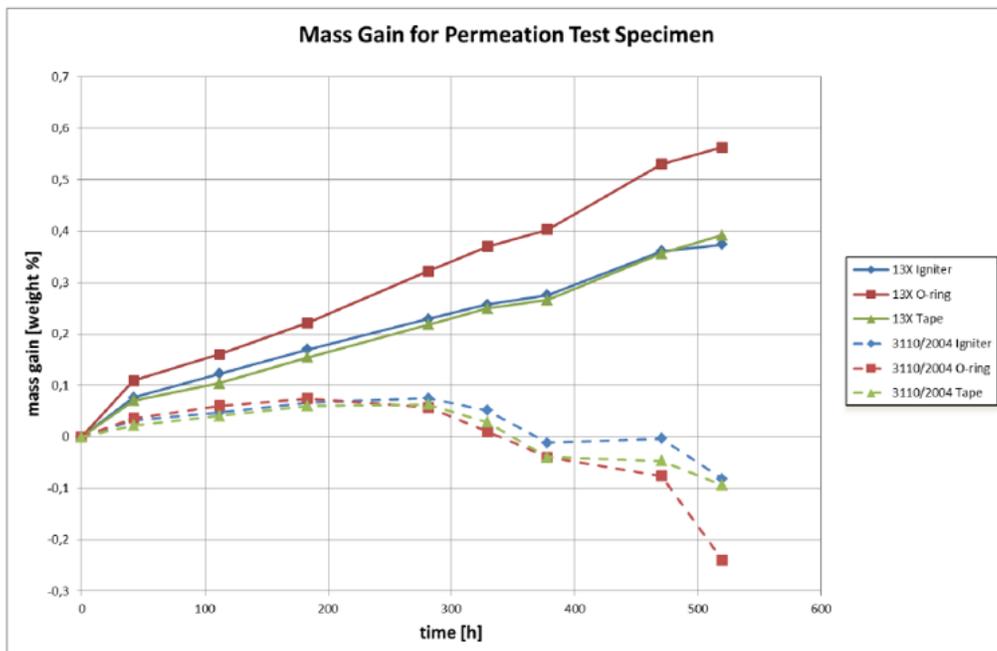
On the second issue—the location and rate by which moisture is permeating into and out of inflators—Fraunhofer found that water was transferring more rapidly through the O-ring, followed by the igniter and tape seal, which showed a similar rate. Furthermore, moisture was entering the inflator faster when 13X desiccant was in the inflator, due to the desiccant’s absorption of moisture causing a higher concentration gradient, though there is no indication the desiccant’s neutralizing effect was compromised. Both relationships can be seen in the graph below.⁵⁷

Moisture permeation through O-ring, igniter, and tape seal, with and without 13X.

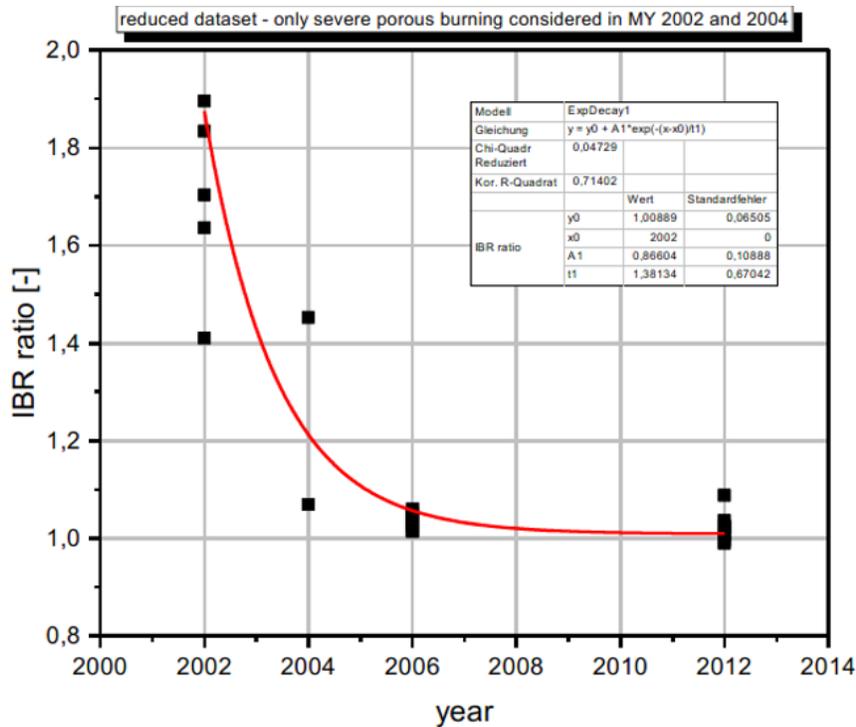
On the fourth issue—the creation of a service life prediction model for Takata inflators—Fraunhofer conducted ballistic testing on 20 field returned inflators from south Florida with different manufacturing dates (all from the same inflator type and “worst case” vehicle model). Fraunhofer then compared the burn rates of these field inflators to the burn rate of virgin 2004 propellant. Fraunhofer found that there was no porous burning in wafers from 2006 or younger. For inflators older than 2006, Fraunhofer found that the burn rate was increasing with age. This result can be seen in the graph below, which plots the relative increase in burn rate by inflator year, with the burn rate of newly made propellant expressed as 1.0.

Burn rate increase over baseline increases exponentially for inflators older than 2006.

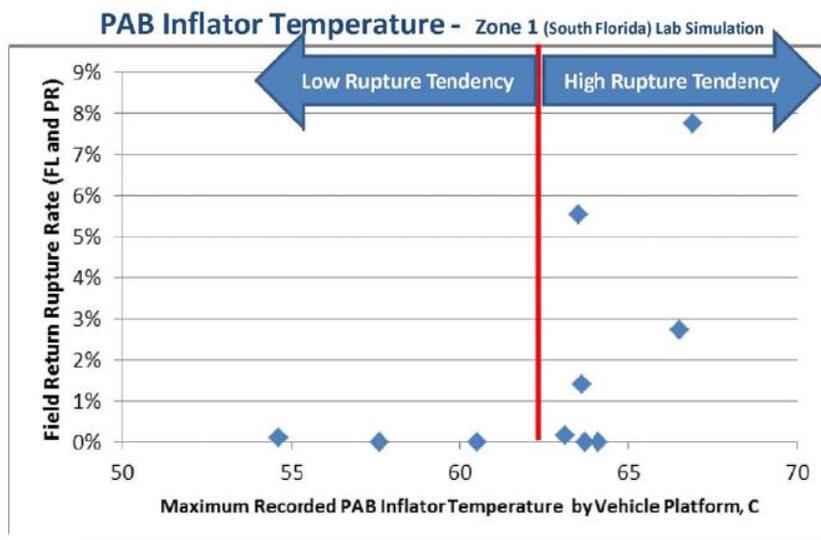
Vehicles that exhibit higher inflator temperatures generally have a higher observed rupture rate

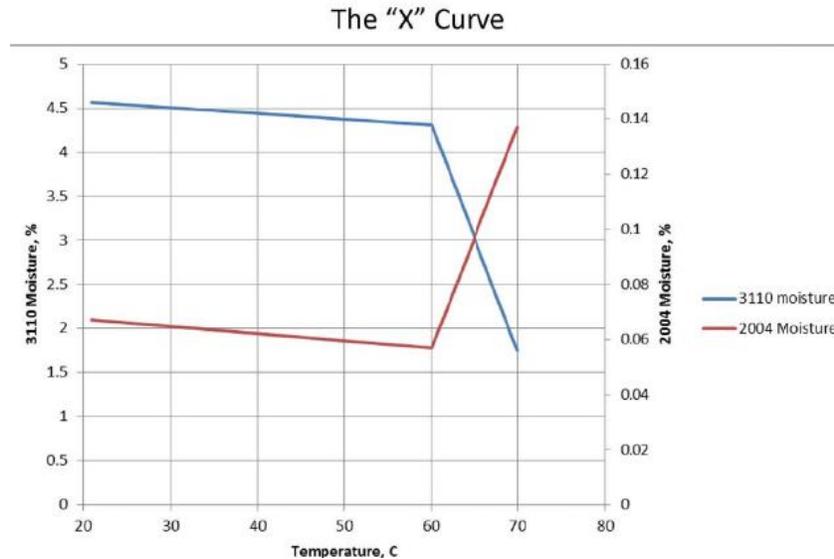
This increased rupture rate above 60°C, Takata observed, may be related to Fraunhofer’s findings regarding the tendency of 3110 propellant to absorb water preferentially, which tend to show that 3110 desorbs its water and transfers it to 2004 propellant at higher temperatures:

These observations indicate a rapid transition of moisture from the 3110 propellant into the 2004 propellant when temperatures exceed 60°C. This transition appears to occur more rapidly as the amount of moisture in the 3110 increases.

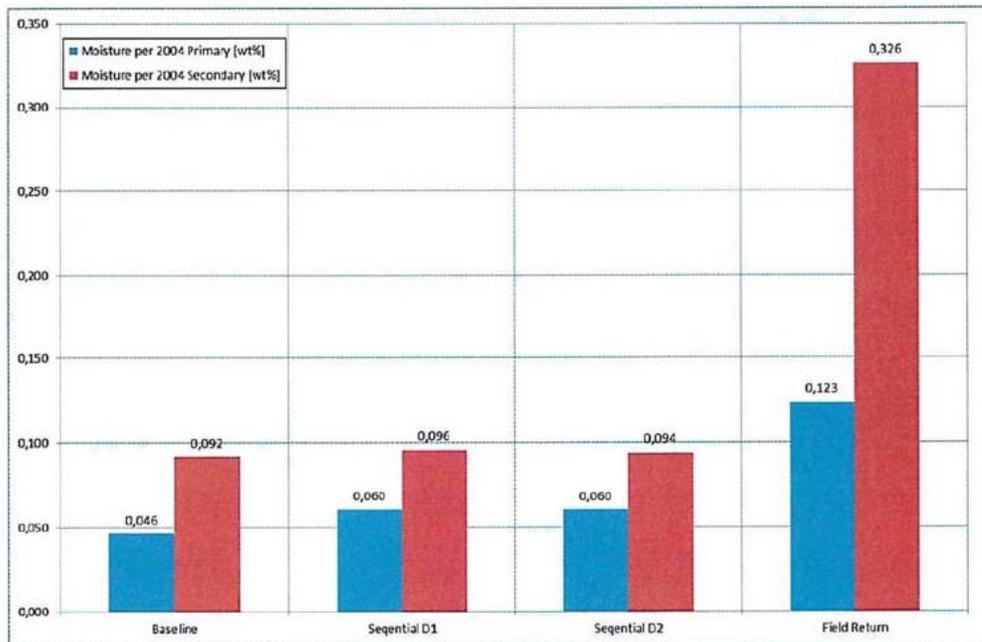
To answer this question, Fraunhofer studied the differences in inflators retrieved from the field from those put through vehicle manufacturer validation environments. Specifically, Fraunhofer compared PSPI inflators subjected by Takata to a series of vehicle manufacturer validation environments to those retrieved from Florida. In a report dated July 31, 2015 (and updated November 30, 2015), Fraunhofer described its findings. Overall, Fraunhofer found “remarkably lower concentrations” of moisture in inflators after vehicle manufacturer validation testing as compared to those seen in the field. As can be seen in Figure 3-3 below, the average moisture was far higher in the field return sample than after USCAR sequential testing.

Fig. 3-3: Moisture inside inflators referred as moisture of 2004 propellant mass before / after USCAR sequential tests and data determined after life dissection from field return inflators (only Florida)

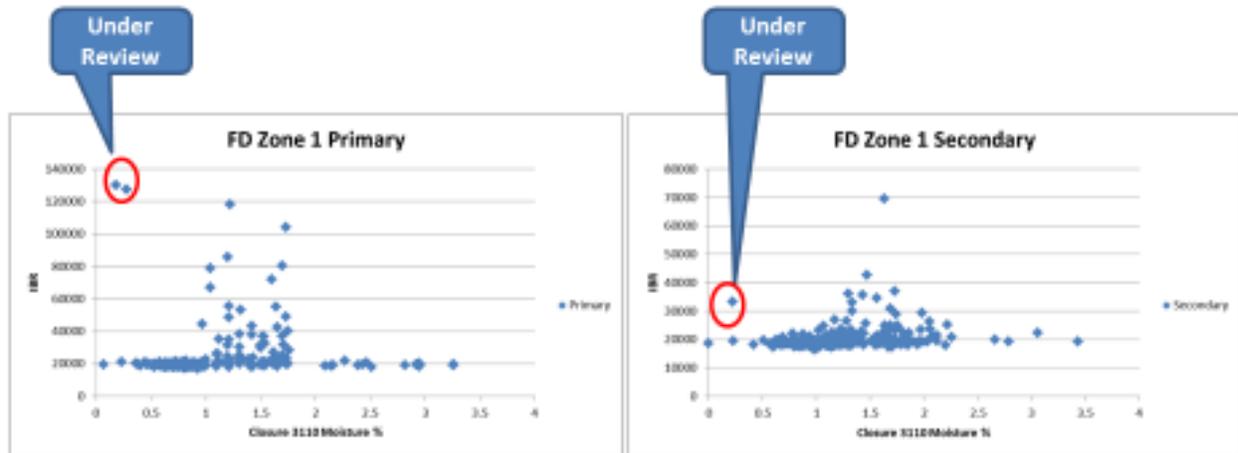
- There appears to be good support for the existence of a moisture threshold needed to convert the propellant.
- We typically do not observe HIGH burning rates with LOW moisture, but there are three test cases that are currently under examination.

With the exception of the three tests circled in red, increases in burn rate are not seen until moisture levels reach approximately one percent. Takata also again confirmed that its testing is showing that moisture alone, without aging, does not alter burn rates. Takata reiterated that moisture is necessary but not sufficient; high temperatures are also required.

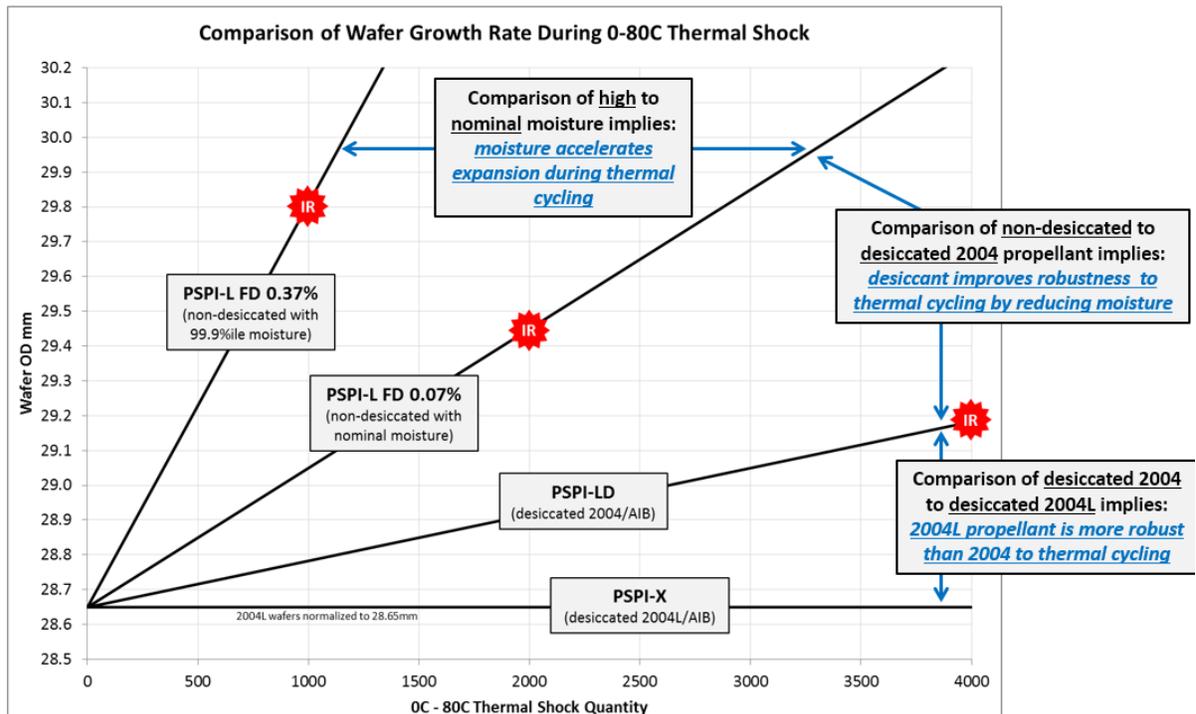
The relative robustness of cylindrical passenger inflators studied here can be compared by looking at the wafer growth rate:

The use of the 2004L propellant and the addition of desiccant appear to prevent grain growth (represented by the slope of the line), such that no grain growth was observed in the desiccated 2004L propellant after 4000 cycles.
