# **REPORT TO CONGRESS**

## **School Bus Safety: Crashworthiness Research**

**April 2002**

**Research and Development  
National Highway Traffic Safety Administration**

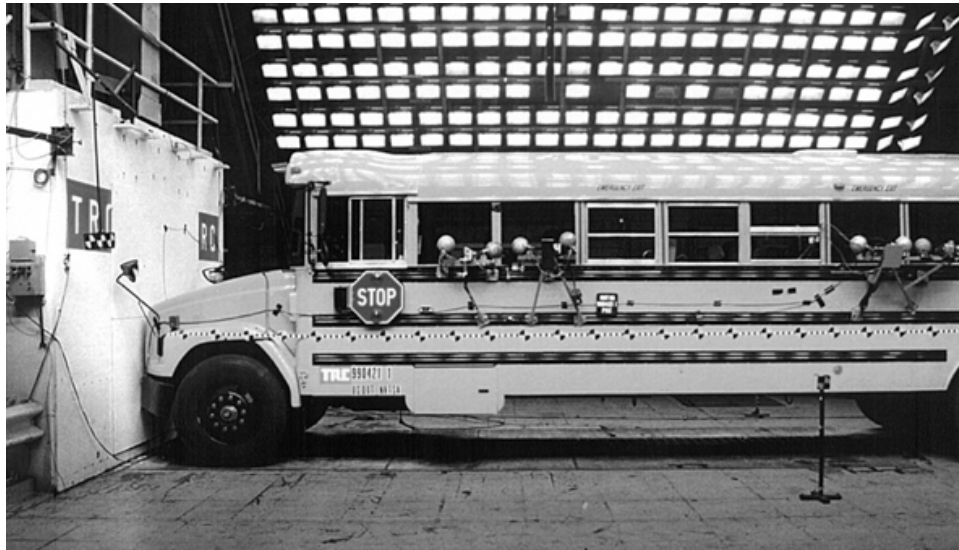
**Figure 1. Pre-Crash Photograph of Frontal School Bus Test.**

Figure 1 shows the pre-impact conditions for the test. Figure 2 presents the final resting position of the bus after the impact with the rigid wall.

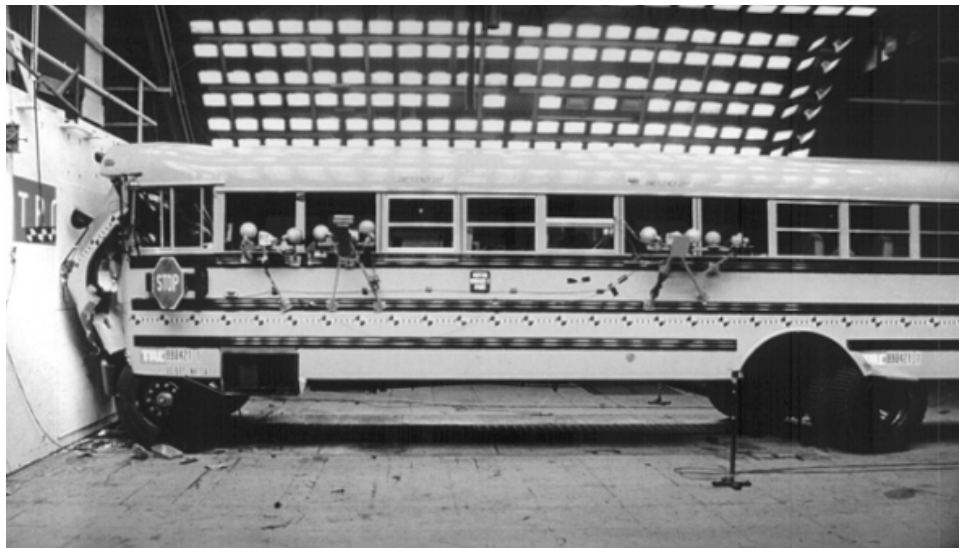
**Figure 2. Post-Crash Photograph of Frontal School Bus Test**

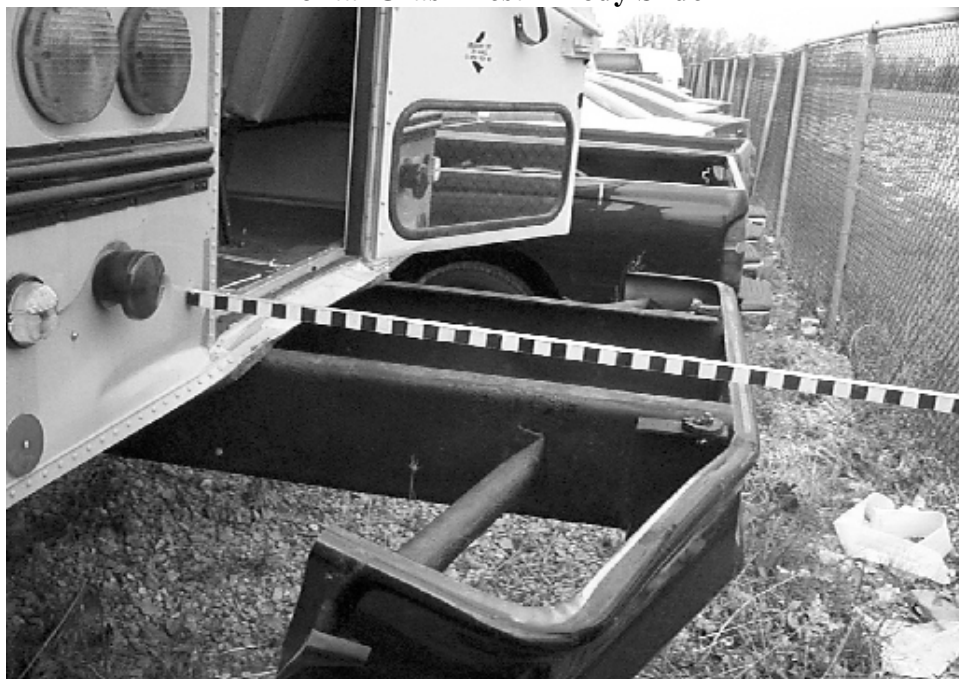
As typical of large school bus manufacture, the body of the bus is mounted to the frame rails of the chassis by a series of clips or clamps. As shown in Figure 3, this non-rigid mounting feature allowed the bus body to slide forward approximately 36 inches (92 cm) during impact. This dissipation of impact energy over a longer time duration acted to reduce the interior contact speeds and resulting acceleration levels on the vehicle's occupants.

Figure 3. Post-Test Photograph of Frontal Test Showing Body to Frame Movement

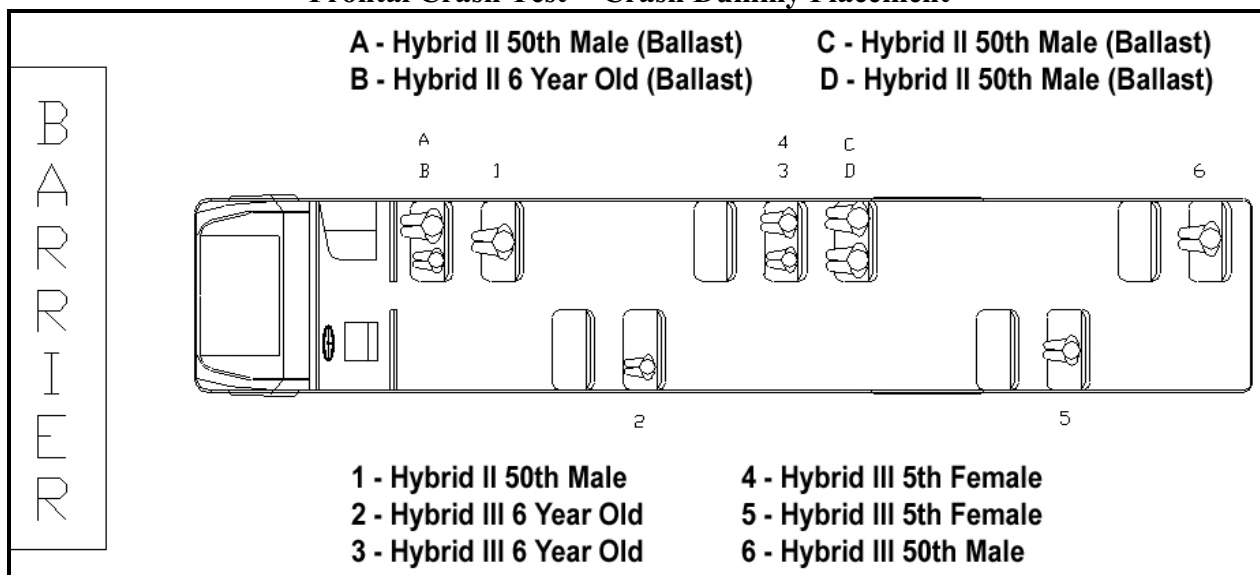
Hybrid III 50<sup>th</sup> percentile male (representing adult and large teenaged occupants), 5<sup>th</sup> percentile female (representing an average 12-year old occupant), and 6-year old dummies were used. Figure 4 shows the dummy seating positions for this test. The dummies were seated so that they were as upright as possible and as rearmost on the seat cushion as possible. There are currently no specific seating procedures for positioning dummies in school bus seats, such as there are in FMVSS Nos. 208 and 214.

Figure 4. Dummy Location for Frontal Test

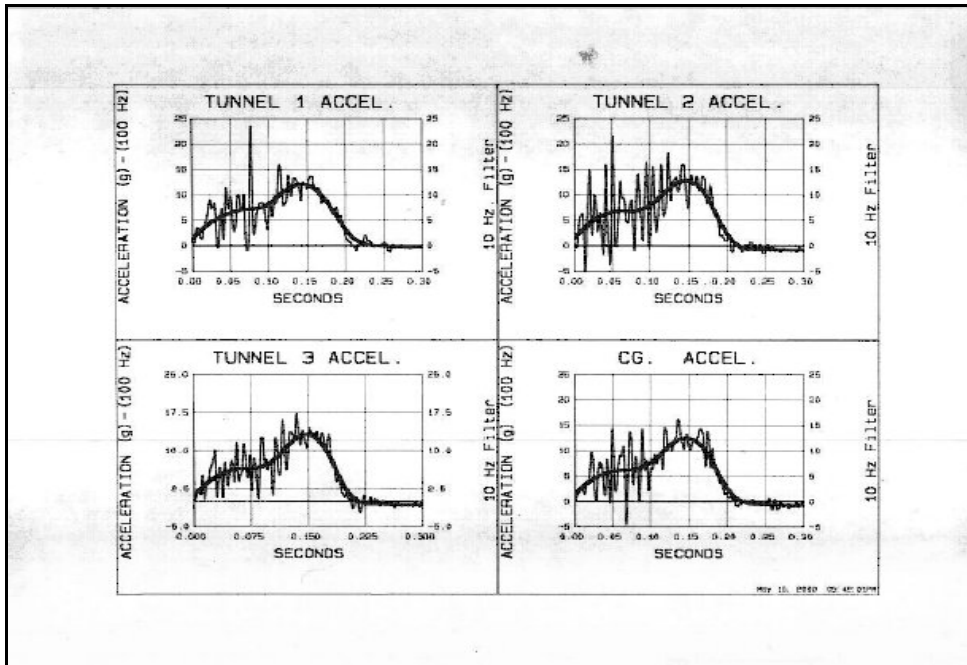
**Figure 5. Longitudinal Deceleration Profiles at Different Locations on the Bus**

The leveling off of the acceleration pulse of the crash test from about 40-90 milliseconds is a result of the bus body sliding along the chassis. The sled’s “metering pin” did not exactly replicate this plateau, producing somewhat higher acceleration in this zone. This resulted in a slightly higher velocity change (delta-V). Delta-Vs for the sled tests were about 35 to 37 mph.

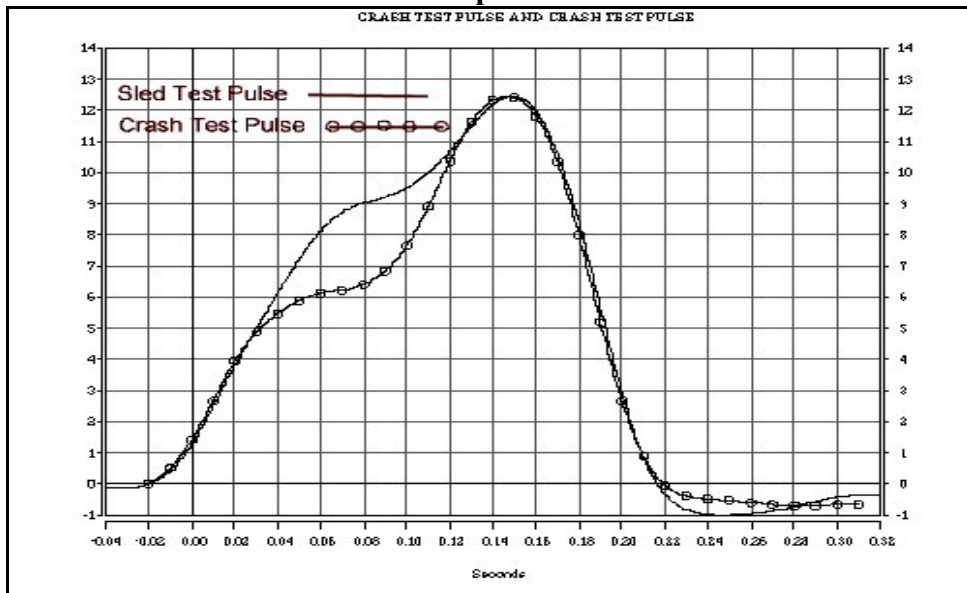
**Figure 6. Crash Test Deceleration Pulse with Sled Pulse Overlay**

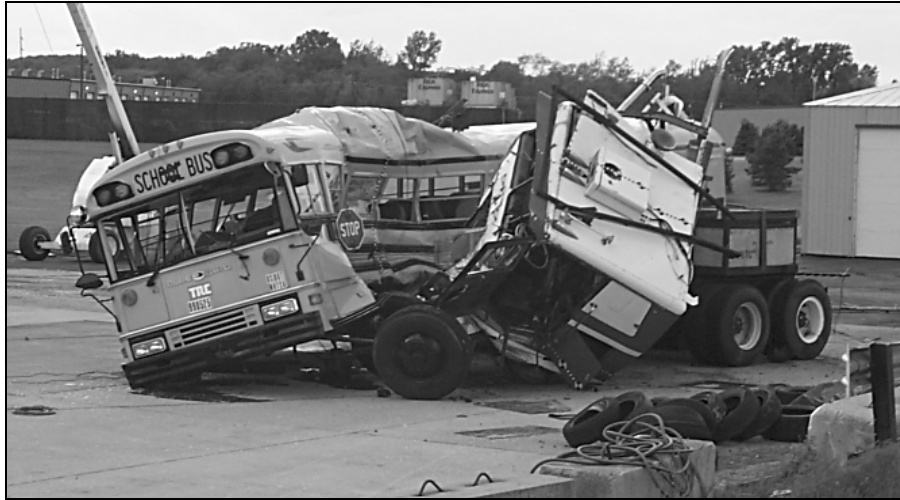
A post-impact photograph showing the post-crash positions of the school bus and truck is contained in Figure 8. During impact, the truck penetrated the bus side approximately half way into the compartment, and remained engaged while rotating 180 degrees before coming to a stop. The front axles were severed from both vehicles as seen in Figure 8.

**Figure 8. Post-Test Photograph Showing Final Resting Positions**

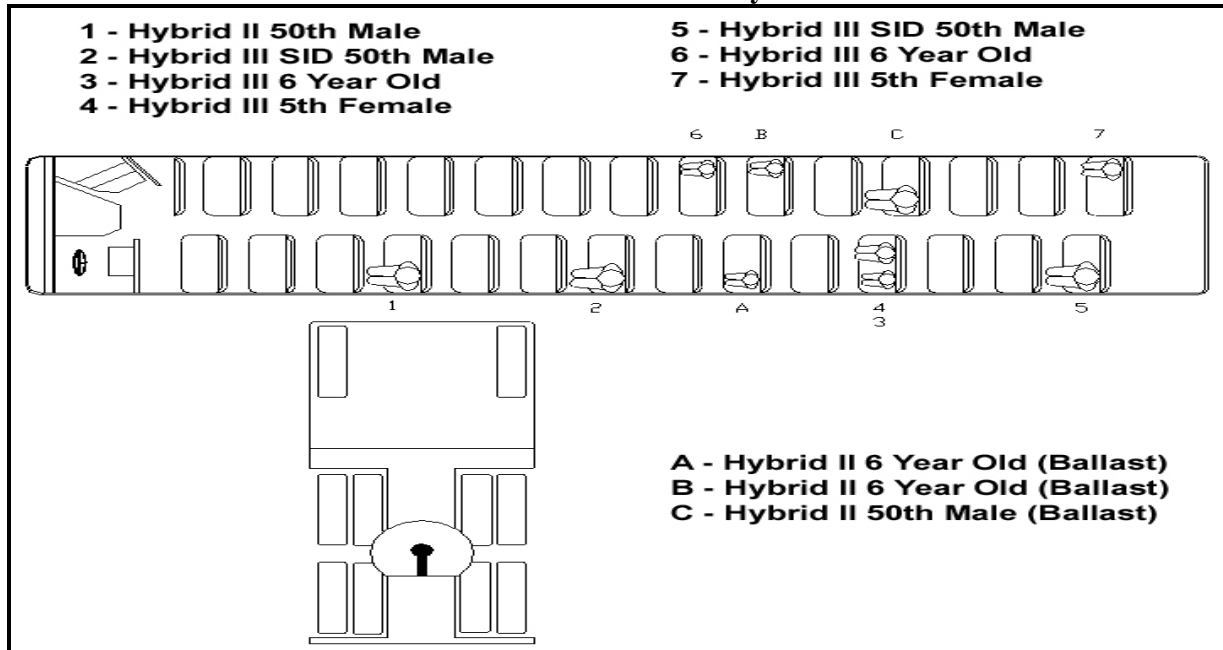
The seating positions of the dummies are shown in Figure 9. As in the frontal crash tests, the Hybrid III 5<sup>th</sup> percentile female and 6 year old dummies were used. Two 50<sup>th</sup> percentile male Side Impact Dummies (SID) which are capable of measuring lateral chest and pelvic accelerations were used in place of the Hybrid III 50<sup>th</sup> percentile male dummies. One of the 50<sup>th</sup> percentile side impact dummies (SID) was positioned in a row behind the direct impact zone of the truck (position 2 in Figure 9). One Hybrid II 50<sup>th</sup> percentile male dummy with a single tri-axial accelerometer array in the head was positioned directly centered at the point of impact to determine “survivability” within the impact zone (position 1 in Figure 9).

**Figure 9. Dummy Seating for Side School Bus Crash**

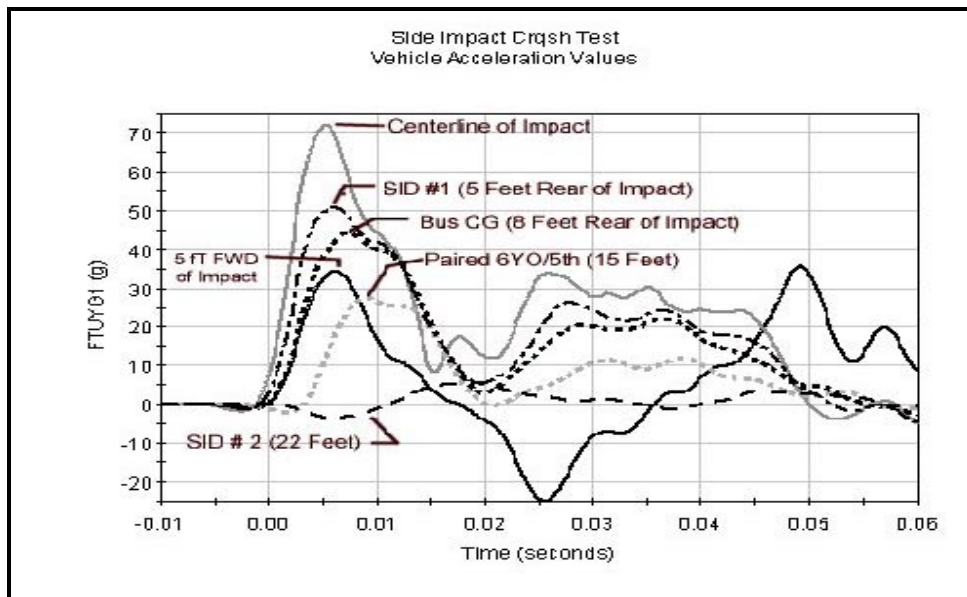
Accelerometers were positioned along the length of the school bus. Figure 10 shows the acceleration time histories overlaid for this test. At the center of impact, the peak lateral acceleration was 72 g's. Acceleration levels drop significantly away from the point of impact. This is largely due to the amount of deformation that occurred at the point of impact. This deformation acted to absorb/dissipate much of the energy that would otherwise have been transmitted to the occupants of the bus.

Figure 10. Side Impact School Bus Acceleration at Various Locations in the Bus

Unlike the frontal crash, no single pulse is fully representative of the range of vehicle responses observed in the side impact crash. Generally, all accelerometers measured an increasing level of acceleration with the peak occurring in the 50 to 75 milliseconds range. The magnitude of the peak acceleration was directly related to the proximity of the accelerometer to the impact point, with the accelerometer directly in line with the impacting vehicle's centerline registering the highest.

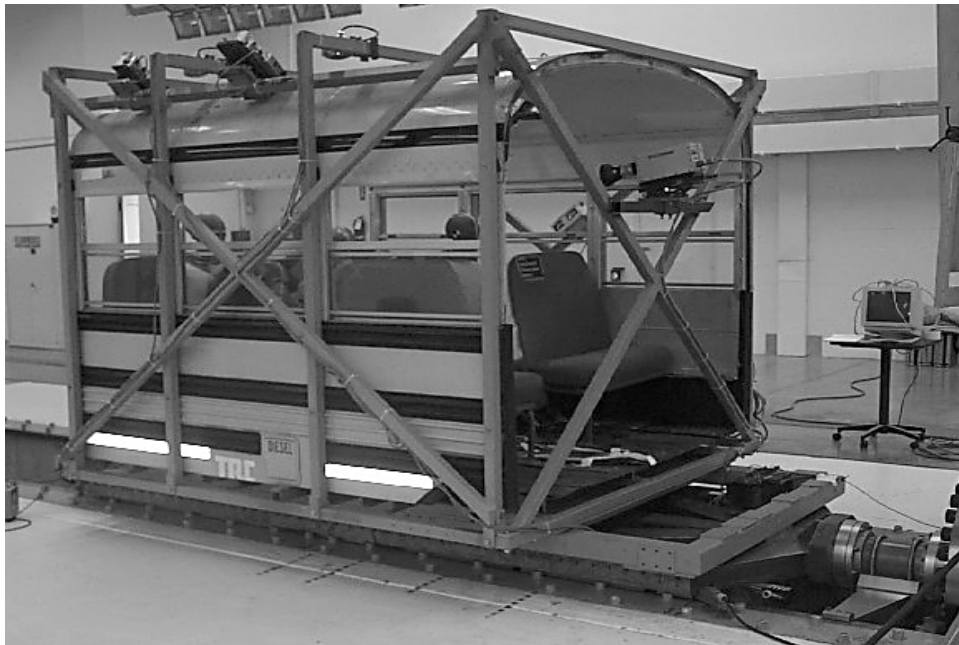
Sled tests were conducted using two different test bucks to evaluate bus safety restraint systems. The first test buck was fabricated by mounting a section from the body of the school bus on the sled. This was done to assess the degree of deformation/energy absorption by the bus floor and its interaction with the seats, and to assess any potential for occupant interaction with portions of the interior other than the seats themselves. The finished test buck is shown in Figure 11. The bus body section contained three rows of seats on both the right and left side of the center aisle. This allowed for testing a maximum of 2 rows of dummies per test.

**Figure 11. First Sled Buck used in Simulating Frontal Crashes**

Testing with the first sled buck showed that there was no significant interaction between the dummies and the walls or ceiling of the bus shell; but there was some incremental damage to the

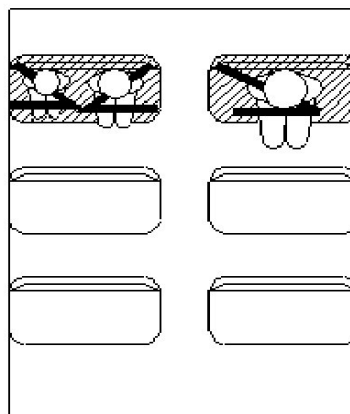
**Figure 13. Restrained Occupants Without any Loading from Occupants Seated Behind Them**

The last factor evaluated was the loading conditions on the occupants. Three different conditions were simulated as shown in Figures 13, 14, and 15.

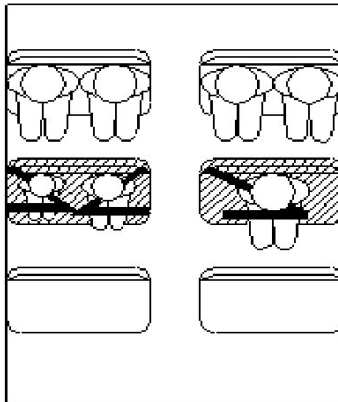
**Figure 14. Restrained Occupants With Loading From Occupants Seated Behind Them**

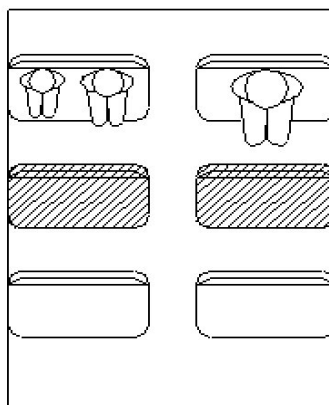
**Figure 15. Unrestrained Occupants Into Seat Back in Front of Them**

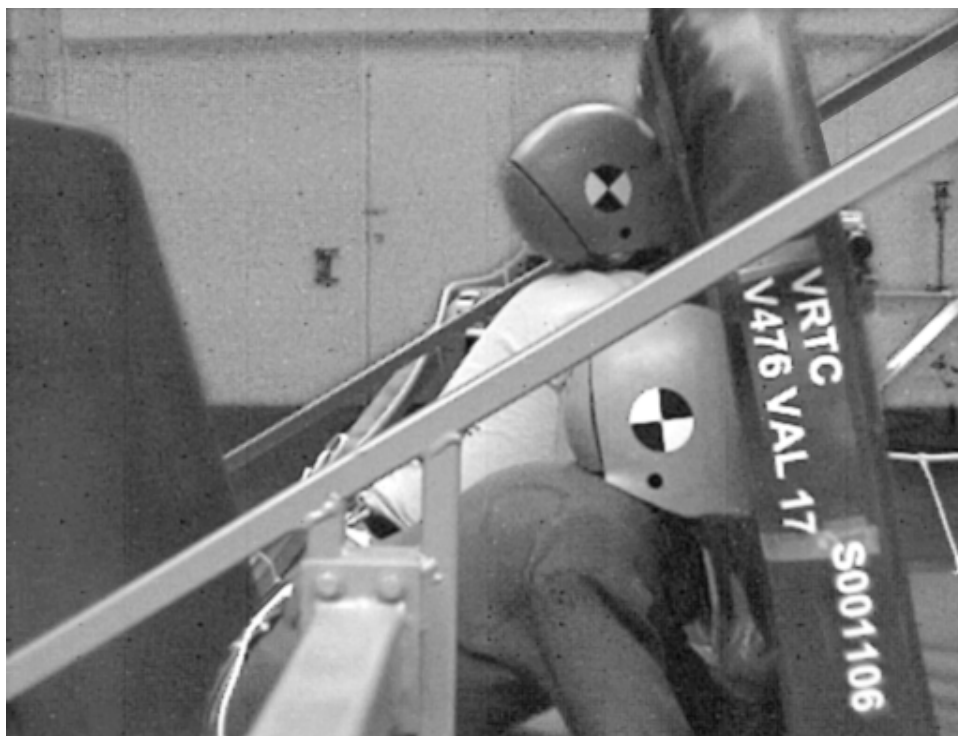
Figure 20. Lap Belt Test at Maximum Neck Extension, 150 msec

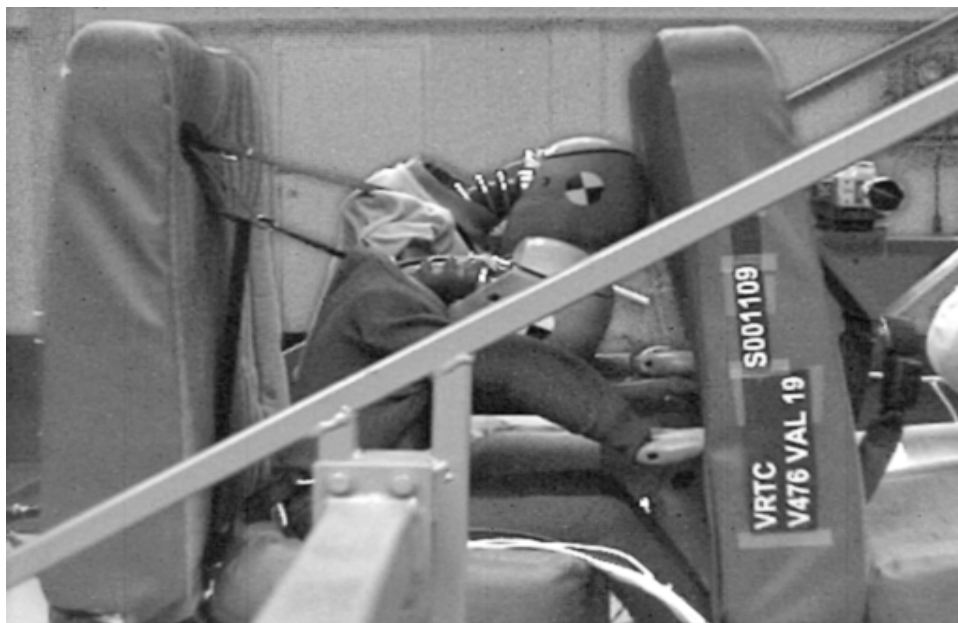
The lap/shoulder belt restraint systems typically prevented head impact into the seat back. The few exceptions with the 50<sup>th</sup> percentile male dummy resulted in very minor impacts with low resulting injury criteria values. As seen in Figure 21, a 5<sup>th</sup> percentile female and 6-year-old dummy were restrained properly with the lap/shoulder belt systems. The injury criteria values observed were the results of inertial loading on the head and neck as they snapped forward when the torso was restrained by the restraint system.

Figure 21. Lap/Shoulder Belt Test at Maximum Neck Flexion

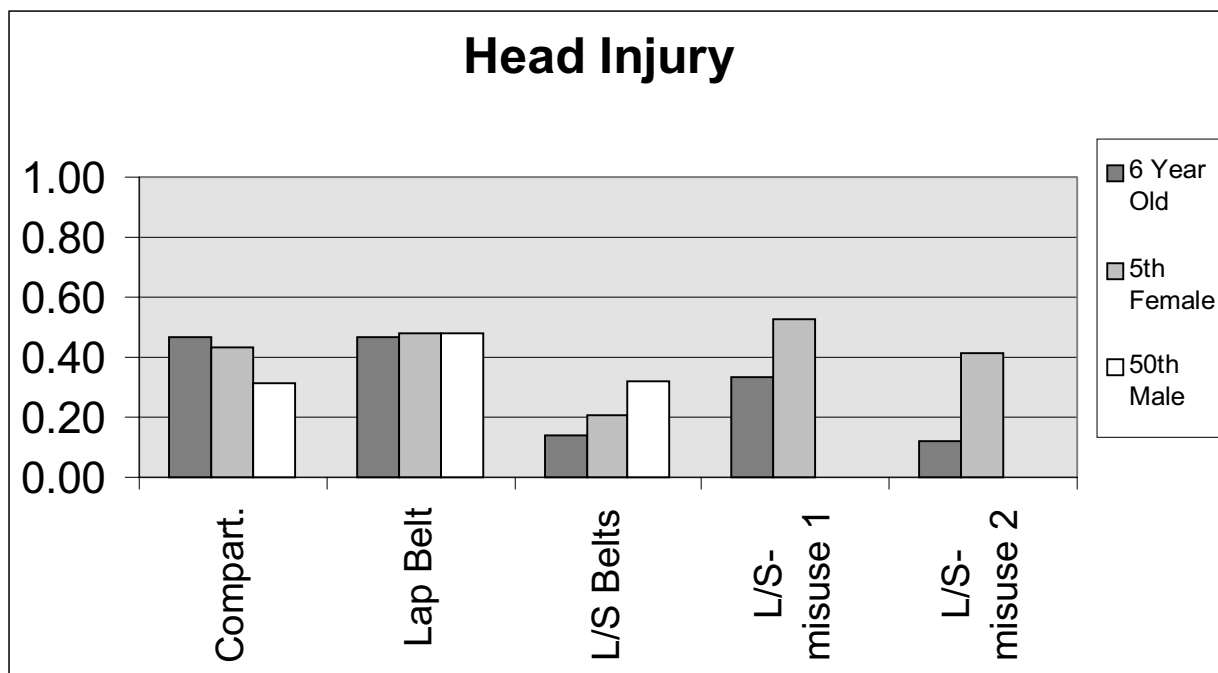
The average head injury scores (described using HIC<sub>15</sub> data) are presented in Figure 22. These data are normalized based on a reference value of 700, thus a 700 HIC<sub>15</sub> is equal to 1 on the chart. Since all the readings are well below 1, the risk for serious head injury is low – around 10 percent. Three lap/shoulder belt configurations are shown in the figures – normal, misuse 1, and misuse 2.

Figure 22. Summary of Average HIC Scores for Sled Tests Simulating Frontal Crashes

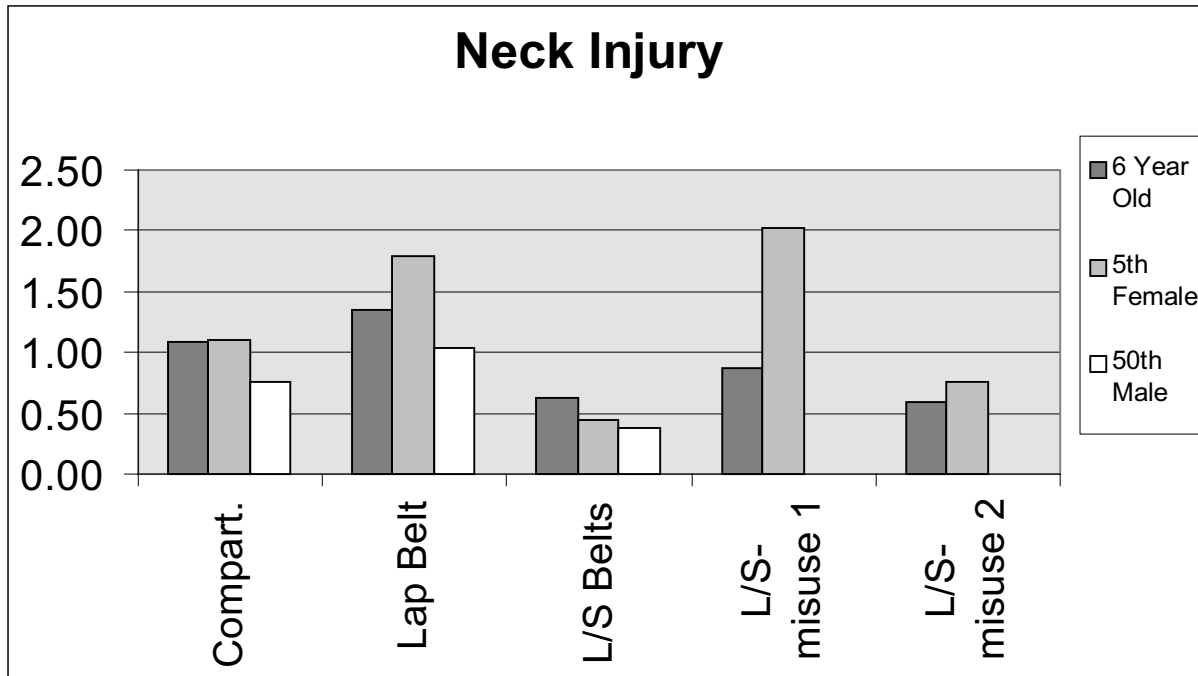
The average neck injury scores (denoted using Nij data) are presented in Figure 23. Here dummy readings are above and below the reference value, indicating some conditions have a much higher risk of neck injury than others. For neck injury, a Nij of 1 equates to a 22 percent risk of a serious neck injury while a Nij of 2 equates to a 67 percent risk of serious neck injury.

**Figure 23. Summary of Average Nij Scores Sled Tests Simulating Frontal Crashes**

**5<sup>th</sup> Percentile Female Dummy:** The average Nij response value for the 5<sup>th</sup> percentile female dummy was higher (See Figure 23) and had a much greater range of responses (Nij = 0.48 to 2.85) than for either the 6-year-old or the 50<sup>th</sup> percentile male dummies. The highest Nij values observed for this test program occurred with the lap belt tests for this dummy size.

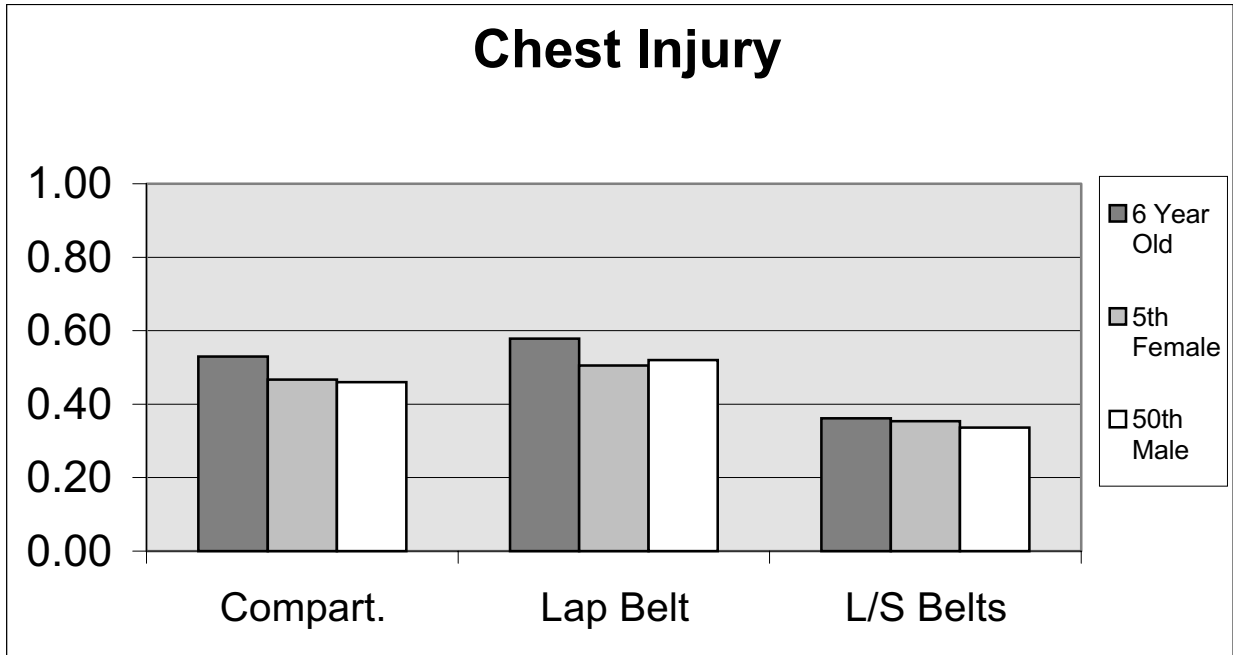
The primary injury criterion used for evaluating chest injury potential is the 3-millisecond Chest Acceleration as specified in FMVSS 208. The reference value for this criterion is 60 g's for all three of the dummy sizes used in these tests. Figure 24 summarizes the normalized average results of the testing. None of the test results showed any significant threat to injury for any of the restraint systems tested.

Figure 24. Normalized 3-msec Chest Acceleration for Frontal Sled Tests

The general kinematics along with the closely spaced and padded seat backs provided good protection to the chest for the unbelted occupant in the compartmentalized seat. The lap belt prevented the upper torso from making significant contact with the padded seat back therefore minimizing any potential loading on the chest. The shoulder portion of the lap/shoulder belt restraint system did potentially apply a load to the chest through the shoulder belt portion of the restraint system. However, the relatively low peak acceleration loads within the passenger compartment kept loading on the chest to very low levels.
