University of
Virginia

Honda Inova Fairfax Hospital CIREN Team

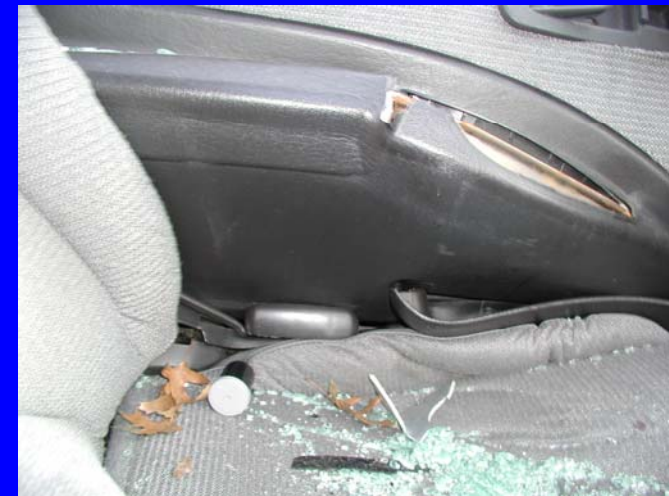
Honda Inova Fairfax Hospital CIREN Center

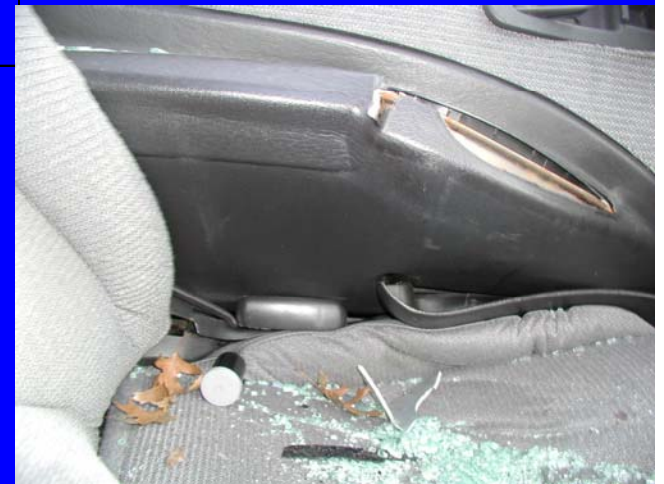
Honda Inova Fairfax Hospital CIREN Center

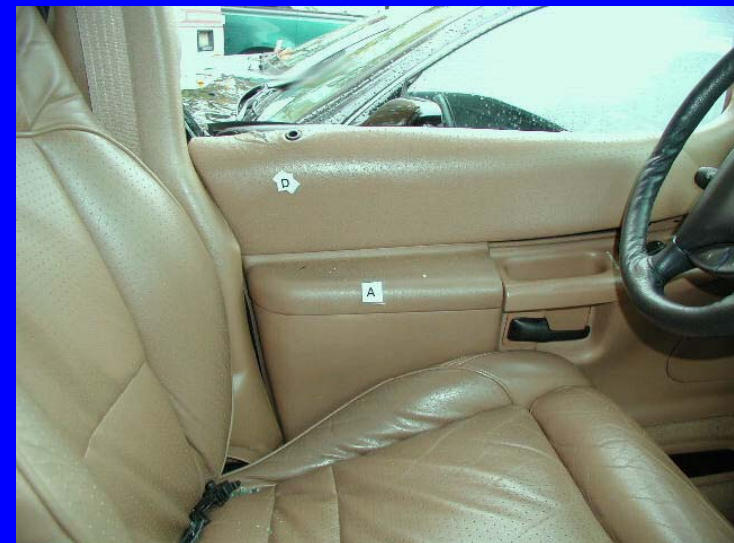
Honda Inova Fairfax Hospital CIREN Center
