**National
Transportation
Safety Board**

Seat Belts on School Buses: NTSB Crash Investigations

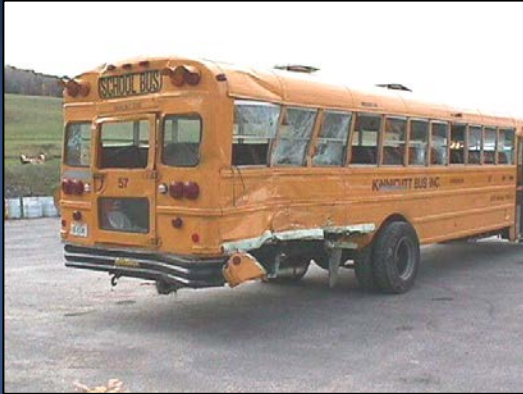
Central Bridge, NY - 1999

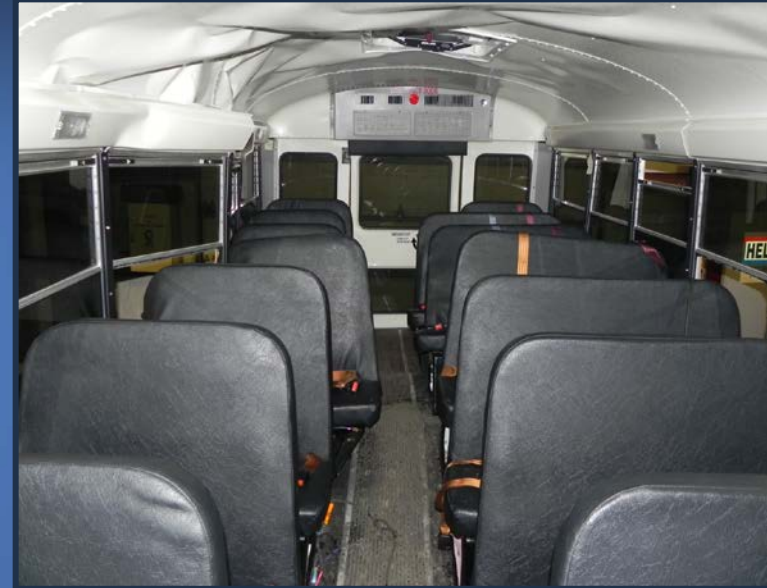
Port Saint Lucie: Crash Description

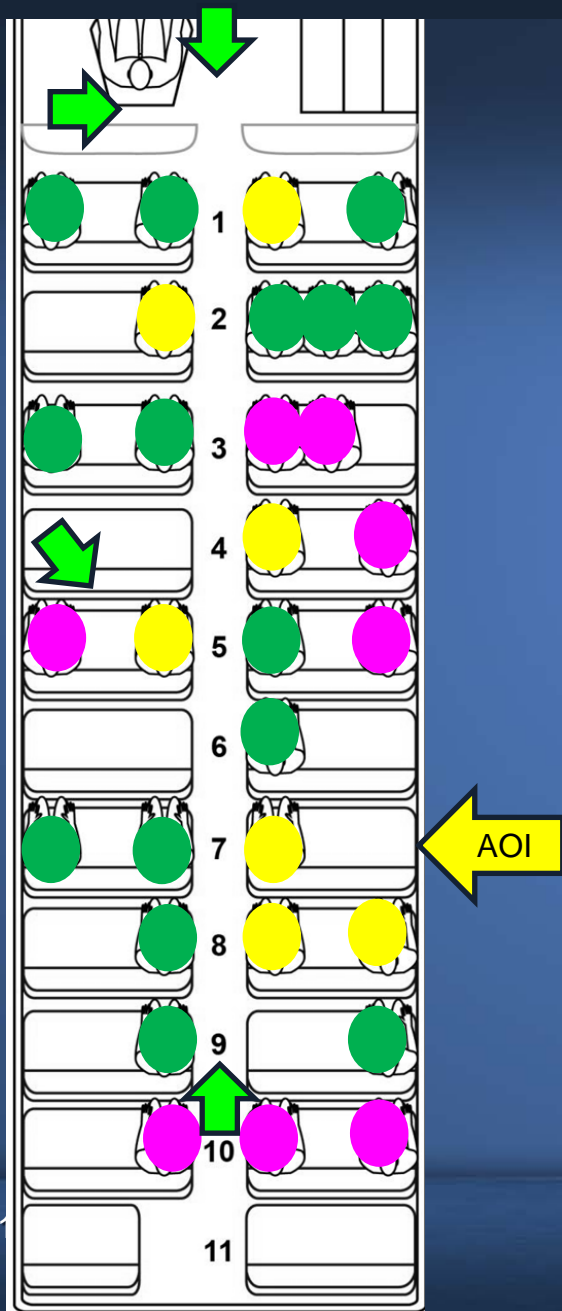
Port Saint Lucie – Belt Use Information

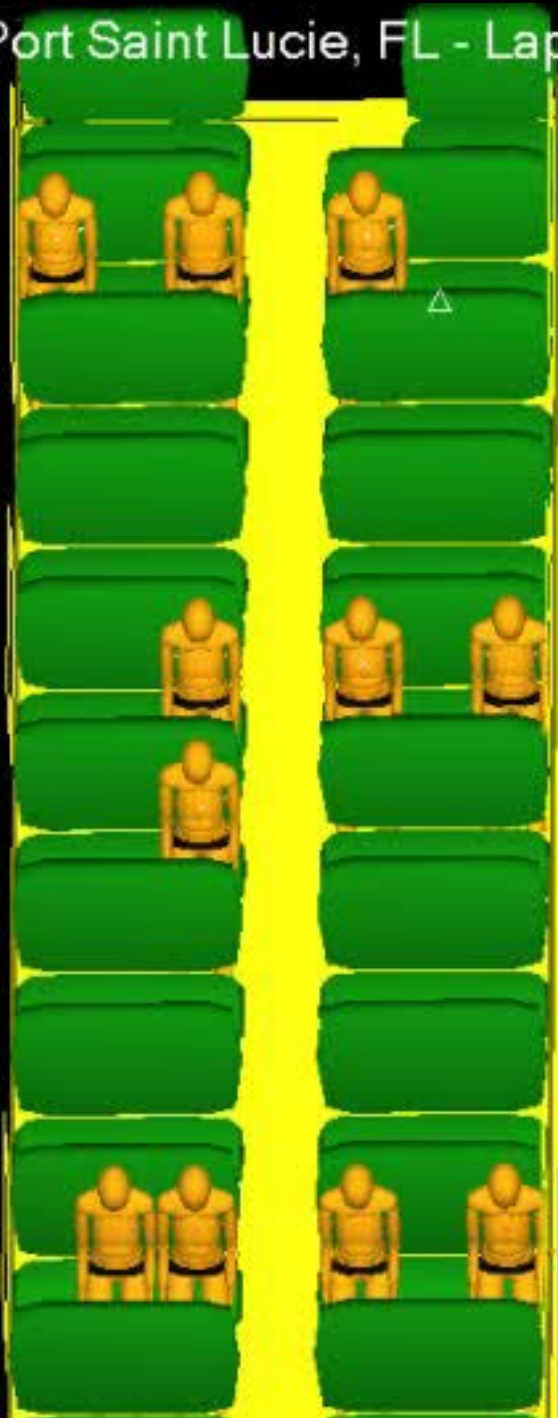
Injury from Contact on Non-Protected Interior Surfaces

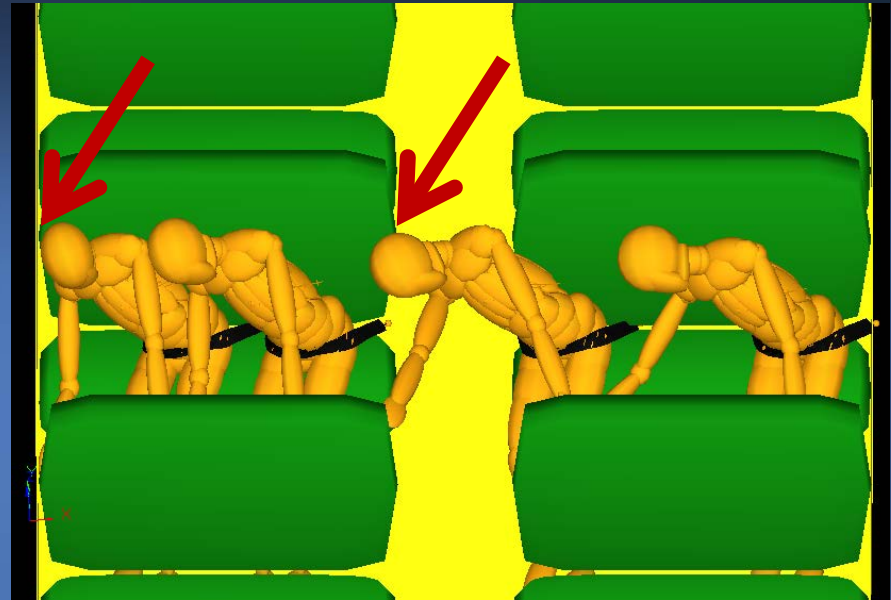
Reducing Flailing Injuries

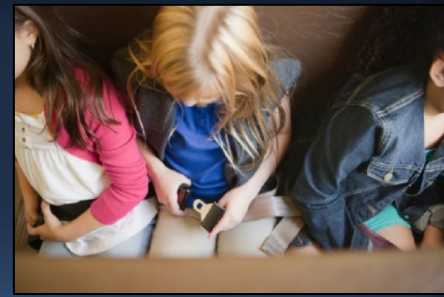
- Some lap belts worn improperly or not at all
- Lap belts can provide a benefit to passengers who wear them properly
- Properly worn seat belts enhance school bus safety

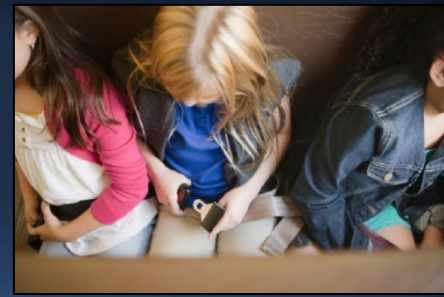
- Properly worn lap/shoulder belts reduce injuries related to upper body flailing
- Educate students, parents and school districts about proper belt use on school buses
