Single Vehicle Multiple Event Rollover Crashes: NASS and CIREN Analysis

University of Virginia

CIREN Center

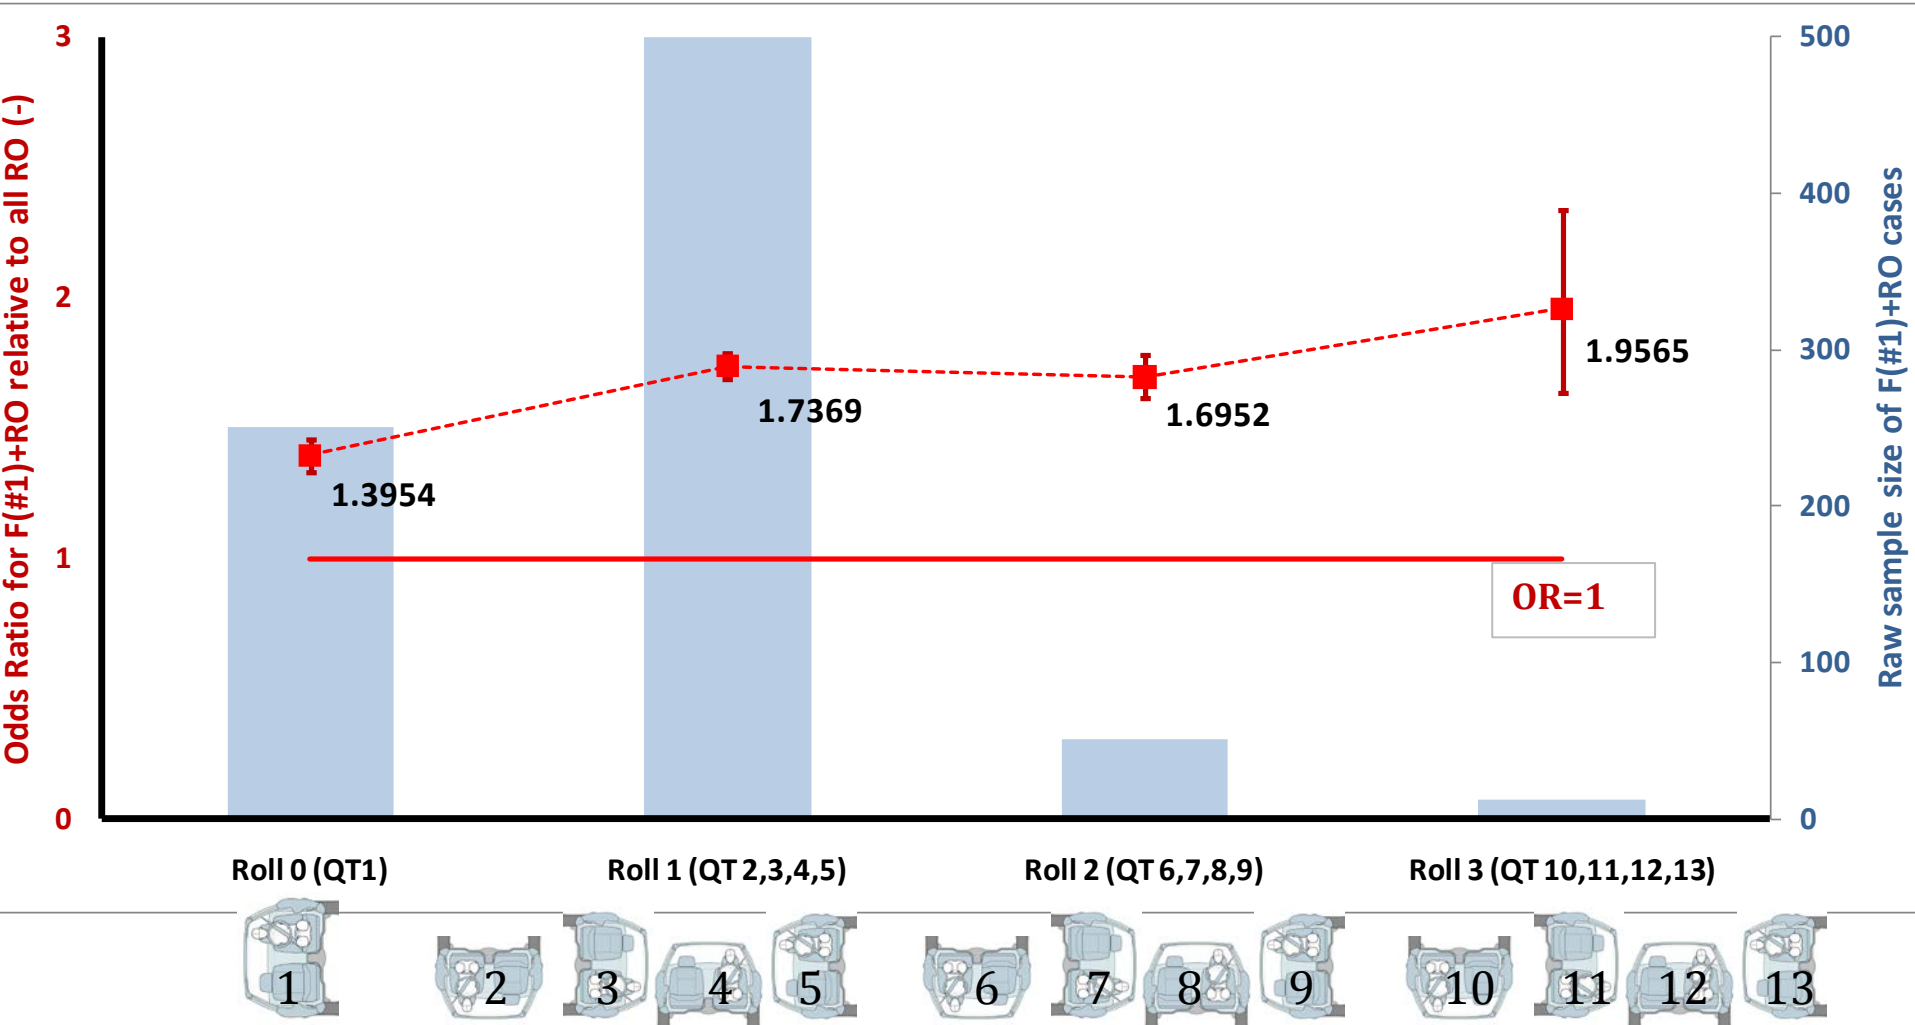
Increased odds of sustaining a MAIS 3+ injury when a Frontal(rank=1) precedes a Rollover (Baseline: all RO, Exposure: F(#1), Outcome: MAIS3+)

(Equivalent QT Distributions)

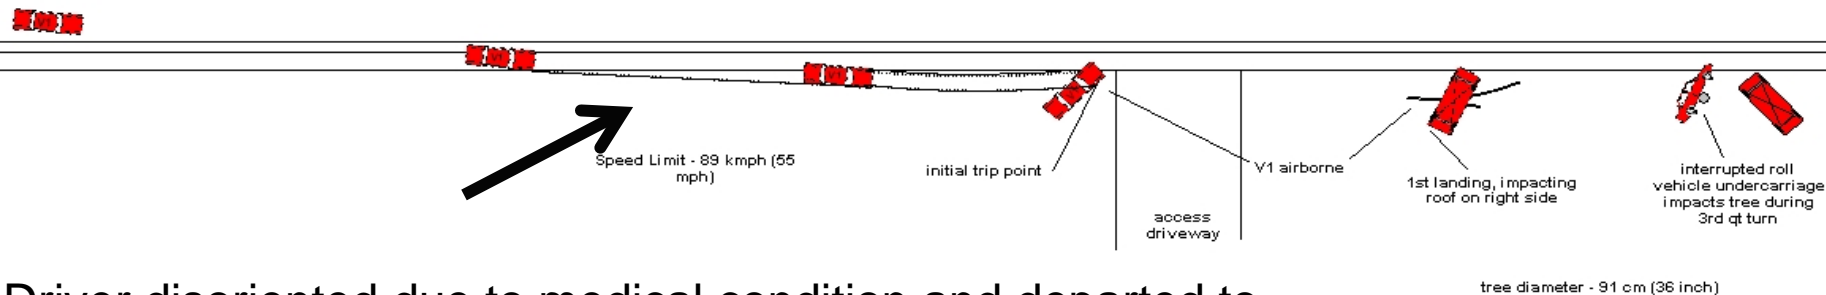
Driver disoriented due to medical condition and departed to the right side of the road.

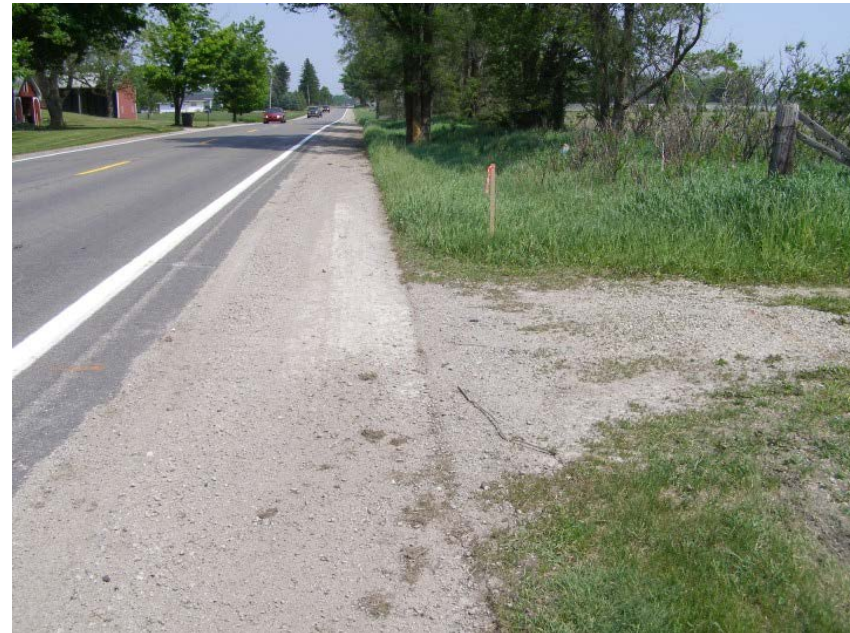
Vehicle began a CCW yaw as he attempted to return to the road.

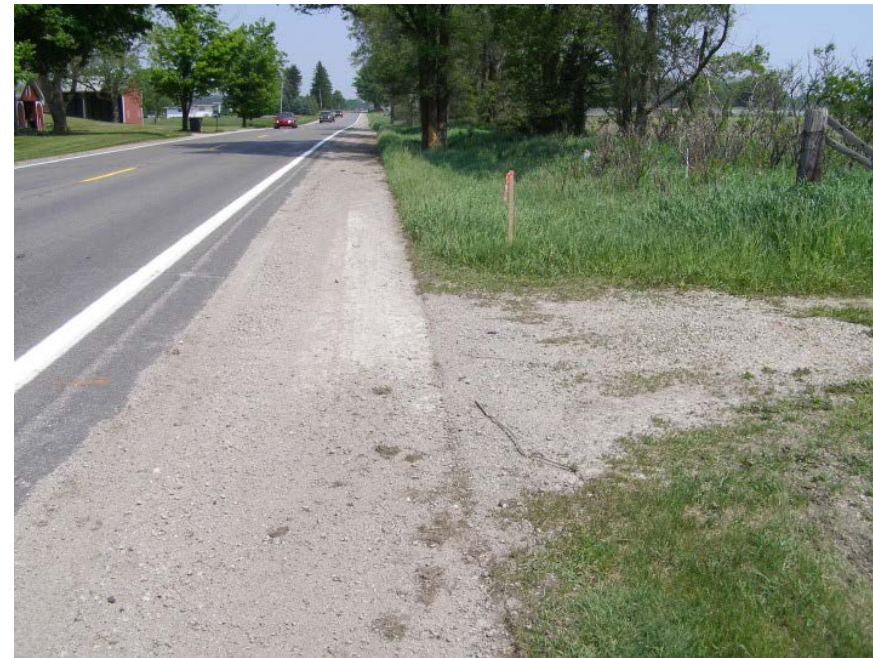
He struck a low driveway berm with his right front wheel. This induced a right side leading rollover.

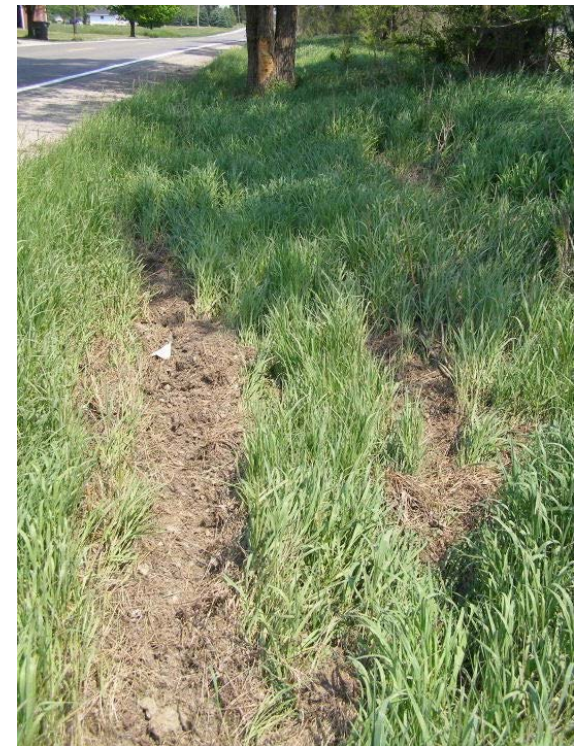
As the vehicle began to enter into the third quarter turn, the undercarriage struck a tree.

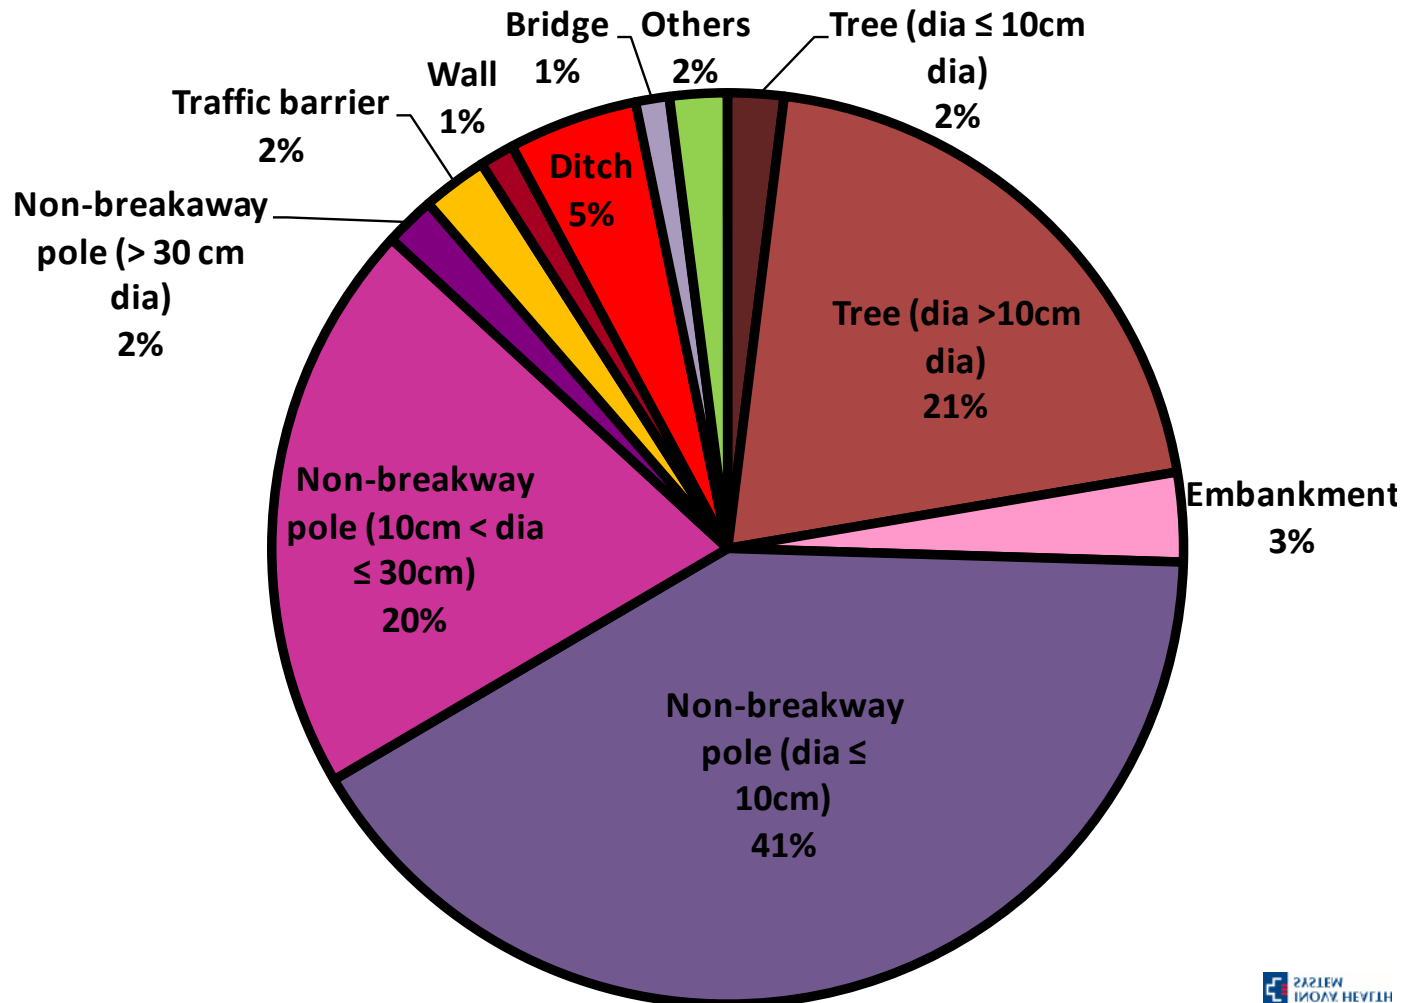
Distribution Object Contacted in Interrupted RO

Collision with fixed object is the **most severe** and **last** event in the rollover crash

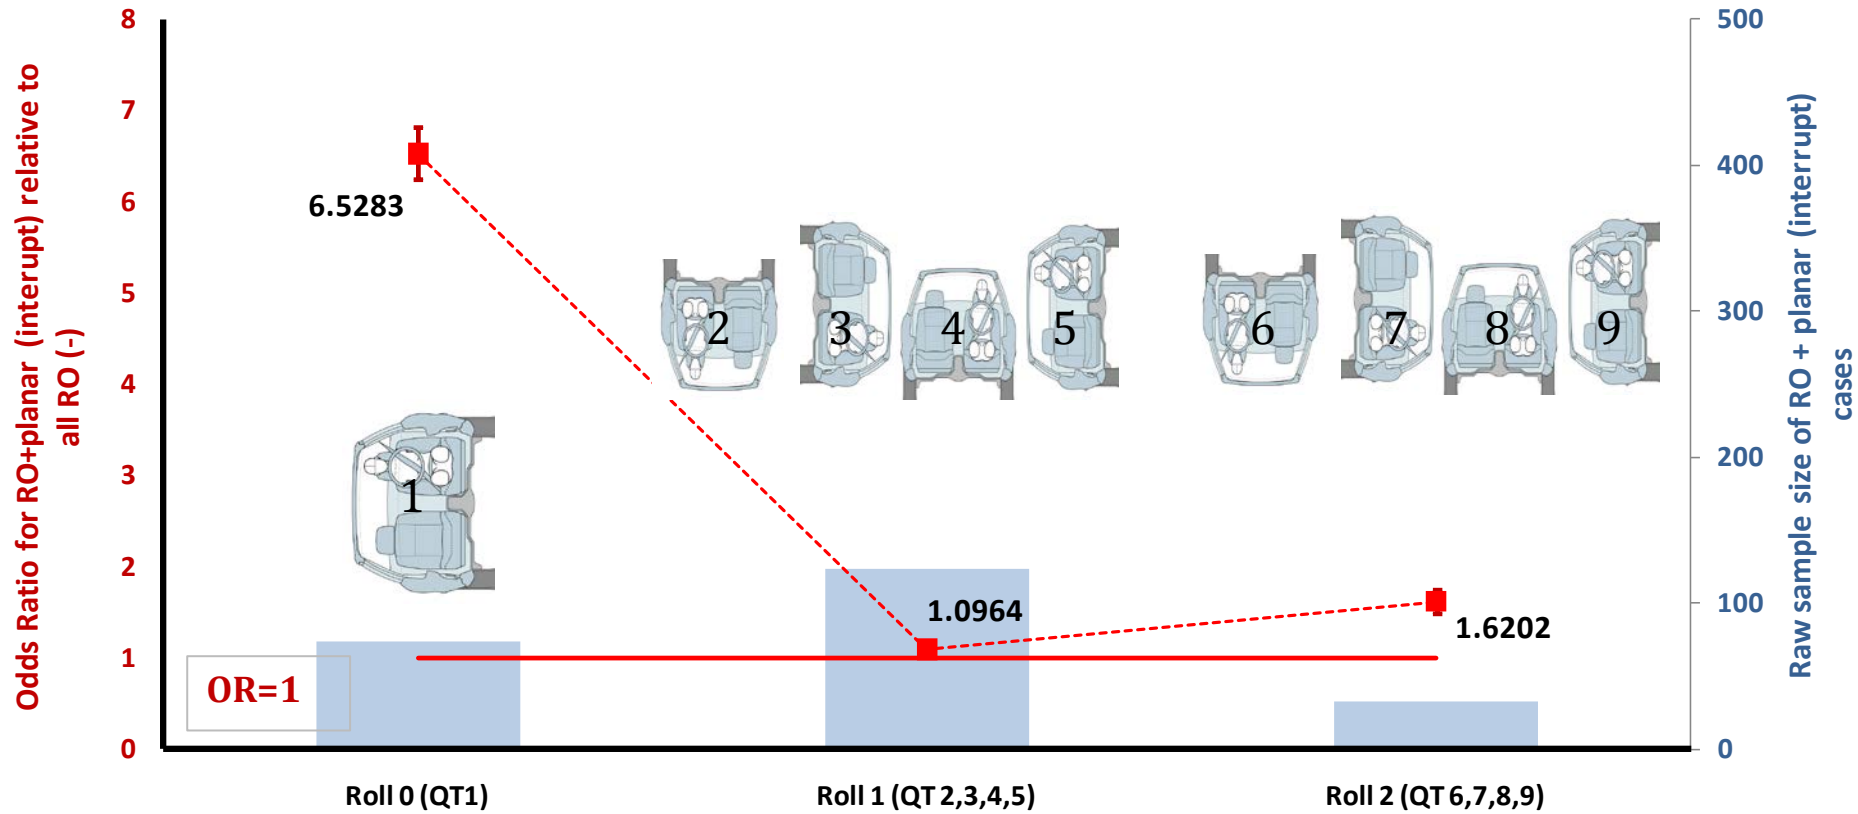
Risk of Injury when a Planar Impact Ends the RO

Increased odds of sustaining a MAIS 3+ injury when a planar impact (rank 1) interrupts a rollover
(Baseline: all RO, Exposure: Planar(interrupt), Outcome: MAIS3+)

Roll number = roof inversions
(equivalent RO QT distributions)

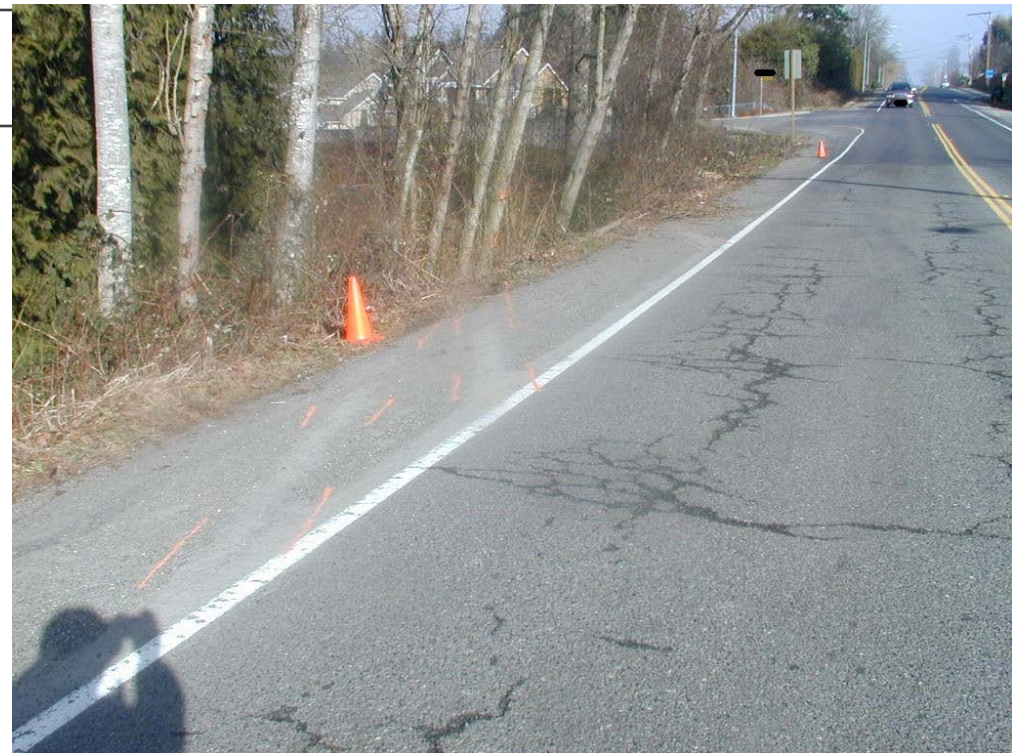
The vehicle lost control due to icy condition, went into southbound lane rotating CCW and departed roadway to the left, down an embankment.

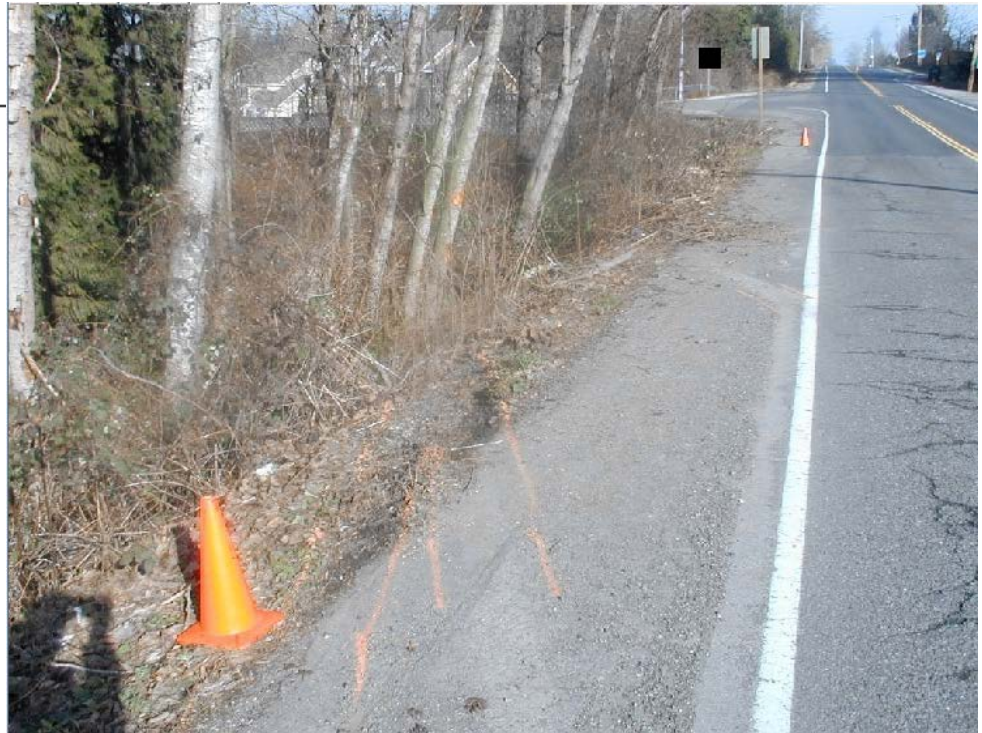
After departing off the paved shoulder. Vehicle tilted to the right, and the top hood and windshield impacted a small tree, resulting in minor damage

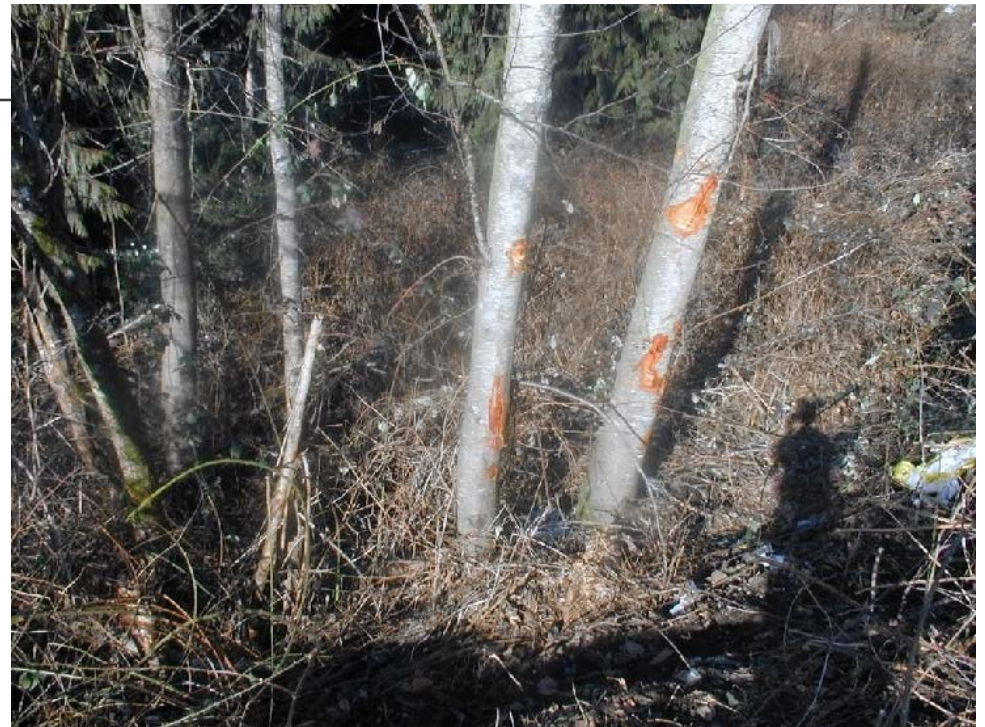
The roof top impacted a second and third tree, resulting in significant passenger roof intrusion.

Lower right side contacted the ground, completing the one quarter turn rollover event, and resulting in minor right side damage. V1 came to final rest angled on the embankment with its lower right side against the ground and its top leaning on the struck trees.

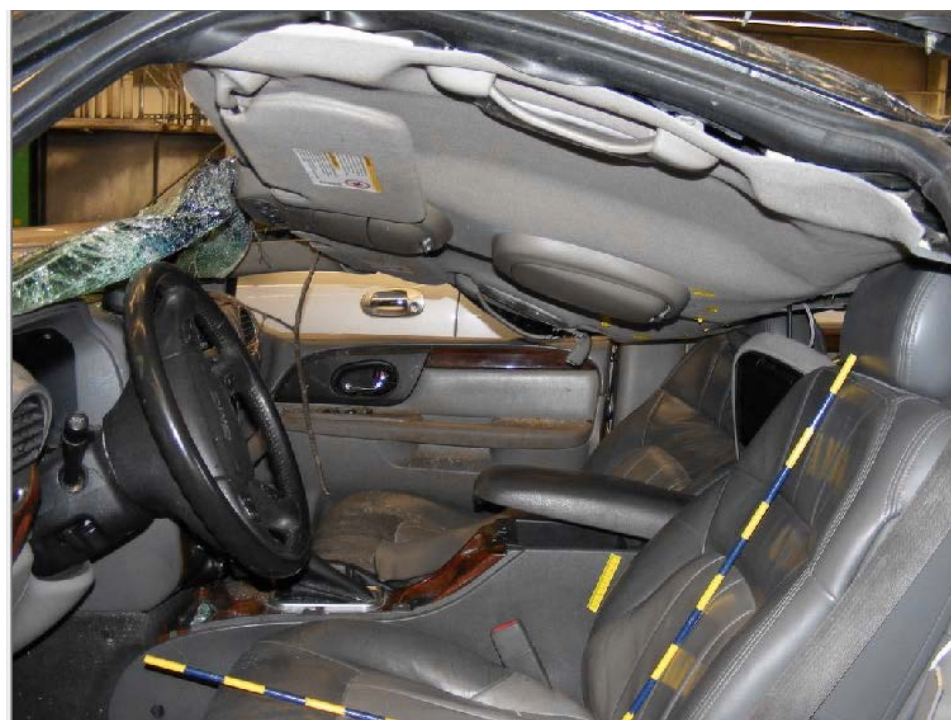
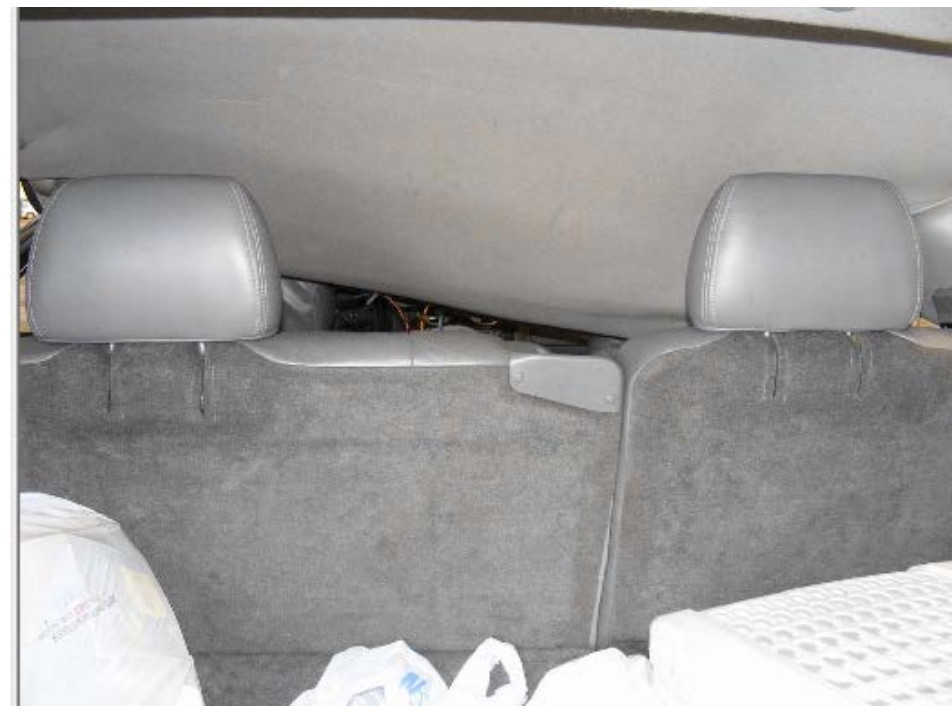
Row	Position	Area	Intruded Component	Comparison	Intruded	Intrusion	Magnitude	Crush Direction
Front Seat	Right	Interior	B-pillar	110	73	37	≥ 30 to < 46 cms	Vertical
Second Seat	Right	Interior	Roof (or convertible top)	75	38	37	≥ 30 to < 46 cms	Vertical
Front Seat	Right	Interior	Roof (or convertible top)	108	73	35	≥ 30 to < 46 cms	Vertical
Second Seat	Middle	Interior	Roof (or convertible top)	75	45	30	≥ 30 to < 46 cms	Vertical
Second Seat	Right	Interior	C-pillar	84	66	18	≥ 15 to < 30 cms	Vertical
Second Seat	Left	Interior	Roof (or convertible top)	75	50	25	≥ 15 to < 30 cms	Vertical
Front Seat	Left	Interior	Roof (or convertible top)	108	82	26	≥ 15 to < 30 cms	Vertical
Front Seat	Middle	Interior	Roof (or convertible top)	108	79	29	≥ 15 to < 30 cms	Vertical

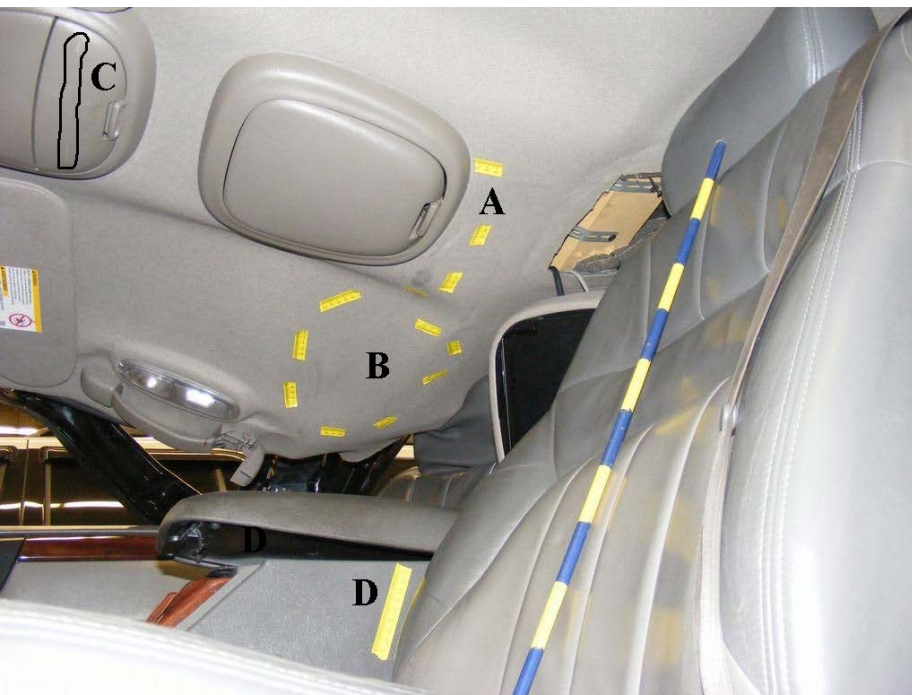
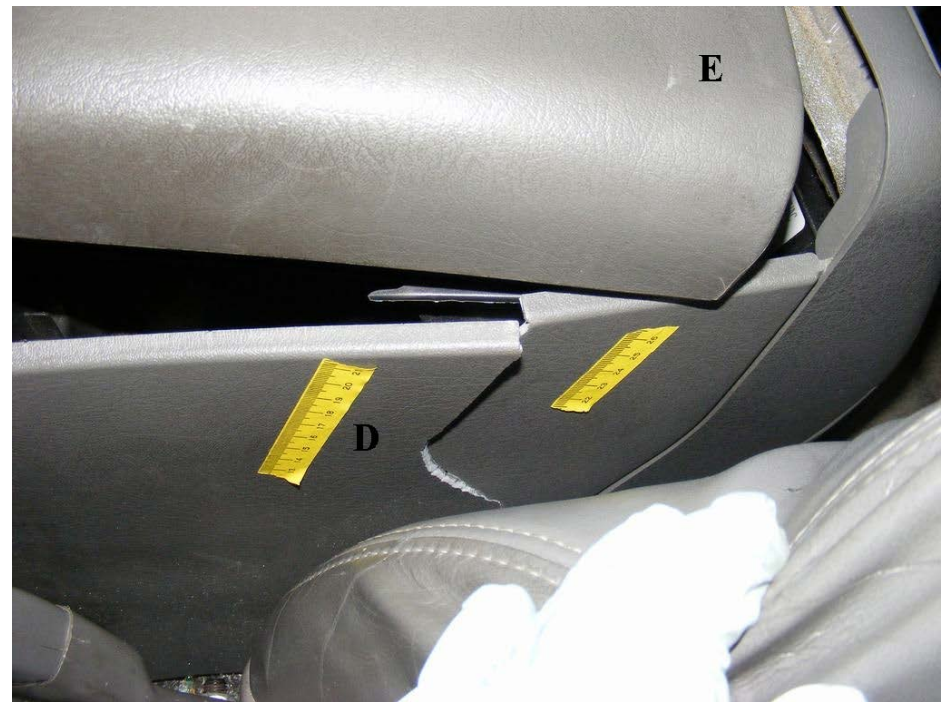
Contacts

Contact	Area	Component	Occ #	Body Region	Evidence	Confidence
A	Roof	Roof or convertible top	1	Shoulder - Left	Scuffed	Certain
B	Roof	Roof or convertible top	1	Back	Combination (Specify)	Certain
C	Roof	Roof maplight/console	1	Hand - Right	Scuffed	Possible
D	Floor	Floor or console mounted transmis	1	Hip - Right	Cracked	Certain
E	Floor	Floor or console mounted transmis	1	Hip - Right	Combination (Specify)	Possible
F	Interior	Belt restraint webbing/buckle	1	Multiple Regions (spec	Other (Specify)	Probable
G	Left Side	Left B-pillar	1	Multiple Regions (spec	Combination (Specify)	Possible

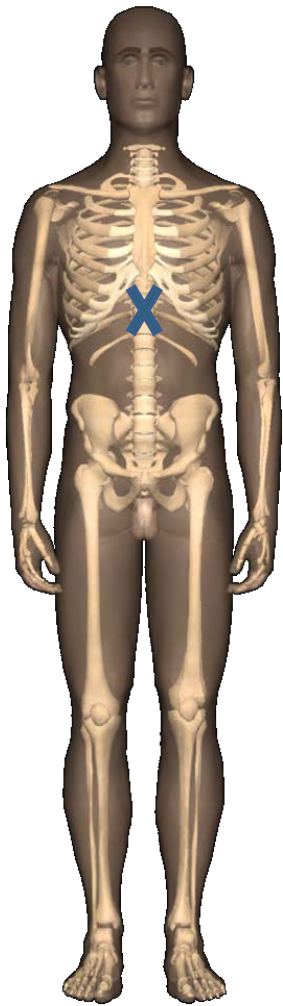
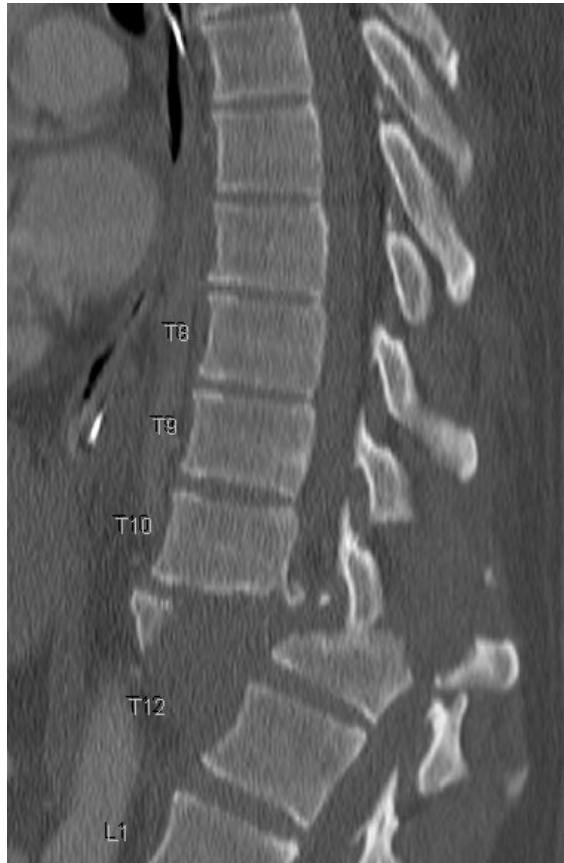
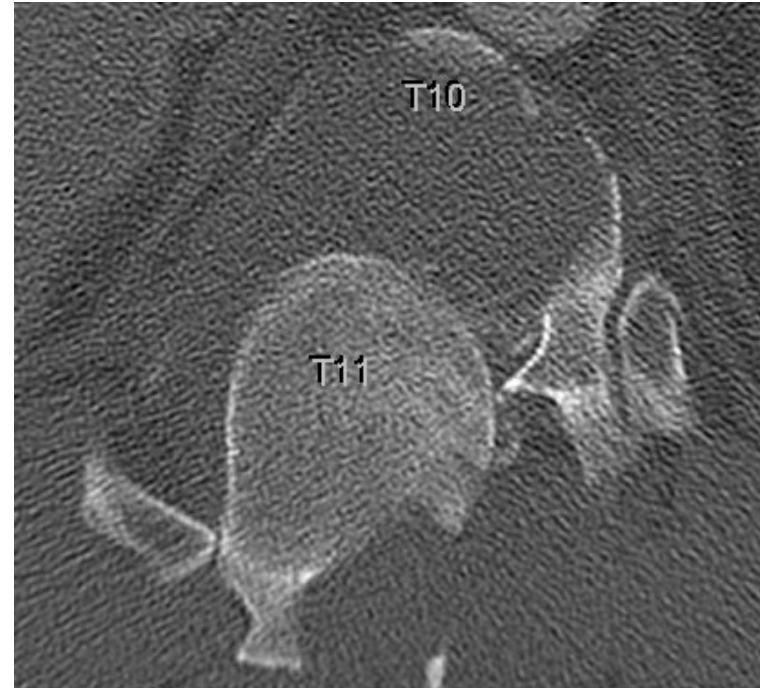
T10-11 FRACTURE DISLOCATION WITH COMPLETE CORD TRANSECTION, NO SENSATION OR MOTOR FUNCTION UMBILICUS DOWN; FRACTURE THROUGH VERTEBRAL BODY.

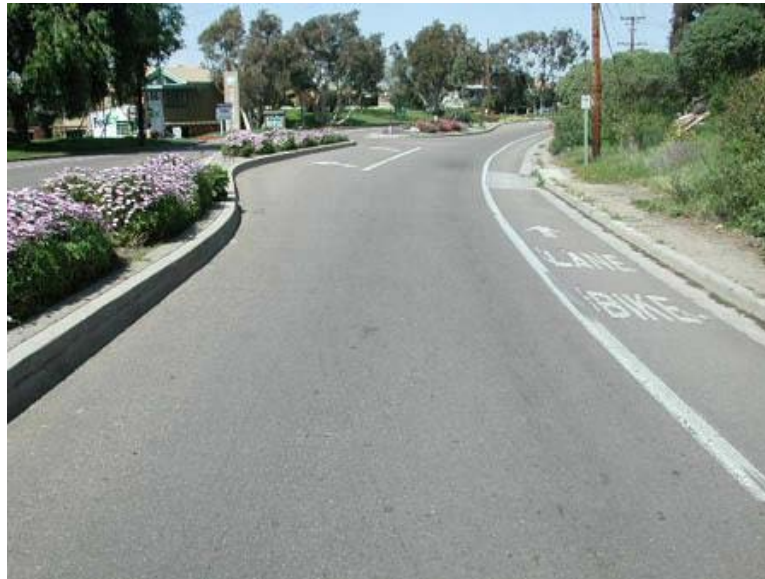
The vehicle descended a hill, negotiating a right curve, travelled into the left lane, was about to hit the median, overcorrected to right, began a clockwise yaw and slid right.

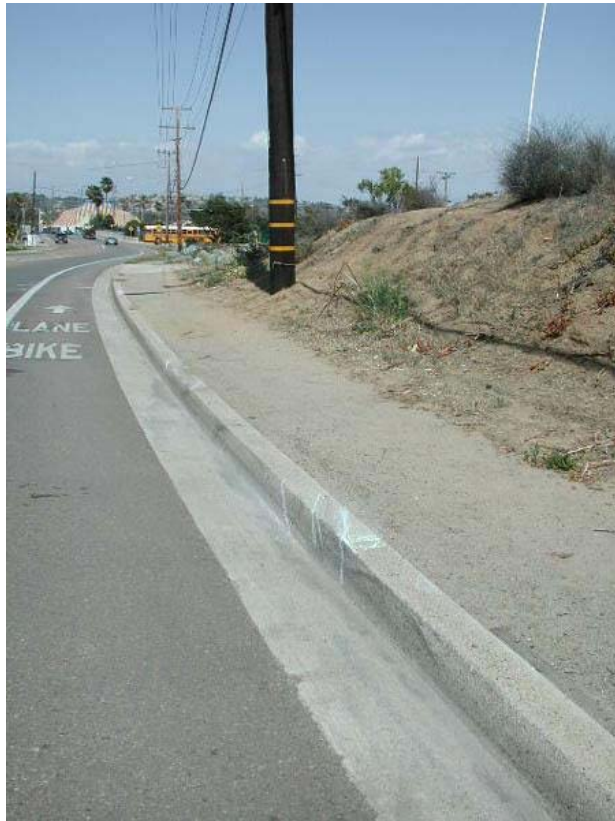
Vehicle hit the curb with rear wheel.

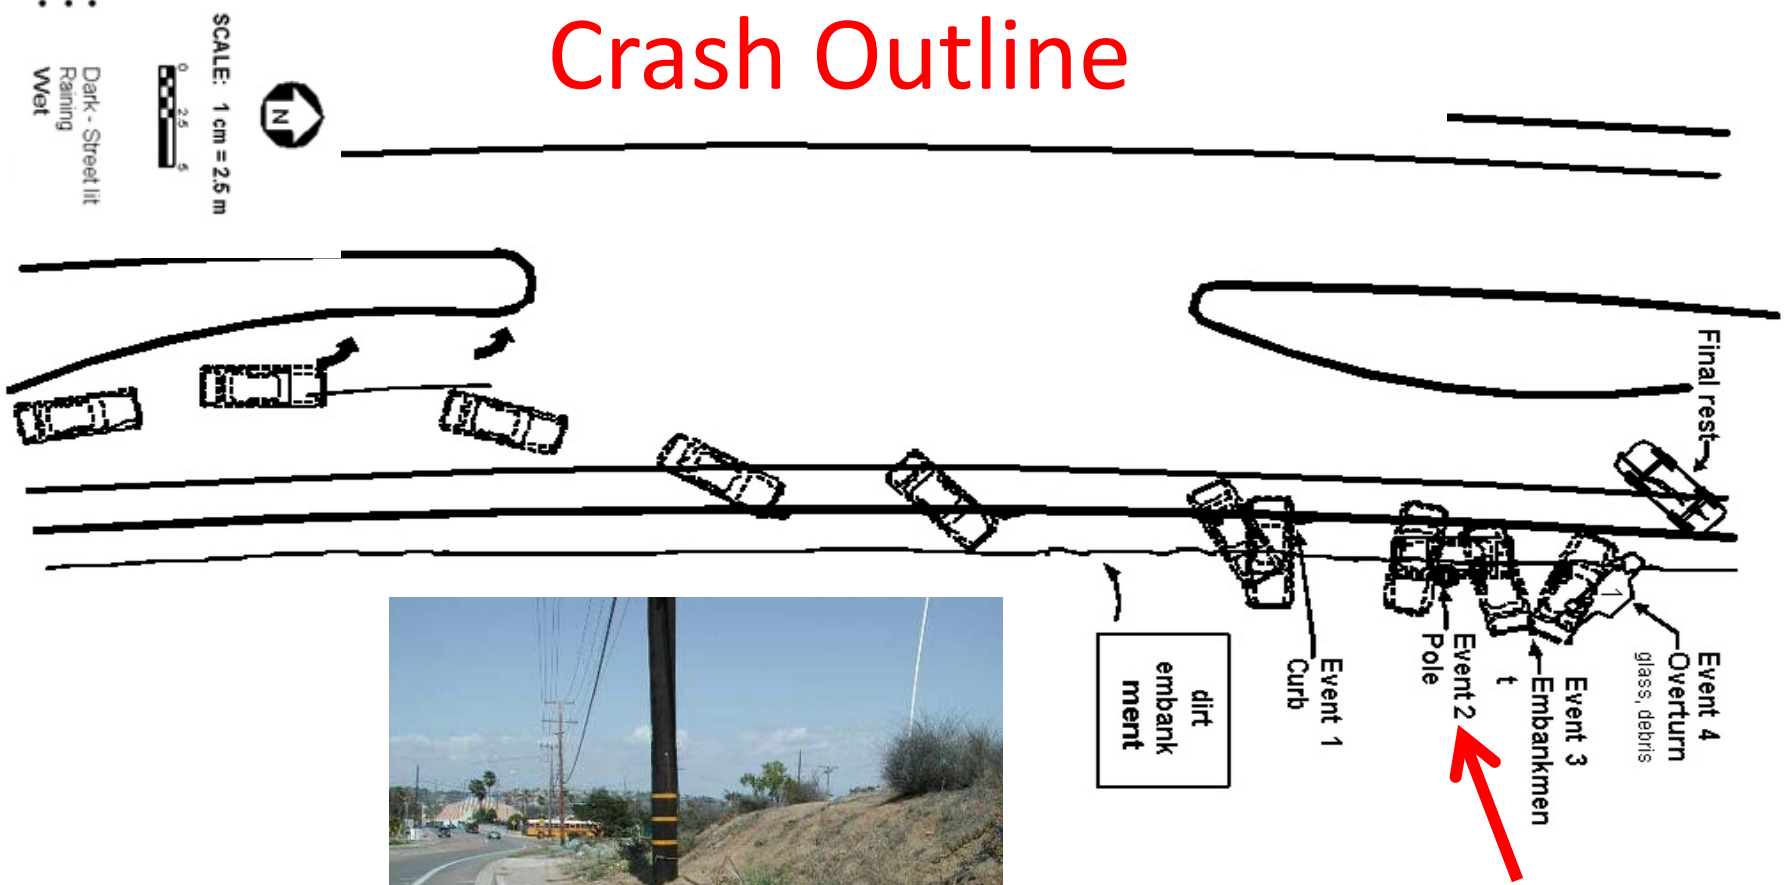
Scenario 1: Vehicle struck a utility pole with left side driver door, rotated 180 deg CW around the pole

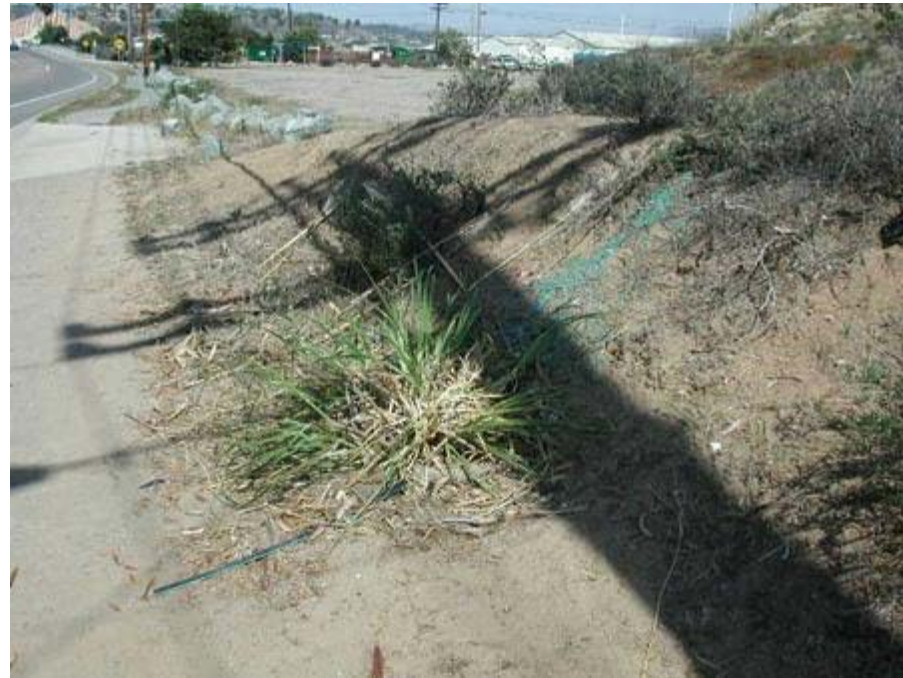
Final rest
Event 4
Overturn
glass, debris
Event 3
Embankment
Event 2
Pole
Event 1
Curb
dirt embankment

Scenario 1: When it disengaged the pole the rear undercarriage struck the embankment.

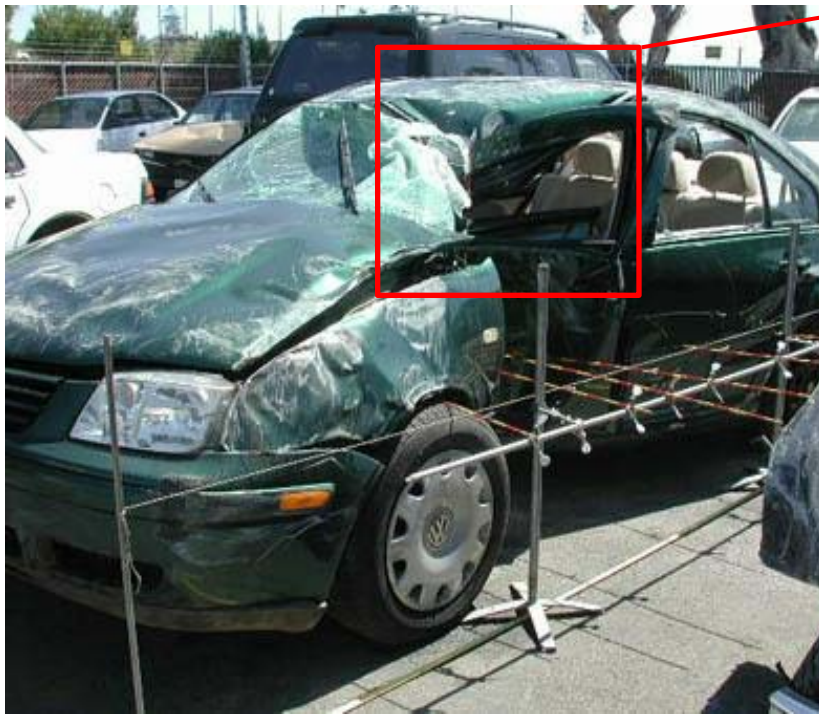
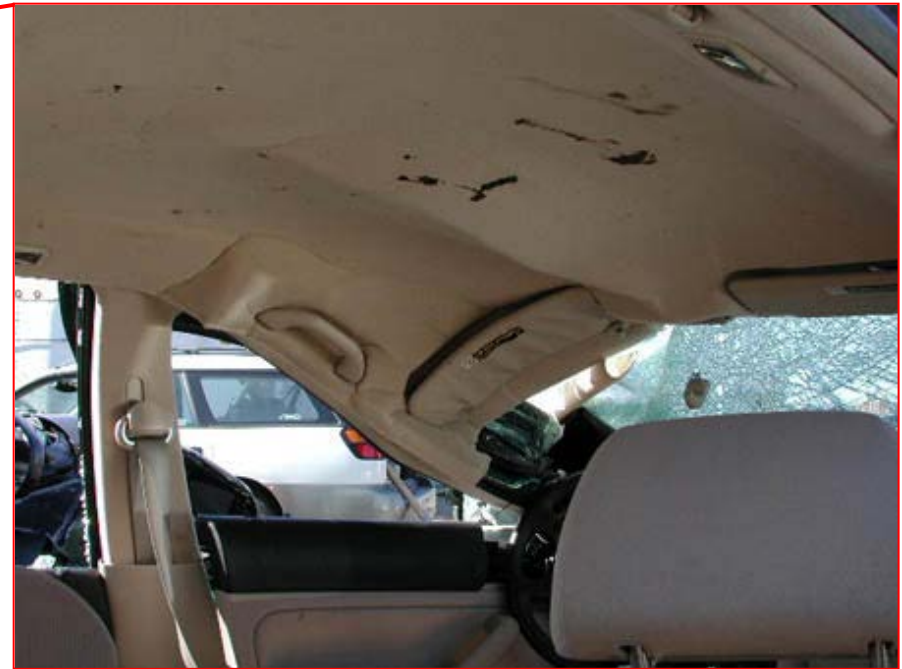
Row	Position	Area	Intruded Component	Comparison	Intruded	Intrusion	Magnitude	Crush Direction
Front Seat	Left	Interior	Door panel (side)	68	12	56	>= 46 to < 61 cms	Lateral
Front Seat	Left	Interior	Floor pan (includes sill)	68	21	47	>= 46 to < 61 cms	Lateral
Front Seat	Left	Interior	Side panel - forward of	64	8	56	>= 46 to < 61 cms	Lateral
Second Seat	Left	Interior	Front seat back	0	55	55	>= 46 to < 61 cms	Longitudinal
Front Seat	Left	Interior	A (A1/A2)-pillar	65	29	36	>= 30 to < 46 cms	Lateral
Front Seat	Left	Interior	Windshield header	29	6	23	>= 15 to < 30 cms	Vertical
Front Seat	Left	Interior	Roof (or convertible top)	33	7	26	>= 15 to < 30 cms	Vertical
Front Seat	Left	Interior	Roof side rail	59	33	26	>= 15 to < 30 cms	Lateral
Second Seat	Left	Interior	Door panel (side)	136	129	7	>= 3 to < 8 cms	Lateral

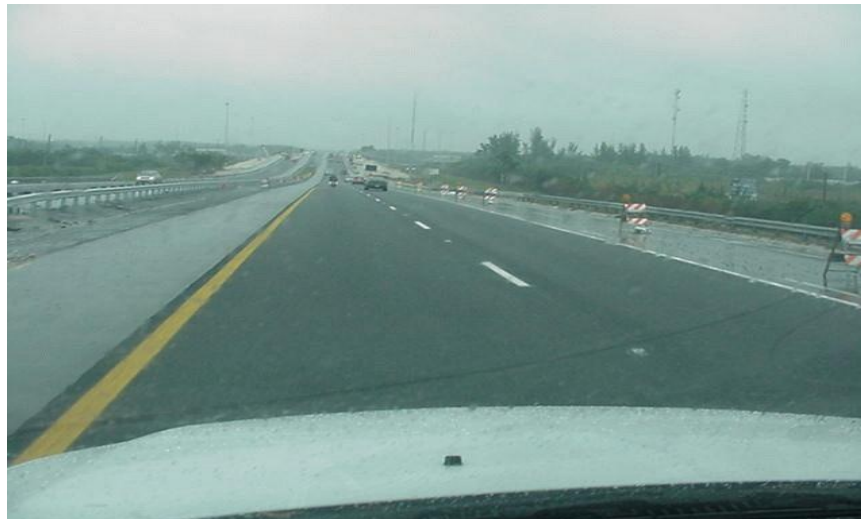
It began a CCW yaw ,
slid laterally in north-
east direction and
began to roll over to the
right.

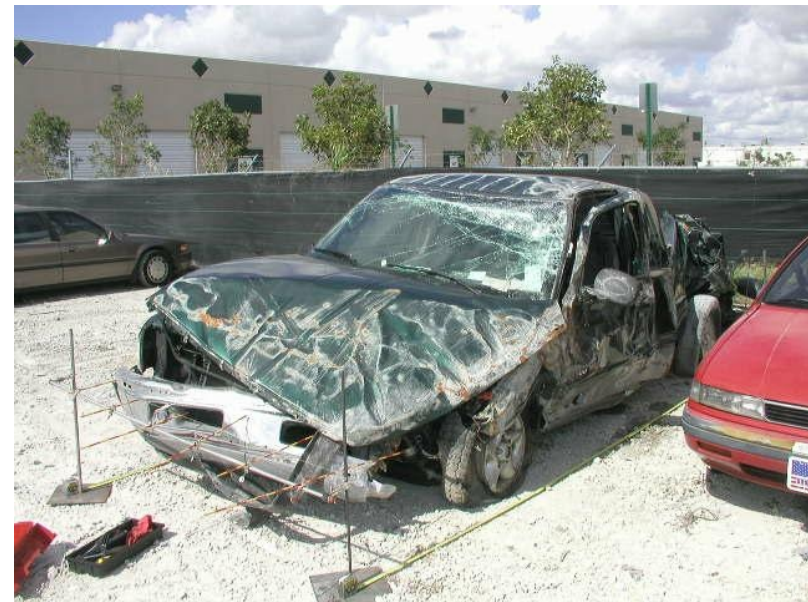
At the same time between 2nd and 4th QT, top and the left side was touching the road surface.

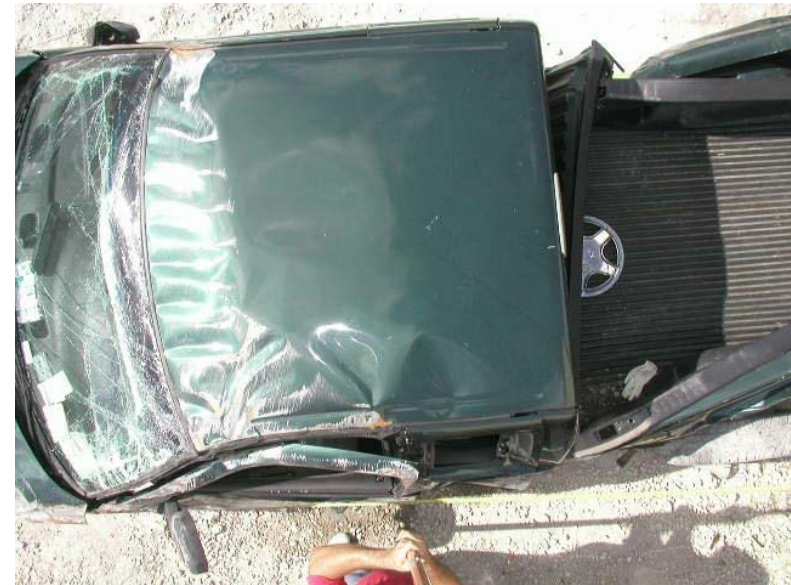
The case vehicle rolled a total of 6, quarter turns and came to final rest on its roof and hood,

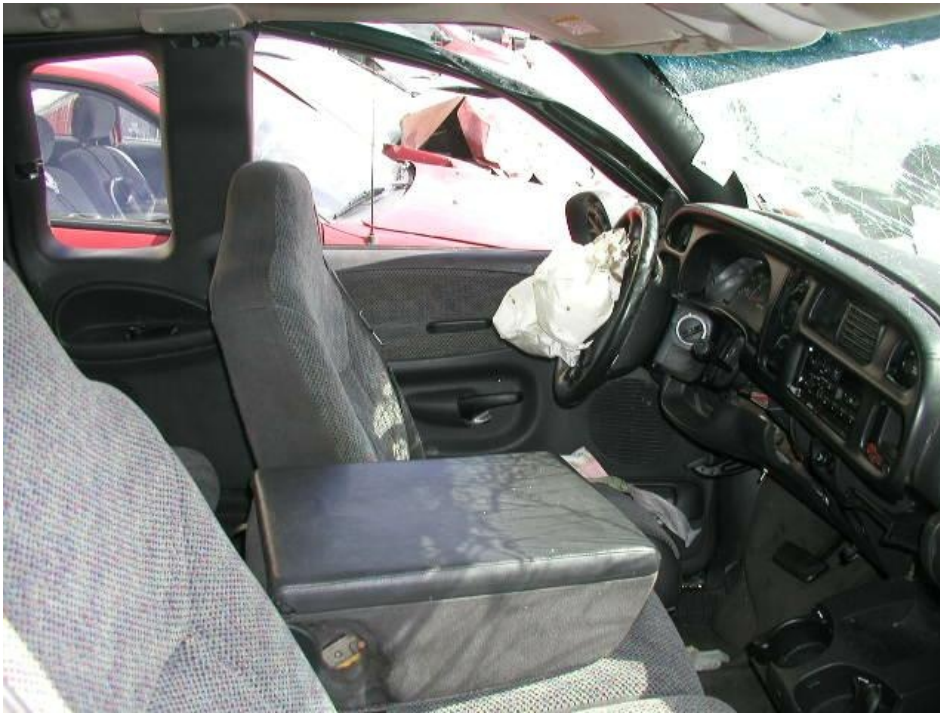
Contacts

Contact	Area	Component	Occ #	Body Region	Evidence	Confidence
A	Front	Windshield	1	Lower Arm - Left	Transfer (Specify)	Certain
B	Air Bag	Air bag-driver side	1	Face	Scuffed	Certain
C	Front	Left instrument panel and below	1	Hand - Left	Cracked	Certain
D	Roof	Roof or convertible top	1	Shoulder - Right	Scuffed	Probable
E	Interior	Center console first row	1	Hip - Right	Bent	Probable
F	Front	Knee bolster	1	Knee - Left	Scuffed	Certain
G	Front	Knee bolster	1	Knee - Right	Scuffed	Certain

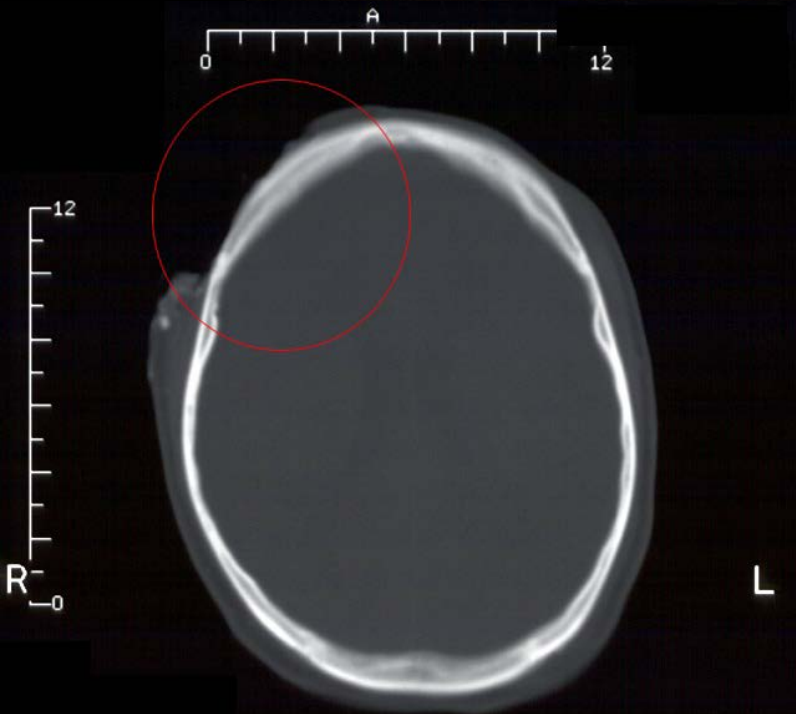
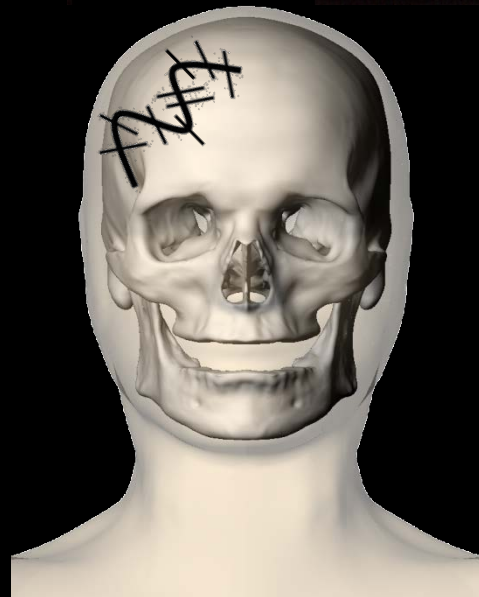
**LARGE
LACERATION IN
THE SKIN OVER
THE RIGHT
FRONTAL REGION
(INBOARD)**
