Single Vehicle Multiple Event Rollover Crashes: NASS and CIREN Analysis

University of Virginia

CIREN Center

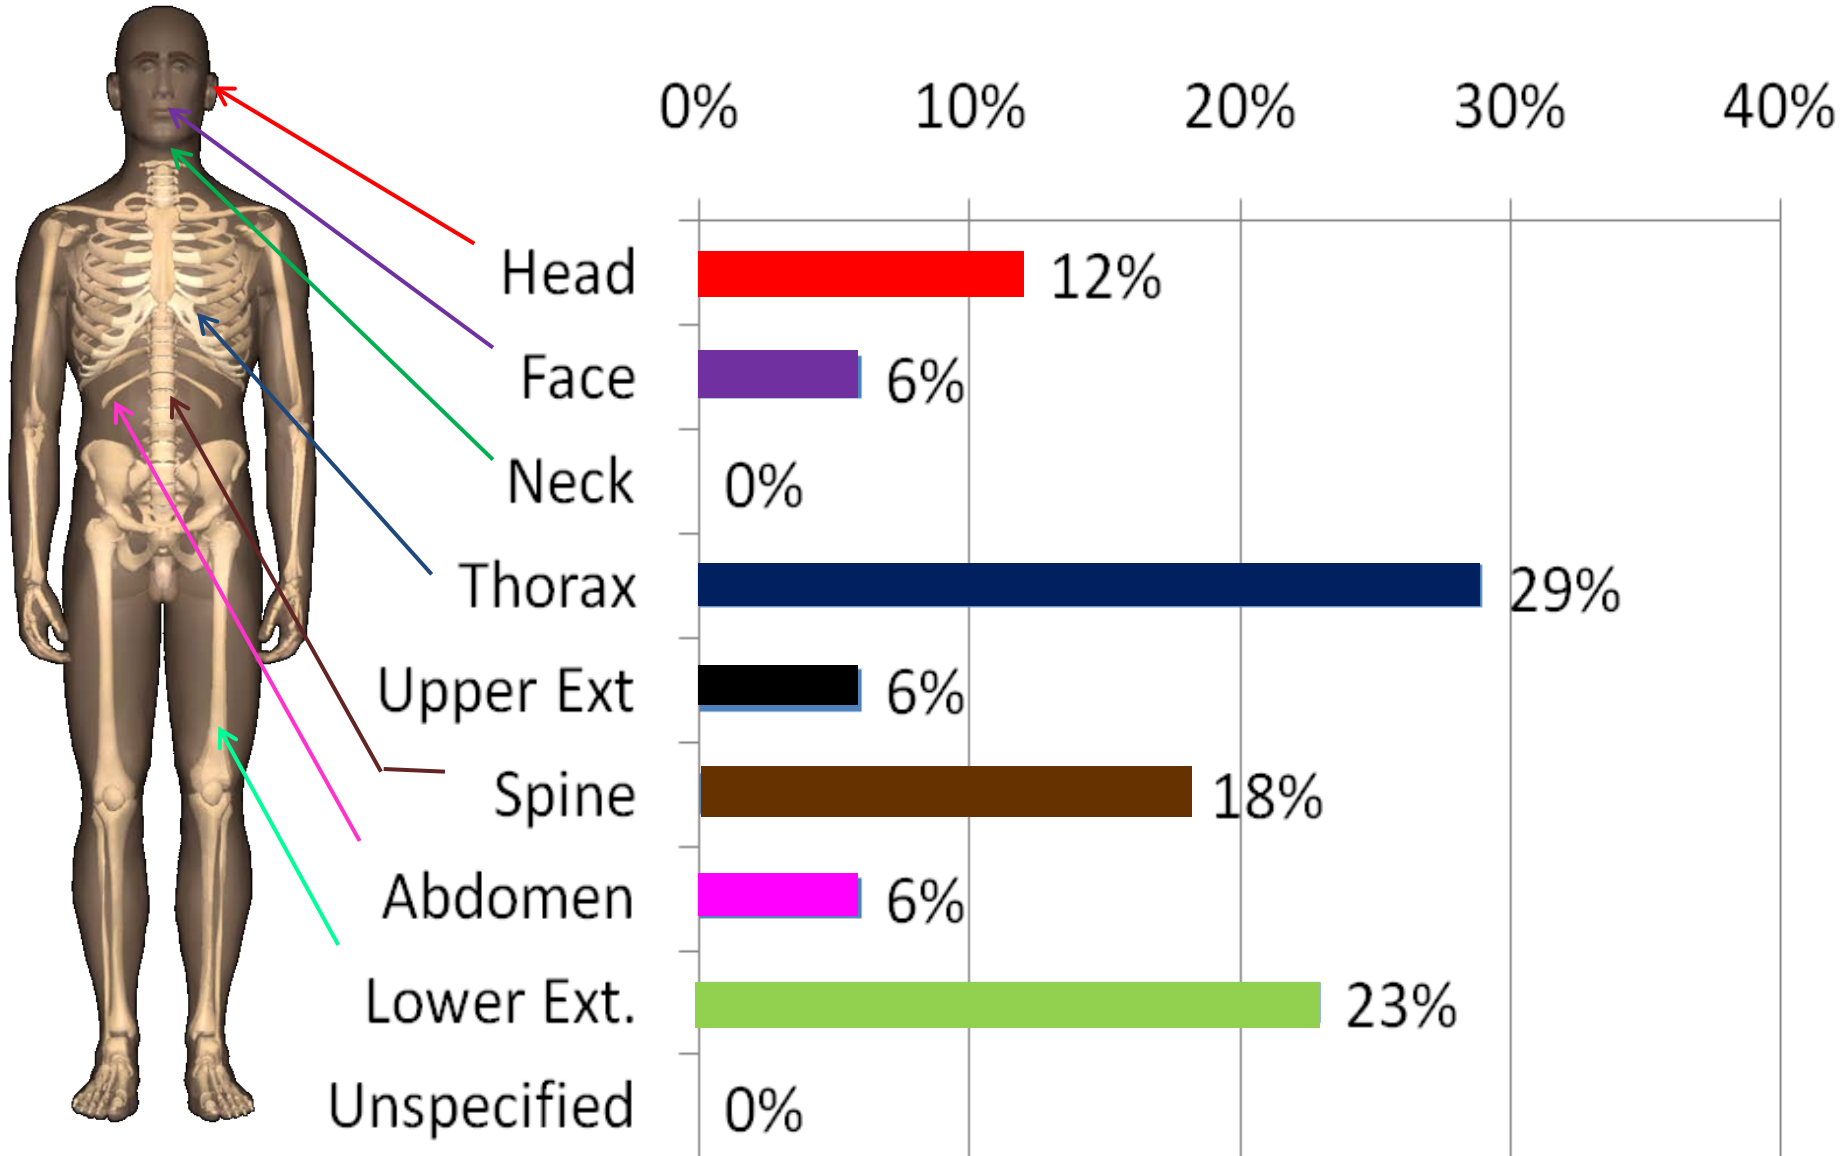
CIREN SVME Planar Injury (Rank 1)

* Includes partial ejections

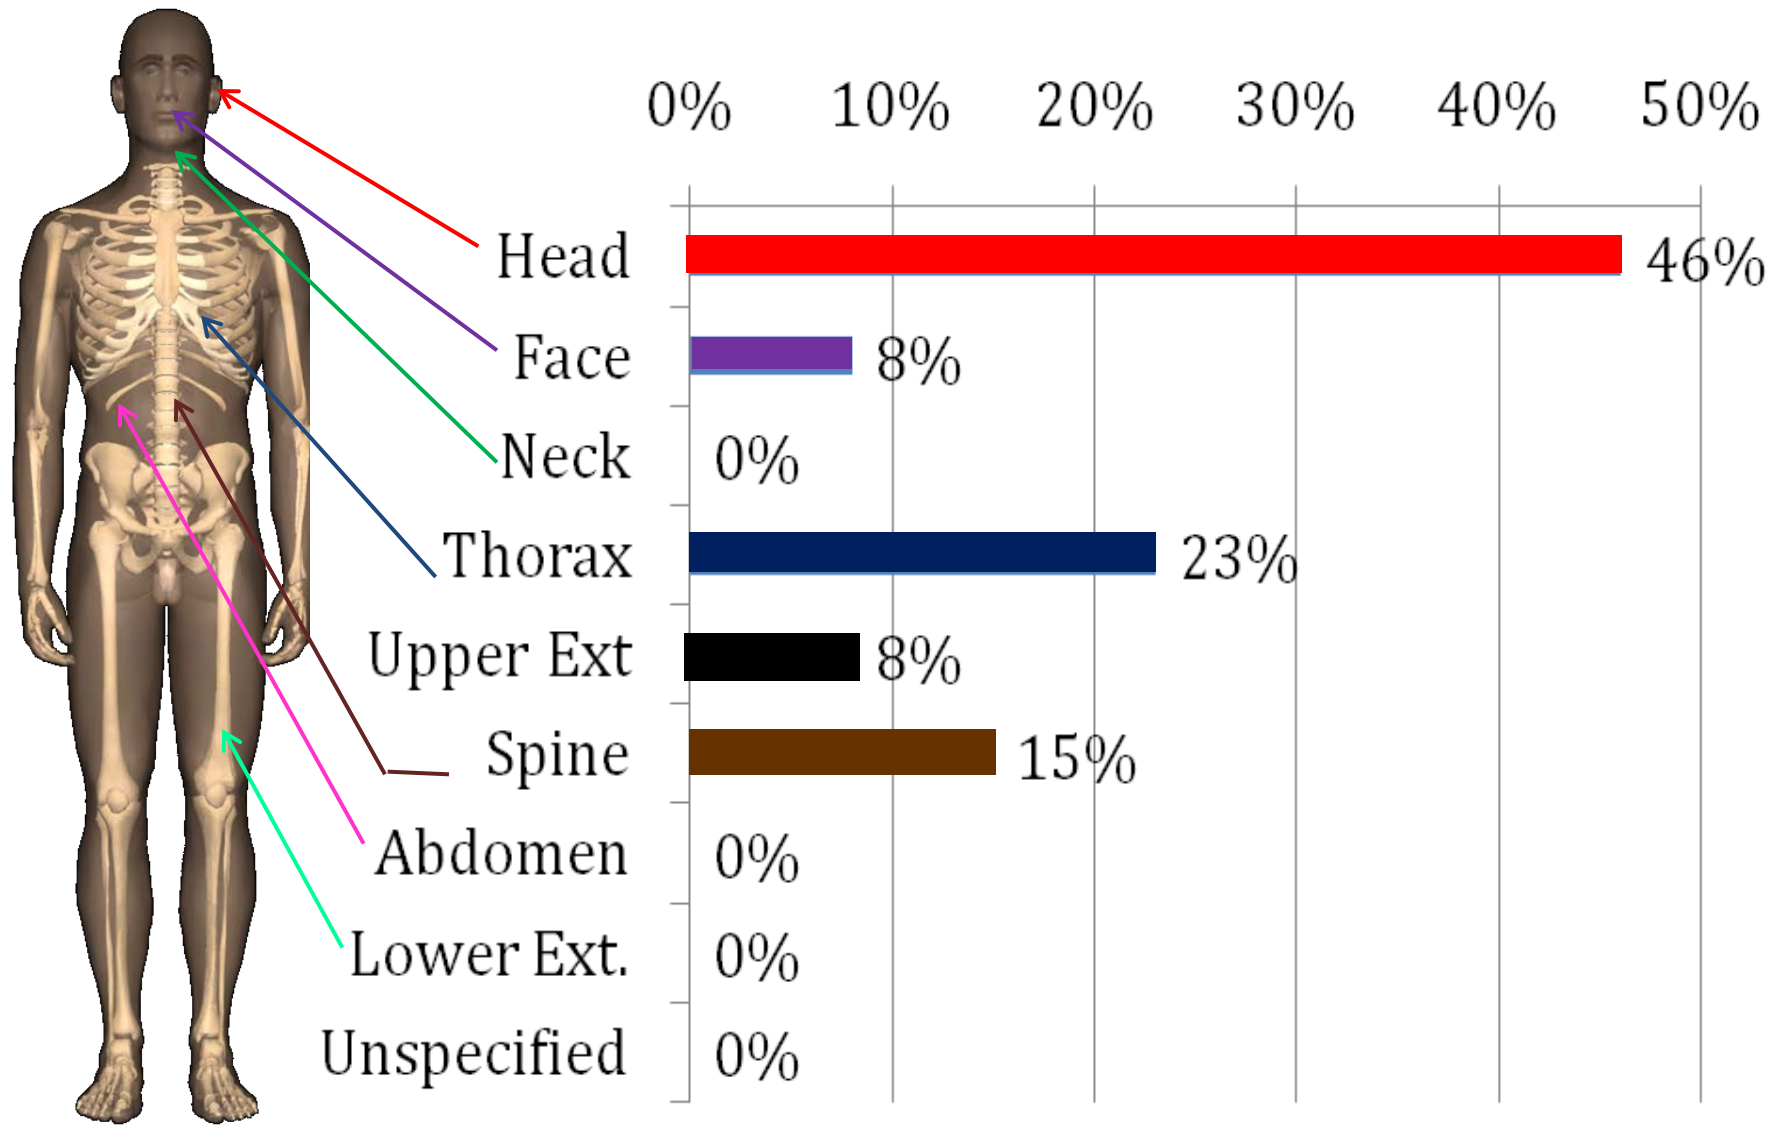
CIREN SVME Rollover Injury (Rank 1)

* Includes partial ejections
