NHTSA Tire Aging Project: Roadwheel Removal Codes v2.2 4/13/06

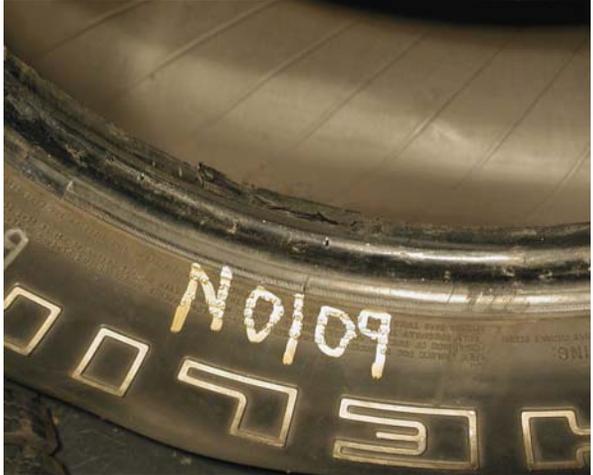
Code	Designation	FMVSS Definition	Illustration
Bead Region			
BdD	Bead Damage

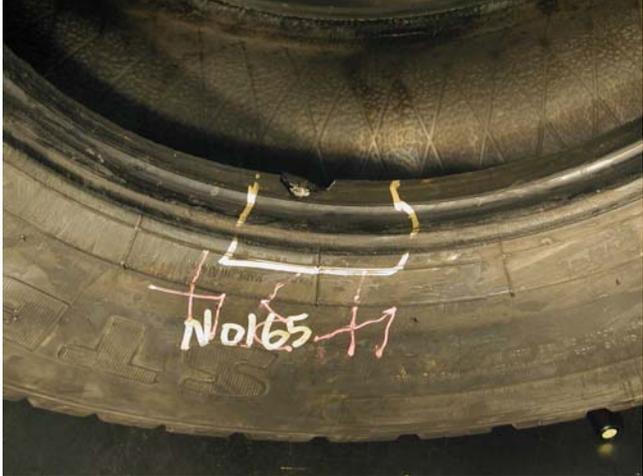
BdRi	Bead Ripped	A breakdown of bond between components in the bead area

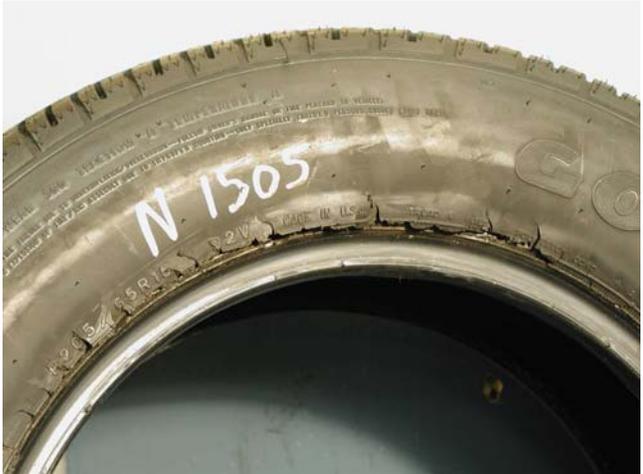
BdTuCr	Bead Turnup Cracking

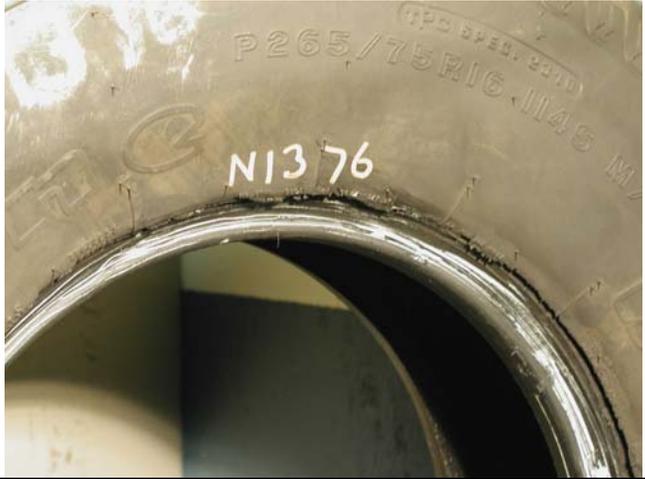
Code	Designation	FMVSS Definition	Illustration
BdTuR	Bead Turnup Rupture of body ply cords with radial cracking

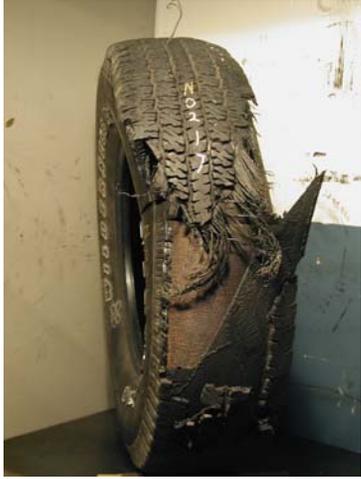
Belt Package Region			
B1P1D	Belt to Carcass Detachment

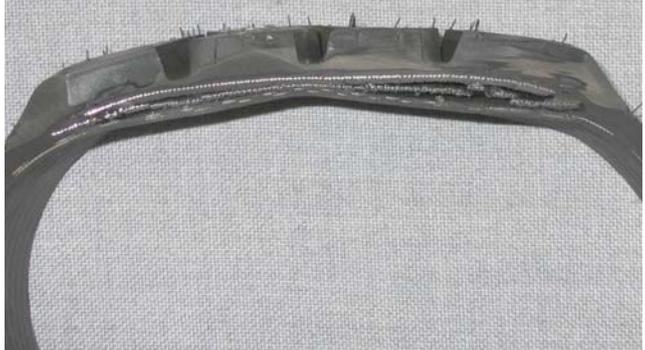
BBS	Belt to Belt Separation (photo also includes Belt to Carcass Detachment)

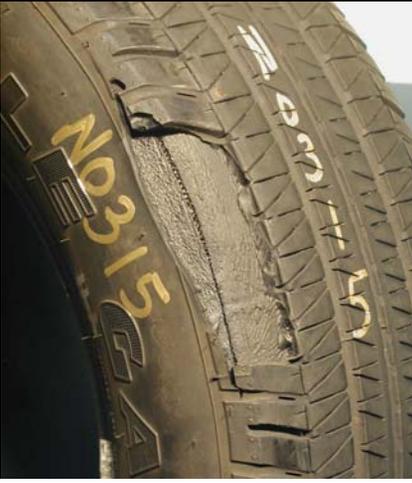
Code	Designation	FMVSS Definition	Illustration
BEE	Belt Edge Exposed

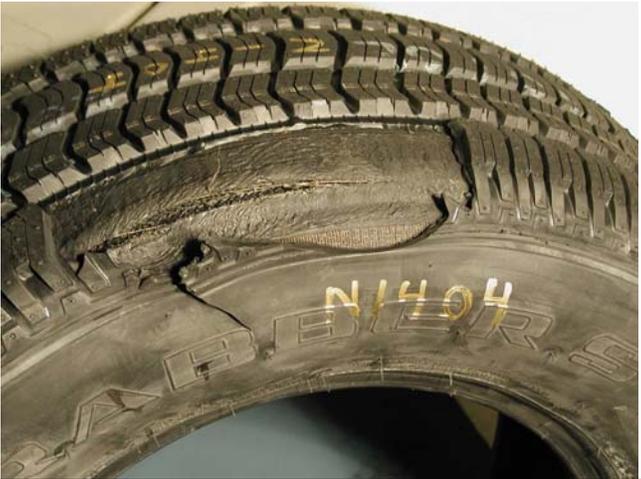
BEL	Belt Edge Loosened

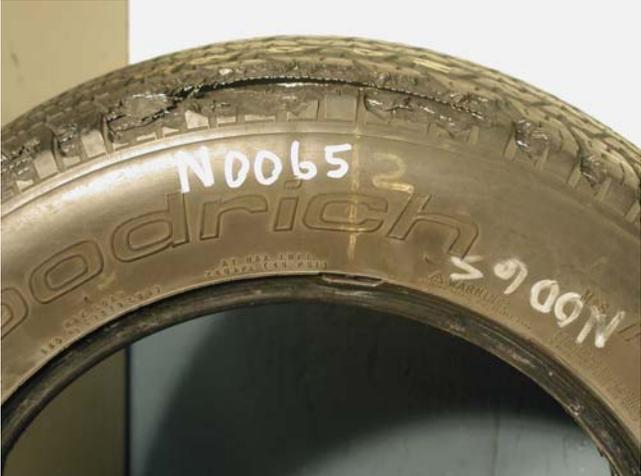
BES	Belt Edge Separation

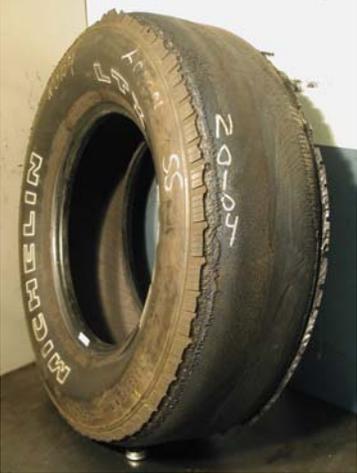
Code	Designation	FMVSS Definition	Illustration
CT+B2D	Complete Tread and Belt 2 Detachment

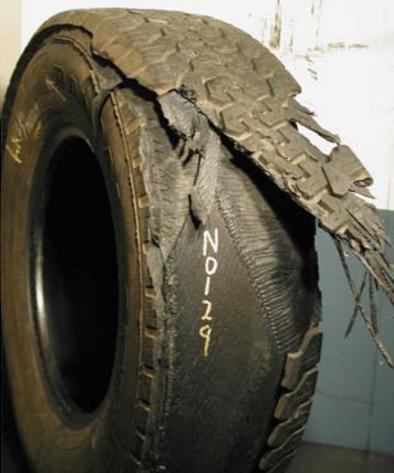
PT+B2D	Partial Tread and Belt 2 Detachment

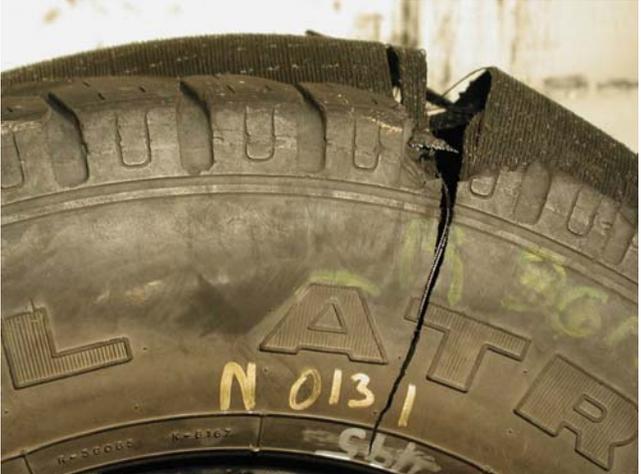
Carcass Region			
CaR	Carcass Rupture

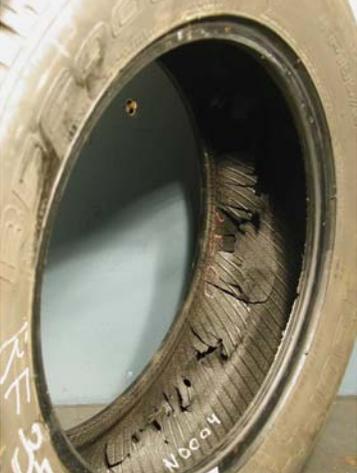
Code	Designation	FMVSS Definition	Illustration
Innerliner Region			
ILD	Innerliner Damage

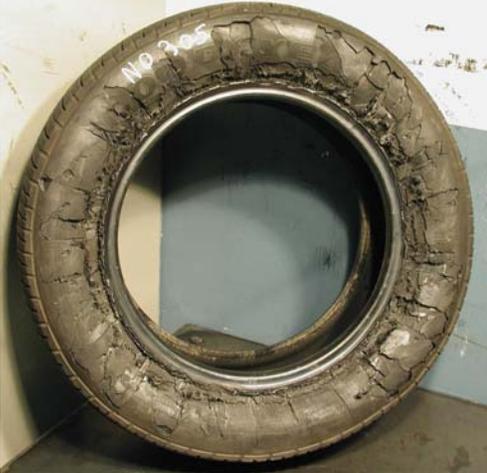
ILF	Innerliner Failure

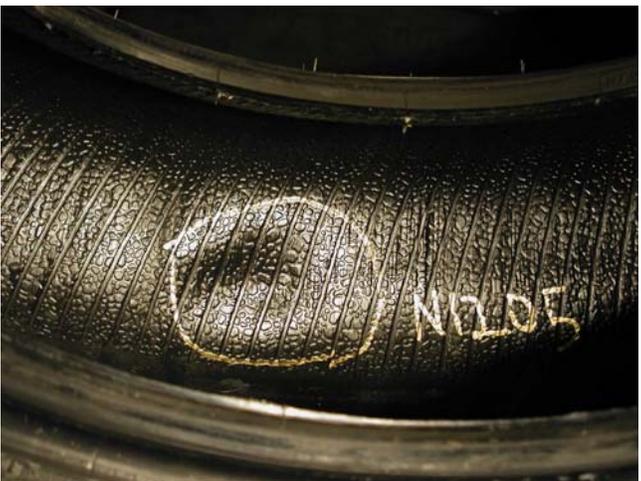
ILS	Innerliner Separation	A parting of the innerliner from cord material in the carcass

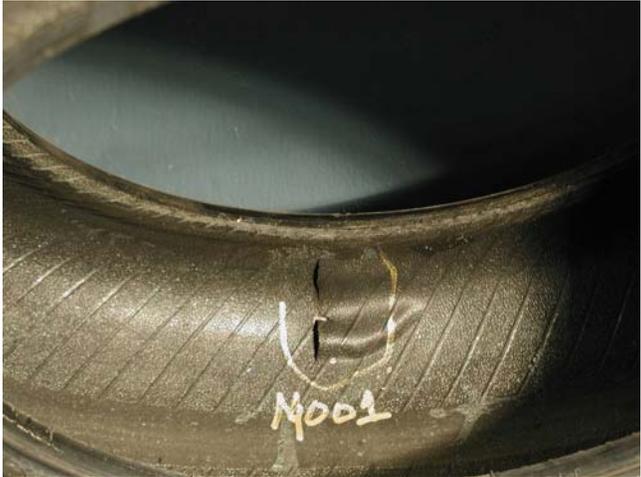
Code	Designation	FMVSS Definition	Illustration
ILSplit	Innerliner Split

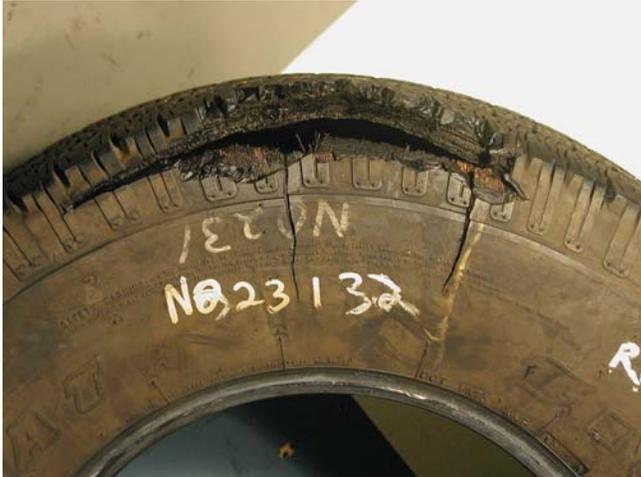
Other			
Mistest	Machine malfunction, test interrupted, or Mistest		
NVD	No Visual Finding		
TAL	Total Air Loss		
WhlF	Wheel Failure		
Shoulder Region			
ShR	Shoulder Rupture

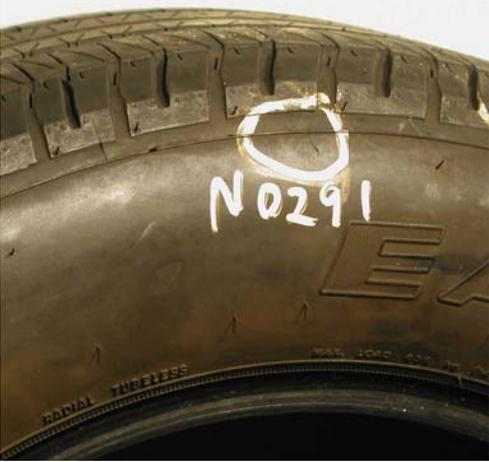
Code	Designation	FMVSS Definition	Illustration
ShSlit	Slit on Shoulder

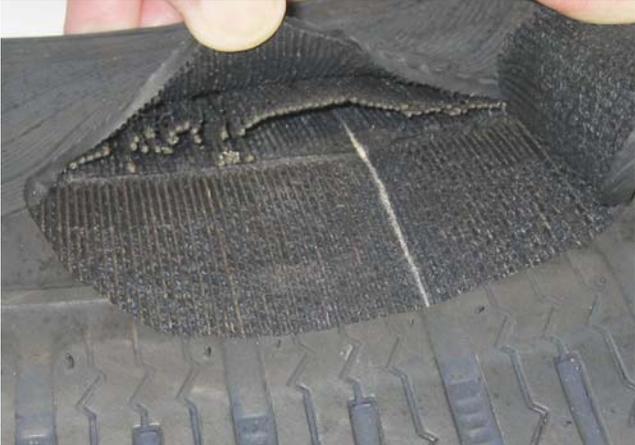
Sidewall			
PCD-I	Ply Coat Delamination - Interface

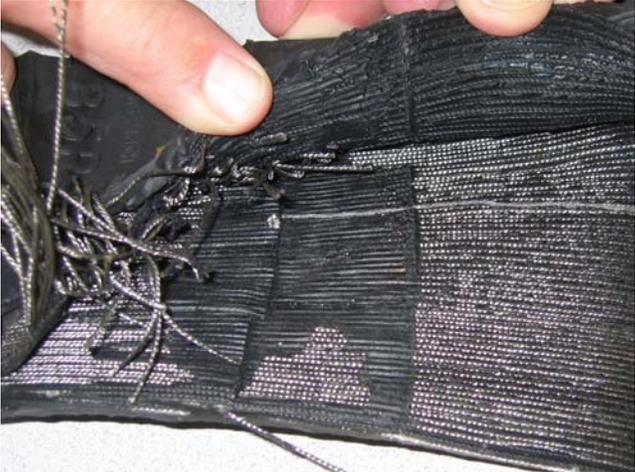
PCD-TC	Ply Coat Delamination – To Cords

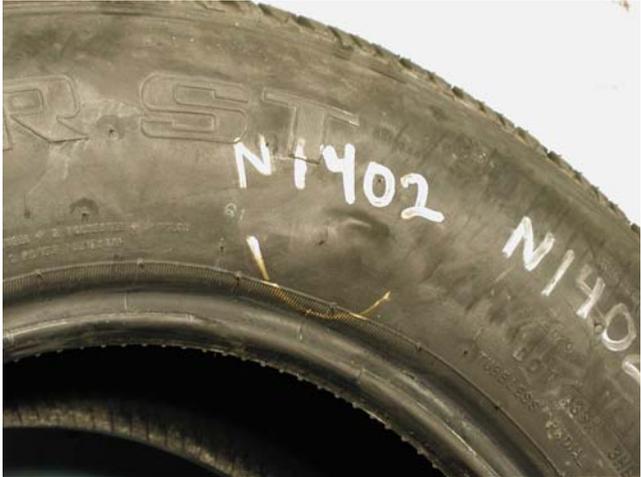
Code	Designation	FMVSS Definition	Illustration
SwBlister	Blister on Sidewall

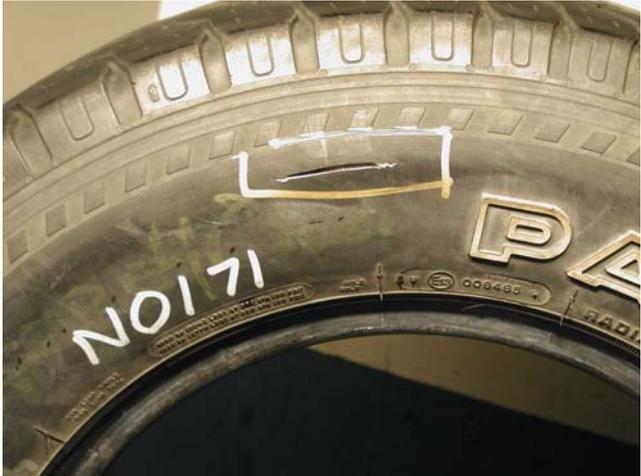
SwCr	Sidewall Cracking

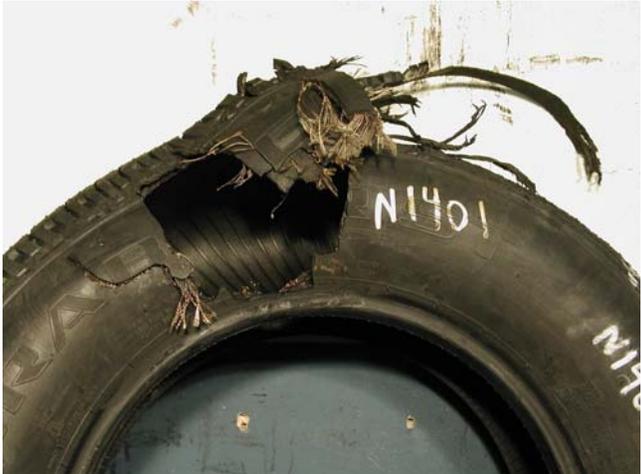
SwR	Sidewall Rupture	The breaking away of pieces of the sidewall (with or without total air loss)

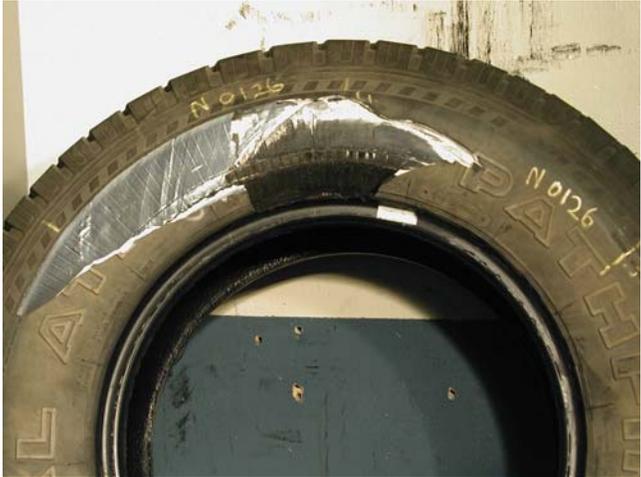
Code	Designation	FMVSS Definition	Illustration
SwR+DL	Sidewall Rupture with Delamination

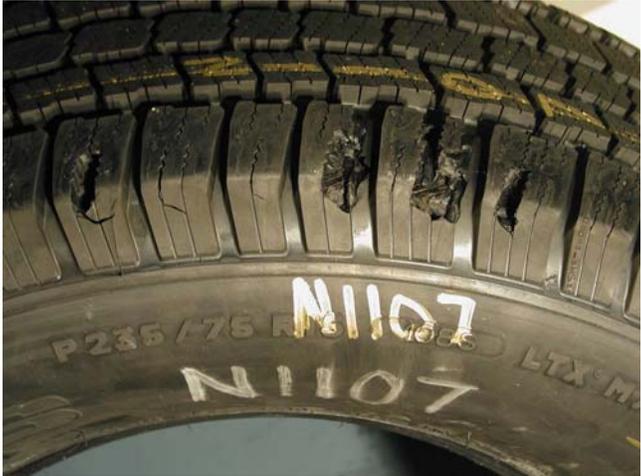
Tread			
TC	Tread Chunking	The breaking away of pieces of the tread (at tread region)

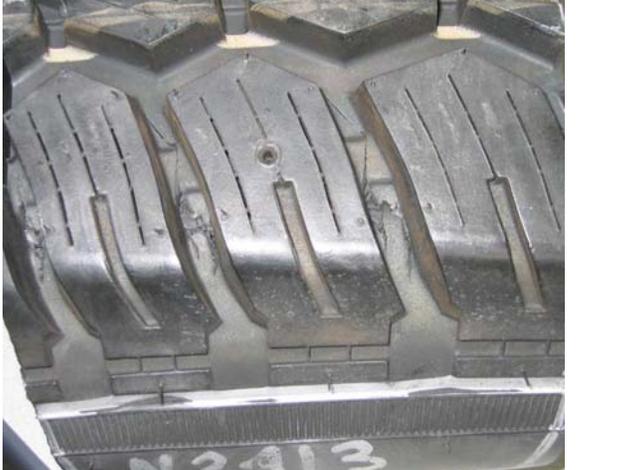
TGCr	Tread Groove Cracking

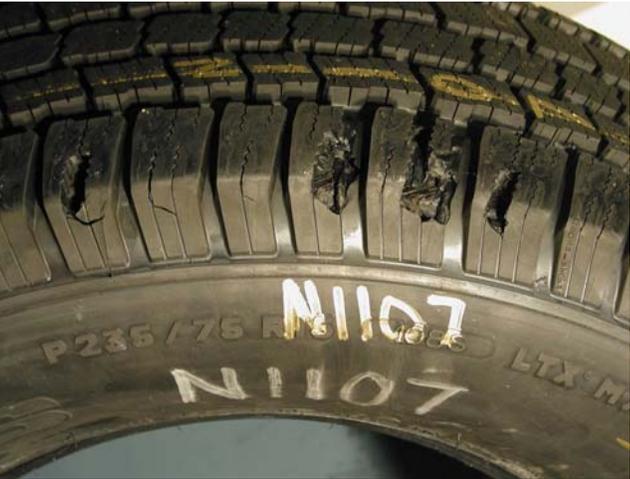
TShC	Tread Shoulder Chunking	The breaking away of pieces of the tread (at shoulder region)

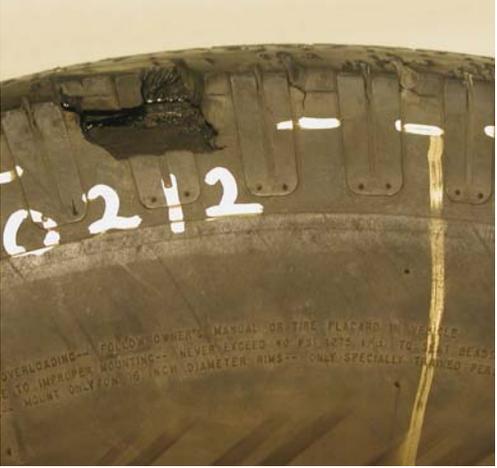
TShC+BE	Tread Shoulder Chunking with Belts Exposed

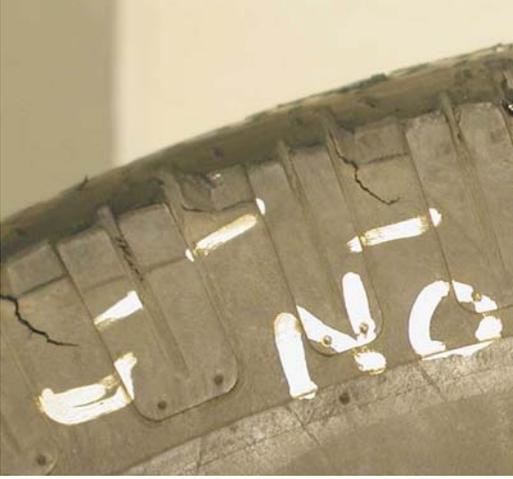
Code	Designation	FMVSS Definition	Illustration
TShCr	Tread Shoulder Cracking

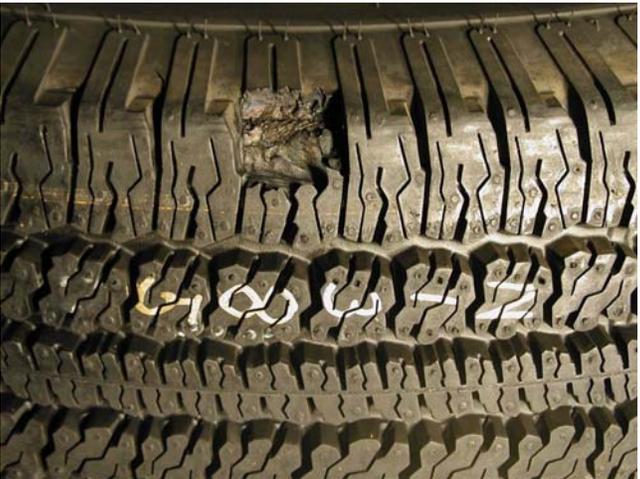
TShPoCr	Tread Shoulder Pocket Cracking	The breaking away of pieces of the tread (at tread region)
