LARGE SCHOOL BUS SAFETY RESTRAINT EVALUATION

National Highway Traffic Safety Administration

Paper No. 345

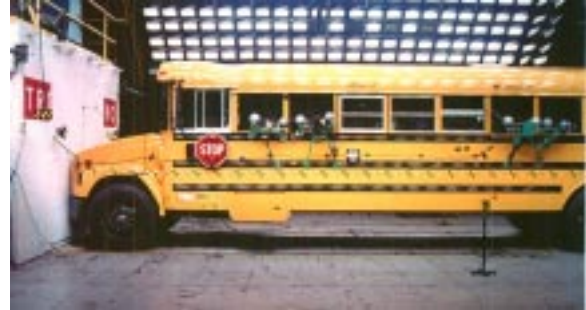
Figure 1. Pre-Test Photograph of Frontal Rigid Barrier Crash Test

Figures 1 and 2 show pre-impact and post-impact photographs, respectively, for the frontally impacted bus. As typical of large school bus manufacture, the body of the bus was mounted to the frame rails of the chassis by a series of clips or clamps. This non-rigid mounting feature allowed the bus body to slide forward approximately 92 cm (36 in.) during impact (see Figure 3). This dissipation of impact energy over a longer time duration acted to reduce the acceleration levels seen by the vehicle's occupants

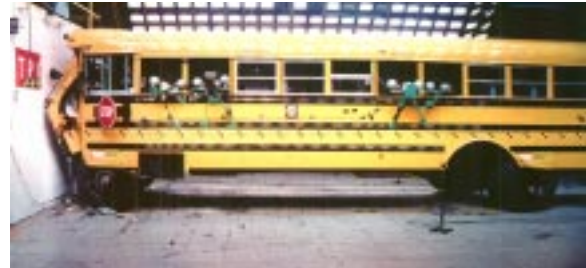
Figure 2. Post-Test Photograph of Frontal Rigid Barrier Crash Test

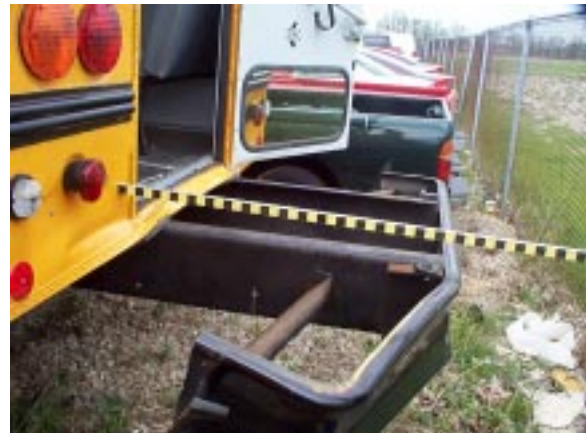
Figure 3. Movement of Bus Body Along the Frame (Rear of Bus Body and Frame)

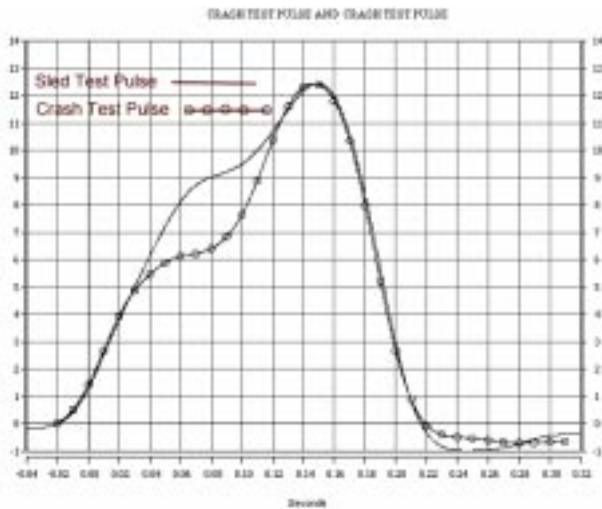
Figure 6. Crash Test Acceleration Pulse With Sled Pulse Overlay

relatively smooth trace that can be replicated with the sled impactor. Upon deriving these acceleration time histories, a metering pin was designed and fabricated by HYGE, Inc. to be used in the sled impactor. The derived sled acceleration pulse is shown overlaid with the center of gravity pulse (circle symbols) from the school bus crash test in Figure 6. The sled pulse agrees very well with the time duration (approximately 210 msec) and the peak acceleration (approximately 12-13 g’s). The

leveling off of the acceleration pulse of the crash test from about 40-90 msec is a result of the bus body sliding along the chassis. The sled metering pin did not exactly replicate this plateau, allowing a somewhat higher acceleration level at this point in the curve. This resulted in a slightly more severe test pulse since the peak velocity of the sled was approximately 6.4-8 kph (4-5 mph) higher than the barrier equivalent velocity measured during the frontal crash test.

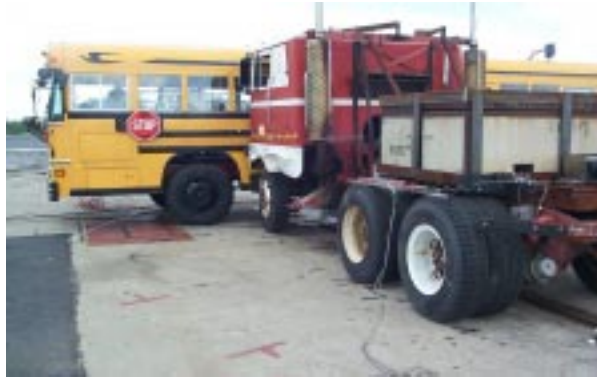
Figure 7. Pre-Test Photograph - Side Impact Crash Test

The second crash test was conducted by towing a 11,406 kg (25,265 lb) cab-over truck, at 72.4 kph (45 mph) and 90°, into the side of a transit style school bus (Class D). The school bus was stationary at time of impact. The impact point was chosen such that the left front edge of the truck was directly behind the front axle of the school bus to eliminate contact with

rigid structures on the frame during the initial penetration of the truck into the bus body. Figure 7 shows the pre-impact positioning of the heavy truck relative to the side of the school bus. A post-impact photograph showing the positioning of the school bus and truck is contained in Figure 8. During impact, the truck penetrated the bus side approximately half way into the compartment, and remained engaged while rotating 180° before coming to a stop. The front axles were severed from both vehicles (Figure 8).

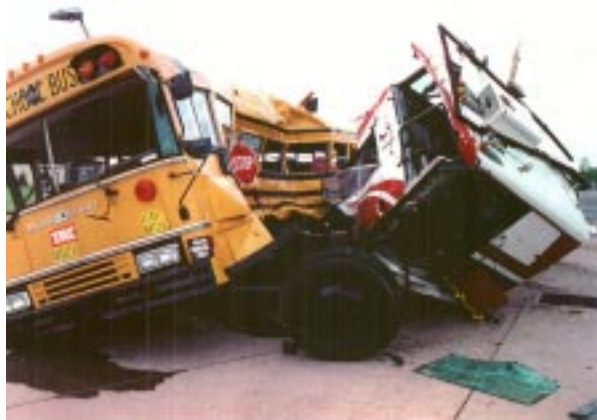
Figure 8. Post Test - Side Impact Crash Test

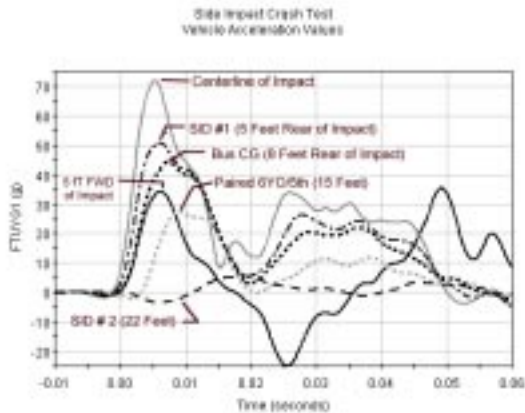
Figure 10. Side Impact Crash Test Vehicle Acceleration Pulses

Accelerometers were positioned along the length of the school bus. Figure 10 shows the acceleration time histories overlaid for this test. At the center of impact, a peak lateral acceleration of 72 g's was recorded. Acceleration levels drop significantly away from the point of impact. This is largely due to the amount of deformation that occurred at the point of impact. This deformation acted to absorb/dissipate much of the energy that would otherwise have been transmitted to the occupants of the bus.

Unlike the frontal crash, no single pulse is fully representative of the range of vehicle responses observed in the side impact crash. However, the overall pulse shape and pulse duration remain similar for most of the measured locations along the length of the bus.

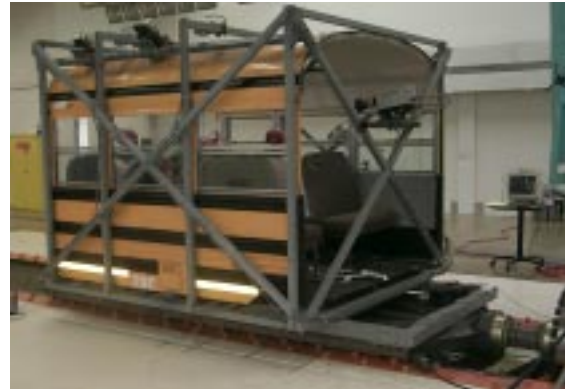
Figure 11. Sled Buck - Frontal Crash Simulation Testing

The first series of sled tests were conducted to replicate the acceleration time history of the school bus full scale frontal impact test. As stated previously, a metering pin was designed and fabricated based on the pulses derived from the crash test. For the initial series of sled tests, a test buck was fabricated by mounting a section from the body of a large school bus to the sled. This was done to: 1) assess the degree of deformation/energy absorption by the bus floor and its interaction with the seats, and 2) assess any potential for occupant interaction with portions of the interior other than the seats themselves. The finished test buck is shown in Figure 11. The bus body section contained three rows of seats on both the right and left side of the center aisle, which allowed for testing a maximum of 2 rows of dummies per test.

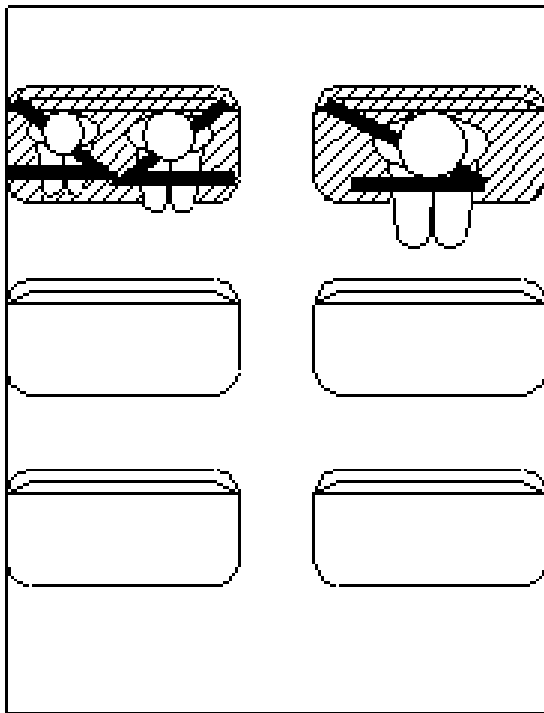
Figure 12 - Schematic For Condition#1 Seating (Restrained Without Rear Occupant Loading)

The last factor evaluated was the loading conditions on the occupants. Three different conditions were simulated: (1) restrained occupants without any loading from occupants seated behind them, (2) restrained occupants with loading from unrestrained occupants seated behind them, and (3) unrestrained occupants into seat back in front of them. Figure 12 contains a schematic showing the seating configuration for Condition #1 - restrained without rear occupant loading. Condition #2 - restrained with rear occupant loading, is shown in Figure 13. The schematic for Condition #3 - unrestrained into front seat back, is contained in Figure 14.

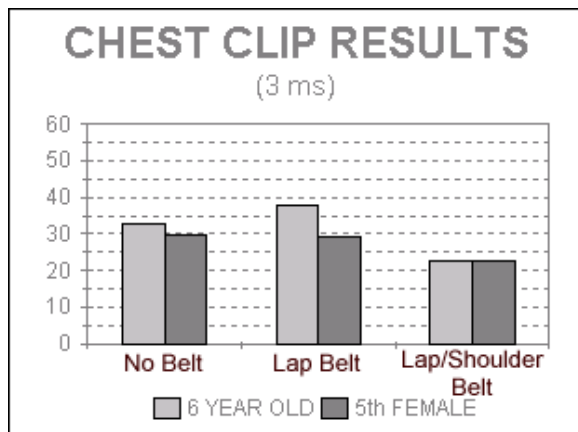
Figure 15 is a comparison of the chest 3 ms acceleration values for the 6 year old and 5th female dummies. The data shown here are average response values for the unrestrained, lap belted, and lap/shoulder belted tests (individual values for each test can be reviewed in the tabulated data).

Figure 15 - Comparison of Chest Injury Criterion Results

The lap/shoulder belted tests resulted in slightly lower injury values than the lap belt only and compartmentalization tests.

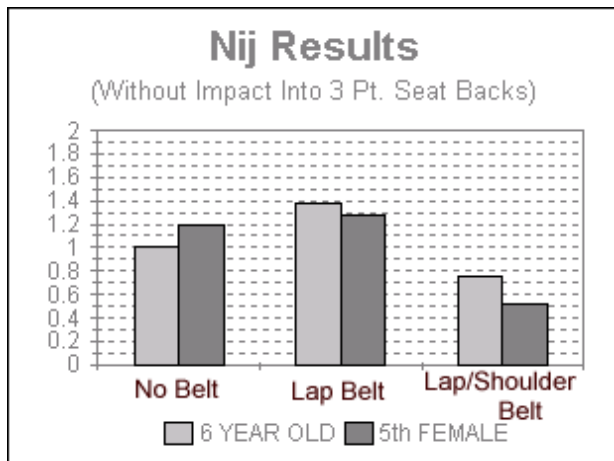
Hybrid III 6 Year Old and 5th Female Neck Injury (Nij) Results Figure 17 shows the comparison of restraint performance based on the Nij results for the 6 year old and 5th female dummies.

Figure 17- Comparison of Neck Injury Criterion Results

The tolerance threshold limit for Nij is 1.0 for all dummy age groups. Both the 6 year old and 5th female dummies had average responses that exceed 1.0 for both the lap belted and the unbelted tests. The average Nij values were somewhat higher for the lap belted occupants than for the unbelted occupants. This difference was more pronounced for the 6 year old dummy than for the 5th female dummy.

The lap/shoulder belted occupants had significantly lower Nij responses. None of the tests conducted in this series with a lap/shoulder belted occupant exceeded the Nij tolerance threshold limit of 1.0, however, several of these tests had values of 0.80 or higher.
