Pelvic and Thoracic Injuries in Nearside Impact Crashes: Analysis of Contributory Factors

Allan Tencer, Rob Kaufman, Charles Mock
Seattle CIREN team

To determine whether vehicle design factors relate to thoracic and pelvic injuries from near-side impacts

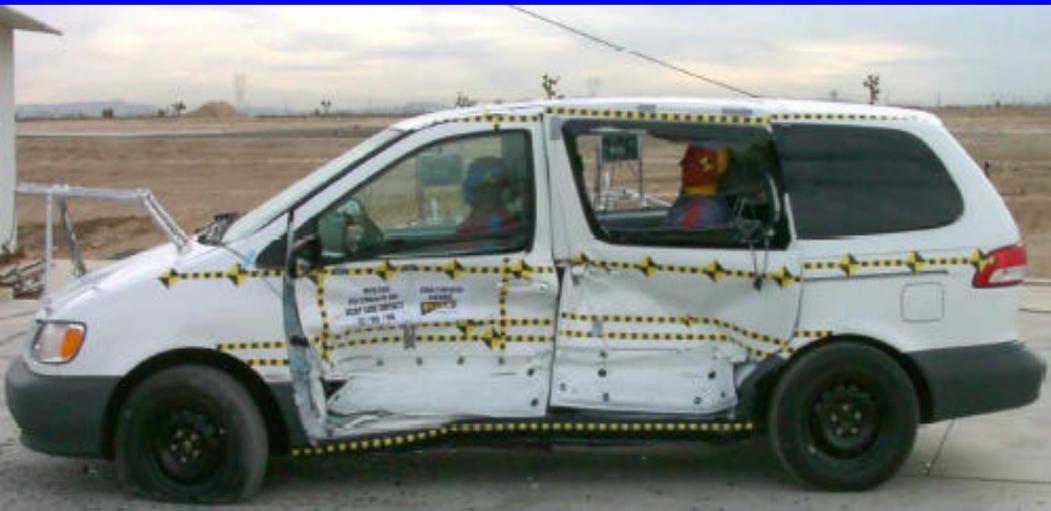
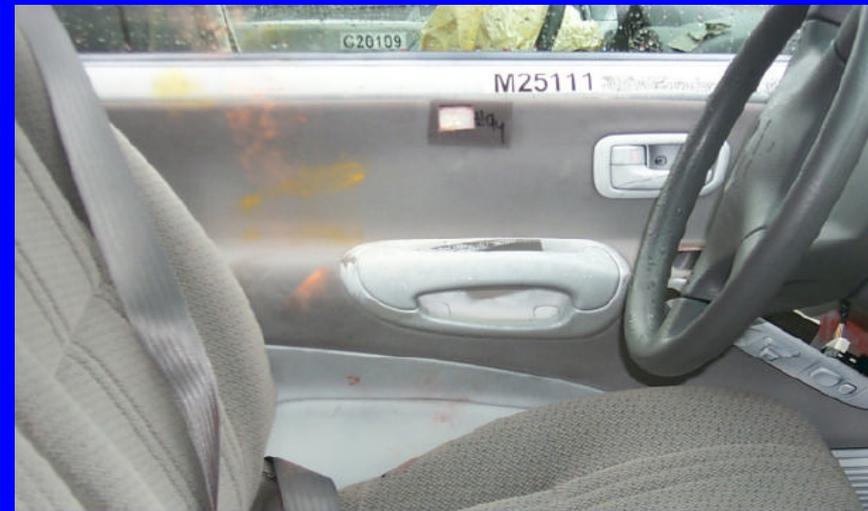
2001 Toyota Sienna, Weight = 2029 kg, Door crush = 29.7 cm
Driver TTI = 69, pelvic g = 94, No side airbag

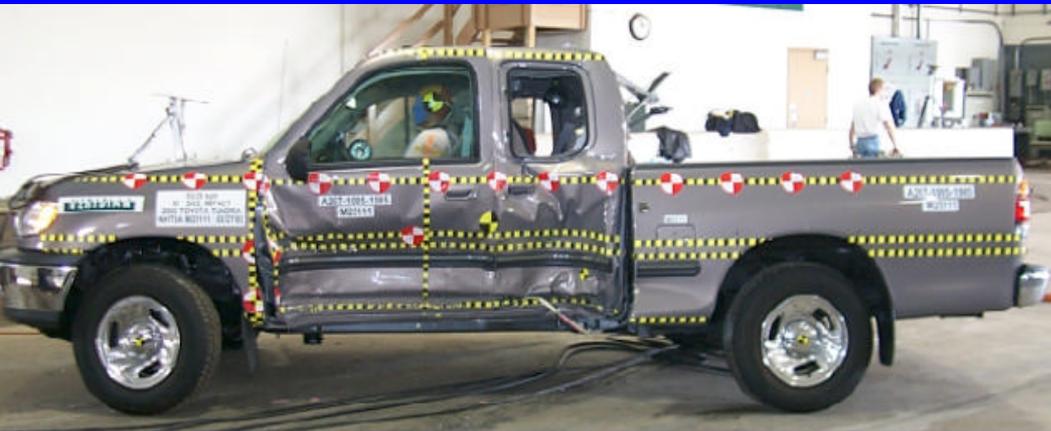
2002 Toyota Tundra, Weight = 2229 kg, Door crush = 29.8 cm
Driver TTI = 22, pelvic g = 27, No side airbag

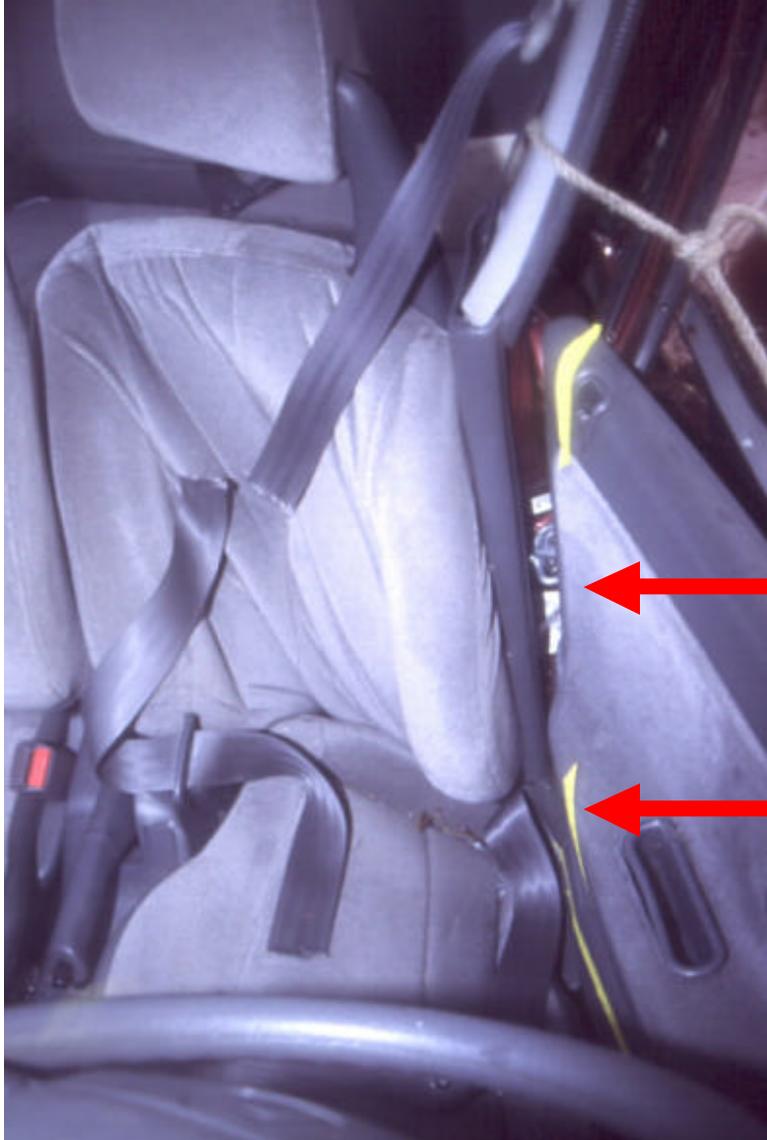
Lateral door
intrusion at
chest and pelvis

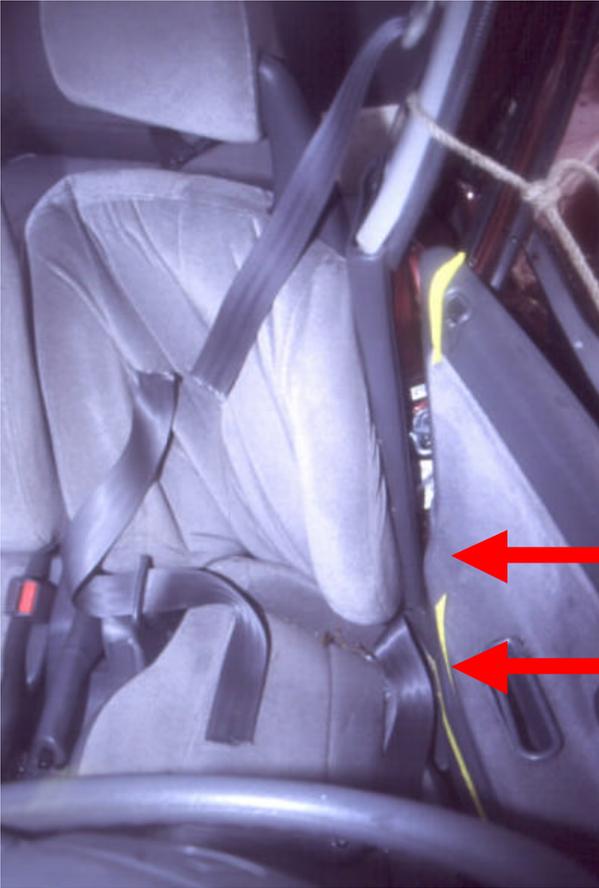
Lower lateral door intrusion

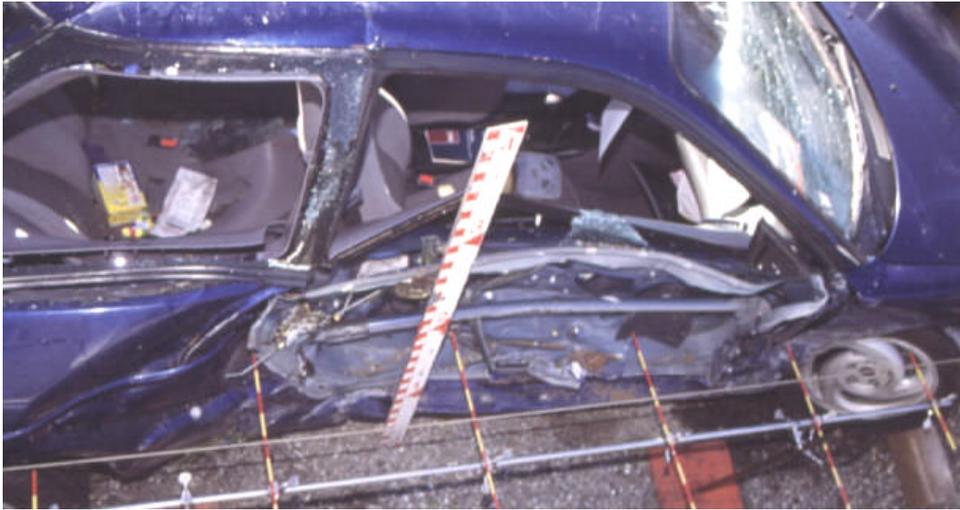
- 1997 Compact 2HB
- Minimal intrusion
- No injury to front right restrained passenger

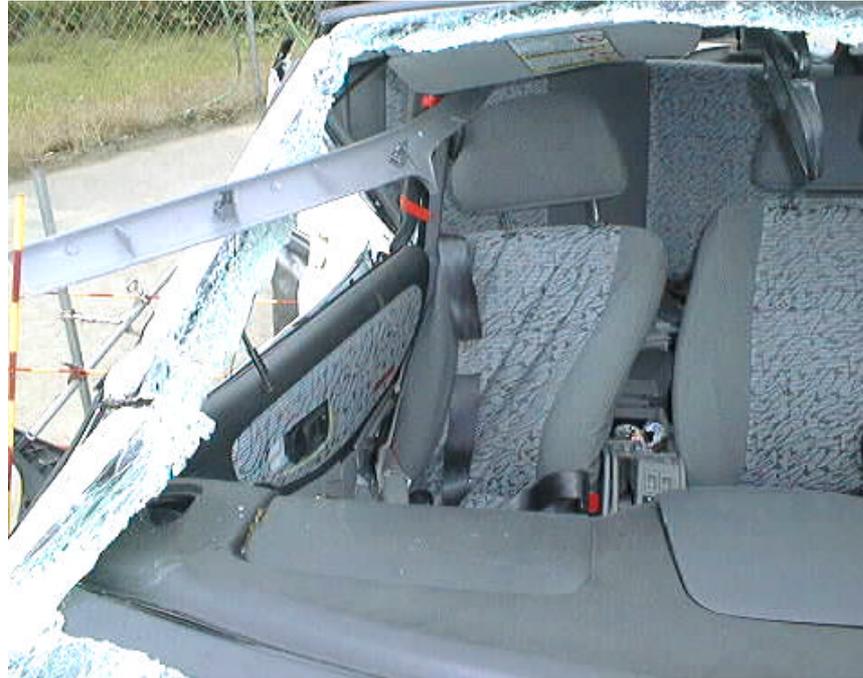
1998 Subaru Impreza vs. SUV

Most light trucks, vans, and SUVs will collapse the upper door panel, and even override the support beam

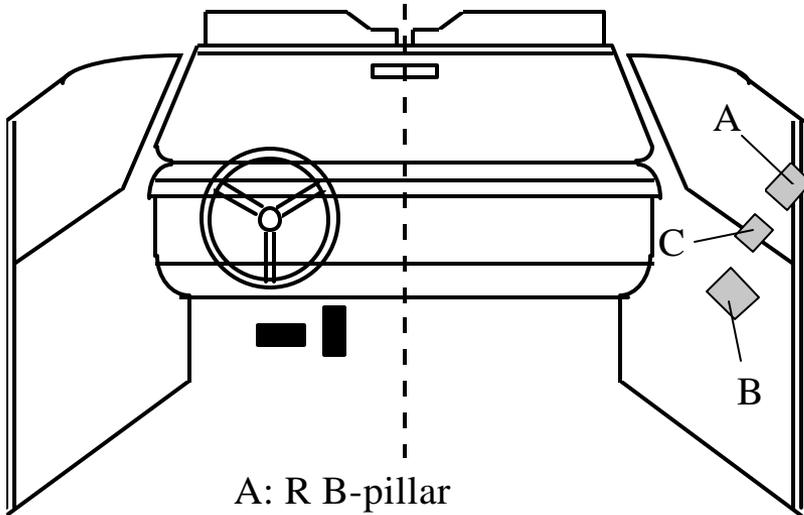
A: R B-pillar
B: R side interior
C: R window frame

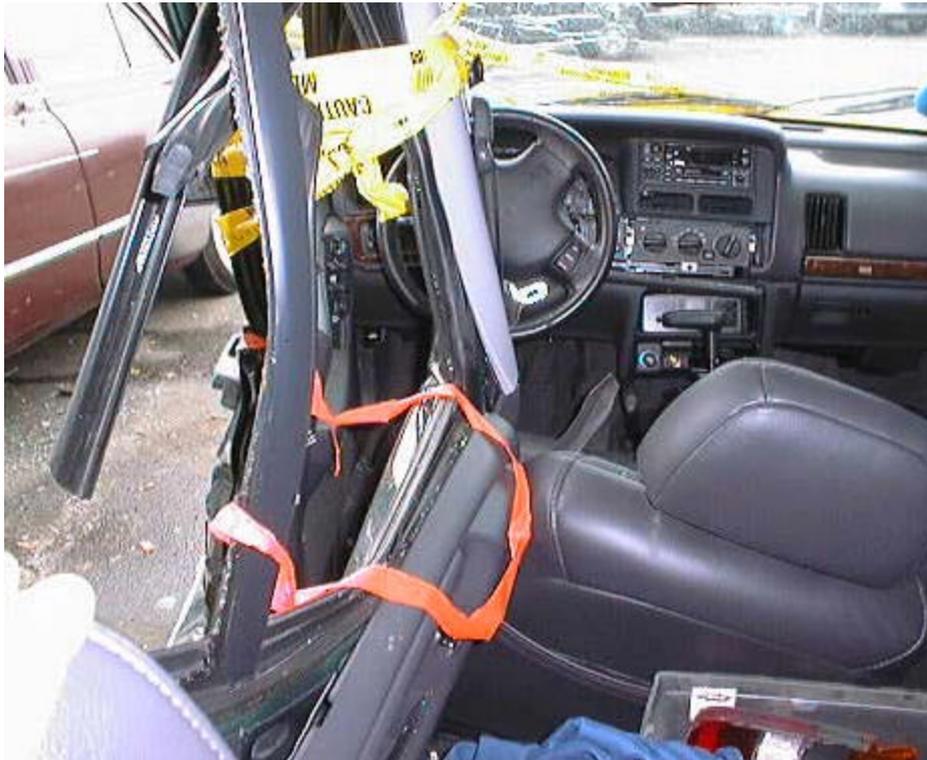
Left B pillar - 22cm - Lat

Driver Door - 16cm - Lat

Roof rail - 12cm - Lat

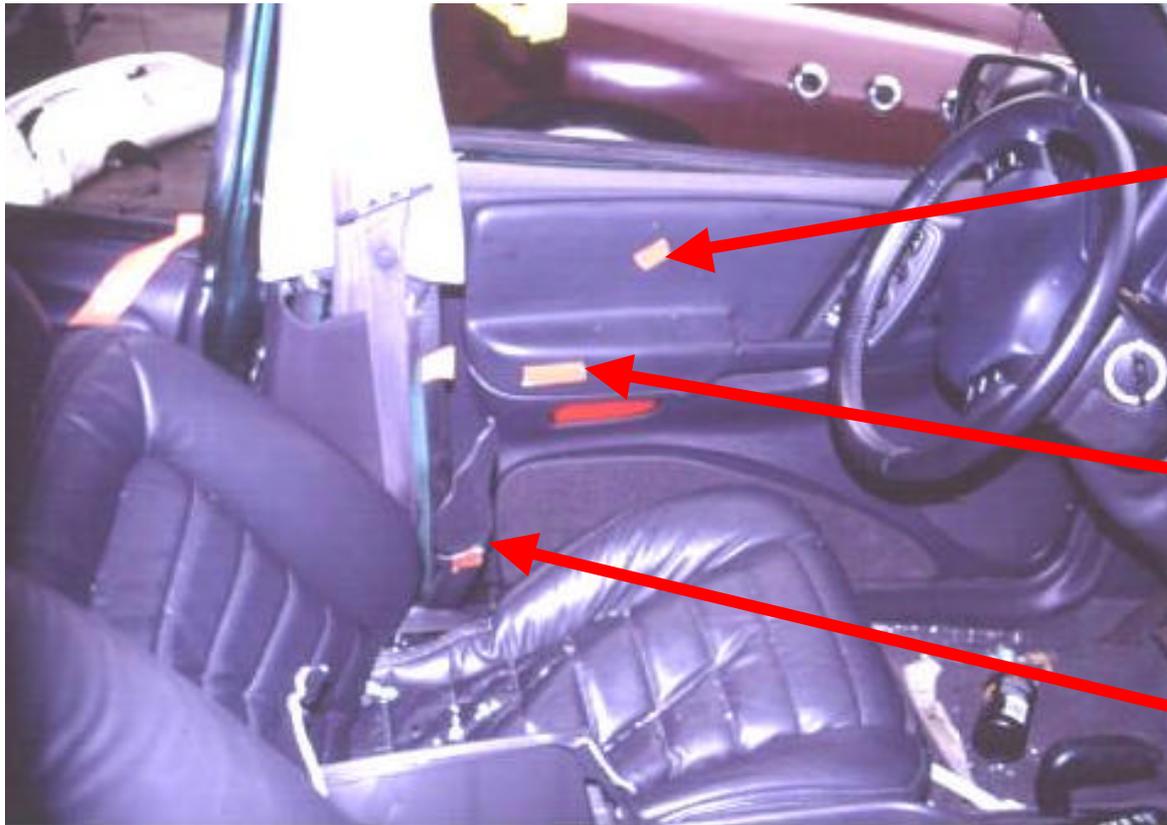
Upper Door
Panel Scuff

Protruding
Armrest scuffed

B pillar / Door
panel cracked

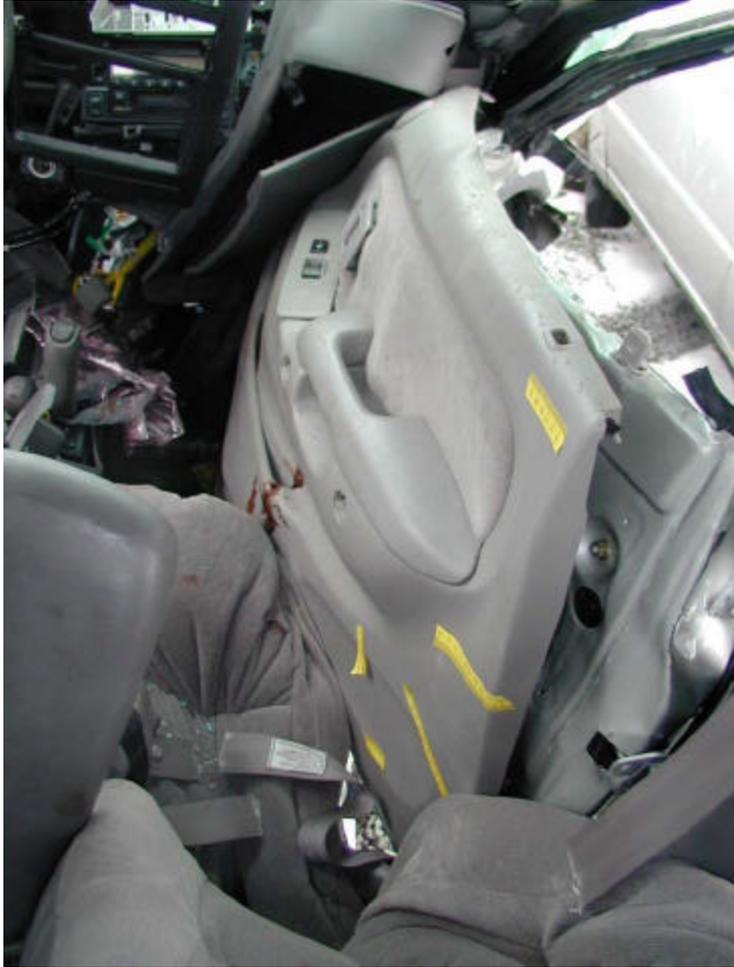
Door panel intrusion = 45 cm/17.7inches

Contact evidence on door/center console

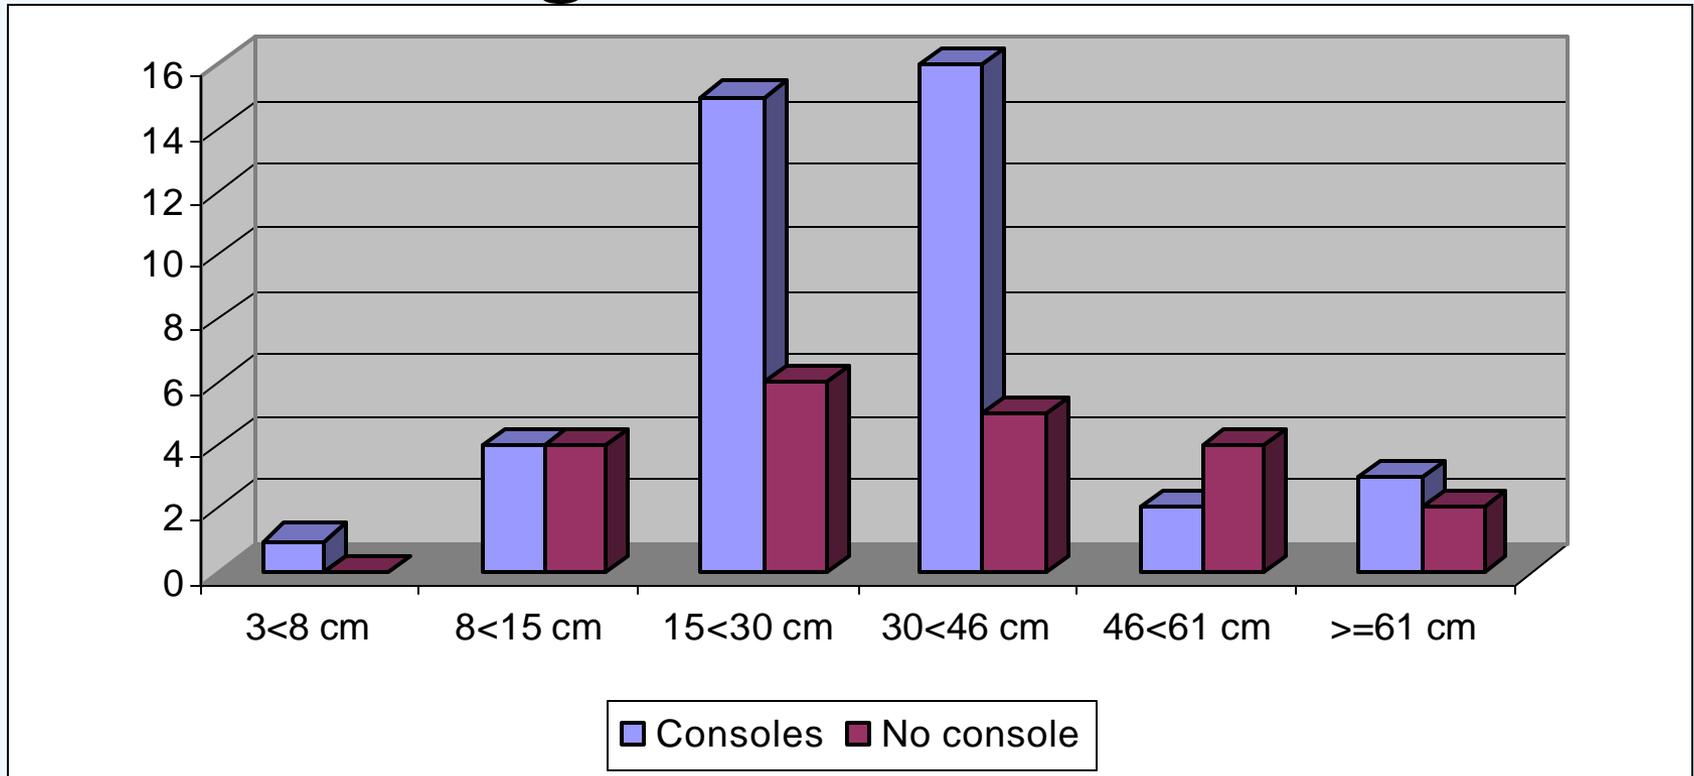
Moderate (AIS 2) and serious (AIS 3) pelvic injury in nearside crashes by magnitude of intrusion

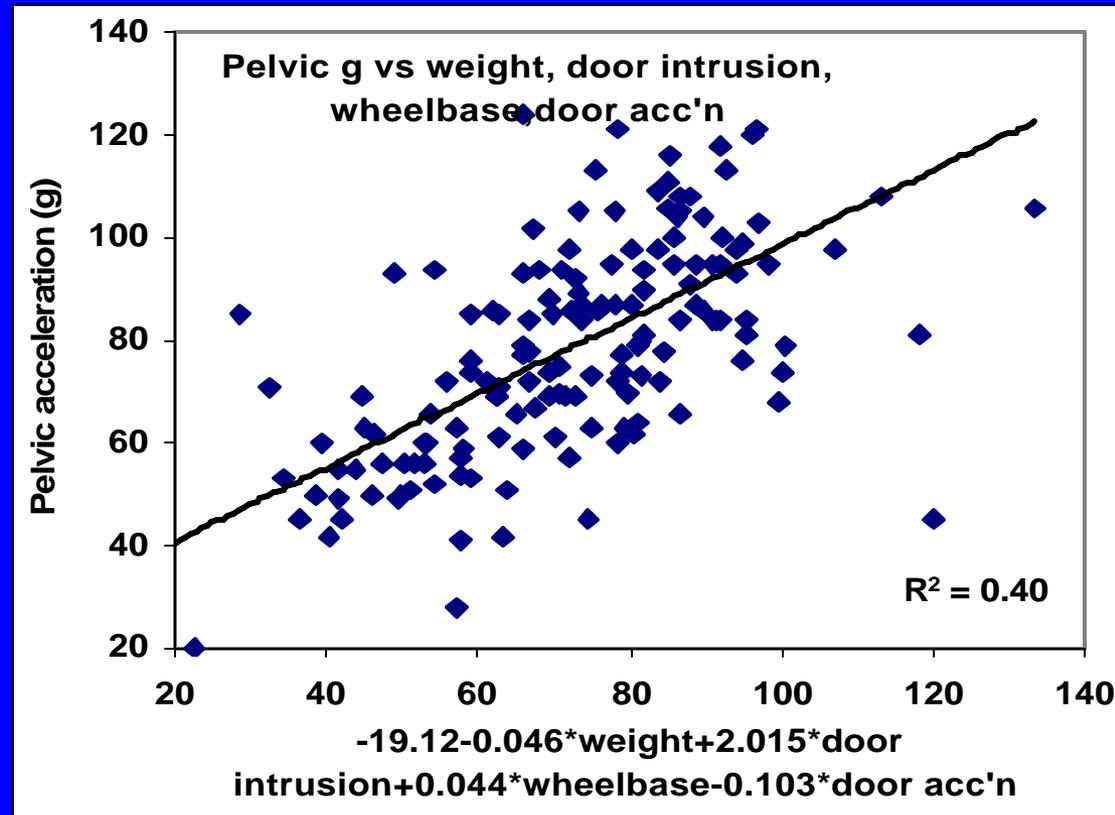
variable	Pelvic accel
overall r squared	0.580
overall p value	0.002
vehicle weight	0.003
max door intrusion	0.003
max intrusion height	0.250
max intrusion level	0.297
max door velocity	0.221
door velocity diff	0.271
door acceleration	0.171
wheelbase	0.045
panel deflection	0.522
dummy H point	0.503

- Vehicle weight, door intrusion, wheelbase correlate to pelvic g
- All variables explain about 58% of pelvic g variation

- For a given vehicle weight, door intrusion, wheelbase correlate to pelvic g, and door velocity to TTI
- Vehicle variables studied only account for 41% of TTI, 58% of pelvic g variation
- A center console increases peak pelvic g
- A thoracic airbag lowers peak TTI
- Real-world crash studies also show correlation of door intrusion and thoracic and pelvic injury
- Door intrusion is not directly related to vehicle weight but increases with greater wheelbase

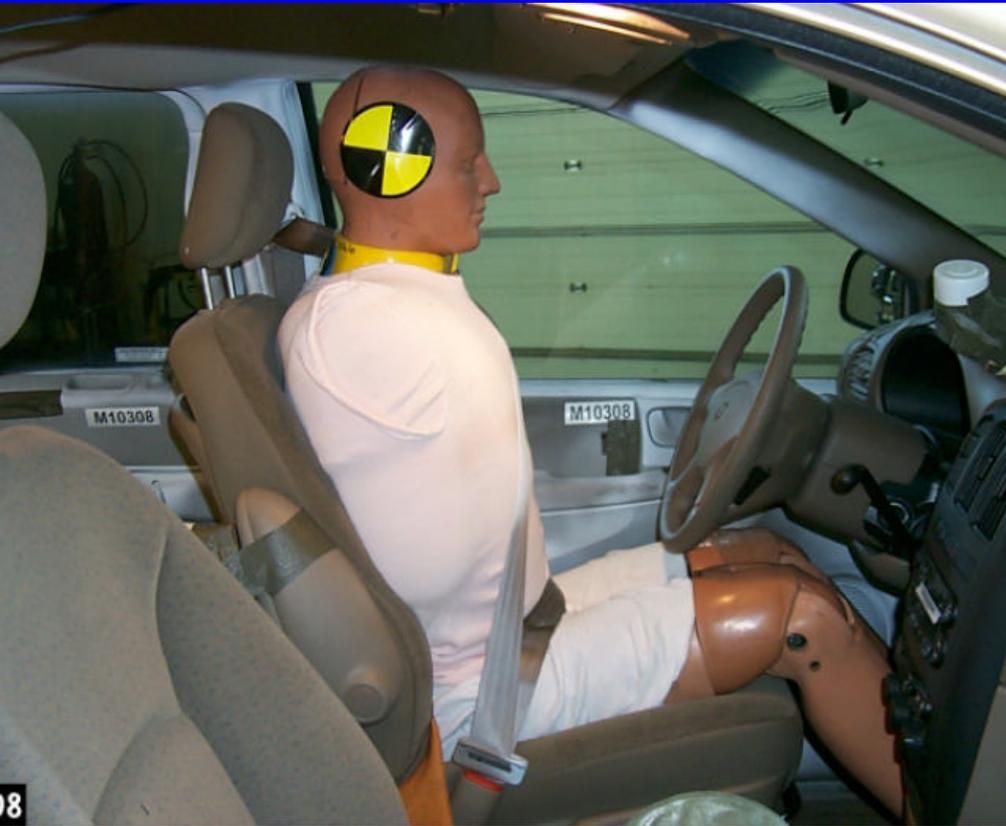
without center consoles, 69.4g
sd = 19.7g, n = 41

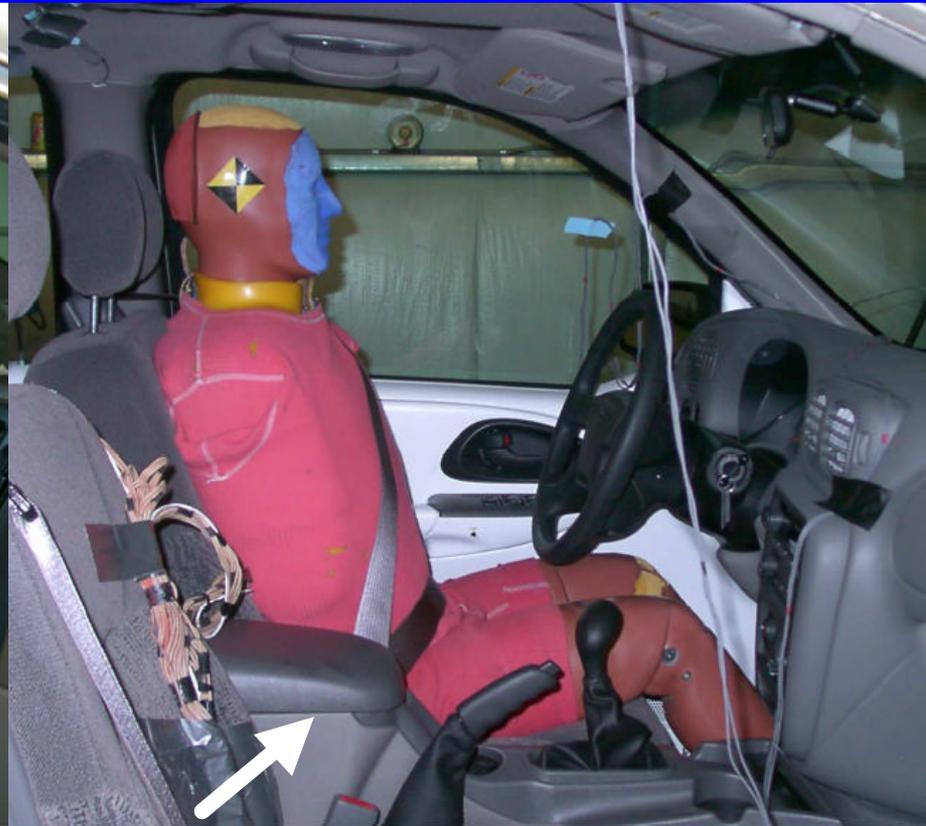
with center consoles, 77.3g
sd = 21.8g, n = 96

(p = 0.05)

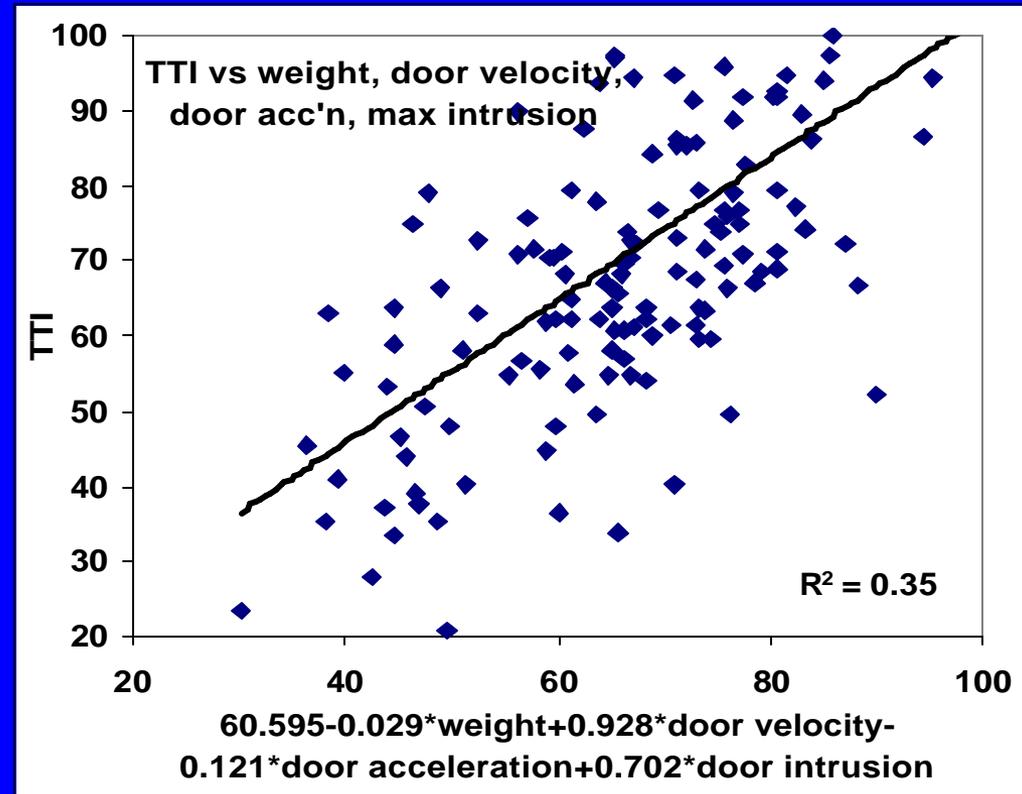
variable	TTI
overall r squared	0.410
overall p value	0.030
vehicle weight	0.064
max door intrusion	0.191
max intrusion height	0.976
max intrusion level	0.779
max door velocity	0.049
door velocity diff	0.756
door acceleration	0.128
wheelbase	0.926
panel deflection	0.866
dummy H point	0.550

- Vehicle weight and max door **velocity** correlate to TTI
- All variables explain about 41% of TTI variation

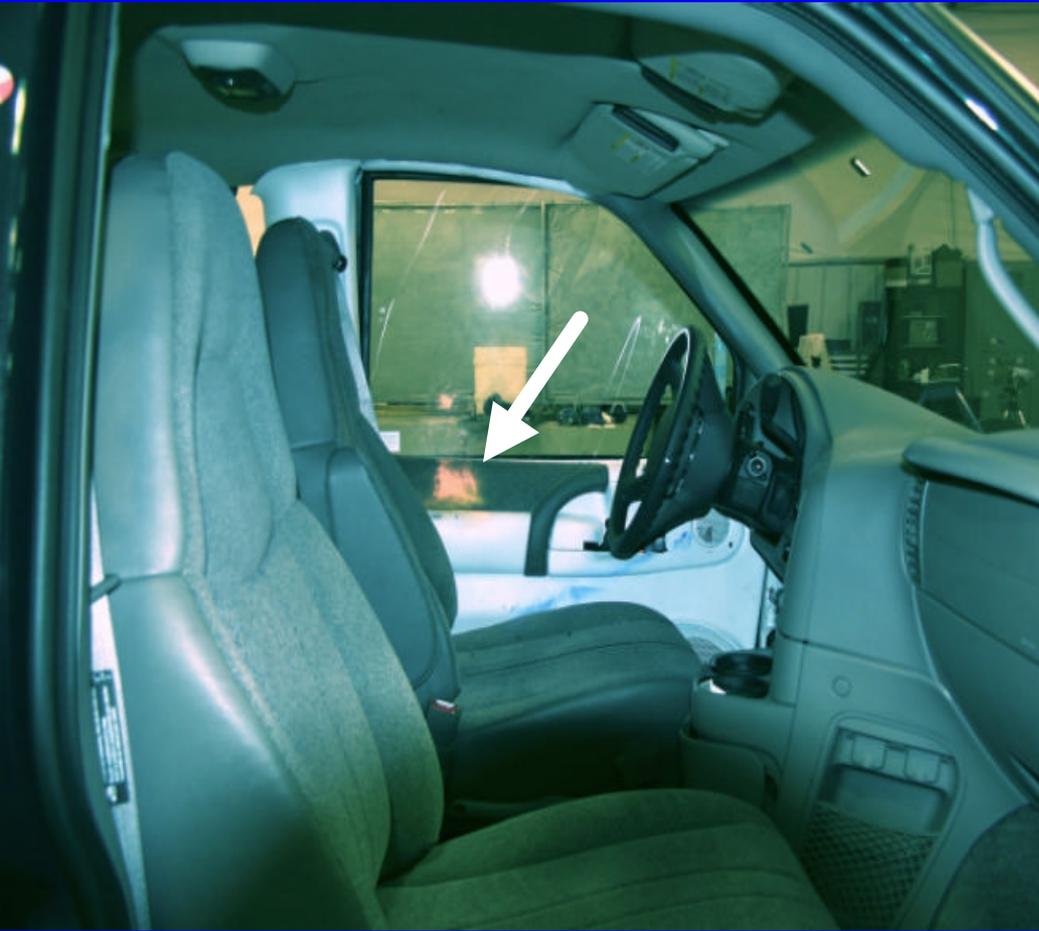
without thoracic airbag, 63.7g
sd = 20.7g, n = 108

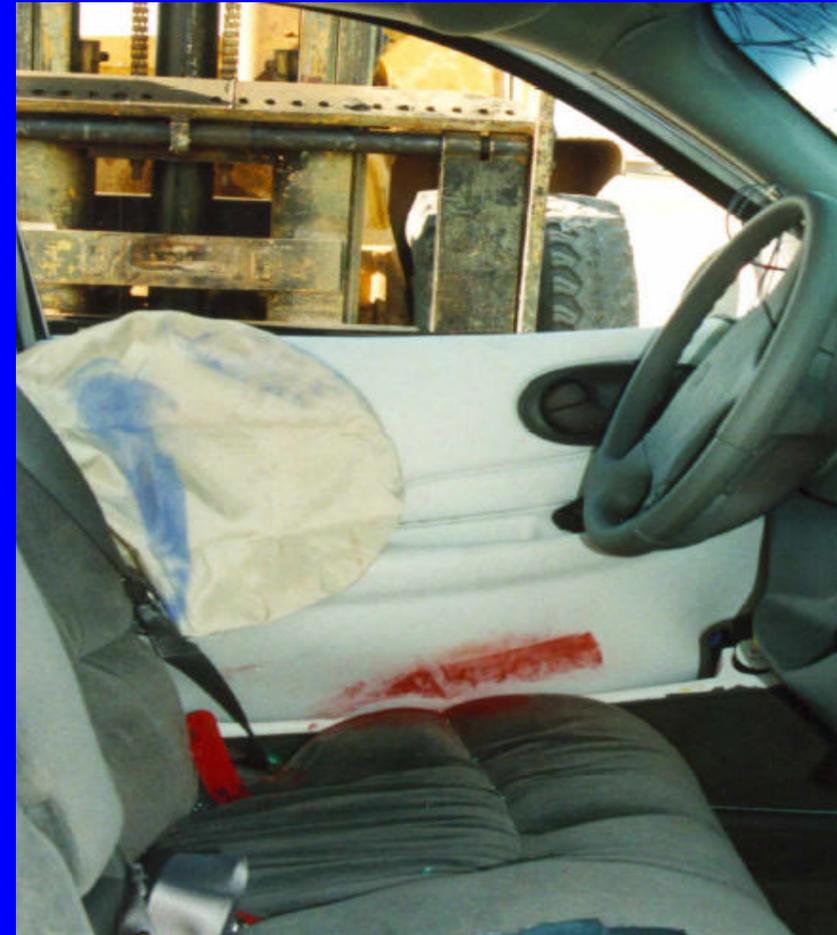
with thoracic airbag, 55.6g
sd = 13.7g, n = 54
(p = 0.003)

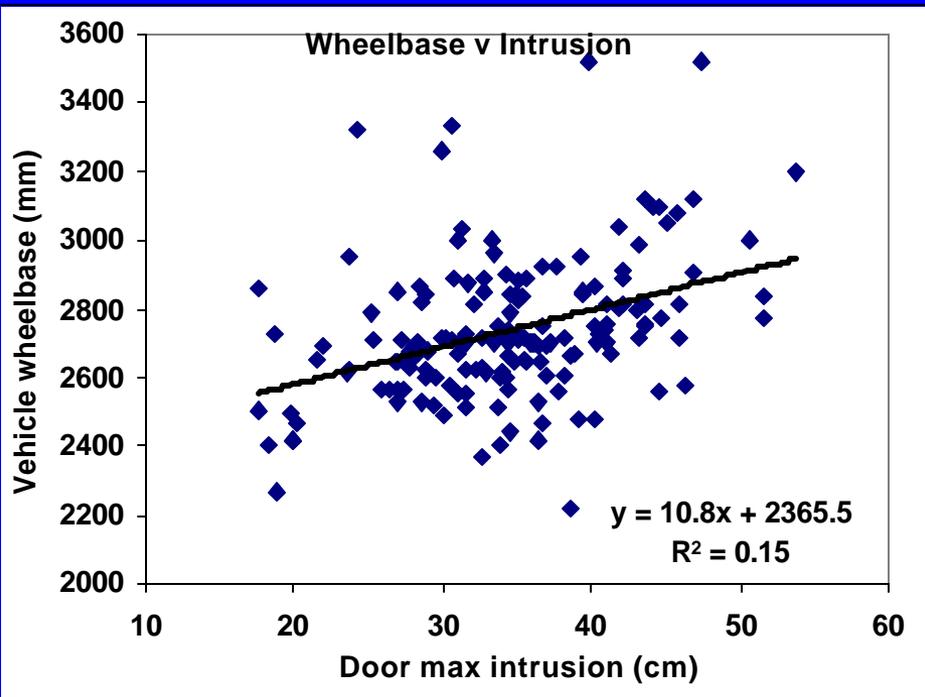
Door intrusion, weak correlation to wheelbase ($r^2 = 0.15$)

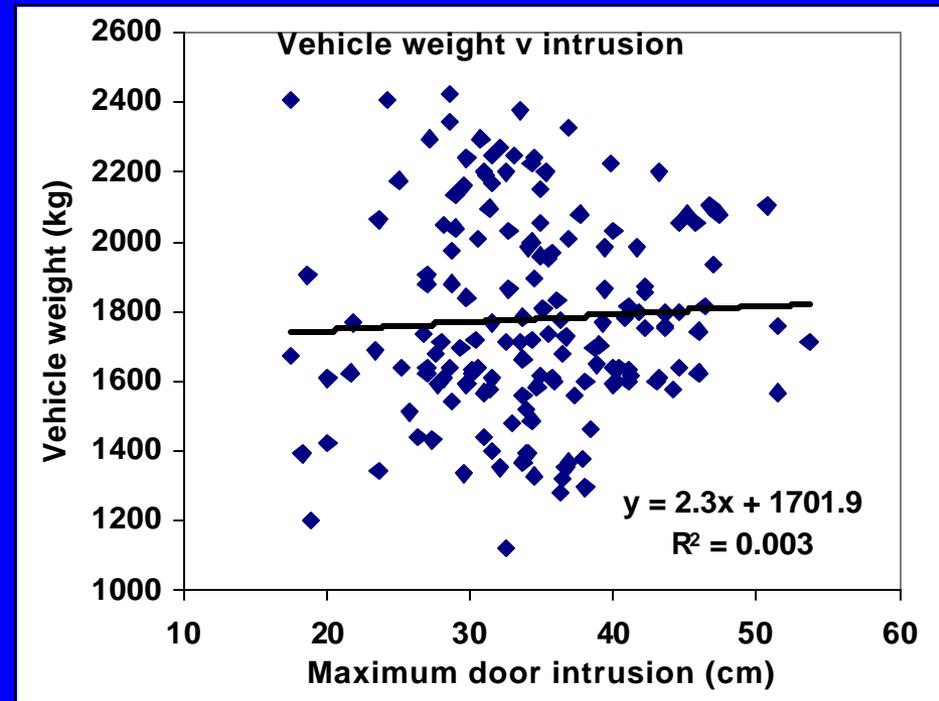
Door intrusion, none to vehicle weight ($r^2 = 0.003$, NS)
