Status of NHTSA's Ejection Mitigation Research

*Aloke Prasad, NHTSA
Stephen Duffy, TRC Inc.*

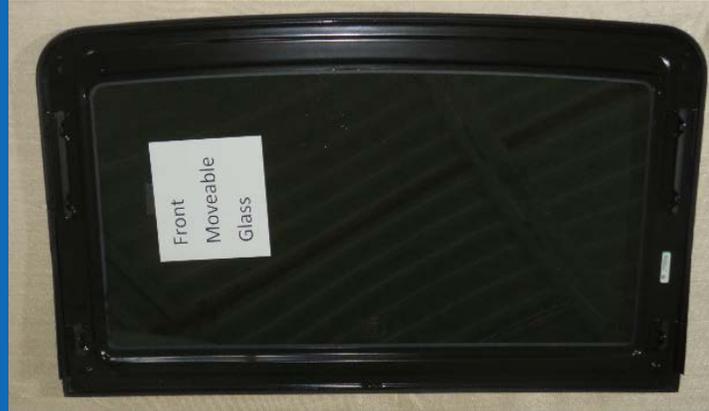
Front (movable) panel

Front and rear panels attached to sunroof module

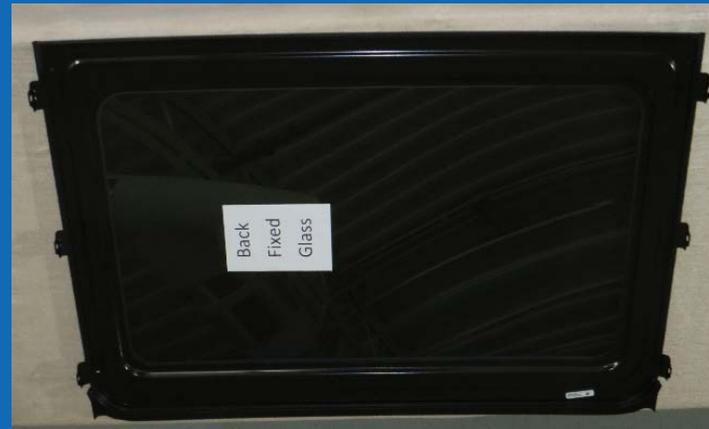
Rear (fixed) panel

Sunroof module attached to vehicle roof from the inside- using 22 bolts

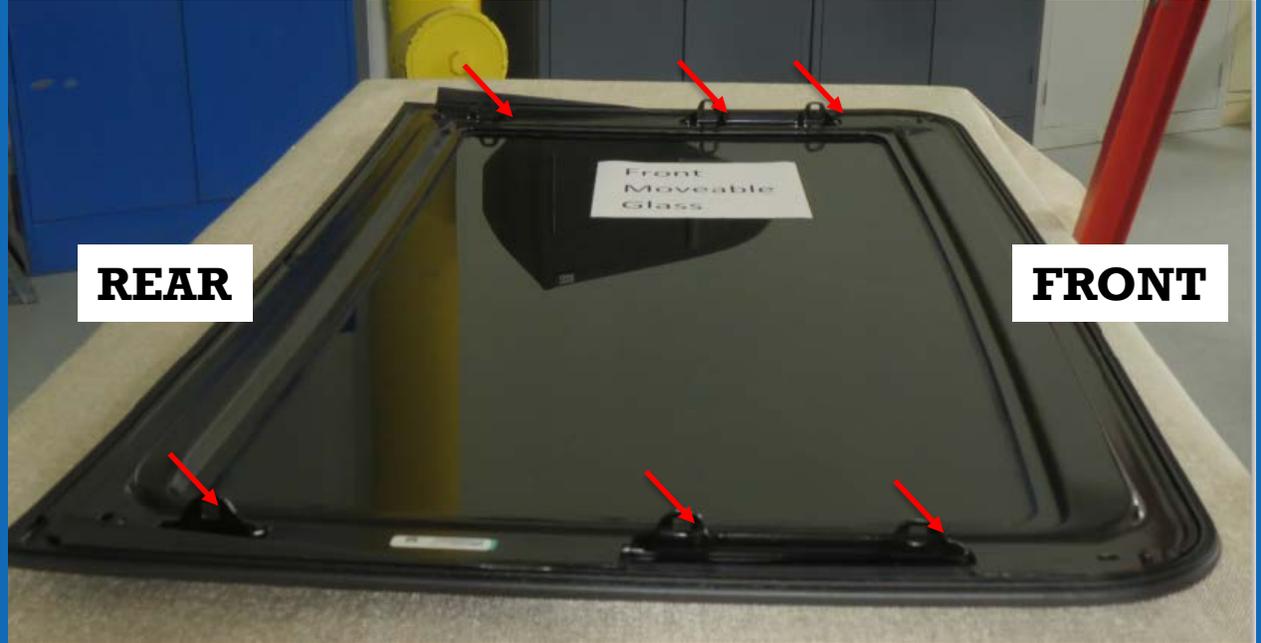
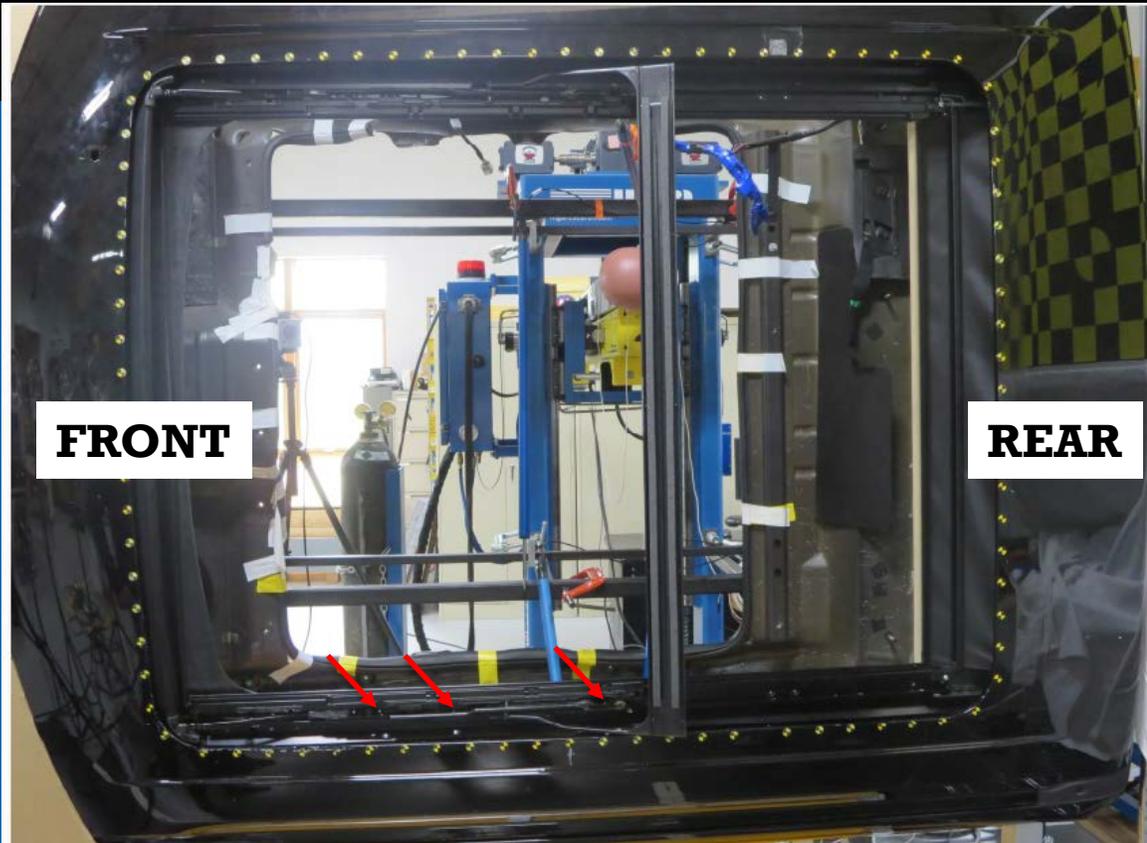
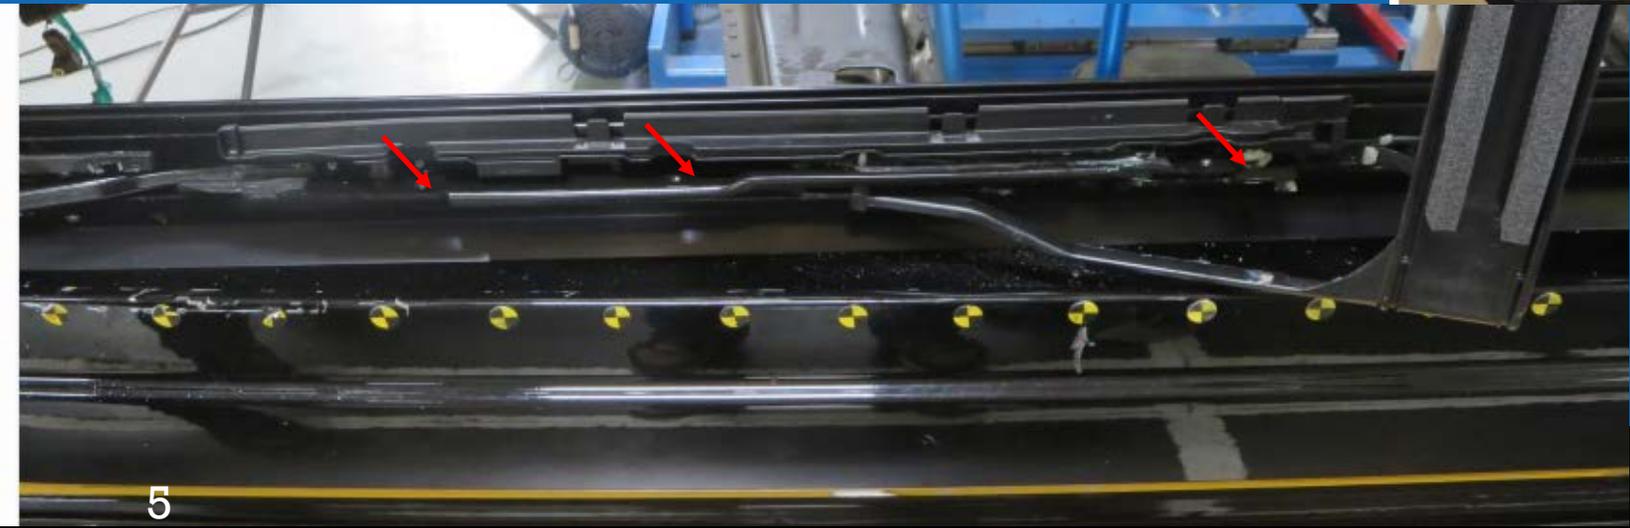
**Front (movable) panel**

Panel attached (6 screws) from the outside to rails that moves in a C channel
Rail attached to the C channel with metal and plastic inserts

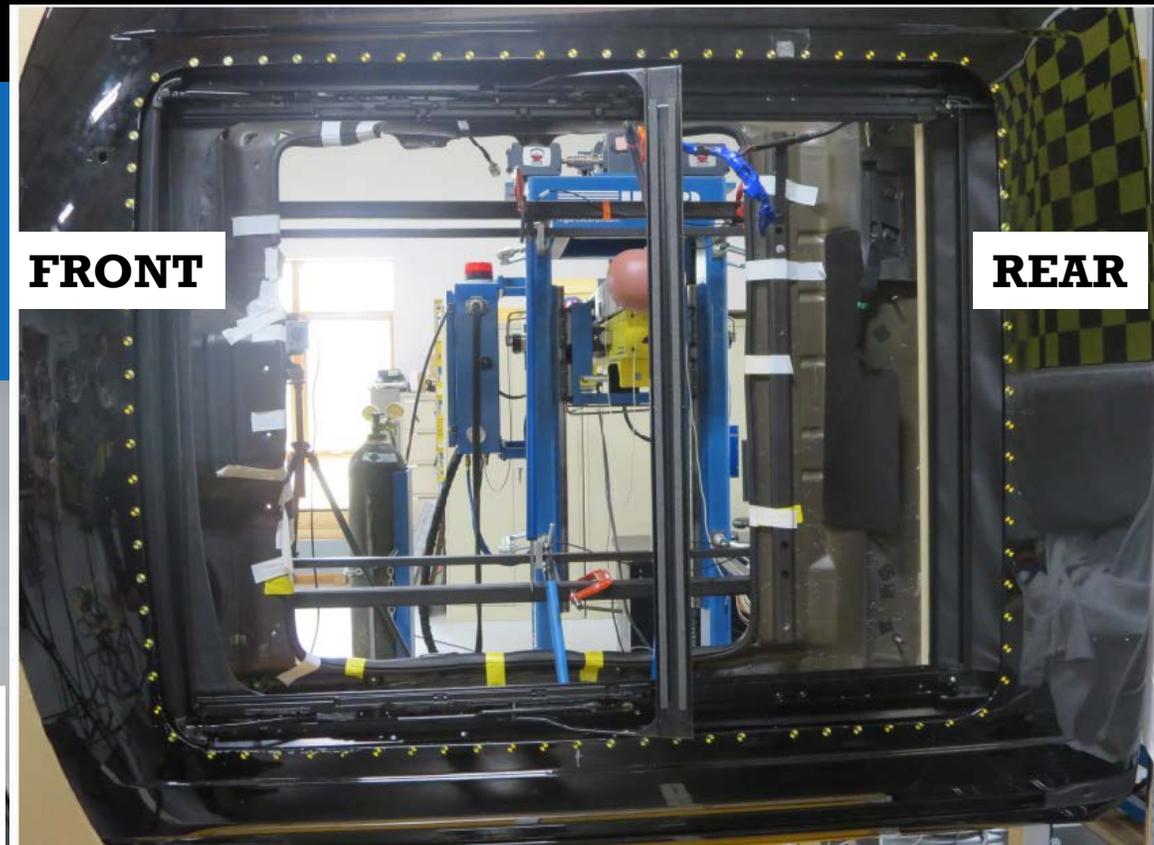
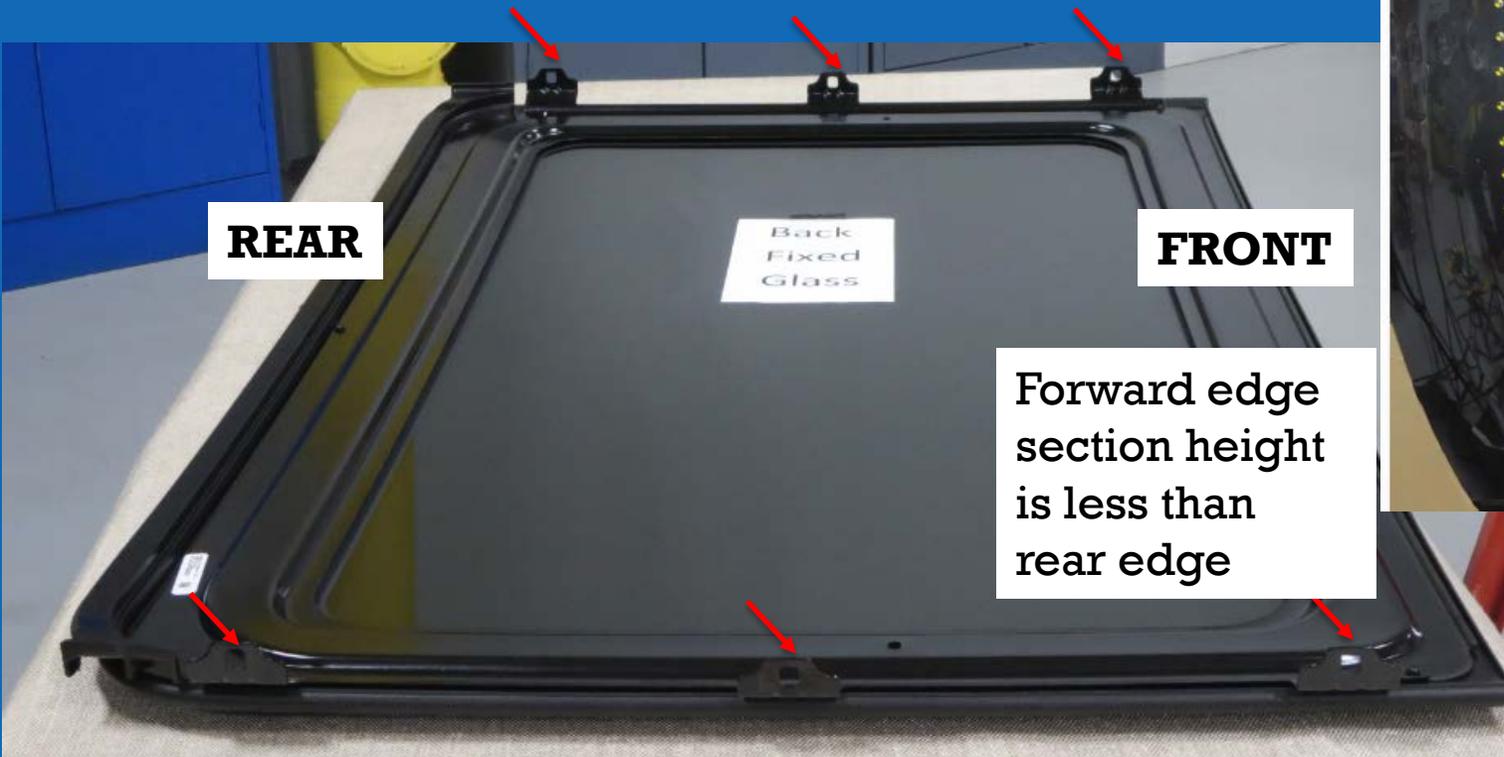
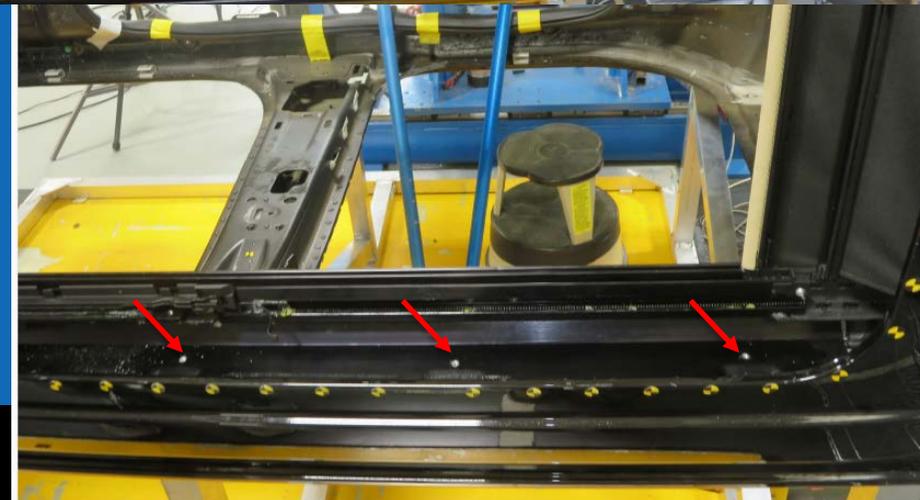
Rear (fixed) Panel

Forward edge section height is less than rear edge

Panel attached (6 screws) from the outside

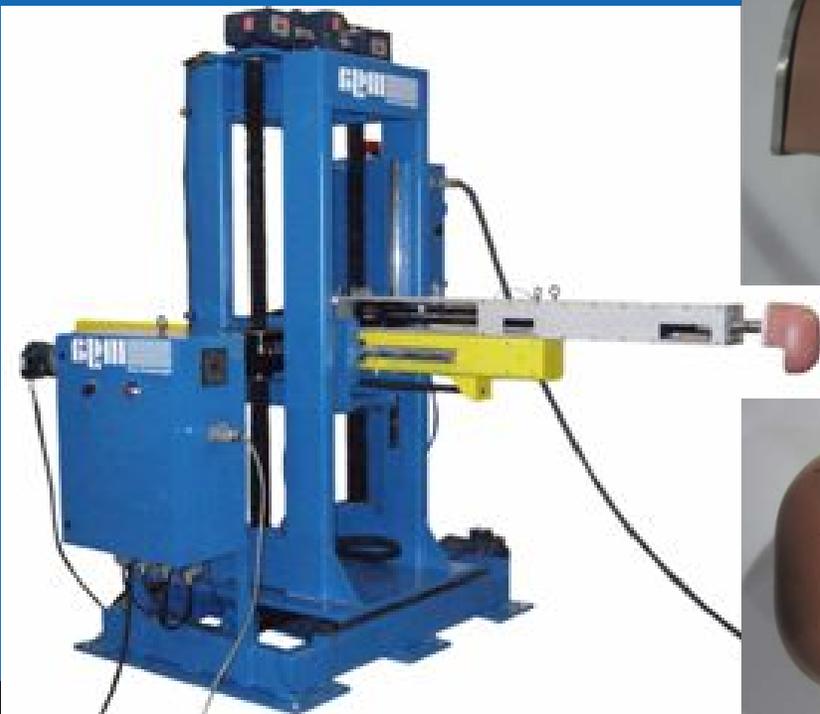
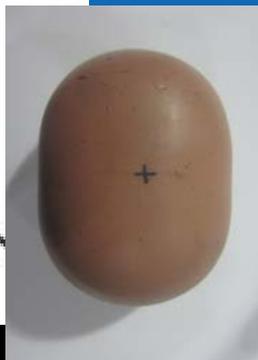
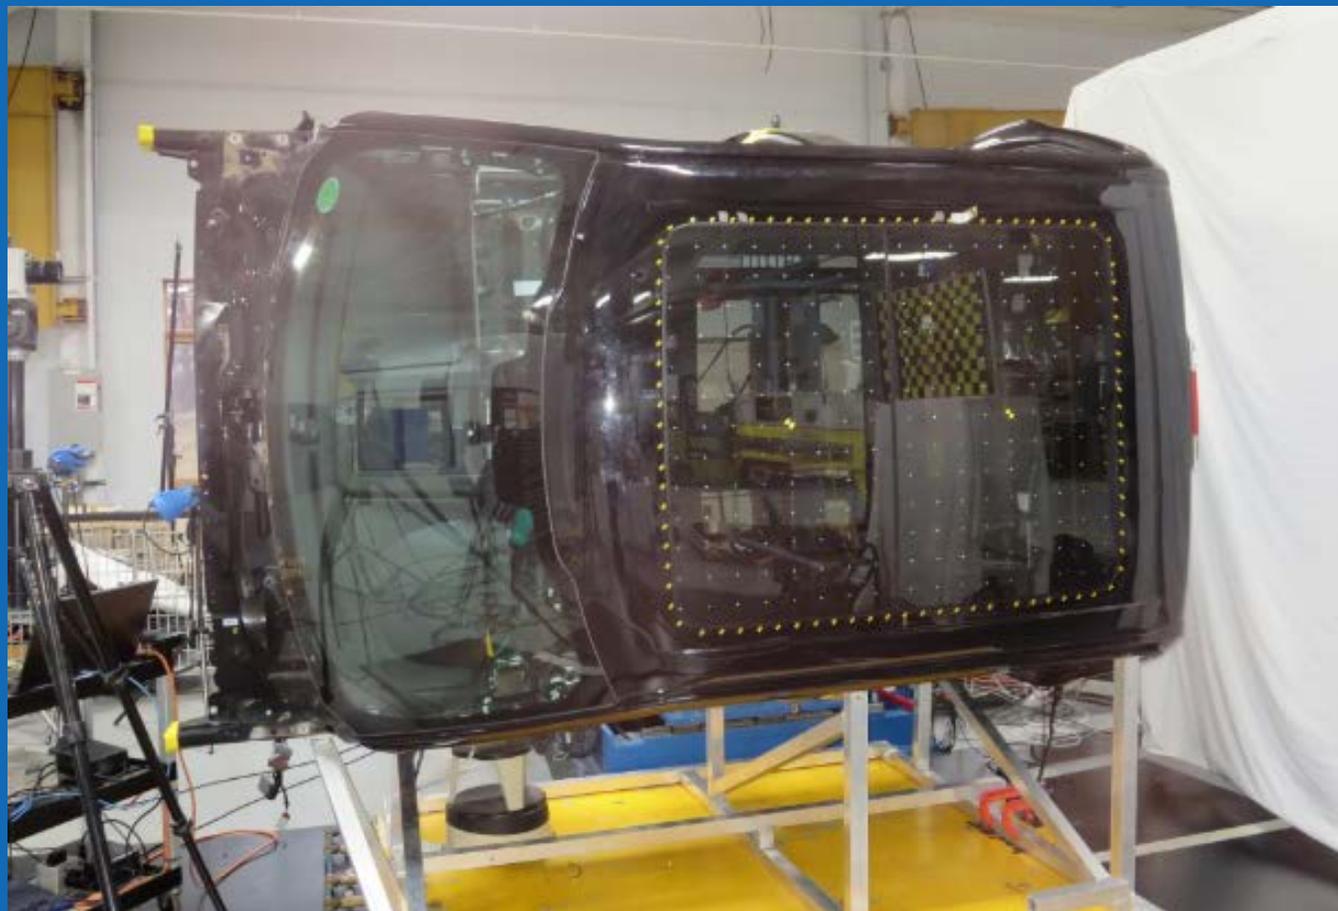
Guided Impactor

- Featureless Headform(176.8 x 226.1 mm)
 - 40 lbs. (18 kg)
 - Displacement from Linear Pot (LVDT)
 - Impact Velocity – 14/16*/20* kph
- *Used in FMVSS No. 226**

Mounted sideways

Glass pre-broken on both sides (except ProTEC II)
75 mm offset pattern per FMVSS No. 226

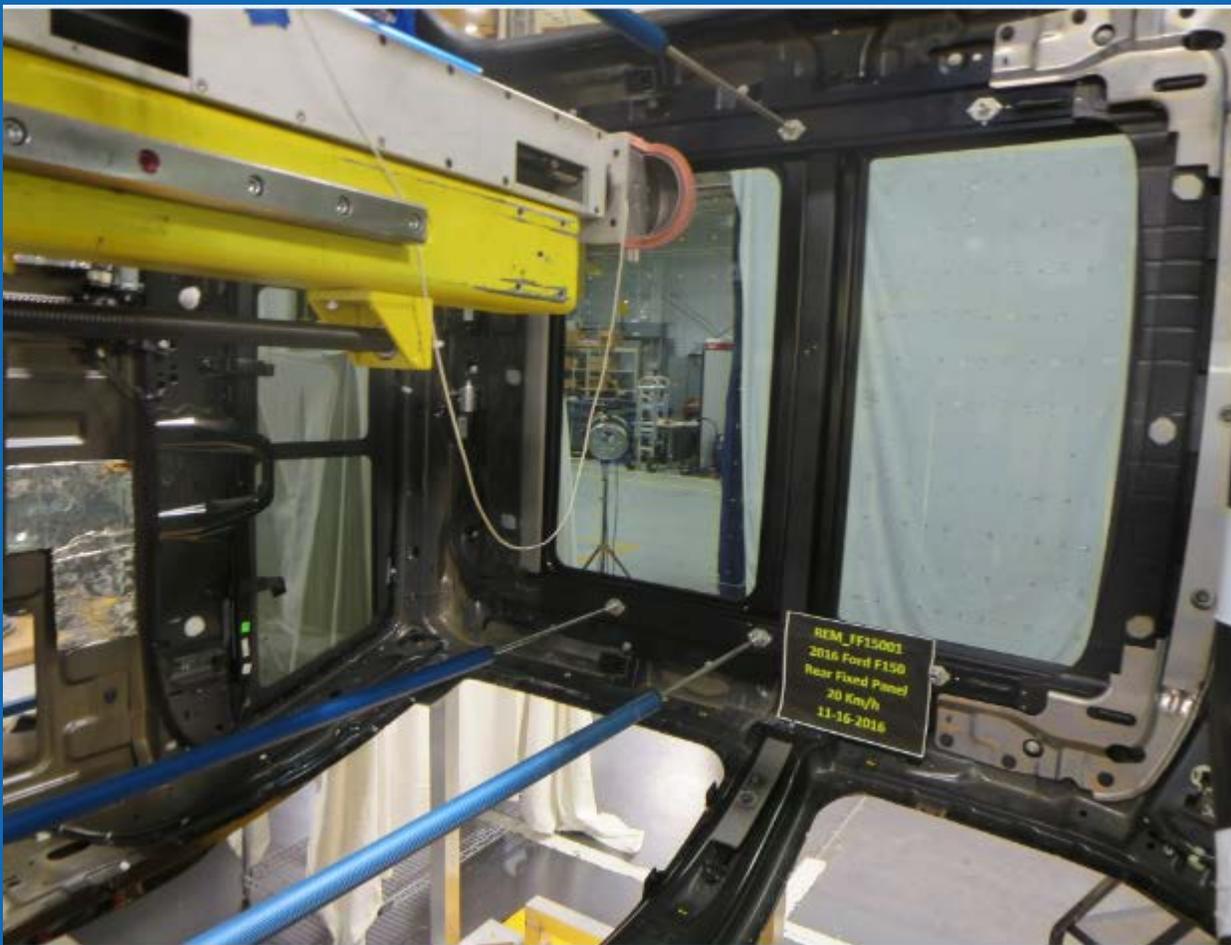
Instrumentation

Linear potentiometer measures ram displacement
4 linear potentiometer on the sunroof frame (detect permanent deformation)

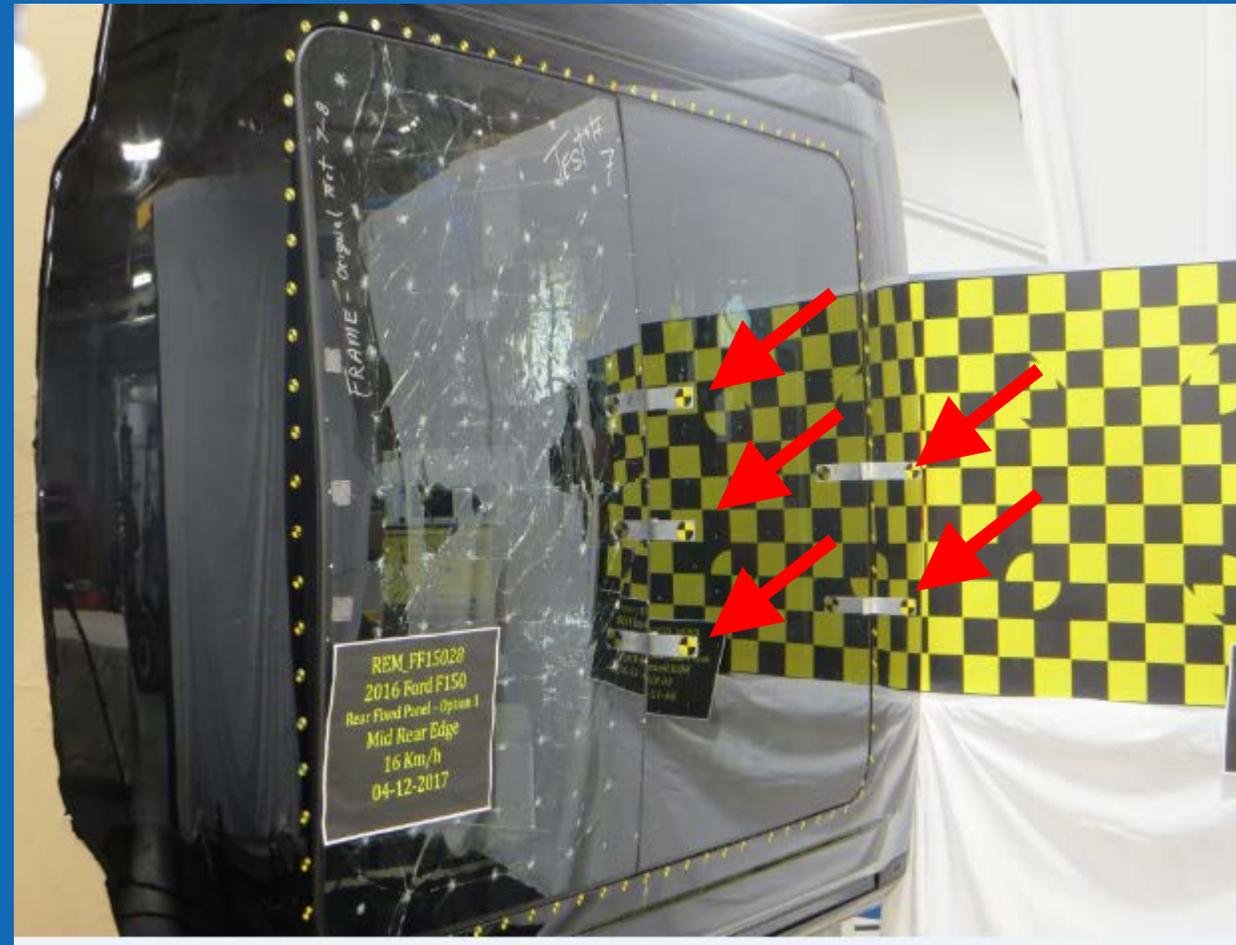
Targets at unsupported edges to measure dynamic excursion using photogrammetry (TEMA)

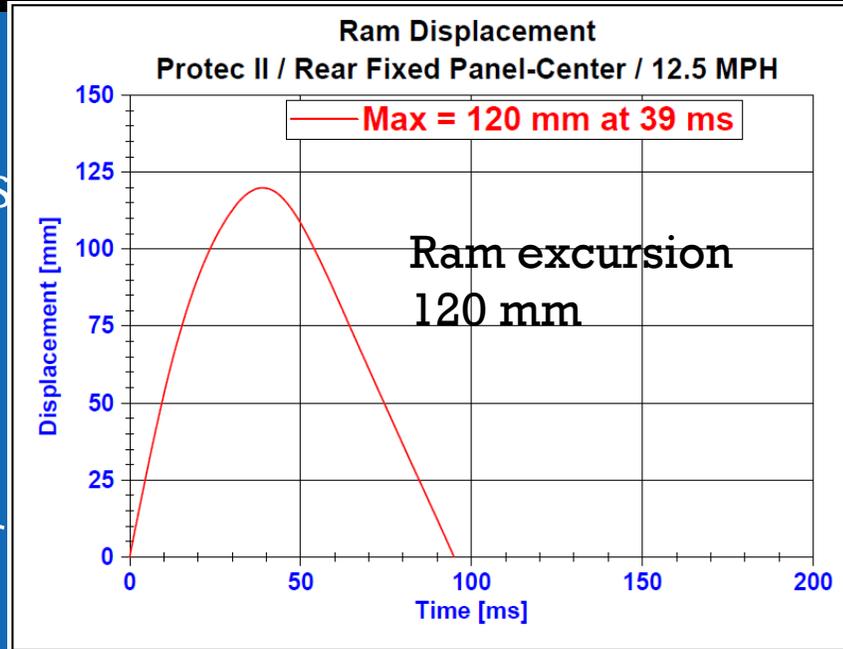
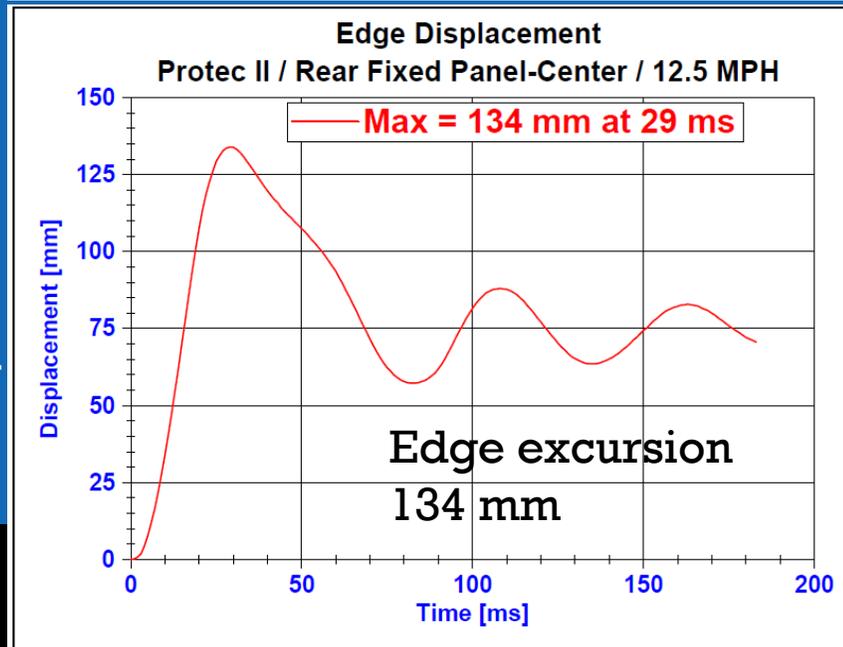
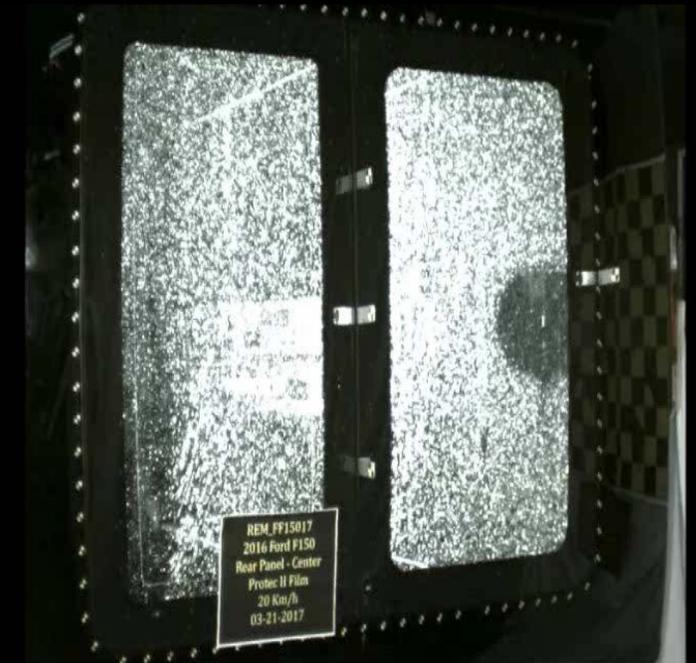
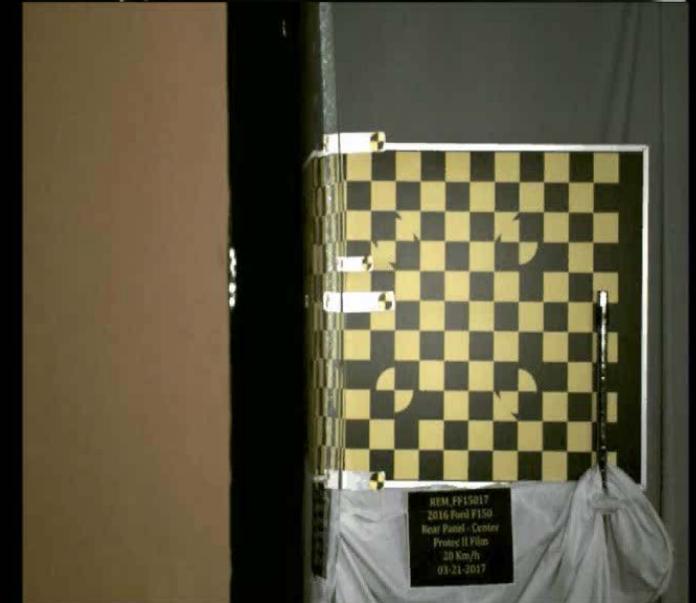
Example of Video and Data

- ProTEC II panel
 - Single tempered glass
 - Plastic layer inside
- Center of panel
- 20 kph
- Ram excursion (LVDT)
 - Used in test procedure
- Edge excursion (TEMA)
 - For research

Note: Edge excursions were higher than ram excursions for ProTEC panels

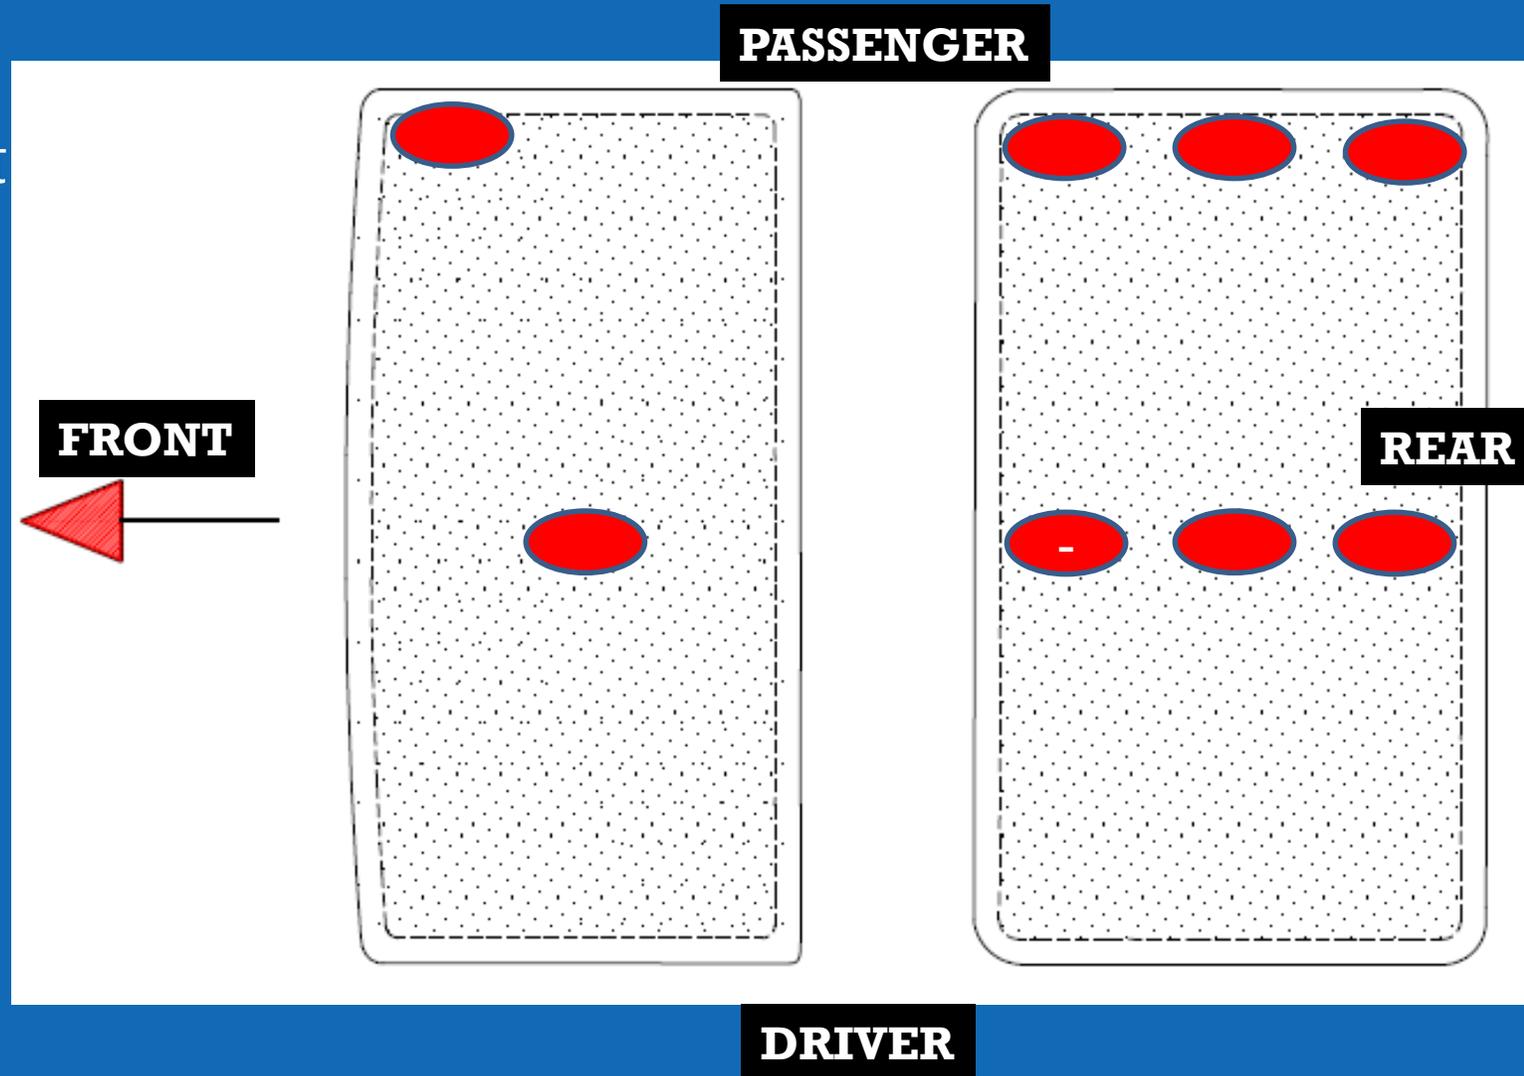
Initial Assessment Impact locations

- Based on engineering judgment
 - Loading on glass
 - Loading on panel attachment
- Assumes
 - Left-right sides are identical
 - Front-rear are NOT identical

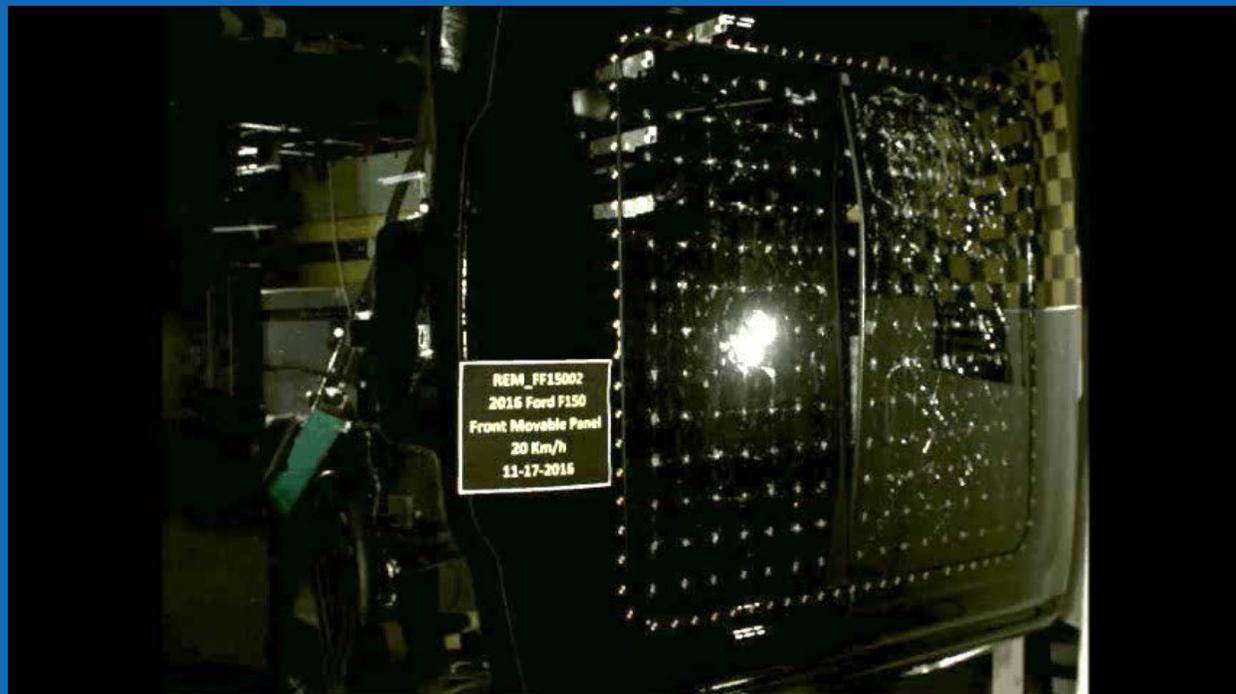
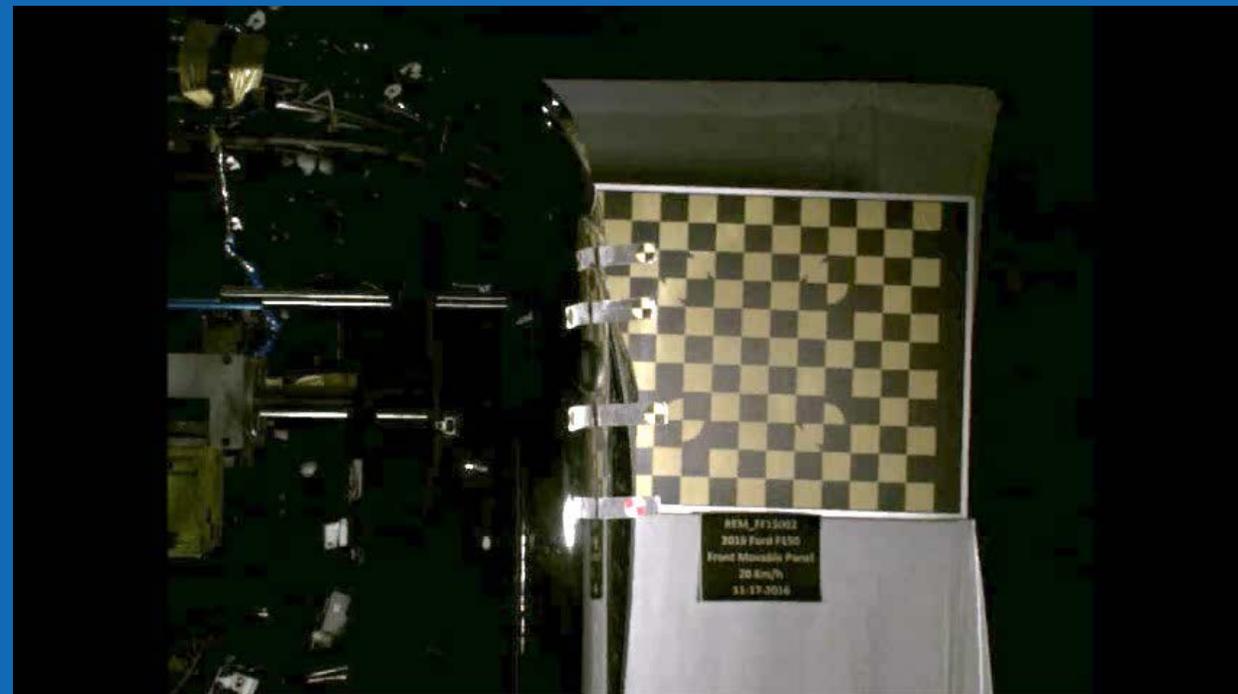
Video of Front Panel Corner

Glazing: Baseline (production)
Location: Front Panel Front Corner
Speed: 20 kph (12.4 mph)
Excursion: 178 mm (at the ram)

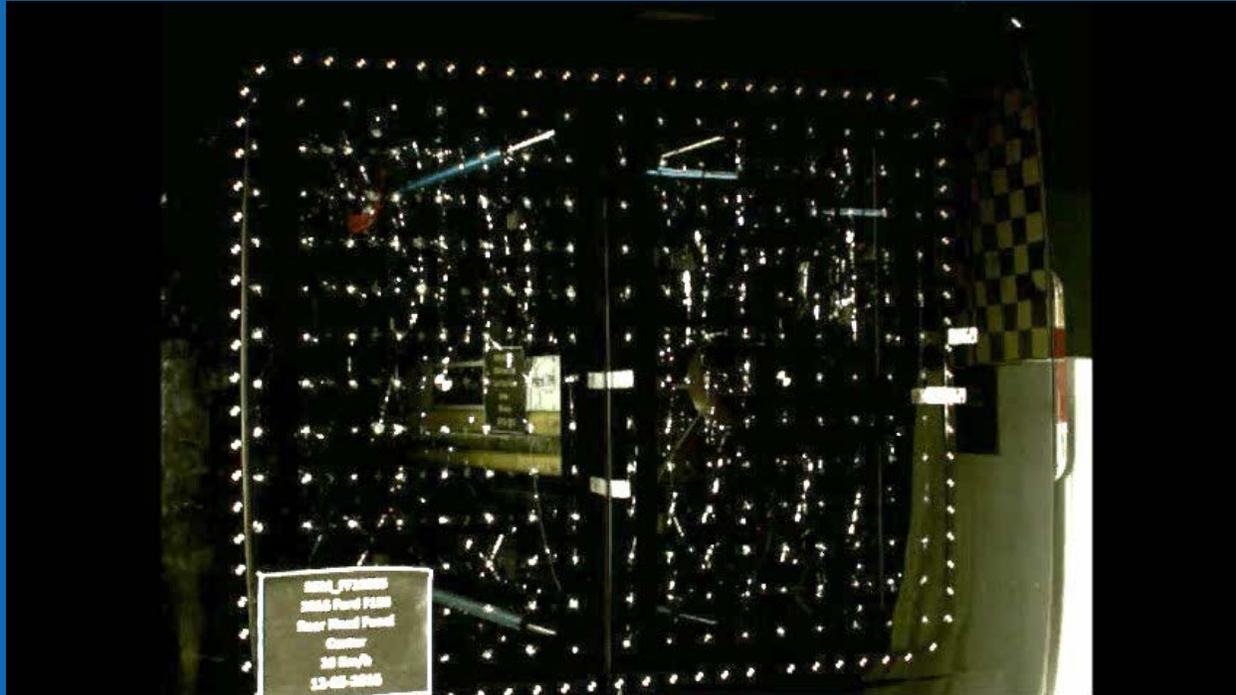
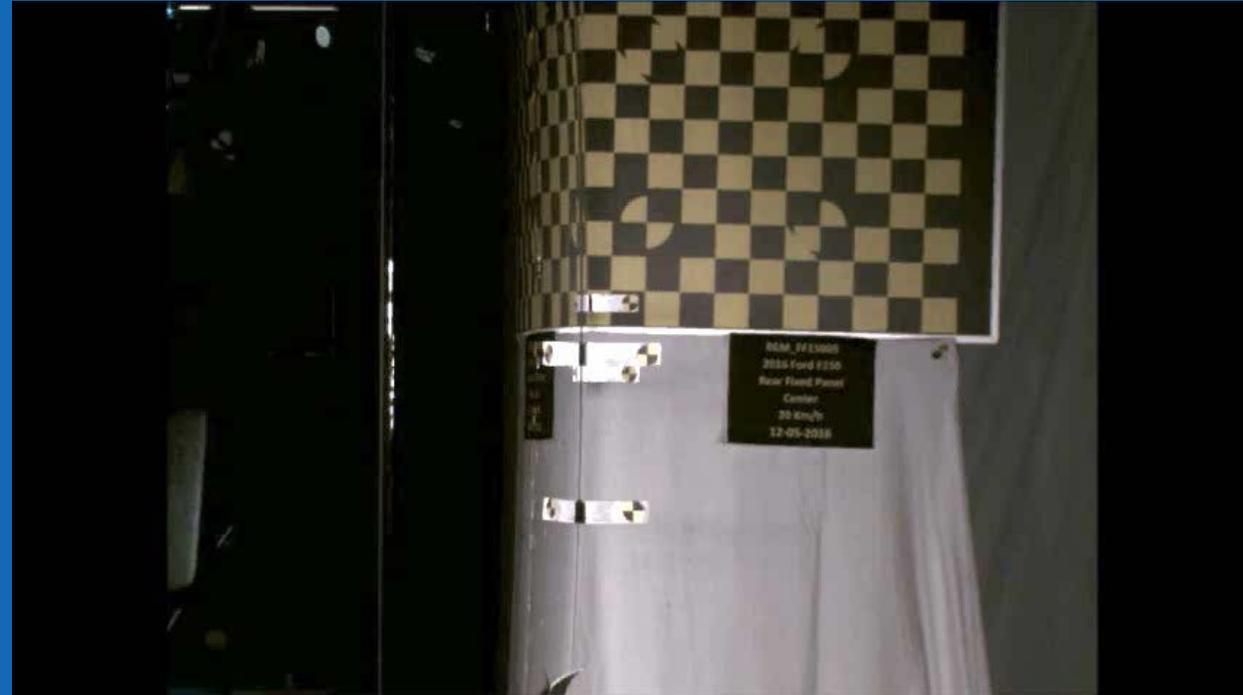
Video of Rear Panel Center

Glazing: Baseline (production)
Location: Rear Fixed Panel Center
Speed: 20 kph (12.4 mph)
Excursion: 138 mm (at the ram); 101 mm (at the edge)

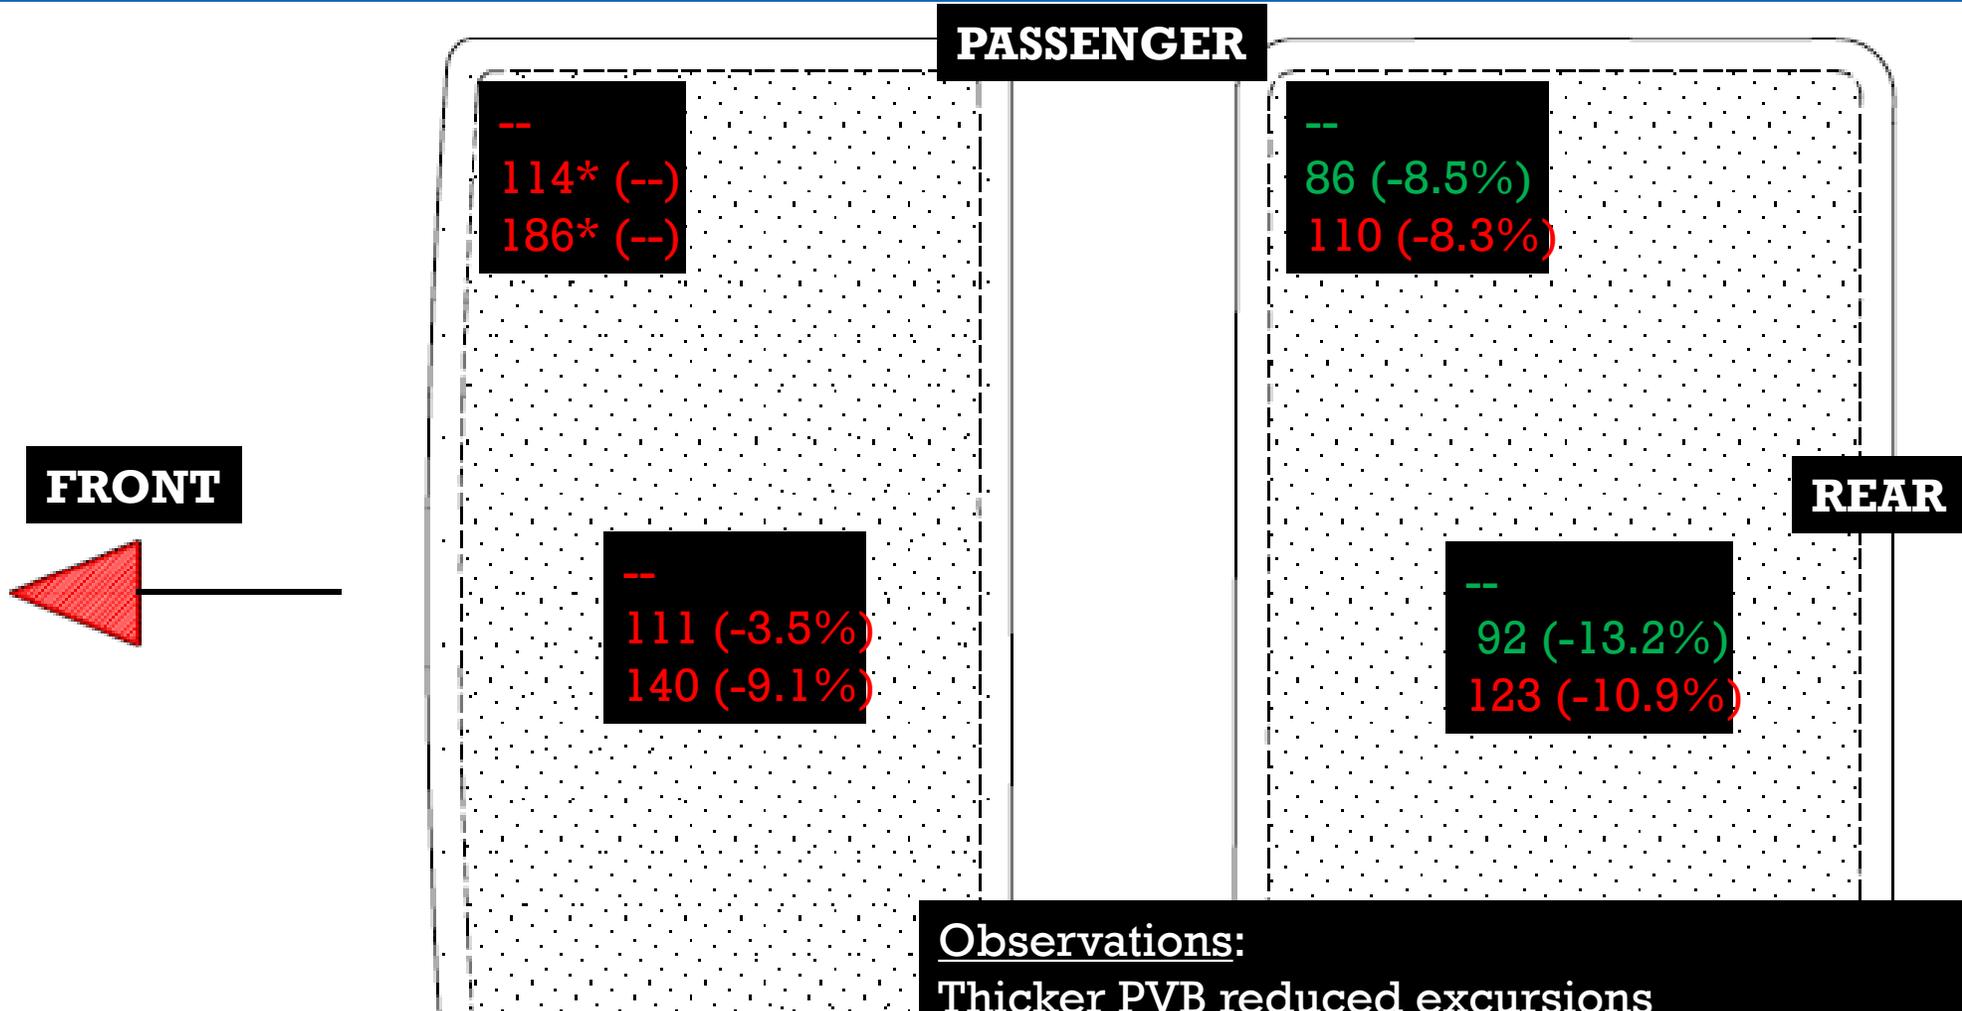
Ram Excursions (Double Thickness PVB Panel)

Observations: Front Movable Panel
 Center - Less PVB stretch; more transverse frame bending
 Corner - catastrophic edge failure

Observations:
 Thicker PVB reduced excursions
 ~ 10% reduction in excursion (rear)
 Stronger glazing => transfer of loads to edges

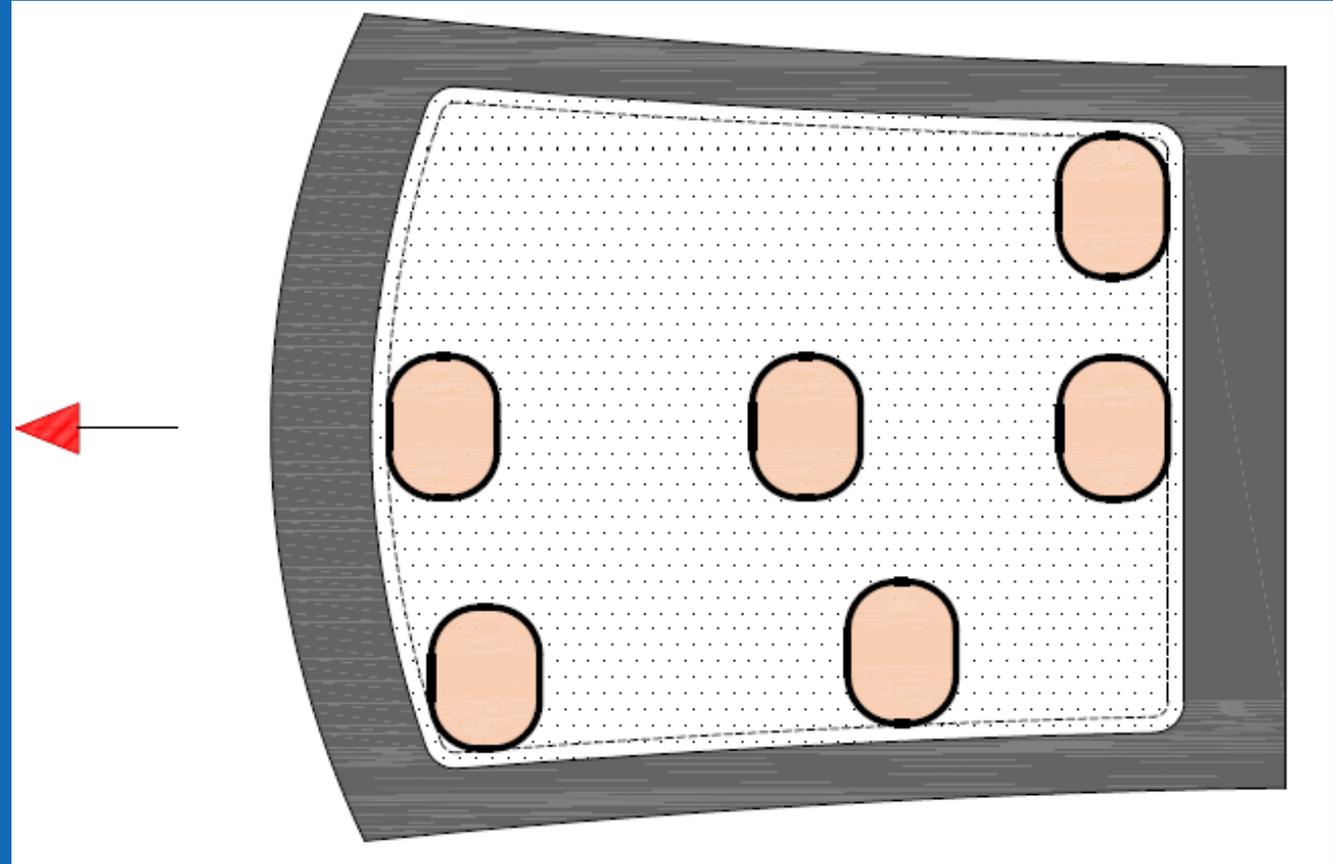
Revised Test Procedure

- Based on results and engineering judgement
- Headform rotated
- Additional speed (14/16/20 kph)
- Assumes
 - Left-right side are identical
 - Front-back are NOT identical
- Test each panel at
 - Front corner
 - Rear corner
 - Center
 - Mid-point of front transverse edge
 - Mid-point of rear transverse edge
 - At 2/3 of longitudinal edge

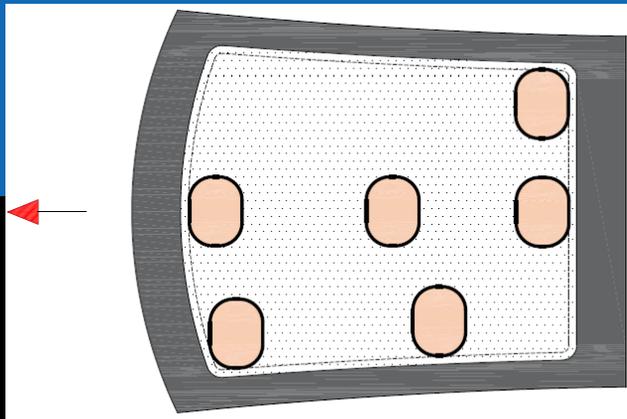
Ram Excursions (Production Glass - Baseline)

Observations:

Front movable panel:

Center - PVB stretch + transverse frame bending

Corner - Rail failure => large excursions

Rear fixed panel: No edge failure

Forward transverse edge is thinner and weaker

Test showed good repeatability

Thicker PVB reduced excursion by ~9 mm

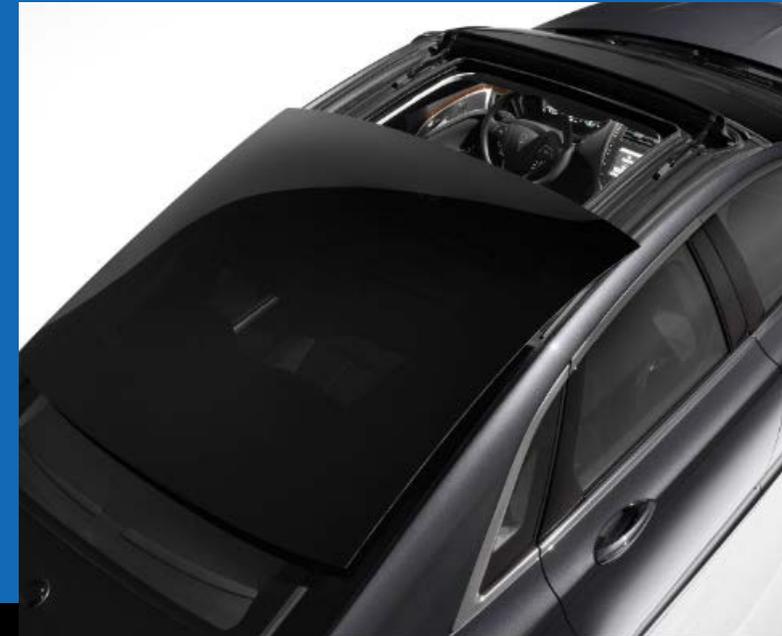
- Movable panels present more challenges to contain than fixed panels
 - Ford Flex; CMax; Subaru Forester (with movable panel) [2017 ESV]
 - True for F-150 including countermeasures
 - Moving panel - Failure at the inserts (into the rails)
 - Fixed panels can have higher excursions at unsupported transverse edges (F-150 fixed rear panel has front and rear unsupported edges)
- Thicker plastic PVB interlayer (laminated) and PET film (Protec II) :
 - Did not tear
 - Reduced stretch (and ram excursions)
 - Transferred more forces to the edges
 - Greater challenge for movable panels
 - Can produce larger opening at an edge (not ram)
- Headform orientation can affect ram excursions
- Results may change for different sunroof designs

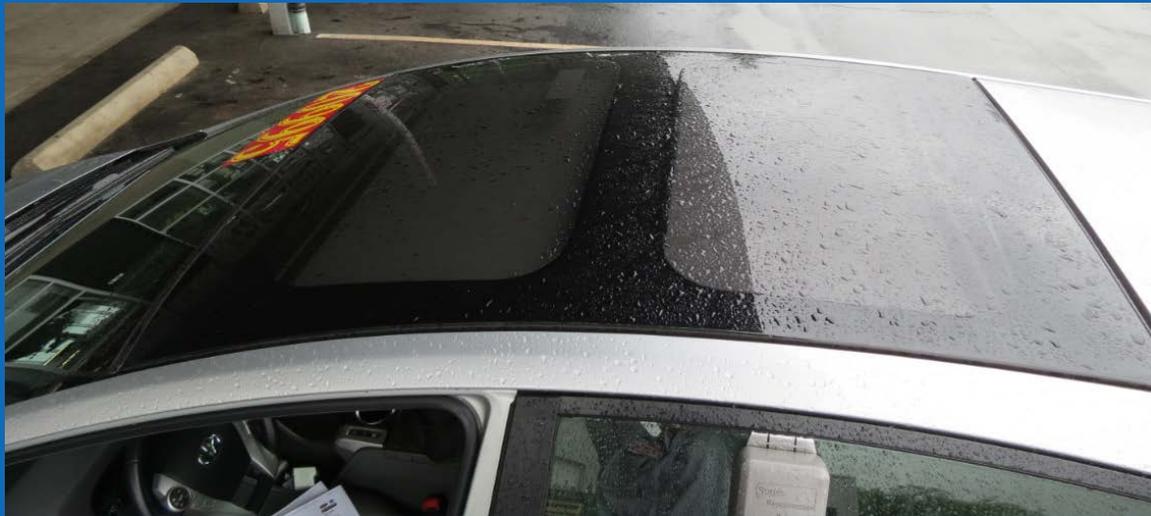
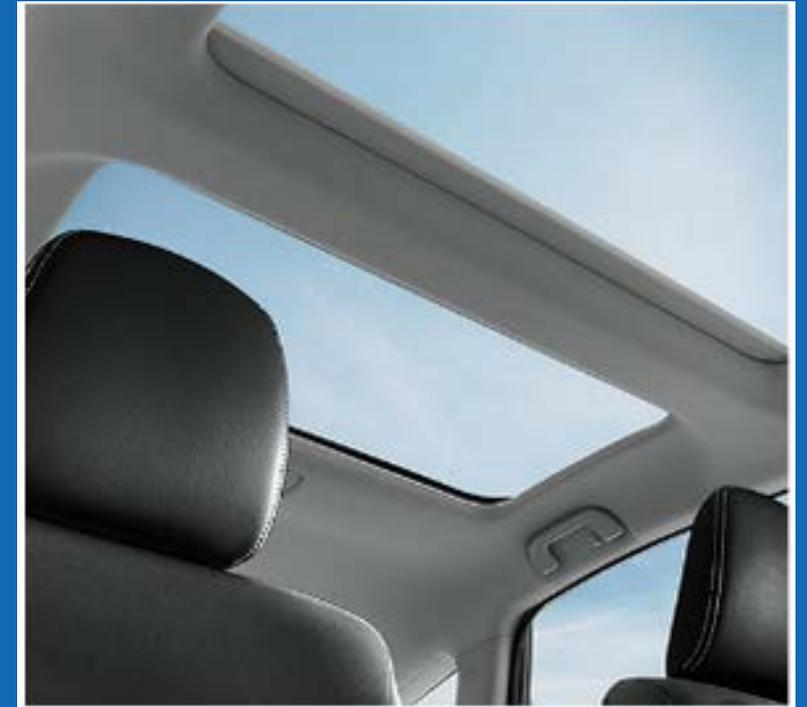
2013 Prius v

- 2012 Toyota Prius v (trim Five) Technology Package option
 - Polycarbonate sunroof panel -1 fixed panel with 2 daylight openings
- Additional sunroof designs (opening to the outside; curtains)
