Head Contacts in Pedestrian Crashes

Field Data Study

NHTSA Non-Motorist Data Collection

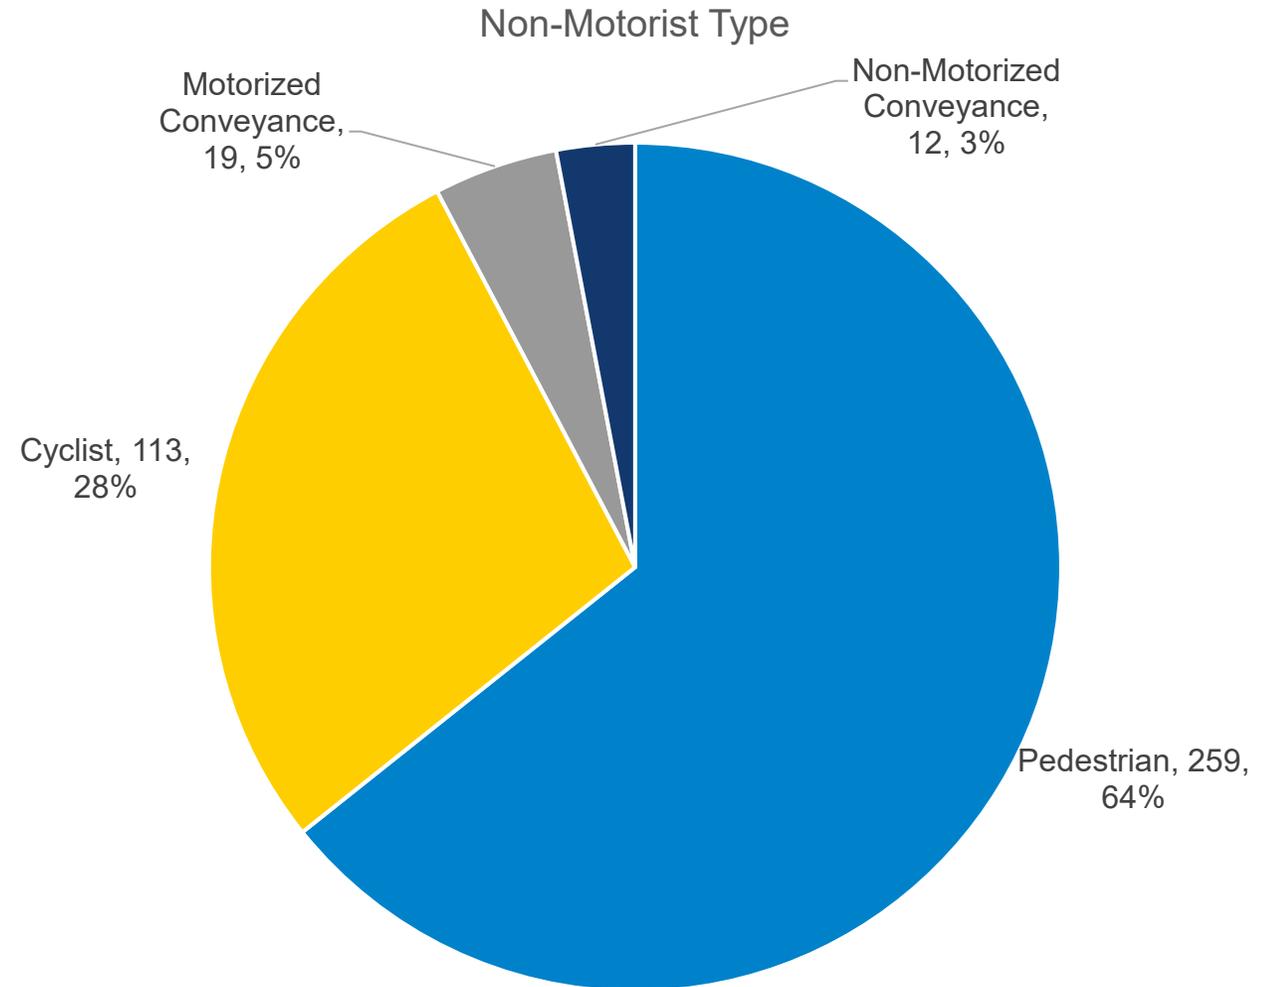
CISS 2024 Non-Motorist Crash Data

- 404 total Non-Motorist cases
 - 259 pedestrians
 - 113 cyclist
 - 31 on personal conveyance
 - 19 motorized
 - 12 non-motorized / unknown

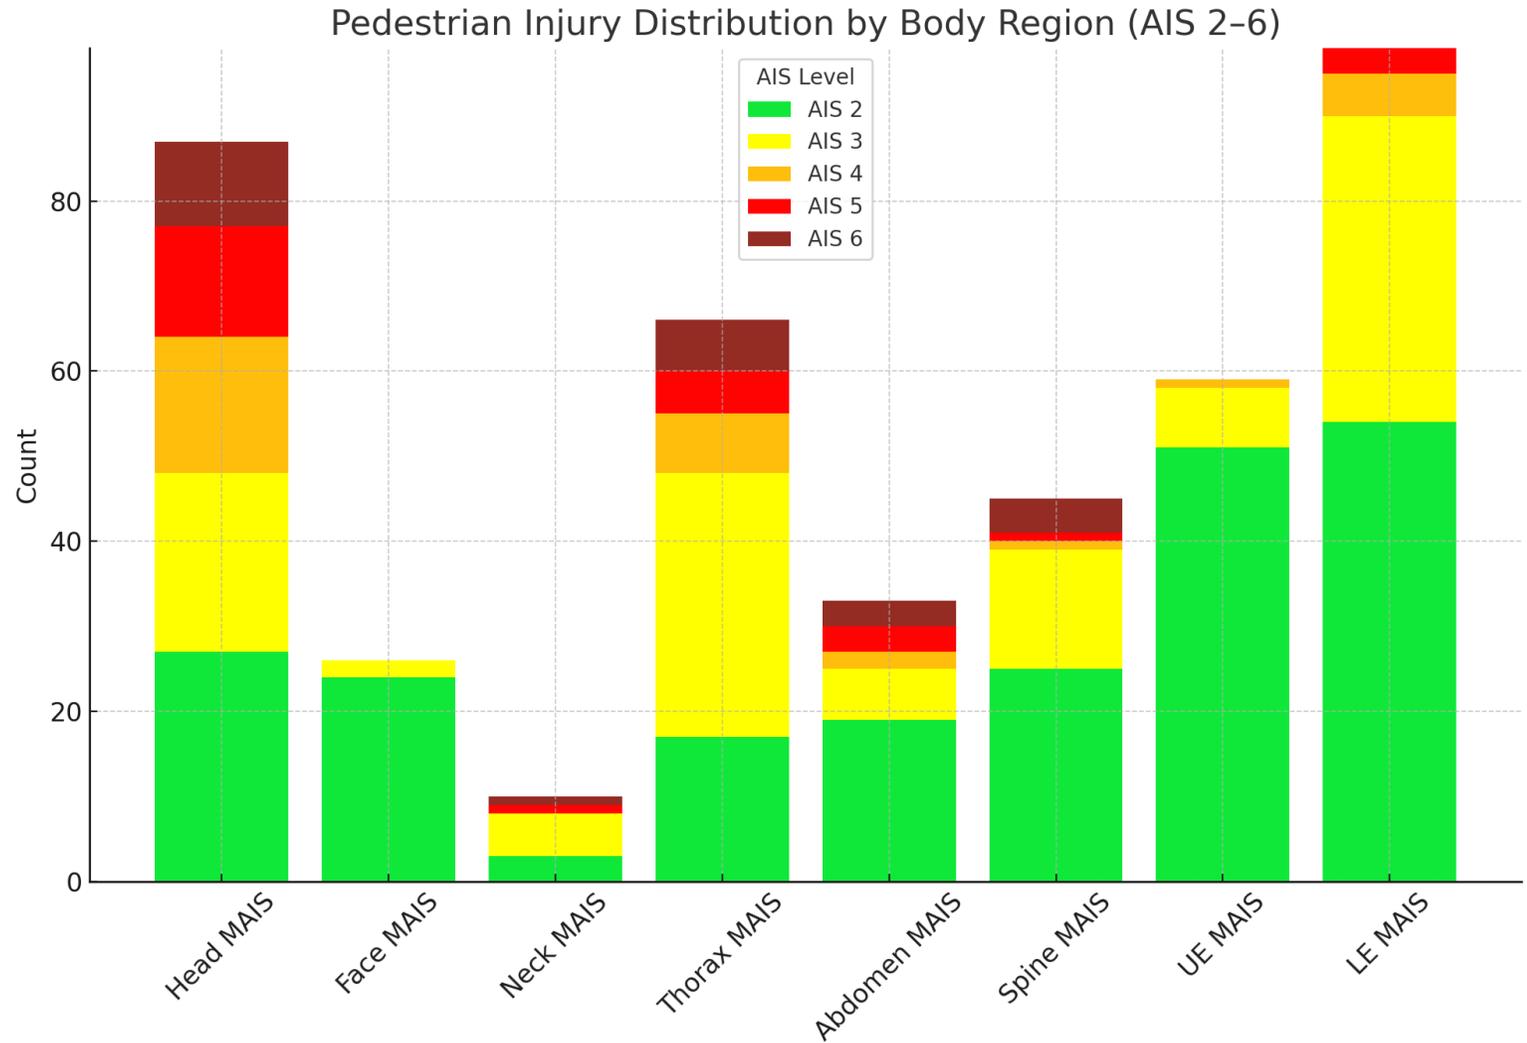
CISS 2024 Pedestrian Injury Distribution

- 259 pedestrian cases
- MAIS 2+
 - Lower Extremity, 98
 - Head, 87
 - Thorax, 66
- MAIS 3+
 - Head, 60
 - Thorax, 49
 - Lower Extremity, 44

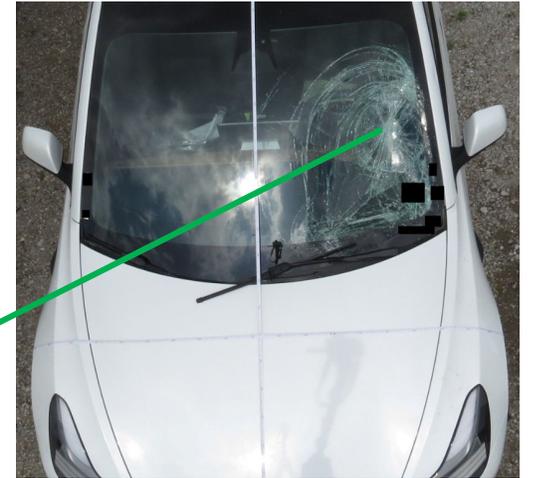
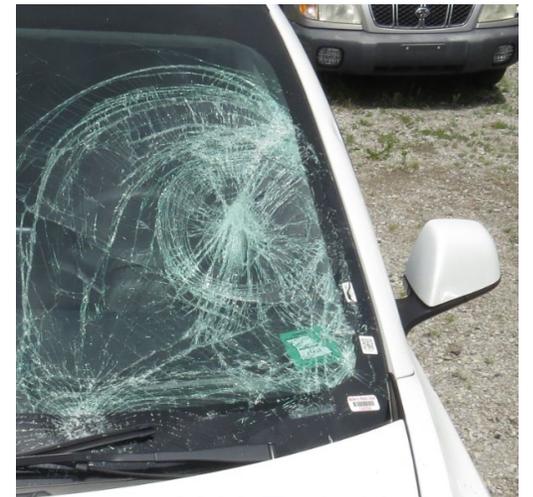
2023 Tesla Model 3

Wrap Around Distance (WAD)

- Crash Investigators measured front end geometry WADs with flexible tape
 - Front/Top Transition
 - Hood Rear
 - Windshield Top
 - Head Contact

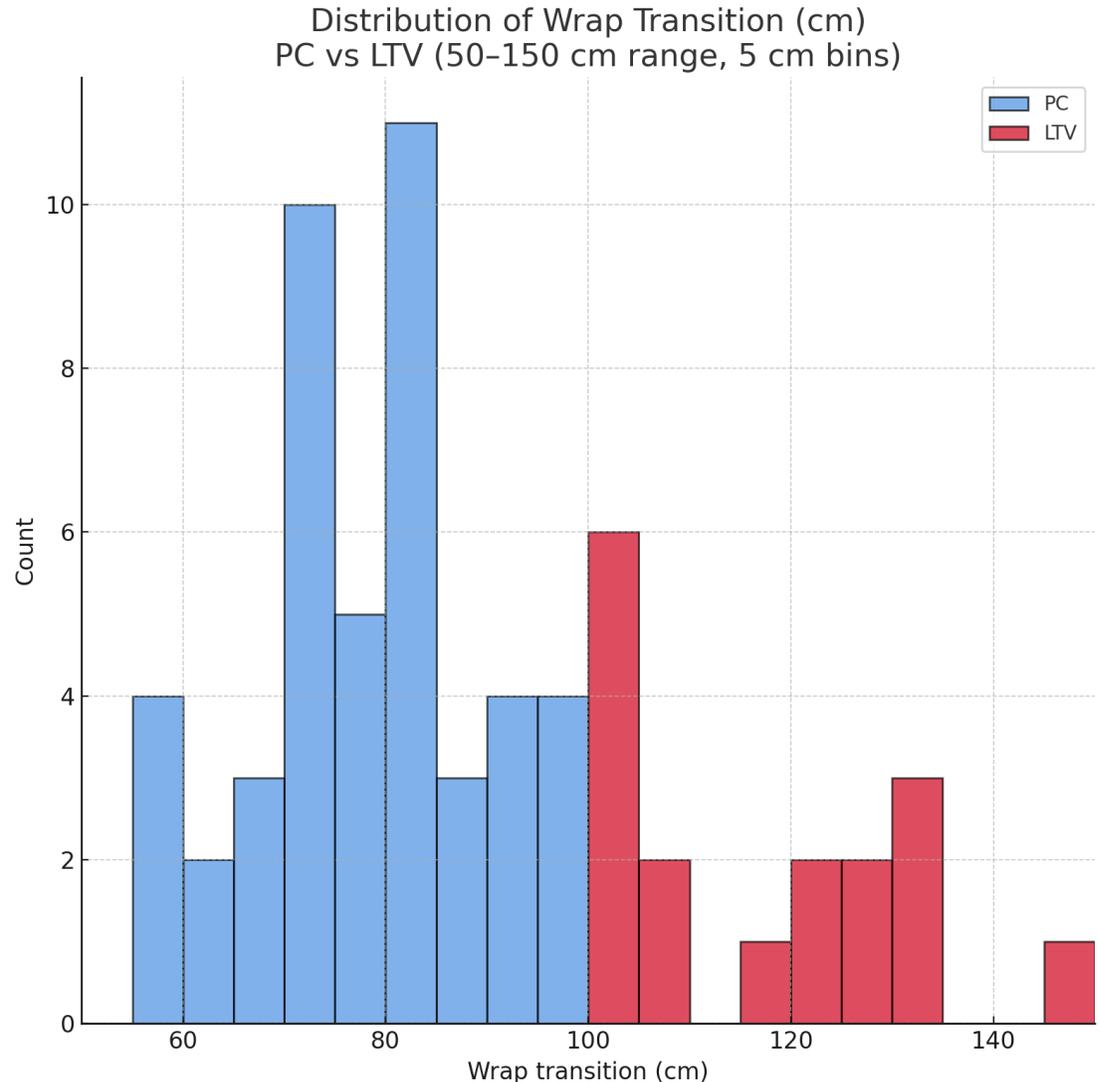
Front / Top Transition

- Group vehicles by Front/Top transition WAD 1000
 - Passenger Cars (PC) with transition WAD <100 cm, 63%
 - Light Truck Vehicles (LTVs) with transition \geq 100 cm, 37%

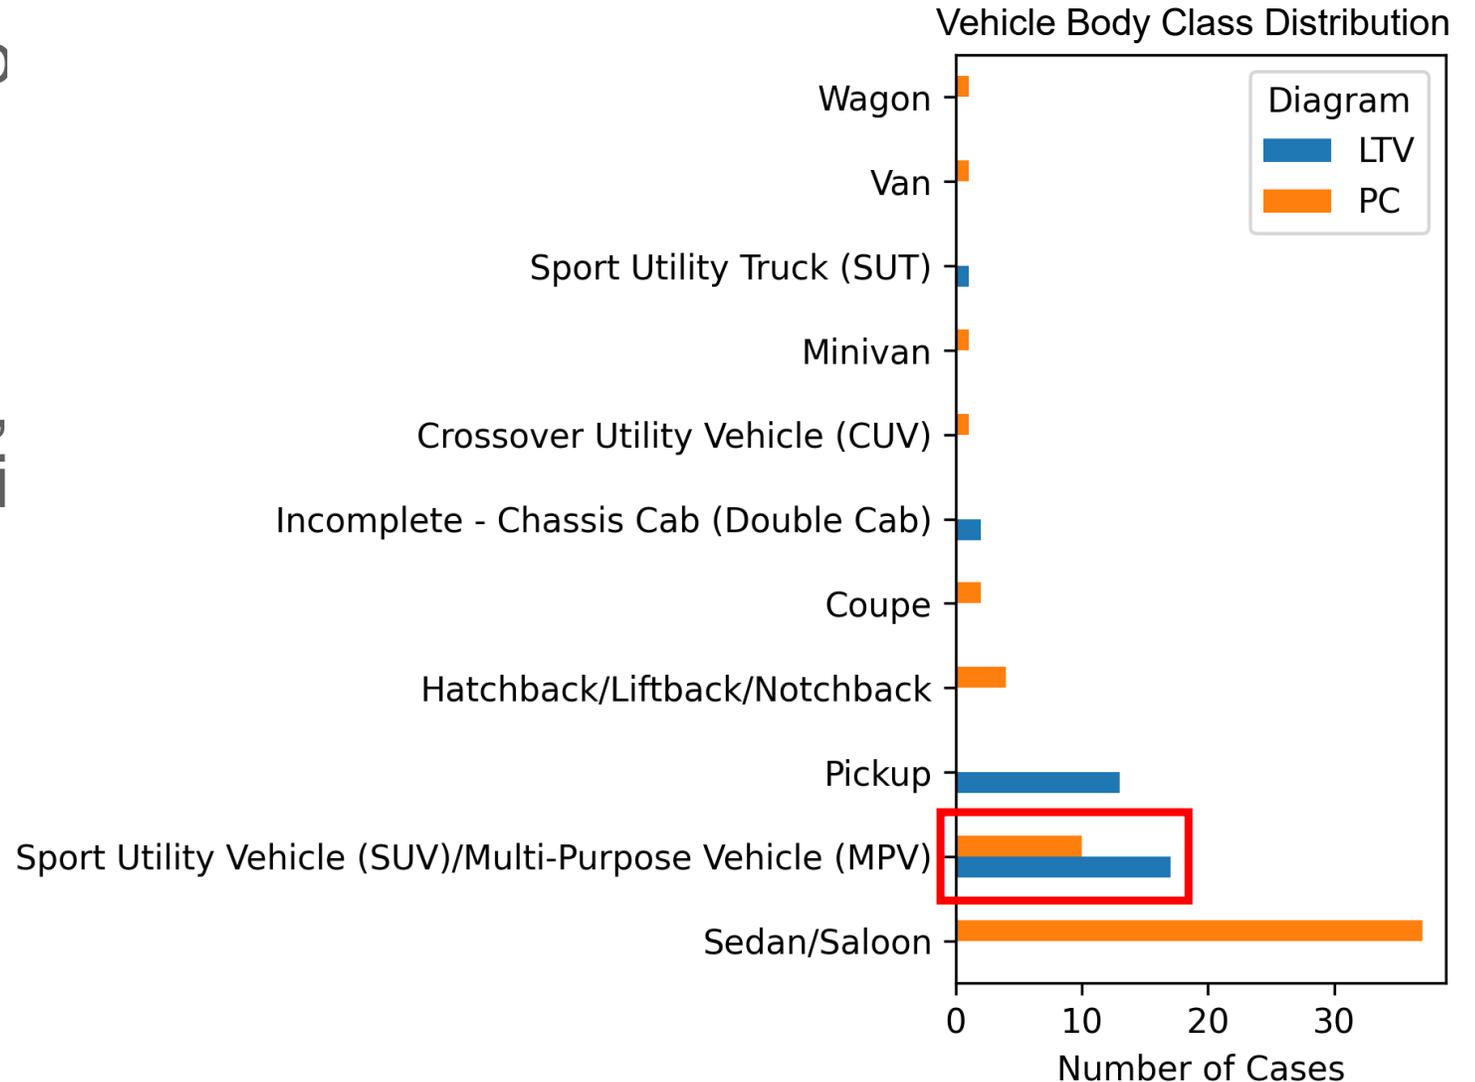
Front / Top Transition

- 100 cm is comparable to IIHS “tall” category used recent studies
- 50th male CG at ~98 cm, wrap vs. forward projecti kinematics threshold

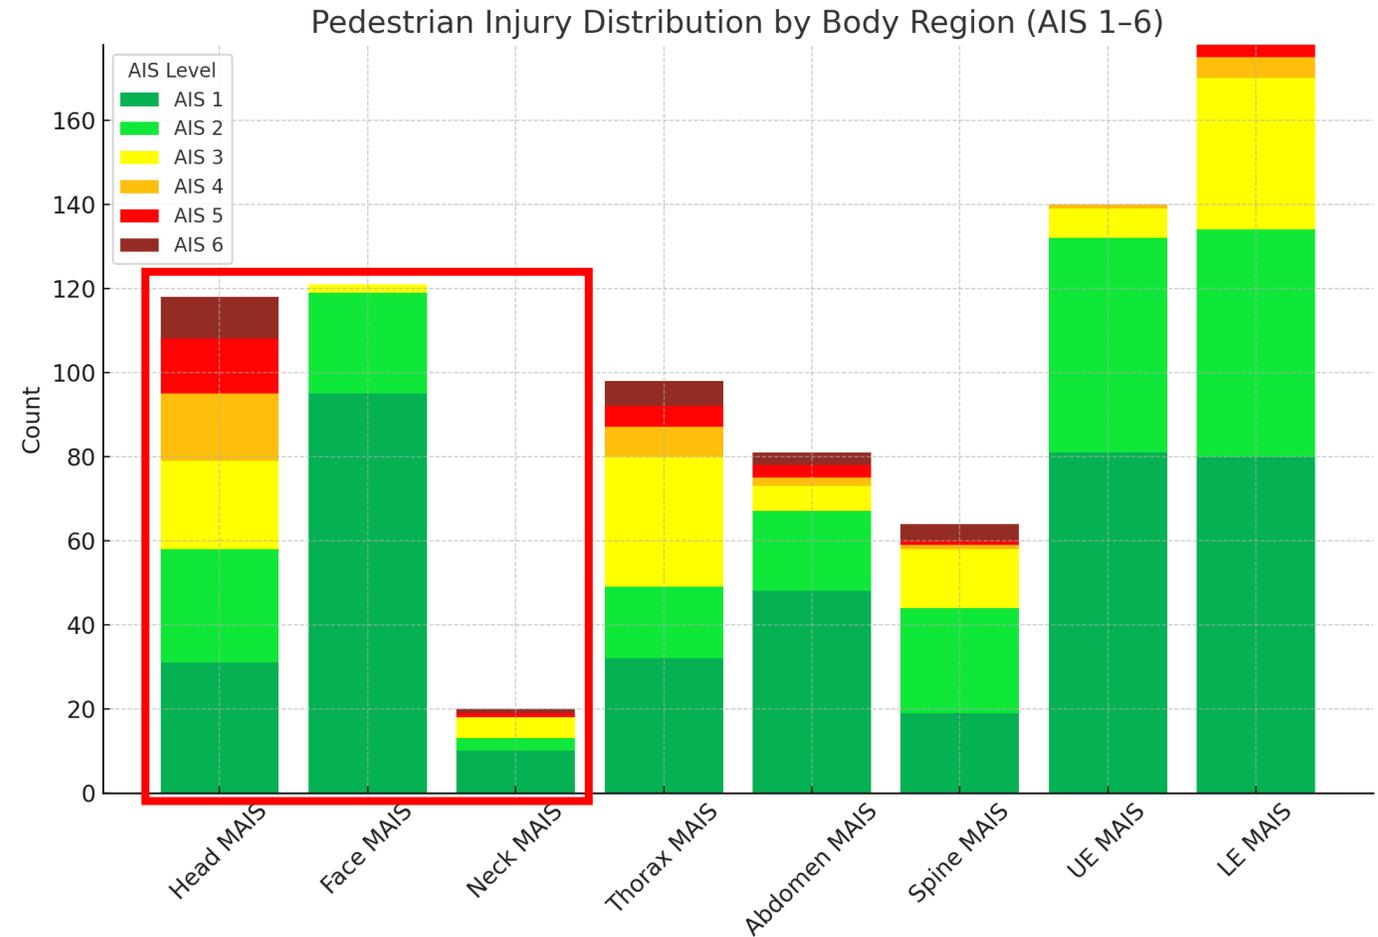
Head / Face / Neck (HFN) Injuries

- CISS 2024: 156 pedestrians with HFN AIS 1+
 - 57 passenger car
 - 33 LTVs
 - 66 N/A – no photos, unknown ICS, multiple vehicles, overlapping damage, etc
- CIREN/VICIS: 60 pedestrians with HFN AIS 1+
 - 34 passenger car
 - 23 LTV
 - 3 N/A

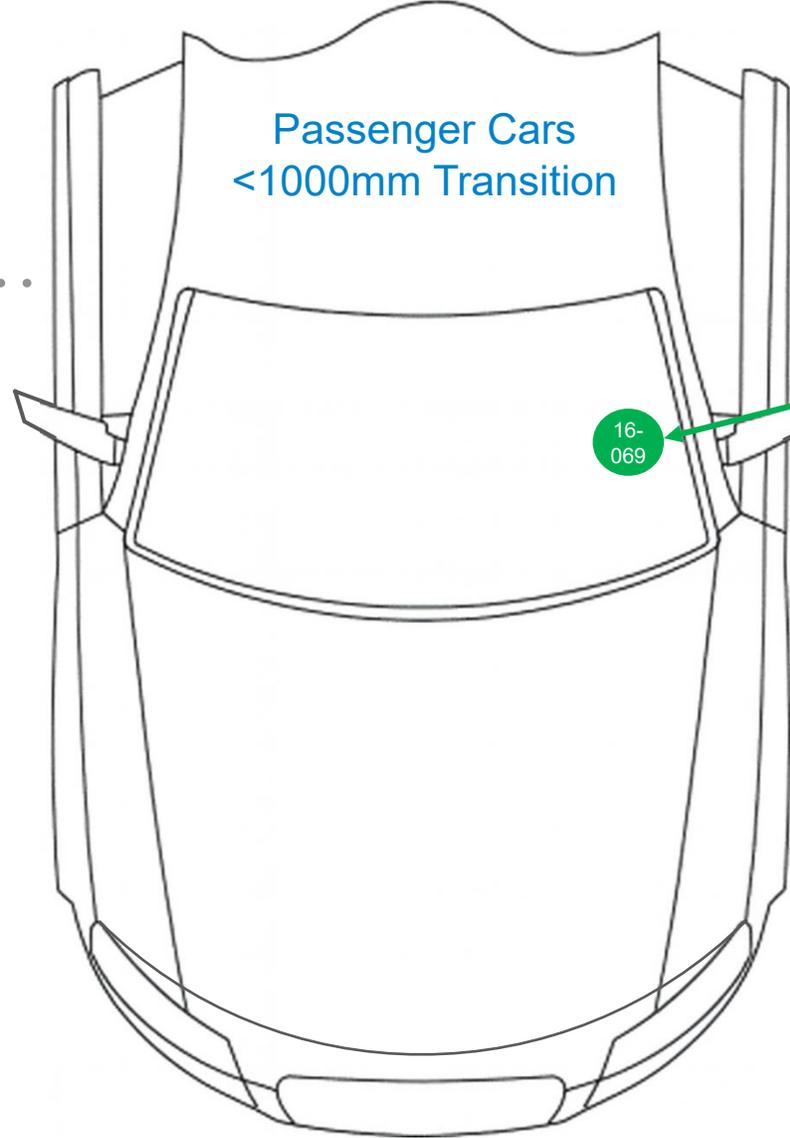
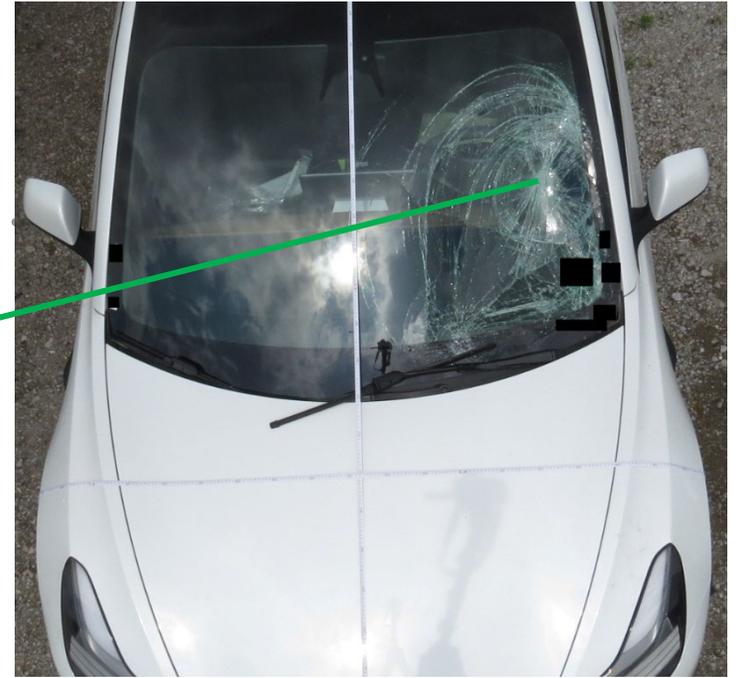
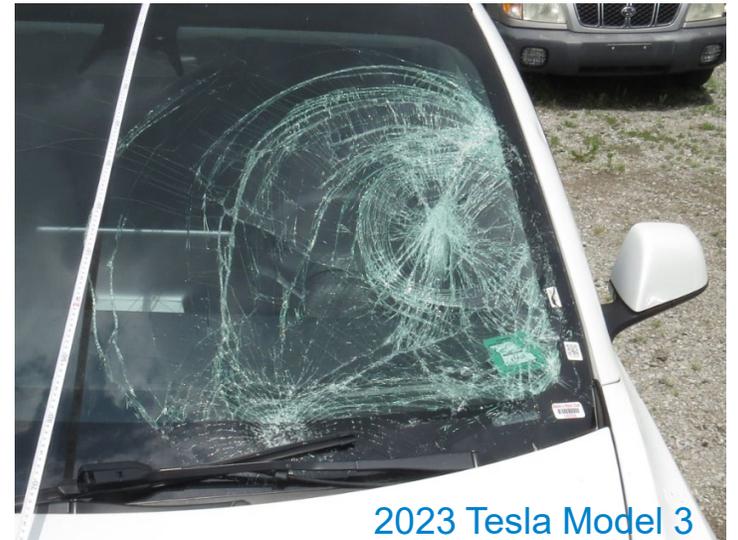
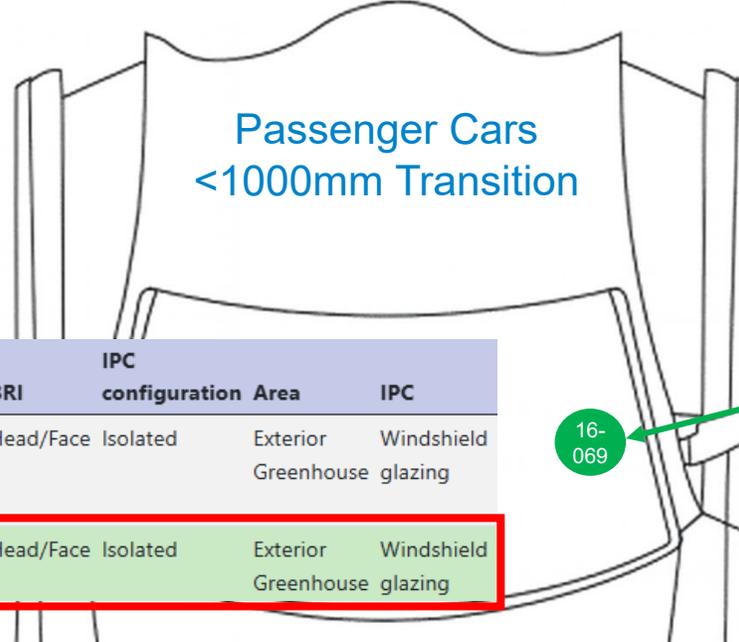
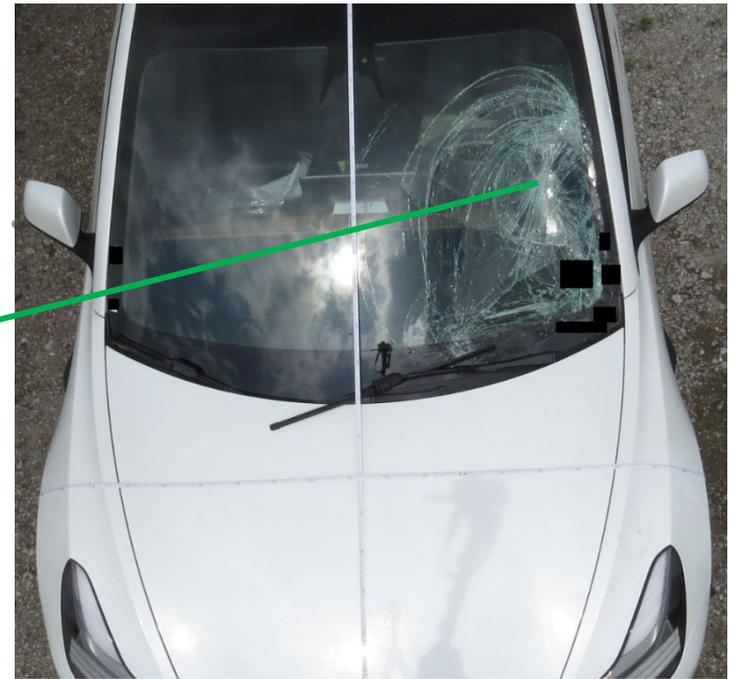
2023 Tesla Model 3

51 yo female
160 cm height
~40 kph speed

Injury #	Rank	AIS ICS #	Code	Severity	AIS Description	Localizer	BRI	IPC configuration	Area	IPC
1	1	110402.1	1 - Minor	Scalp contusion; subgaleal hematoma, individual >6 months old	Left	Head/Face	Isolated	Exterior	Windshield Greenhouse glazing	
2	1	110600.1	1 - Minor	Scalp laceration NFS	Left	Head/Face	Isolated	Exterior	Windshield Greenhouse glazing

Contact Area	Area	Component	NM #	X cm	Y cm	Crush-CM	Body Region	Evidence	Confidence
A	Front	Front bumper	1	60	-40	0	Thigh - Right	Combination (specify): Video evidence	Certain
B	Top	Hood surface	1	73	-24	0	Buttock - Right	Scuffed	Certain
C	Top	Front fender top surface	1	120	-70	0	Buttock - Left	Scuffed	Certain
D	Greenhouse	Windshield glazing	1	228	-62	6	Head	Hair	Certain
E	Top	Wiper blades and mountings	1	175	-22	Not Applicable	Unknown	Bent	Probable
F	Greenhouse	Windshield glazing	1	185	-50	Unknown	Elbow - Right	Cracked	Probable
G	Other object	Ground	1	Not Applicable	Not Applicable	Not Applicable	Unknown	Combination (specify): Ground contact	Probable

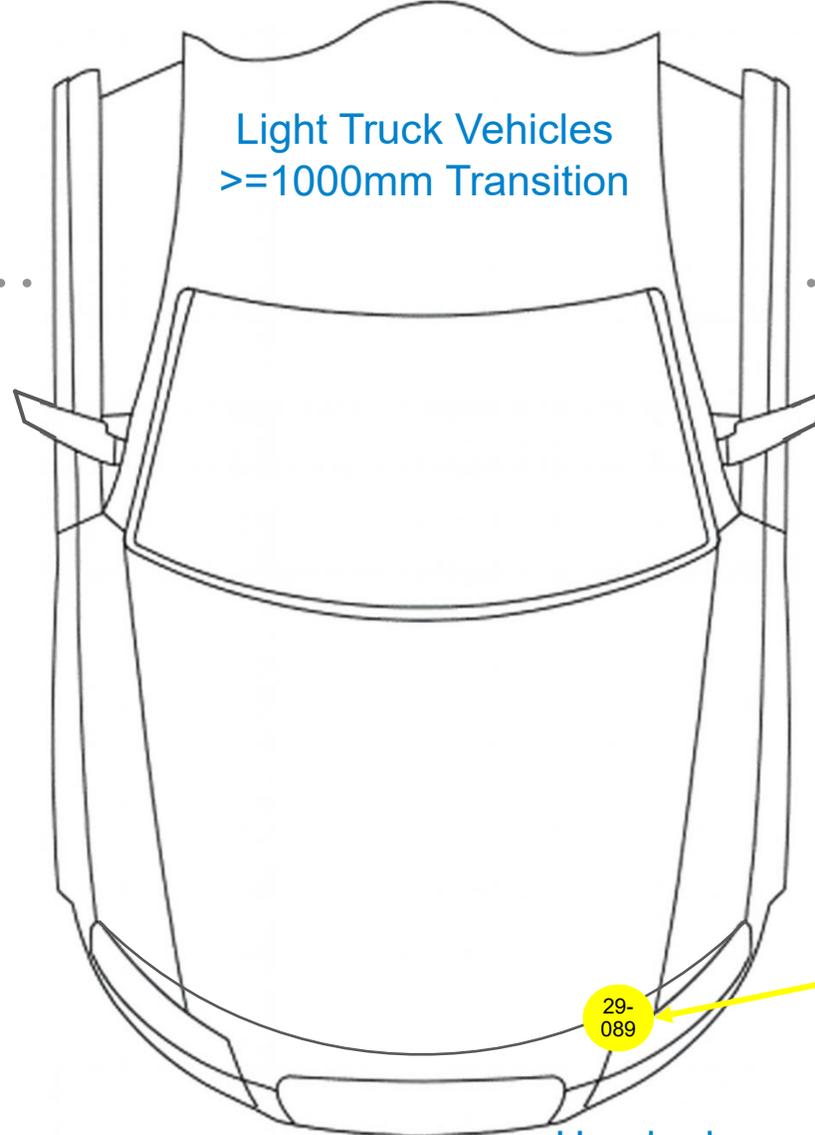
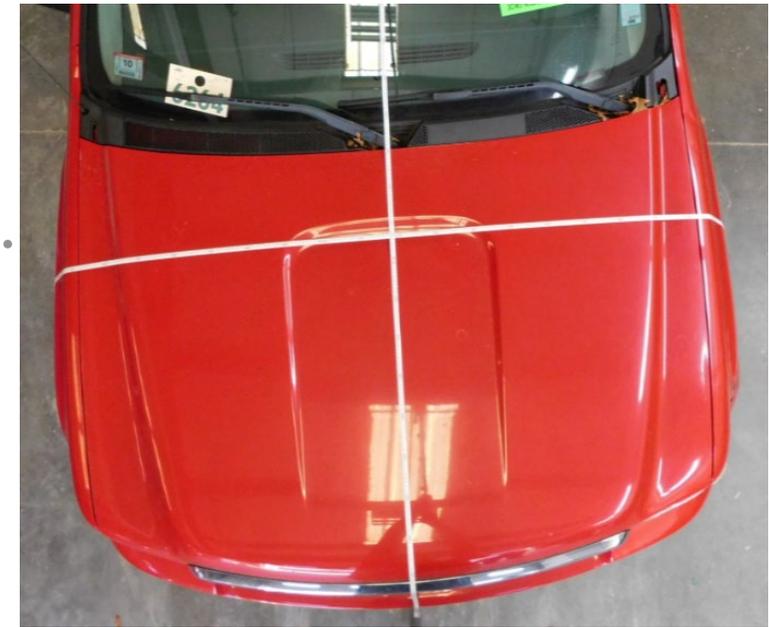
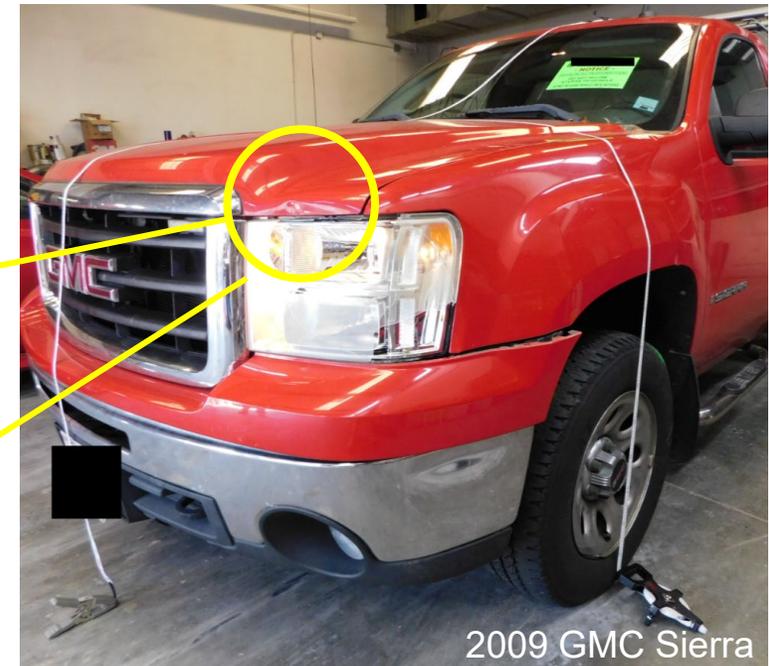
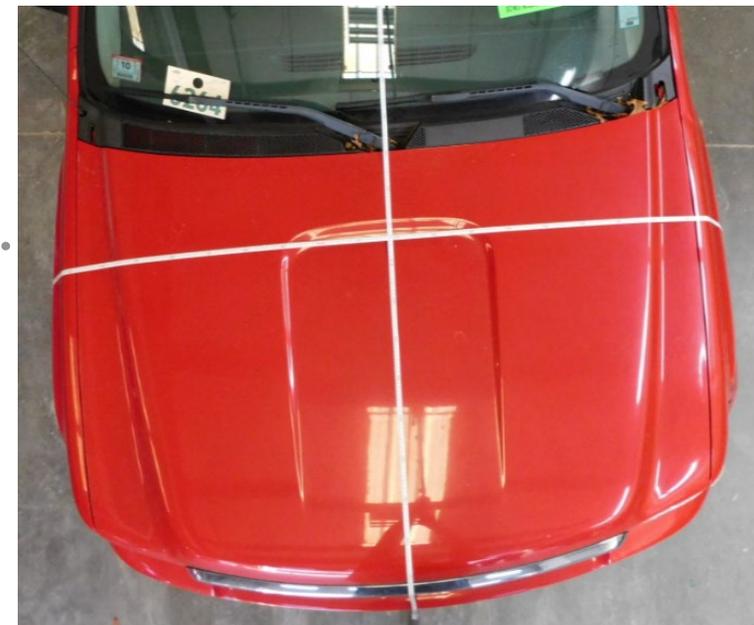
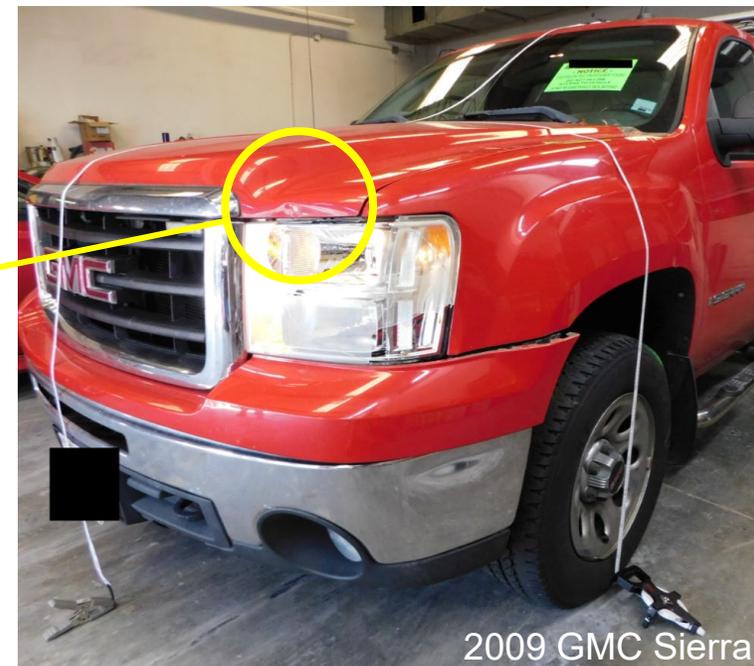
2009 GMC Sierra

14 yo female
Unknown height
~50 kph speed

Hood edge
or ground?

Injury #	Rank	ICs #	AIS Code	Severity	AIS Description	Localizer	BRI	IPC configuration	Area	IPC
5	1	140638.3	3 -	3 - Serious	Cerebrum hematoma (hemorrhage)-> intracerebral NFS [include perilesional edema for size]	Right	Head/Face	Isolated IPC	Other Exterior Object	Ground
								possible		
5	2	140638.3	3 -	3 - Serious	Cerebrum hematoma (hemorrhage)-> intracerebral NFS [include perilesional edema for size]	Right	Head/Face	Isolated IPC	Exterior Hood Front Exterior and/or Front trim Headlight	
								probable

Contact Area	Component	NM #	X cm	Y cm	Crush-CM	Body Region	Evidence	Confidence
A	Front bumper	1	75	-90	0	Flank - Right	Deformed	Probable
B	Headlight	1	100	-90	Unknown	Unknown	Cracked	Certain
C	Hood edge and/or trim	1	110	-95	1	Unknown	Deformed	Probable
D	Other object	1	Not Applicable	Not Applicable	Not Applicable	Unknown	Other (specify): ground contact	Certain

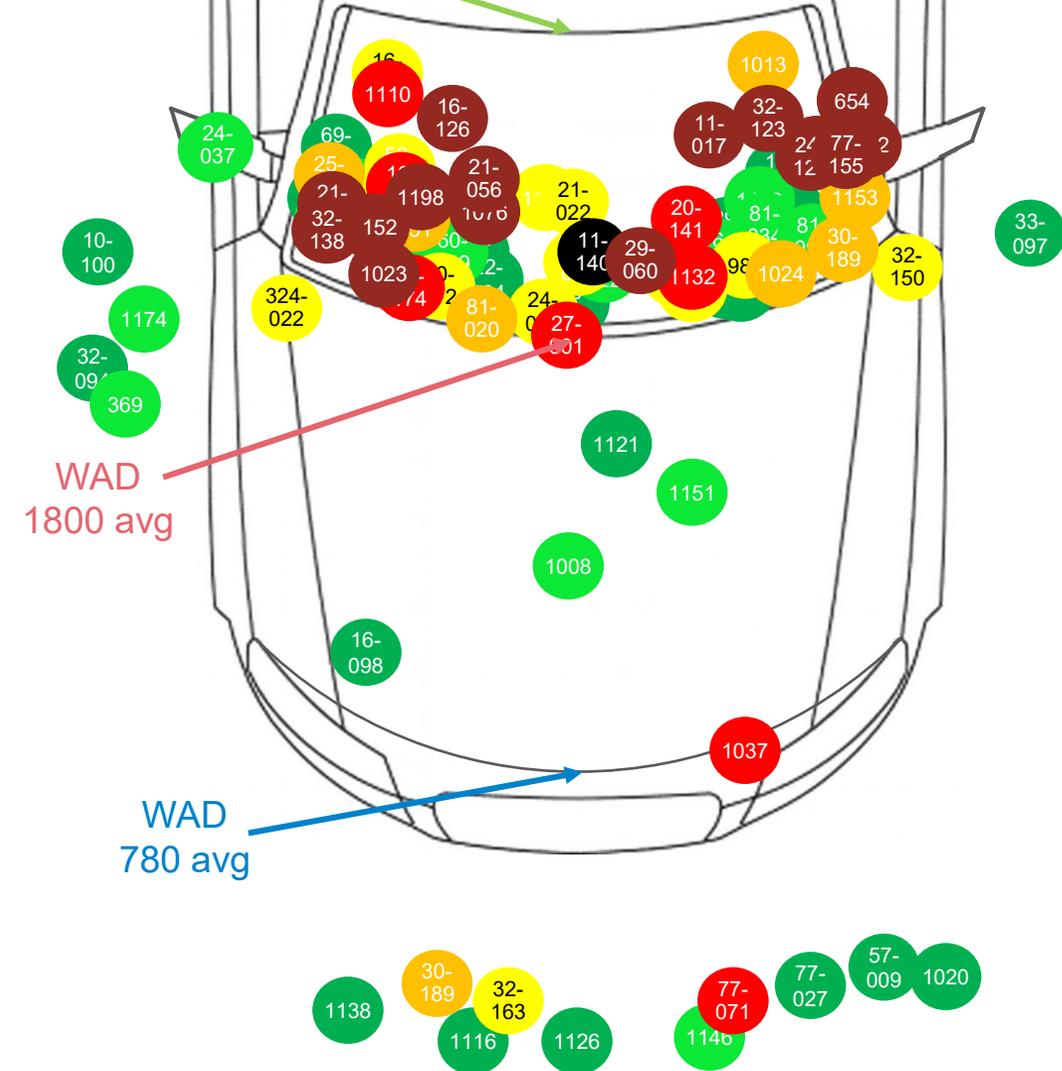
Passenger Cars
<1000mm Transition
91 Cases

WAD
2760 avg

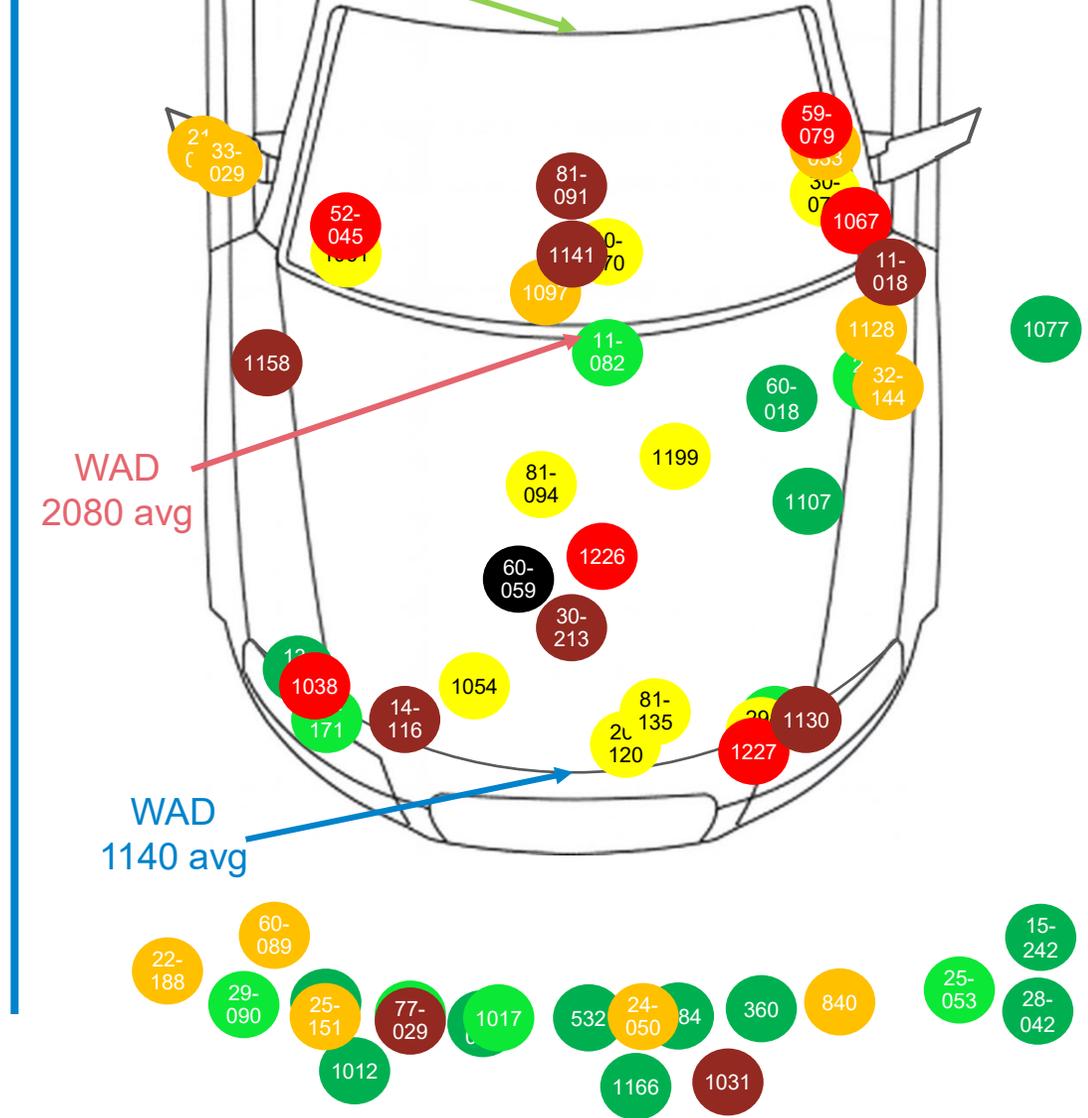
Light Truck Vehicles
≥1000mm Transition
56 Cases

WAD
3030 avg

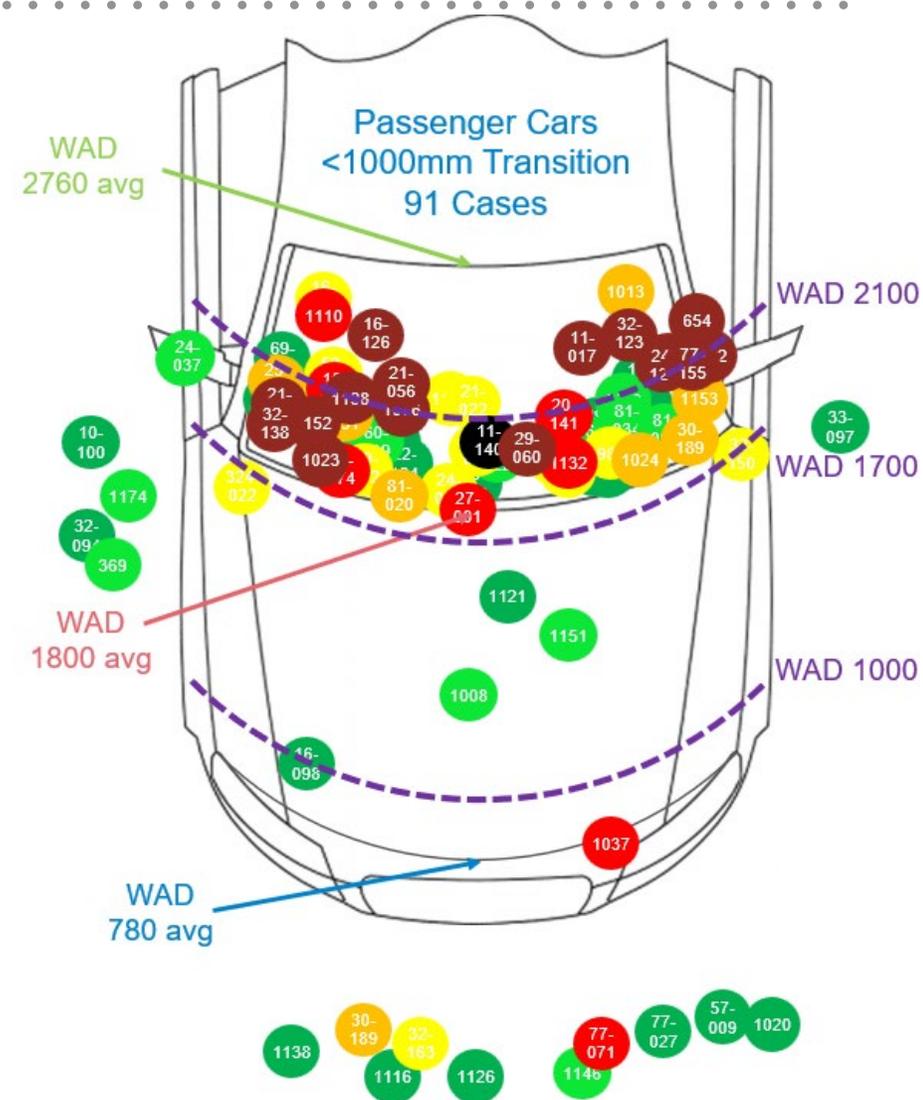
Conclusions

- Passenger Cars
 - Hood contacts appear to be less common, with less severe injury outcomes
 - Windshield glazing, cowl, and a-pillars common contacts with more severe outcomes
 - Wrap kinematics common with sliding along the hood
 - ~75% of head-to-vehicle contacts between WAD 1000 and WAD 2100
 - ~25% of head-to-vehicle contacts above WAD 2100

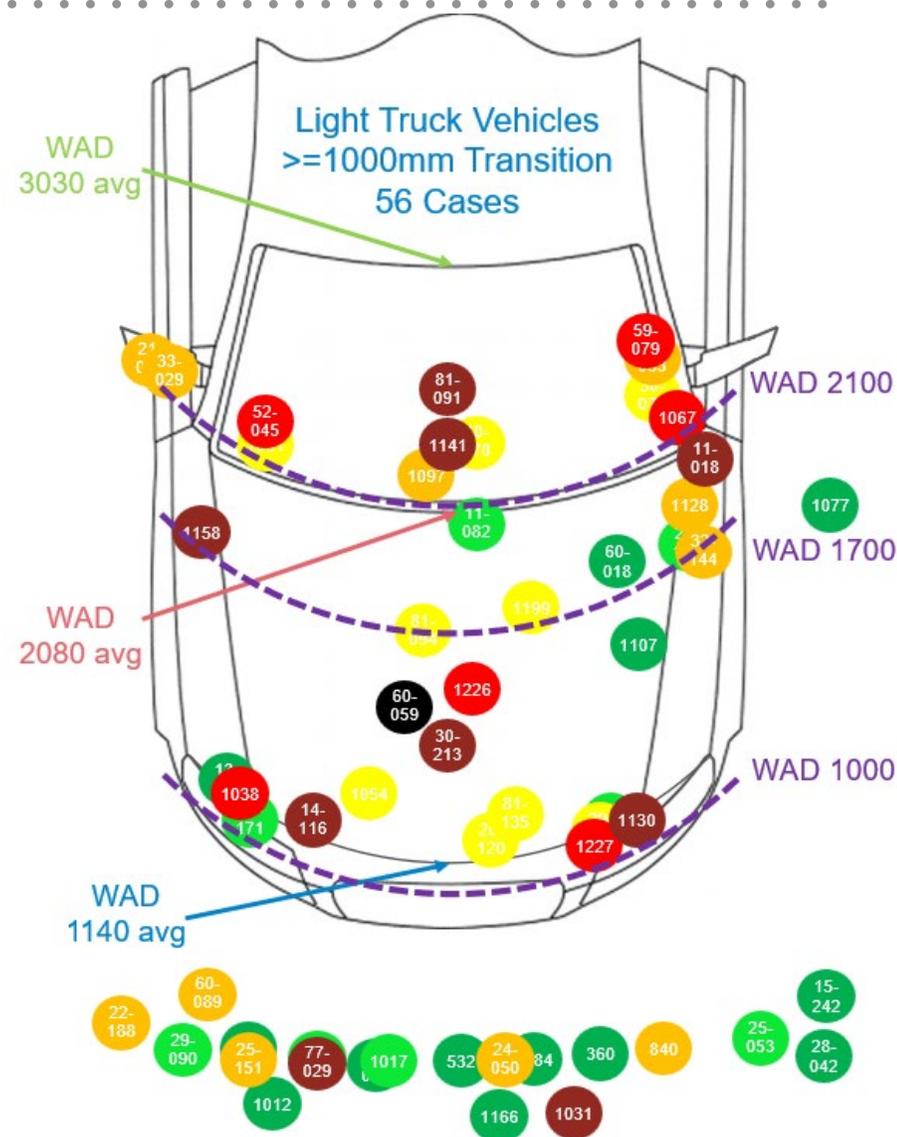
Conclusions

- Light Truck Vehicles
 - Hood contacts more common than windshield, cowl, a-pillars
 - Cluster of head contacts at hood leading edge and headlight junction areas just above WAD 1000
 - Forward projection kinematics common with increased number of ground contact ICS
 - ~70% of head-to-vehicle contacts between WAD 1000 and WAD 2100
 - ~30% of head-to-vehicle contacts above WAD 2100
