DOT HS 811 303

March 2010

Localized Fire Protection Assessment for Vehicle Compressed Hydrogen Containers

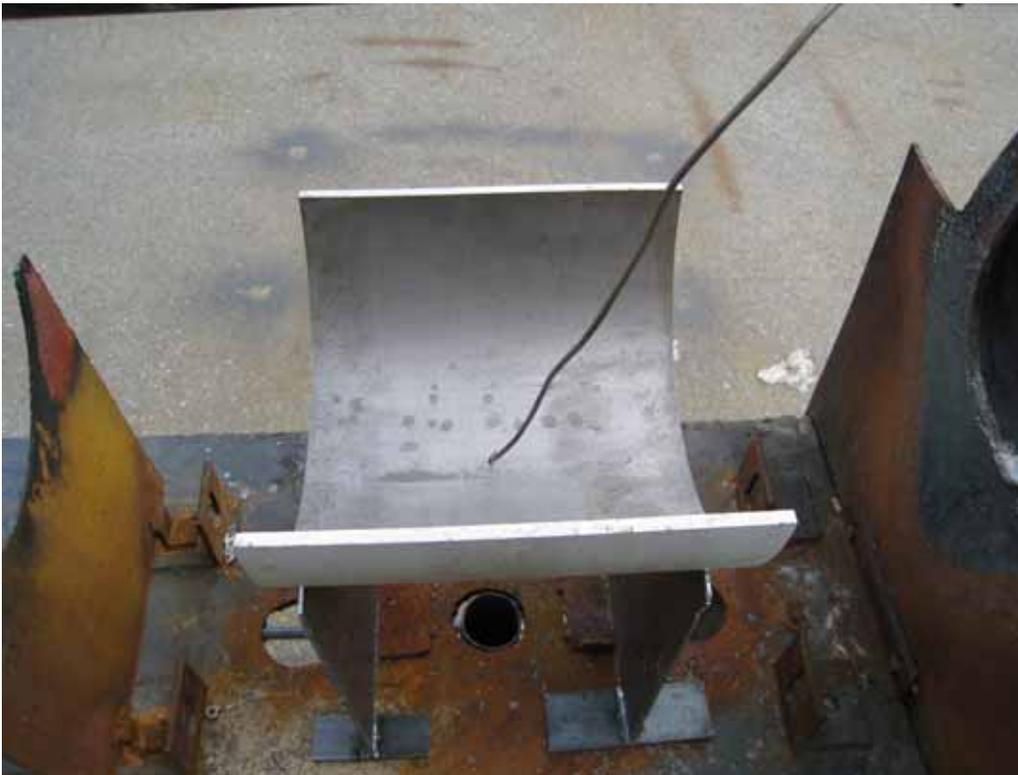
Figure 1 – Arrangement for fire testing steel pipe half-sections with one side coated by intumescent paint. Note thermocouple touching pipe surface on side opposite burner.

An intumescent flame retardant coating from PyroTech of Addison, Illinois, trade-name “PyroCide II” (an intumescent system in a water resistant polymer latex) was evaluated. Various layers were applied to steel half-pipe sections, which were then heated on the coated side while temperatures were monitored on the uncoated side (see Figures 1 and 2). Figure 3 summarizes the temperature difference generated on the inside steel surface through the use of coatings of different thickness. The results were not encouraging, since the coating would break-down and flake off after several minutes of exposure to the high temperatures used in the test. Note that these test temperatures exceeded the specifications for the coating.

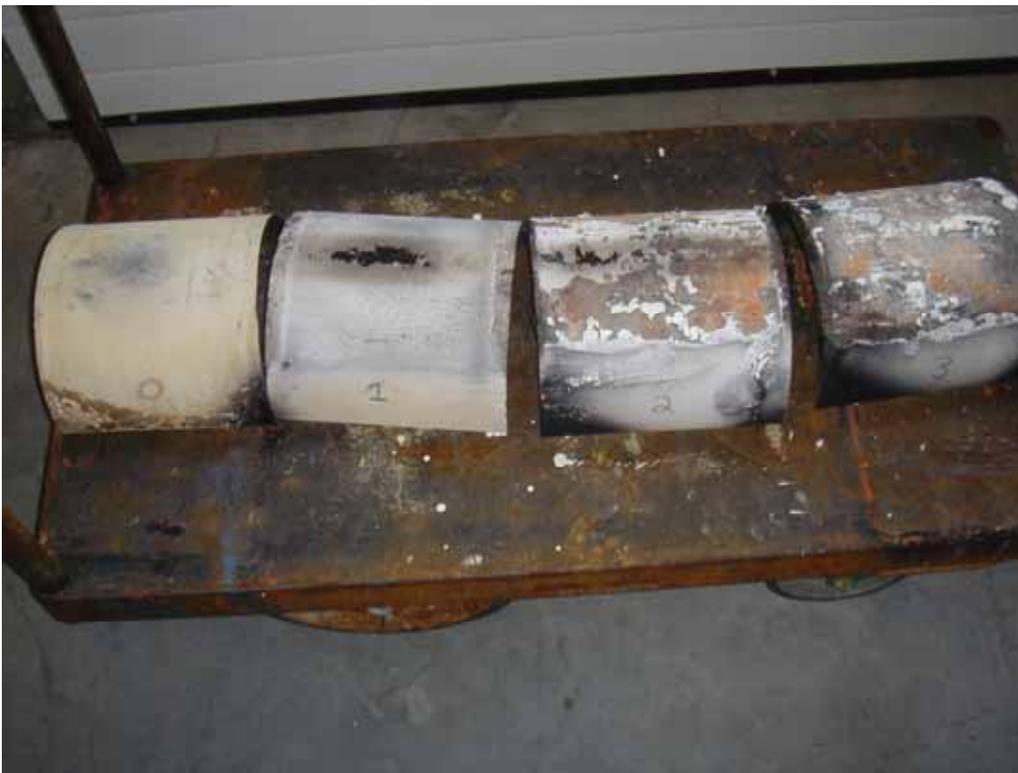
Figure 2 – Results of fire testing on PyroCide II paint coating of various thicknesses (#0 = bare steel, #3 = 3 coats of paint).

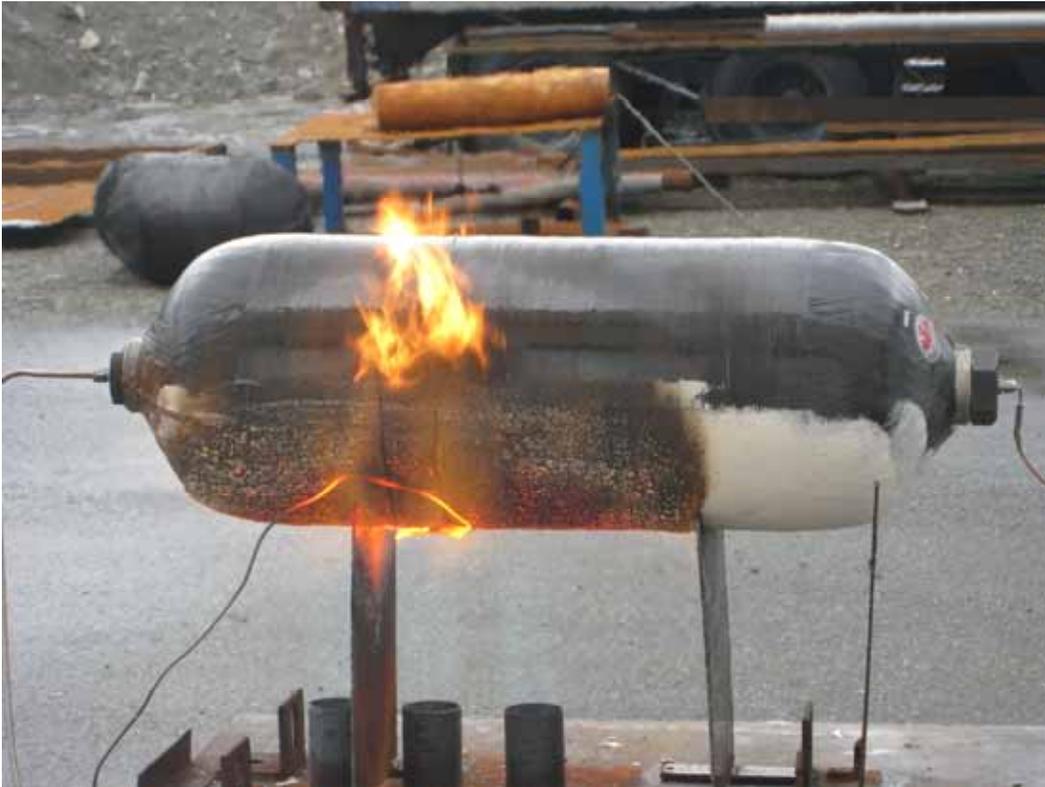
Figure 4 – Performance of PyroCide II intumescent paint coating on bottom of carbon fiber composite tank during exposure to 3-burner fire test.

A base-line fire test was conducted on an uncoated 39L carbon fiber composite tank with an aluminum liner. The 200 bar tank design was sealed at atmospheric pressure, and heated using the new fire test arrangement for 10 minutes, while the increase in internal temperature was measured. The underside of a tank of the same carbon fiber design was then painted with 4 coats of the PyroCide II coating (approximately 5 mm dry thickness), and subjected to the same test. The test is illustrated in Figure 4. Figure 5 is a graphical comparison of the results between the baseline tank and the coated tank. The data suggests that intumescent paint coatings will only offer limited protection from heat effects, especially where high flame temperatures might be encountered.

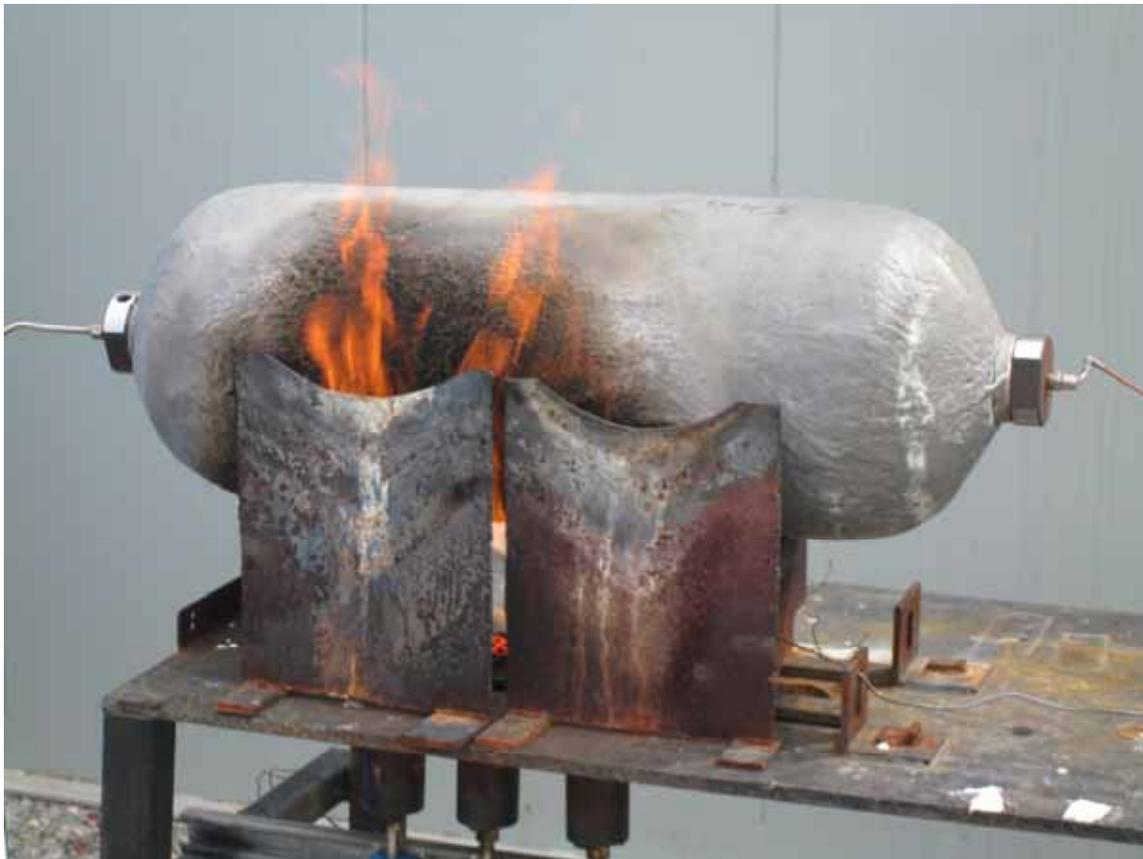
Figure 6 – Low pressure fire test of 5mm thick epoxy intumescent.

Since specialized spray application equipment is required, 4 carbon fiber tanks were sent to PPG for coating. Two tanks were coated 5 mm thick, and 2 tanks coated 8 mm thick. One tank (5 mm thick) was pressured to 7 bar with nitrogen and placed on the 3-burner unit (see Figure 6) for exposure to 800°C for 10 minutes. It was found that the intumescent expanded under heat (see Figure 7), and provided the required heat protection (see Figure 8).

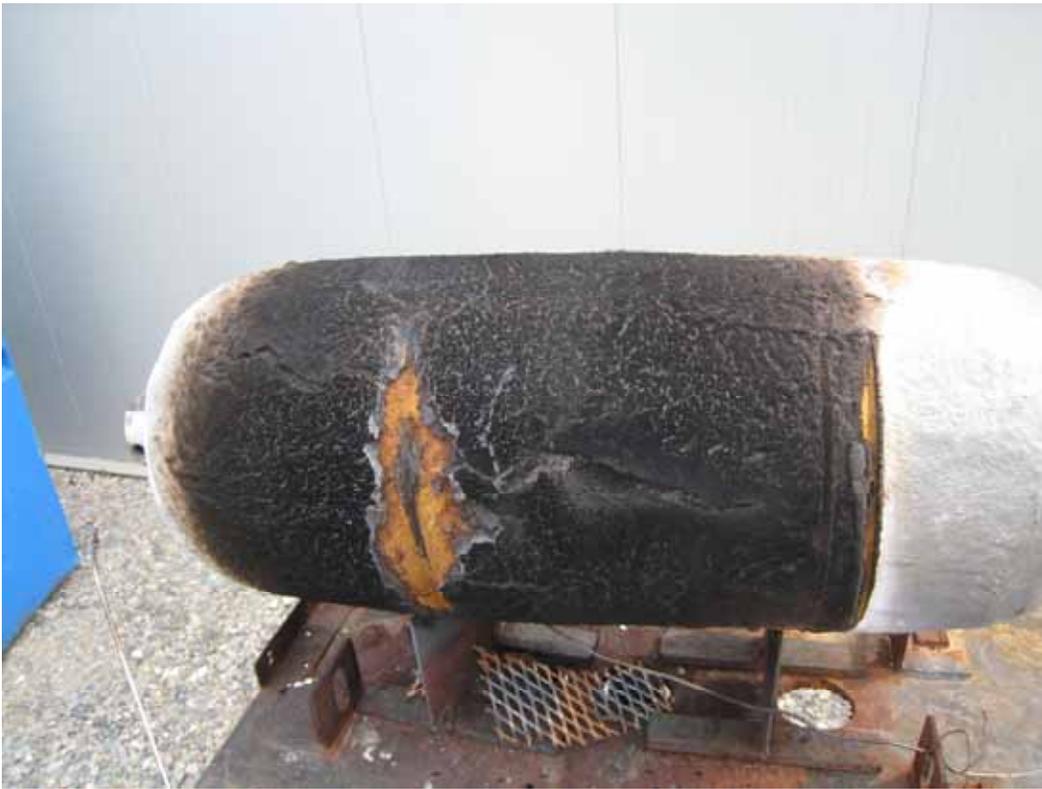
Figure 7 – Tank rotated after fire test to show foaming effect of coating. Note that the damaged area in the coating was caused by the metal support stand.

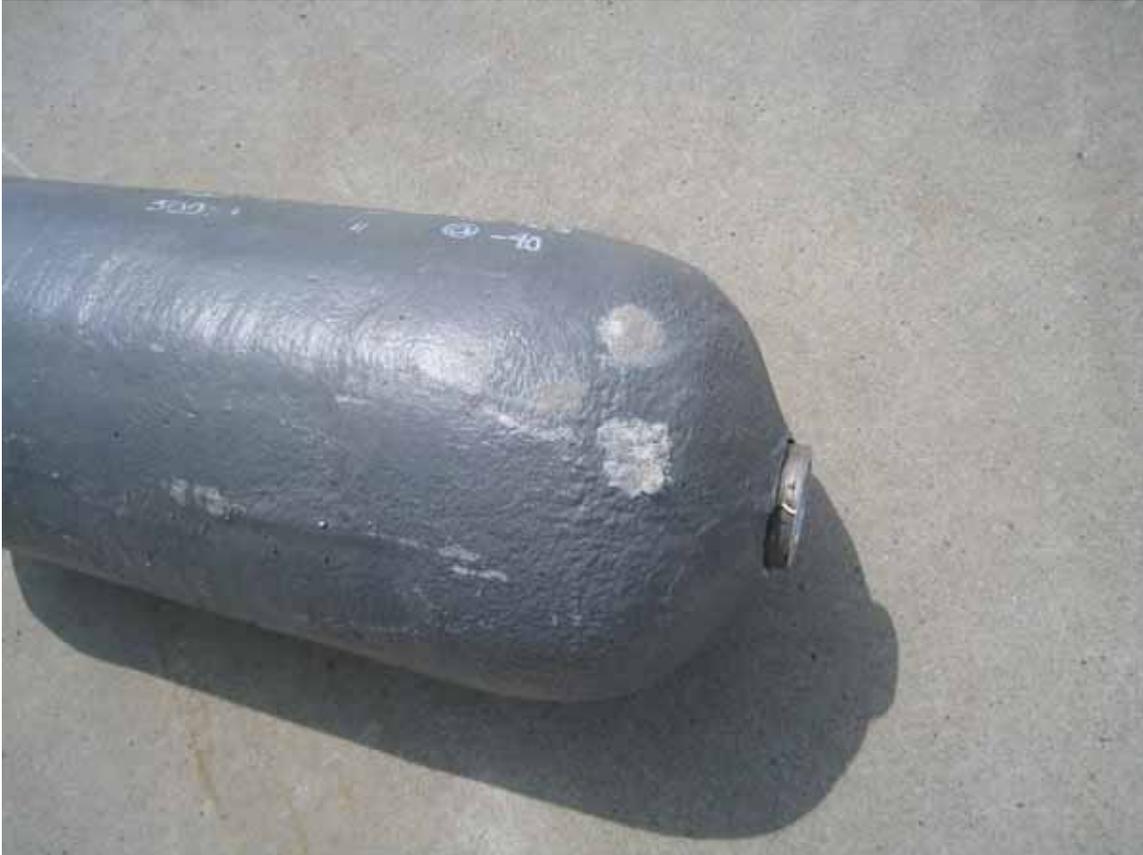
Figure 9 – Appearance of drop impact damage (rebound end) on dome end of 8 mm thick epoxy intumescent coating.

One of the two 8mm thick tanks was then subjected to performance testing, to determine if it could withstand localized impacts. The 200 bar tank was drop impacted on the dome end (2 m drop onto a concrete surface at 45 degrees from horizontal (see Figure 9), then subjected to hydraulic pressure cycling between 20 bar and 250 bar. Five hundred pressure cycles were conducted at ambient temperature, 500 hundred cycles at -40°C, and 500 cycles at +82°C. There was no apparent damage to the epoxy intumescent coating.

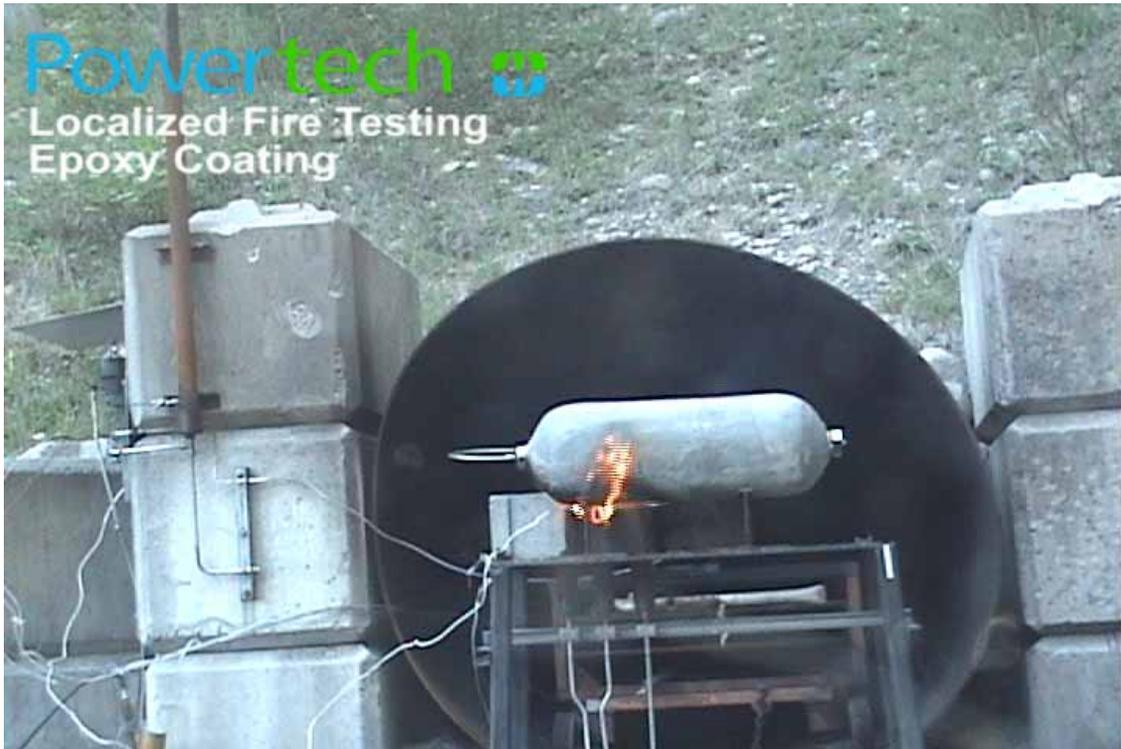
Figure 10 – Localized fire test of epoxy intumescent (8 mm thick) on carbon fiber tank containing 138 bar hydrogen for 30 minutes.

The second 8 mm thick coated tank was initially pressured to 200 bar (2,900 psi) with hydrogen, and subjected to the 3-burner test for an intended 30 minutes. During the test, there was a concern that the localized fire could burn through the protective coating and destroy the composite underneath in a very small area, causing the tank to rupture. Theoretically, if this area of damage was small enough, it could occur without any significant increase in the internal tank pressure. As a result, the tank pressure was reduced during the test to 138 bar (2,000 psi). The fire test illustrated in Figure 10, and the temperature/pressure results are provided in Figure 11. Note that after the pressure was reduced to 138 bar, some of the pressure increase observed during the test was from the chilled gas returning to ambient temperature.

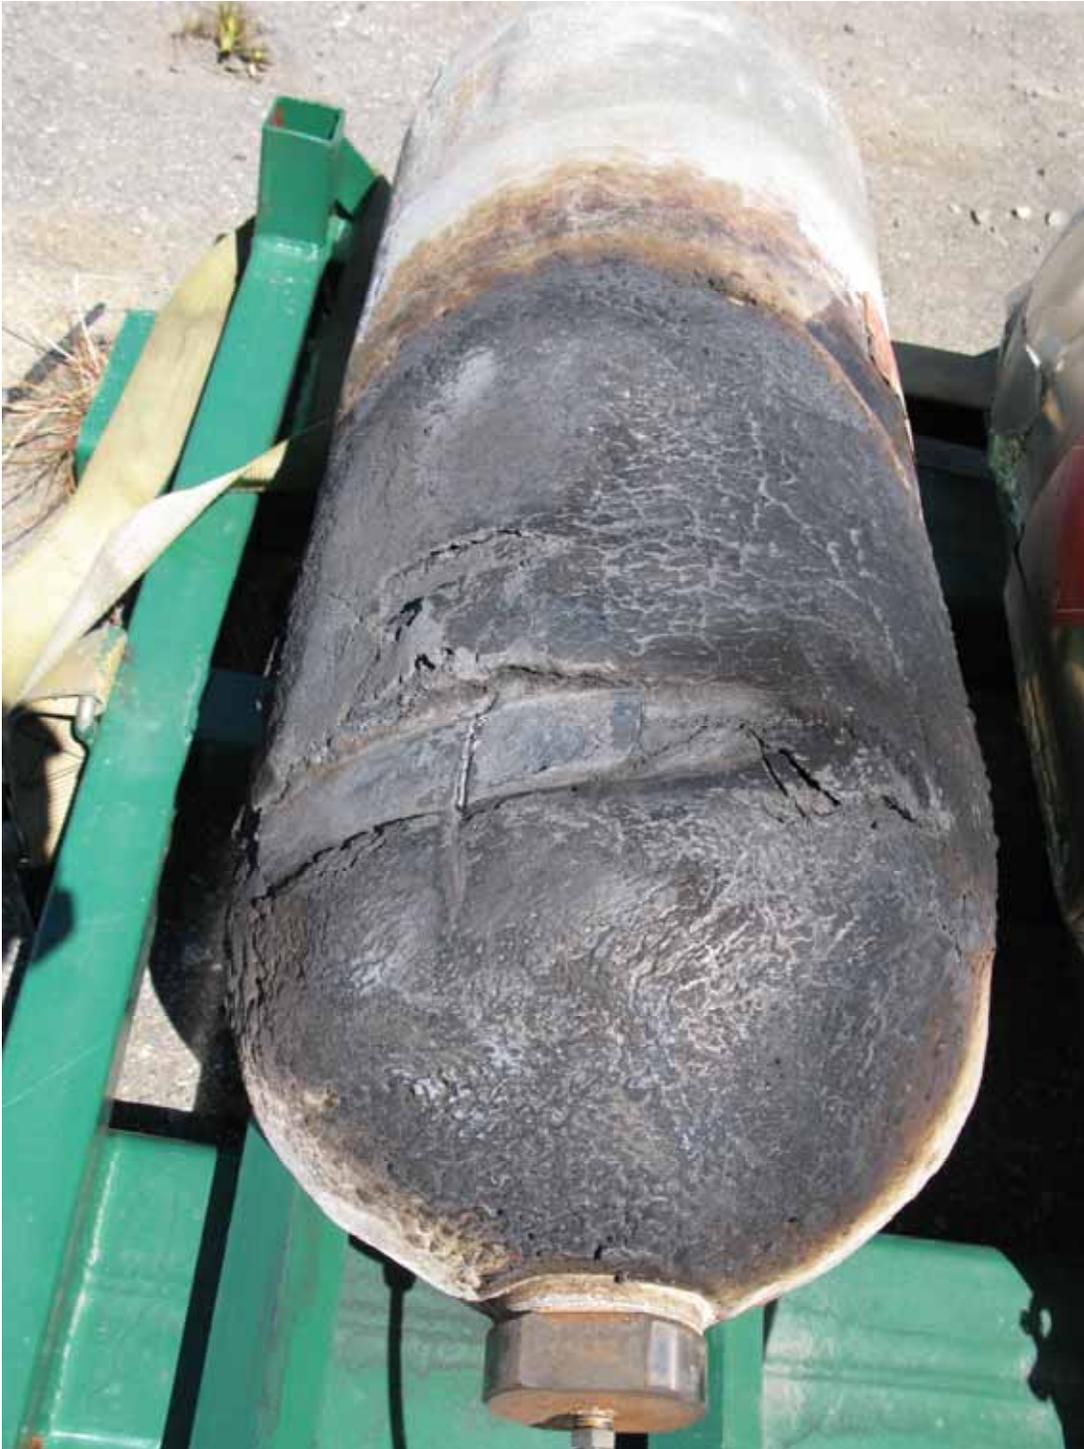
Figure 12 – Appearance of 8 mm thick epoxy intumescent coating after 30 minutes exposure to 900°C. Note that the flattened area is from handling after the test.

Upon conclusion of the test, it was observed that the intumescent epoxy was still intact, continuing to protect the carbon fiber composite from heat damage (see Figure 12). Based on the result of the 10 minute test of the 5 mm thick coating, and the 30 minute test of the 8 mm coating, it is likely that the 5 mm (or less) coating would provide adequate fire protection for a fuel tank.

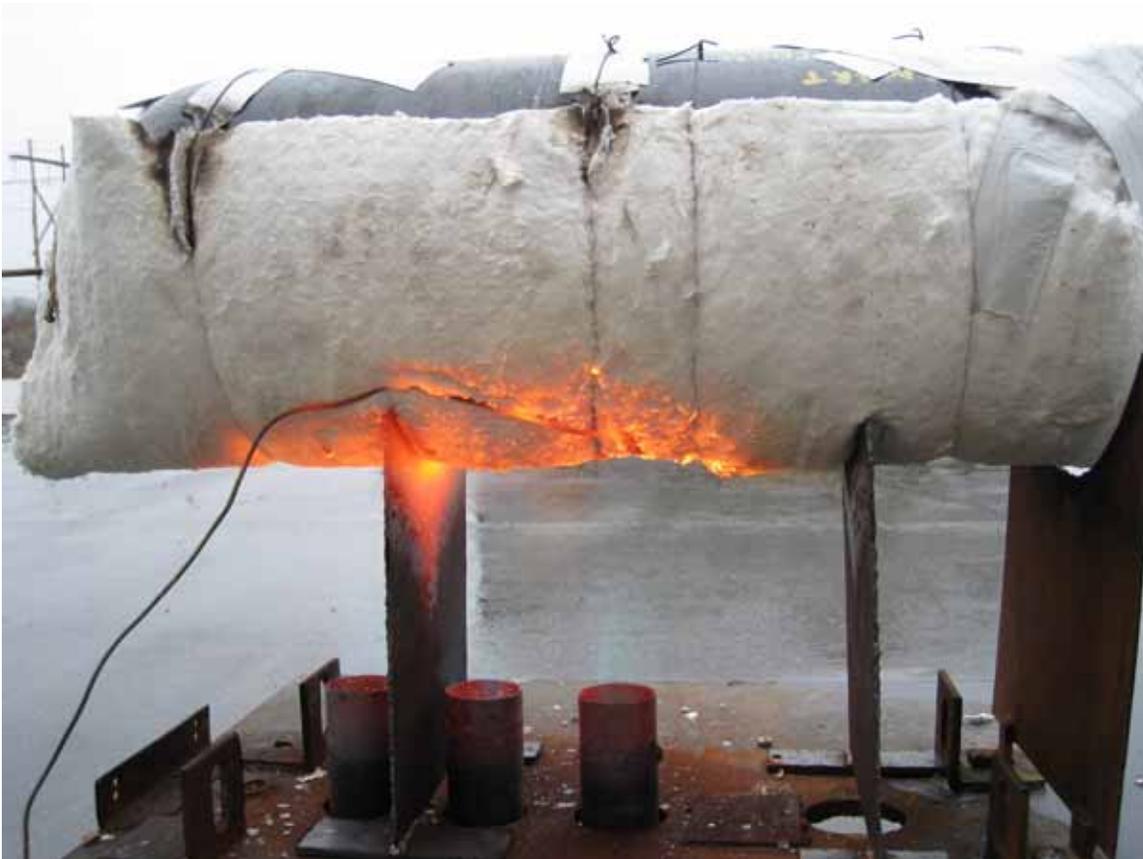
Figure 13 – Localized fire test of SuperWool 607 Plus blanket

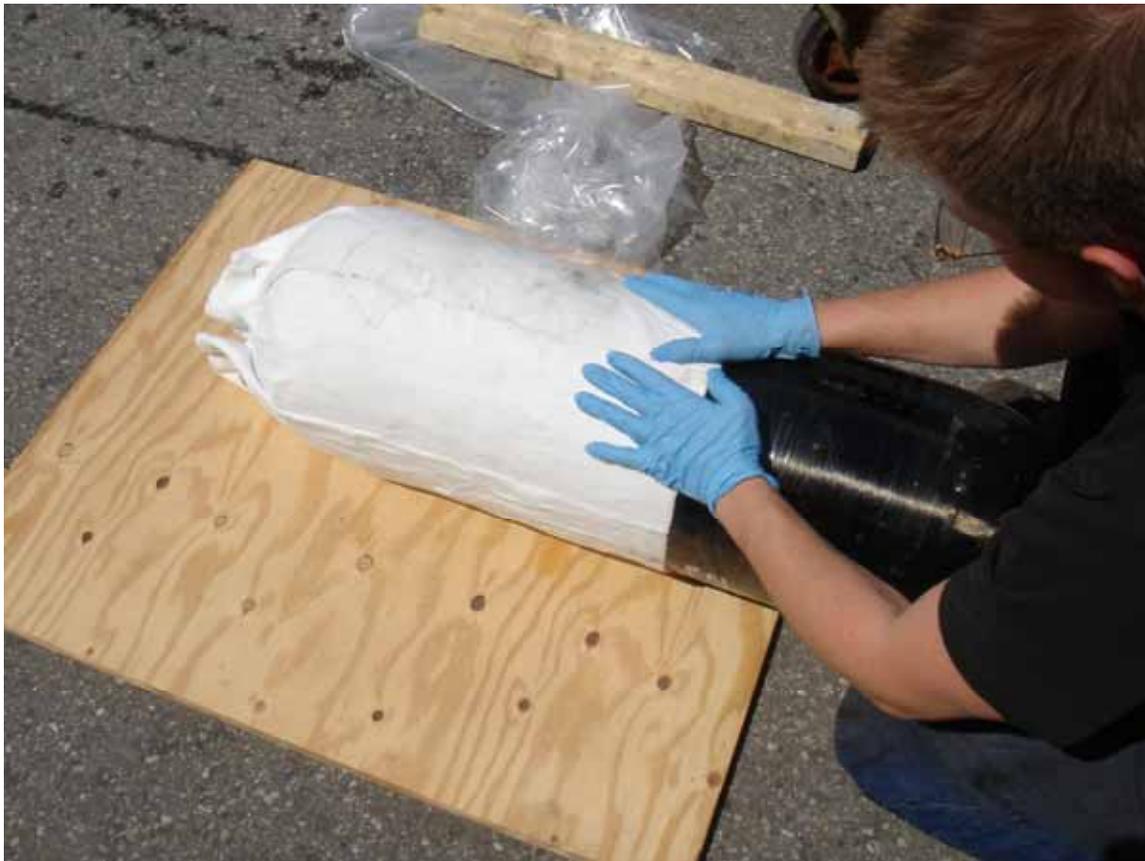
Figure 16 – Application of wet felt wrap to tank

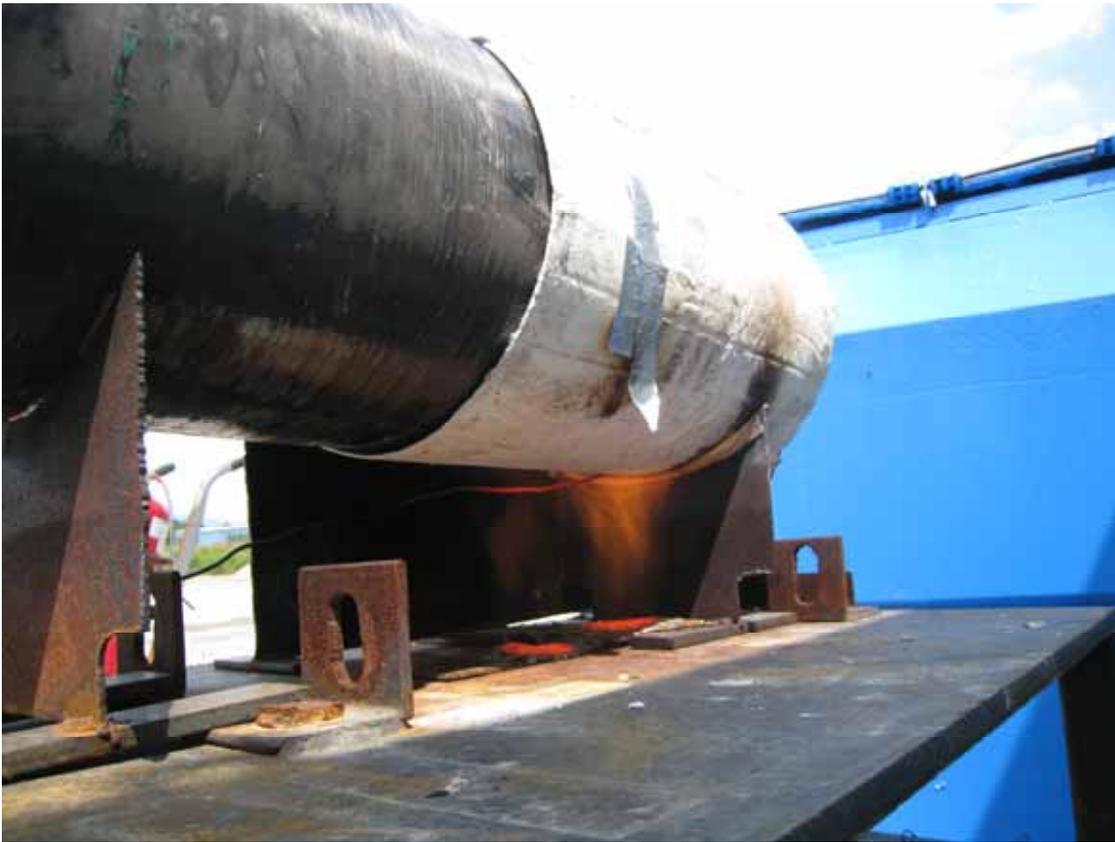
Figure 17 – Localized fire test of felt wrap after drying.

A carbon fiber type-3 composite tank wrapped on one end with the wet felt was pressured to 7 bar (100 psi) with nitrogen and subjected to the localized fire test for 5 minutes (see Figure 17). The internal pressure and temperature rise that occurred are provided in Figure 18.

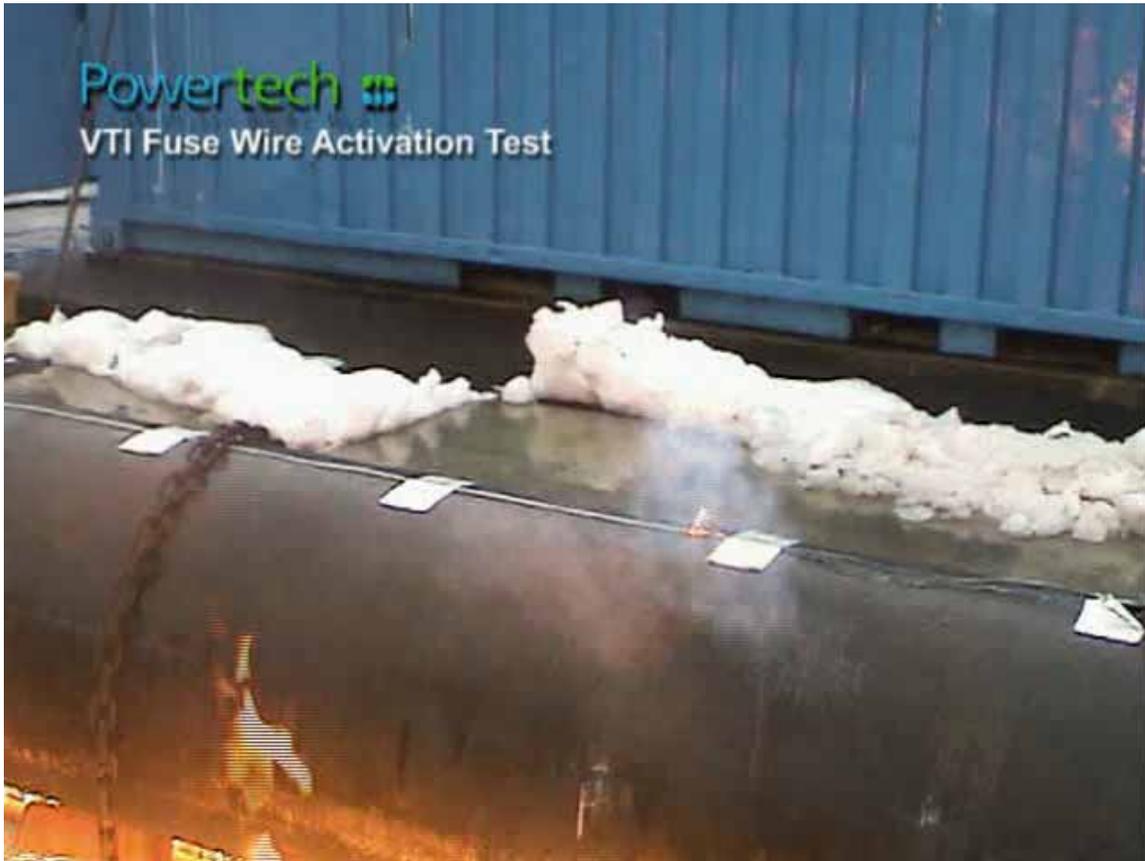
Figure 20 – Video capture from fire test of carbon fiber composite tank protected with fuse wire and TPRD at one end. Note the fuse wire burning along the top of the tank towards the TPRD (not visible in picture).

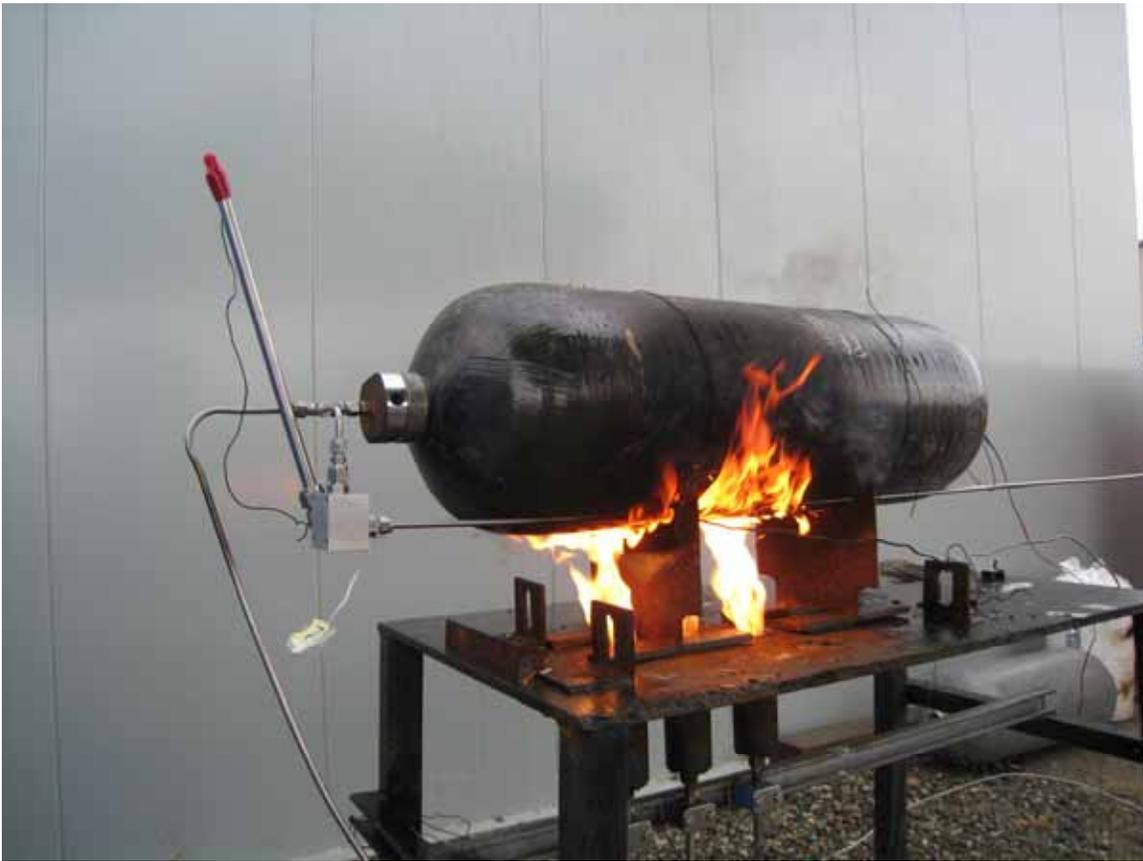
Figure 21 – Localized fire test of carbon fiber composite tank protected using a long SMA tube connected to a piston-activated PRD located outside of the fire.

Another promising heat detection technology is the use of a shape memory alloy (SMA) wire retained within a tube. When a small portion of the tube is heated (around 300mm), the SMA wire within contracts, and pulls open a piston in the pressure relief device, releasing the tank pressure. The SMA wire used in this device shrinks roughly 5% when heated to 108°C. The SMA can be placed in a tube up to 2.4m long, and can therefore protect along the entire length of tanks up to 2.4m in length. An example of a localized fire test of the device is provided in Figure 21.

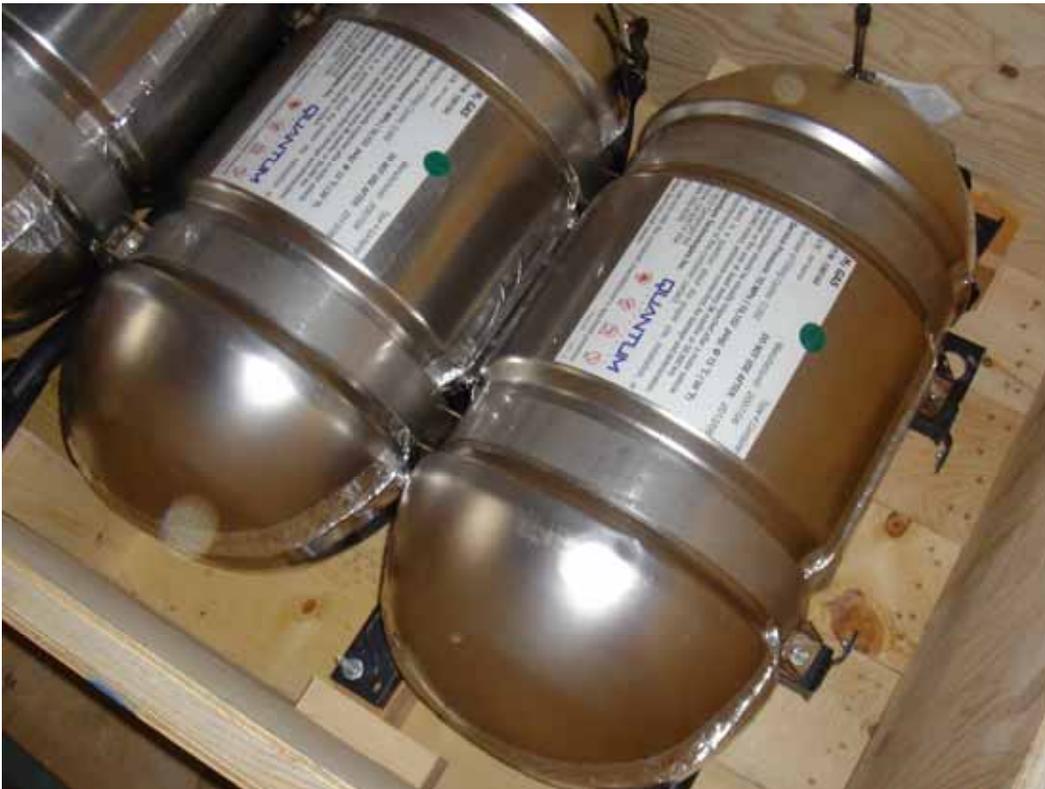
Figure 22 – Quantum fuel system assembly, complete with stainless steel shell covering.

A 700 bar hydrogen fuel storage system, complete with a manufacturer's proprietary fire protection system, was obtained from Quantum Technologies (see Figure 22). The Type 4 tanks were covered in a thin stainless steel shell of 0.635mm (0.025 inch) thickness. Within the stainless steel shell were pads of a ceramic blanket material of 12.5mm thickness separating the tank surface from the shell. The shell covering the approximate 35L (water volume) tank has a weight of 4.55 kg.

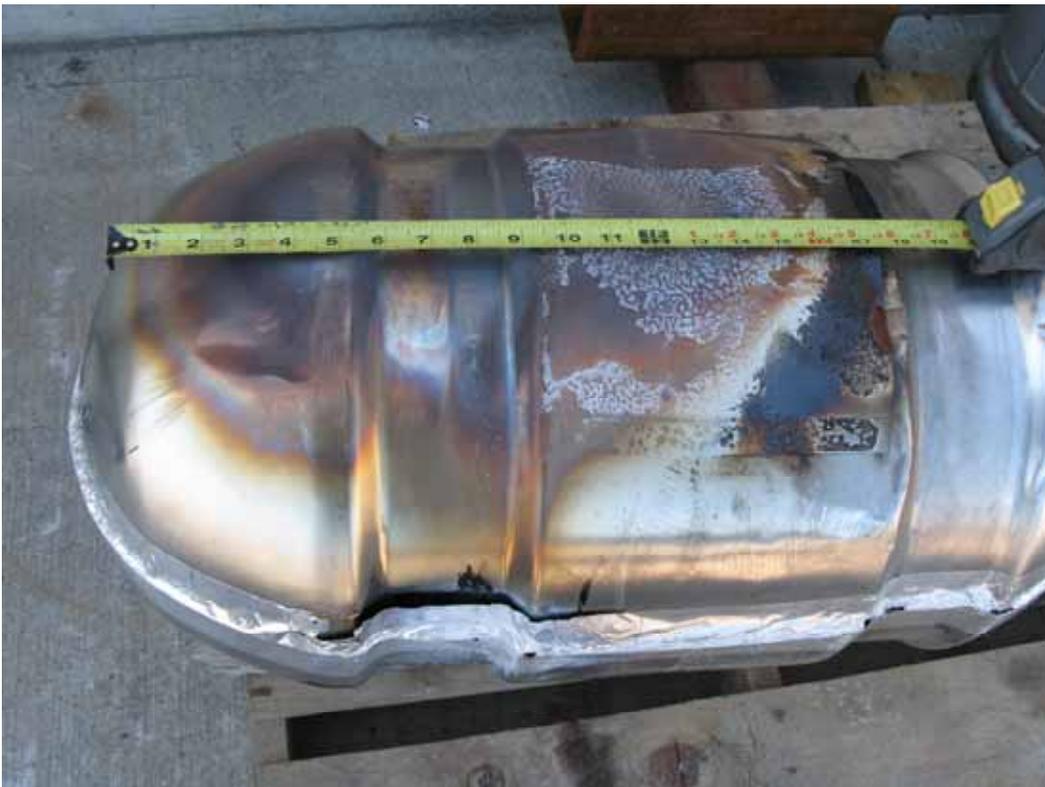
Figure 23 – Heat damage to stainless steel shell. Note that the length of the burn area is approximately 0.45 m.

One tank was removed from the assembly, filled to 7 bar with compressed nitrogen, and subjected to a localized fire test. The resulting heat damage is illustrated in Figure 23. The tank temperature and pressure rise data is provided in Figure 24.

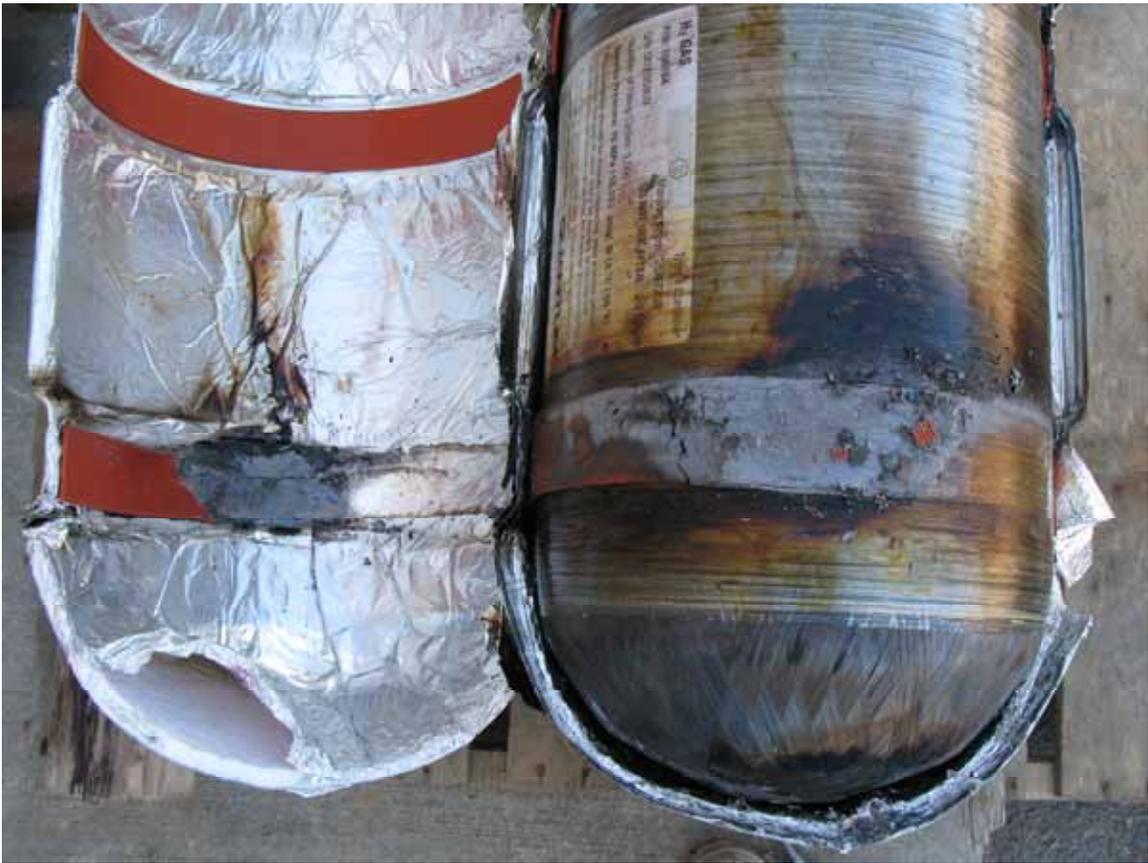
Figure 25 – Heat damage to surface of composite tank (right) revealed when heat-damaged half of shell folded open. Note the white ceramic blanket material exposed under the aluminum foil wrap (left).

The construction of the tank shell is illustrated in Figure 25. Aluminum foil is used to hold the white ceramic blankets in place. The ceramic blanket material is only placed on the end domes and the mid-wall portion of the sidewall. At the location of the assembly strapping, the only separation between the shell and the composite tank surface is a rubber strap. This strapping area also happened to be at the centre of the localized heat source. It is interesting to note that while a portion of the rubber strap melted away, the heat damage on the tank was not severe, i.e. the resin matrix did not burn away. This result suggests that perhaps the stainless shell by itself, with minimal separation from the surface of the tank, may be sufficient to prevent damage from localized fires.

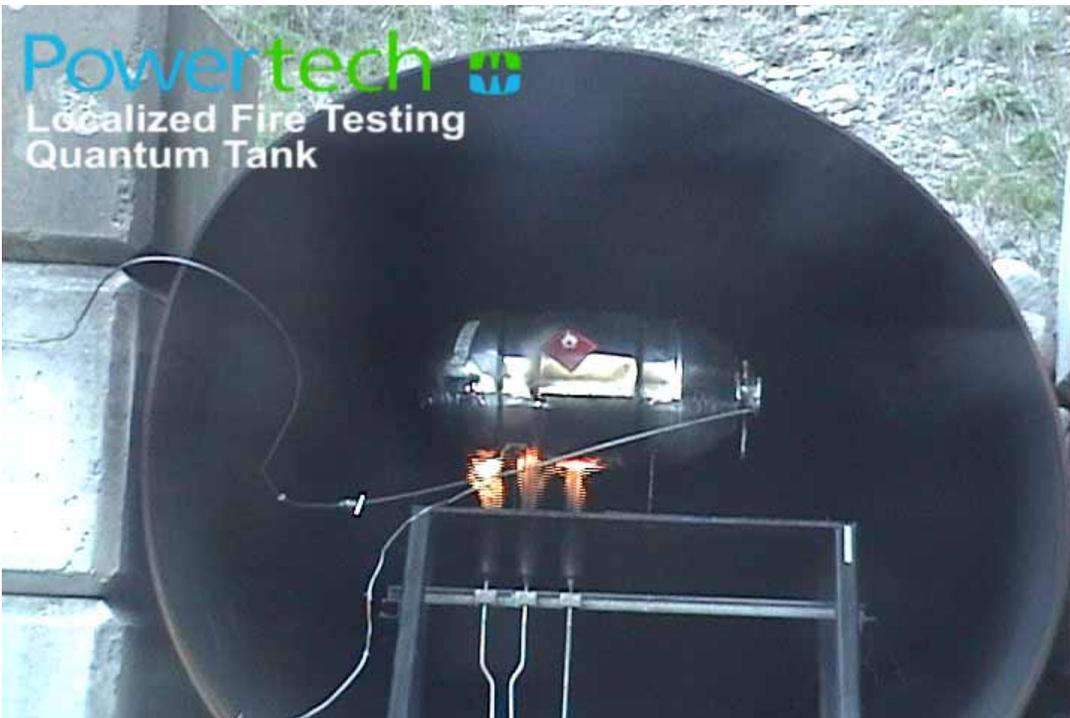
Figure 26 – Localized fire test of Quantum fuel tank containing 700 bar hydrogen for 30 minutes.

A second Quantum unit from the fuel storage system assembly was removed and pressured to 700 bar with hydrogen for field testing (see Figure 26). The tank survived the 30 minute test at localized fire temperatures of 900°C without incident. The temperature and pressure profiles are provided in Figure 27.

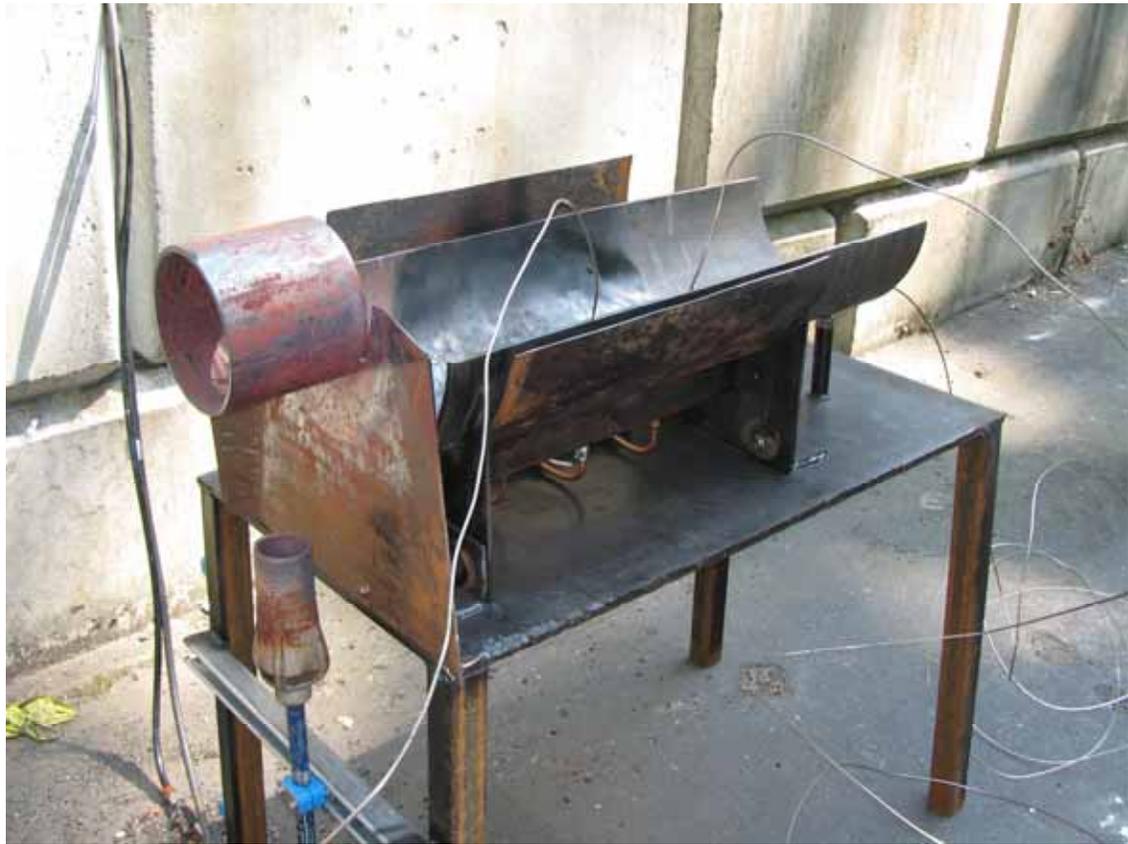
Figure 28 – Metal cradle used to generate different heat zones on a tank. In addition to burners located under the sidewall area, note the torch under the valve end.

In a previous study, in response to a specific definition of a localized fire condition involving several different heat zones on a tank, Powertech developed a “hot plate” method for testing [6]. This approach involved placing the tank on a curved metal cradle that matched its diameter (see Figures 28 and 29). By heating the metal cradle from below, it was possible to closely control the temperature on the surface of the tank.

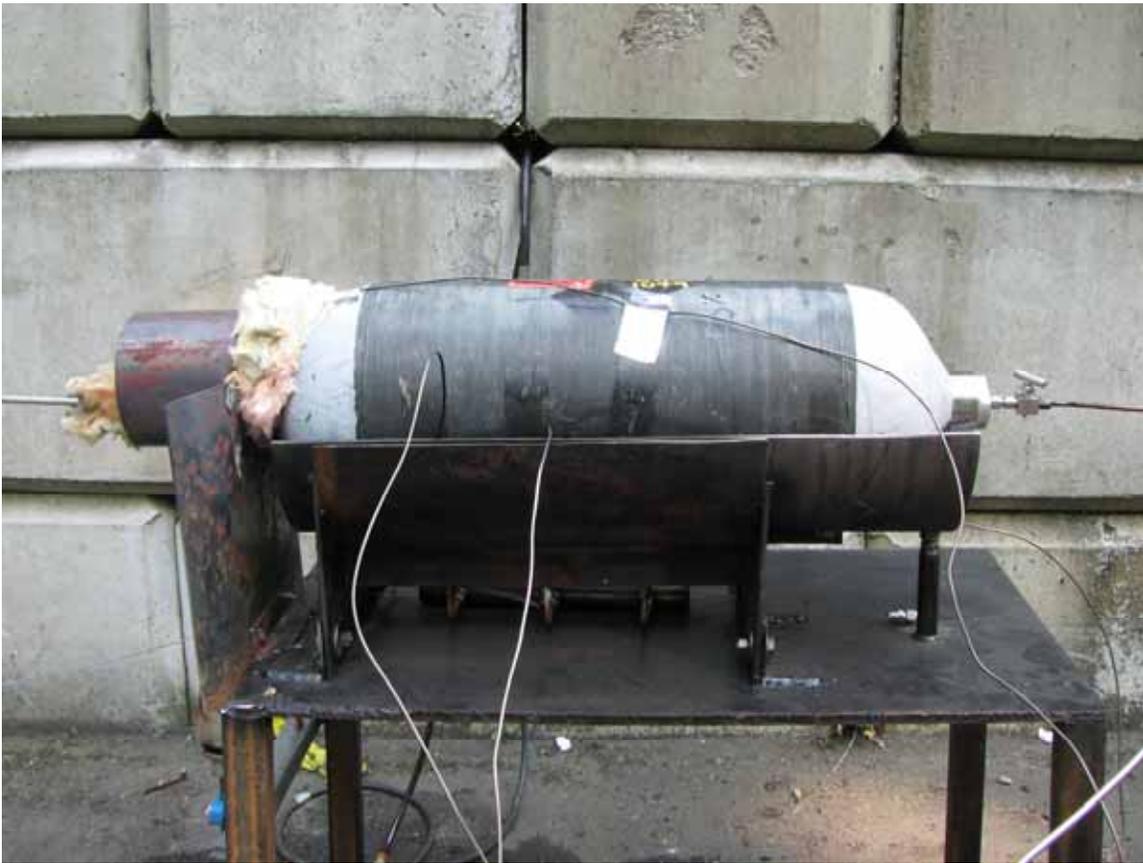
Figure 29 – Tank set-up for fire testing on the cradle.
