To: Area General Managers
From: Nancy Fein ^{NF} Vice President Lexus Customer Services
Subject: 2007 Lexus ES 350 All Weather Floor Mats

2007 Lexus ES 350 All Weather Floor Mat

Caution Label Installation Instructions
(If your vehicle has the Lexus All Weather Floor Mat)

2007 Lexus ES 350 All Weather Floor Mat Q&A

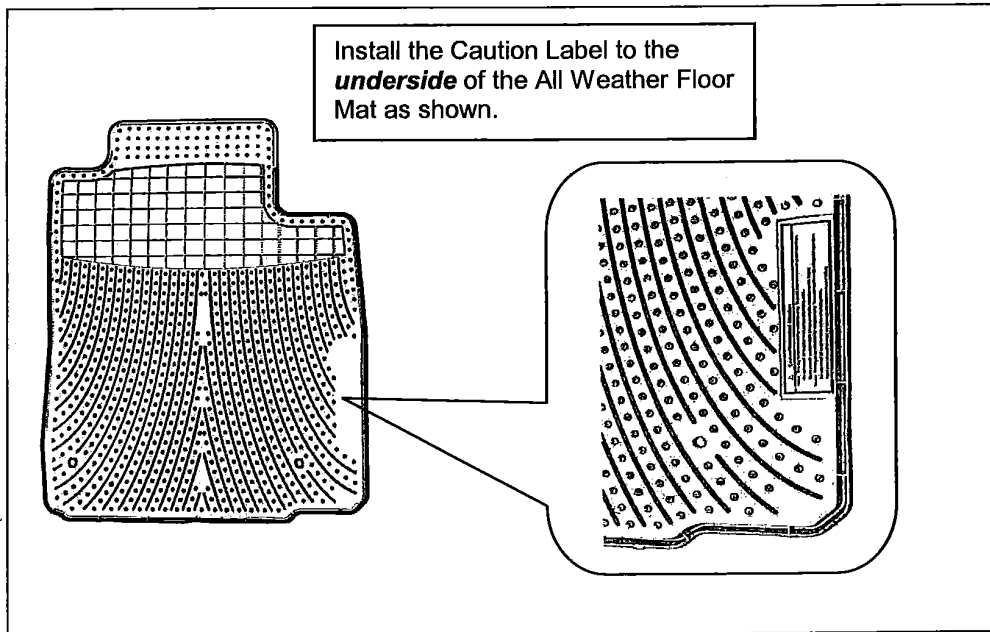
1. Remove the Driver's side Lexus All Weather Floor Mat from the vehicle.
2. Wipe the area where the Caution label will be affixed with a clean, dry cloth to remove any dust or dirt.
3. Affix the Caution Label at the indicated location while smoothing out any air bubbles in the new label.
 - Caution label installation location, see illustration below.

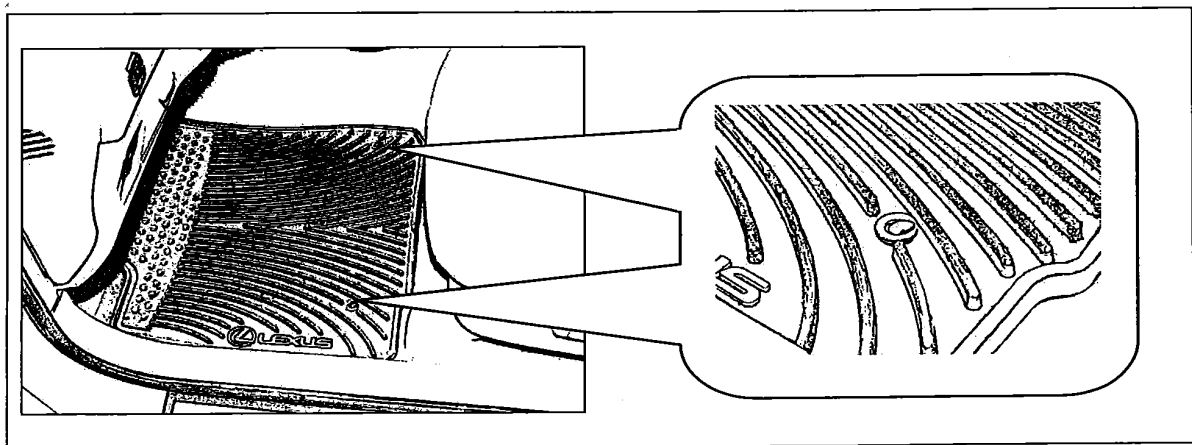
4. If the Carpet Floor Mat has been placed underneath, please remove it. (The ES 350 driver's side seating position is designed to accommodate only one floor mat at a time.)
5. Position the All Weather Floor Mat on the floor and secure the floor mat to the two hooks as shown.

A1: On certain 2007 model year Lexus ES 350 vehicles, if the Lexus All Weather Floor Mat is placed on top of the existing Lexus Carpeted Floor Mats, the All Weather Floor Mats would not be secured by the retaining hooks (clips) and may slip forward interfering with the accelerator pedal.

A3: If the Lexus All Weather Floor Mat is placed on top of the existing Lexus Carpeted Floor Mats, the All Weather Floor Mats would not be secured by the retaining hooks (clips) and may slip forward interfering with the accelerator pedal.
