## Floor mat is reason for sudden acceleration of local Lexus

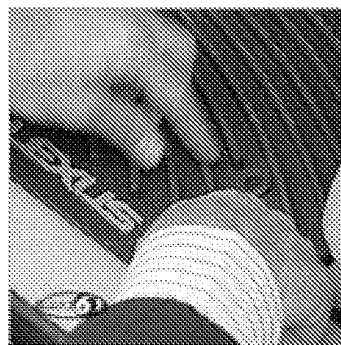
When the winter floor mat is put on top of the regular one, there's no way to hook it.

The regular floor mat is hooked with clips. When the winter mat is put on top of the regular one, there's no way to hook it. Consequently, the rubber mat can slip forward and come over the accelerator pedal.

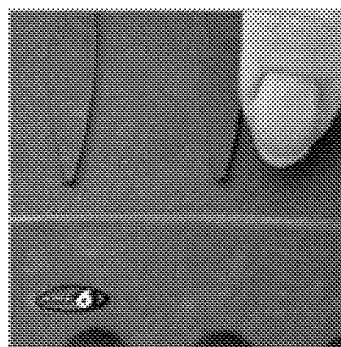
[REDACTED] is pointing to the warning on the winter floor mat. It's extremely hard to see.

There is a warning label on the winter mat but it's difficult to see. "Do not place on top of existing floor mat," [REDACTED] reads. "It is what, about an eighth of an inch?"
