UPDATE ON NHTSA'S OBLIQUE RESEARCH PROGRAM

National Highway Traffic Safety Administration

CURRENT RESEARCH OBJECTIVE

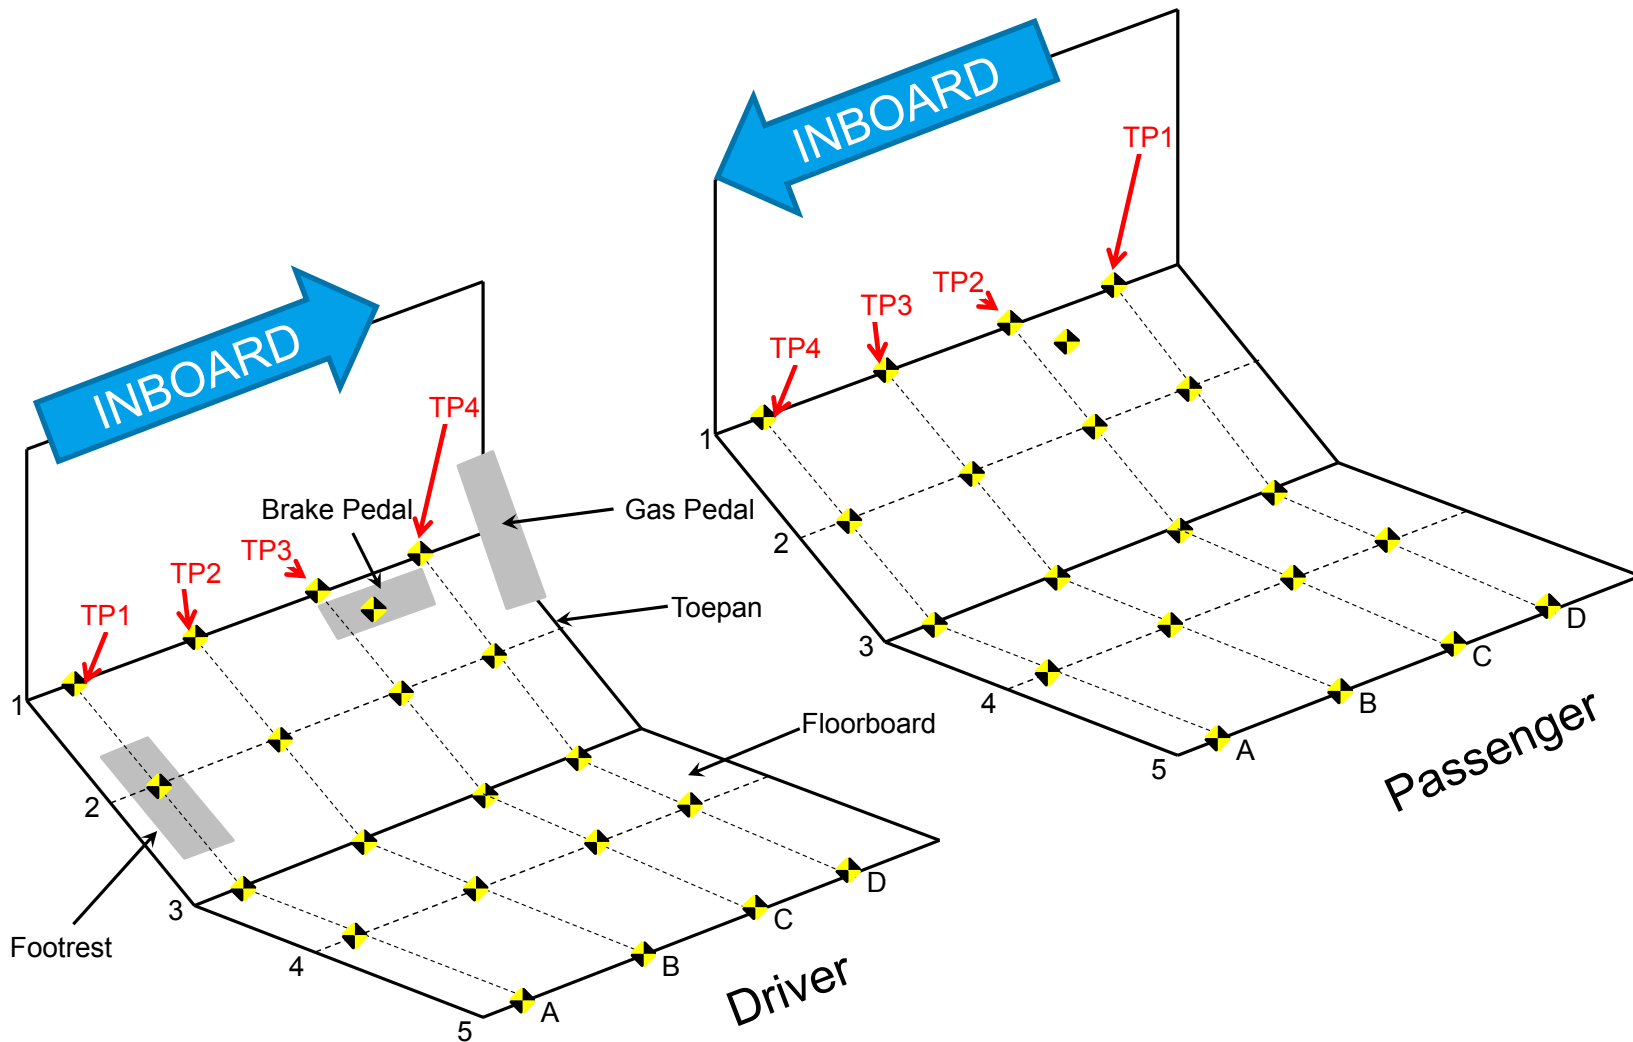
INTERIOR INTRUSION MEASUREMENTS

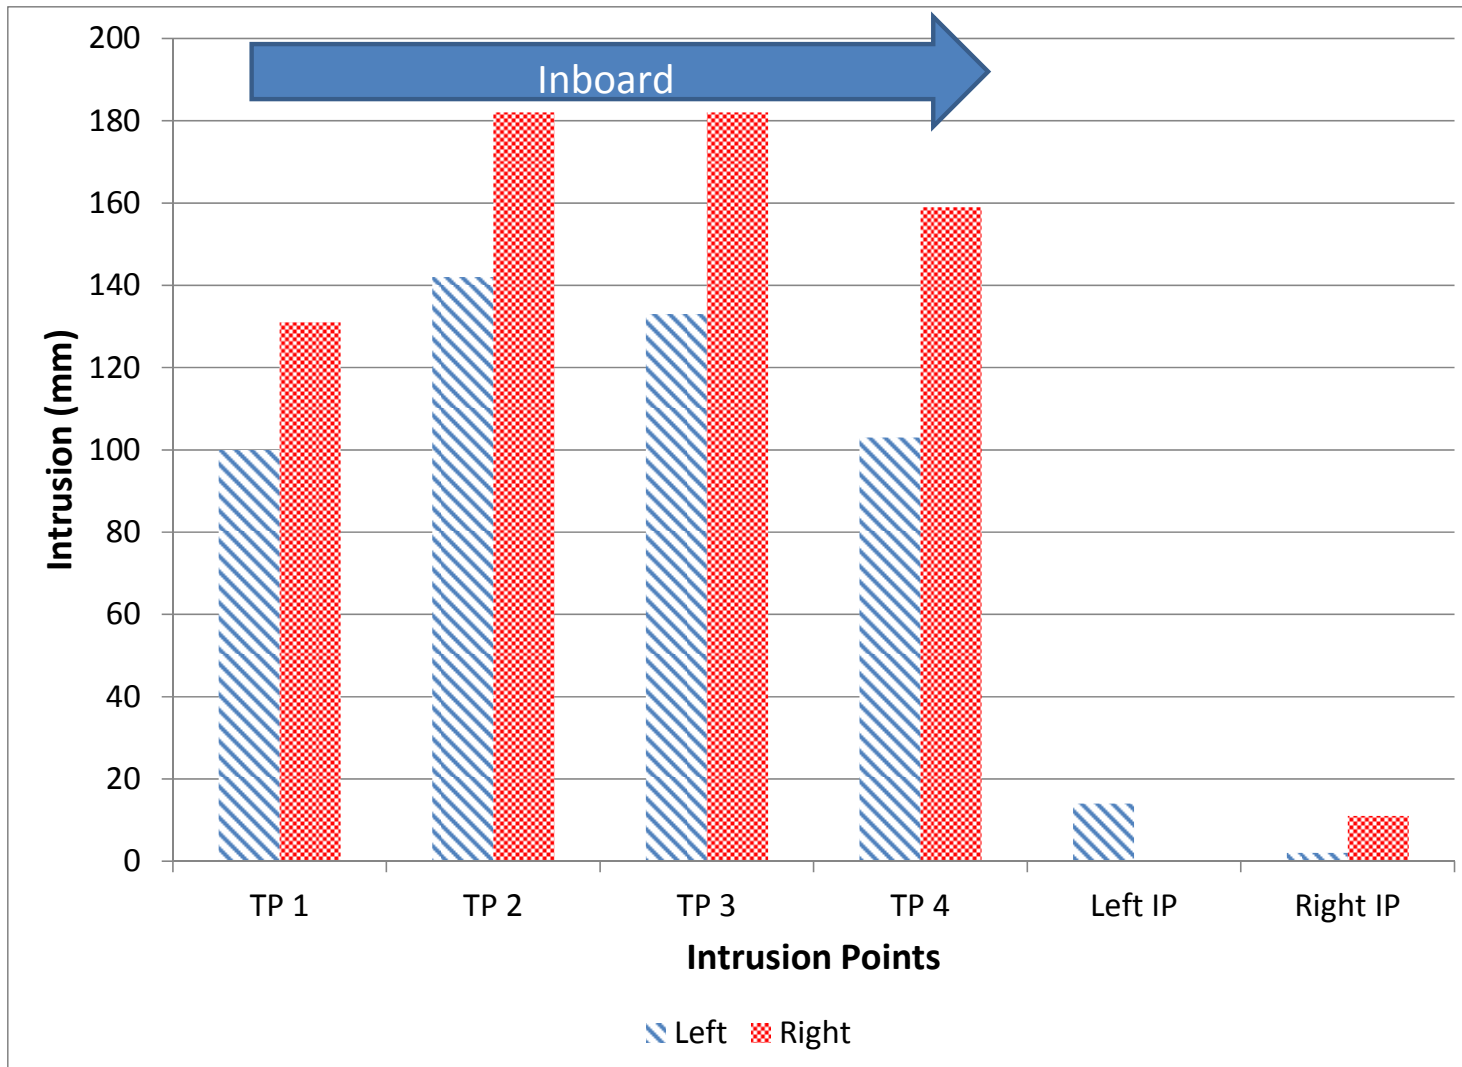
HONDA ACCORD NEAR SIDE INTERIOR INTRUSIONS

- **Toepan intrusion trend was to have higher intrusions inboard**
 - TP3 for right side impact had higher intrusions
- **Near side THOR goes between the FMVSS No. 226 side curtain air bag and frontal air bag**
- **Far side THOR slides off the frontal air bag and comes out of the shoulder belt**

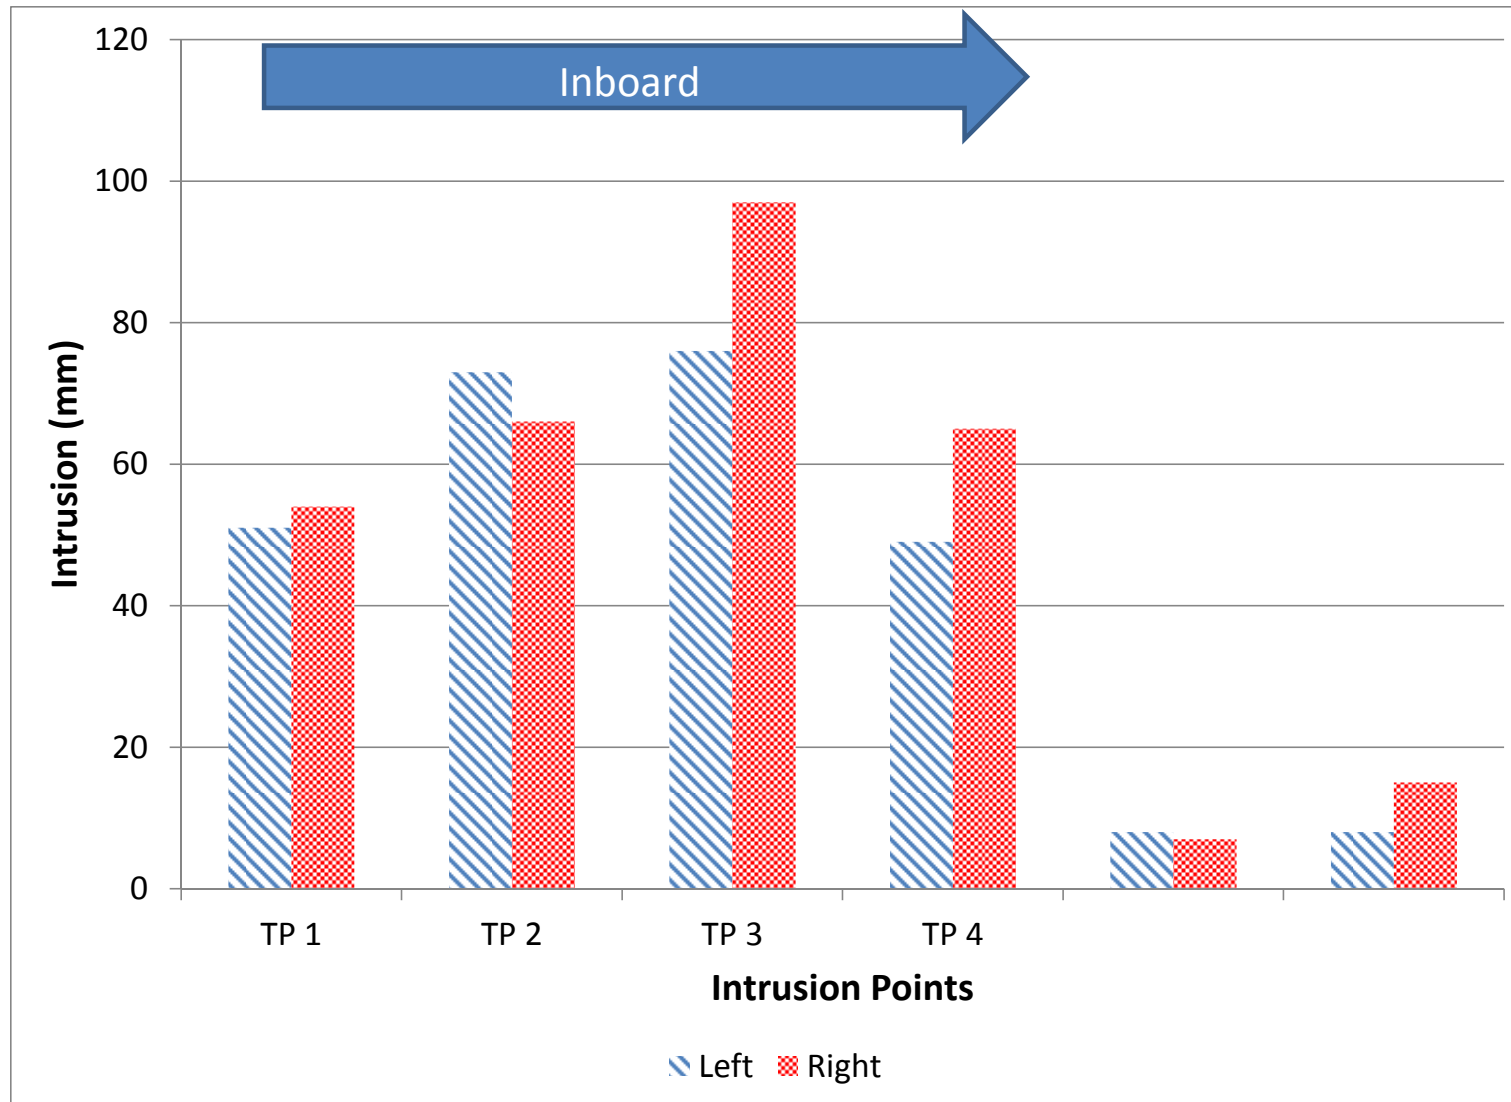
MAZDA 3 NEAR SIDE INTERIOR INTRUSIONS

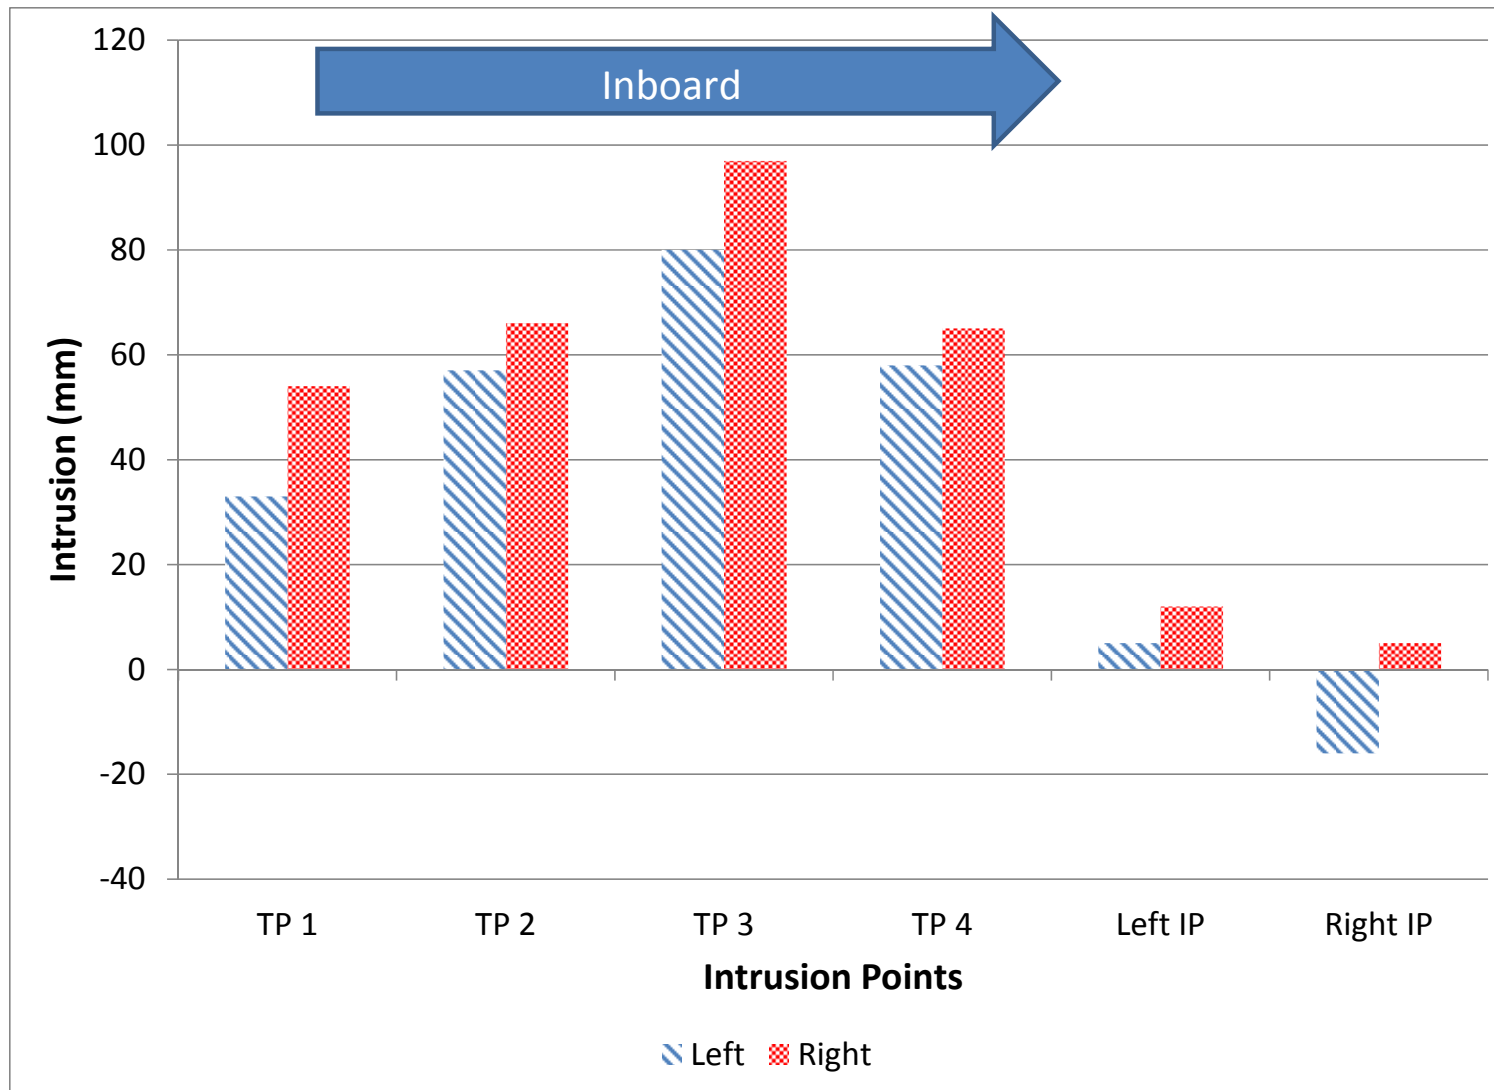
MAZDA CX5 NEAR SIDE INTERIOR INTRUSIONS

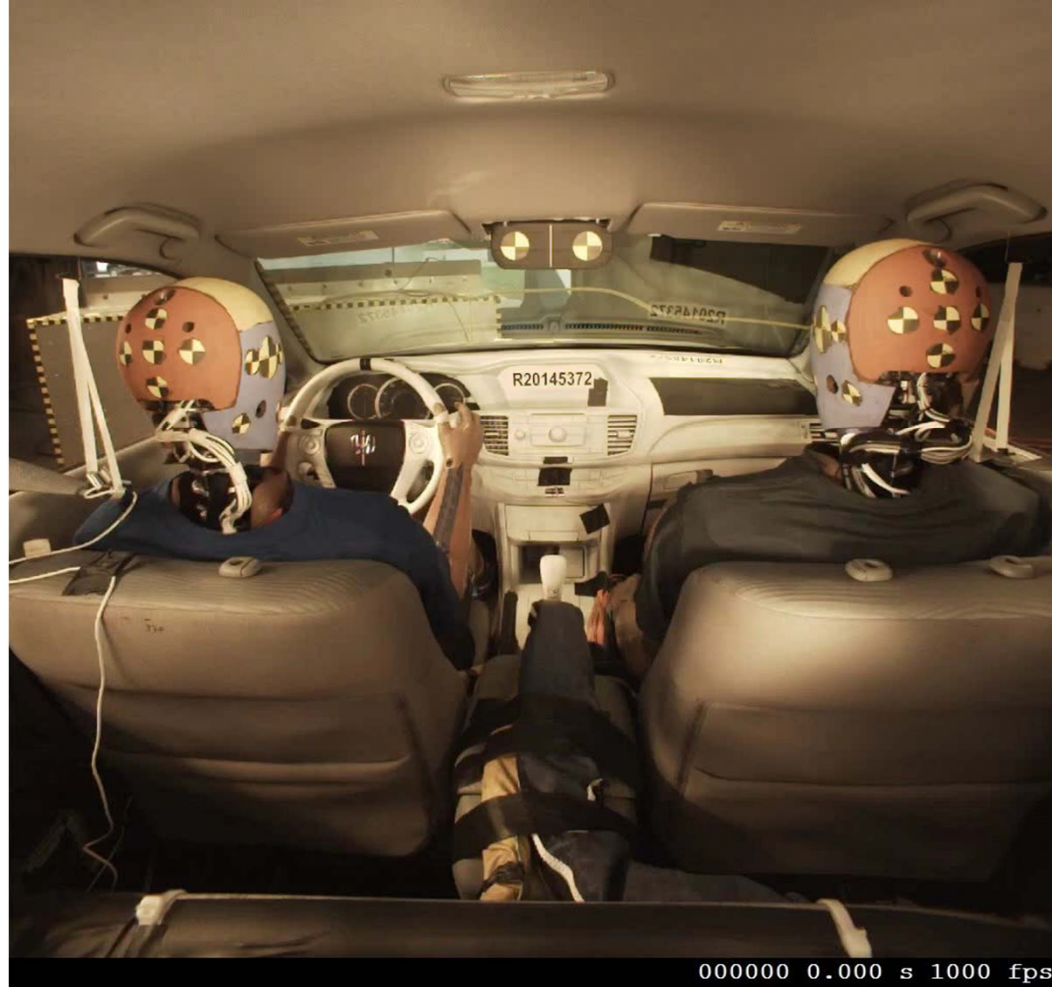
Accord Left Side Impact

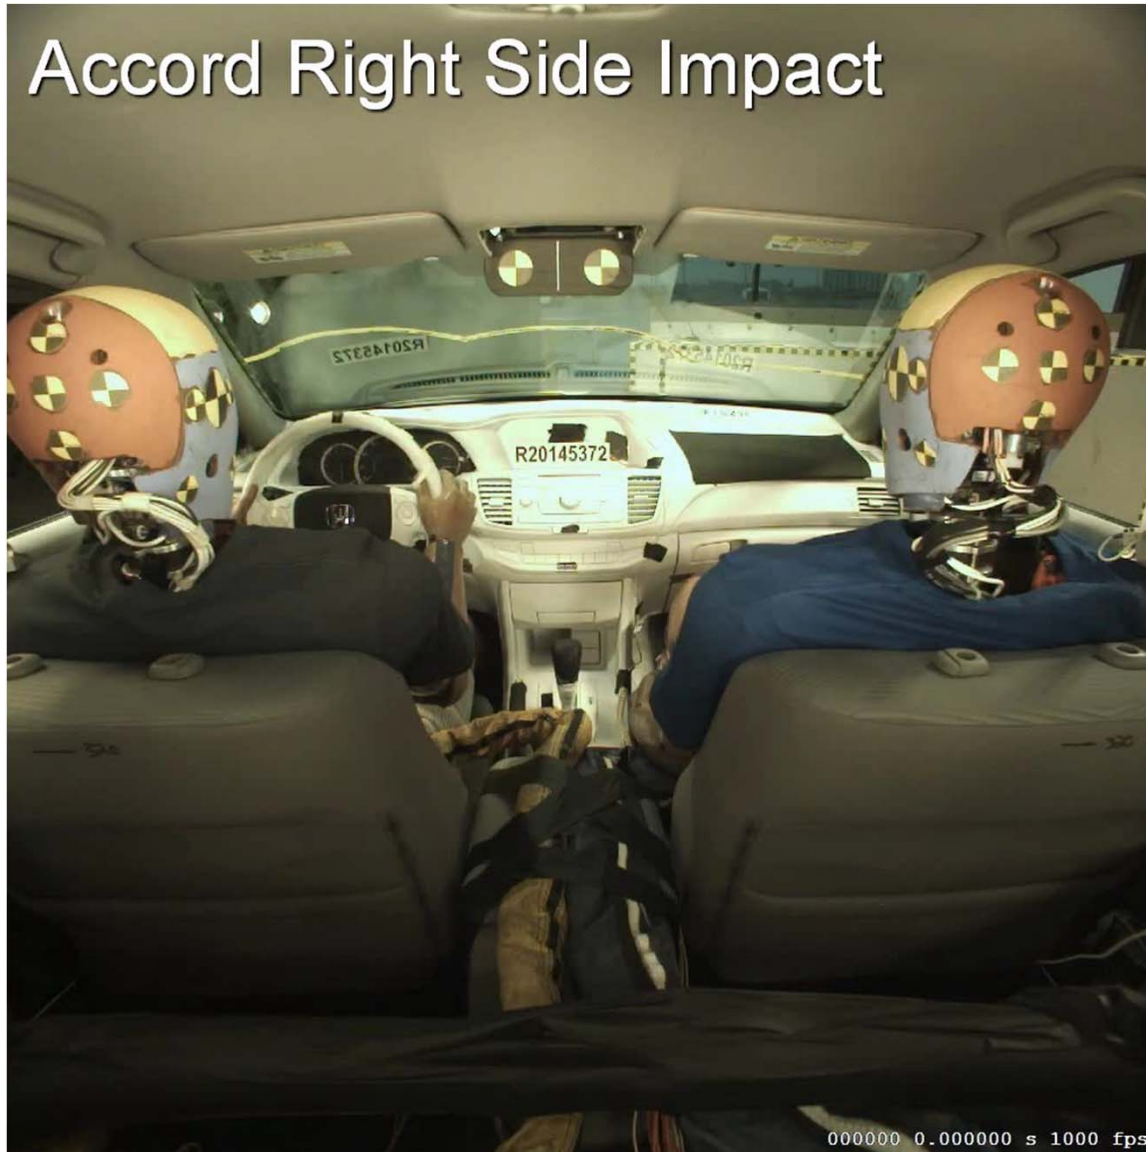
Accord Right Side Impact

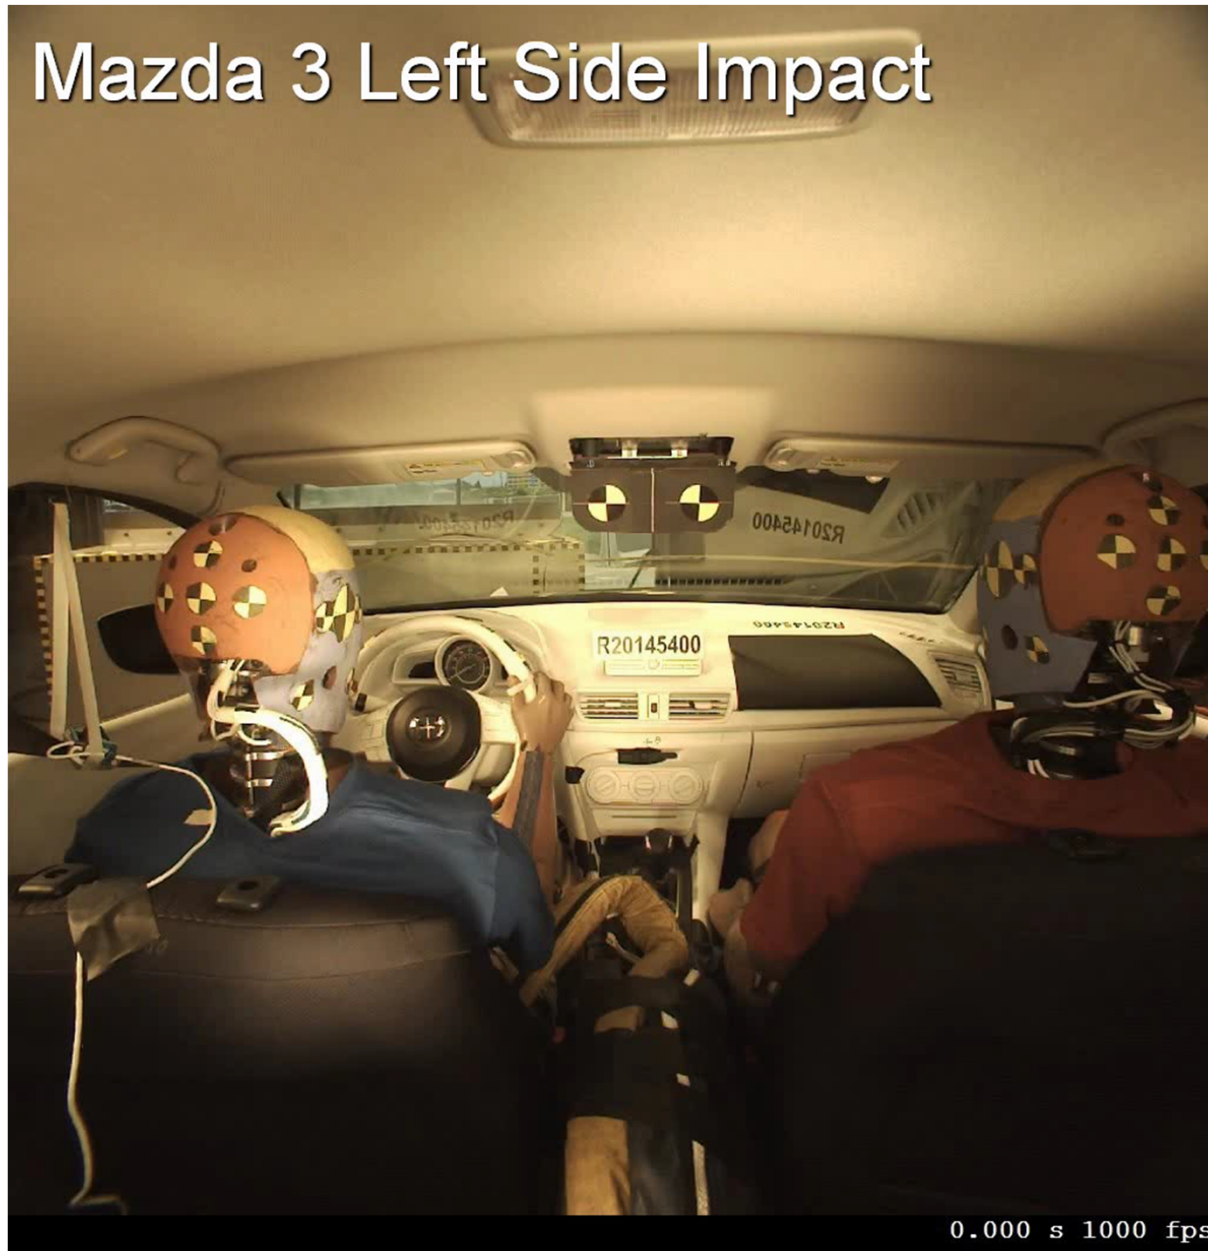
Mazda 3 Left Side Impact

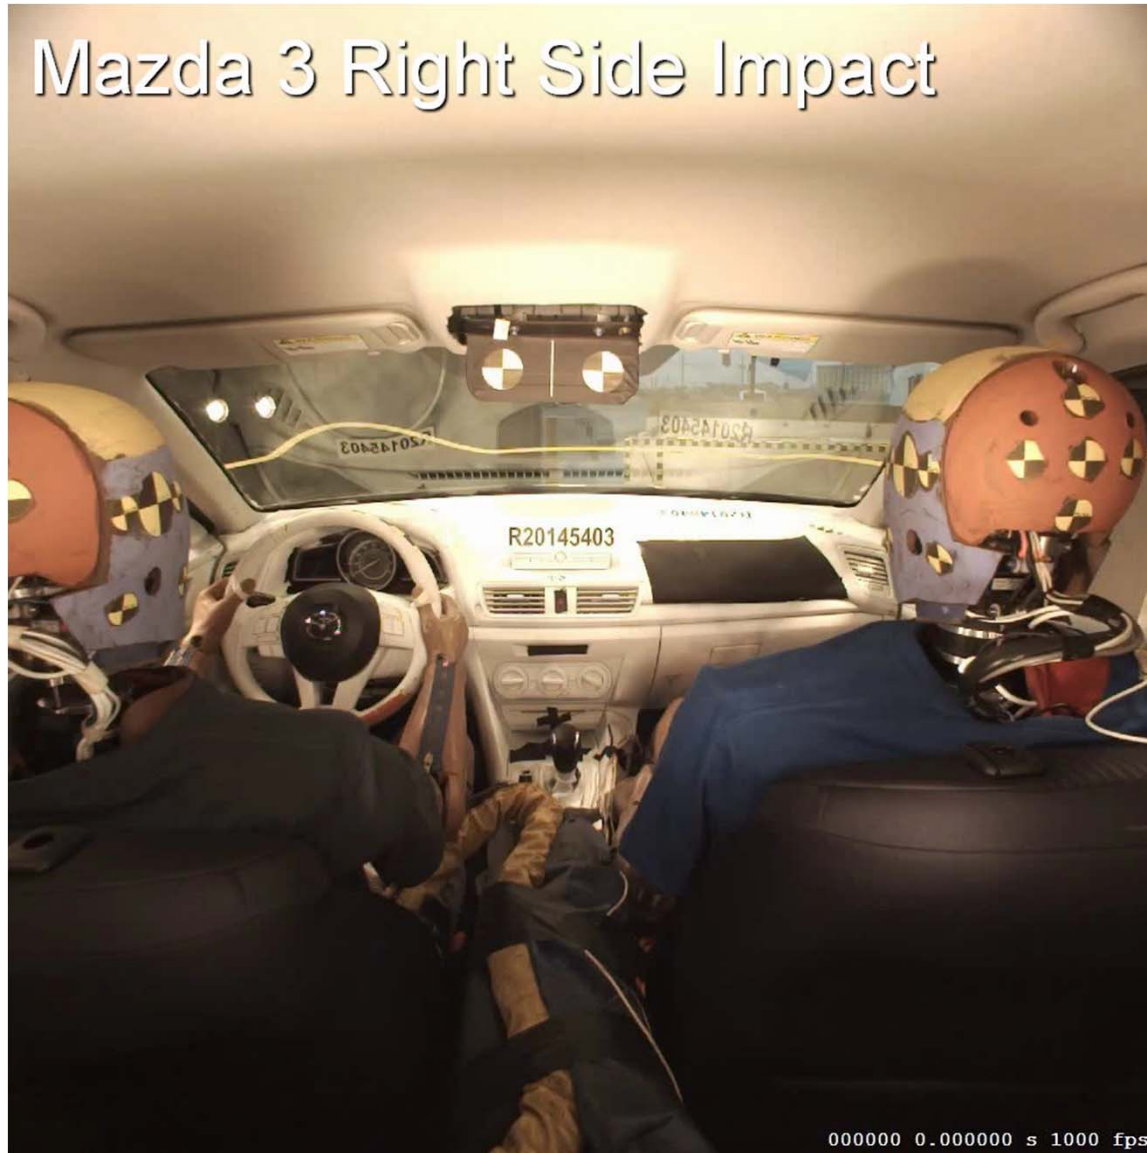
Mazda 3 Right Side Impact

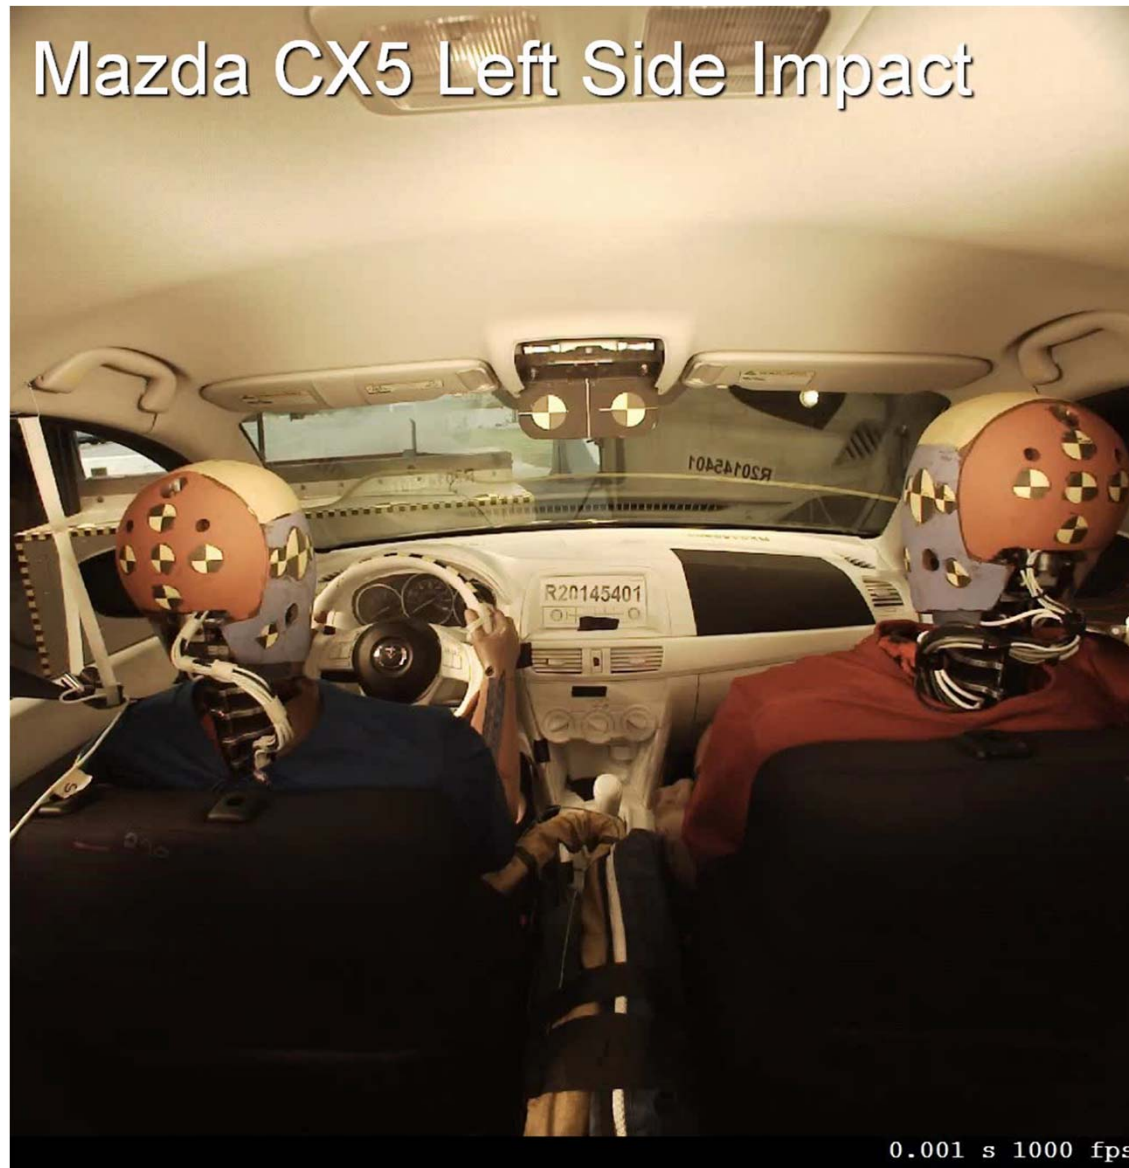
Mazda CX5 Left Side Impact

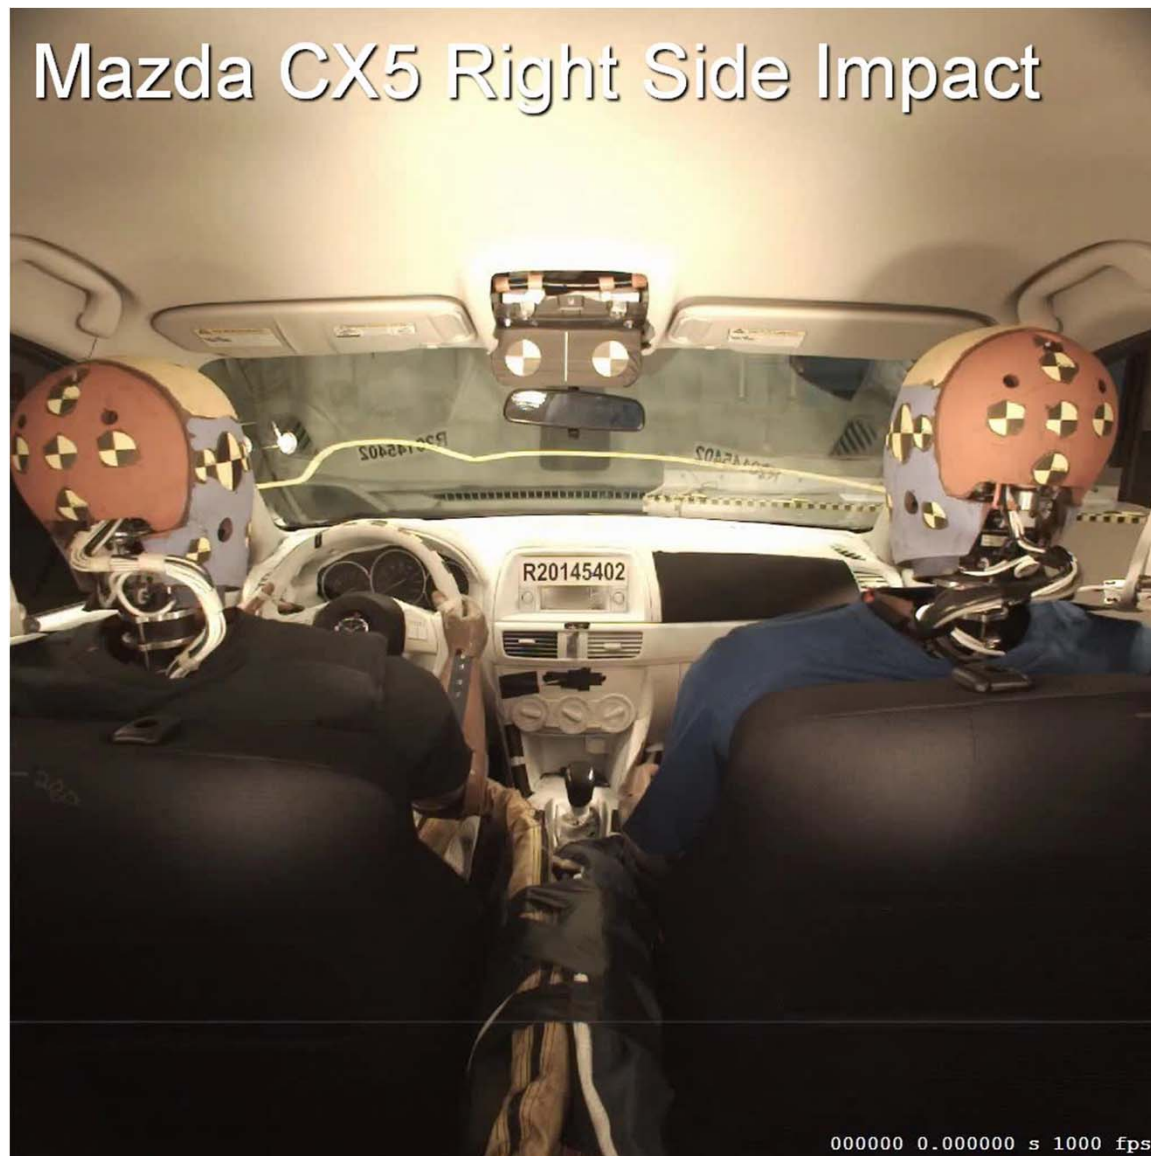
Mazda CX5 Right Side Impact

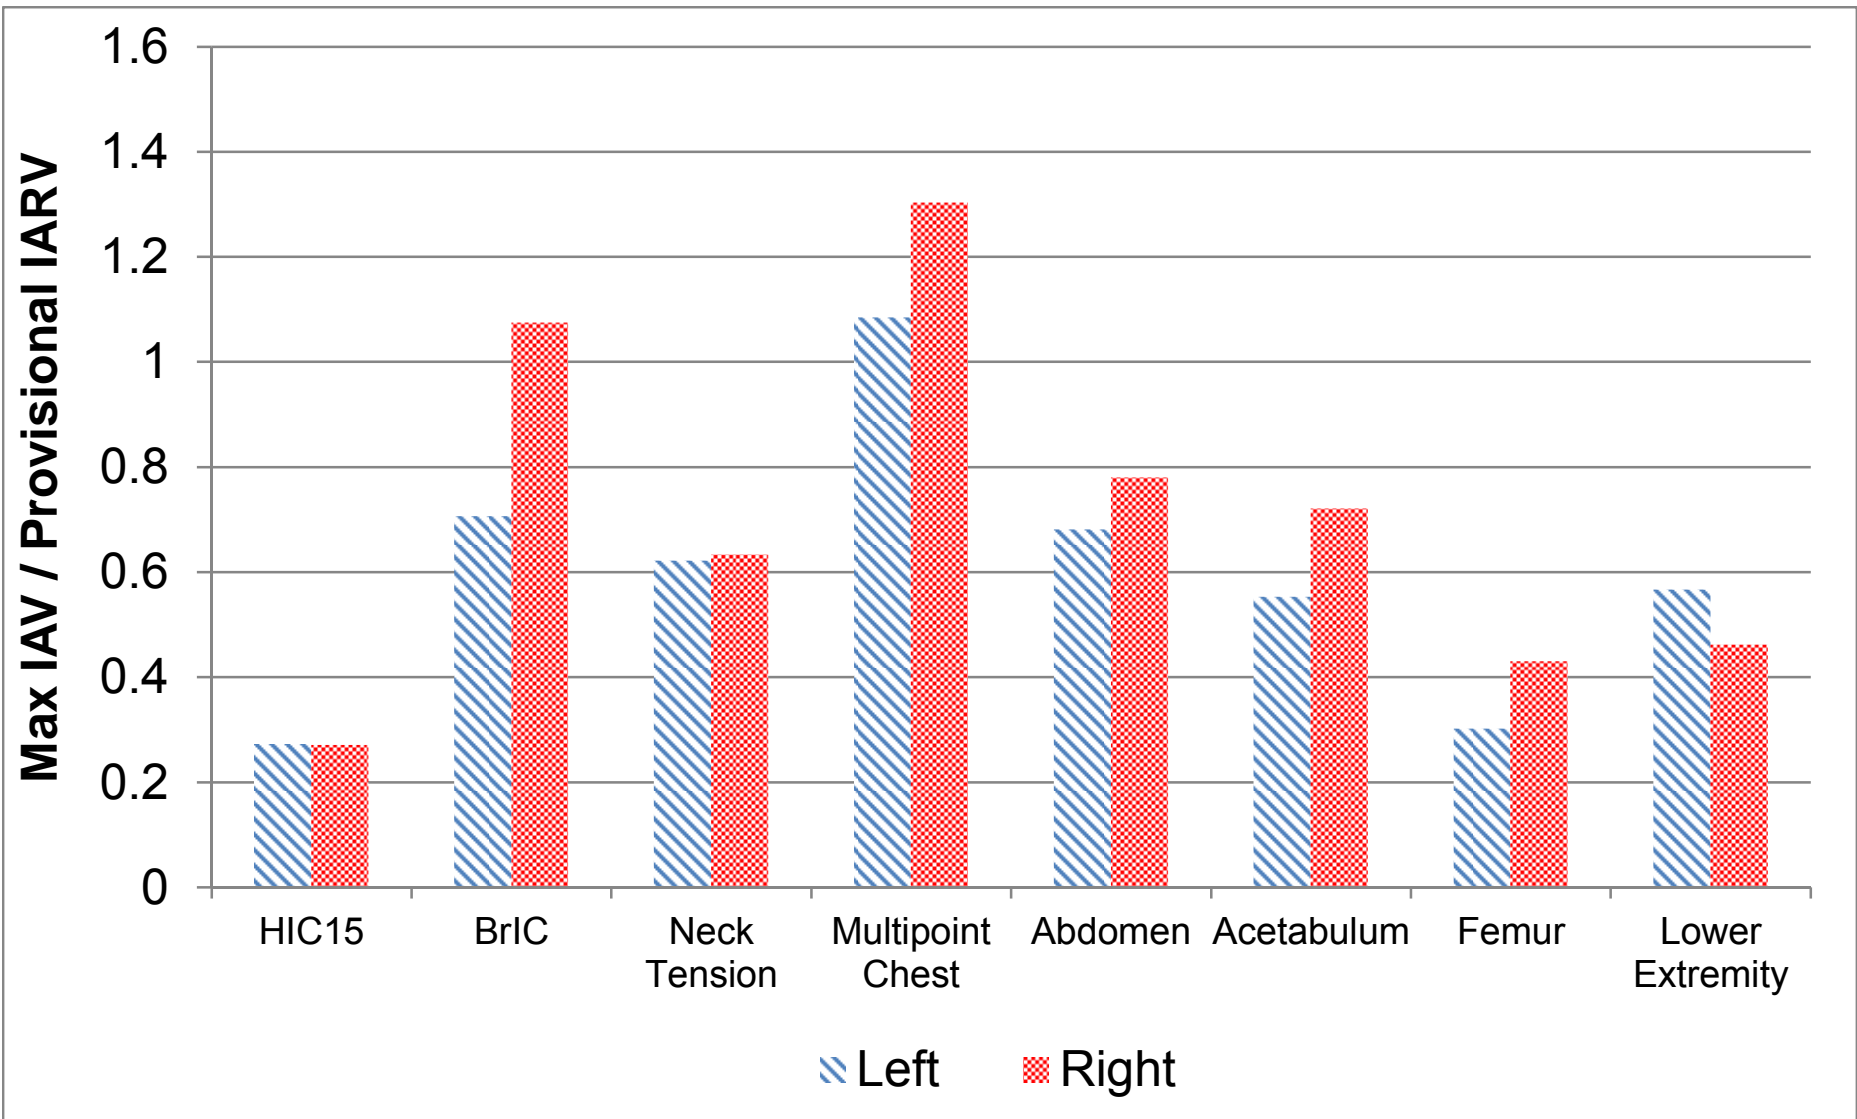
HONDA ACCORD INJURY NEAR SIDE OCCUPANT

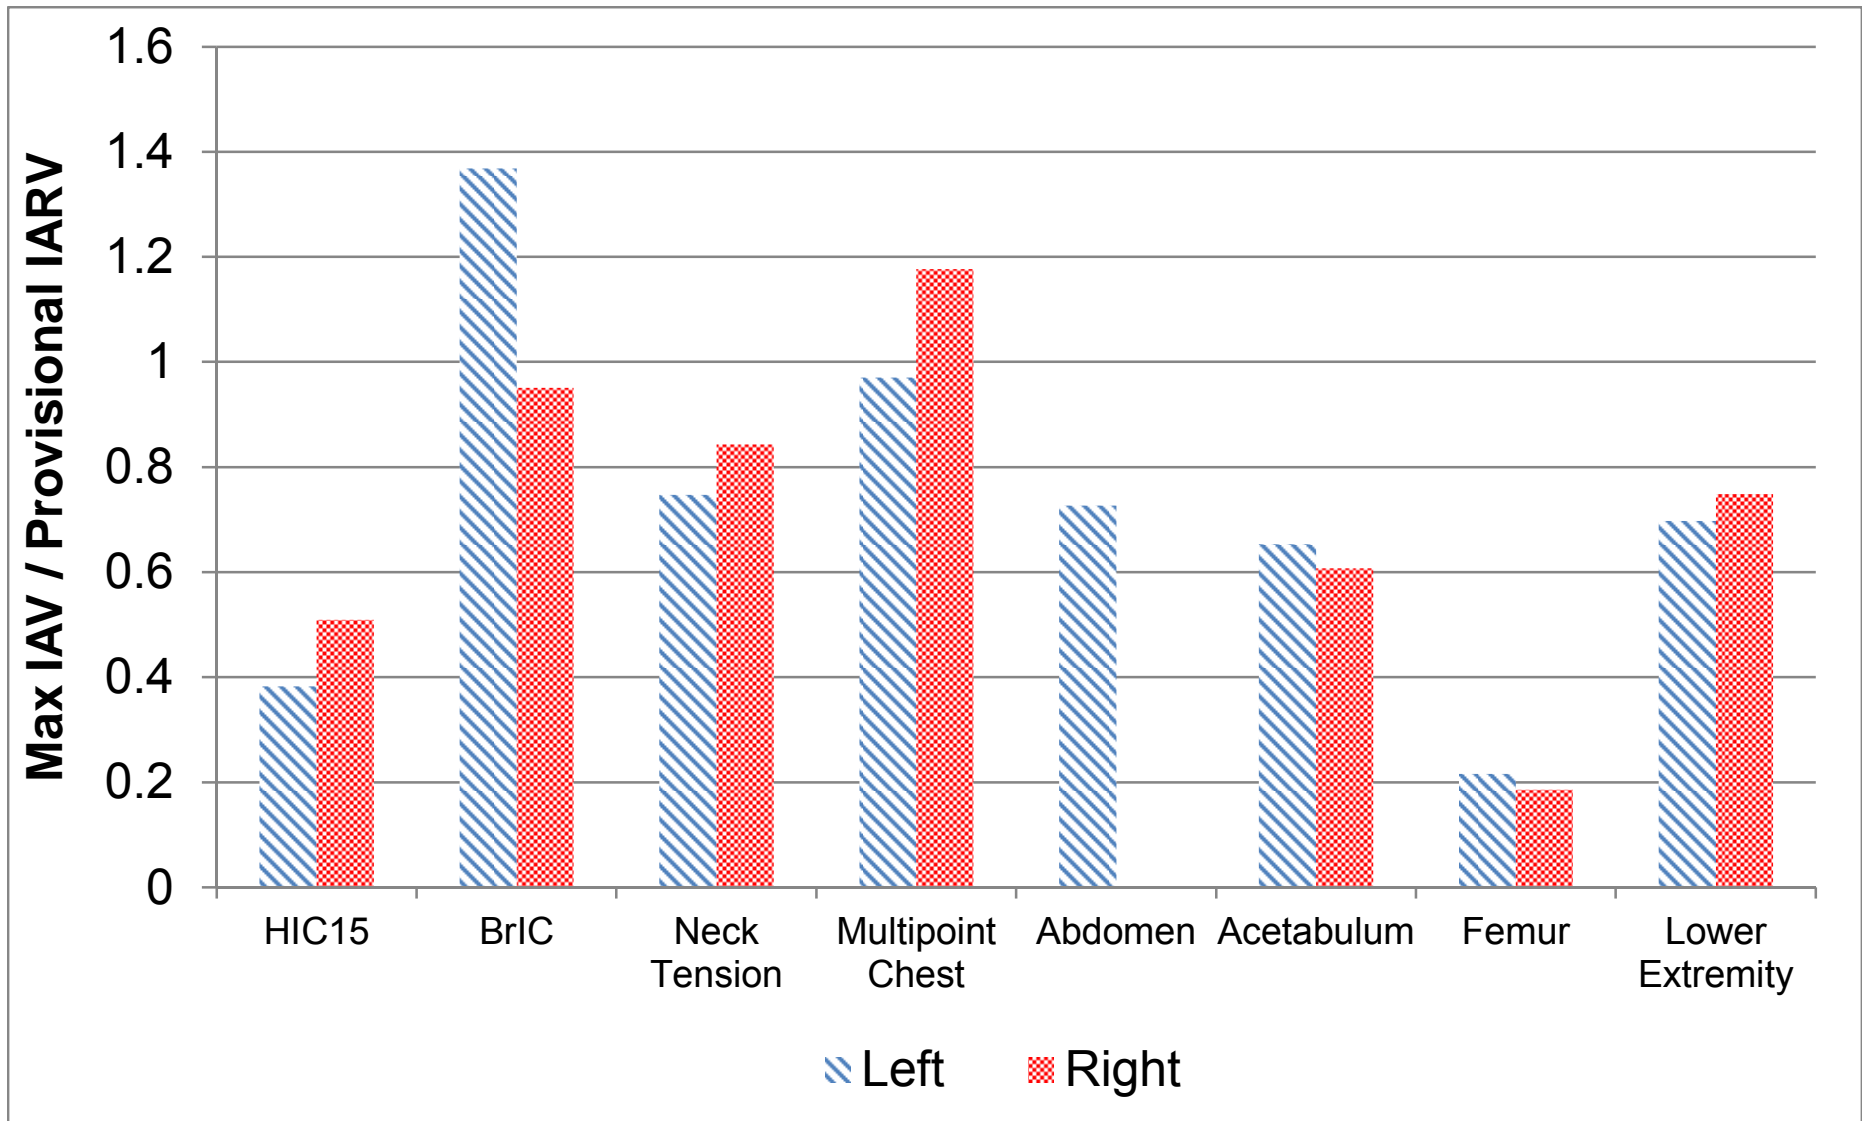
MAZDA 3 INJURY NEAR SIDE OCCUPANT

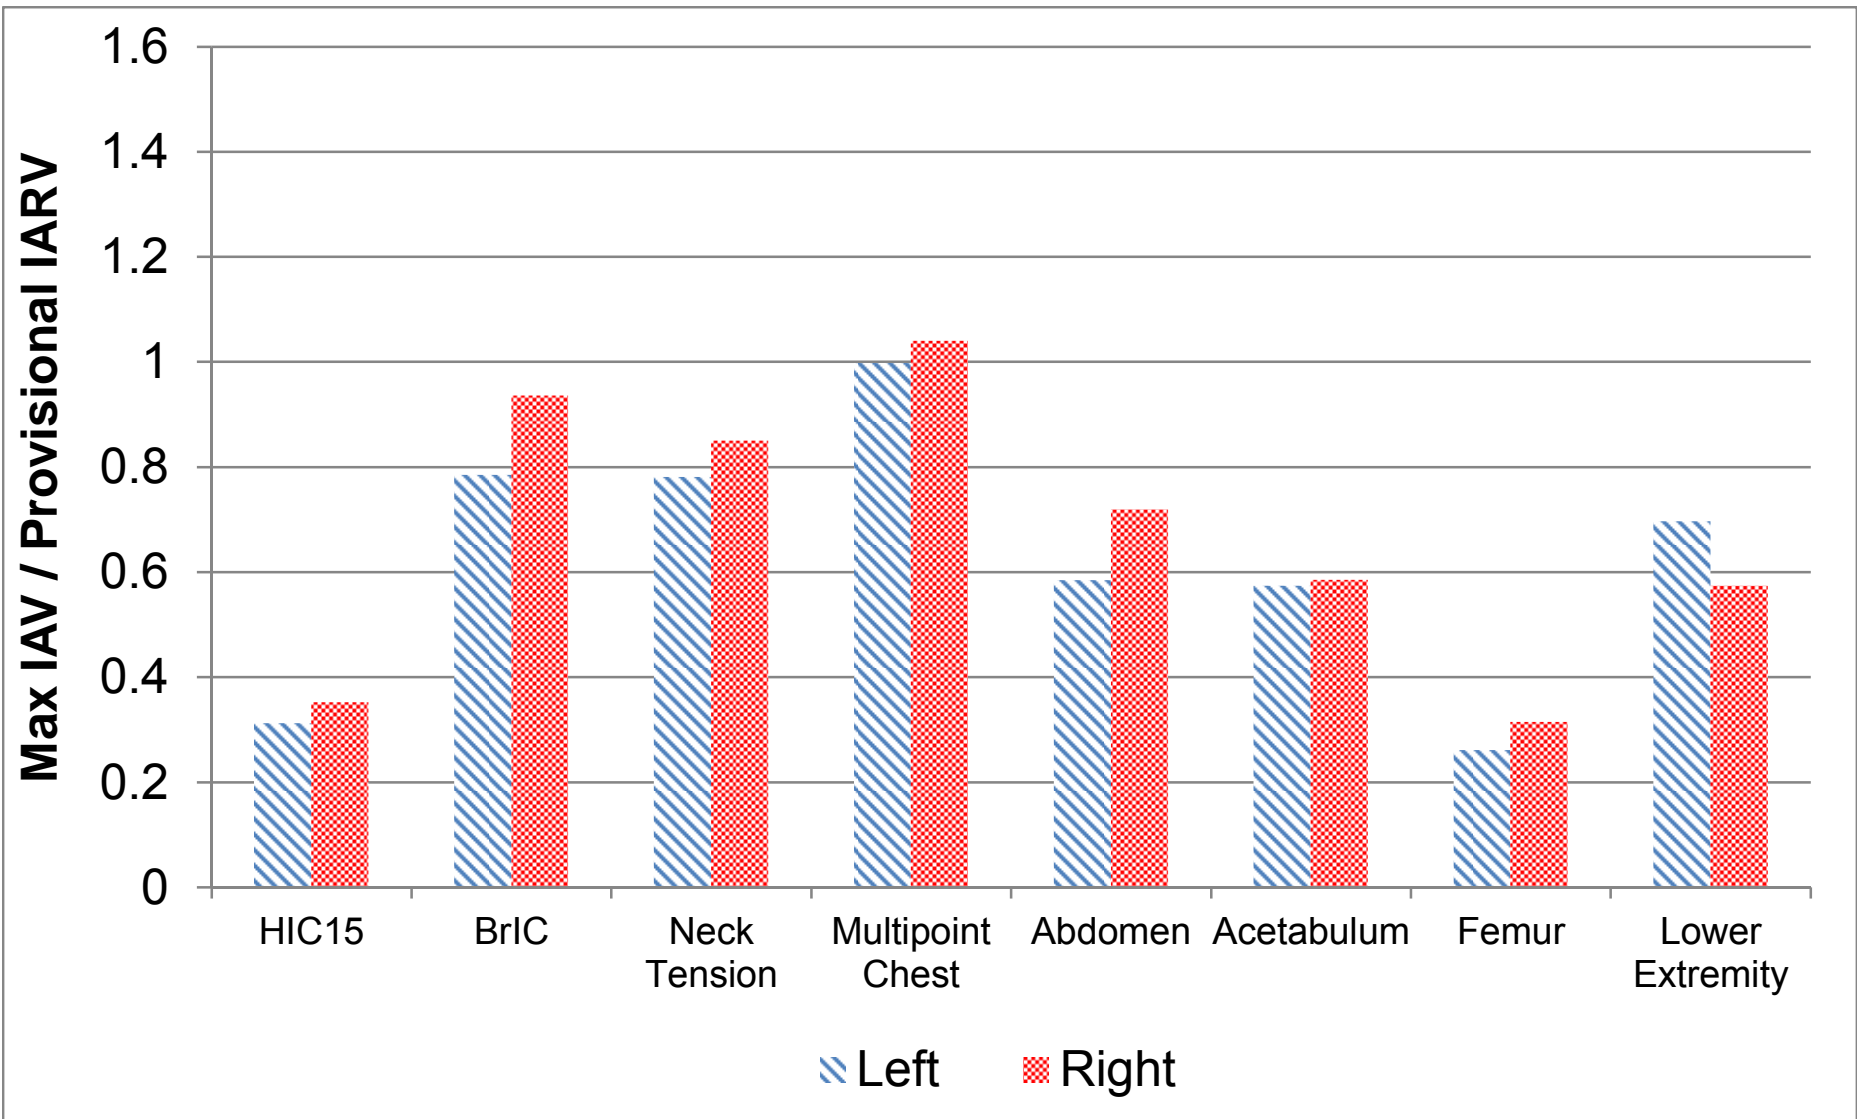
MAZDA CX5 INJURY NEAR SIDE OCCUPANT
