Child Restraint Systems in Side Impact Crashes: Injury Patterns and Causation

CIREN Public Meeting
October 8, 2009
Baltimore, MD

- To delineate injury causation scenarios for rear-seated, CRS-restrained children in side impact crashes
- To create a contact map of the vehicle interior

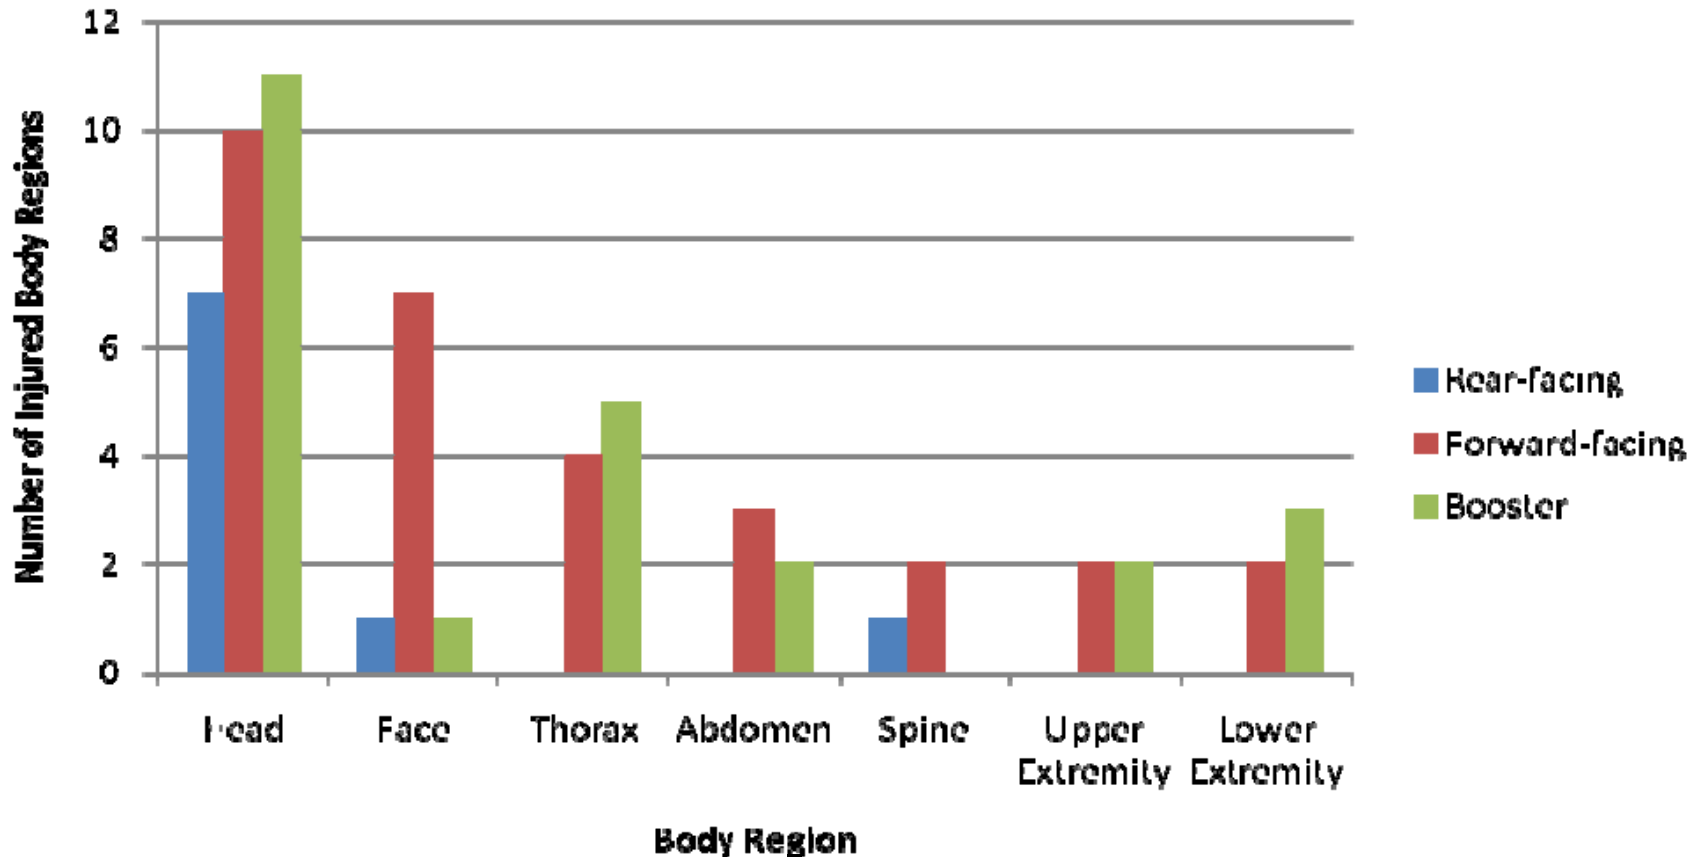
Body Region of AIS2+ Injury by Restraint Type

100% AIS2+
54% AIS3+
32% AIS4+

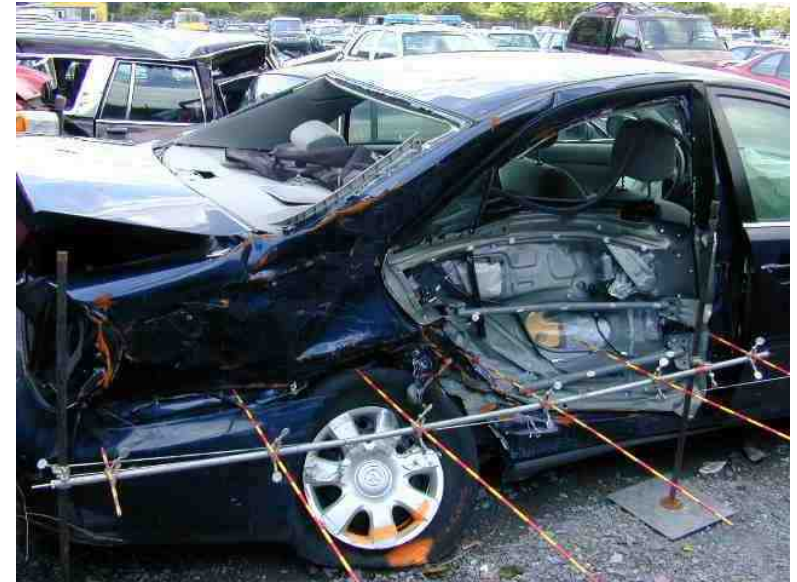
Exemplar Near Side Crash

- 2002 Toyota Camry
- Making left turn
 - Delta V = 28 kph
 - Lat. Comp.= 24 kph
 - Long. Comp. = 14 kph
 - PDOF = 60°
 - Intrusion at occupant seating position: 39 cm
- Occupant
 - 5 year old (21 kg, 46 lbs)
 - Right rear
 - Restrained in booster seat

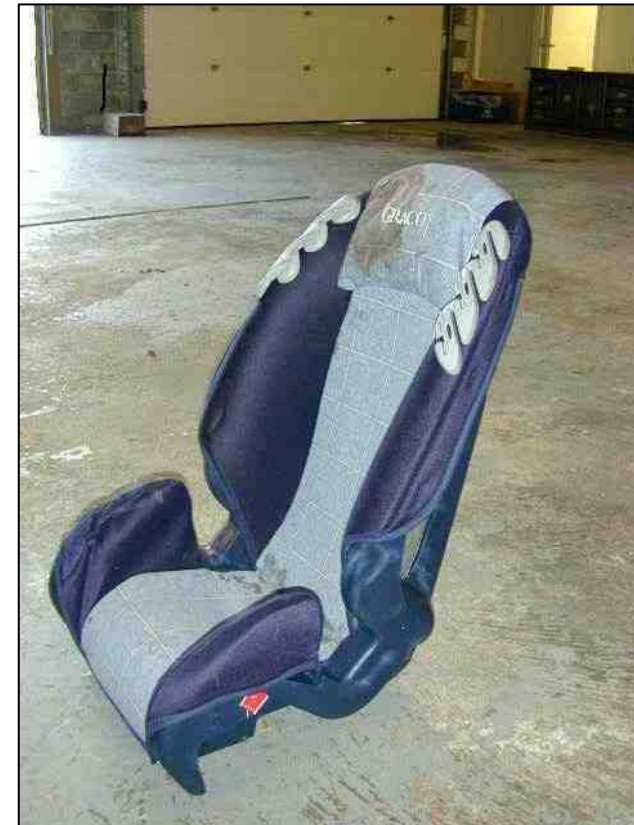
Exemplar Near Side Crash

- Head
 - Cerebral subarachnoid hemorrhage
 - Cerebellar subarachnoid hemorrhage
 - Hemorrhage in midbrain/brainstem
- Thorax/Abdomen
 - Bilateral pulmonary contusions
 - Diaphragm laceration
 - Liver laceration
 - Renal vein transection

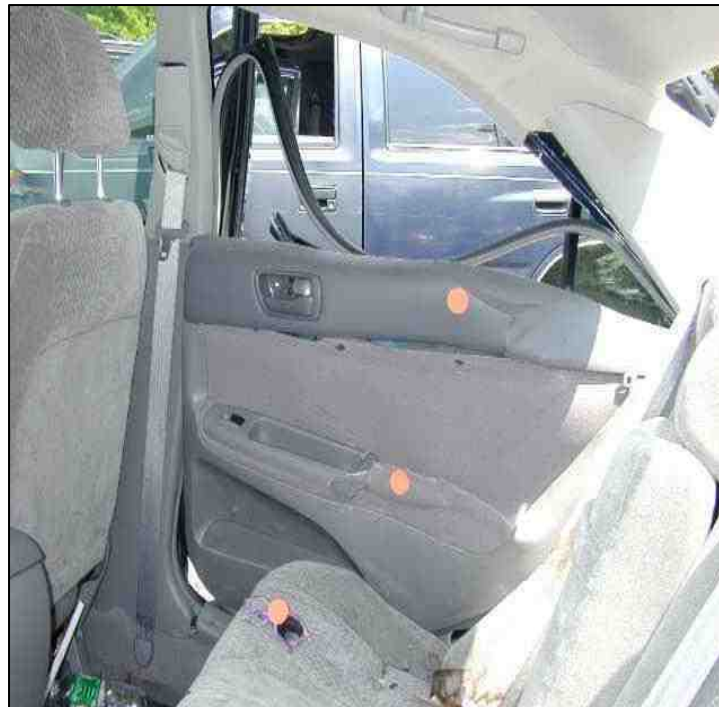
Exemplar Near Side Crash

Case Number	Impact Side	Body Region	ICS	IPC to Body Region Contacted	IPC Confidence	Specific Injury Description	AIS Code
377044651	R	Head	Contact with vehicle interior	Door interior to head	Probable	Cerebrum subarachnoid hemorrhage	140684.3
						Cerebellum subarachnoid hemorrhage	140466.3
						Cerebellum hematoma/hemorrhage subdural small	140442.4
		Thorax	Contact with CRS shell	CRS shell to thorax	Probable	Lung contusion bilateral with or without hemo-/pneumothorax	441410.4
						Diaphragm laceration (OIS Grade II thru IV)	440604.3
						Liver venous transection	521499.3
Abdomen	Contact with CRS shell	CRS shell to abdomen	Probable	Liver laceration minor (OIS Grade I or II)	541822.2

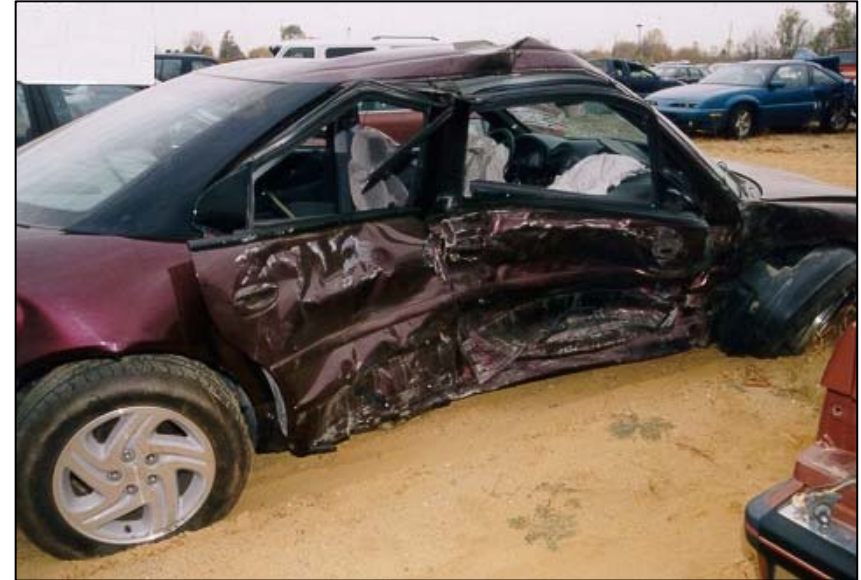
Exemplar Far Side Crash

- 1996 Dodge Intrepid
- Straight through intersection
 - Delta V = 34 kph
 - Lat. Comp.= 29 kph
 - Long. Comp. = 17 kph
 - PDOF = 60°
 - Max. intrusion: 36 cm @ B-Pillar
- Occupant
 - 2 year old (89 cm, 13 kg)
 - Center rear
 - Restrained in FFCRS

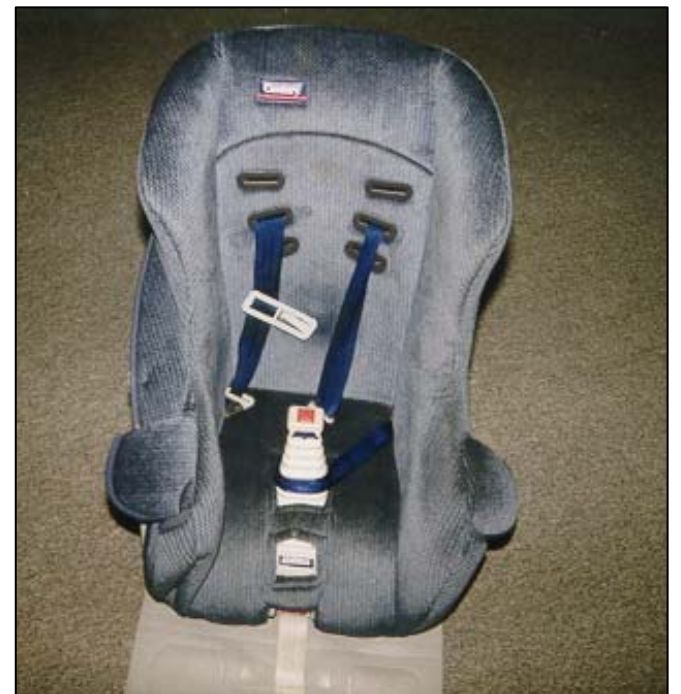
Exemplar Far Side Crash

- Head/Face
 - Right frontal lobe contusion
 - Right superior, medial orbital wall fracture
 - Right maxillary fracture
- Lower Ex
 - Left fibular fracture
 - Comminuted left tibia fracture

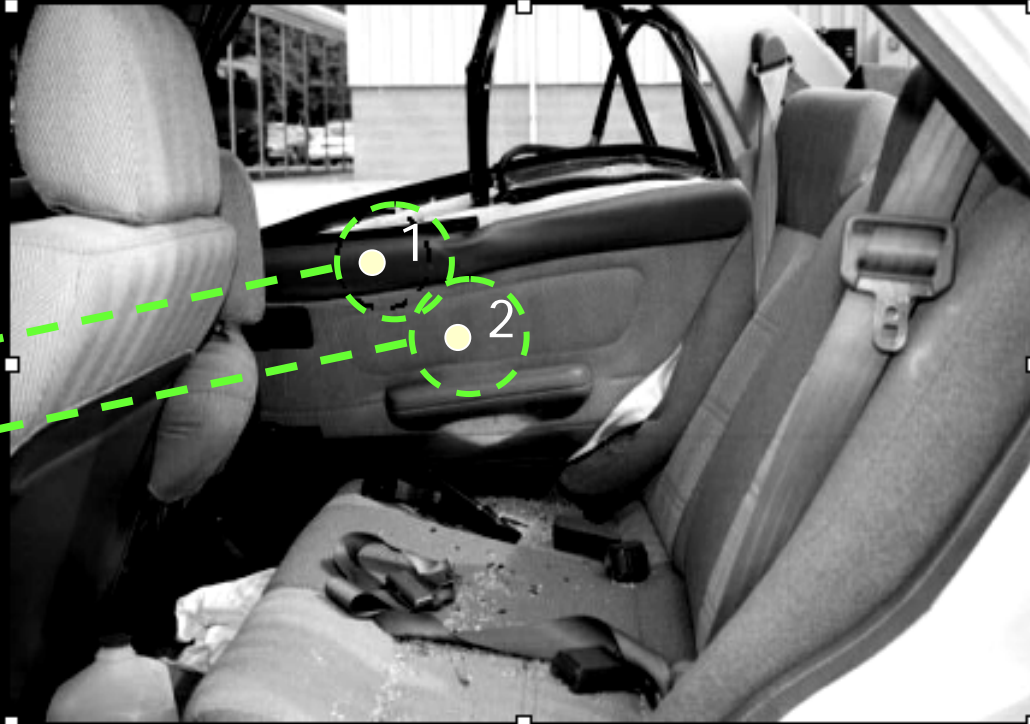
Contact Point Map

On the left, you see an artist's rendering of the interior of a motor vehicle that was involved in a crash, with one or more numbers in the picture. The numbers signify the location inside the vehicle where an occupant contacted the vehicle interior. Your task is to estimate the position of the numbers relative to the position of the seatback, locate the corresponding cell in the image on the left, and type the number in the cell.

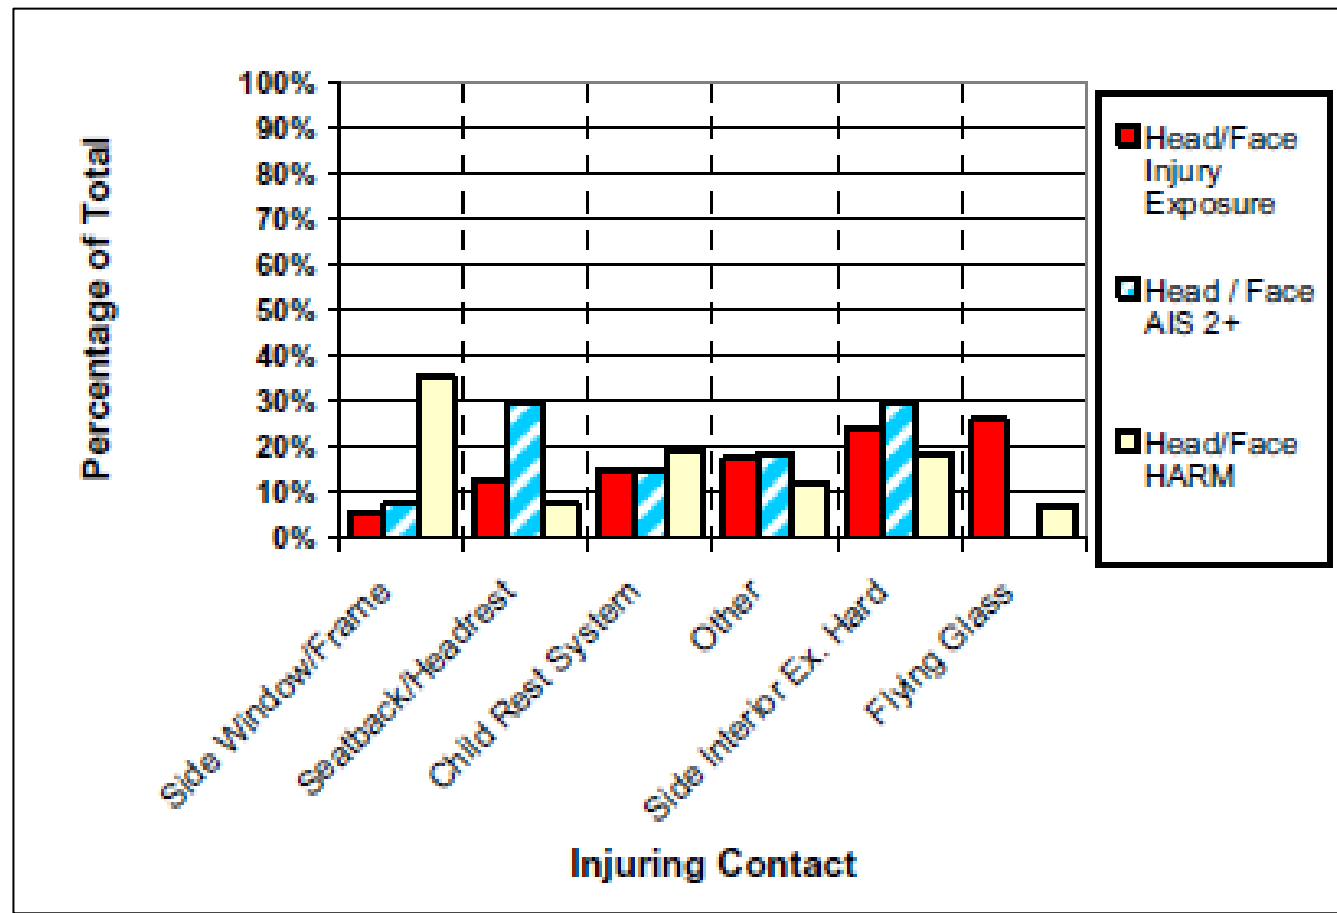
Head and Face Contacts for Children in CRS – Near Side Impacts

Previous Research NASS-CDS 1993-2007
