INVESTIGATION OF HYBRID III FIFTH FEMALE DUMMY USE IN THE CARAVAN AIR BAG TEST ENVIRONMENT

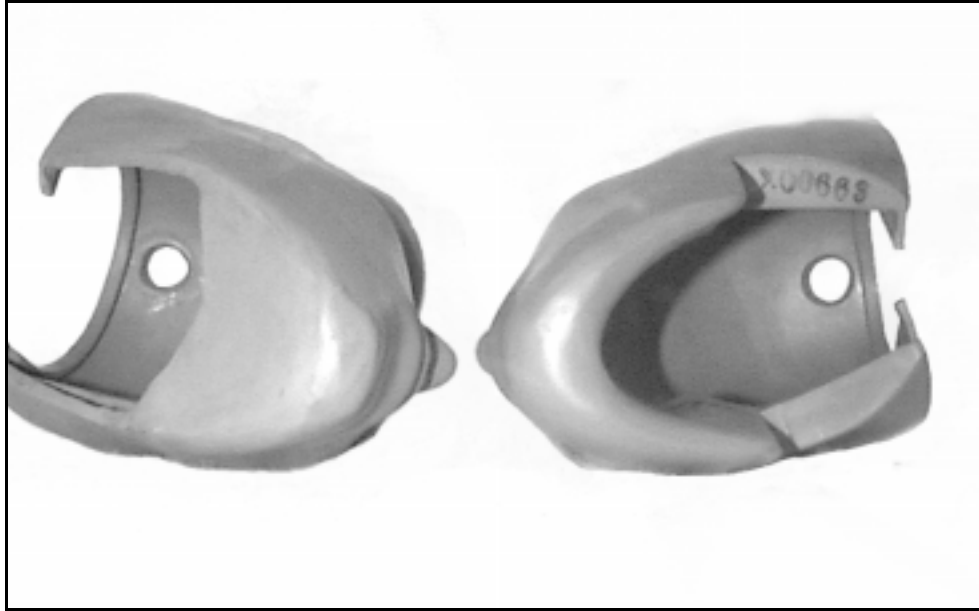
Fig. 2. TMJ Head Skin (left) and Standard Skin.

At the time of the LTV aggressivity tests series, the 5th percentile female test dummy was still being developed. Because of this, the head skin used in the crash test was different from that specified in the Sep. '98 Notice of Proposed Rulemaking (NPRM) for FMVSS 208. Specifically, the NPRM head skin does not have openings under the chin and behind the jaw. The newer head skin, referred to as the TMJ head skin, was intended to reduce the possibility of the deploying airbag to become trapped under the chin during testing. (See Figures 1 and 2)

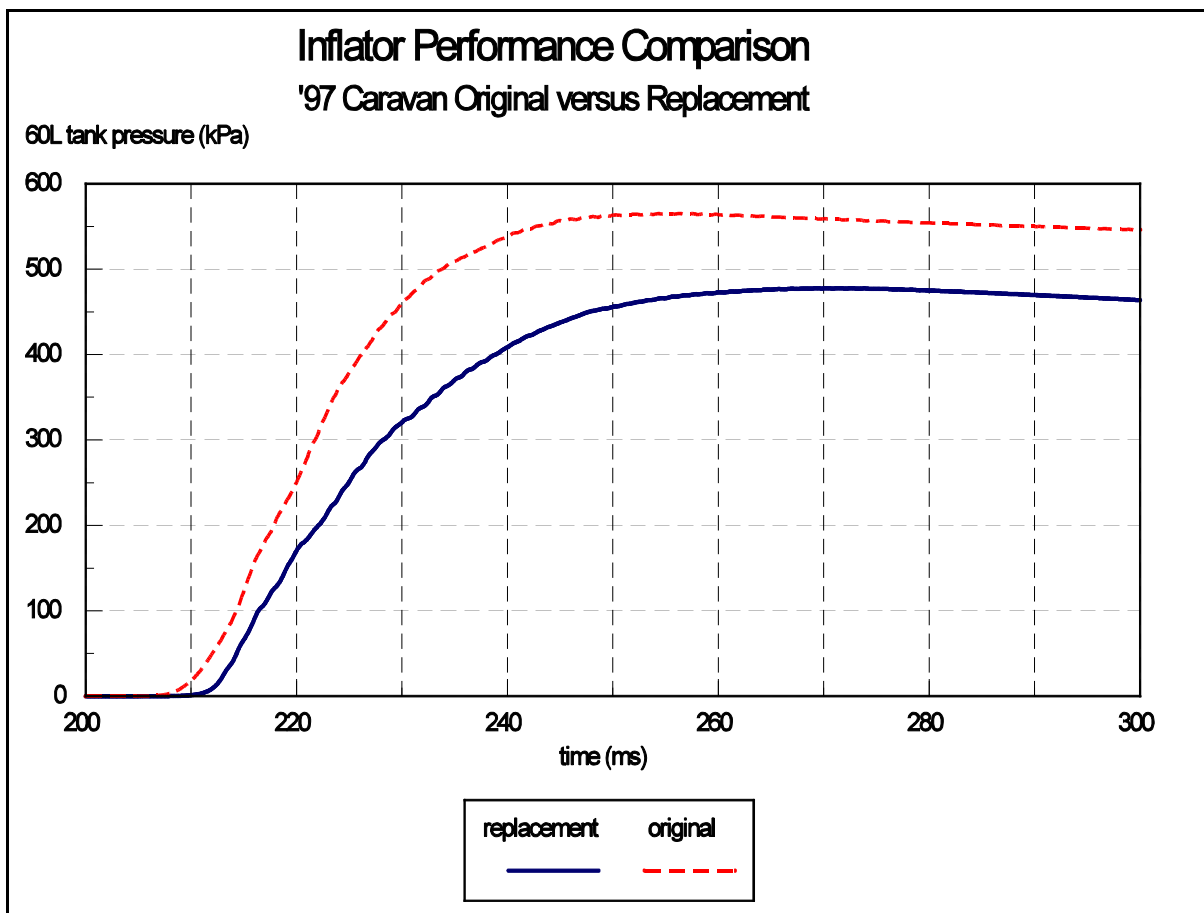
Fig. 4. Inflator Tank Test Results

A 60-liter closed tank test was then conducted with the replacement inflator. The results were compared to previous testing conducted at VRTC with original-vintage '97 Caravan passenger inflators. The results confirmed that there was a significant performance difference between the inflator used in the crash test (peak pressure of approximately 565 kPa with a rise rate slope of approximately 27 kPa/ms) and the one received in the replacement part (peak pressure of approximately 480 kPa with a rise rate slope of approximately 17 kPa/ms) (see Fig.4). VRTC concluded that this difference in inflator performance would translate into a restraint system performance difference, as well.

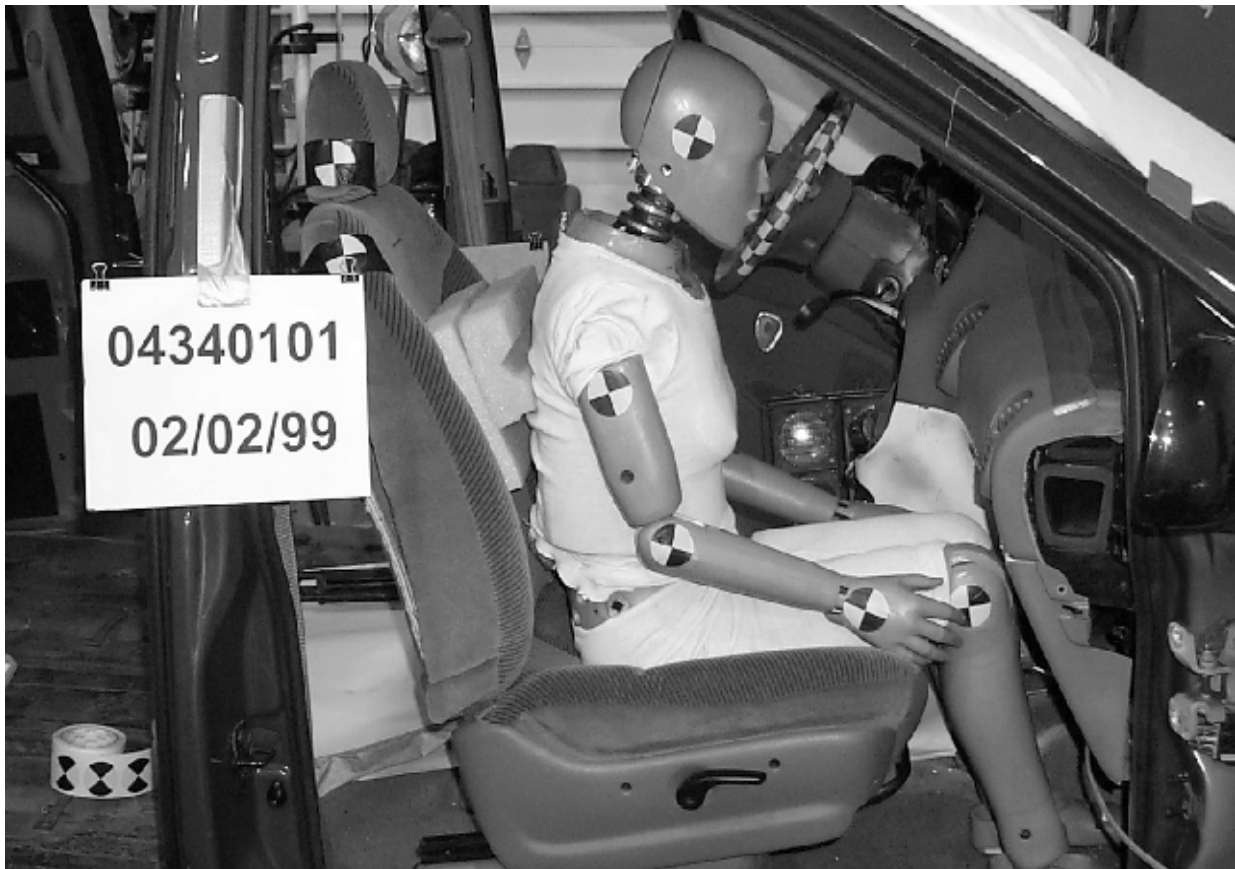
Fig. 5. Typical Test Seating Position.

The sole purpose of the testing conducted by VRTC was to determine whether or not the high neck loading seen in NHTSA crash test #2915 was an artifact of the dummy, and if so, to determine what changes were needed to make the dummy more humanlike. VRTC attempted to replicate the dynamic crash event in a static test environment. To accomplish this, the dummy positioning would need to account for the forward displacement of the dummy which occurred in the dynamic test after impact and before contact with the airbag. Therefore, the dummy was placed in the passenger seat and propped forward with approximately 4" of foam. A typical set-up can be seen in Fig. 5.

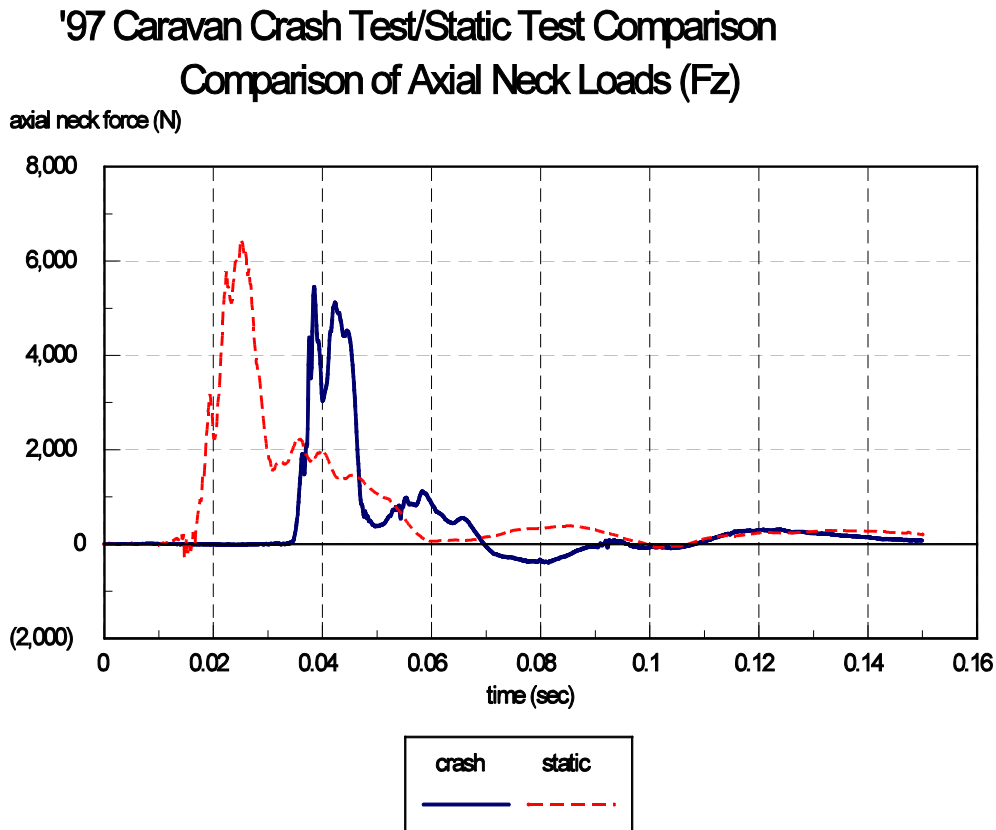
Fig. 6. Comparison of Axial Neck Loads in Crash Test and Static Replication Test

The first test was an attempt to replicate the results observed in the dynamic crash test. This test utilized the original airbag and the dummy contained the standard head skin and no neck wrap. The results indicated that the neck responses were quite similar to that observed in the oblique crash test (see Fig. 6 and 7). Note that the time shift between the two curves is due to the static versus dynamic nature of the two tests - the time shift is inconsequential. The magnitude and shapes of the curves are similar and this is significant. The Nij response for the static test was 4.8 while the Nij for the crash test was 4.4. Review of the high speed digital video also indicated very similar event kinematics: the inflating cushion deployed under the chin of the dummy resulting in the head being projected upward and severe neck extension. This result provided the confidence level needed to proceed with the testing.

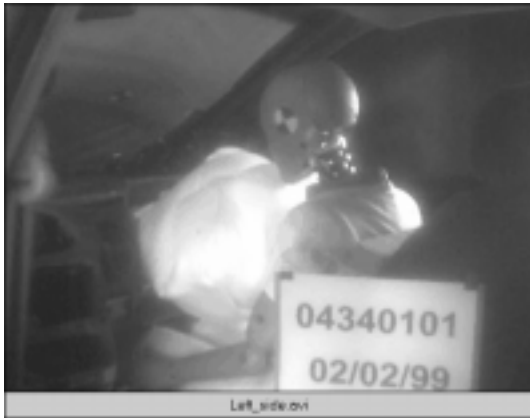
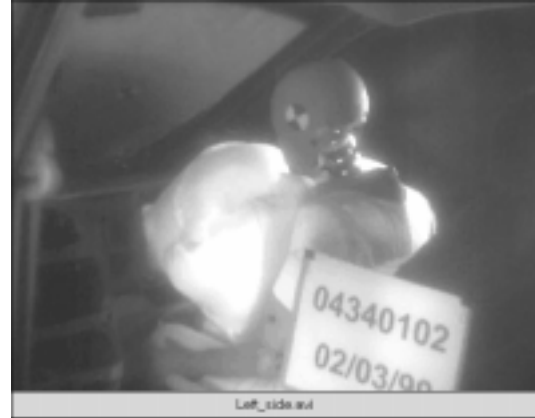
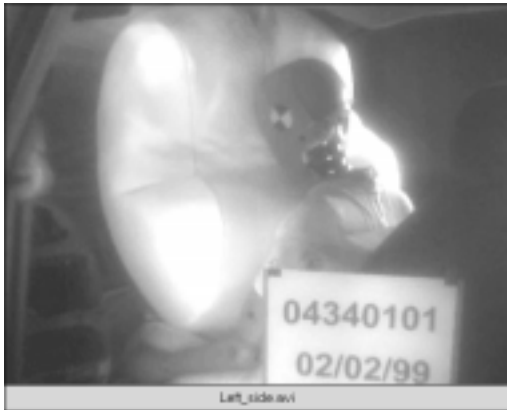
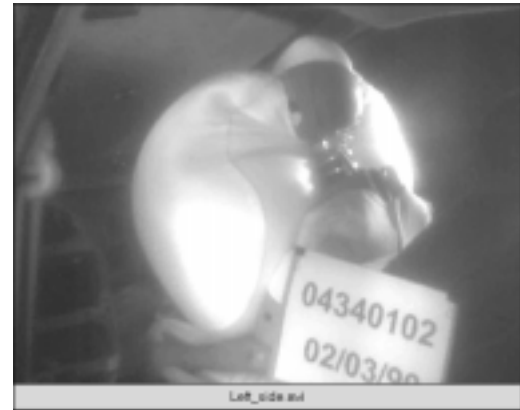
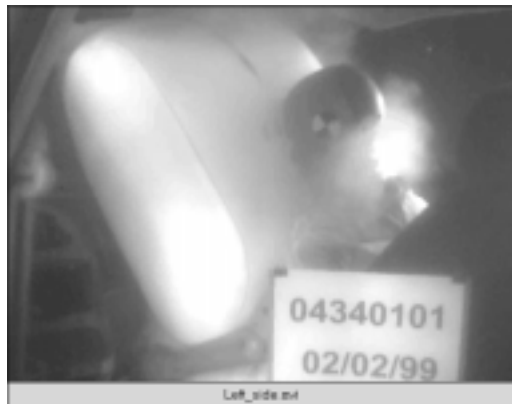
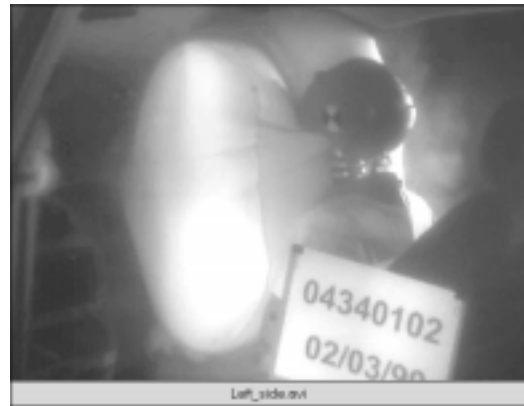
Fig. 8. Cushion Unfolding Differences

This result led to a thorough video review of tests #101 and #102. In this analysis, it was observed that variations in the unfolding and filling of the cushion could explain the difference between the results in these two tests. In test #101, the unfolding cushion first moves rearward in the vehicle and contacts the dummy just above the chin. As the bag continues to inflate upward, the cushion simply slides up along the face of the dummy and pushes rearward on the dummy's chin. In test #102, however, the cushion first contacts the dummy just below the chin. As the airbag tries to inflate upward this time, the chin is in its path and acts as a leverage point for the

airbag to force the head upward and backward, placing the neck into extreme extension. There are only a couple of inches difference in where the unfolding airbag contacts the dummy, but the end result is significantly different. (See Fig. 8.)

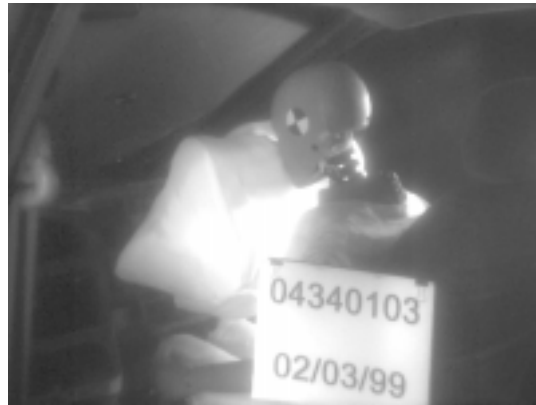
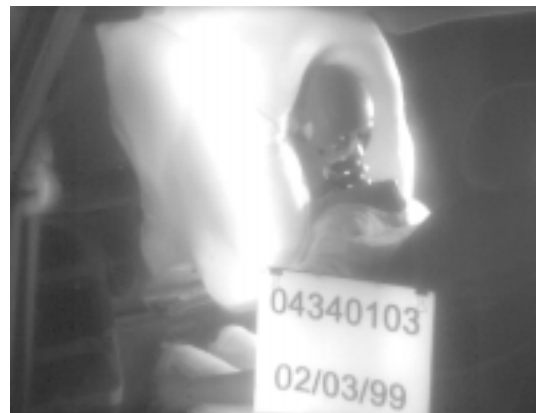
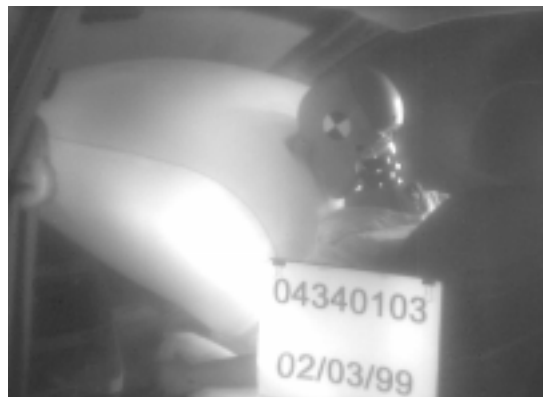
Fig. 9. Cushion Unfolding in Test # 04340103 (Replacement Airbag)

In this test, the replacement cushion was used to determine how its performance would compare to that of the original airbag. The dummy responses in this test confirm the result of the inflator tank test; that is, the replacement bag was much less aggressive. The cushion unfolding kinematics were significantly different as well. In this test, the cushion unfolded much higher resulting in a particularly benign contact with the dummy. (See Fig. 9)

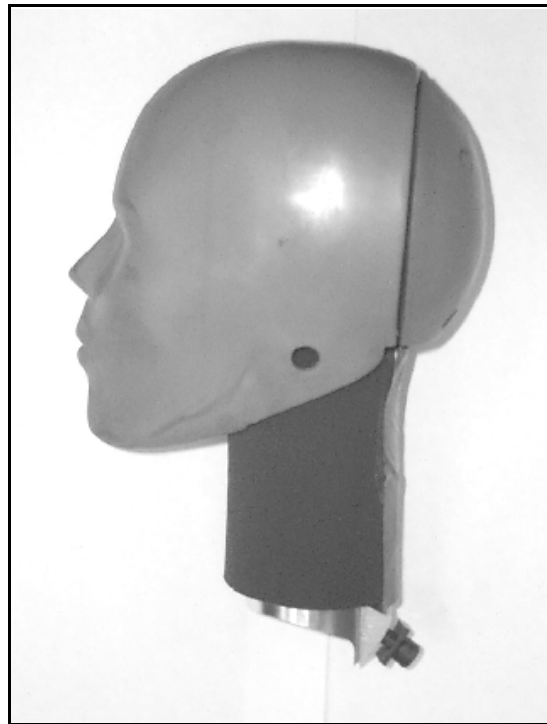
Fig. 10. TMJ Head Skin and SAE "Mouse Pad" Neck Wrap

This test was the same as test #101 and #102, except a neck wrap was added to the dummy. The neck wrap used was previously recommended for use by the SAE and it is also commonly referred to as the "mouse pad" neck wrap (see Fig. 10). The results of this test were similar to that observed in test #101 in that the airbag contacts the dummy's face above the chin, resulting in neck flexion. There were no ruptures in the airbag observed. Since the airbag did not get into the neck area, it was not known if the SAE neck wrap affected the previous high neck extension response.

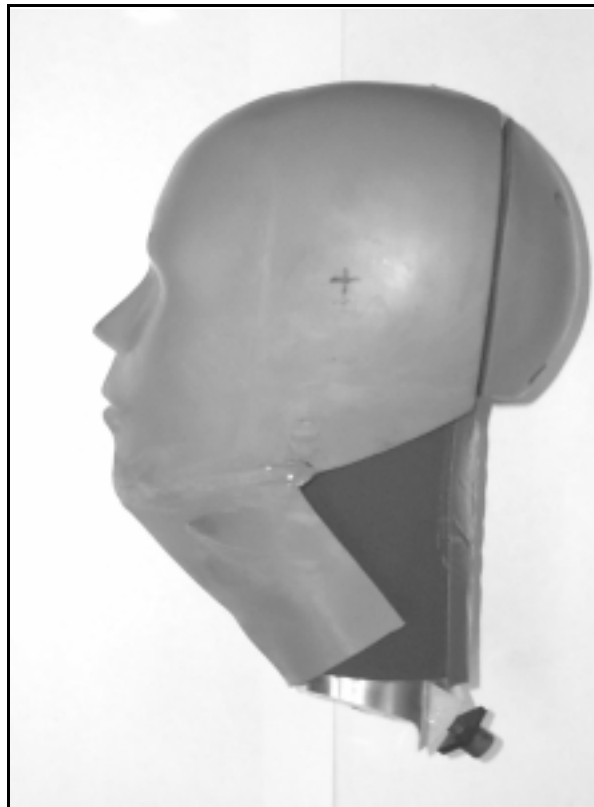
Figure 12. Contour neck skin concept.

For these tests, VRTC used a modified head skin which was referred to as the contour head skin. The skin was modified by attaching a flap of skin to the bottom of the jaw-line and tapering the skin down to meet the neck at the top of the dummy's torso (see Fig. 12). An Ethafoam 220 plug was placed behind the skin to fill in the air-gap between the neck and the skin extended from the chin (see Fig. 13). It was believed that the dummy with only a neck wrap represented small females with a slender neck, thus exposing more chin/jawline to airbag forces. The skin flap and Ethafoam plug therefore represented small females with larger neck sizes and less chin/jawline exposed to the airbag.
