U.S. Department
of Transportation

DOT HS 812 058

Driver Brake and Accelerator Controls and Pedal Misapplication Rates in North Carolina

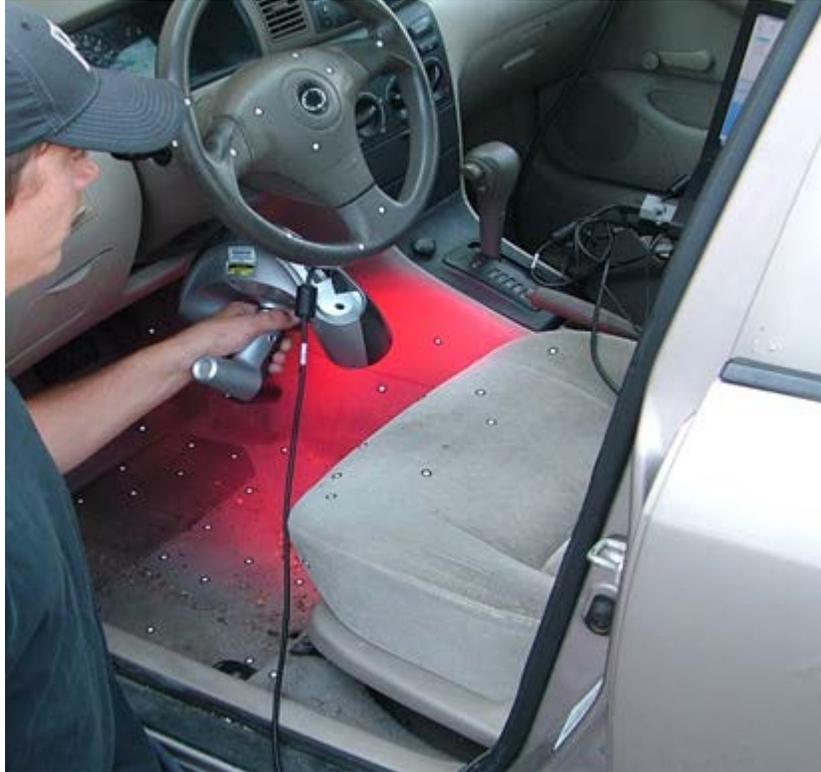
Figure 1 - Typical Scanning Session

The vehicle floor mats (if installed) were removed and reference targets placed arbitrarily around the driver's area. The driver's seat was positioned in the full rearward position. If the vehicle was equipped with a tilt steering column, it was set to the position closest to the center of the arc of travel. On vehicles equipped with adjustable pedals, both ends of the adjustment travel were scanned.

A hand-held 3D laser scanner was used to record the locations of the control pedals, driver's seat, and steering wheel. The scanner operates tethered to a computer, and the data gathered was stored in a standard stereo lithography (*.stl) file format. A typical session of data being recorded is shown in Figure 1. The operator would scan the vehicle surfaces until the computer rendering (Figure 2) showed that all required surfaces had been adequately covered. The accelerator pedal was scanned in three positions. The first was the static position, the second was the fully depressed wide open throttle position, and the third was a point of travel at the approximate center of the first two positions.

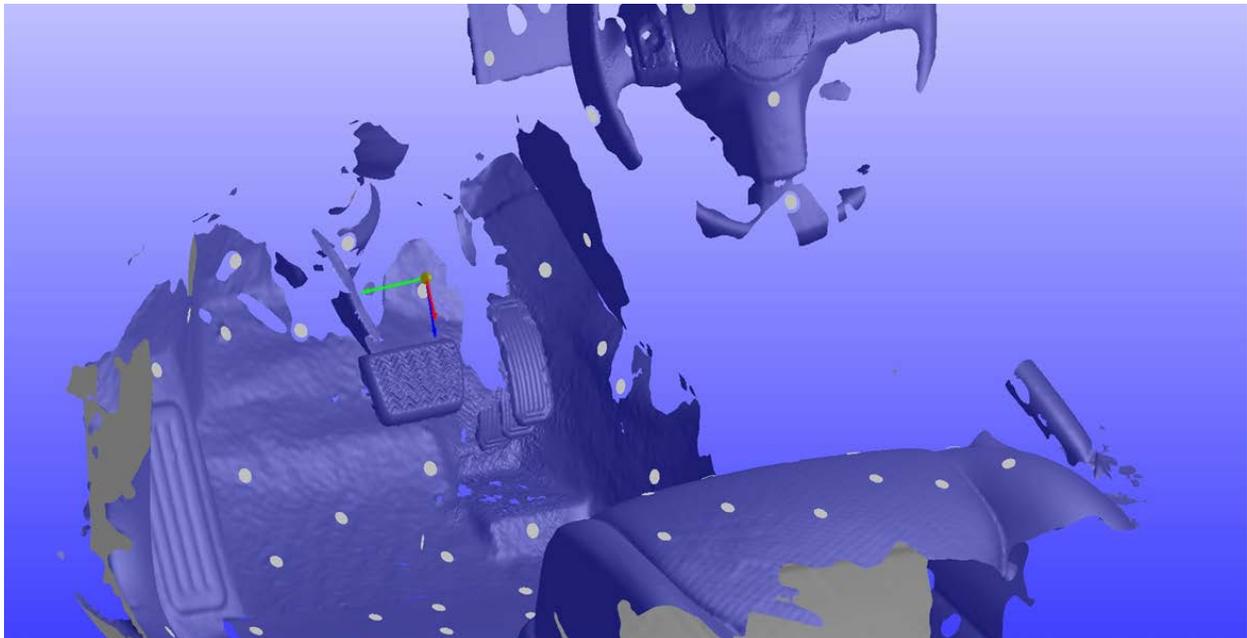
Figure 2 - Typical Screenshot of Computer Rendering

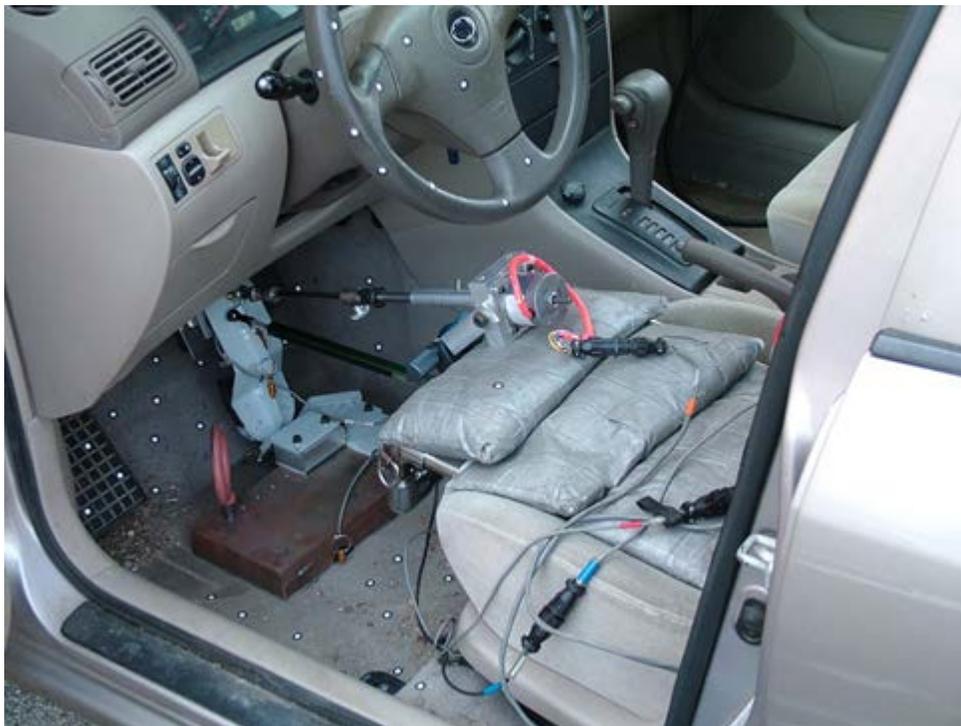
Figure 3 - Pedal Force and Displacement Measuring Device

Pedal force and displacement measurements were taken for both the accelerator and brake pedals. The measuring device shown in Figure 3 included a force transducer with a working range of 0-50 pounds force and a linear potentiometer with a working range of 0 to 8 inches. The device was installed and aligned with the accelerator pedal. The position of the linear actuator was advanced until the device came into positive contact with the pedal, which occurred with between 1 and 2 pounds of applied force. This location was set as the starting position in the motor's control software, and the output of both the force transducer and the linear potentiometer were set to zero. The linear actuator was advanced until the force applied reached 15 pounds force in order to meet or exceed the most resistant pedal. This position was set as the hold position in the control software. The linear actuator was returned to the start position.

The data collection system was started and the motor's control software was used to record the data from three complete cycles. The data collection system was stopped, and the device was repositioned to the brake pedal to repeat the process. When testing the brake pedal, the vehicle

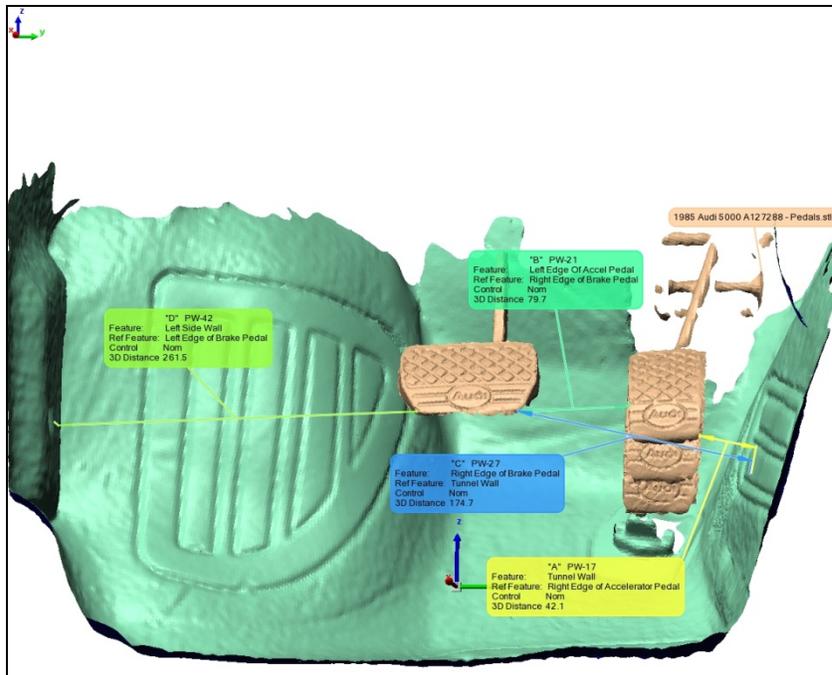
Figure 4- Typical View the 3D Rendering Used for Variables A, B, C, and D Showing the Accelerator Travel Path

The data acquired by the 3D laser scan of the vehicle’s driver controls was analyzed in a computer aided design (CAD) software program. The program allowed the 3D rendering of the vehicle to be rotated to the optimal viewing angle and measurements taken. A table of all measurement results can be found in Appendix C. NHTSA identified five views displaying the measurement results for each vehicle, and Figure 4 shows a typical image from the first view. A complete set of images for each vehicle can be found in Appendix D.

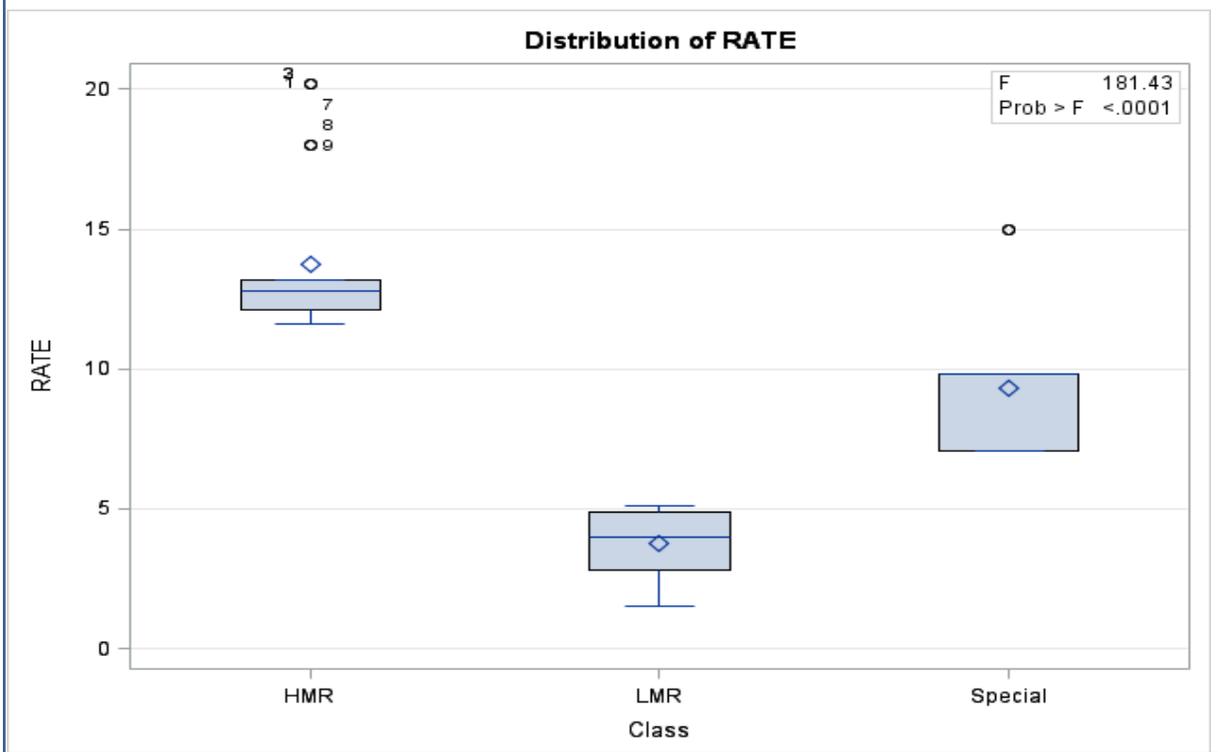
Figure 5 - ANOVA for Difference Between LMR, HMR and Special Interest Rates of Pedal Misapplication

As discussed previously, the LMR and HMR groups were selected as the vehicles with the lowest and highest rates of pedal misapplications per 100,000 vehicles. To verify that these vehicles represented distinct groups, the pedal misapplication rate (hereafter rate) for the groups, as well as the rates for the Special Interest group, were analyzed using the general linear model (GLM) procedure of the SAS statistical analysis software, to evaluate a one-way ANOVA at $\alpha=0.05$ using Scheffe's test for significance. This analysis was limited to only vehicle dimensions. The groups had significantly different rates as shown in Figure 5. All data is shown in Appendix F.

Group Comparison	Difference Between Means	Simultaneous 95% Confidence Limits		
HMR - LMR	10.0134	8.7018	11.3250	***
Special - HMR	-4.4345	-5.8577	-3.0114	***
Special - LMR	5.5788	4.1647	6.9929	***

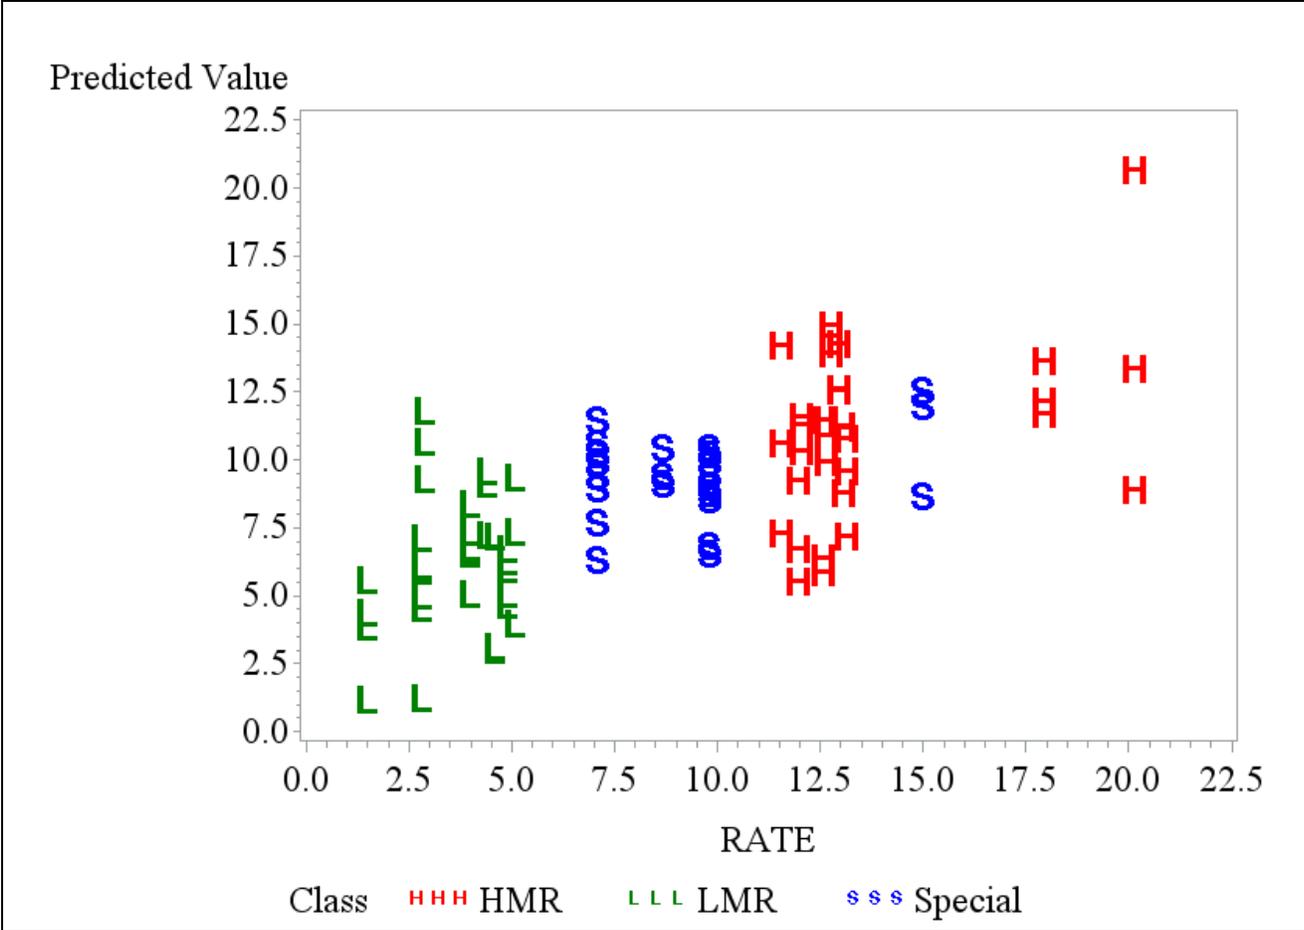
**Figure 6 - Predicted Value Versus Measured Rate of Pedal Misapplication for Vehicles:
L = LMR, S = Special Interest, H = HMR Groups**

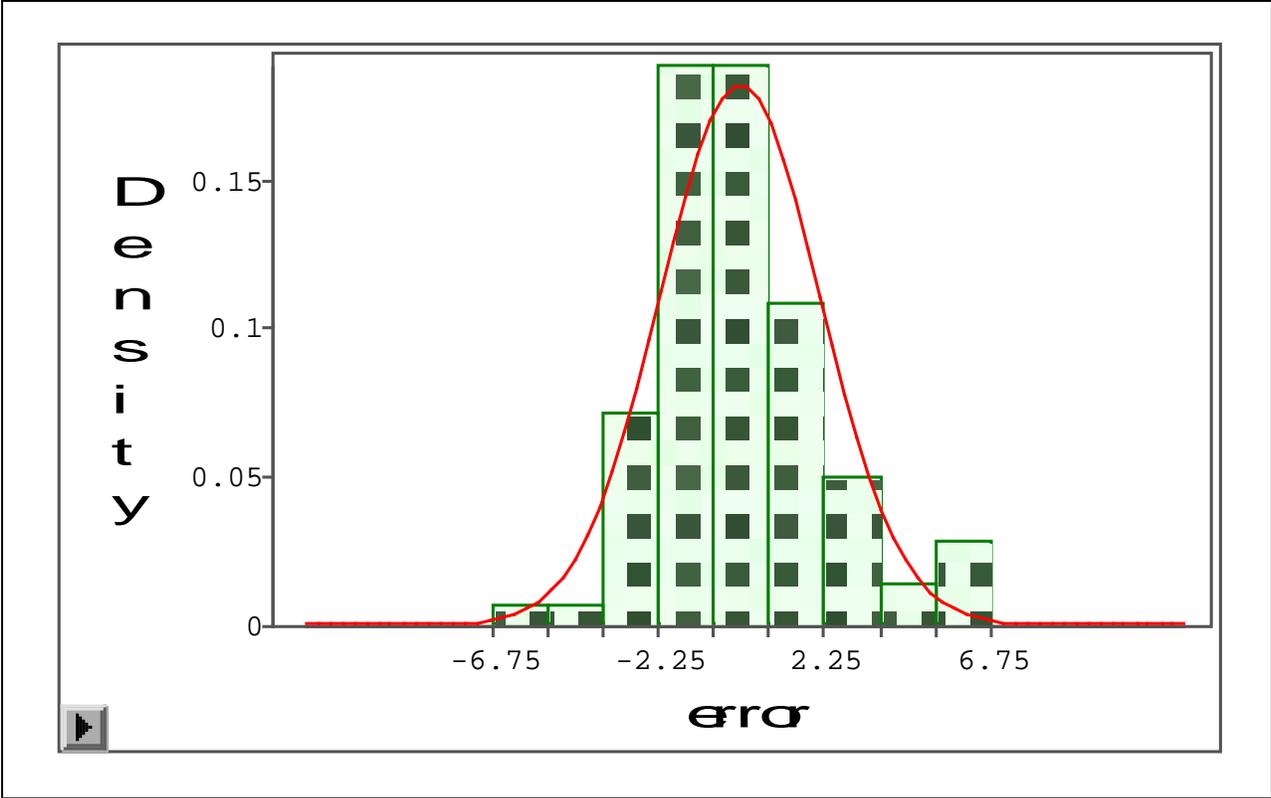
Figure 7 - Distribution of Error Term From Regression

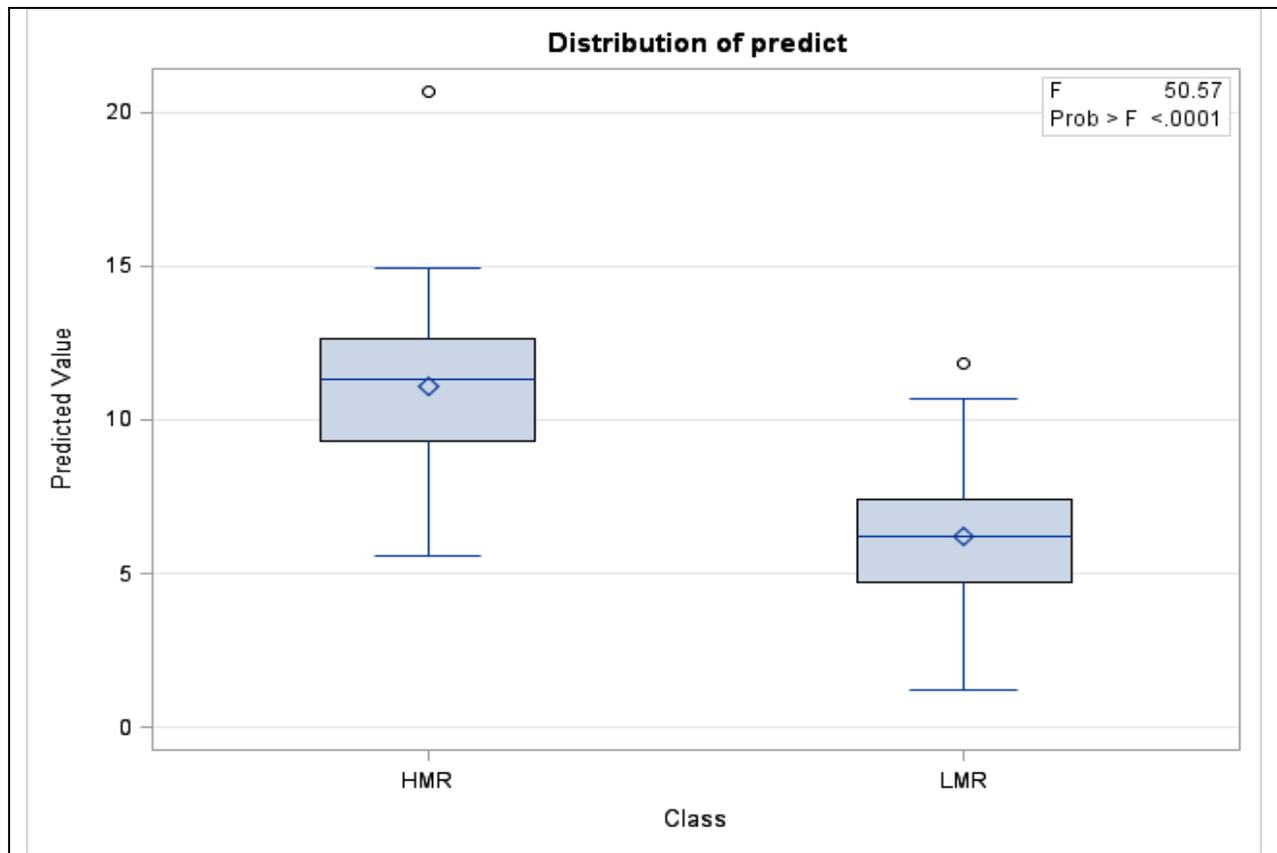
Figure 8 - ANOVA of Predicted Value for LMR and HMR Groups

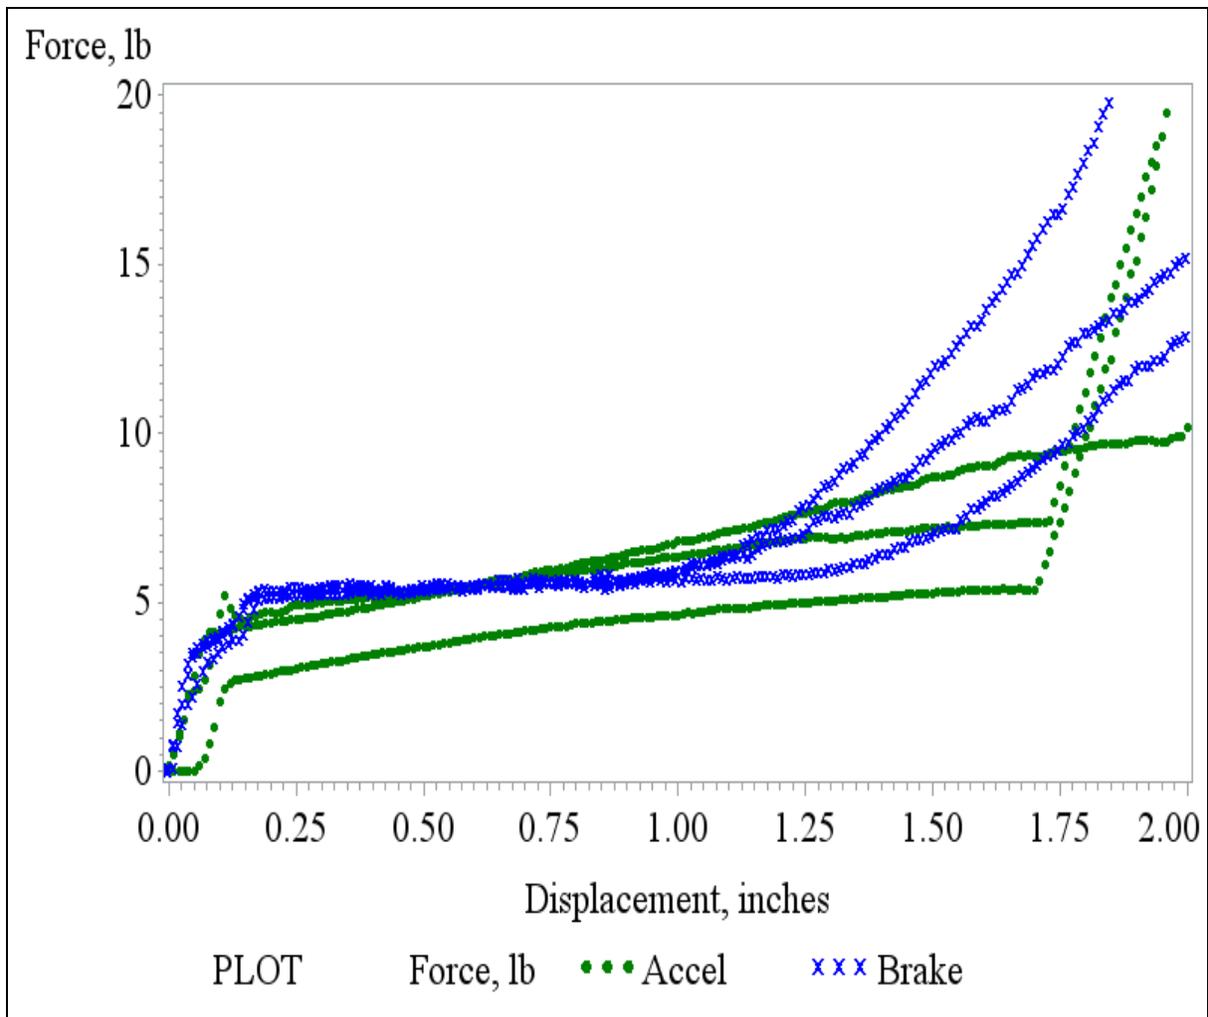
Figure 9. Force Versus Deflection Example for Vehicle With Similar Brake and Accelerator Responses

Researchers theorized that pedal misapplication might be exacerbated by pedals with similar “feel.” For example in Figure 8, the force versus deflection response of the brake and accelerator are similar while in Figure 10, the forces versus deflection responses are more distinct.

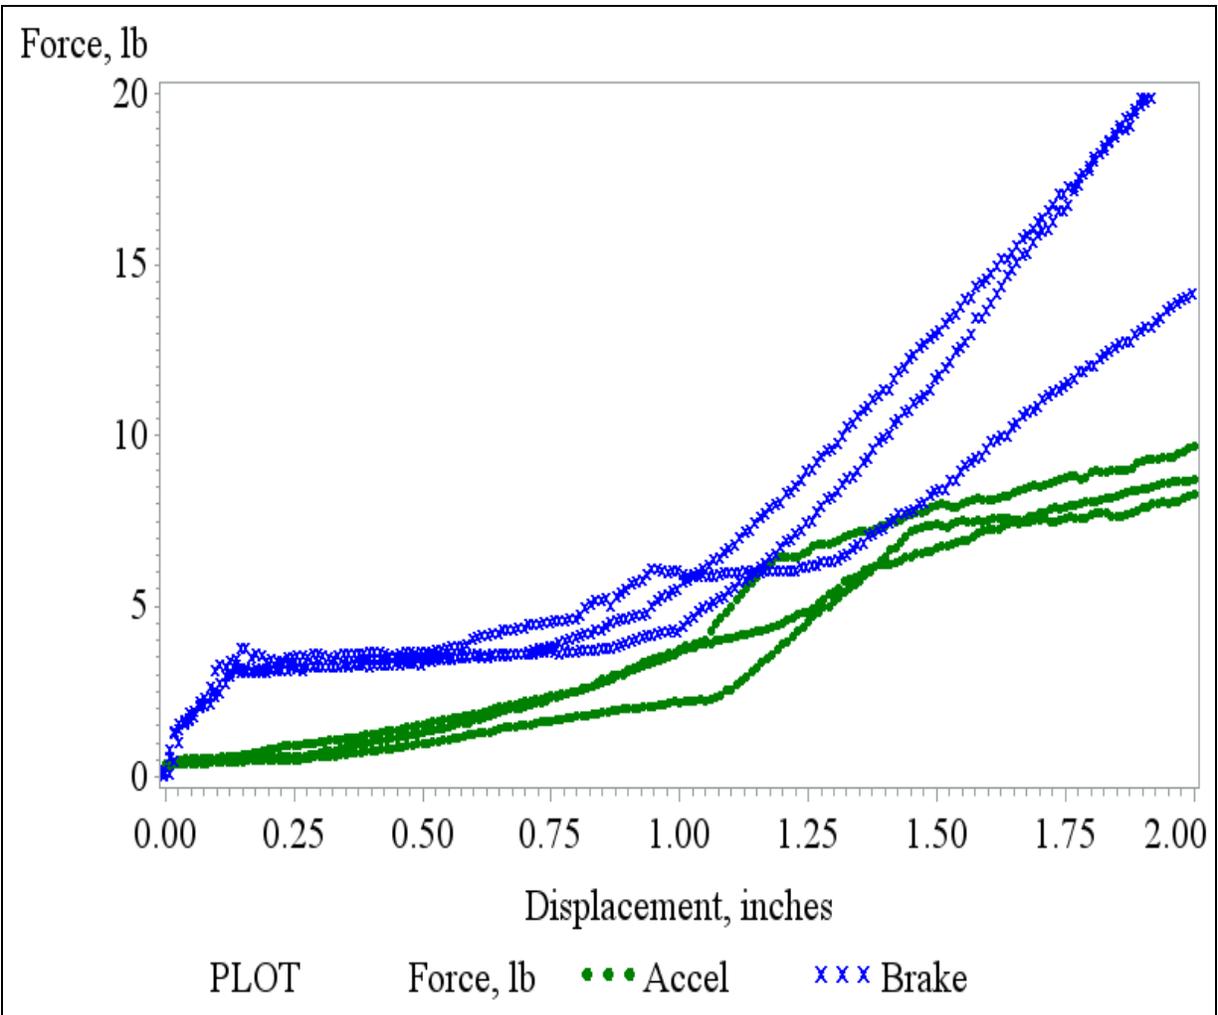
Figure 10. Force Versus Deflection Example for Vehicle With Different Brake and Accelerator Responses

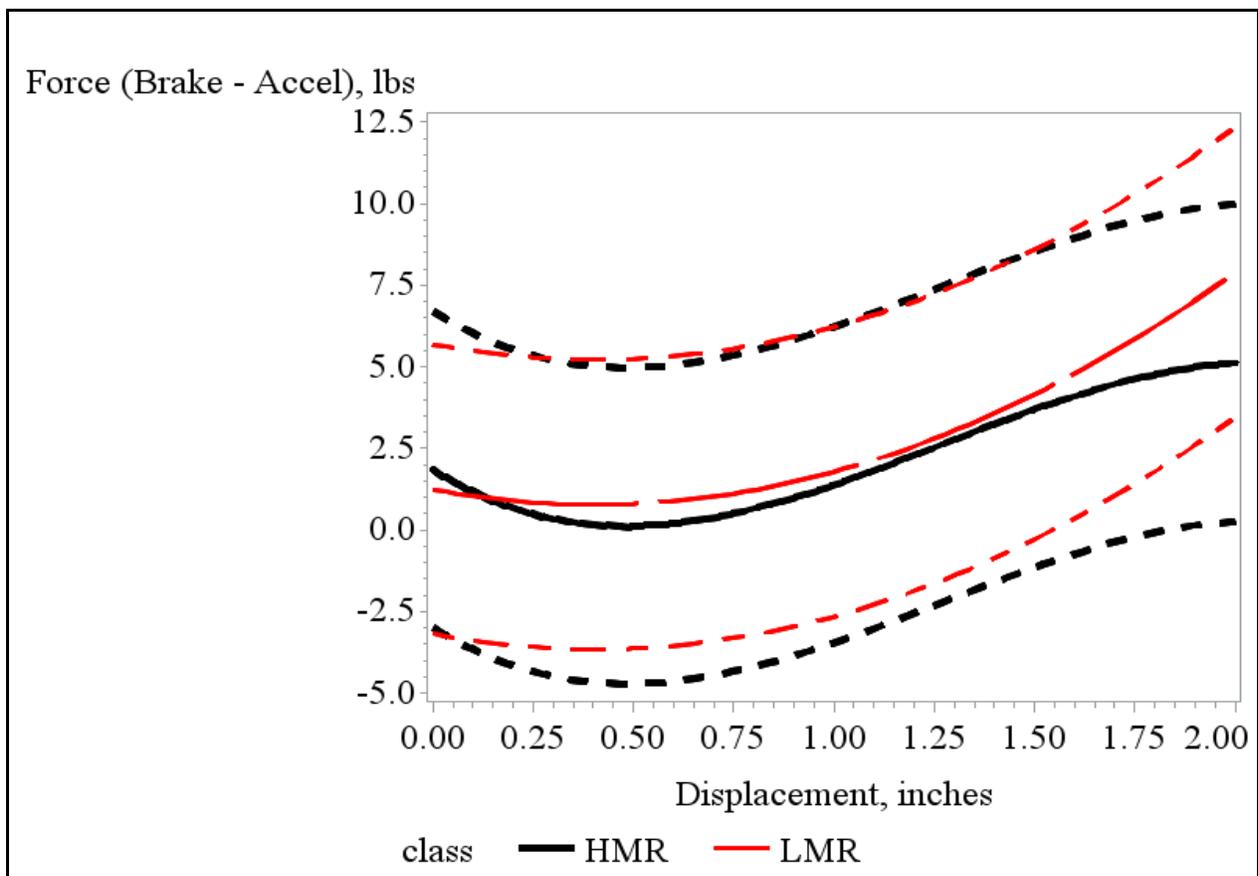
Figure 11 - 95 Percent Confidence Levels for Difference Between Brake-Force and Accelerator-Force Versus Deflection for LMR and HMR Groups, With 95 Percent Confidence Intervals

There were no significant differences between the LMR and HMR groups for any of the variables at $\alpha=0.05$. The 95 percent confidence levels of the difference between the brake and accelerator force at each 0.1 inch deflection for the HMR and LMR groups are shown in Figure 11 below. A complete set of Force Versus Displacement curves for each fundamental vehicle group is available in Appendix E. In summary, the data did not support the theory that pedal misapplication might be exacerbated by pedals with similar “feel.”

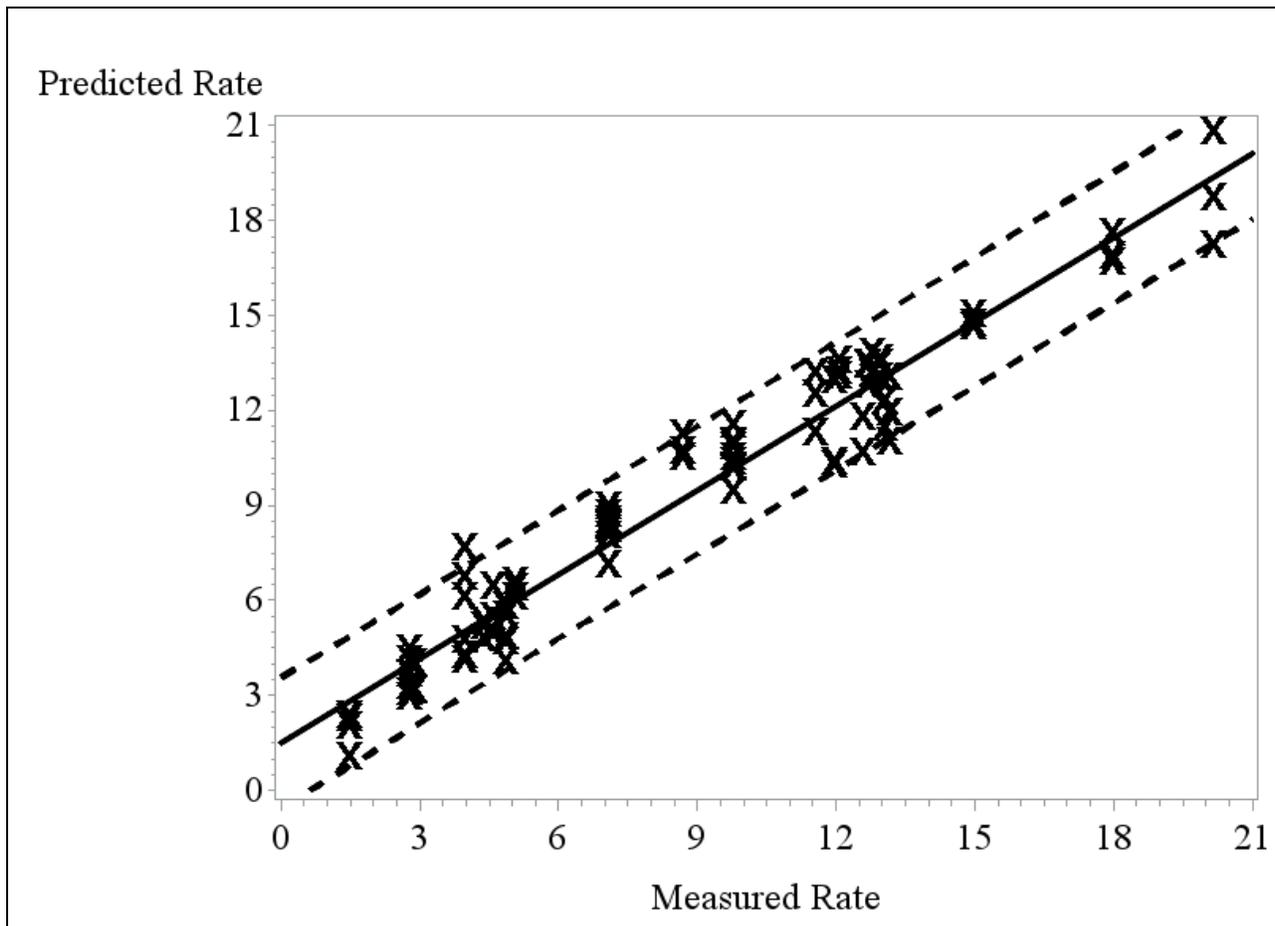
Figure 12 - Predicted Rate of Pedal Misapplication versus the Measured Rate, With 95 Percent Confidence Levels Shown

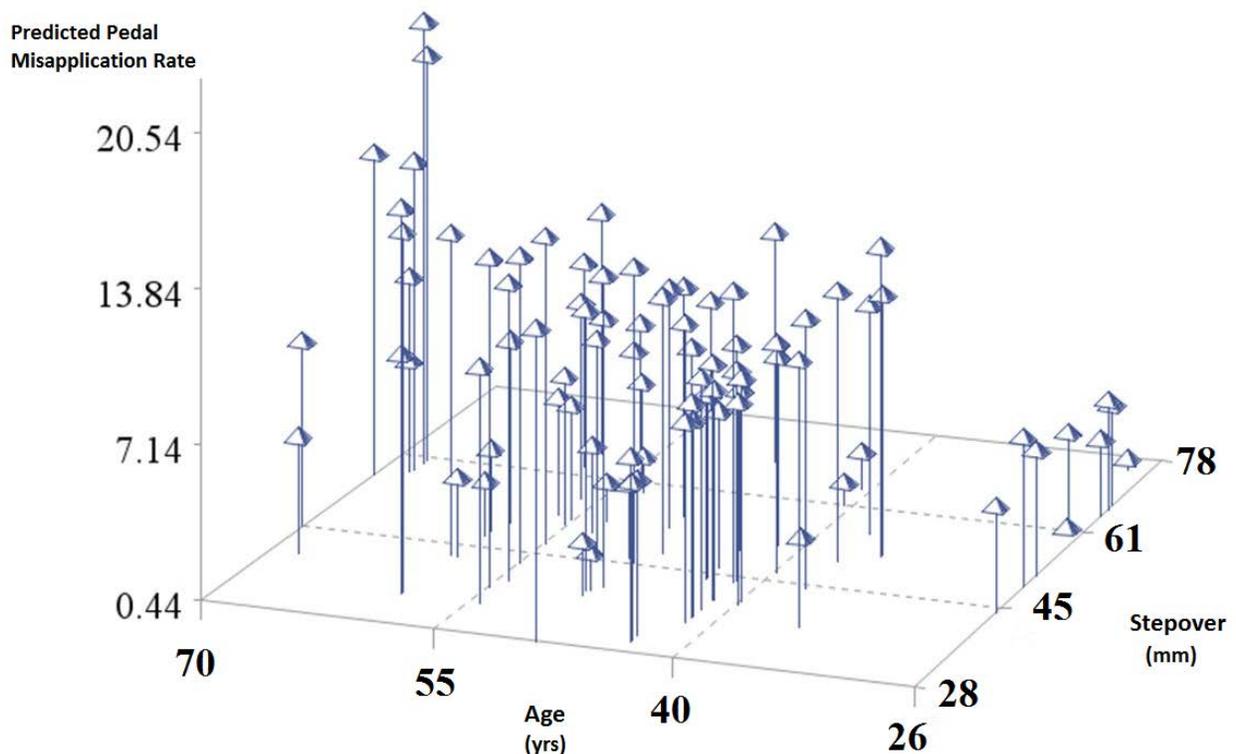
Figure 13 – Effects of the Interaction of Driver Age and Stepover. Predicted Rate Increases Significantly When Stepover is Very High for Older Drivers. Calculated From Stepwise Regression Model With Driver Characteristics and Measured Pedal Dimensions

Figure 13 shows the predicted values from the stepwise regression model versus driver age and stepover. The predicted rate increases significantly when stepover is high for older drivers.

In the first analysis, stepover ranked among the most correlated variables, though with a generally negative correlation. Once the driver characteristic of age is added, the correlation is shown to be positive for older drivers, though this does not suggest that low stepover is not a problem for drivers in general. Both effects are significant, with the highest predicted values of pedal misapplication for the greatest age and the largest stepover dimension for older drivers. The effects of driver height and pedal separation predicted from the model for driver heights greater than and less than 66 inches tall are shown in Figure 14. There is generally a higher rate for large pedal separation and taller drivers, whereas the rate is essentially constant for large pedal separation and shorter drivers. Figure 14 also contains 95% confidence bands (dashed lines) that quickly diverge, indicating the model would not make accurate rate predictions for small and excessively large separations.

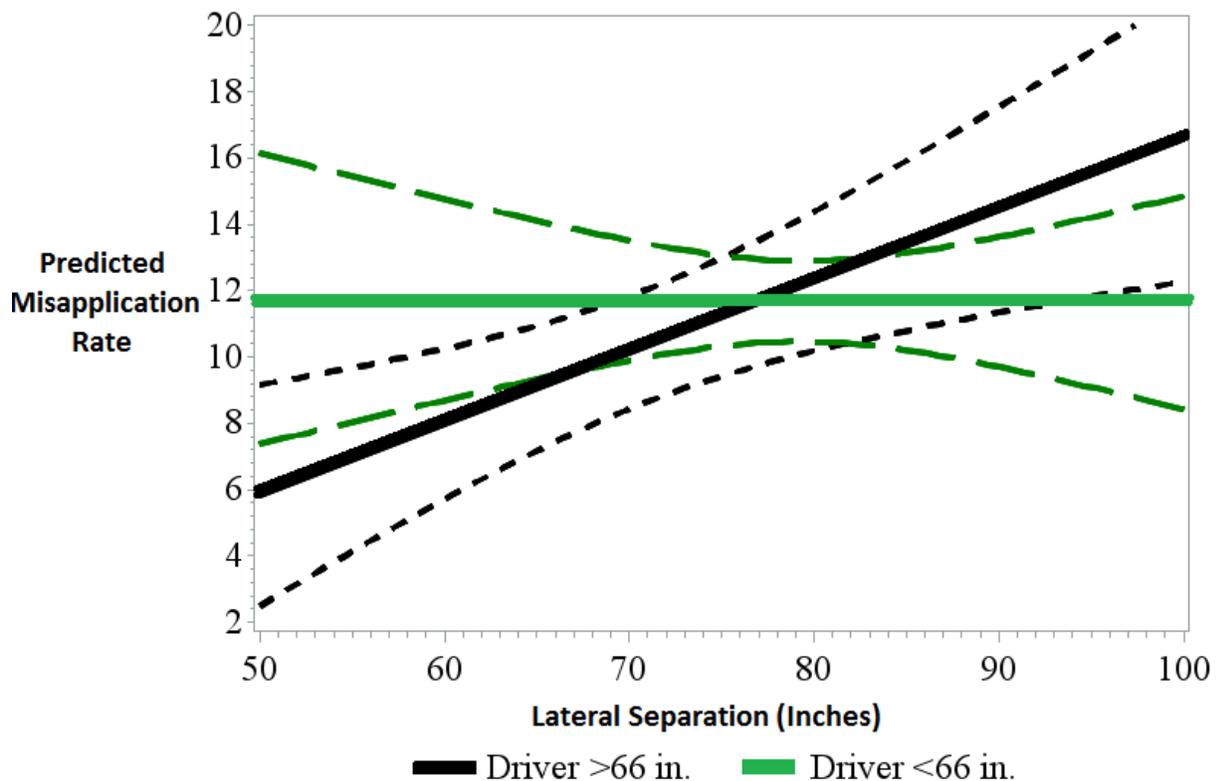
Figure 14 – Effects of the Interaction of Driver Height and Pedal Lateral Separation Shown with 95% Confidence Levels (Dashed Lines). Large Pedal Separation is Predicted to be Associated with Higher Rates of Pedal Misapplication for Taller Drivers Within a Narrow Working Range. Calculated From Stepwise Regression Model With Driver Characteristics and Measured Pedal Dimensions

The two most significant interaction terms are the interaction between the average driver age and the stepover height, and the interaction between the driver height and the separation between the brake and accelerator pedal.
