National Highway
Traffic Safety
Administration

DOT HS 808 080
Final Report

January 1994

A Study of Commercial Motor Vehicle Electronics-Based Rear and Side Object Detection Systems

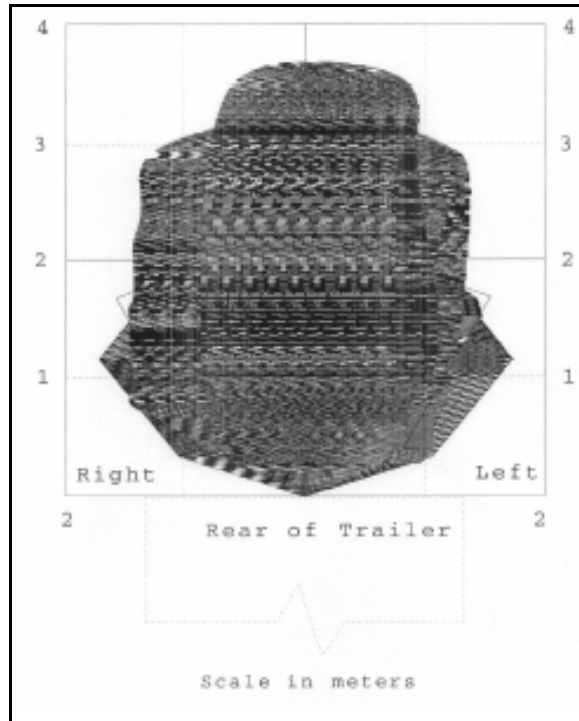
The shortest and longest detection zones measured for the cardboard target are shown in **Figure 1**. These zones cover most, but not all of the area immediately behind the trailer. The detection zone, however, did not extend beyond the sides of the trailer. The maximum rearward distance ranged from about 2.2 meters to 3.6 meters.

Figure 1 Shortest and Longest Detection Zones to Cardboard Target Covered by Rear Object Detection Systems

The results of the detection range measurements illustrate several aspects of device performance. The devices have a limited range of about 2 to 4 meters for detecting objects. The limited range helps prevent the devices from sounding an alarm at non critical objects far away from the backing vehicle. Because the range does not extend beyond the sides of the trailer, the devices will be less helpful to drivers in preventing backup crashes to objects that are moving into the path of the backing vehicle. The detection range varies from device to device and depends on the reflective characteristics of the object. Also, some devices were observed to exhibit day to day variability in detection performance. Because of this variability in object detection capability, drivers can not solely rely on device warnings to determine where objects are located. Thus, these devices supplement but do not substitute for the driver's need to be attentive when backing.

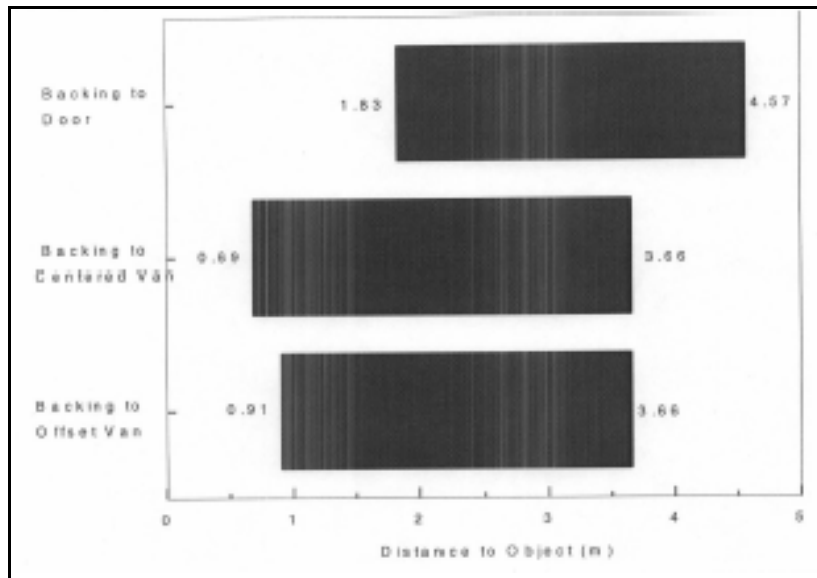
The range of distances at which the five different devices first detected the overhead garage door and van are shown in **Figure 2**. These distances are generally less than the cardboard detection distances.

Figure 2 The Range of Maximum Detection Distances to Three Different Objects Provided by Five Rear Object Detection Systems

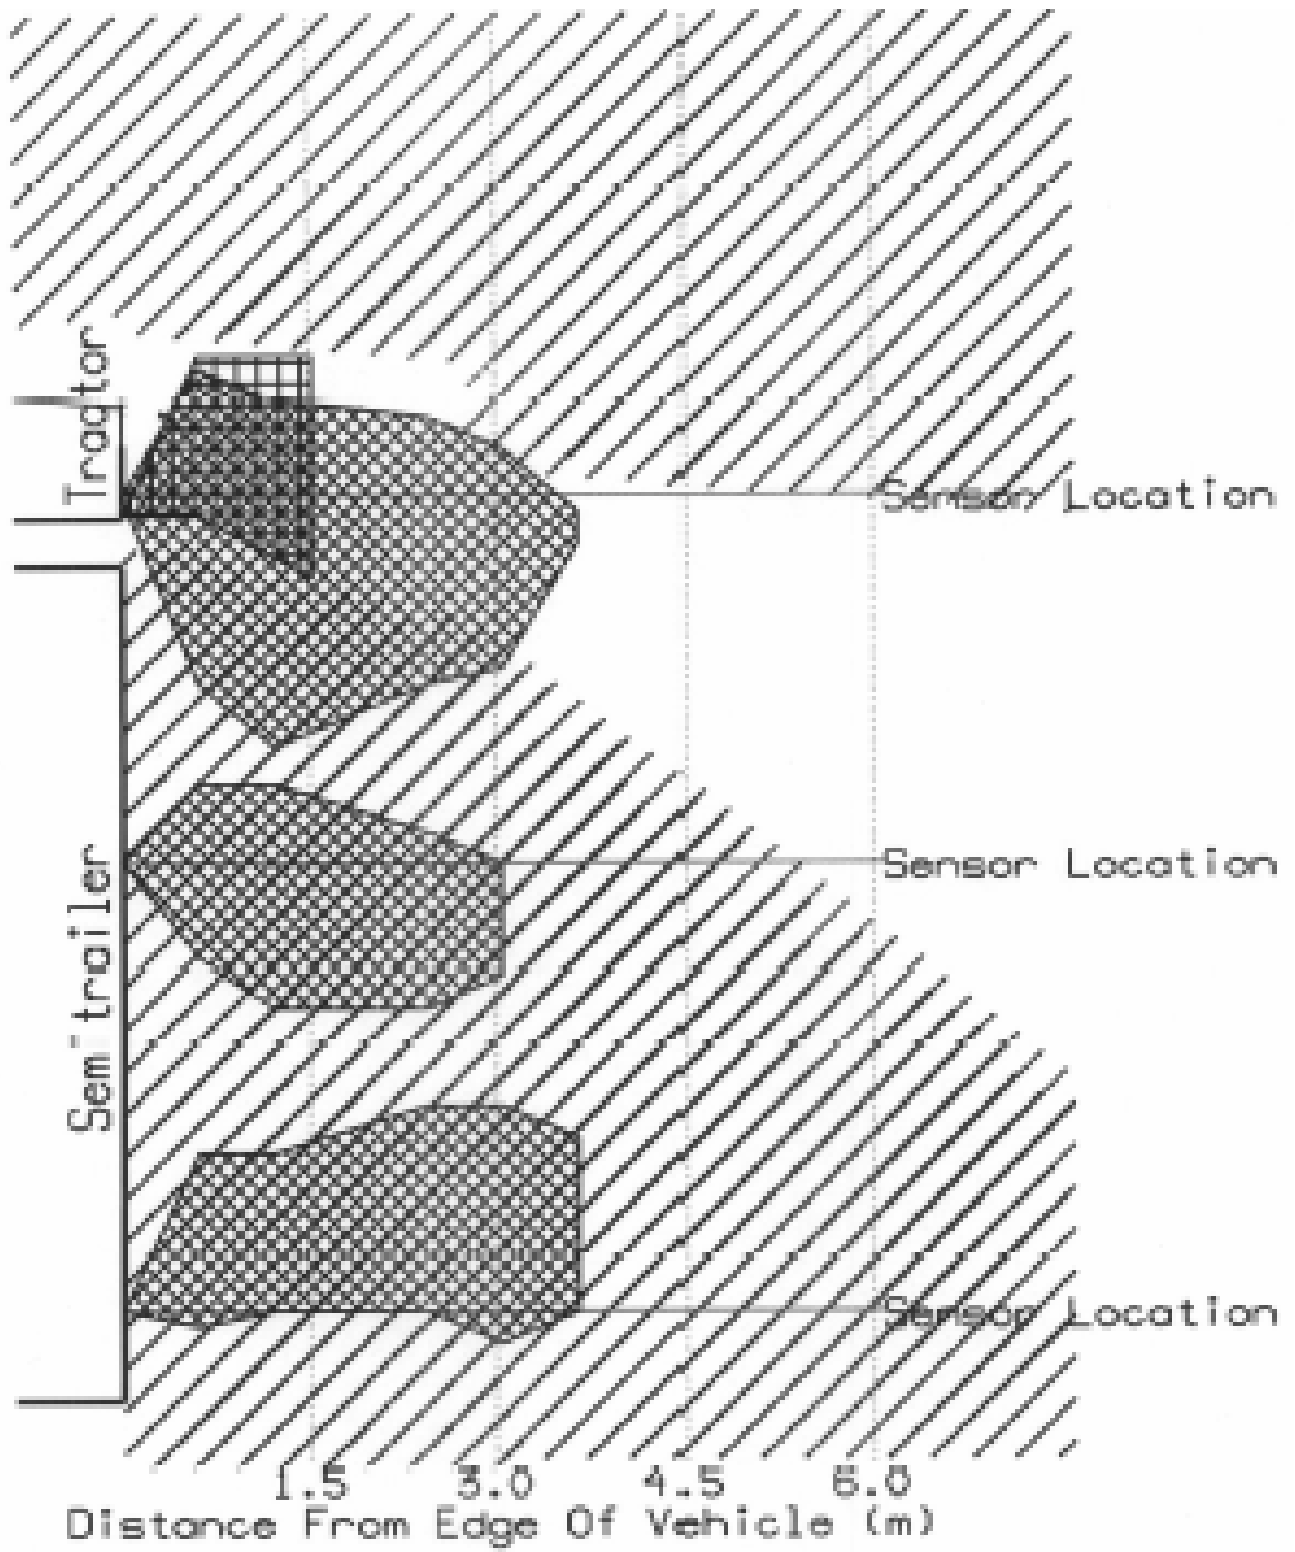
The passenger car detection zones for two right side object detection systems are shown in **Figure 3**. The figure is a schematic depiction of the right half of a tractor-semitrailer. The sparse, diagonal hatching in this figure shows the area over which a driver can detect an object with a height of 1.180 meters using either the right-side mirror system (consisting of a plane mirror and a 373-millimeter radius of curvature shallow convex mirror) or direct observation through the windows of the tractor cab. (The height of 1.180 meters corresponds to the height of the roof of a small car.) The area that is not covered by this sparse hatching is the area that is not visible either directly or indirectly, i.e., the so-called "blind spot."

The dense hatching shows the detection fields of each of the sensors of two, right-side object detection systems. The square hatching is an ultrasonic system; the diagonal hatching is a radar system. The fields were determined by locating the midpoint of a very slowly moving car when the vehicle was first detected by each sensor and when the sensor stopped detecting the vehicle. Note that the ultrasonic system uses only one sensor to detect adjacent vehicles while the radar system has three.

Figure 3 Detection Zones of Two, Right-Side Object Detection Systems and Driver View From the Tractor Cab

This figure shows that the coverage can overlap the existing area visible to drivers as well as the "blind spot" to the immediate right of the tractor.
