Ford Inova Fairfax Hospital
CIREN Team

A Case Study in Offset Frontal Collision

Vehicle #1: 1998 Chevy Lumina 4door

Vehicle #2: 1999 Honda Civic 2door

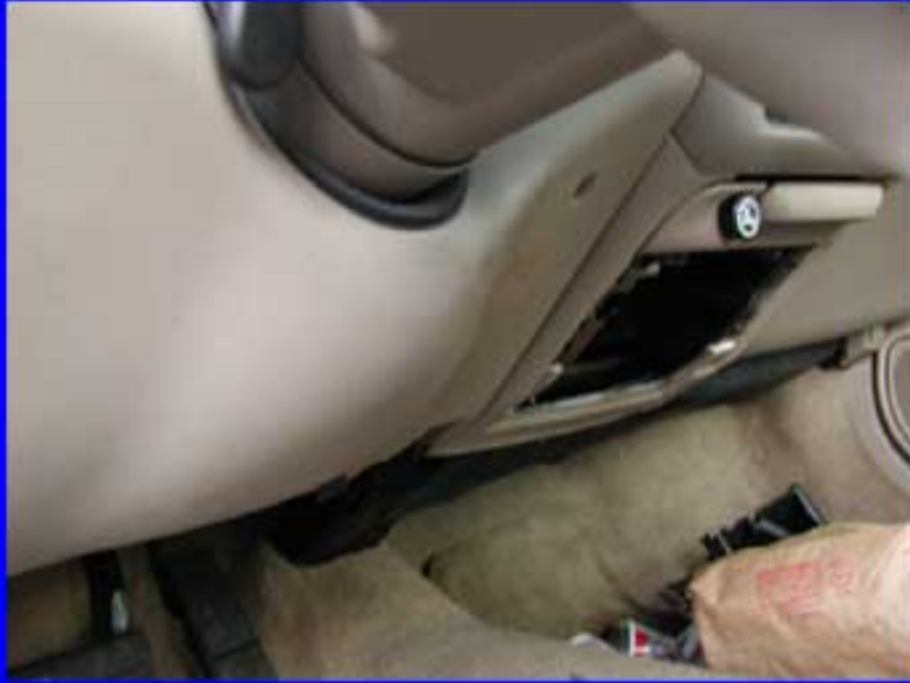
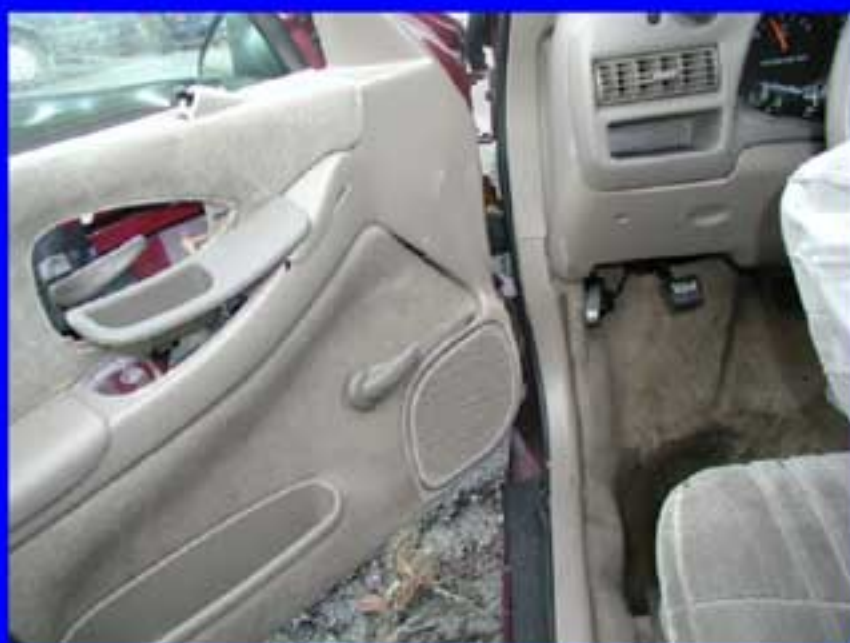
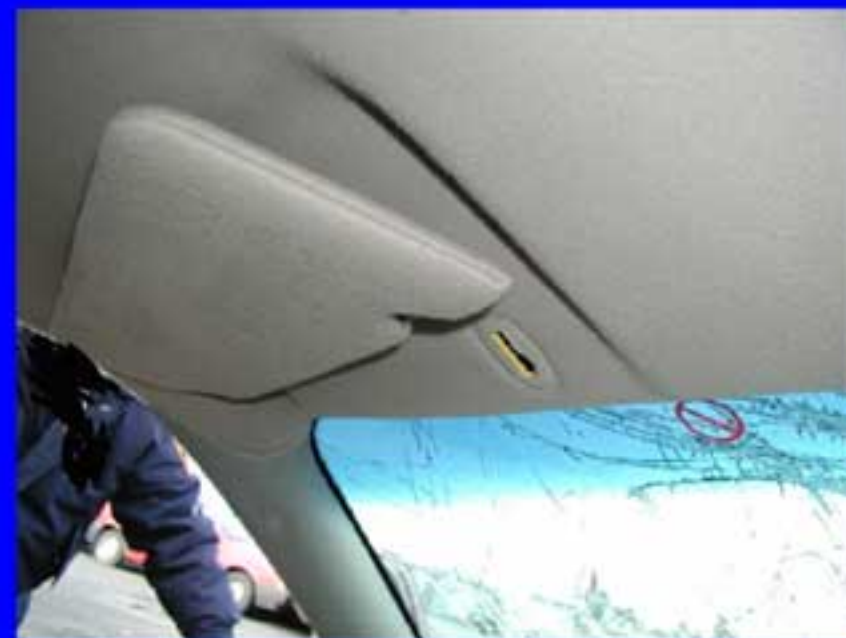
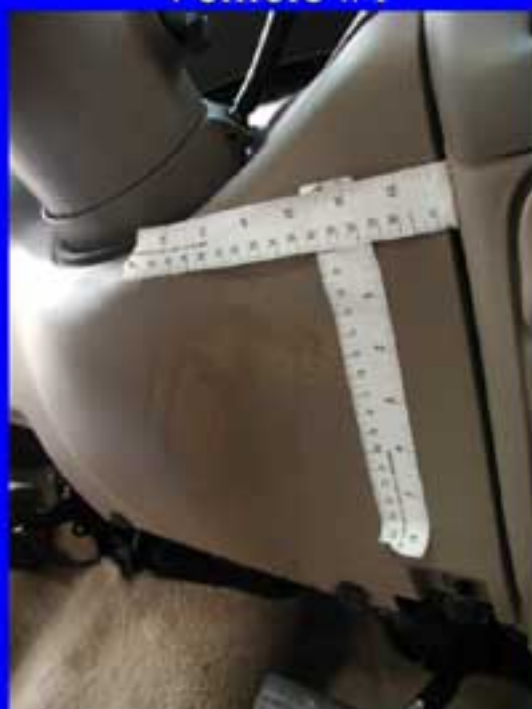
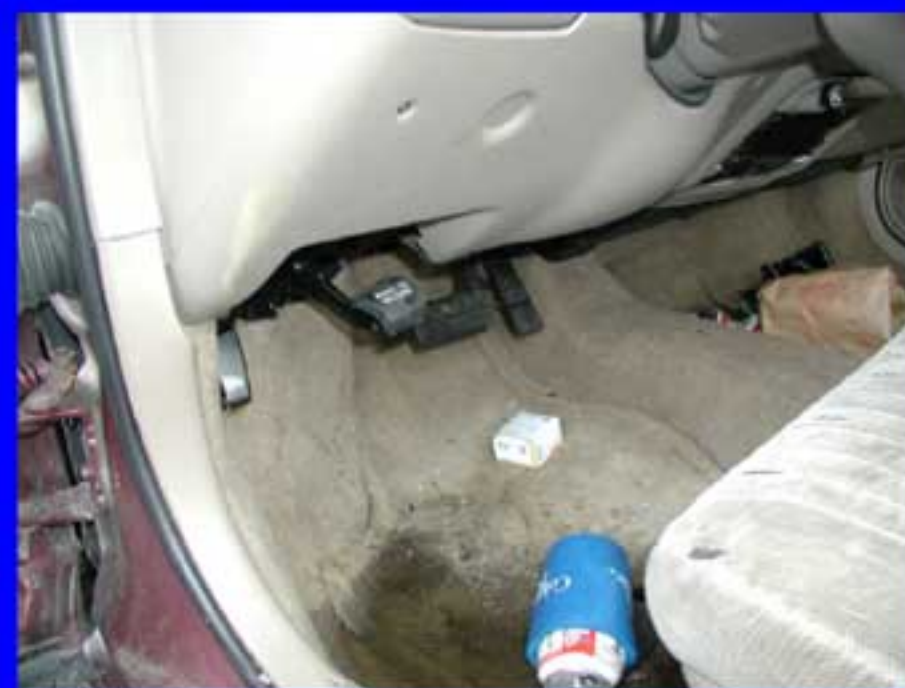
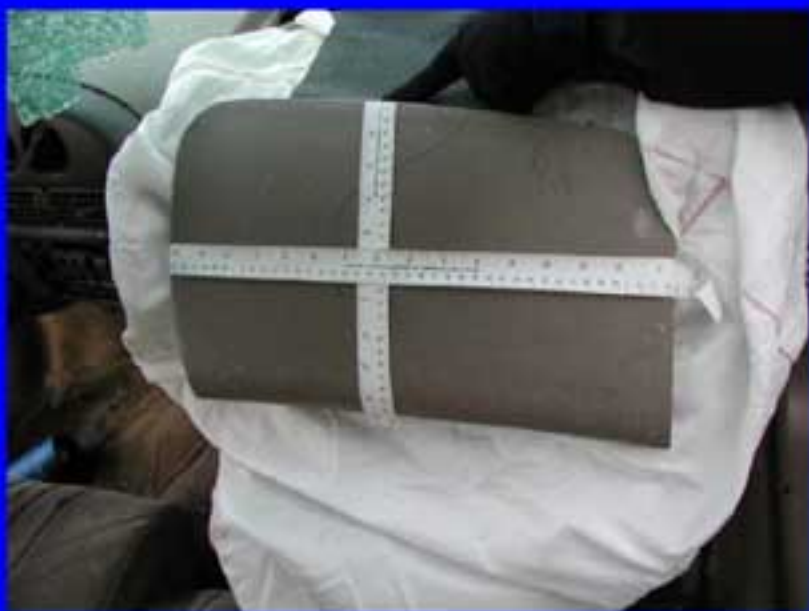
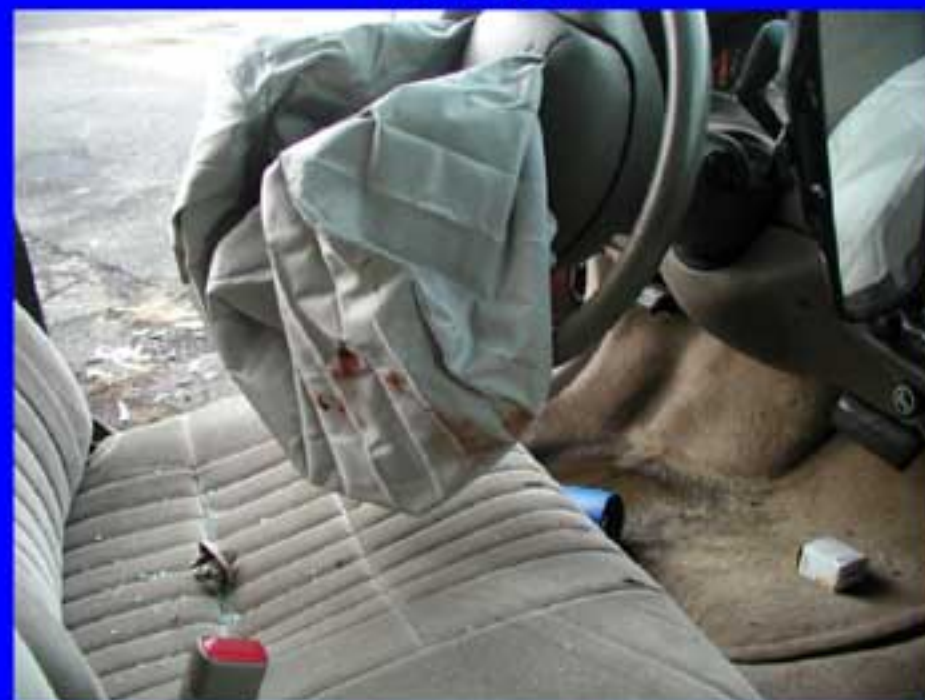
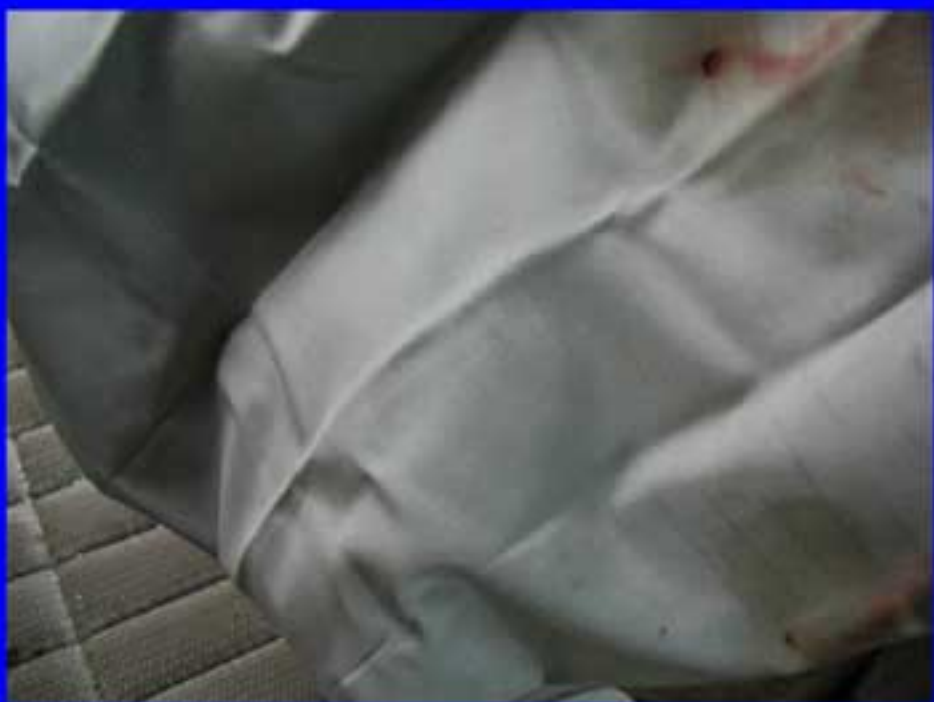
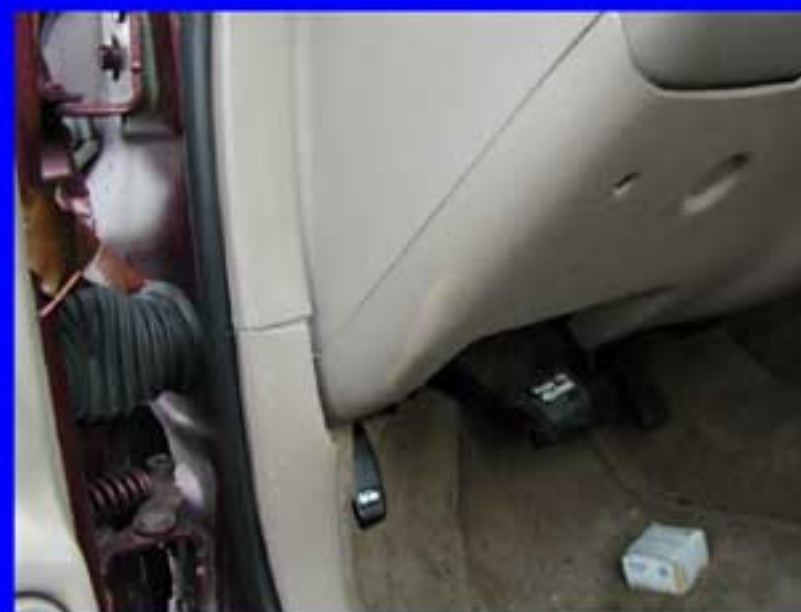
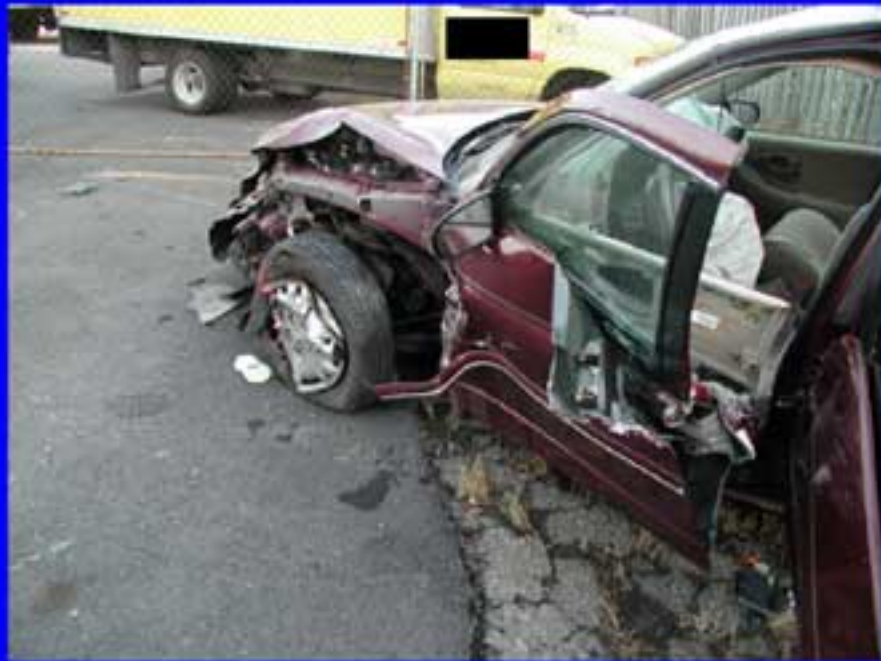
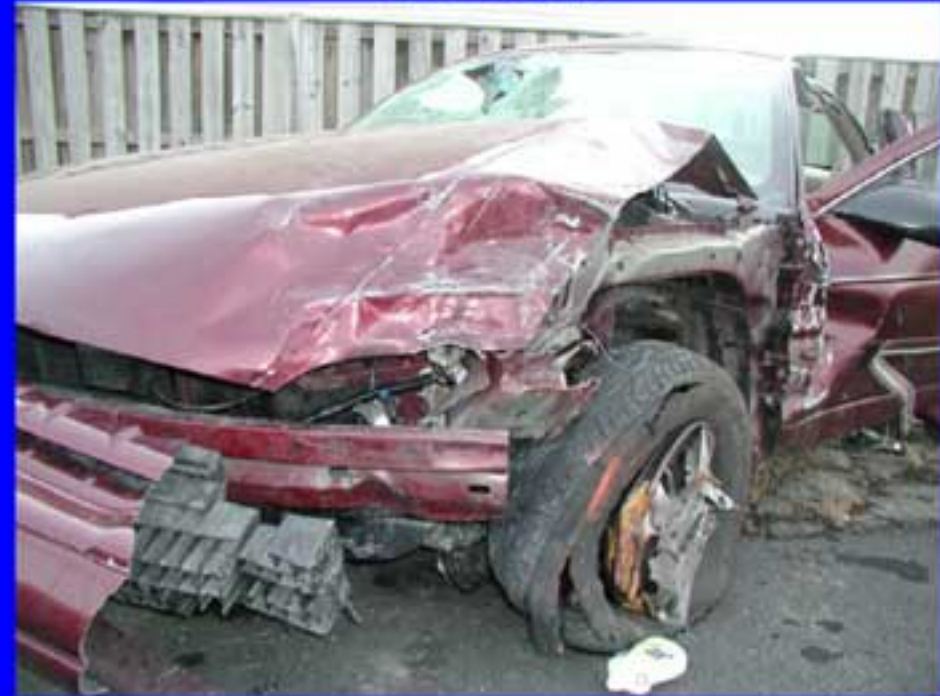
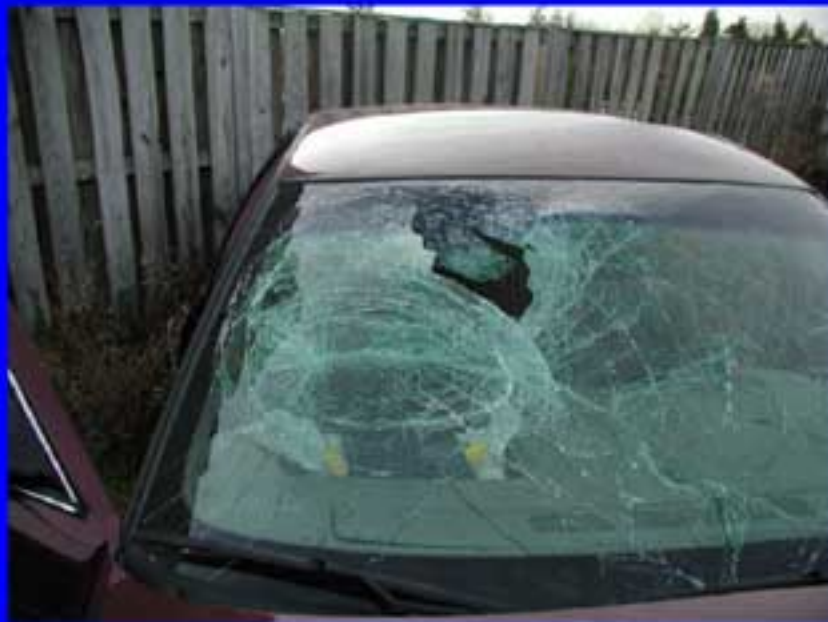
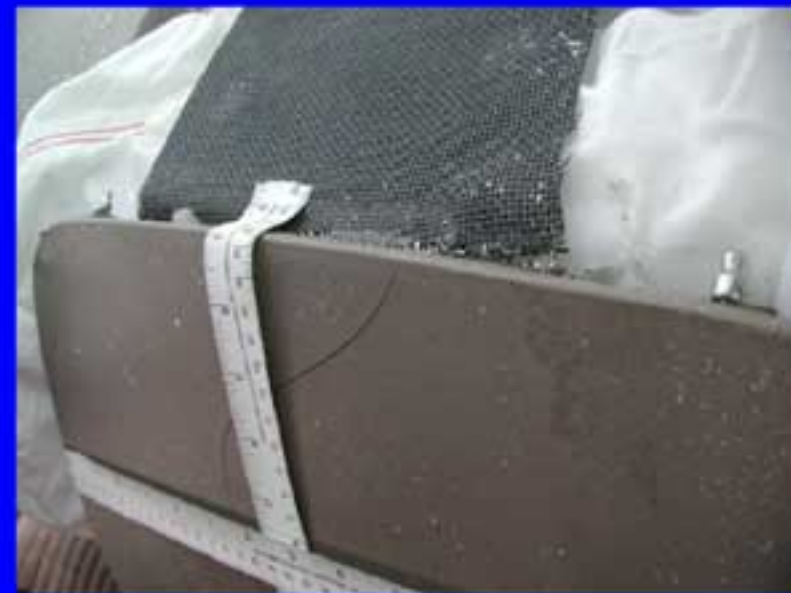
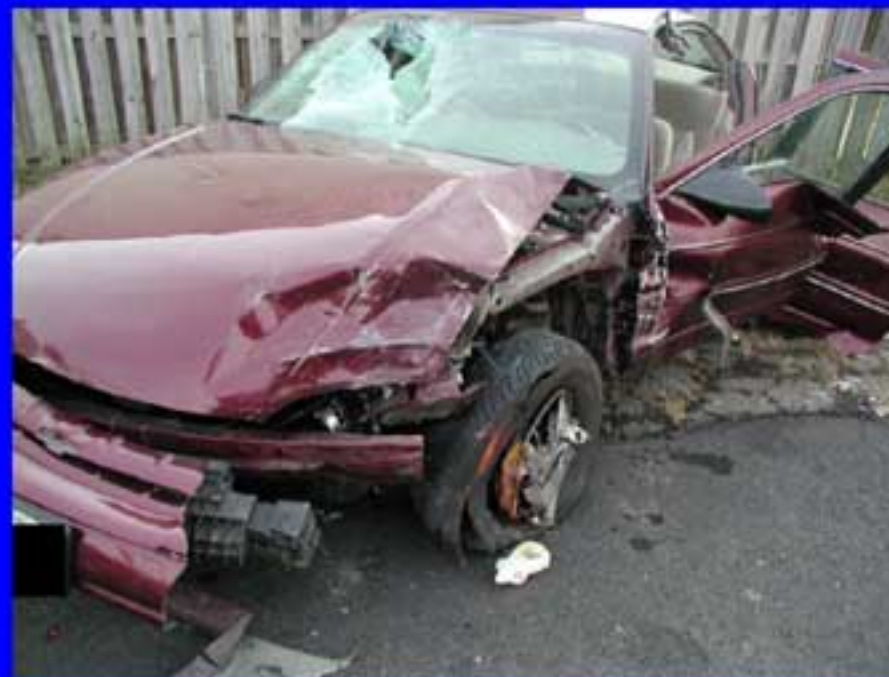
Weight: 3,330 lbs.
PDOF: 345
? V: 23.3
CDC: 11FYEW2
Max Crush: 46cm @ C6

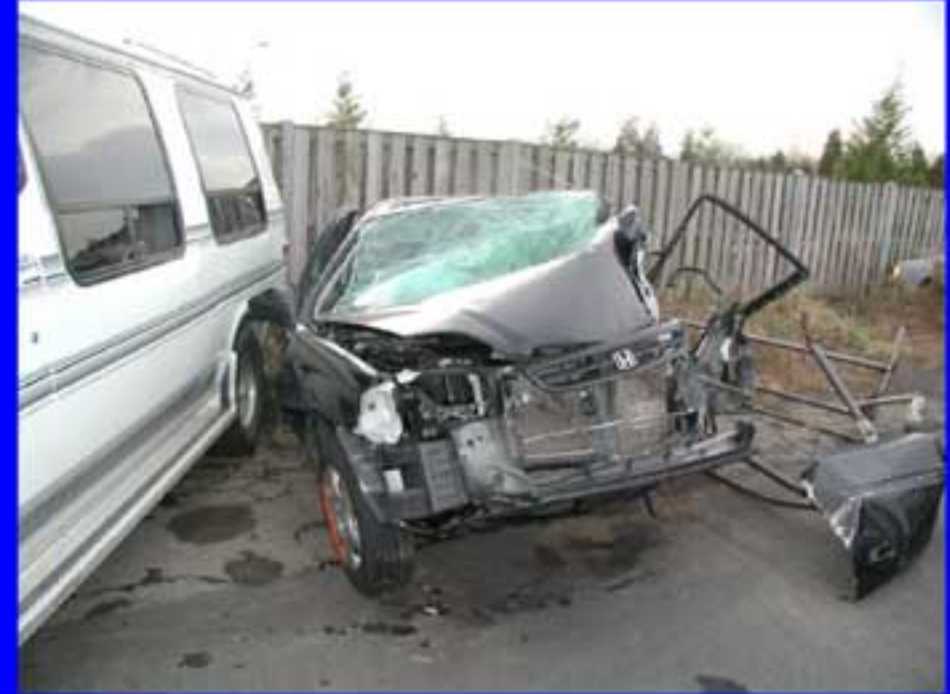
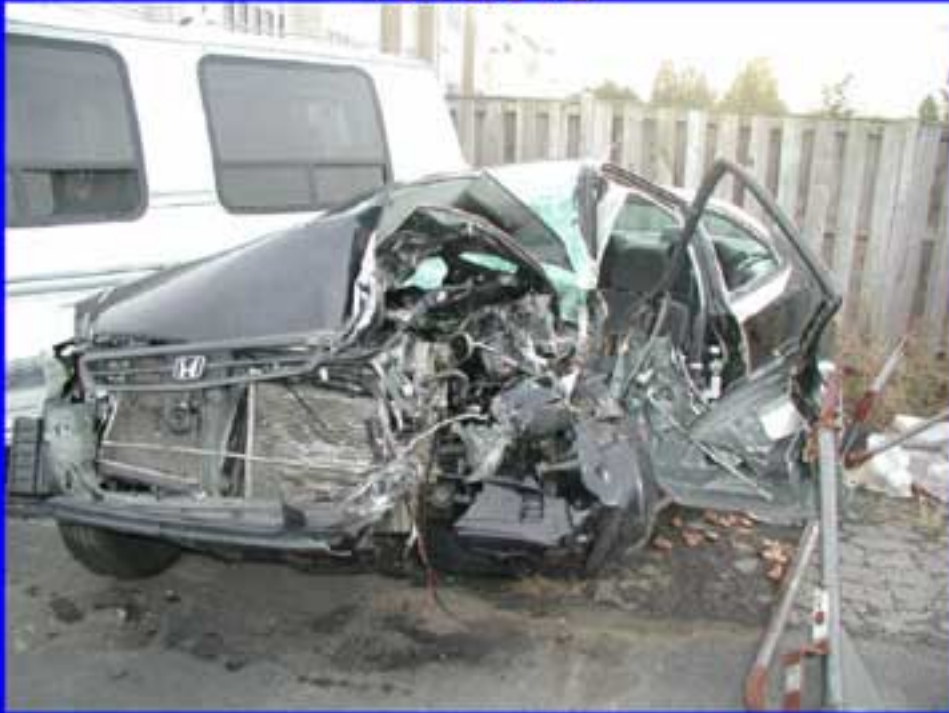
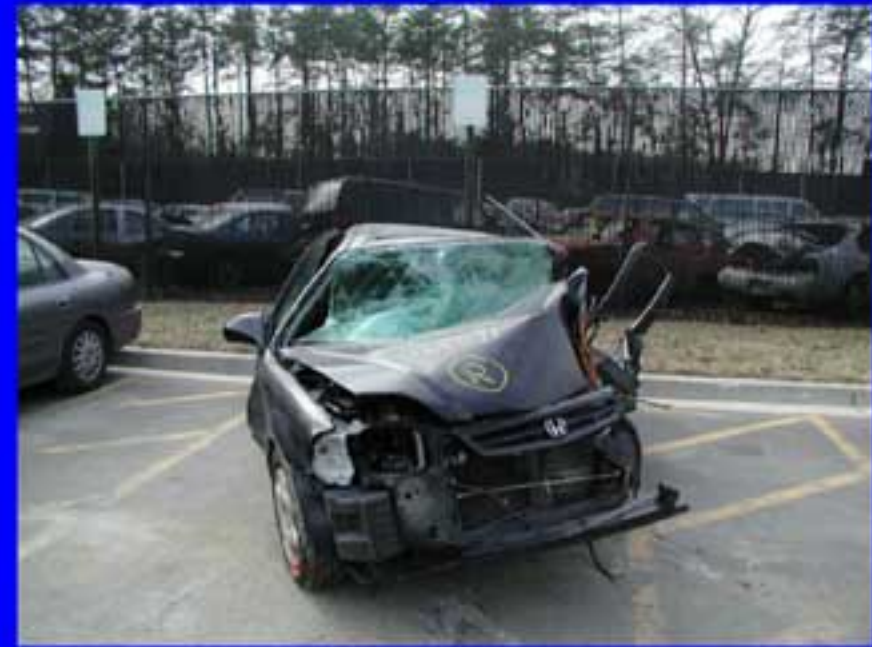
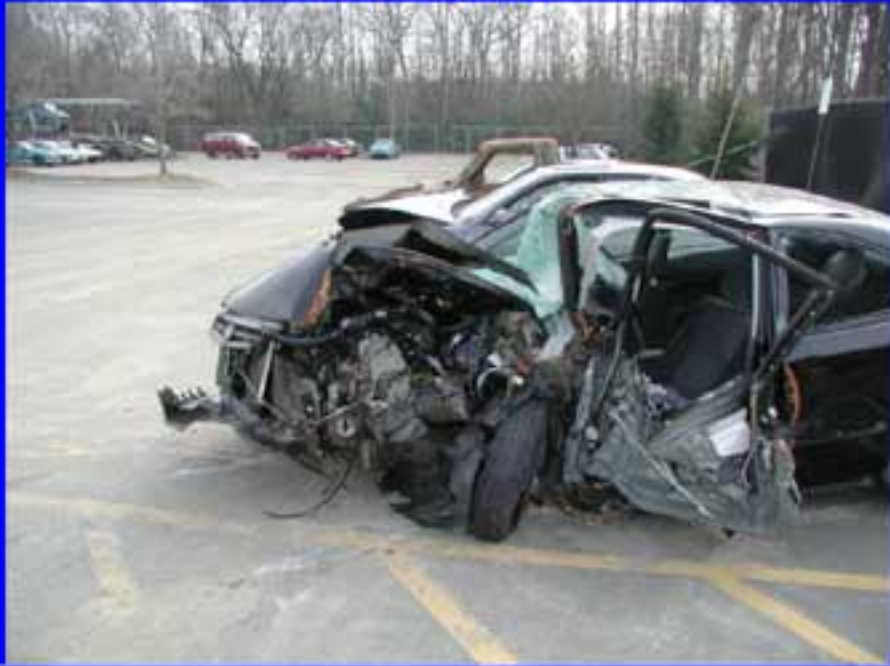
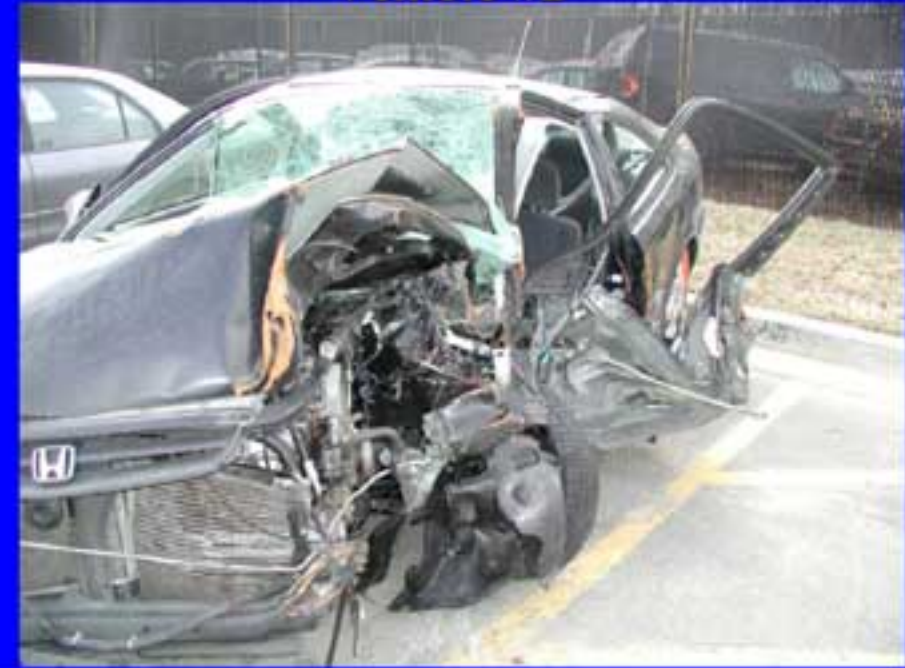
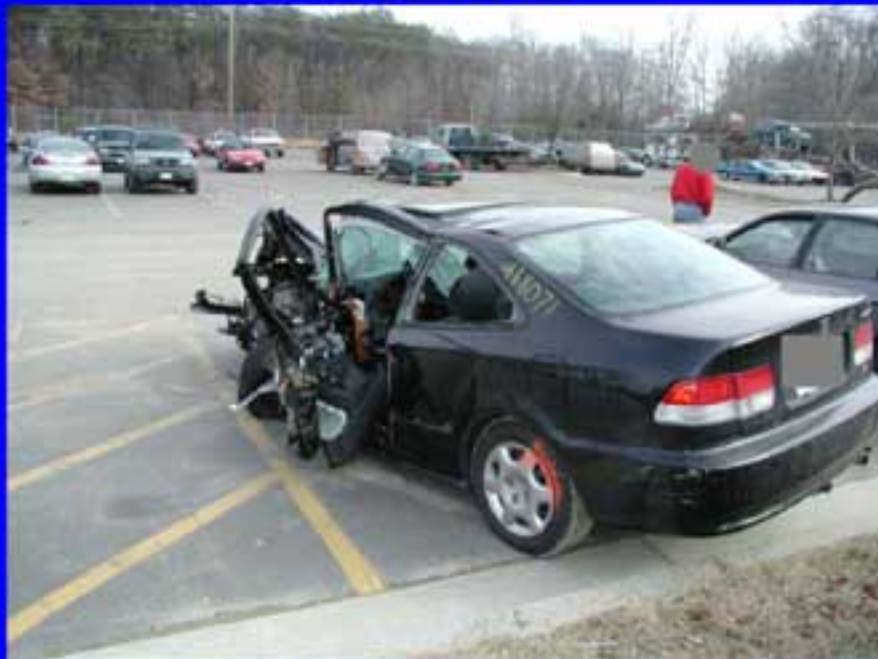
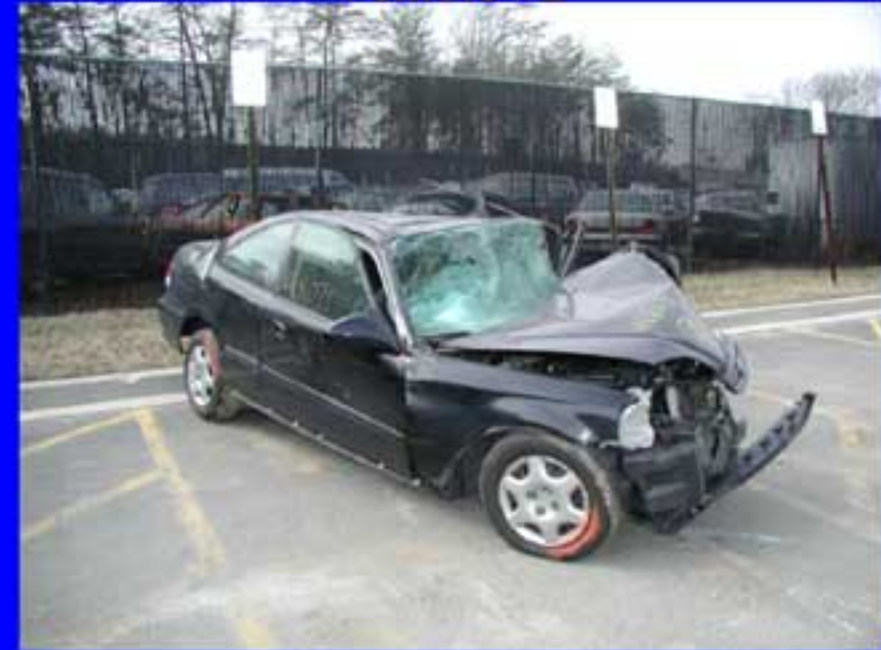
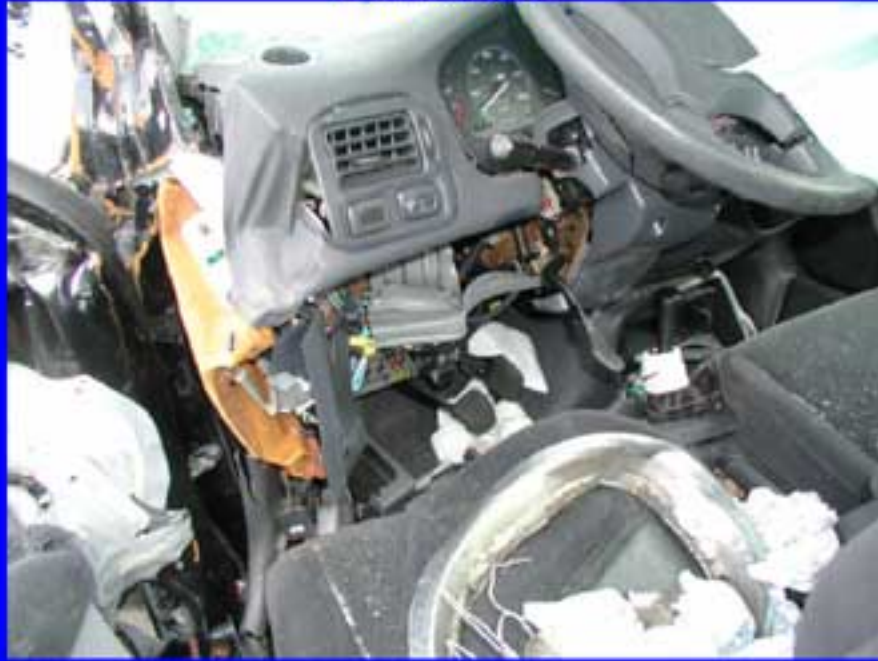
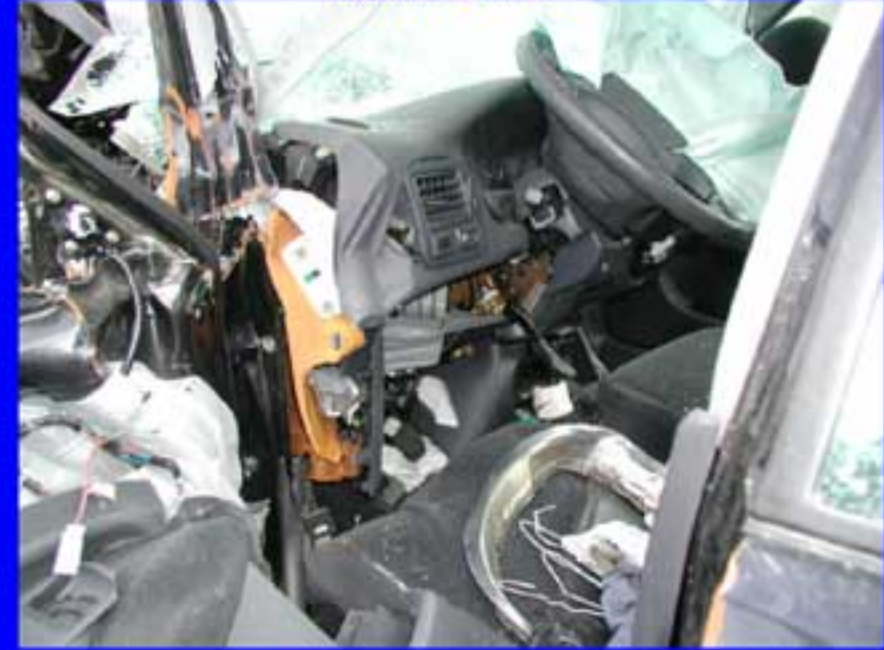
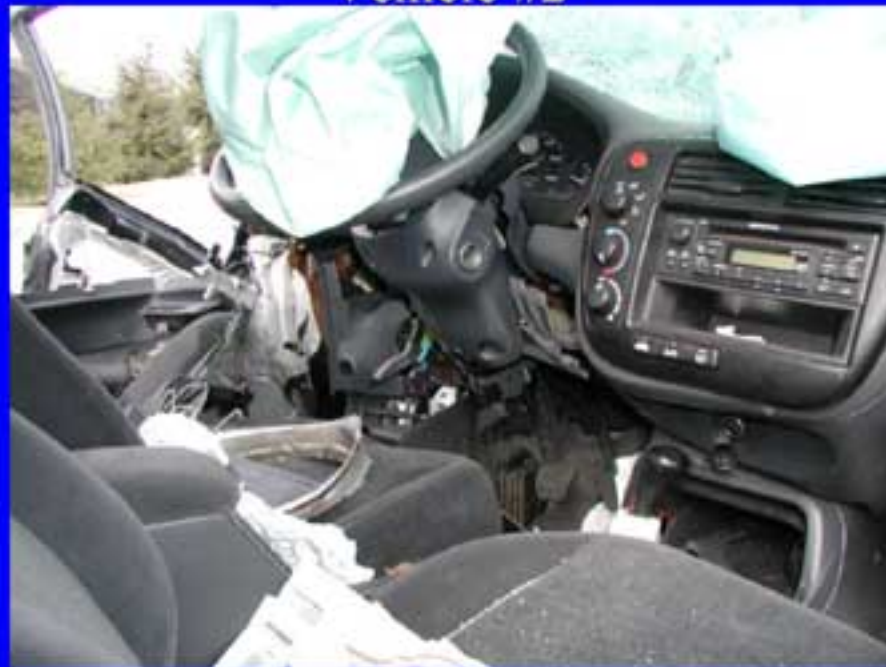
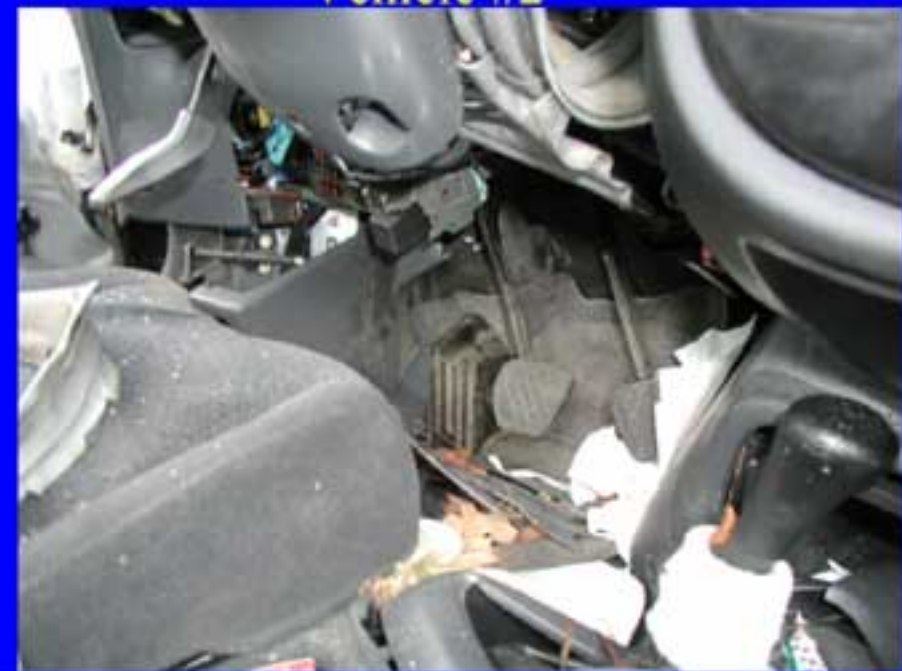
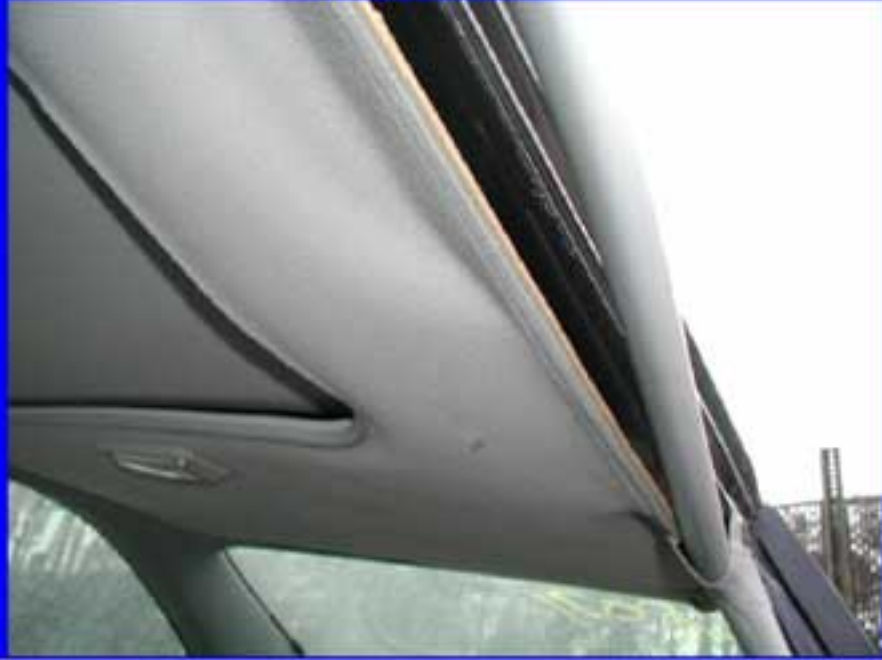
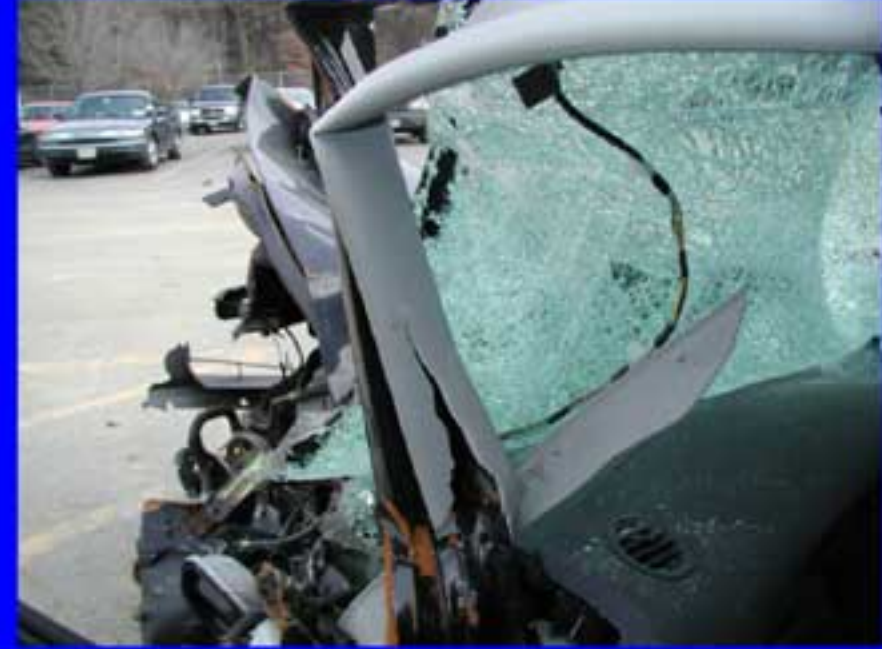
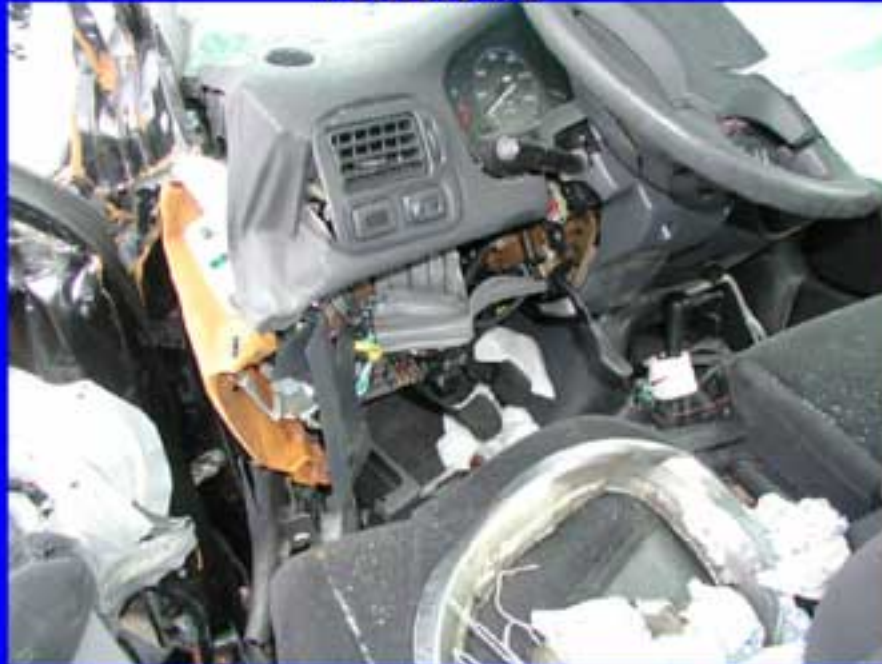
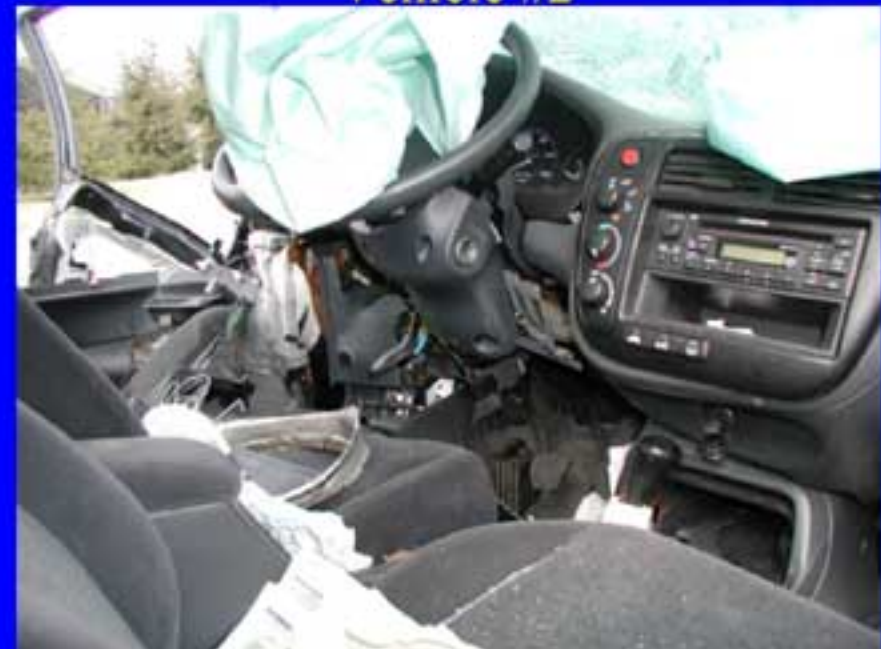
Weight: 2513 lbs.
PDOF: 25
? V: 30.9
CDC: 01FYEW4
Max Crush: 119cm @ C1
