PEDESTRIAN HEAD IMPACT TESTING AND PCDS RECONSTRUCTIONS

National Highway Traffic Safety Administration

Paper 326

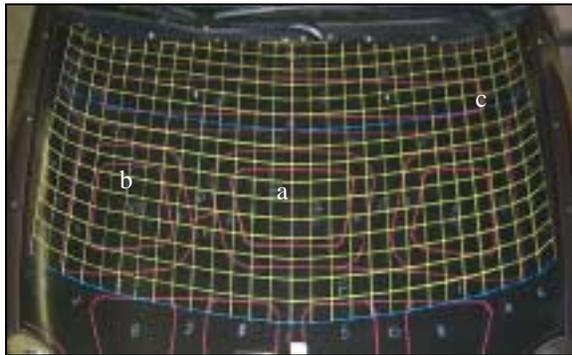
Impact points for the test matrix were chosen based on the structure of the hood and the amount of clearance to underhood engine components since it was desired to have a wide range of results. Three impact points were chosen for the Taurus. These points are marked with a, b, and c in Figure 1a, and the corresponding points in the engine compartment are shown in Figure 1b. The first point, referred to as the No Reinforcement / Open Area impact point (a), had no hood reinforcement structure and a large amount of clearance to engine components. The second point also had no hood reinforcement but had little clearance to the alternator, and was referred to as the No Reinforcement / Alternator impact point (b). The third point had heavy hood reinforcement and very little clearance to the shock tower, and was called the Reinforcement / Shock Tower impact point (c). Each point was impacted three times with each procedure to evaluate repeatability.

Figure 1a. Taurus hood impact points.

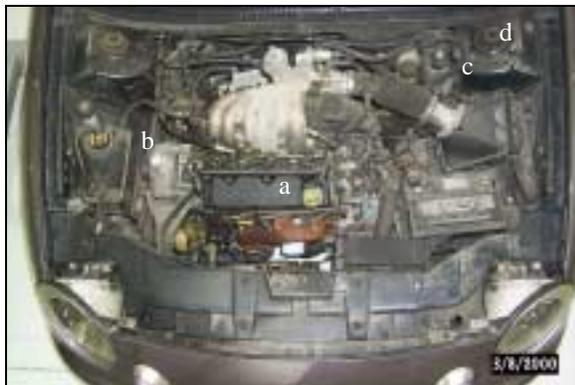
Figure 1b. Corresponding impact point locations in the engine compartment.

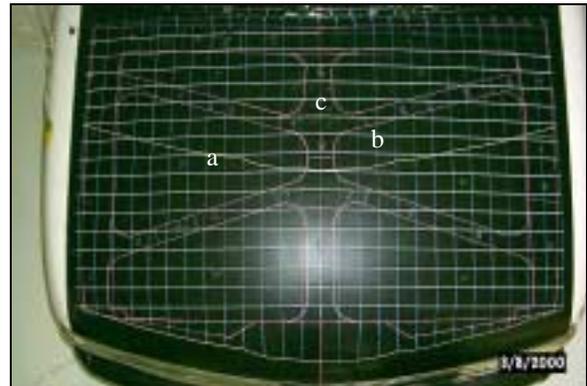
Three impact points were also chosen for the Blazer, and are shown in Figures 2a and 2b. The Open Area impact point (a) had no hood reinforcement and a large amount of clearance to engine components. The AC Lines point (b) had no hood reinforcement but little clearance to metallic lines from the AC compressor. The third point had hood reinforcement structure and little clearance to the engine air intake cover. This point was impacted a second time for each procedure with the intake cover removed to evaluate the contribution of low clearance to the HIC value of this particular point. This also allowed a comparison of the HIC value at this point with hood reinforcement and no obstructions to that of the point with no hood reinforcement or obstructions. This point was referred to as the Reinforcement with or without Intake Cover point (c). Since repeatability results had been previously obtained for the Taurus series, only one test per location was conducted with each procedure.

Figure 2a. Blazer hood impact points.

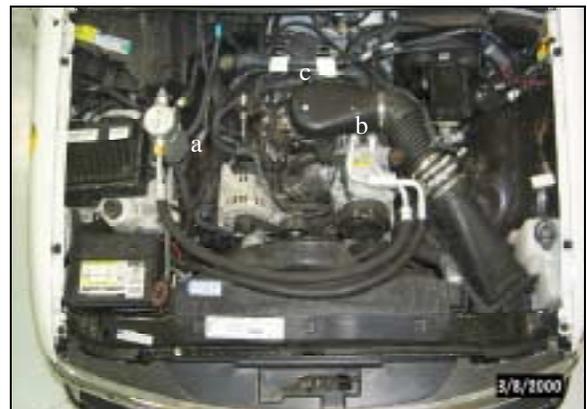
Figure 2b. Corresponding impact point locations in the Blazer engine compartment.

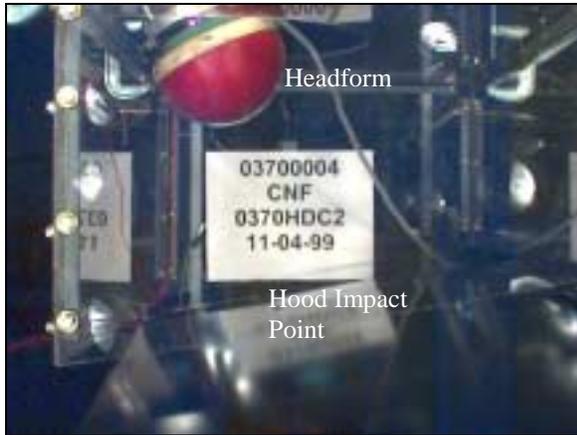
This is the definition used in this testing for all three procedures. This means that the center of gravity of the headform is actually aimed at a different location for each procedure. The impact test setup is shown in Figure 2c.

Figure 2c. Head impact test setup.

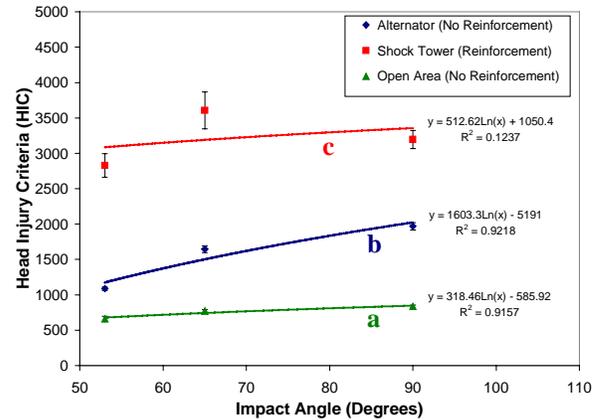
Figure 3 shows the results of the adult head impact testing performed on the Taurus. This graph shows that in general, impacts that were more perpendicular to the hood resulted in a higher value for the HIC. The only exception to this is for the EEVC and NHTSA impacts to the Reinforcement / Shock Tower impact point, where 65 degree tests resulted in a higher value of HIC than the 90 degree tests. This discrepancy was due to a screw on top of the shock tower that was located slightly rearward of the impact point (see point d in Figure 1b). This effectively resulted in less clearance in the area where the headform was projected during the EEVC tests. Figure 3 also shows good repeatability for all three procedures, particularly for the NHTSA procedure. Also notice that, by comparing the HIC values of the ISO and NHTSA procedures, angle sensitivity of HIC seems to depend on impact location.

Figure 3 shows the effect of underhood clearance on HIC in areas where the hood is not reinforced. It is shown that HIC increases more with impact angle at the low clearance location than at the high clearance area. This indicates that more clearance will lead to a lower HIC for non-reinforced areas.

Figure 3 also shows the effect of hood reinforcement on HIC in areas with low underhood clearance. It is shown that HIC increases more with impact angle at the non-reinforced location (Alternator) than at the reinforced area (Shock Tower). This does not

indicate that reinforced areas cause lower HIC, however, with HIC being around double that of non-reinforced areas. The low R-squared value for the reinforced location is a result of the impact with the screw at 65°.

Figure 3. HIC results for Taurus hood locations with different underhood clearance and hood reinforcement.

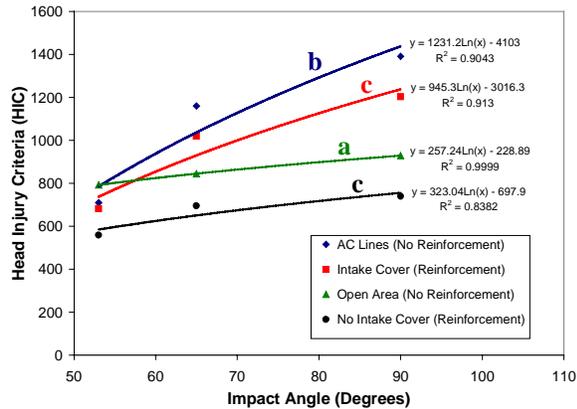
Figure 4 shows the results of the adult head impact testing performed on the Blazer. This figure follows the trend of higher HIC values for more perpendicular impacts at all impact points. A higher HIC value resulted from impacts to the non-reinforced open area than from the reinforced area with no intake cover. This is attributed to the relative shape of the hood at these points. The hood is flat at the open area impact point, which means that the steel must stretch to allow deformation, whereas the hood is slightly crested at the reinforced impact point with the intake cover removed. The HIC at this reinforced area without the underhood obstruction was the lowest value in this test matrix.

Figure 4 shows the effect of underhood clearance on HIC for reinforced and non-reinforced locations. As was observed for the Taurus, low clearance impacts result in a greater increase in HIC with impact angle. Notice that the trends for both are similar.

Figure 4 also shows the same data, this time comparing the effect of hood reinforcement on HIC for low and high clearance locations. As stated previously, the HIC magnitude is greater for non-reinforced locations, which is a result of the relative shapes of the hood impact locations. Results from the Taurus, where hood shape was not an issue, indicated that hood reinforcement significantly increases HIC, which makes physical sense because

reinforcement adds a structure that limits deformation.

Figure 4. HIC results for Blazer hood locations with different underhood clearance and hood reinforcement.

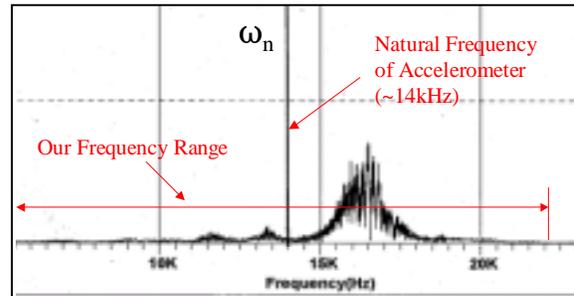
It was questioned whether the accelerometer chosen had the optimal natural frequency for the headform impact test application. This was a valid argument considering the proximity of the testing frequencies and the natural frequency of the accelerometer (5-25 kHz vs. 14 kHz), which is shown in the Fast Fourier Transform (FFT) plot (Figure 5). When these frequency ranges coincide, there is an increased chance that resonance can occur, which could lead to saturation of the amplifiers in the signal conditioning stage of the data acquisition system. This can cause corruption of the data, giving inconsistent or unreliable results [9]. To investigate this potential problem, a damped accelerometer was purchased, and an identical test matrix was repeated to evaluate the effect on HIC. The HIC values became less varied and the resonant frequency content was eliminated, an improvement in instrumentation was made. It should be noted that no resonance was present in FFT plots of adult head impacts on the same alternator location.

Figure 5. Resonance seen in the frequency response of the undamped accelerometer.

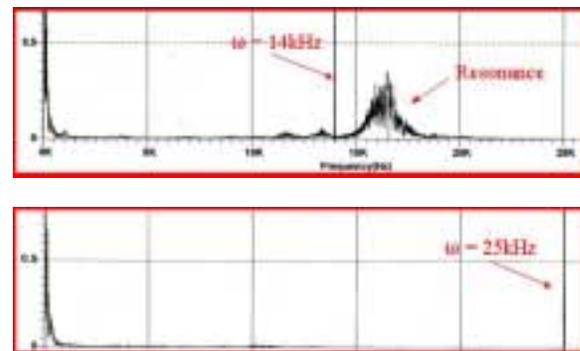
smaller variation for the damped accelerometer, as well as the prevention of resonance in Figure 6.

Figure 6. Resonance is prevented by the use of a damped accelerometer.

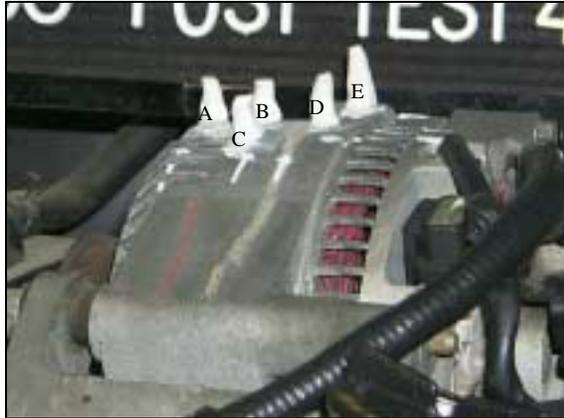
Figure 7 shows the clay cone arrangement on the alternator. Table 3 summarizes the average clay cone heights and shows that hood deflection, which is inversely proportional to clay cone height, increases with impact angle.

Figure 7. Clay Cone Configuration on Alternator

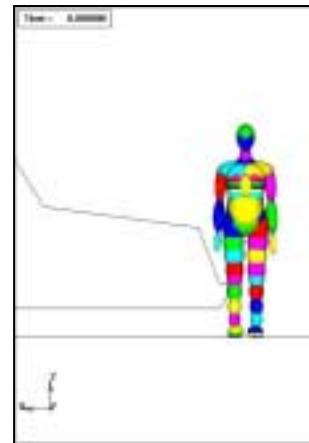
A pedestrian accident case was selected from the PCDS database for reconstruction with computer simulations and laboratory testing. The vehicle used for the reconstruction was a 1996 Ford Taurus Sedan. The recorded speed of the vehicle at impact was 27 km/h, and the pedestrian was a 48-yr old male (height 178 cm, weight 82 kg). The victim sustained AIS 1-2 head injuries from the collision due to windshield impact. Vehicle hood and windshield stiffness were determined from headform impacts to the structures by calculating force and deflection. These pedestrian and vehicle properties were entered into a pedestrian accident simulation model shown in Figure 8 (TNO-MADYMO) that had been validated with biomechanical corridors created from cadaver tests.

Figure 8. Pedestrian accident simulation model

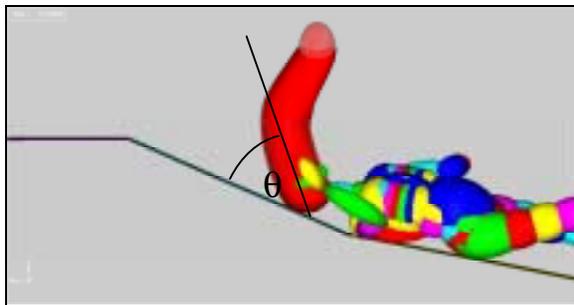
Table 4 shows the results of the pedestrian simulation, and Figure 9 defines the head impact angle.

Figure 9. Relative impact angle

The wrapping of the torso and lower body around the front end of the vehicle caused the neck to rotate past vertical prior to contact with the windshield, forcing the head to impact at an angle less than 90 degrees with the windshield. Also, the relative impact velocity was much greater than the vehicle impact velocity at contact with the legs of the pedestrian. The HIC was lower than in hood impacts due to the greater dynamic deformation characteristics of the windshield. Table 5 outlines the results of the laboratory reconstructions:

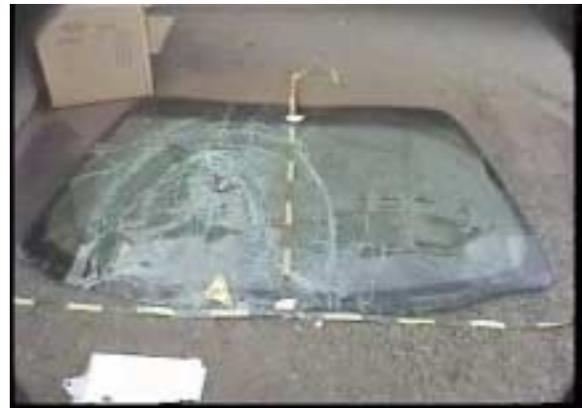
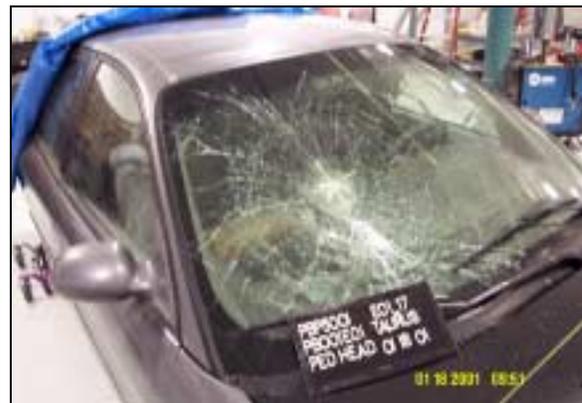
The resulting HIC and windshield contact forces were very close to the values found in the simulation. The HIC values for both simulation and laboratory tests were typical of AIS 1-2 injury levels, as they were in the case [10, 11]. The windshield damage patterns were similar for the accident case and laboratory test (Figure 10).

Figure 10. Accident case (top) and test (bottom)
