Status of NHTSA's Roof Crush Research

Donald T. Willke
National Highway Traffic Safety Administration

SAE Government/Industry Meeting
May 10, 2004

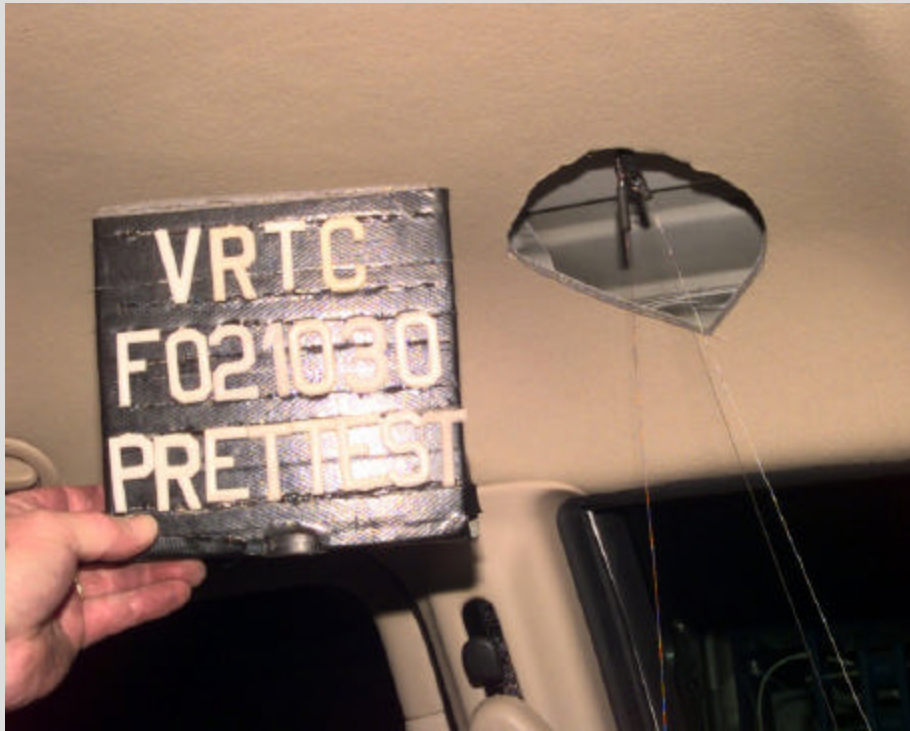
Phase 2 – String Potentiometer Attachment

3 string potentiometers were used to track the roof point initially above the drivers head

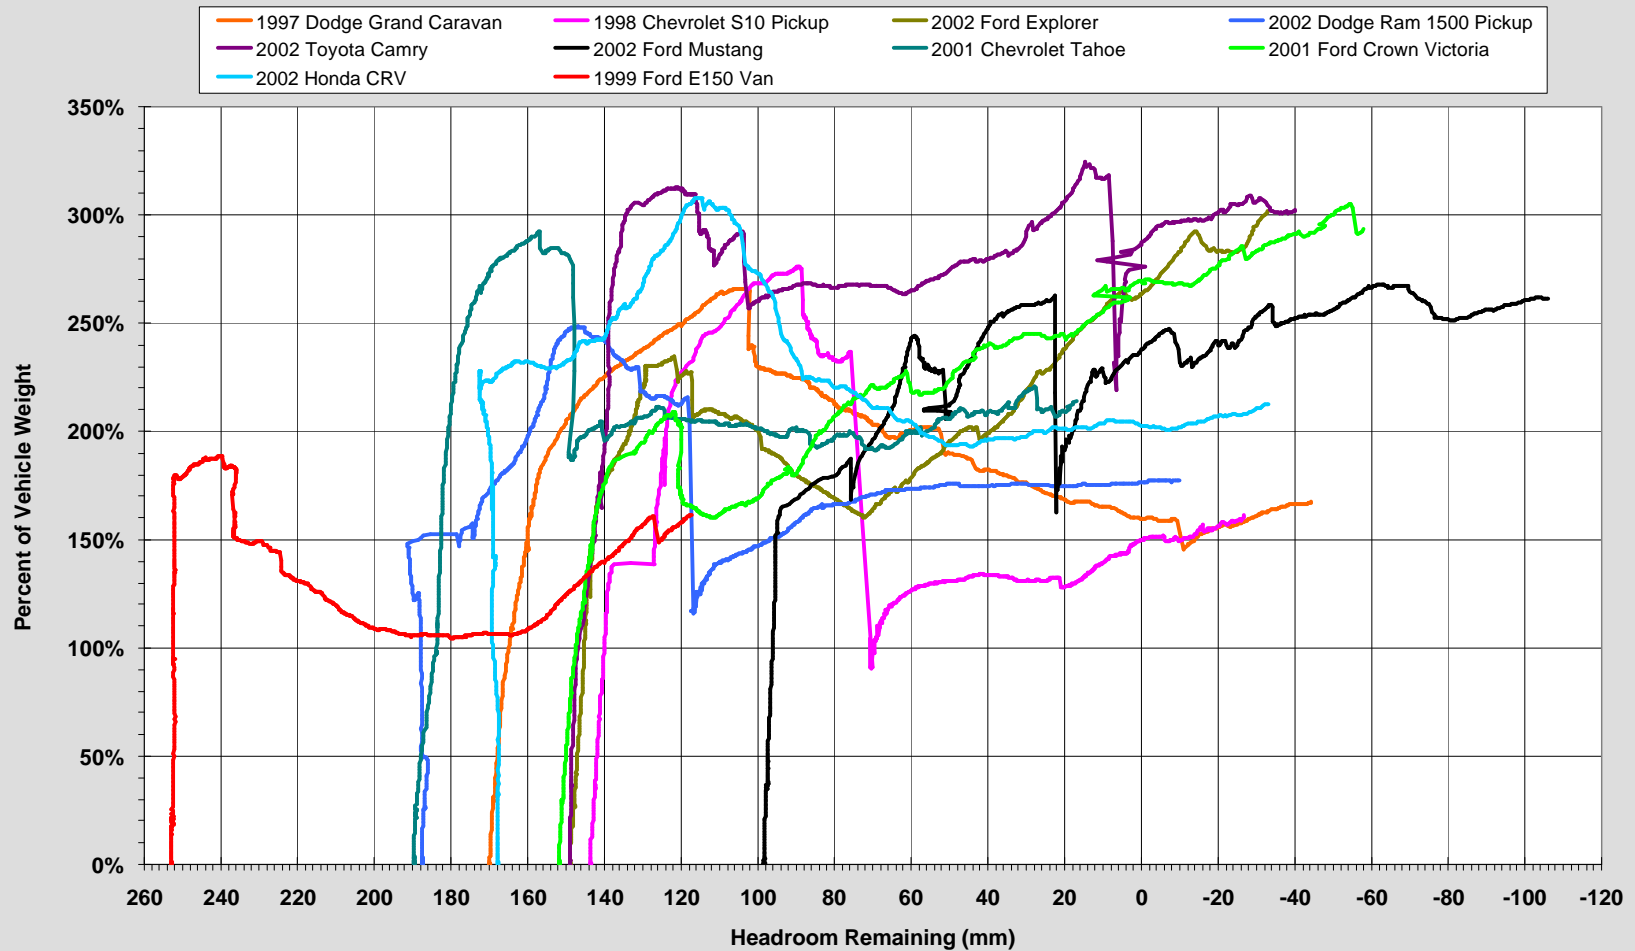
Percent of Vehicle Weight vs. Headroom Remaining to Roof

To 254 mm Load Plate Displacement

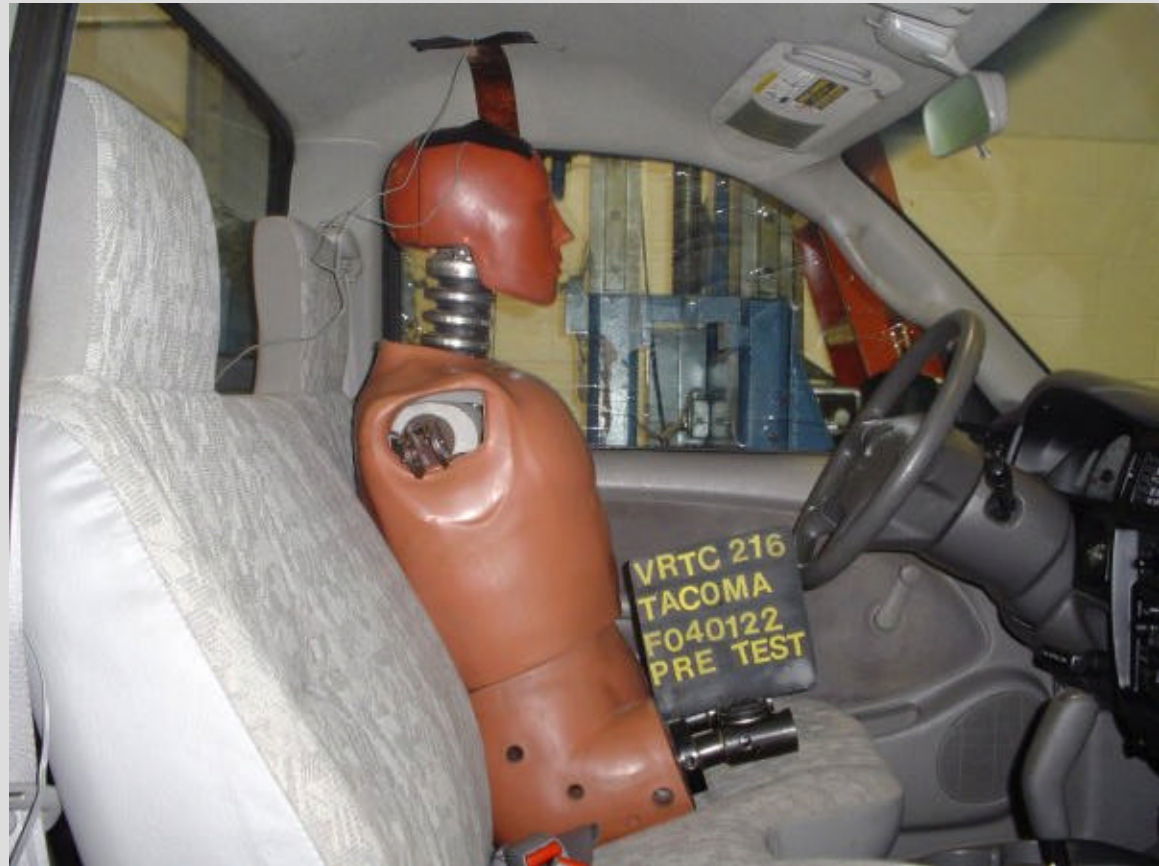
Phase 3 – Dummy Placement

- **Hybrid-III 50th Male**
- **Positioned per FMVSS 208**
- **Arms and Legs Removed**
- **Contact Switch on Head and Liner**

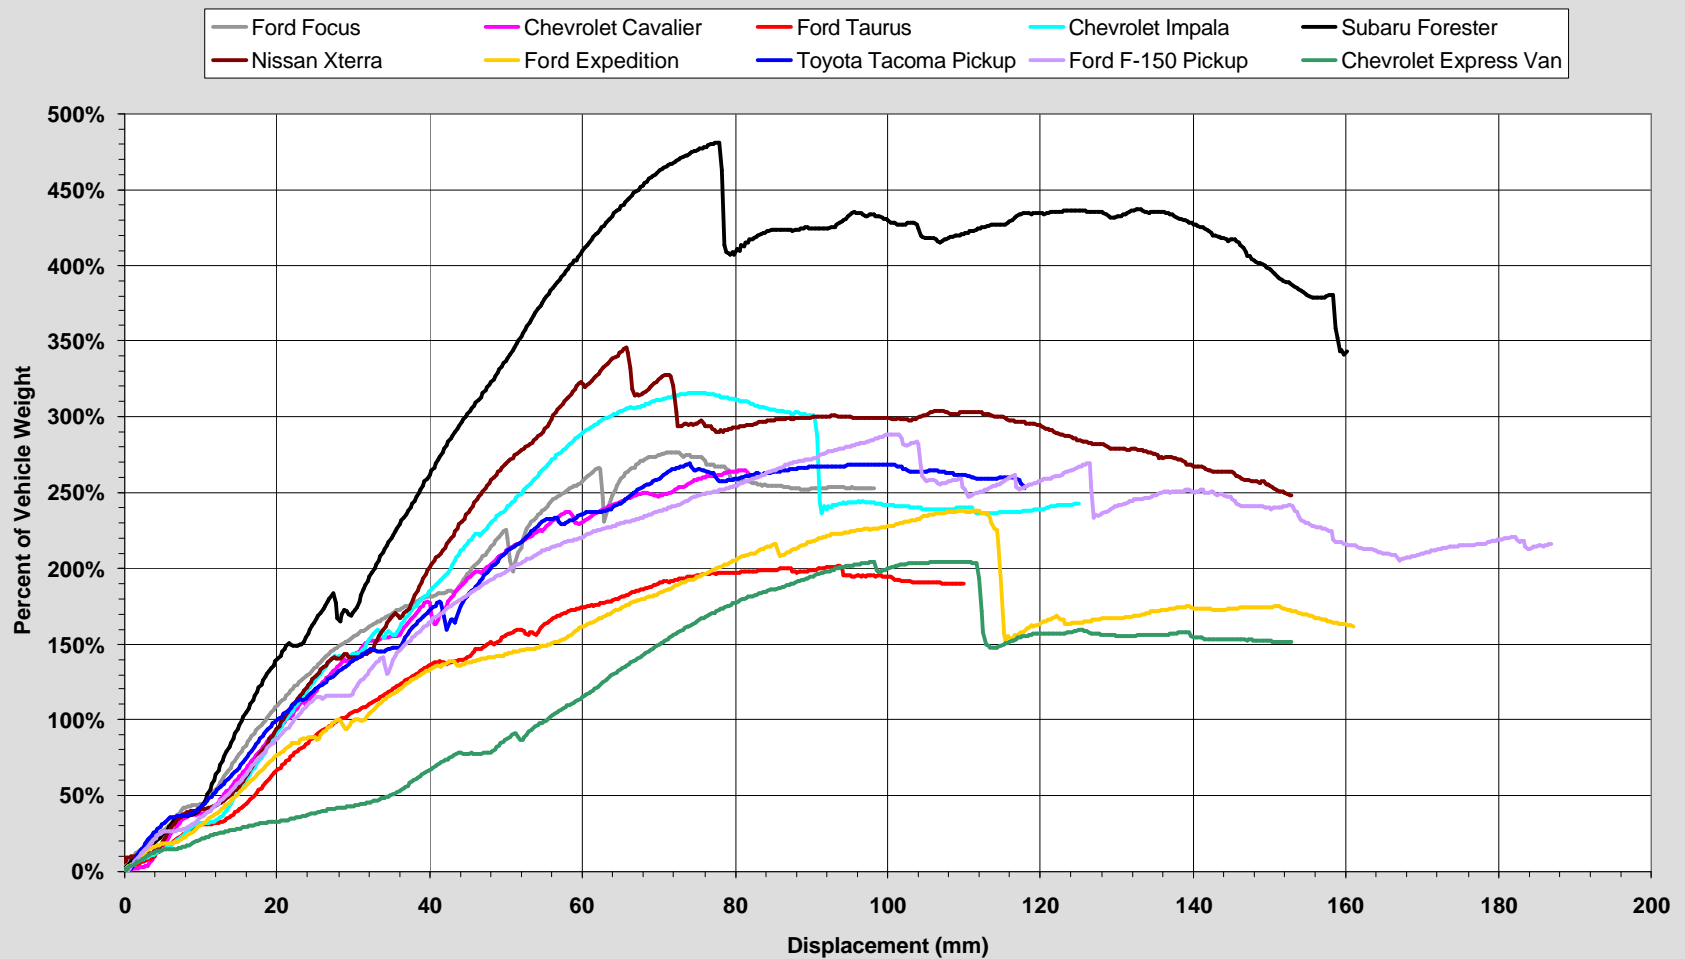
Percent of Vehicle Weight vs. Displacement To Head Contact
