DOT HS 811 150

June 2009

FINAL REPORT

Compressed Hydrogen Cylinder Research and Testing In Accordance With FMVSS 304

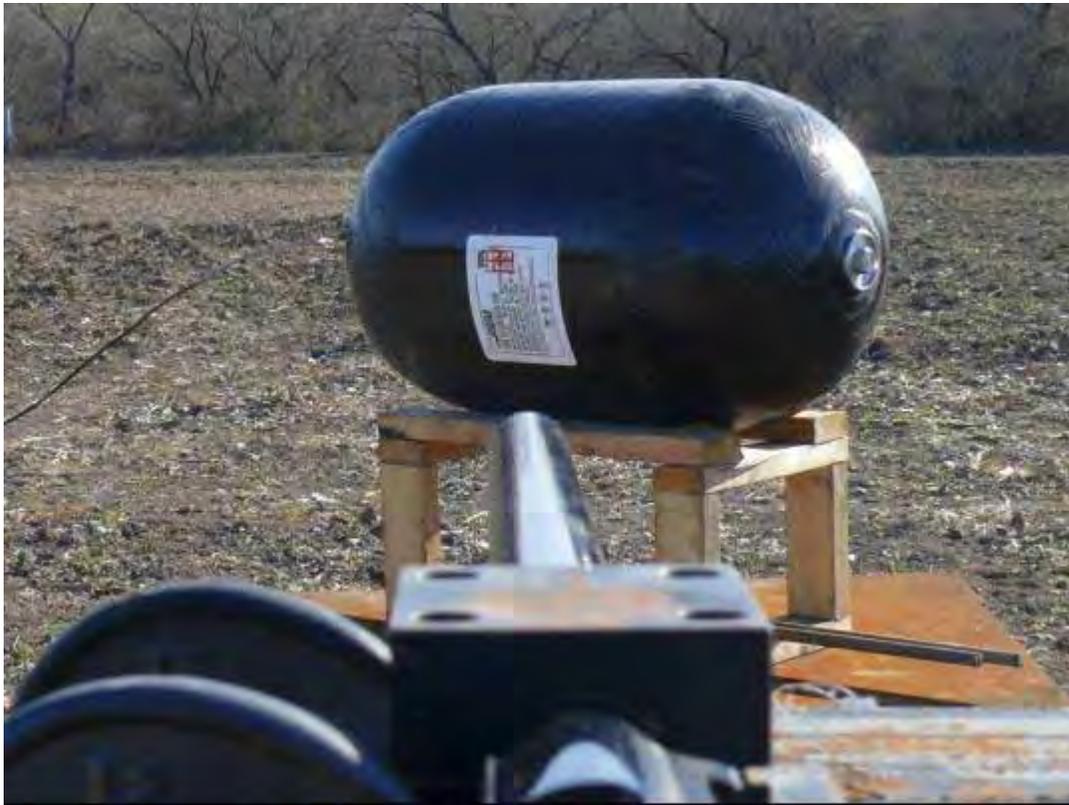
Figure 3. Penetration Test General Setup (Prior to Securing Cylinder to Test Stand).

Test setup and procedures for the penetration test followed the ISO/DIS 15869 protocol. Each cylinder was supported on the test bench and pressurized to its service pressure. A 0.308-caliber (7.62-mm) diameter rifle barrel was supported on a rigid test bench and aimed such that it would penetrate the sidewall of the cylinder at a 45° angle to its longitudinal axis. The following picture shows the general setup for the penetration test.

The trigger mechanism of the rifle barrel is initiated remotely by a lanyard. An armor-piercing bullet is required to penetrate through at least one side of the cylinder. The cylinder must not burst catastrophically following penetration.

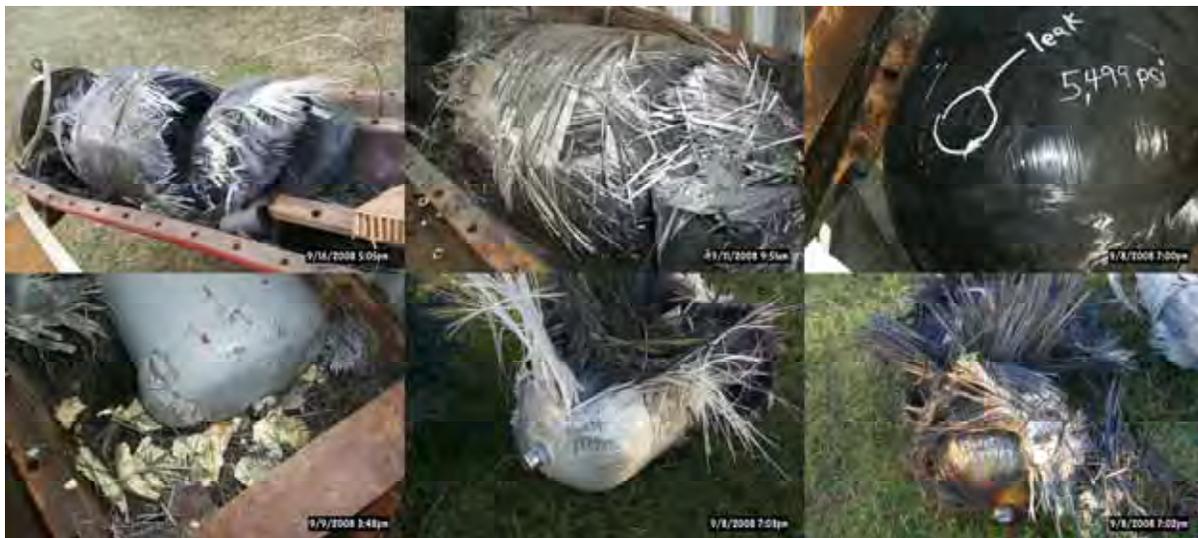
**Figure 5. Cylinders Following Burst Pressure Tests.
Shown Left to Right, Top to Bottom in Order of Results Table.**

The following table outlines the results from each of the burst tests, and the figure depicts the condition of the cylinders following each test.

Cylinder Design	Minimum Design Burst Pressure	Cylinder Condition	Failure Pressure	Failure Mode
10,000-psig Type 4	22,500 psig	New	23,150 psig	Catastrophic Burst
10,000-psig Type 4	22,500 psig	Cycled	24,620 psig	Catastrophic Burst
10,000-psig Type 4	22,500 psig	4-min Fire Exposure	5,500 psig	Excessive Leakage Bursting Not Possible
5,000-psig Type 4	11,250 psig	Cycled	13,010 psig	Catastrophic Burst
5,000-psig Type 3	11,250 psig	Cycled	19,970 psig	Catastrophic Burst
5,000-psig Type 3	11,250 psig	4-min Fire Exposure	19,000 psig	Catastrophic Burst

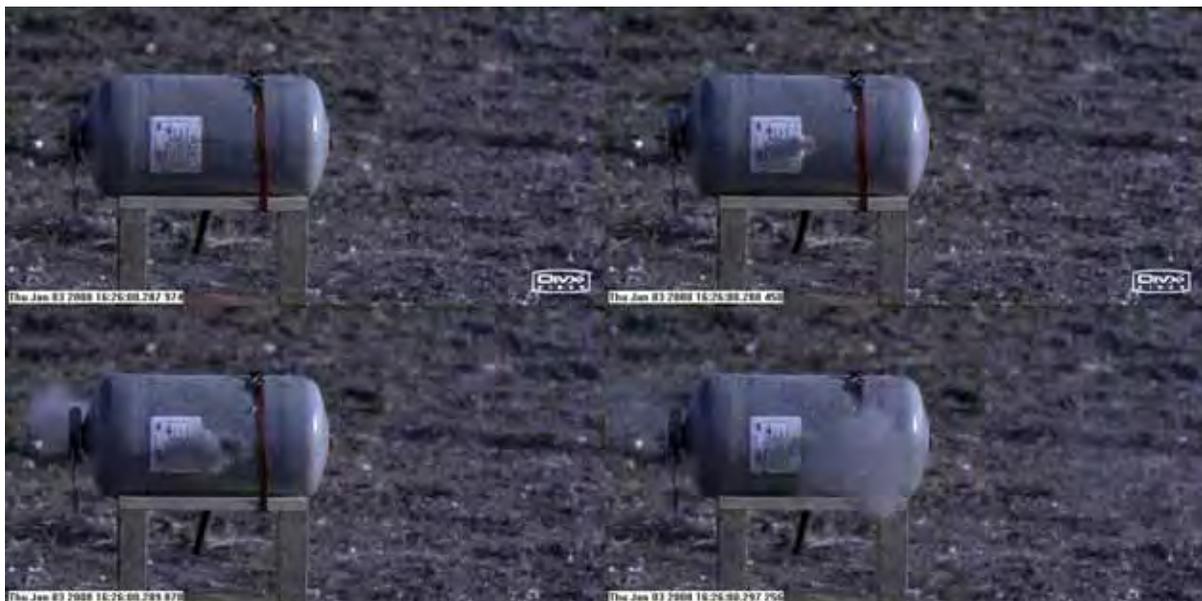
Figure 7. High-Speed Video Frames of 5,000-psig Type 4 Cylinder Penetration Test.

A total of three penetration tests were performed, one of each cylinder design. In both the 5,000-psig Type 3 cylinder and 10,000-psig Type 4 cylinder penetrations, the bullet entered the side of the cylinder at the required 45° angle, but did not exit through the other side. In the 5,000-psig Type 4 cylinder penetration, the bullet entered the side of the cylinder at the required 45° angle and exited the opposite side of the cylinder near the end dome. The force resulting from the exit hole was sufficient to knock over the test stand. Upon impact with the ground, the hydrogen jet exiting the cylinder ignited, producing a large hydrogen flame. The following picture sequences were compiled from the high-speed video.

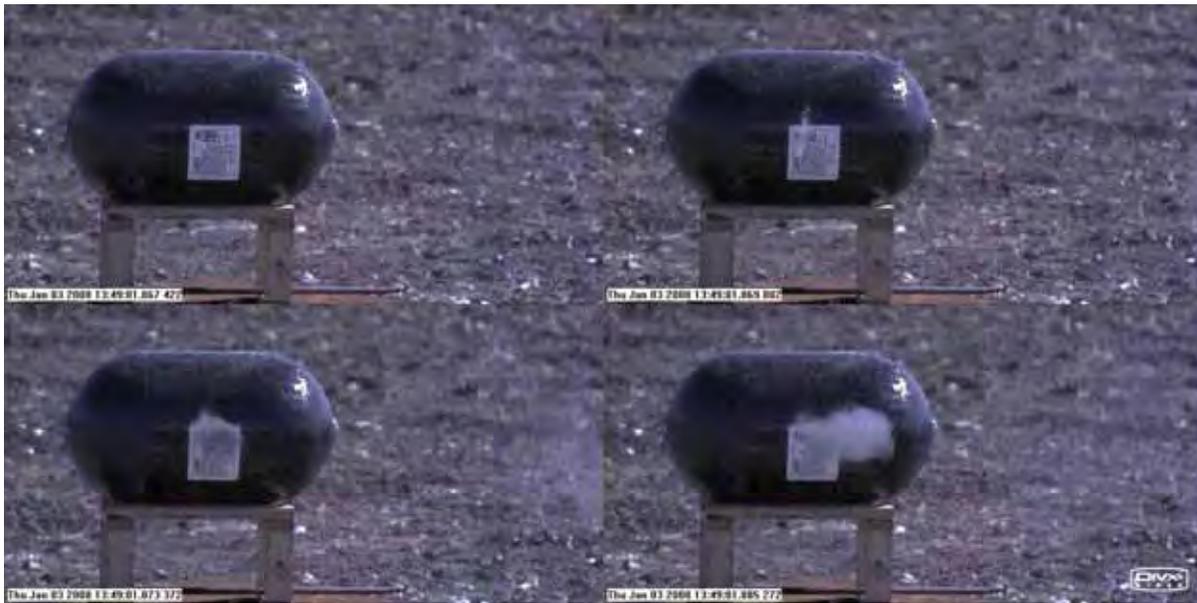
Figure 8. High-Speed Video Frames of 10,000-psig Type 4 Cylinder Penetration Test.

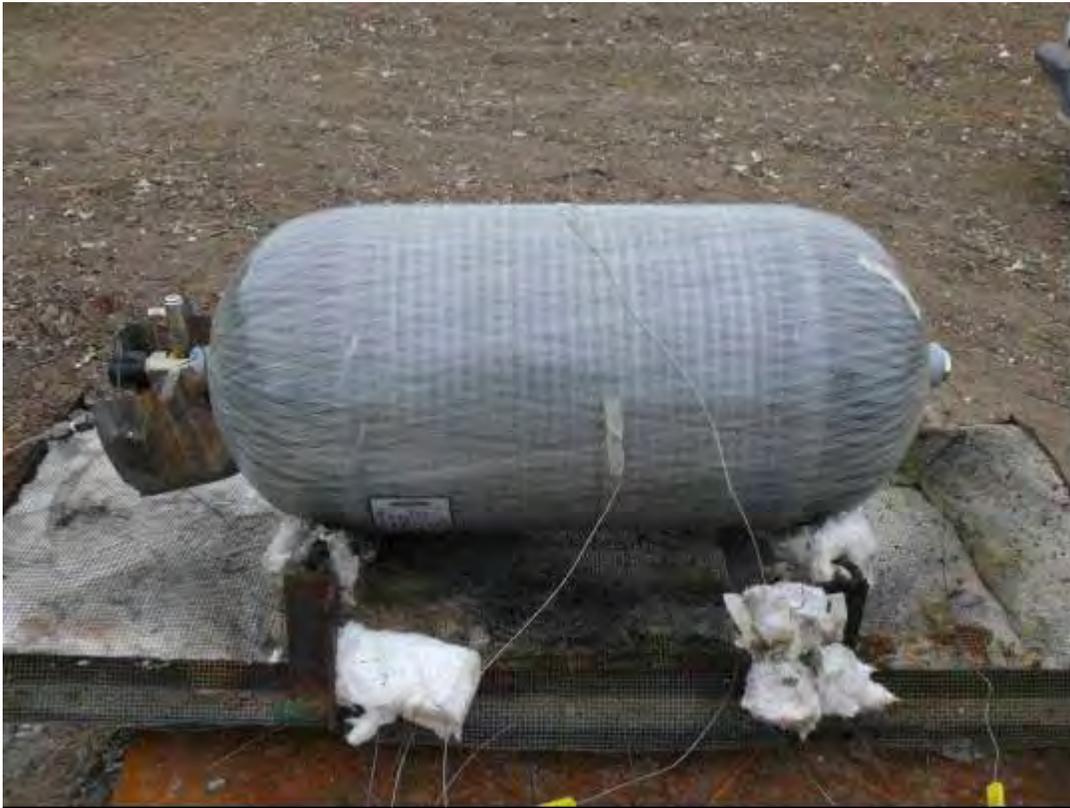
Figure C-1. Overall Setup for Cylinder Bonfire Tests – 5,000-psi Type 3 Cylinder Shown.

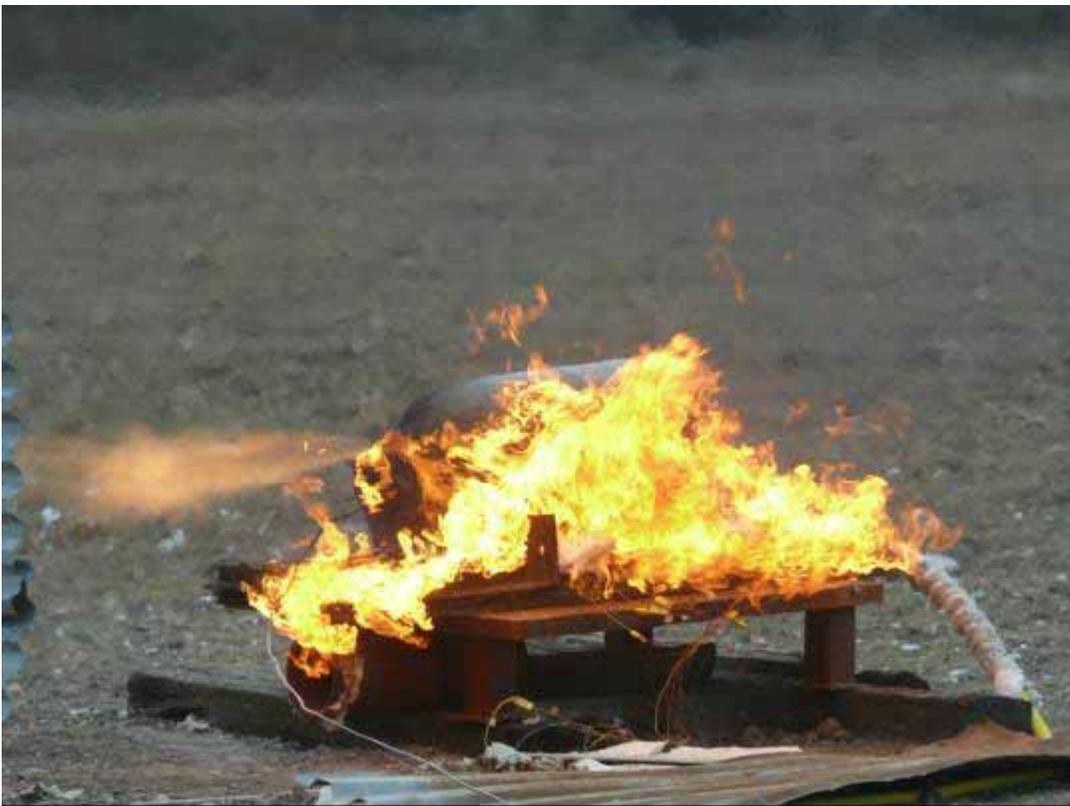
Figure C-2. View of 5,000-psi Type 3 Cylinder Venting.

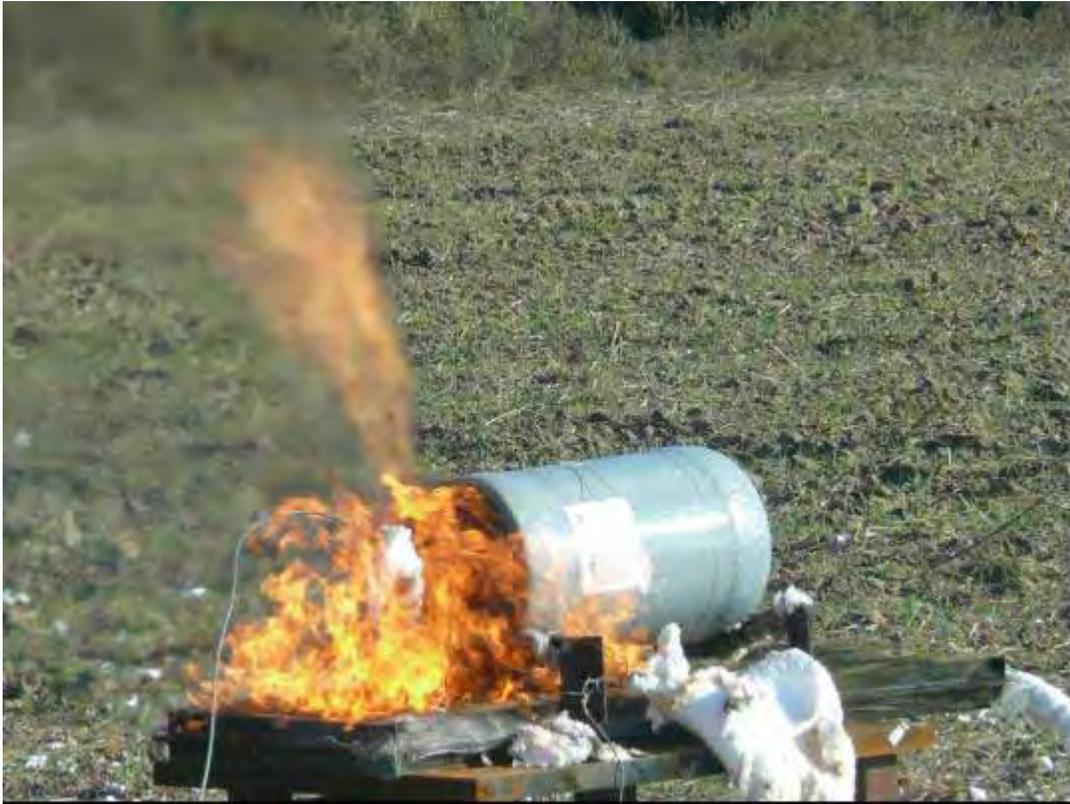
Figure C-3. View of 5,000-psi Type 4 Cylinder Venting.

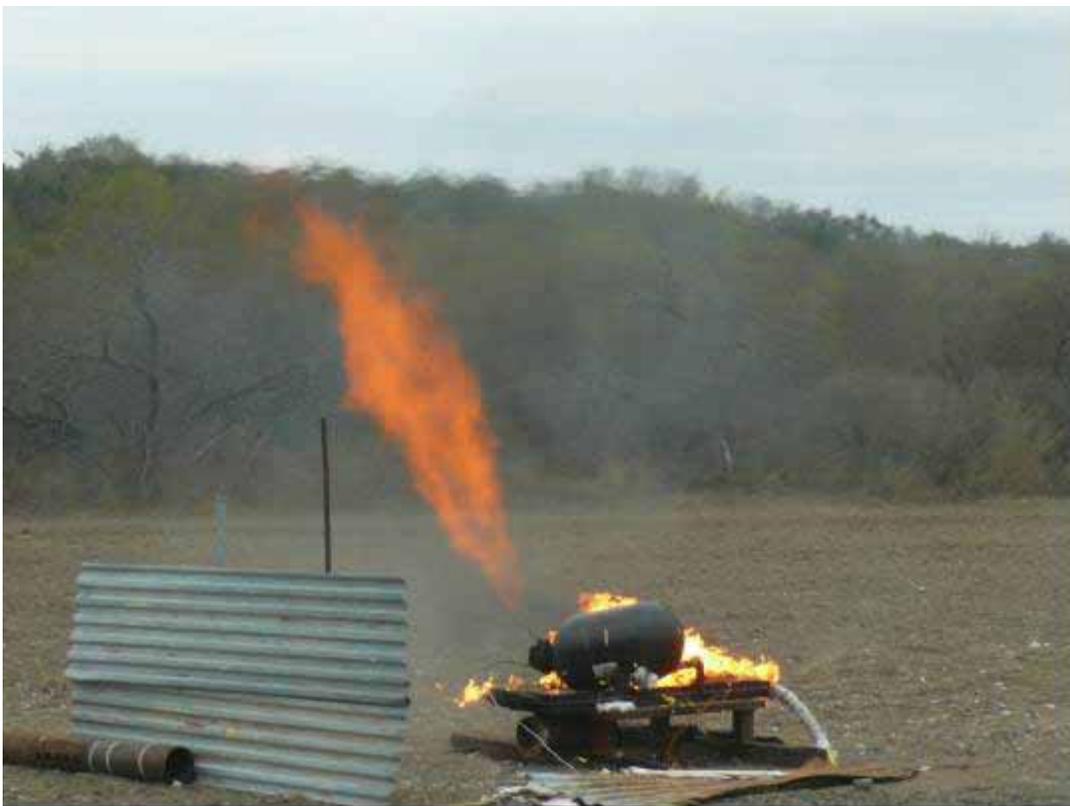
Figure C-4. View of 5,000-psi Type 4 Cylinder Venting.

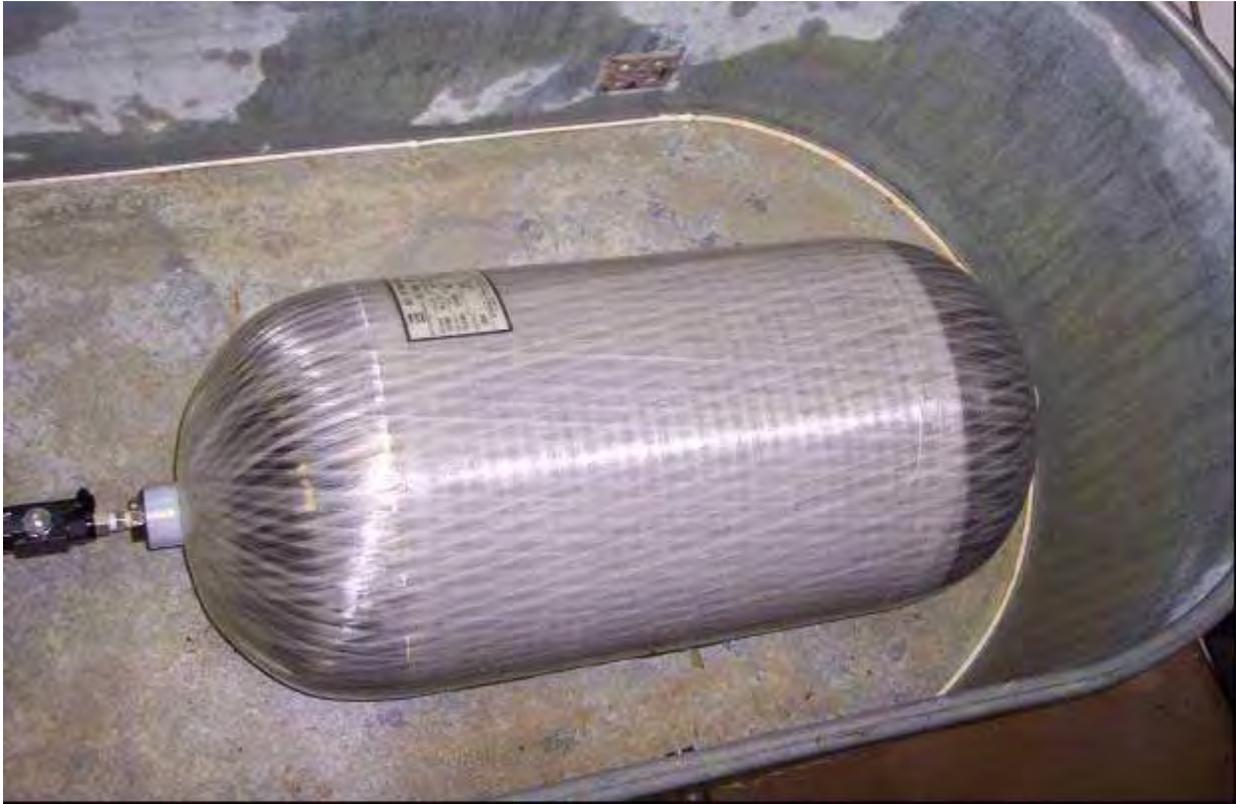
Figure C-5. View of 10,000-psi Type 4 Cylinder Venting.

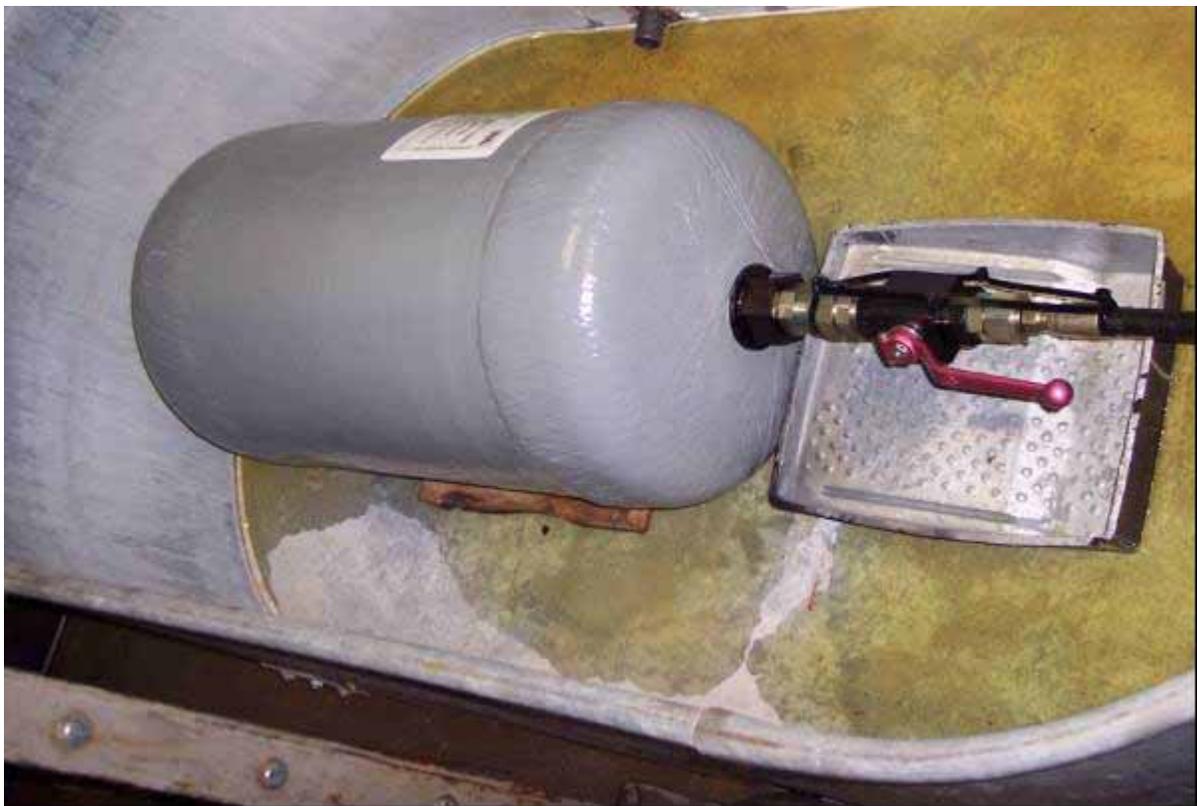
Figure C-6. 5,000-psi Type 4 Cylinder Setup for Pressure Cycling Tests.

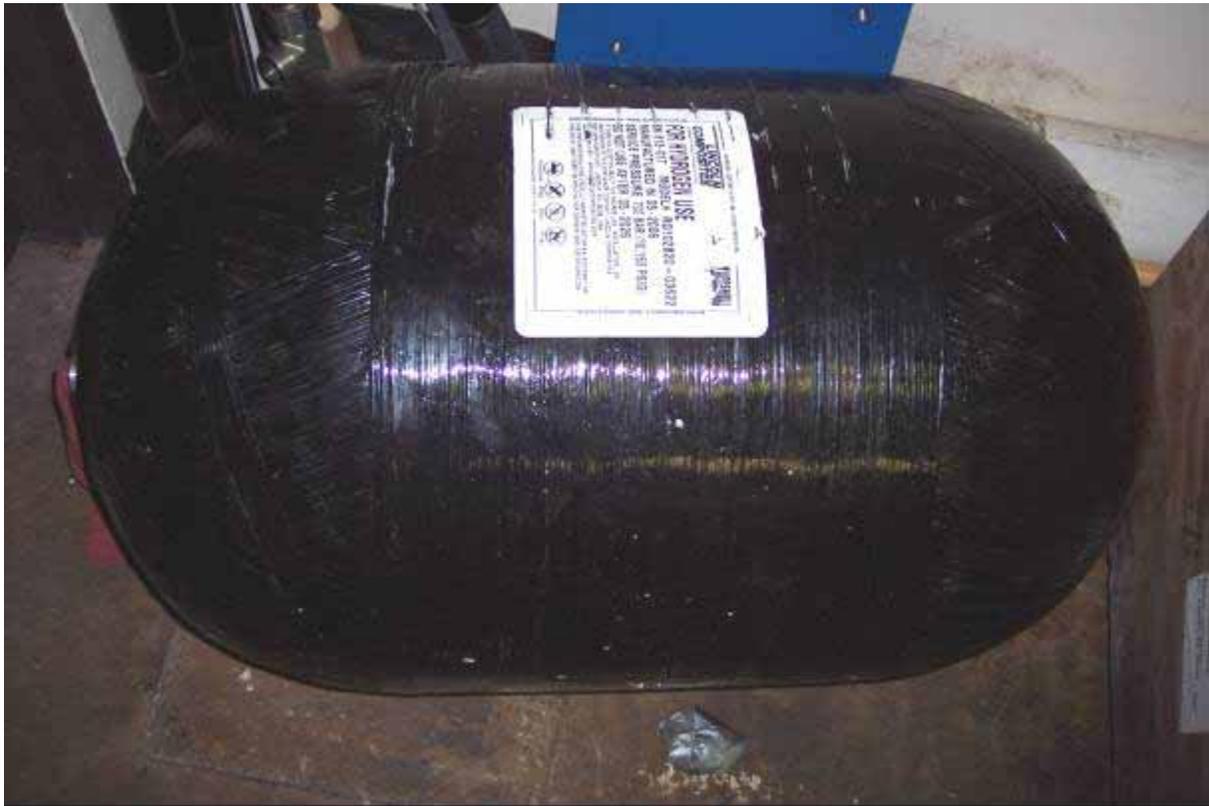
Figure C-7. 10,000-psig Type 4 Cylinder Setup for Pressure Cycling Tests.

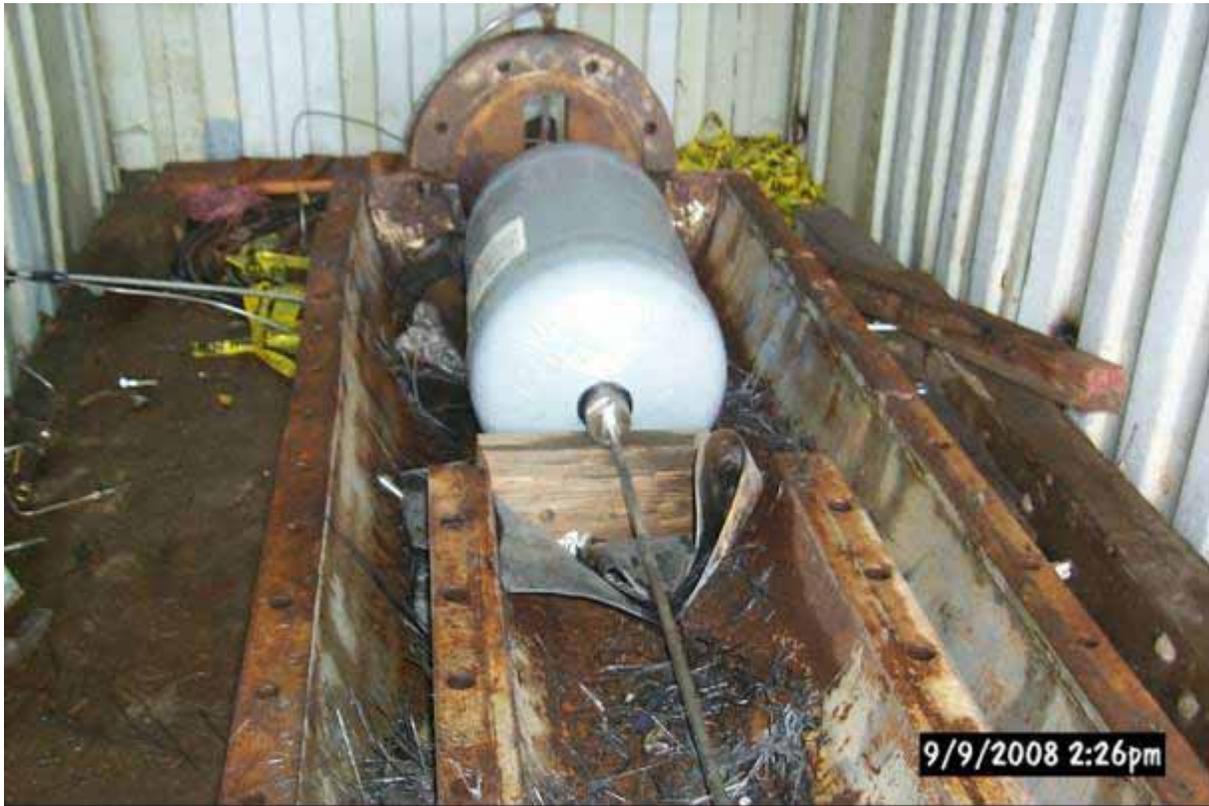
Figure C-9. General Setup for Burst-Pressure Tests. (5,000-psig Type 4 Cylinder Shown)

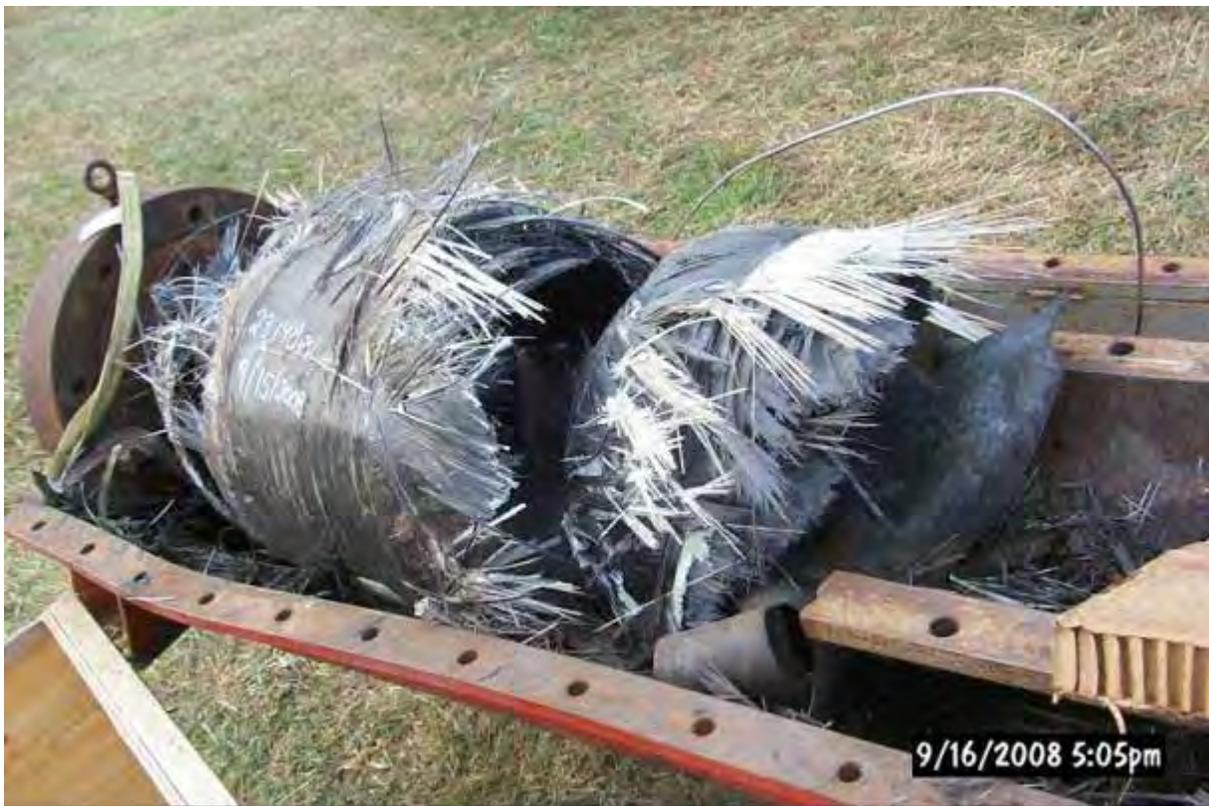
Figure C-10. Typical Failure of Catastrophic Failure Following Burst-Pressure Test.

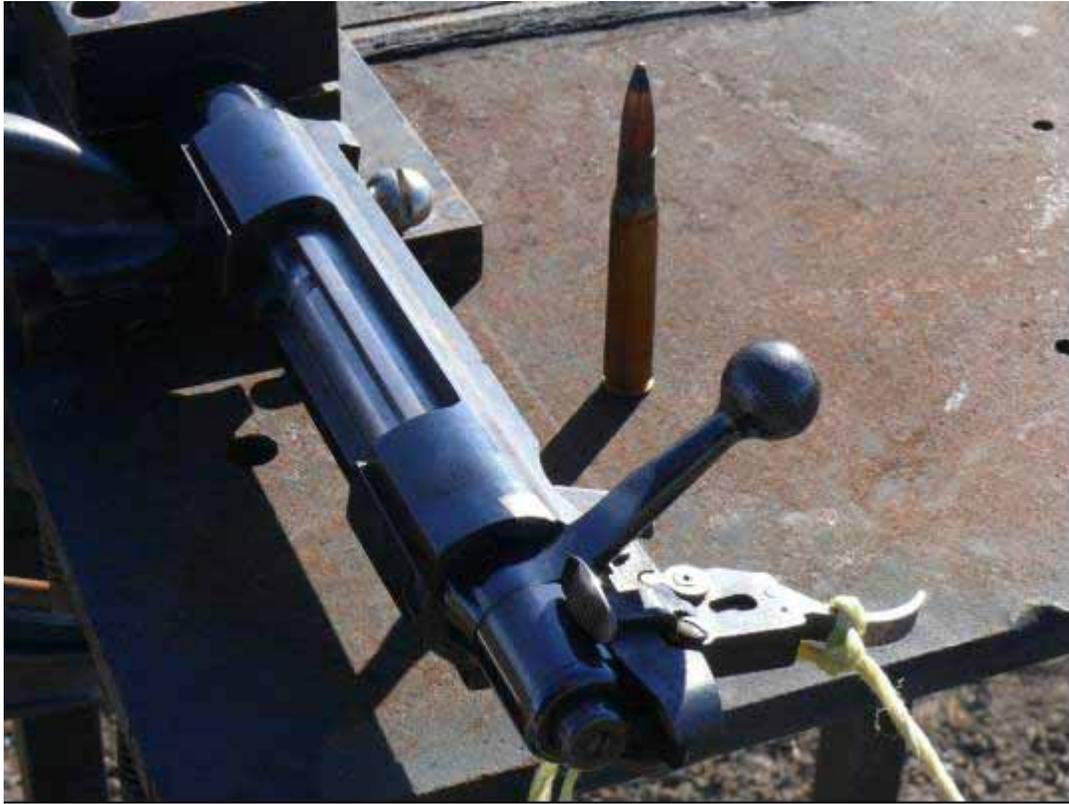
Figure C-11. Gun Bolt and Bullet for Penetration Tests.

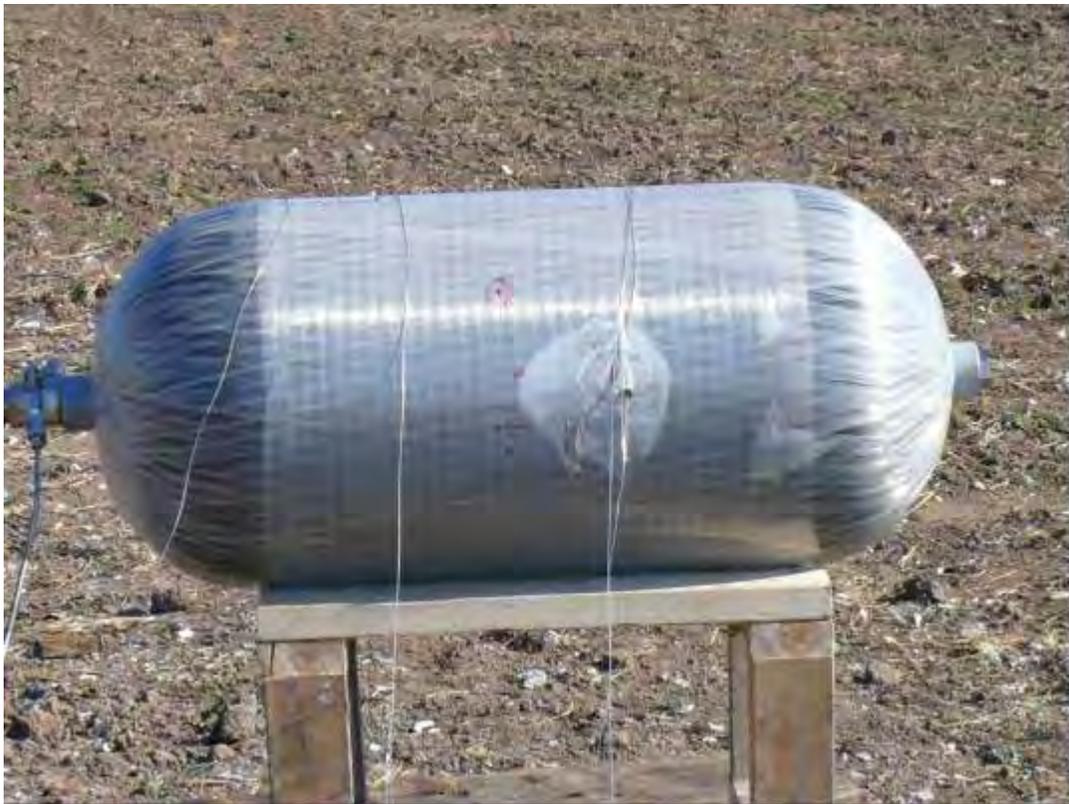
Figure C-12. Hole in 5,000-psig Type 3 Cylinder Following Penetration Test.

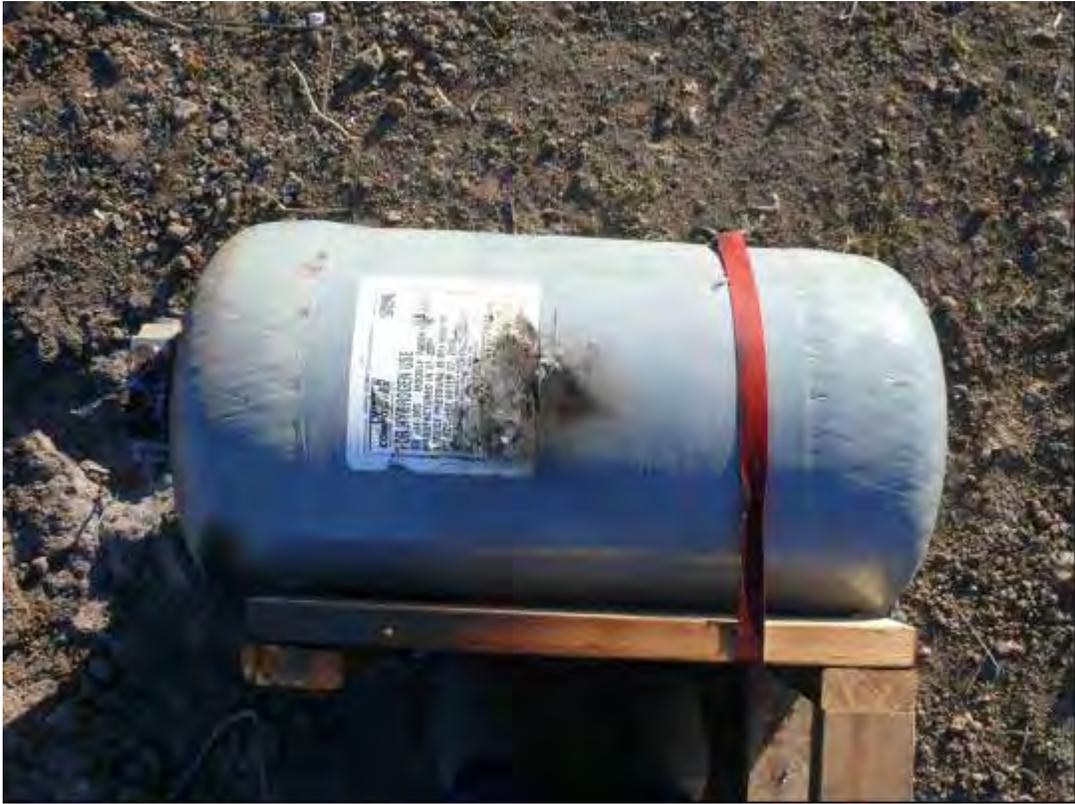
Figure C-13. Hole in 5,000-psig Type 4 Cylinder Following Penetration Test.

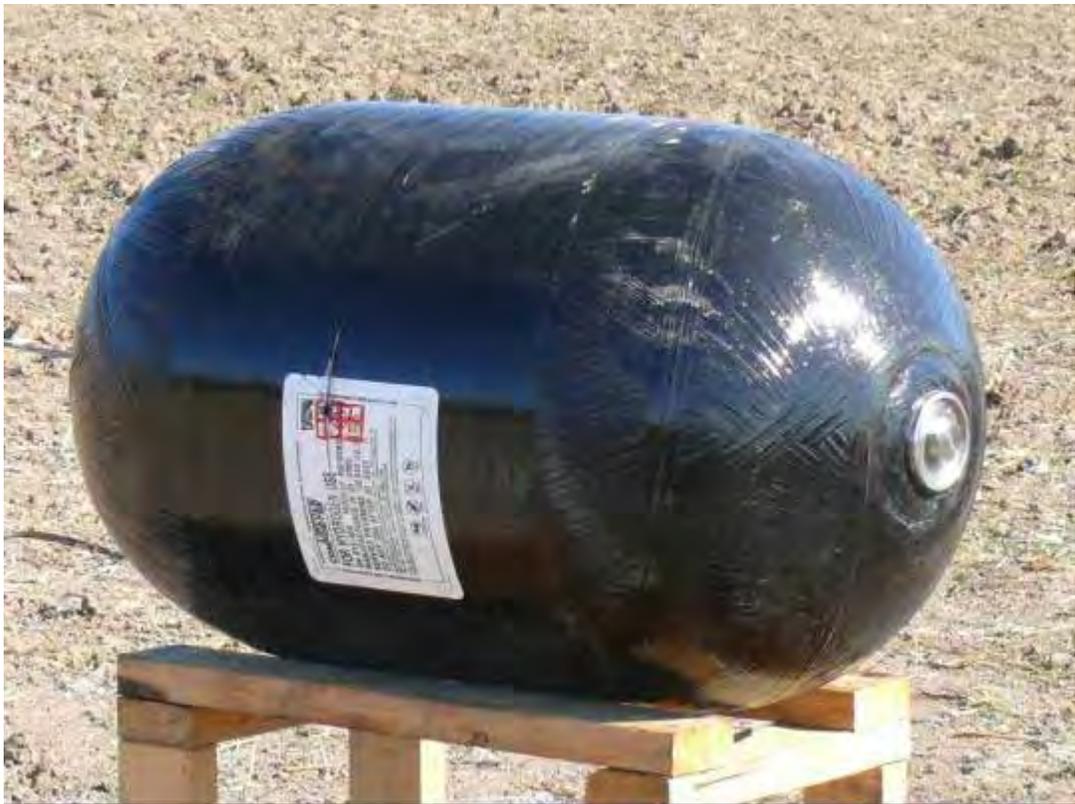
Figure C-14. Hole in 10,000-psig Type 4 Cylinder Following Penetration Test.
