U.S. Department
of Transportation
**National Highway
Traffic Safety
Administration**

DOT HS 811 314

June 2010

Tire Pressure Monitoring System Tests for Medium and Heavy Trucks and Buses

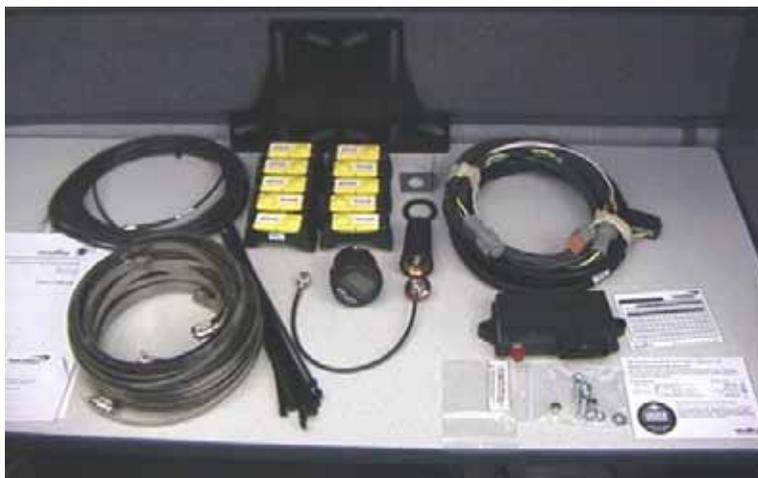
Figure 2.1. Components Kit for SmartWave 10-Tire System

The SmartWave rim-mount installation kit included ten sensing transmitters, receiving antenna and mount, a receiver (Wireless Gateway), a driver’s display, ten rim-mounting bands, and several interface cables to connect the receiving end components together (Figure 2.1). This system supports a maximum of ten sensors.

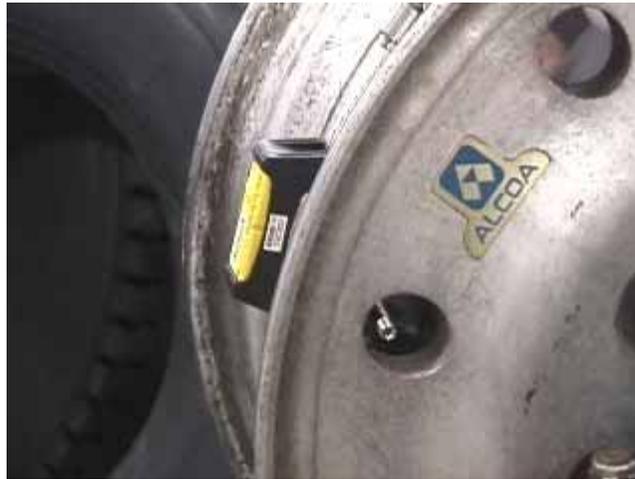
Figure 2.2. SmartWave Sensor Mounted on Lowest Section of Rim with Steel Band

Figure 2.2 shows the correct orientation of the sensor to the valve stem. This is the manufacturer's recommended installation procedure to indicate the approximate location of the sensor so that proper care is used when installing or removing tires from rims. The mounting position of the SmartWave Receiver/Gateway is shown in Figure 2.3 as viewed from the front of the vehicle.

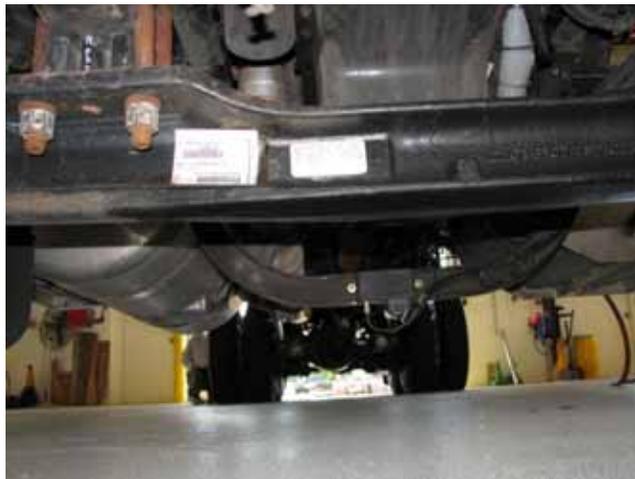
Figure 2.3. SmartWave Receiver/Gateway Mounted on Transmission Lower Crossmember

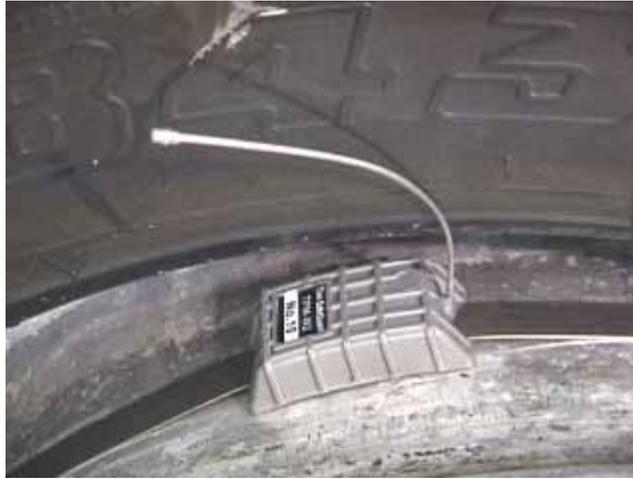
**Figure 2.4. Rim-Mounted Tire-SafeGuard Sensor with High-Gain Antenna
Note-Tire is Pushed Back and Must Clear Antenna When Tire is Moved to Final Position**

The following copies of photographs show the mounting of the Tire-SafeGuard sensors and an overview of the component installation kit. The Tire-SafeGuard sensing transmitters included a high-gain flexible monopole antenna attached to one end of the transmitter housing (Figure 2.4.). The antenna needed to be handled carefully so it wouldn't get damaged when installing the tire onto the rim (Figure 2.5). The manufacturer's installation procedure was for the sensor to be mounted at a position 180 degrees opposite of the valve stem (Figure 2.6).

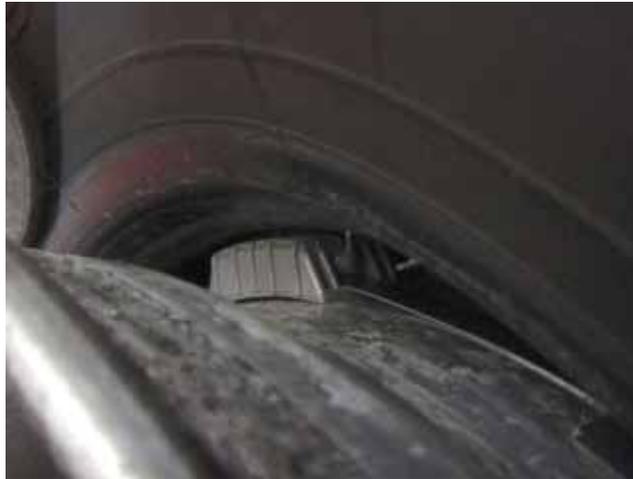
**Figure 2.5. Rim-Mount Tire-SafeGuard with Antenna Pushed Inside Tire
Just Before Seating Bead and Inflating Tire**

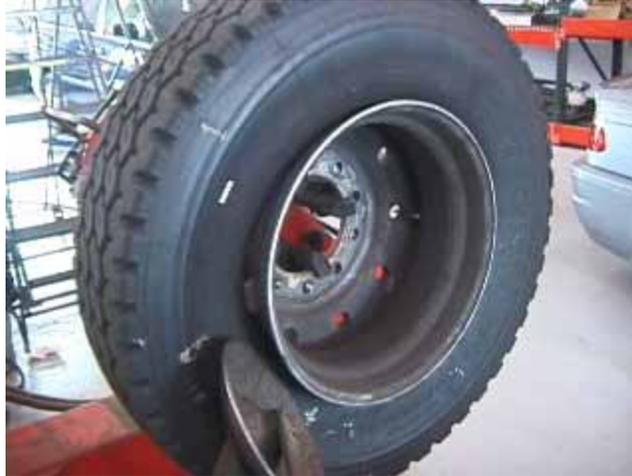
Figure 2.6. Tire Being Removed from Rim-Mount Tire-SafeGuard

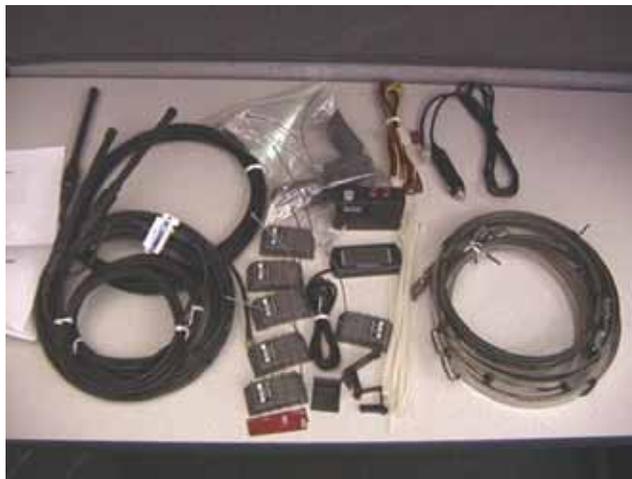
Figure 2.7. Components Kit for Tire-SafeGuard 10-Tire Rim-Mount TPMS

The Tire-SafeGuard rim-mount installation kit included ten sensing transmitters, three remote receiving antennas, a receiver, a driver’s display, ten rim-mounting bands, and several interface cables to connect the receiving end components together (Figure 2.7). This system supports a maximum of ten sensors.

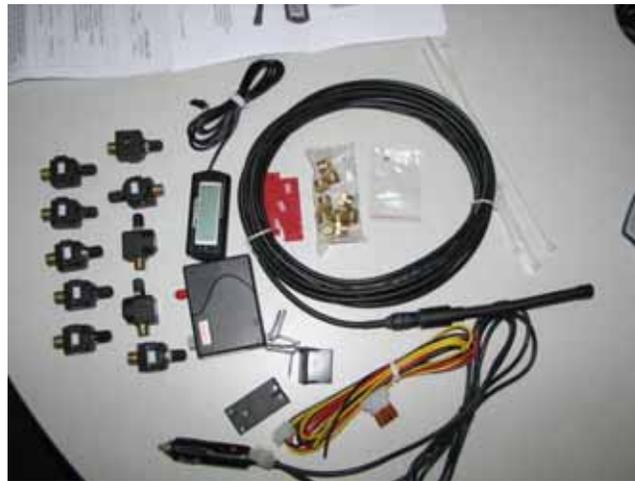
Figure 2.8. Components Kit for Tire-SafeGuard Flow-Through 10-Tire System

mount sensing transmitters with auxiliary inflation ports, a single remote antenna for mounting in proximity of the rear wheels, a small receiver, a driver display, a cigarette-lighter power plug, and cabling for the receiving end components (Figure 2.8). These flow-through sensors attached directly to the valve stem, thereby eliminating the need for any external connecting hoses for a standard installation. It is not known if the added mass may lead to valve stem leakage or fatigue. (Durability issues are outside the scope of this report.) This system supports a maximum of ten sensors.

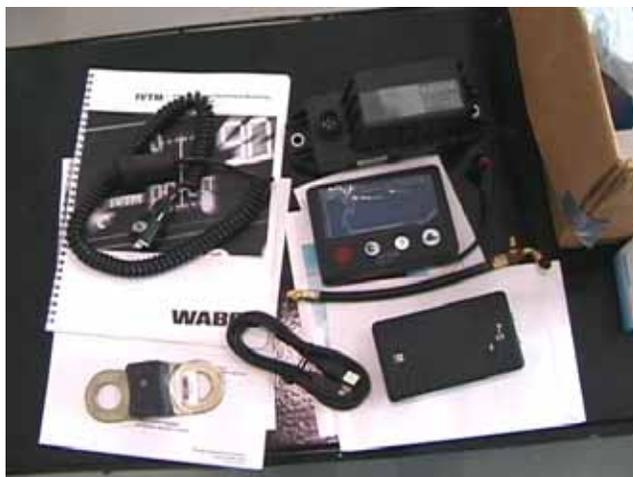
Figure 2.9. Components Kit for IVTM Flow-Through 10-Tire System

Following are a set of copies of photographs showing the IVTM field installation kit (Figure 2.9), driver display (Figure 2.10), and the sensing transmitter and wheel-lug mounting plate (Figure 2.11).

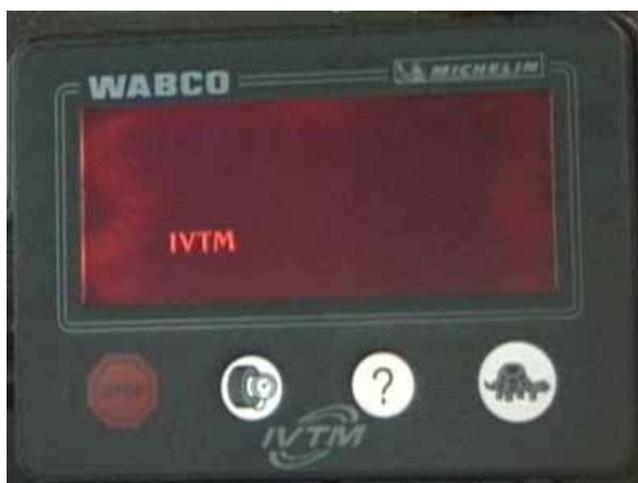
Figure 2.10. IVTM Driver Display

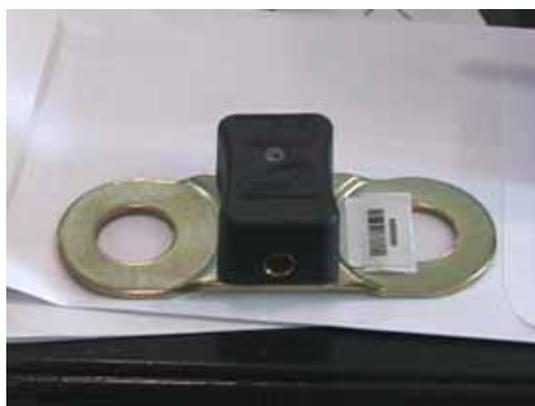
**Figure 2.11. IVTM Wheel Lug Plate with Mounted Transmitter
Port at Front Connects Air Line to Valve Stem**

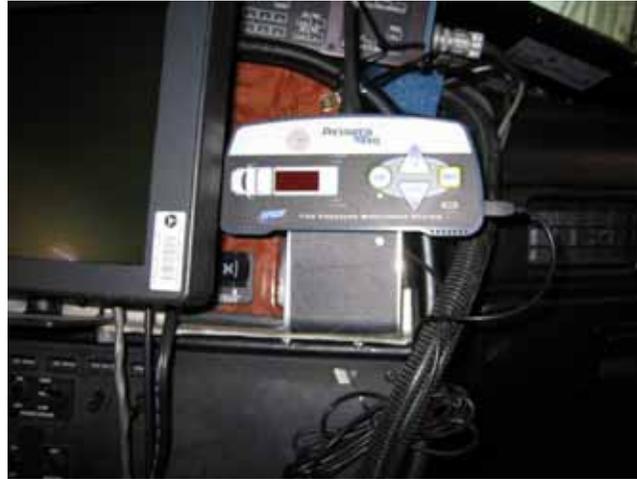
Figure 2.12. PressurePro Driver Display Mounted in the Truck

The fifth TPMS system tested, PressurePro, contained a very small set of components and was easy to install. The single receiving antenna was mounted on the top of the driver display (Figure 2.12) so the only cable installation was for power to the TPMS.

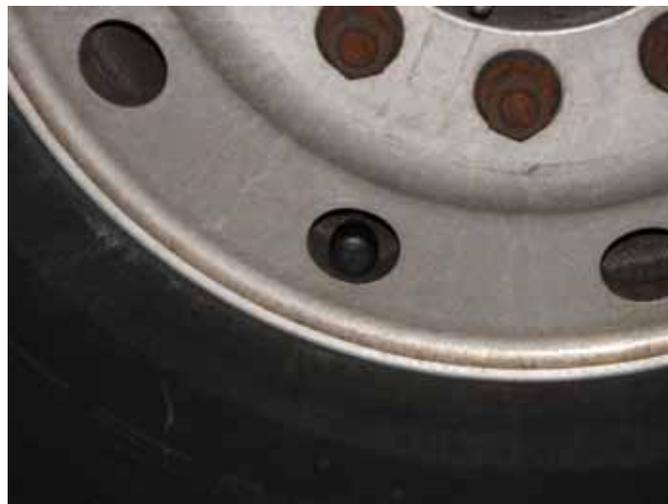
Figure 2.13. PressurePro Transmitter on Valve Stem in Aluminum Steer Wheel of the Tractor with Small Hand Holes

The sensors were installed by removing the valve stem caps and replacing them with the sensors. However, there was some concern raised when installing the sensors on aluminum rims with small hand-holes. The sensor nearly filled the opening in the rim, thus making it challenging for the installer to ensure proper tightness was applied to the sensor (Figure 2.13). The clearance around the sensor was less of a concern for installation on steel wheels with larger hand-holes in the rim (Figure 2.14).

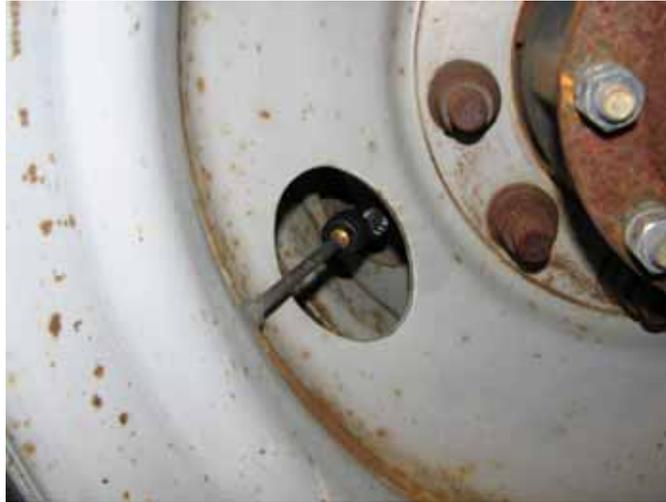
**Figure 2.14. Side View of Two PressurePro Sensors Mounted on Dual Steel Wheels
Sensors Were Installed With the Wheels Already Mounted on the Hubs**

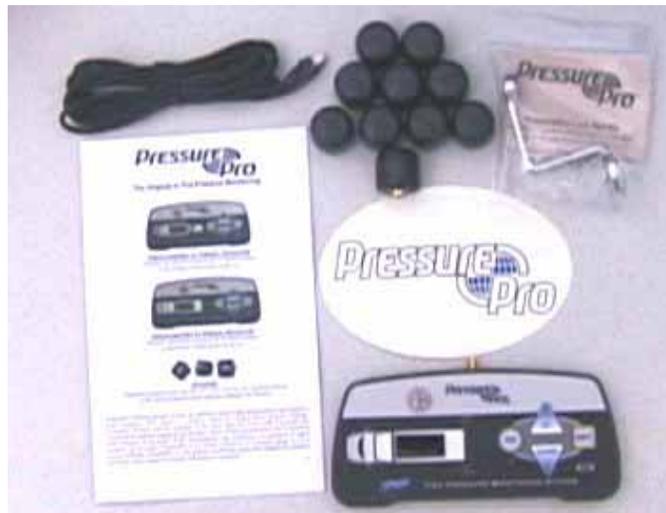
Figure 2.15. Components Kit for PressurePro Valve-Stem Mount 10-Tire System

Figure 2.15 shows the installation kit for the PressurePro TPMS. The packet contained ten sensors, a driver display, monopole antenna, and power cable. This system supports a maximum of thirty-four sensors.

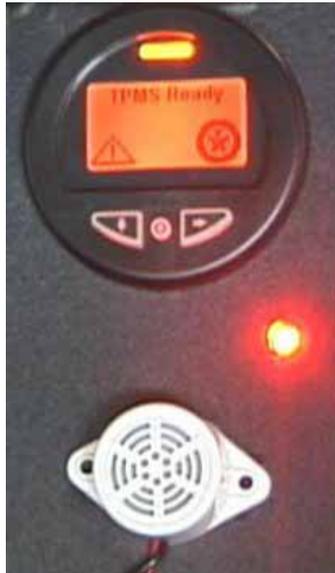
Figure 2.16. SmartWave Display

SmartWave provides a round driver display with a red plasma display, an amber (yellow) warning lamp, and two programming buttons. VRTC connected an external buzzer to the provided annunciator output wire. The round driver display and the annunciator (buzzer) were mounted on a sheet metal bracket fabricated for these tests. Also a red LED was located on this bracket between the display and the buzzer. These components can be seen in Figure 2.16.

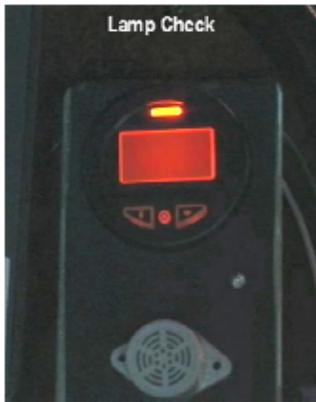
Figure 2.17. Power-Up Lamp Check

At power-up the display screen, warning lamp, and buzzer come on for approximately three seconds (Figure 2.17). Then the logo screen appears for about two seconds (Figure 2.18). The initialization progress is displayed for ten to fifteen seconds. This screen is followed by the “TPMS Ready” and the full tire icon (Figure 2.19).

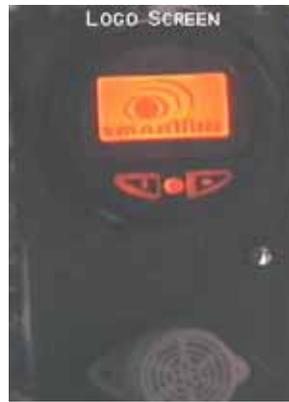
Figure 2.18. Logo Screen

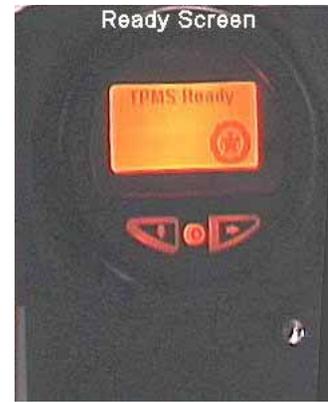
Figure 2.19. Ready Screen

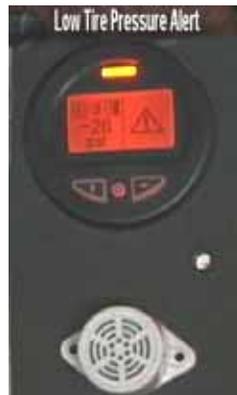
Figure 2.20. Low-Pressure Warning

The warning lamp flashes at a rate of about three times a second. The audible alarm (buzzer) is on for two seconds. On the display, the axle and wheel position are indicated graphically as is the pressure deviation icon; a triangle enclosing an exclamation point (Figure 2.20).

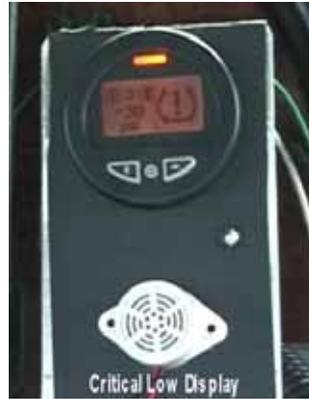
Figure 2.21. Critical Low-Pressure Warning

The warning lamp flashes at a rate of about three times a second. The audible alarm (buzzer) is on for two seconds. On the display, the axle and wheel position are indicated graphically as is the Second Alert Level icon; a tire cross section enclosing an exclamation point (Figure 2.21).

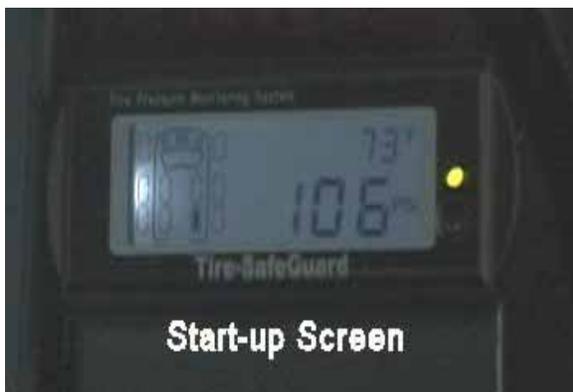
Figure 2.22. Display at Power-up

At power on, the green power light turns on and the tractor/truck icon with the wheel position indicators is displayed as shown in the left photo (Figure 2.22). The monitor display then cycles through each tire pressure and temperature. Then only the green status light remains lit in the normal mode as shown in the right photo (Figure 2.23). There is no audible alert sounded during startup unless there is a warning pending.

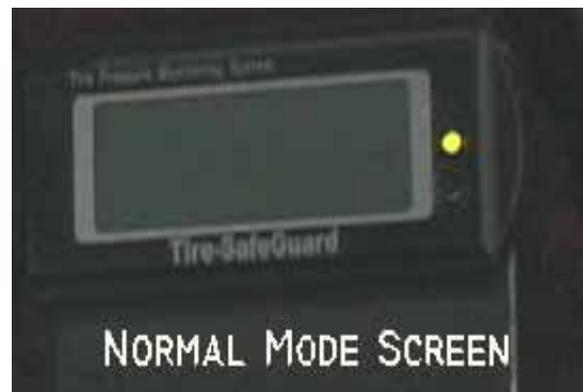
Figure 2.23. Display in “Run” Mode Immediately After Power-up Cycle

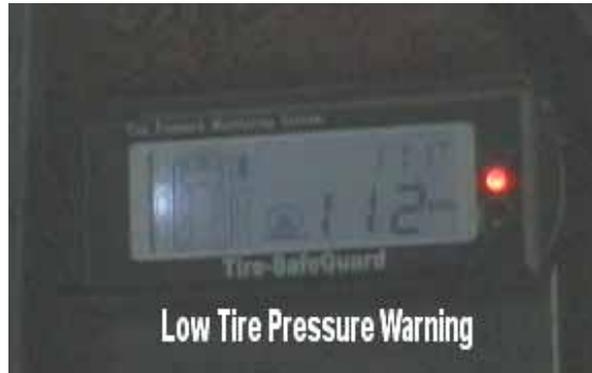
Figure 2.24. Low-Pressure Detection in Right Front Steer Tire

tire temperature and tire pressure are also displayed. After the initial visual and audible alarm, the screen then cycles through the remaining tire pressures and temperatures.

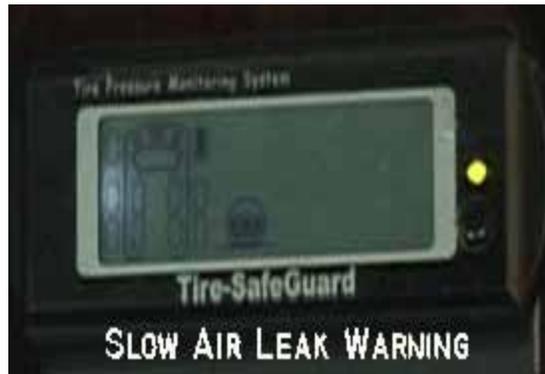
Figure 2.25. Slow Leak Warning for Left Front Steer Tire

The slow leak warning is indicated by a green status light, tire position indicator highlighted, and the slow air leak icon. The slow leak icon is represented by a graphic that shows the tire two-thirds full. This warning is shown in the photo below (Figure 2.25).

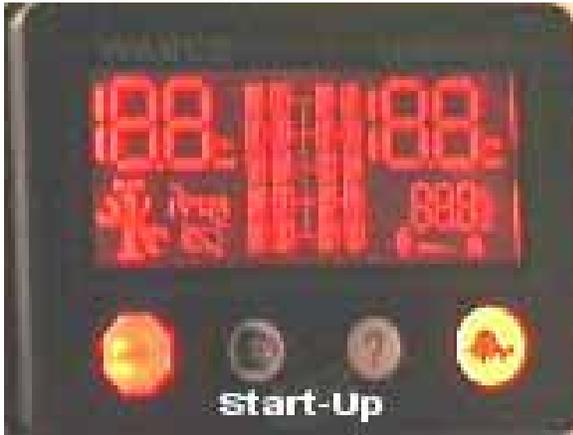
Figure 2.26. Startup Lamp Check

At startup, the audible alarm beeps twice and all of the red icons light for a duration of about one second. The two warning symbols below the main display flash on for one second also (Figure 2.26). After initialization the normal mode displays only the IVTM icon as seen in the right photo (Figure 2.27).

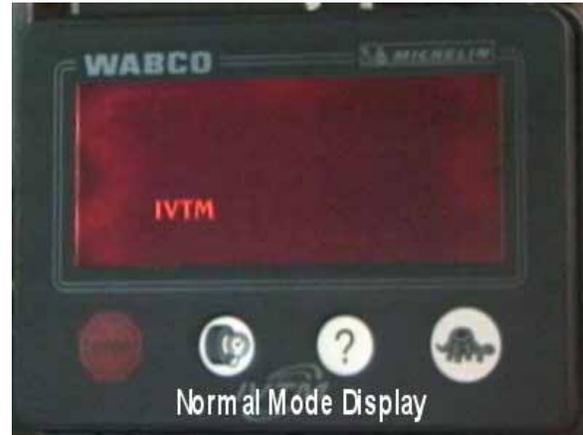
Figure 2.27. Display in Ready Mode – for Normal Operation

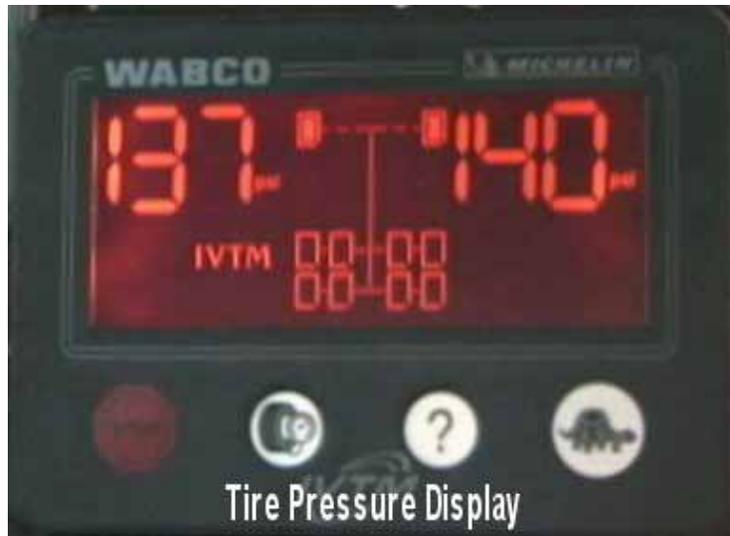
Figure 2.28. Steer Tire Pressures after “Hot” Calibration Test

From the normal mode, individual tire pressure readings can be read by pushing the button with the pressure gauge/tire graphic (bottom row, second icon from the left). Individual axles are highlighted one at a time. The following photo shows the steer axle with both the left and right tire pressures displayed. In the case of dual tires on a single wheel end, the outer tires are displayed first, and then the inner tires follow on the next screen, as the pressure/gauge icon is depressed to scroll through the pressures (Figure 2.28).

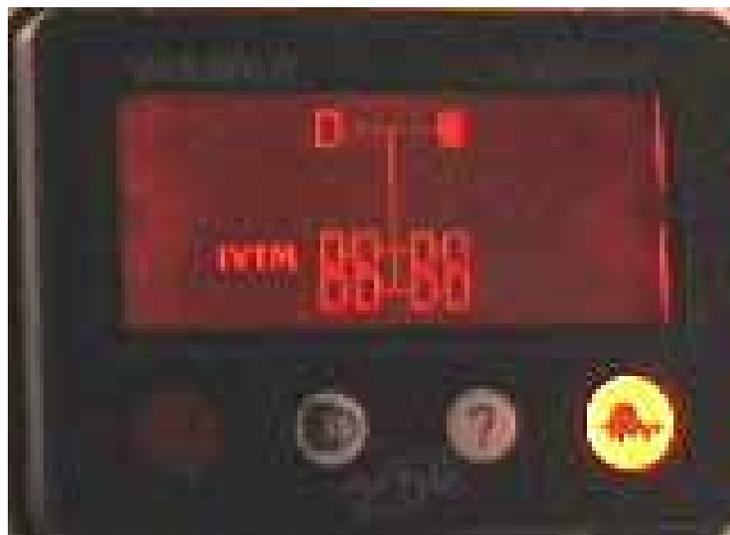
Figure 2.29. First Low-Pressure Warning in Right Front Steer Tire

At the First Setpoint Low-Pressure Alert the tire position of the low pressure tire flashes once per second (Figure 2.29). The audible alert beeps twice at about the same rate. The yellow warning light with the turtle graphic lights and stays on (does not flash).

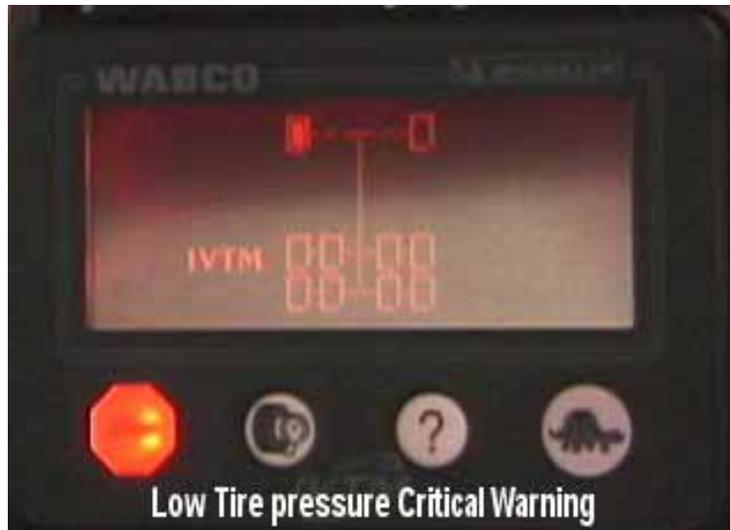
Figure 2.30. Critical Low-Pressure Warning Indicates to Driver to Stop and Service Tire

The Second Stage Low-Pressure Alert is similar to the First Stage Alert, but the tire position indicator lamp flashes two times per second and the audible alert beeps twice per second (Figure 2.30). These two indicators activate in unison. The red warning light with the stop-sign graphic lights and stays on (does not flash).

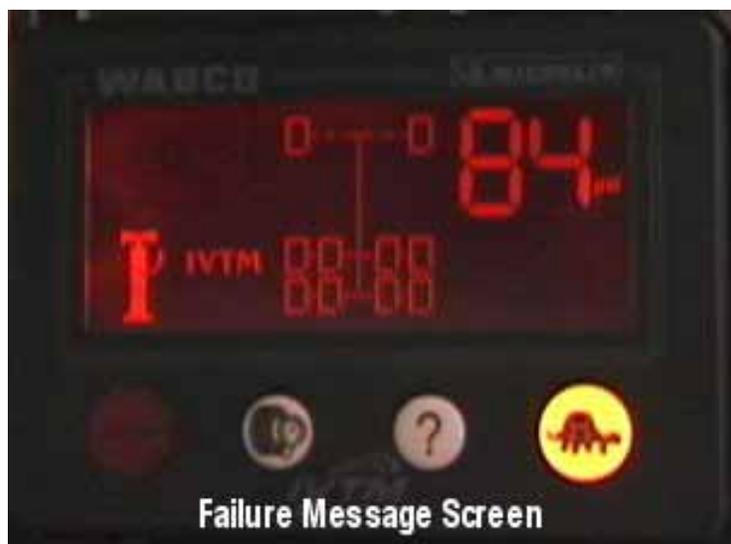
Figure 2.31. Information Screen Showing Tire Pump Signifying that a Tire Needs to be Re-Inflated

By pushing the button with the large question mark icon, detailed and additional information about an alert will be displayed. The photo below is an example of the information display for a low tire pressure alert. The tire pump signifies that a tire is underinflated and needs attention soon (Figure 2.31).

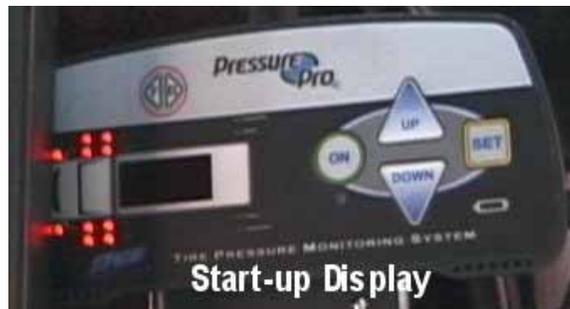
Figure 2.32. Lamp Check at Power-On

At power on, the green power light turns on and then flashes about every five seconds. The red tire position indicator LEDs for all programmed tires light for five seconds and then turn off. The LEDs remain off until prompted by the operator pressing a button, such as scrolling through the tire list to read tire pressures (Figure 2.32). The green power light continues to flash every five seconds in the normal mode (Figure 2.33). There is no audible-alert check during the startup lamp-check sequence.

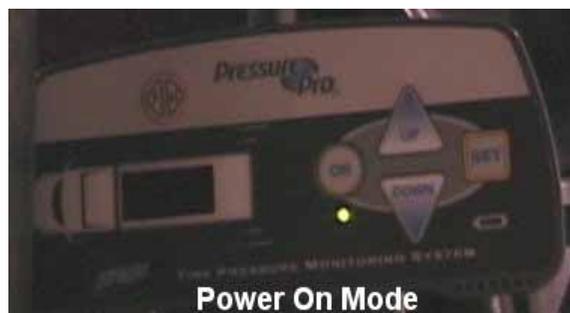
Figure 2.33. Display in Ready Mode

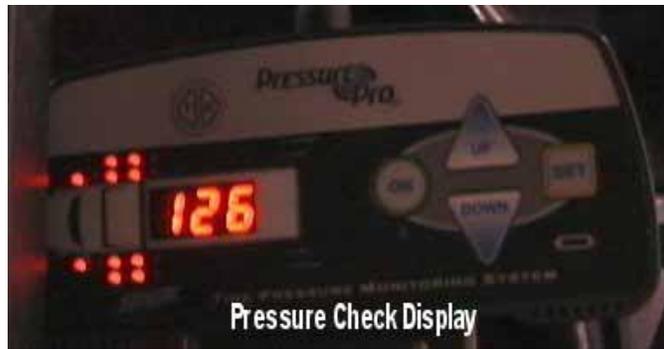
Figure 2.34. Current Pressure is 126 psi in Left Front Steer Tire

In the normal mode, individual tire pressure readings can be displayed by pushing either the up-arrow button or the down-arrow button. The up-arrow button scrolls through the tire positions clockwise and the down-arrow button scrolls through them counterclockwise. The tire position flashes about once per second while the pressure remains lit (Figure 2.34).

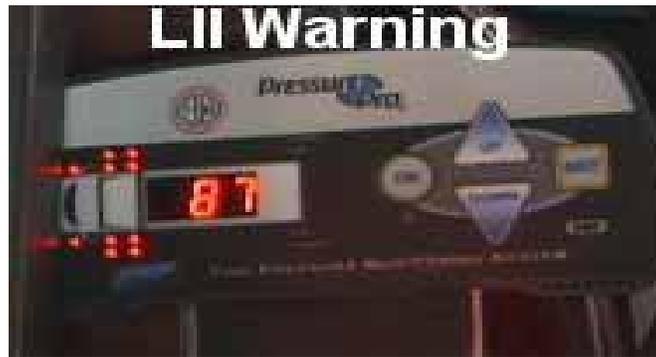
Figure 2.35. Inside Tire on Left Intermediate Axle Channel Is Warning of a First Stage Low-Pressure Detection

At the First Stage Low-Pressure Alert the tire position indicator lamp and the pressure-display number flash once per second and the audible beeper sounds once per second. These three indicators alert in unison (Figure 2.35).

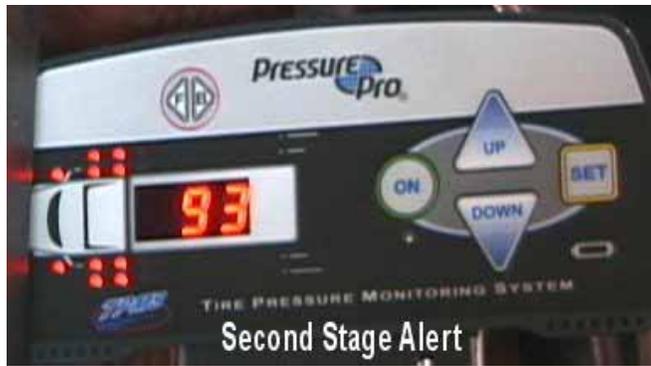
Figure 2.36. Left Front Steer Tire Channel Is Warning of a Second Stage Low-Pressure Detection

The Second Stage Low-Pressure Alert is similar to the First Stage Alert, but the tire position indicator lamp and the pressure display number flash two times per second and the audible beeper sounds two times per second. These three warning indicators activate in unison (Figure 2.36).

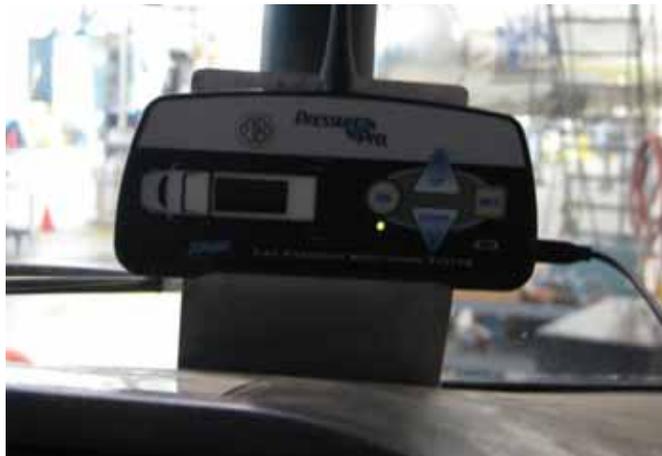
Figure 2.37. PressurePro Driver Display Showing “Ready Mode” on Screen; Only the Green Light is Visible in This Mode When Not Hand Selecting Pressures

Following are a set of photographs showing: the driver display in ready mode (Figure 2.37), showing a TPMS measured pressure of 126 psi in the right front tire (Figure 2.38), and showing all active sensors, but no pressure readings (Figure 2.39).

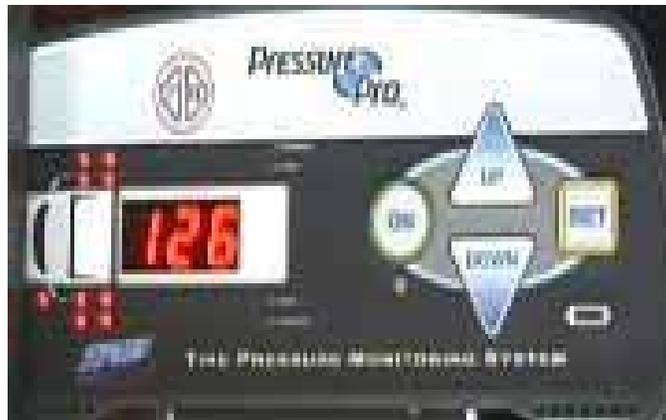
Figure 2.38. PressurePro Display Showing 126 psi Tire Pressure in Right Front Tire Instead of the Applied 130 psi CIP

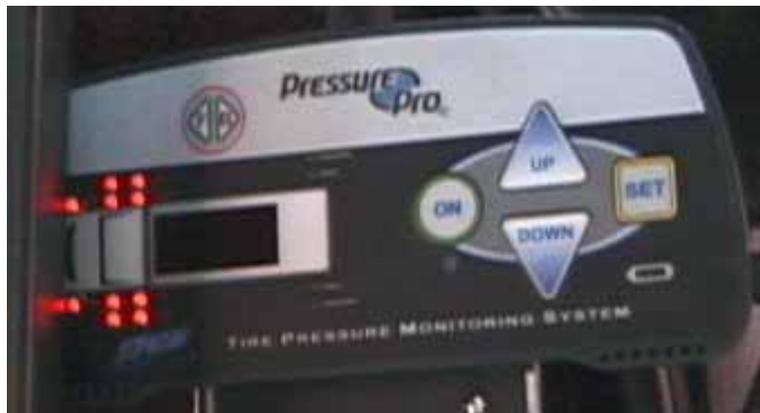
Figure 2.39. PressurePro Display Showing All Active Sensors, But No Pressure Indications

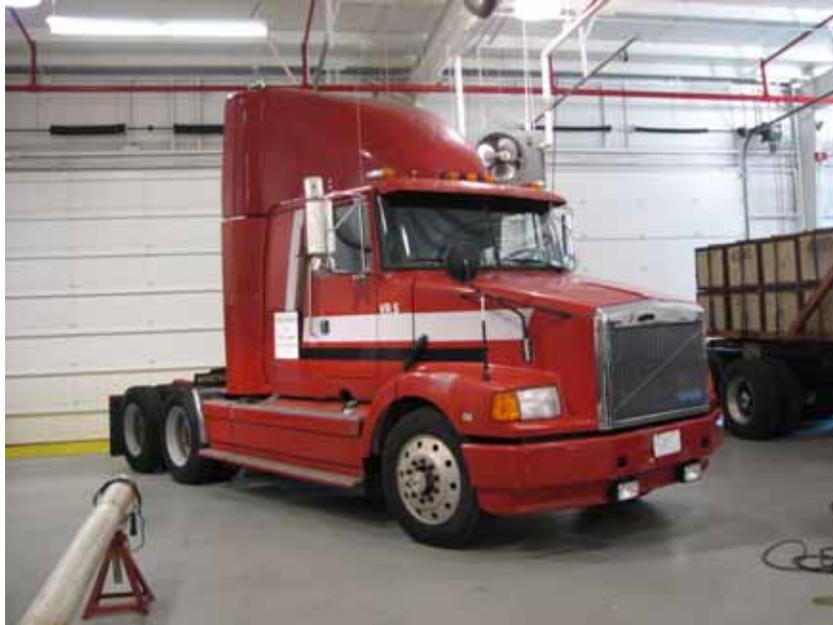
Figure 3.1. Volvo Tractor

Volvo Tractor was a 1991 Model No. WIA64T sleeper-cab tractor with a 189-inch wheelbase (Figure 3.1). The GVWR was 50,000 lb and the Gross Axle Weight Ratings (GAWRs) were 12,000 lb (steer axle) and 19,000 lb (each drive axle).

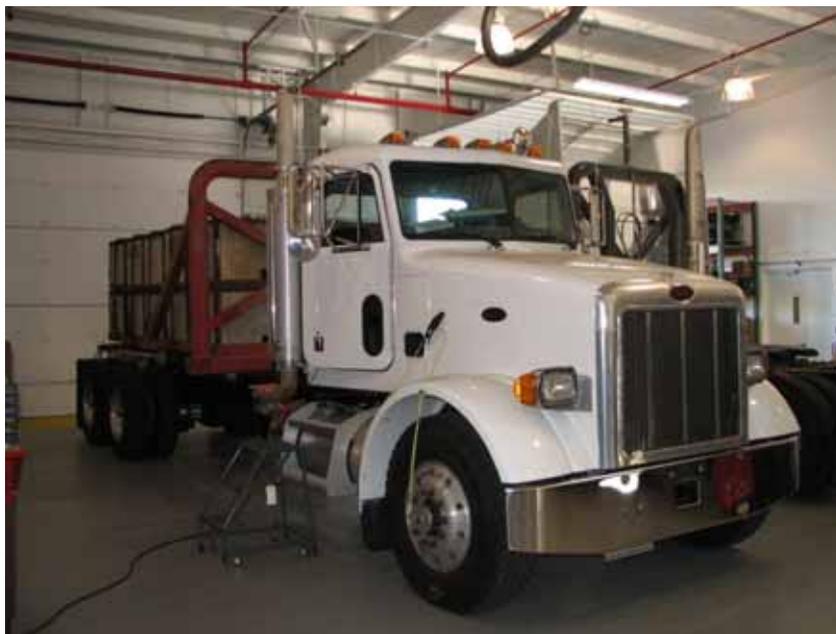
Figure 3.2. Peterbilt Straight Truck

Peterbilt Truck was a 2004 Model No. 357 day cab straight truck with a 273-inch wheelbase (Figure 3.2.). The GVWR was 62,000 lb and the GAWRs were 18,000 lb (steer axle) and 22,000 lb (each drive axle).

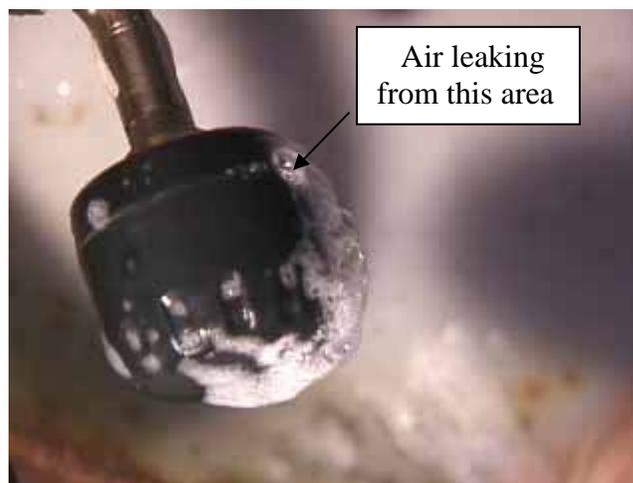
Figure 9.1. Sensor Body Leak

One of the valve stem mounted sensors developed a leak on the periphery of the sensor body. This leak was not coming from the mounting threads or seal, but from the midsection of the sensor housing as denoted by the arrow in Figure 9.1.

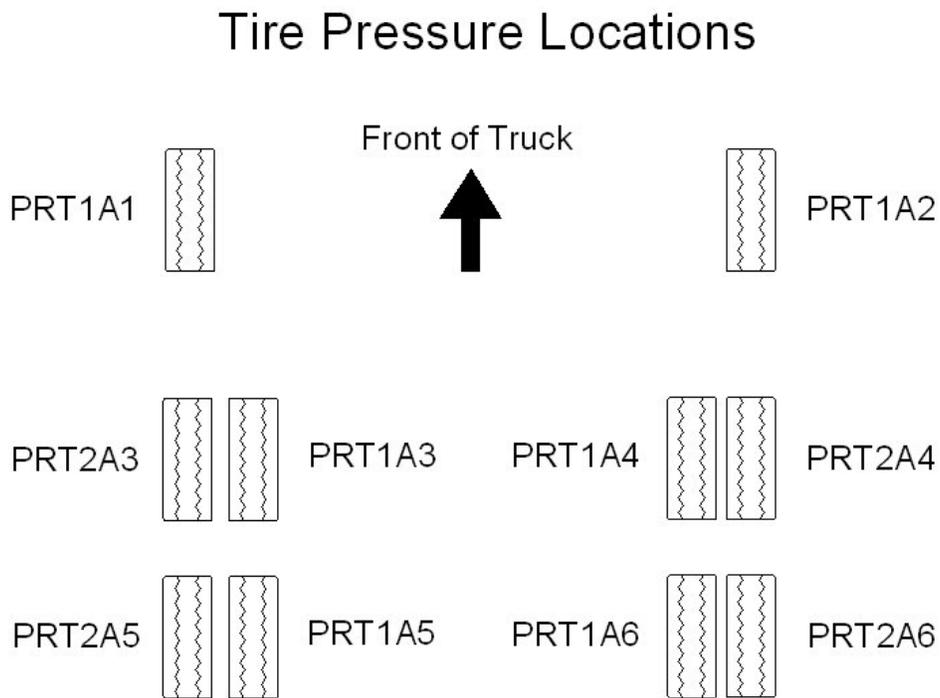
Figure A.1. CDAS Computer Orientation for Tire Pressure Control System

When tire pressure lines were connected from each individual tire to the pressure transducers on the data system, a 3-character prefix was added to each data channel. “PR” indicated a pressure transducer. The third character “T” declared that it was attached to a tire position. Therefore, a CDAS data acquisition system channel representation of the previous example was programmed as “PRT2A6,” or pressure transducer for an outer tire on the right-rear drive wheel of a lead vehicle. Figure A.1 displays the wheel layout of the two, 10-tire trucks, and overlays the assigned CDAS tire data channel names.

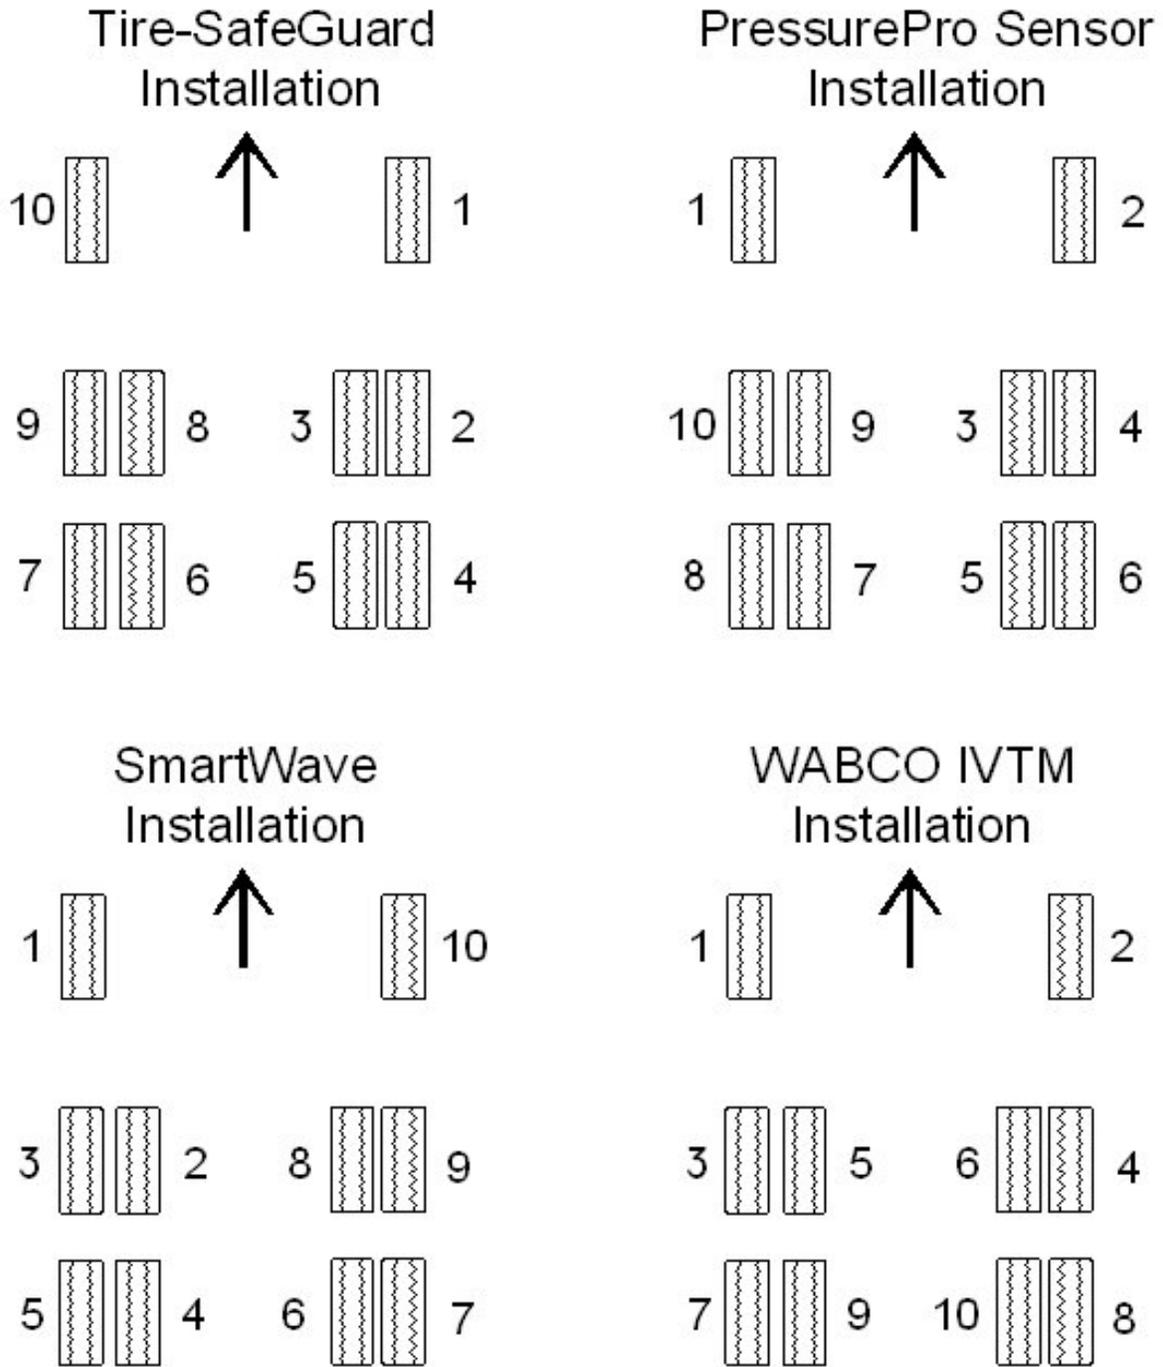
Figure A.2. Differences in Tire Location Identification among TPMS Suppliers

Both installers and the tire maintenance crews could greatly benefit by standardization of the tire numbering sequence. With the disarray in the current numbering schemes, much time may be wasted trying to keep the sensors assigned to specific tire locations during tire rotations or replacement. Some sensors do not have permanent ID tags that indicate channel codes or serial numbers required to program the displays to read the respective channels.

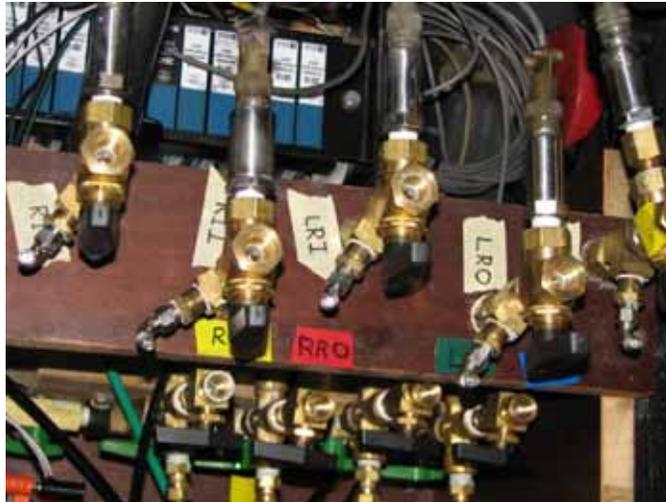
Figure B.1. Pressure Transducers and Signal Conditioners

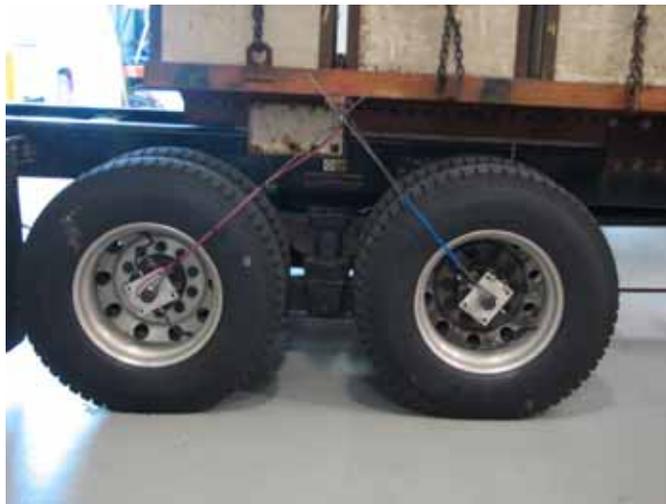
Figure B.2. Air Lines and Rotary Unions on Right Side Drive Tires of the Truck

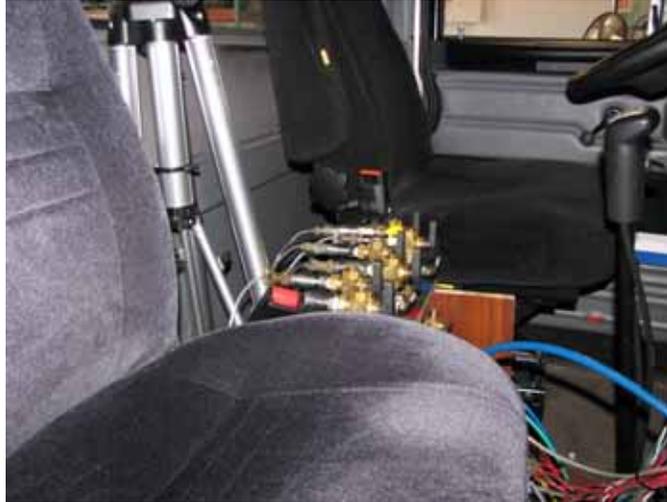
Figure B.3. Observer's View of Tire Pressure Control Manifold

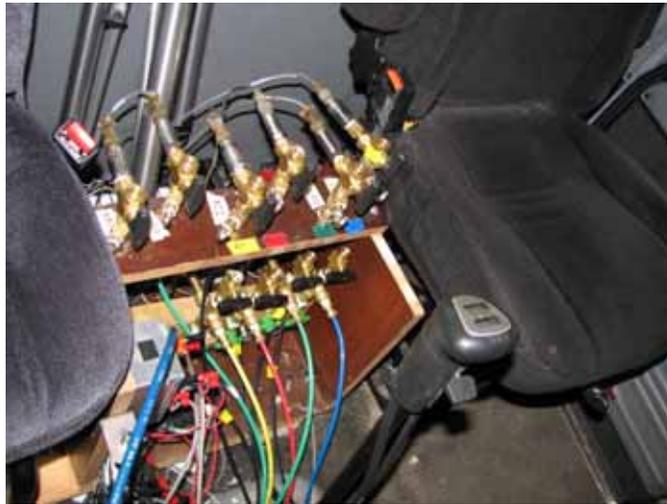
Figure B.4. Pressure Control Manifold Showing All Ten Ports

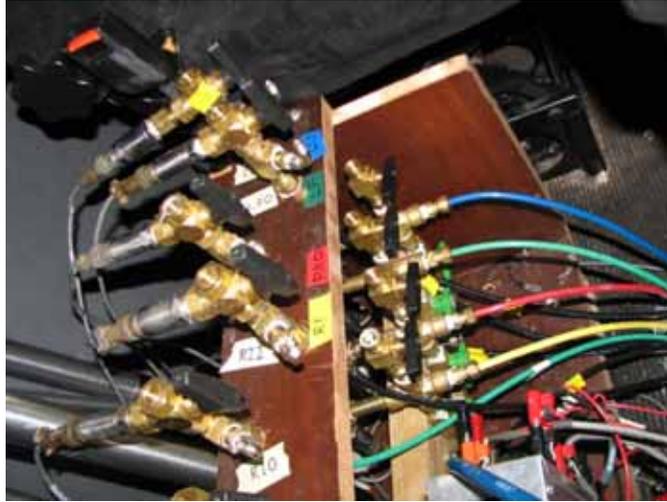
Figure B.5. Close-up View of Pressure Control Manifold

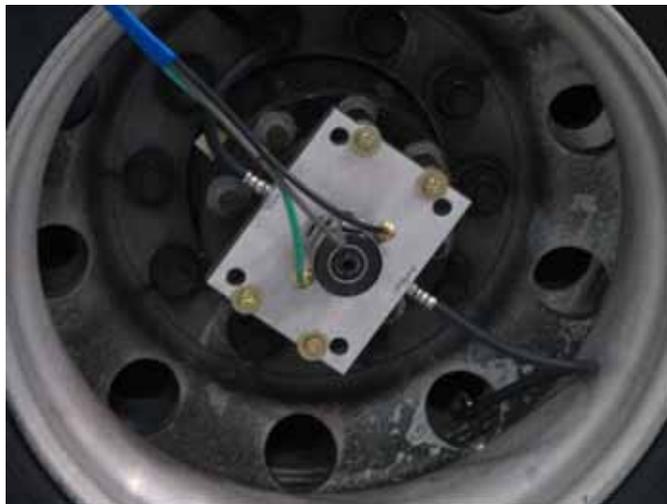
Figure B.6. Two Port Rotary Union on Drive Wheel

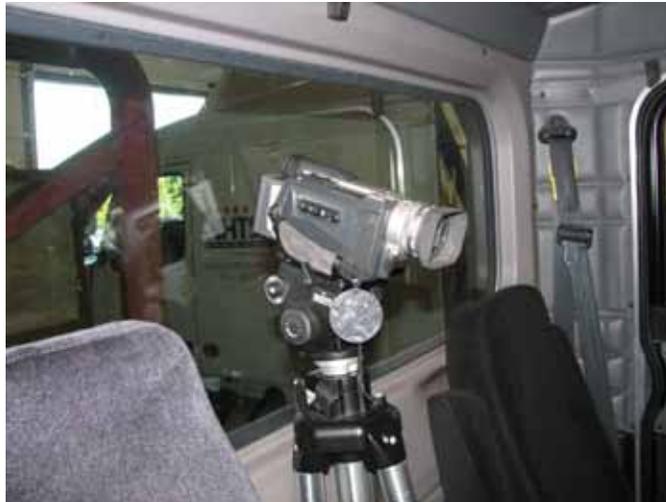
Figure C.1. Video Camera Mounted Between Driver and Observer For Logging All Test Activities

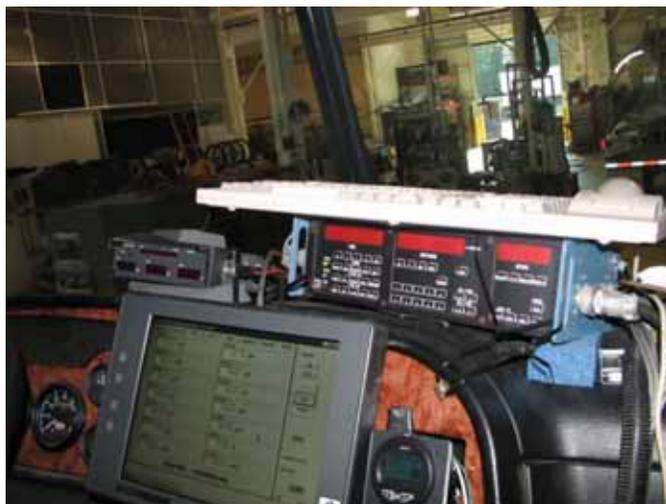
Figure C.2. SmartWave Display (Lower-Right) Along with CDAS Screen and Speed and Distance Measuring Equipment

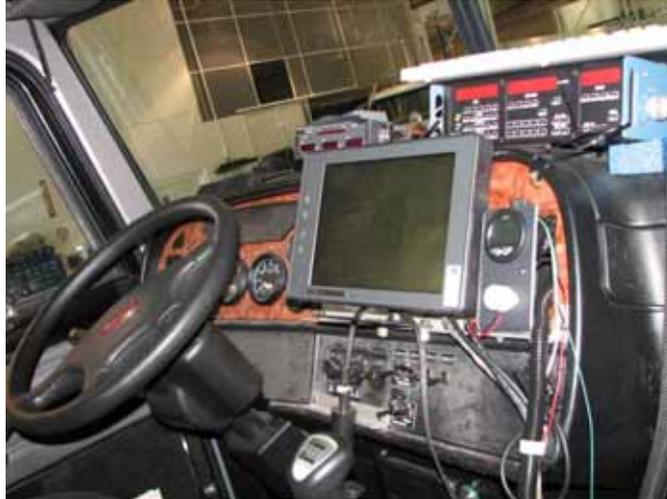
Figure C.3. Right-Seat Observer's View of Instrumentation Displays

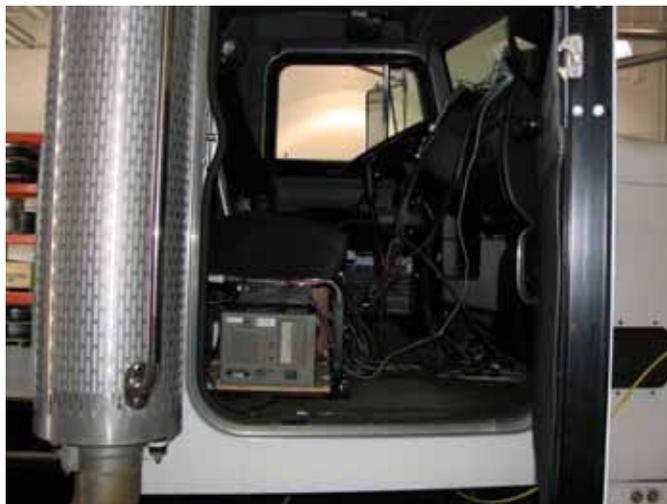
Figure C.4. Data Acquisition Computer Mounted Beneath the Observer's Seat

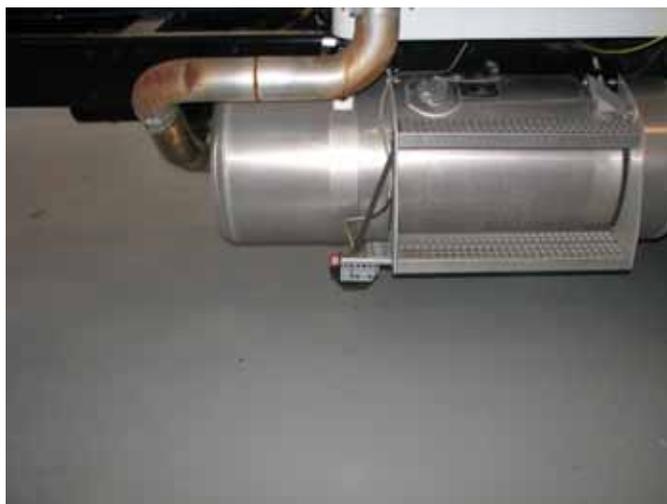
Figure C.5. Noncontact Radar Speed Sensor Mounted Beneath the Aluminum Fuel Tank
