U.S. Department
of Transportation
**National Highway
Traffic Safety
Administration**

DOT HS 811 633

Test Track Lateral Stability Performance of Motorcoaches Equipped With Electronic Stability Control Systems

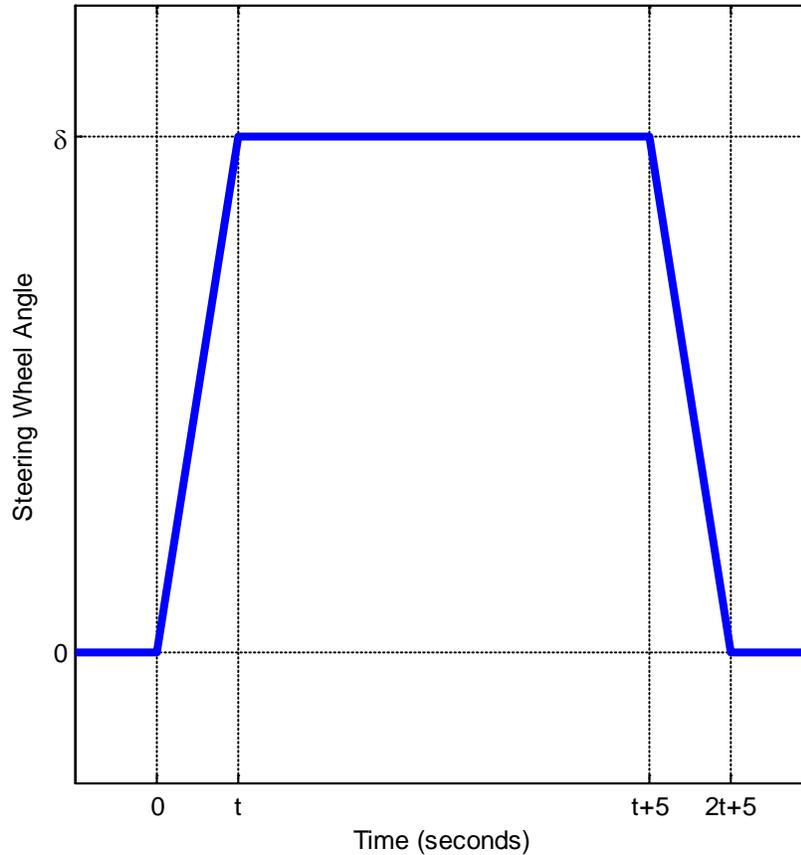
Figure 2.3. Steering wheel profile used for RSM tests.

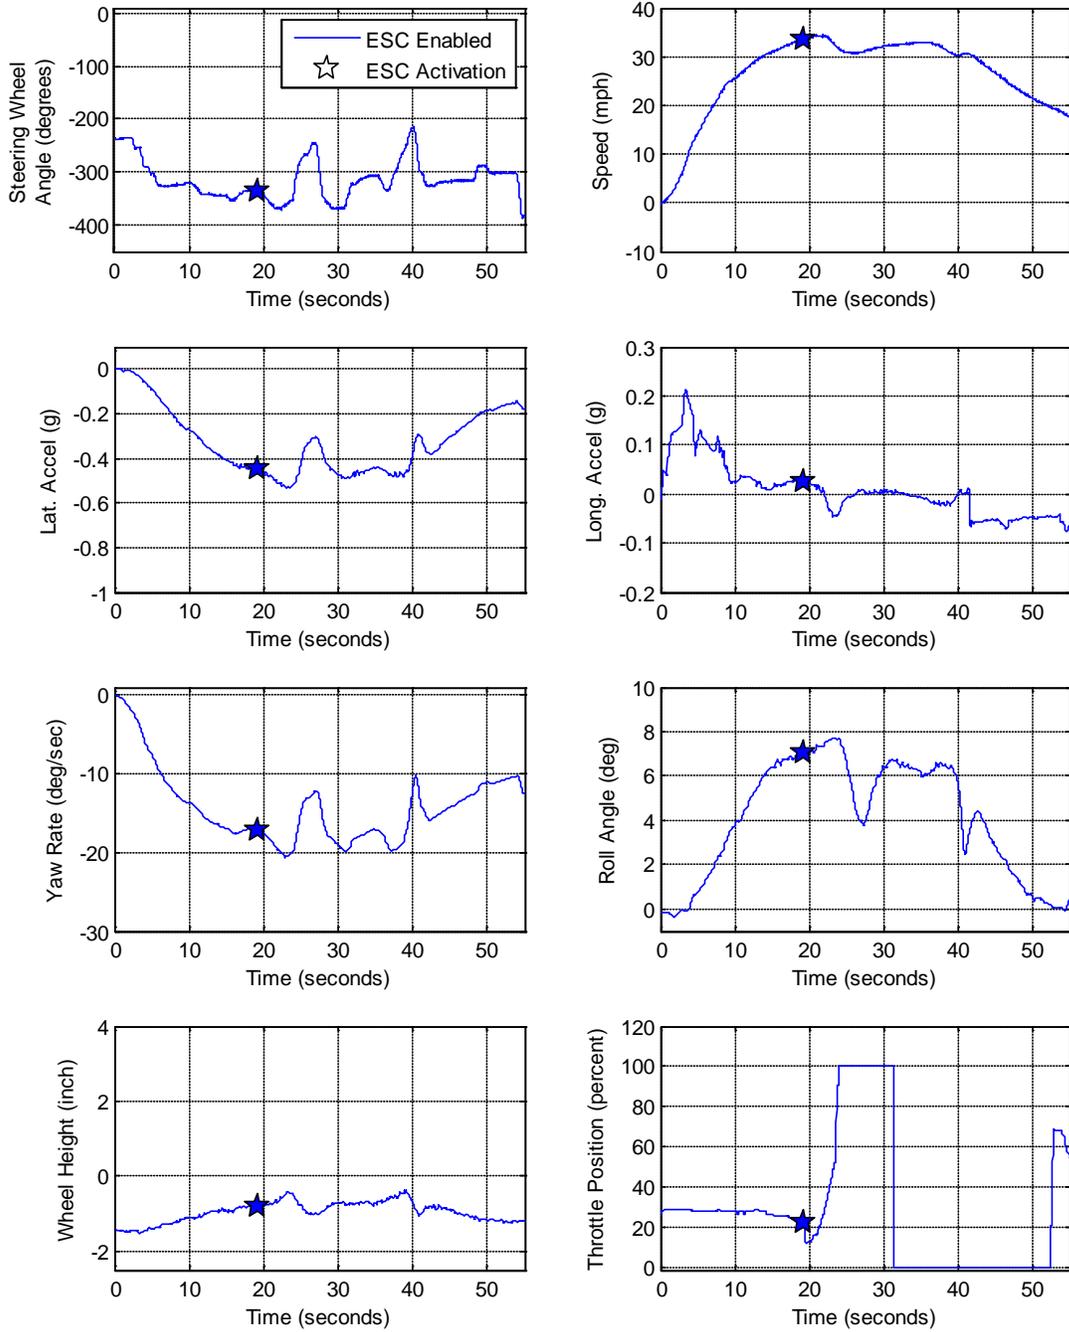
Figure 3.1. Graphs show test data from the MCI #1 CR maneuver counter-clockwise in the GPOW load condition with ESC enabled only.

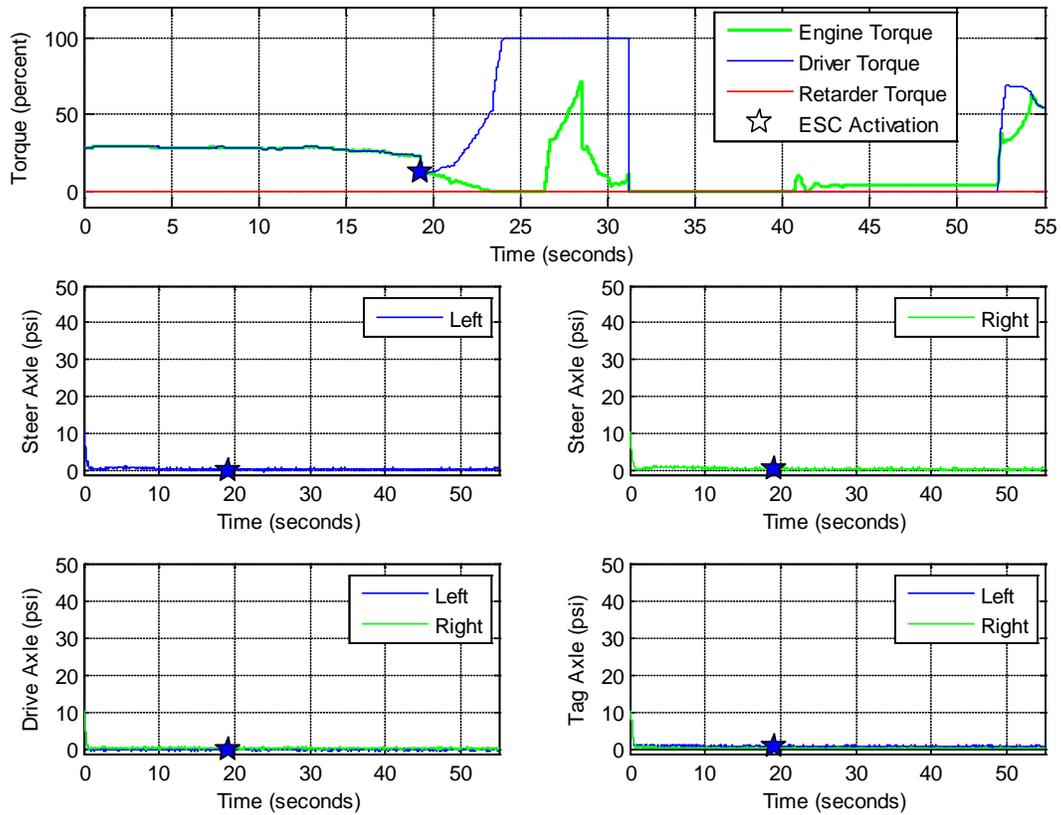
Figure 3.2. Graphs show torque and brake pressure test data from the MCI #1 CR maneuver in the GPOW load condition with ESC enabled only. At ESC activation, the driver requested 100 percent throttle.

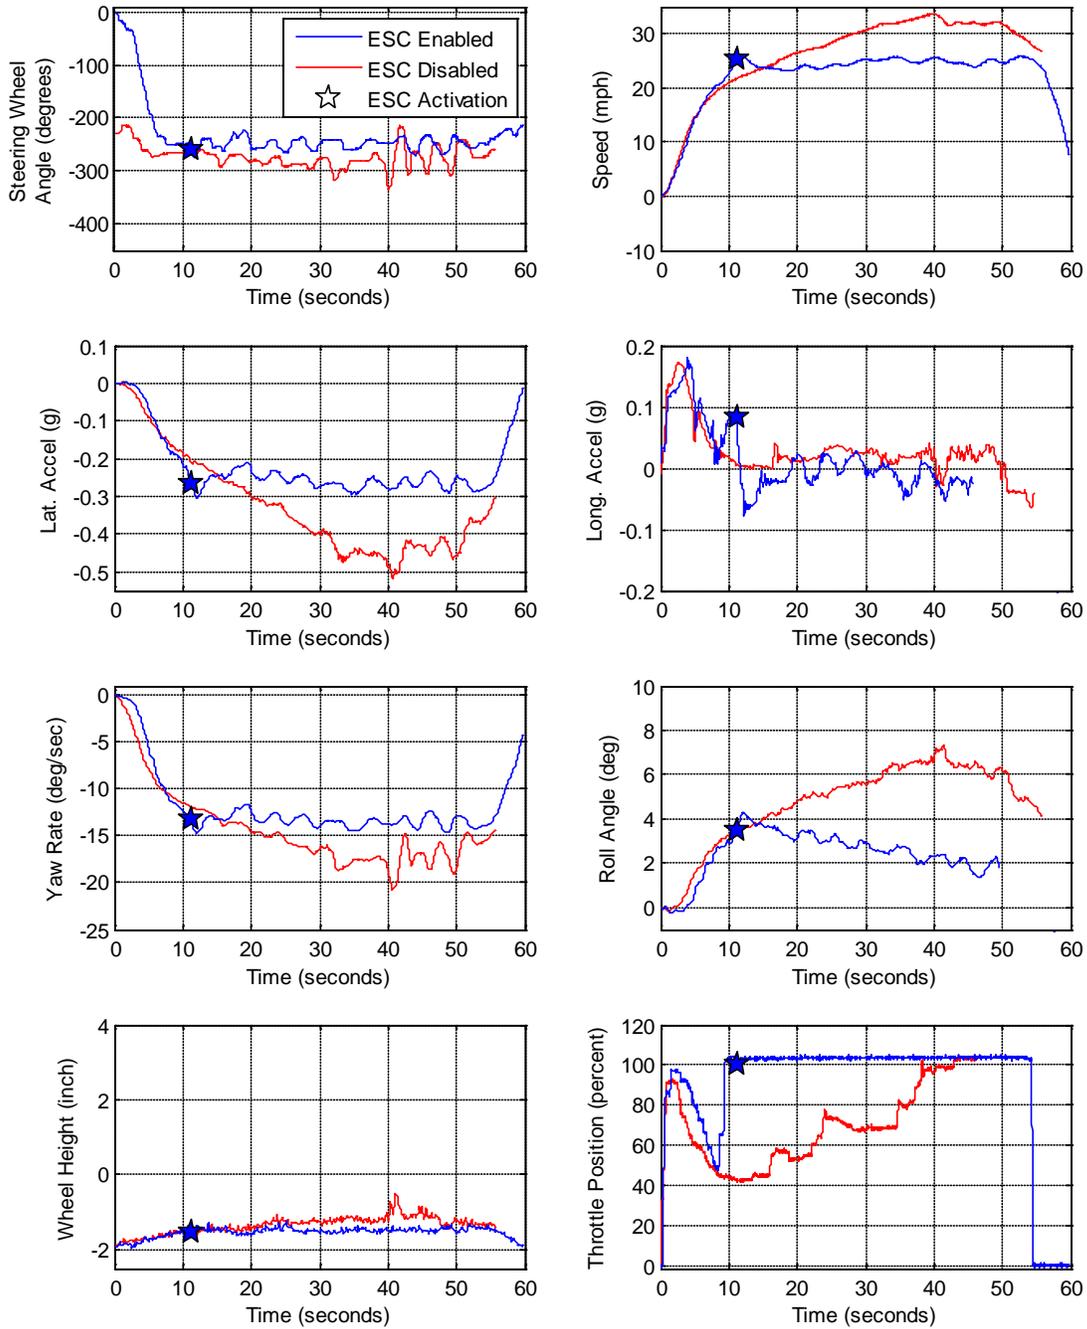
Figure 3.3. Graphs show test data from the Prevoist CR maneuver in the GPOW load condition with ESC enabled and disabled. The ESC disabled test is shown in red and the ESC enabled test is shown in blue.

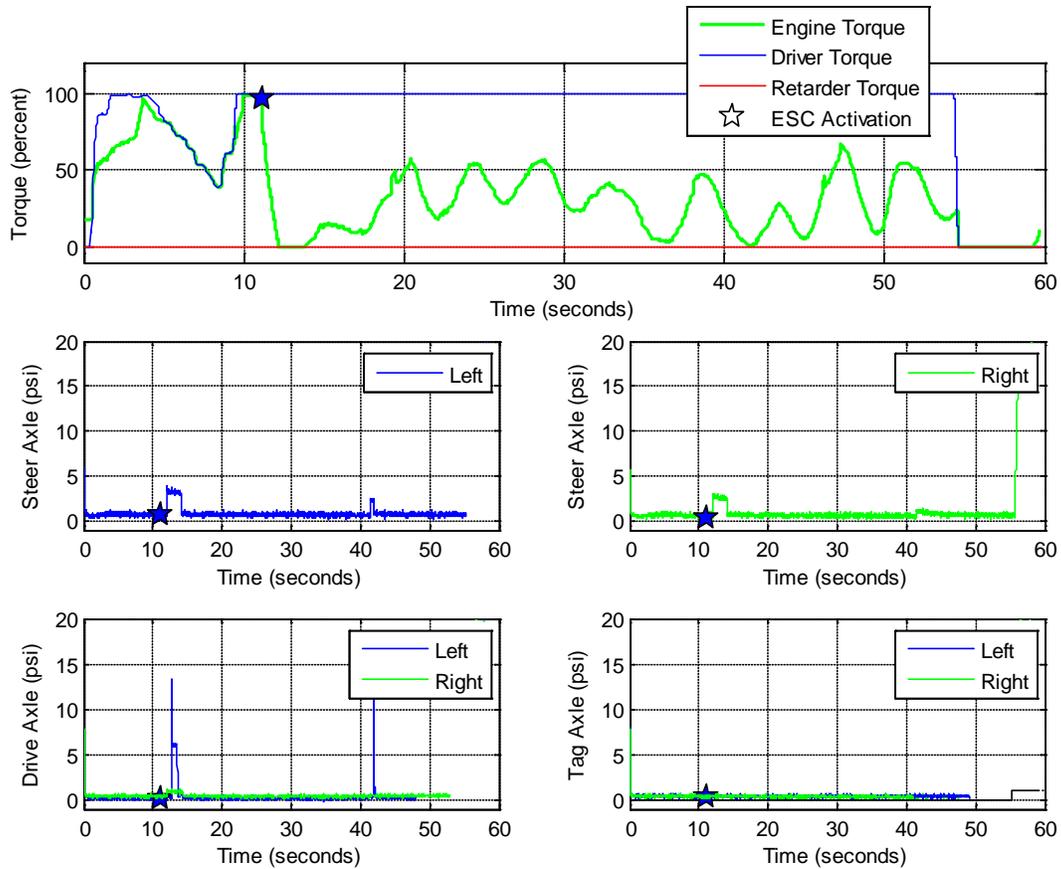
Figure 3.4. Graphs show torque and brake pressure test data from the Prevost CR maneuver in the GPOW load condition with ESC enabled only. At ESC activation the driver requested 100 percent throttle.

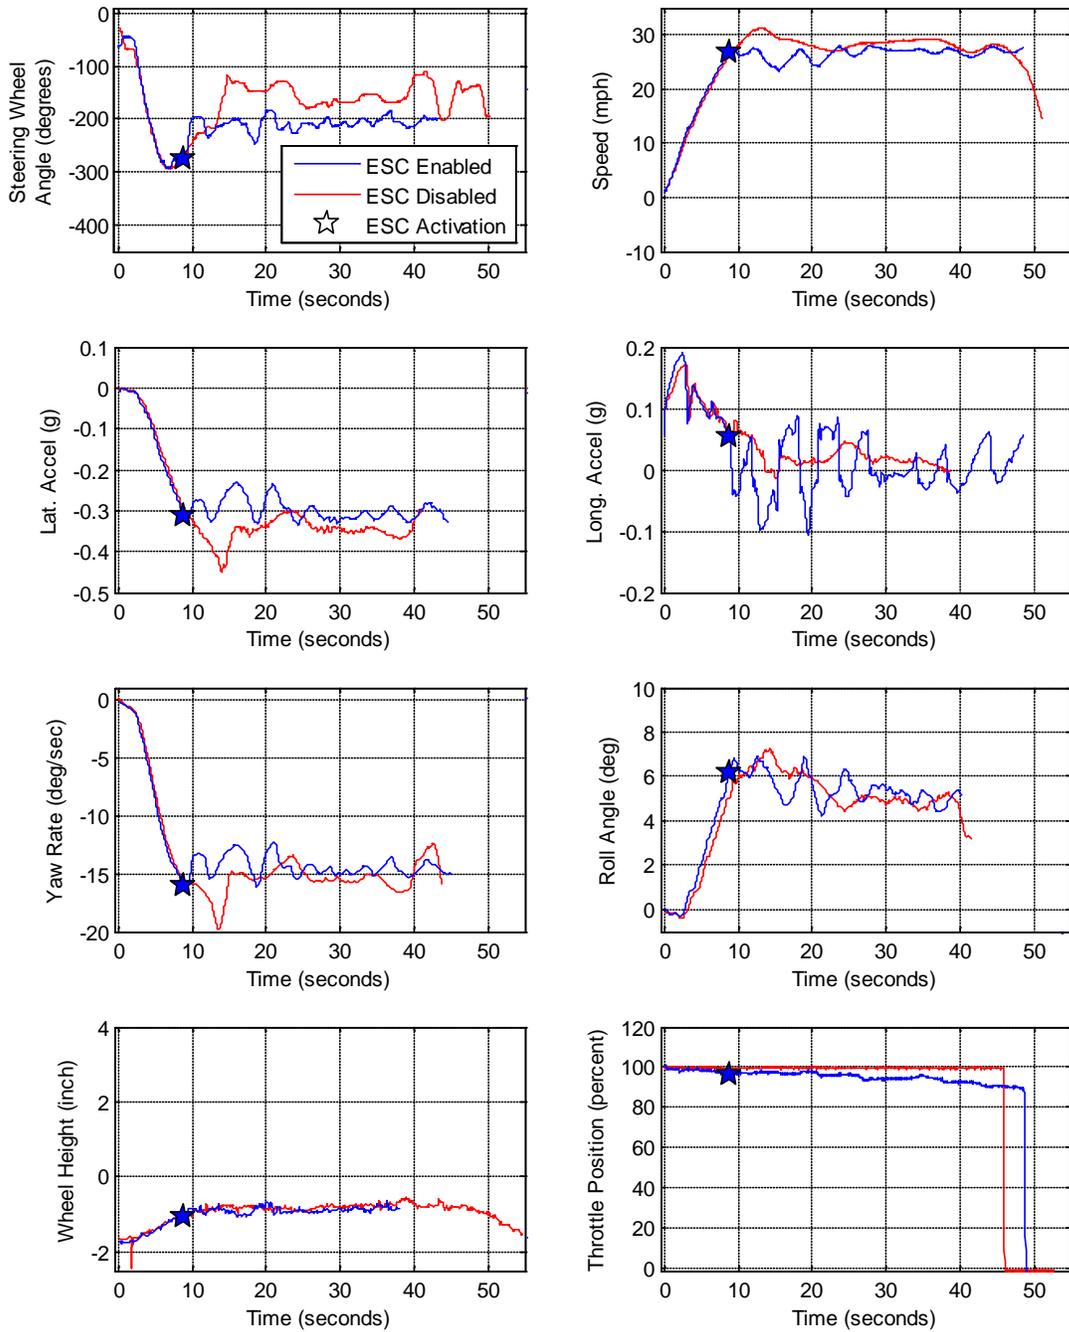
Figure 3.5. Graphs show test data from the MCI #2 CR maneuver in the GPOW load condition with ESC enabled and disabled. The ESC disabled test is shown in red and the ESC enabled test is shown in blue.

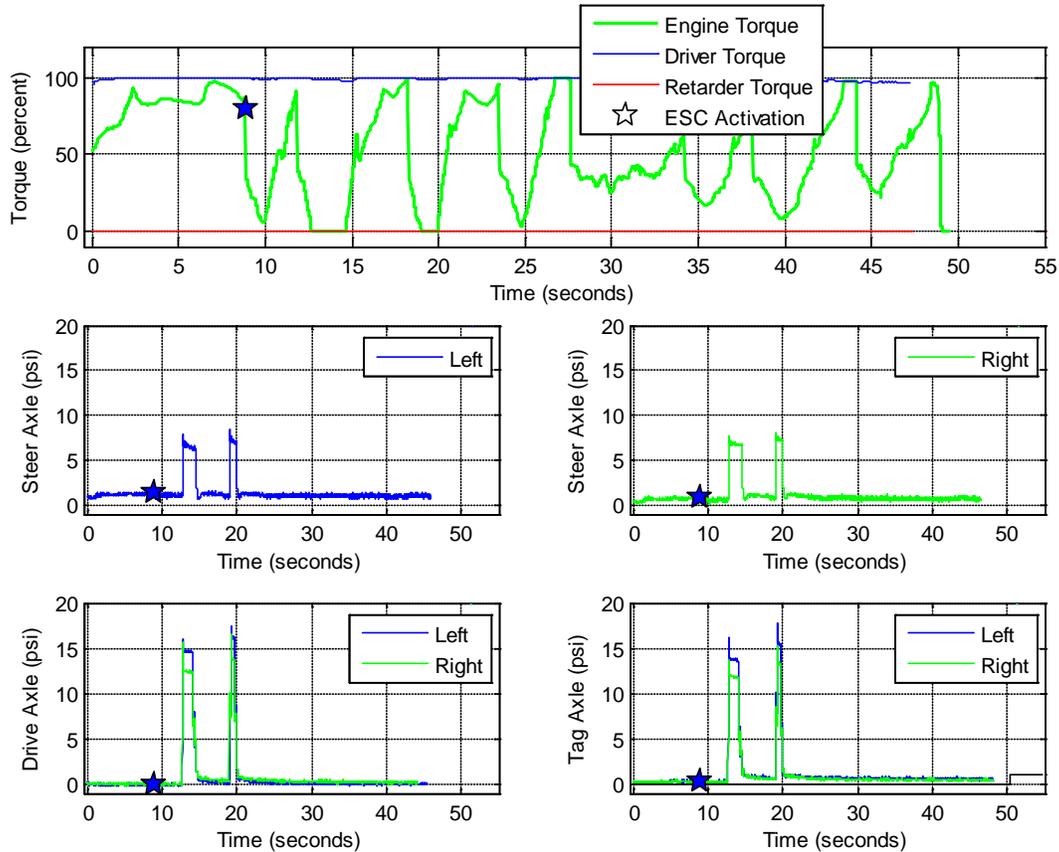
Figure 3.6. Graphs show torque and brake pressure test data from the MCI #2 CR maneuver in the GPOW load condition with ESC enabled only. At ESC activation the driver requested 100 percent throttle.

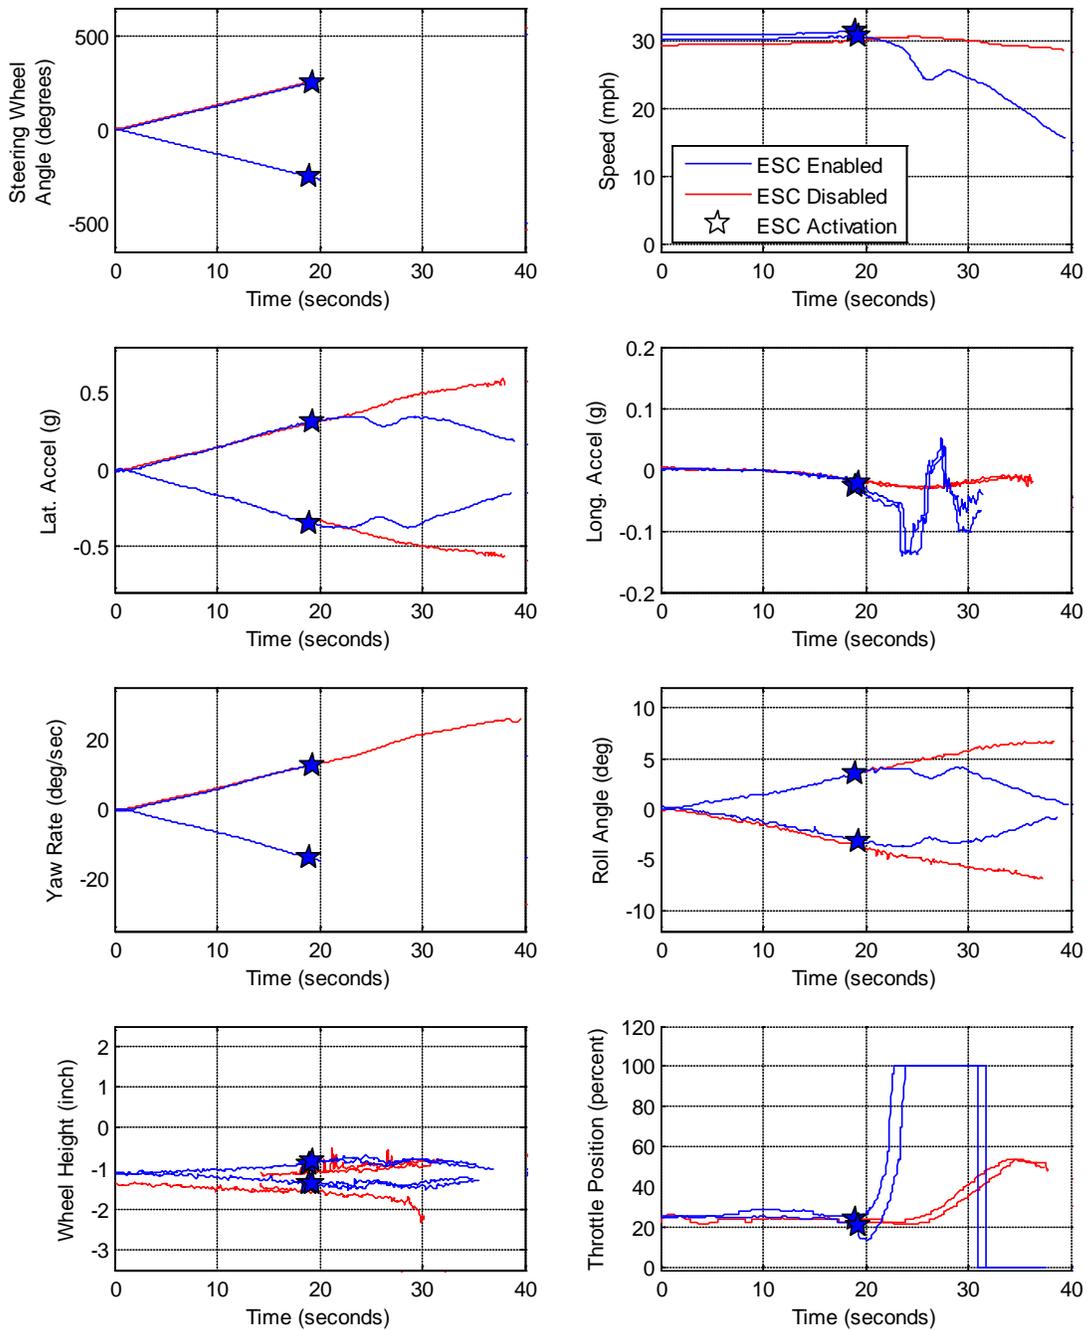
Figure 3.7. Graph shows an example of test data from the MCI #1 SIS maneuver one (one left and one right) in the LLVW load condition with ESC enabled and disabled.

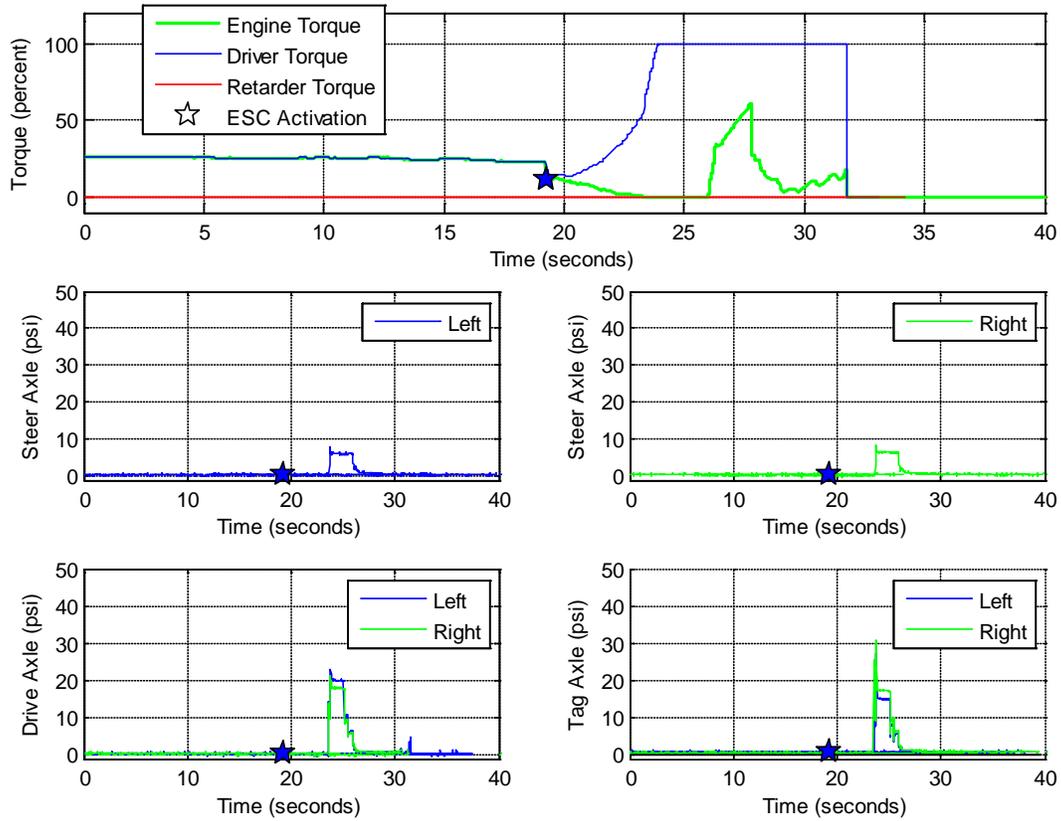
Figure 3.8. Graphs show brake pressures at each wheel and torque outputs for the MCI #1 during a SIS maneuver to the right, with ESC enabled in the LLVW load condition.

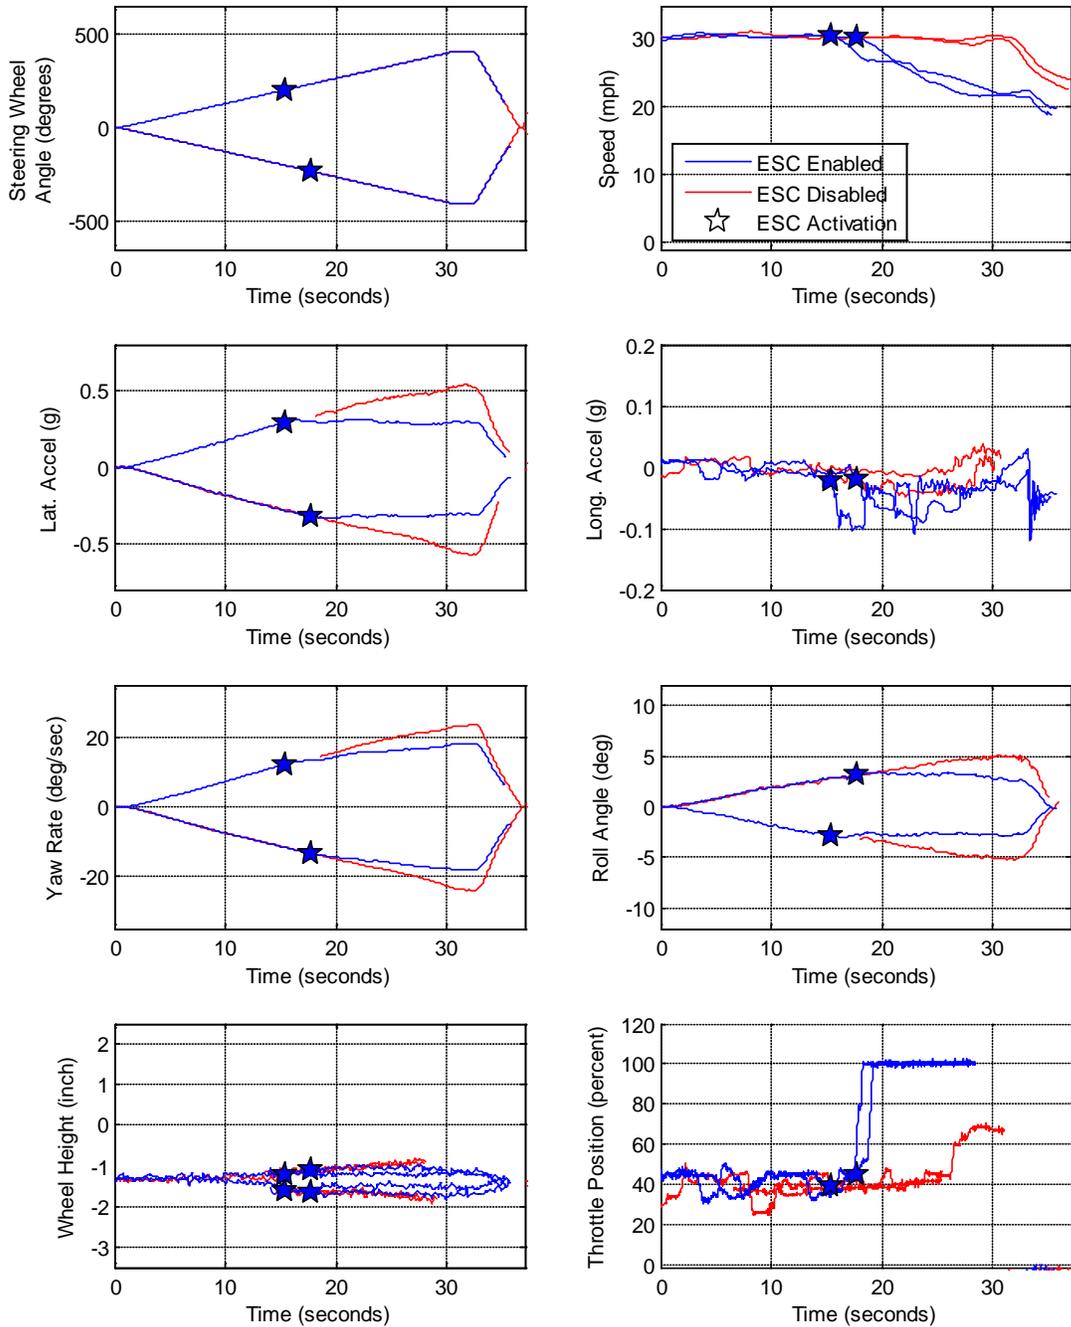
Figure 3.9. Graphs show an example of test data from the Prevest SIS maneuver one (one left and one right) in the LLVW load condition, with ESC enabled and disabled.

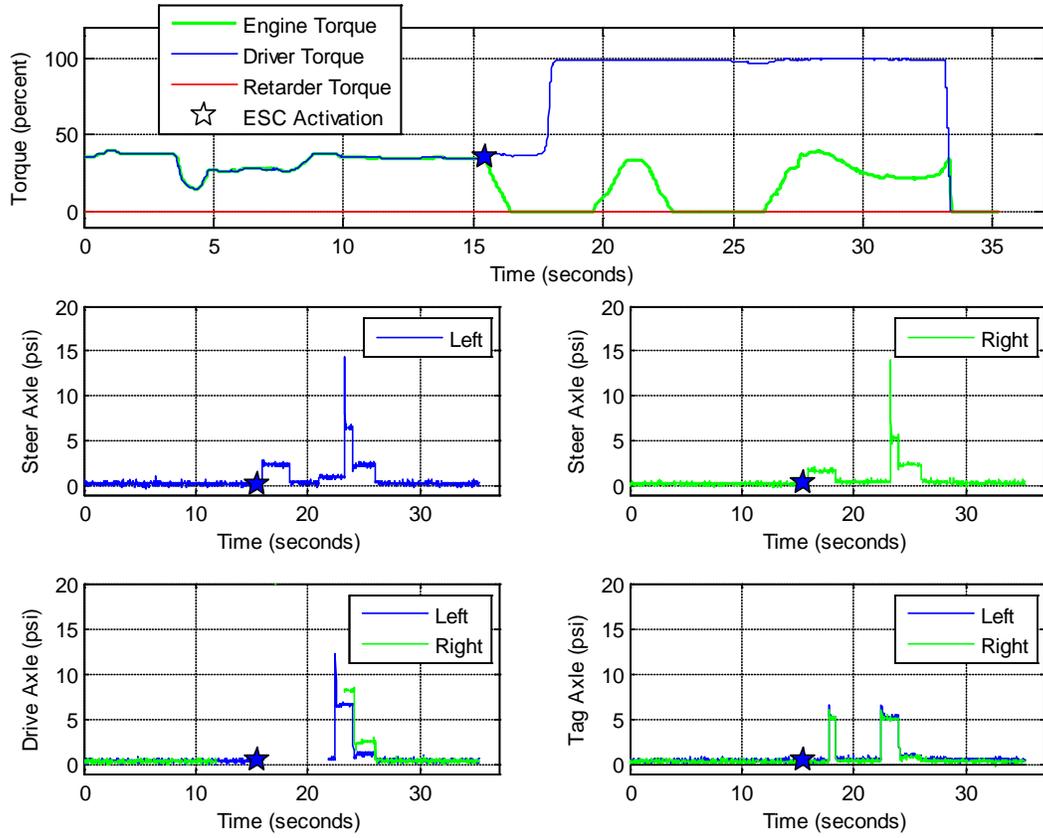
Figure 3.10. Graphs show brake pressures at each wheel and torque outputs for the Prevost during a SIS maneuver to the right, with ESC enabled, in the LLVW load condition.

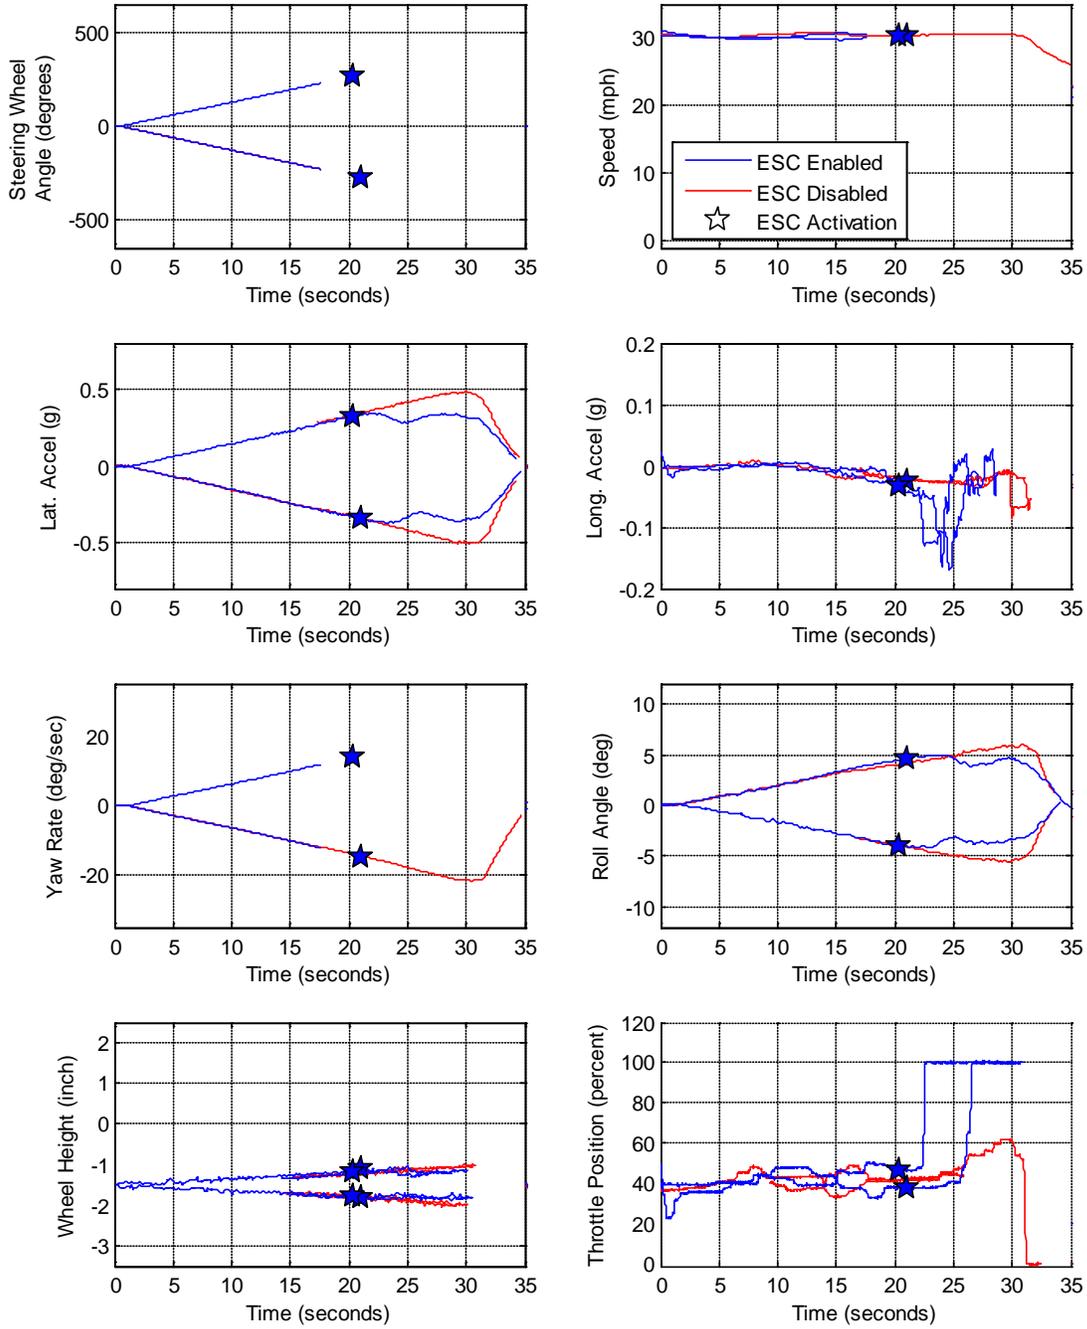
Figure 3.11. Graphs show an example of test data from the MCI #2 SIS maneuver one (one left and one right) in the LLVW load condition, with ESC enabled and disabled.

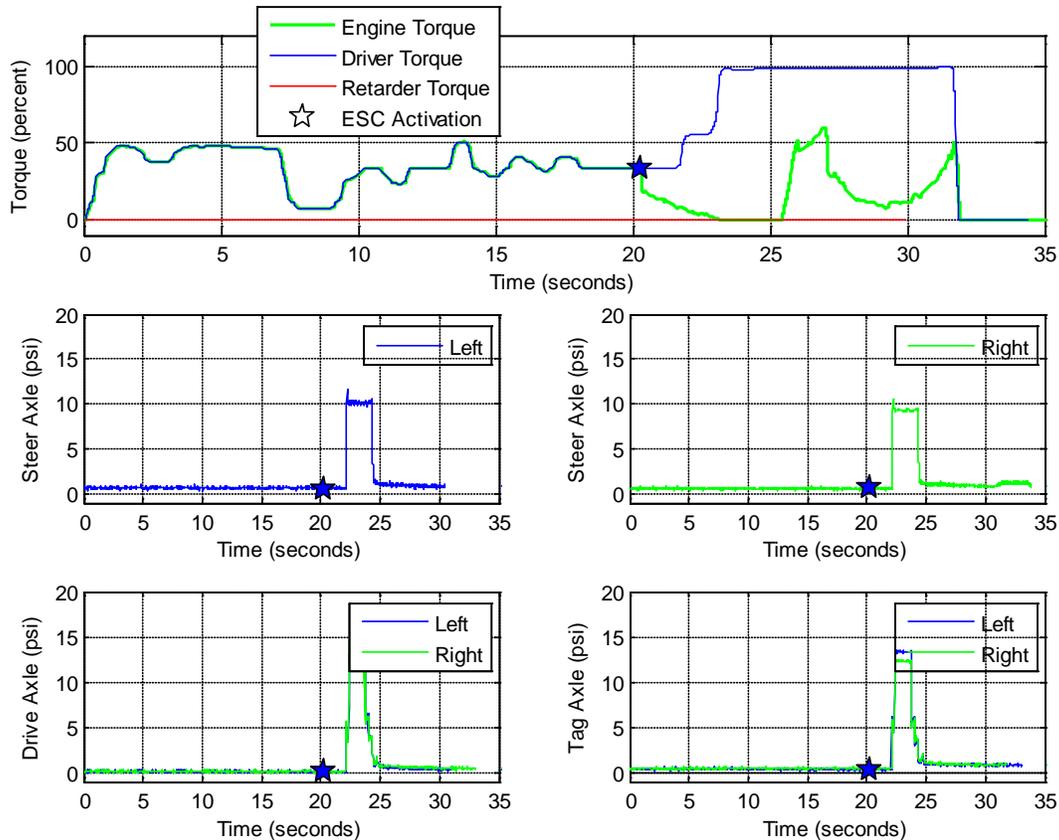
Figure 3.12. Graph shows brake pressures at each wheel and torque outputs for the MCI #2 during a SIS maneuver to the right, with ESC enabled in the LLVW load condition.

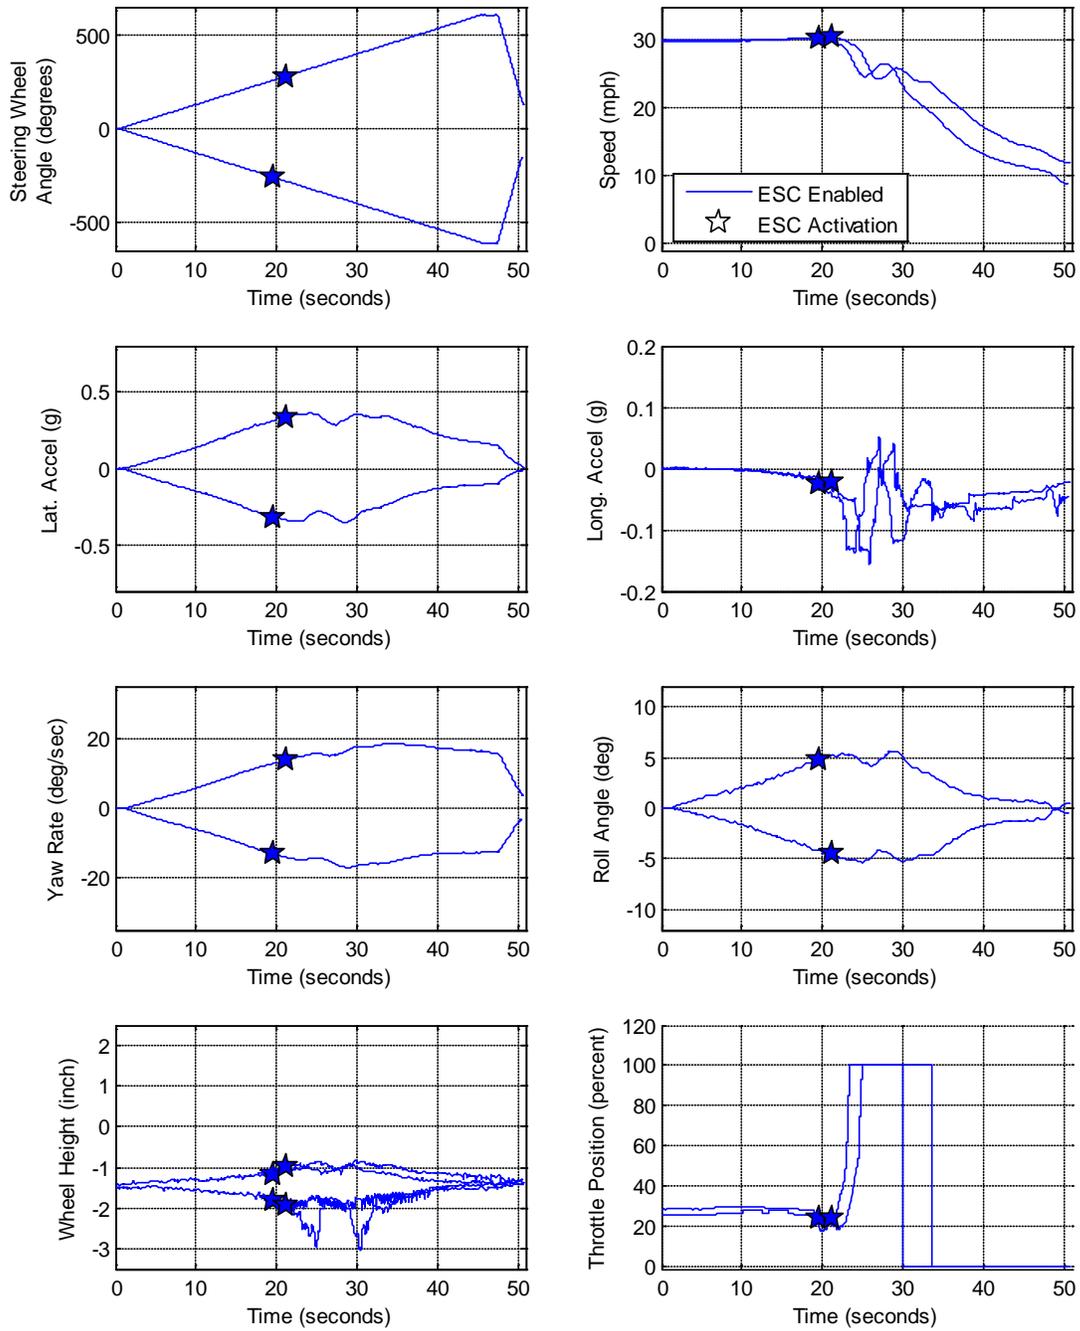
Figure 3.13. Graphs show an example of test data from the MCI #1 SIS maneuver one (one left and one right) in the GPOW load condition, with ESC enabled only.

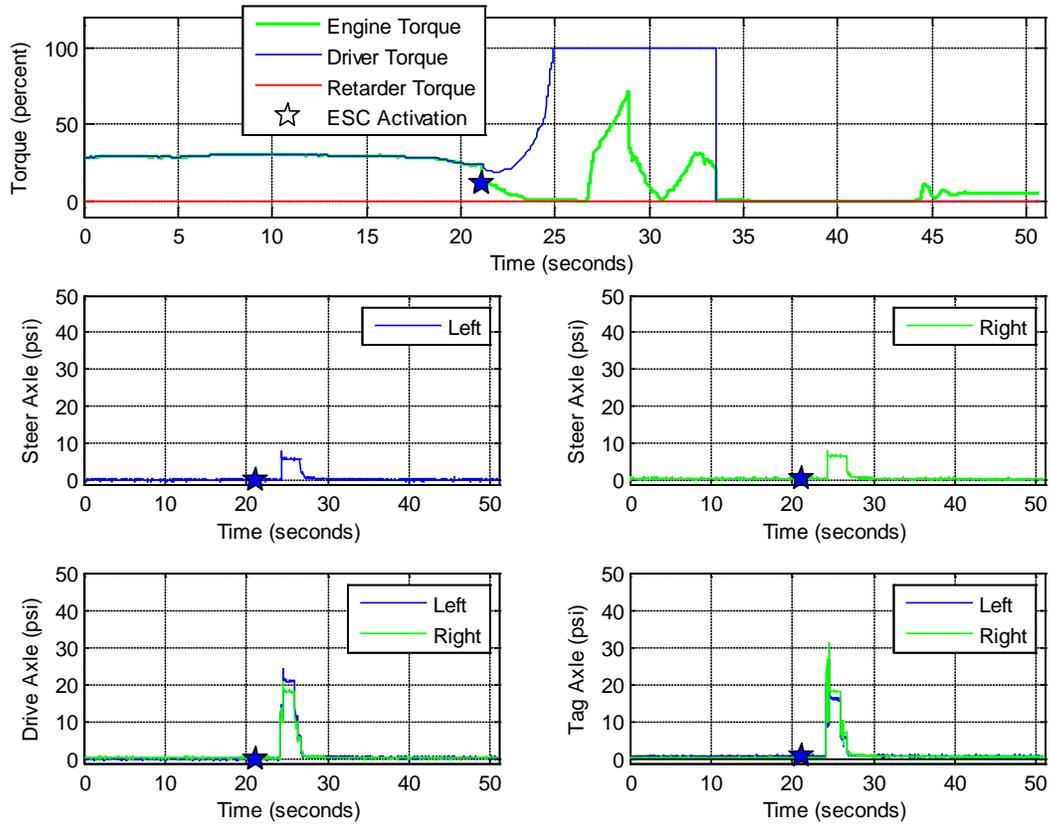
Figure 3.14. Graphs show brake pressures at each wheel and torque outputs for the MCI #1 during a SIS maneuver to the right, with ESC enabled in the GPOW load condition.

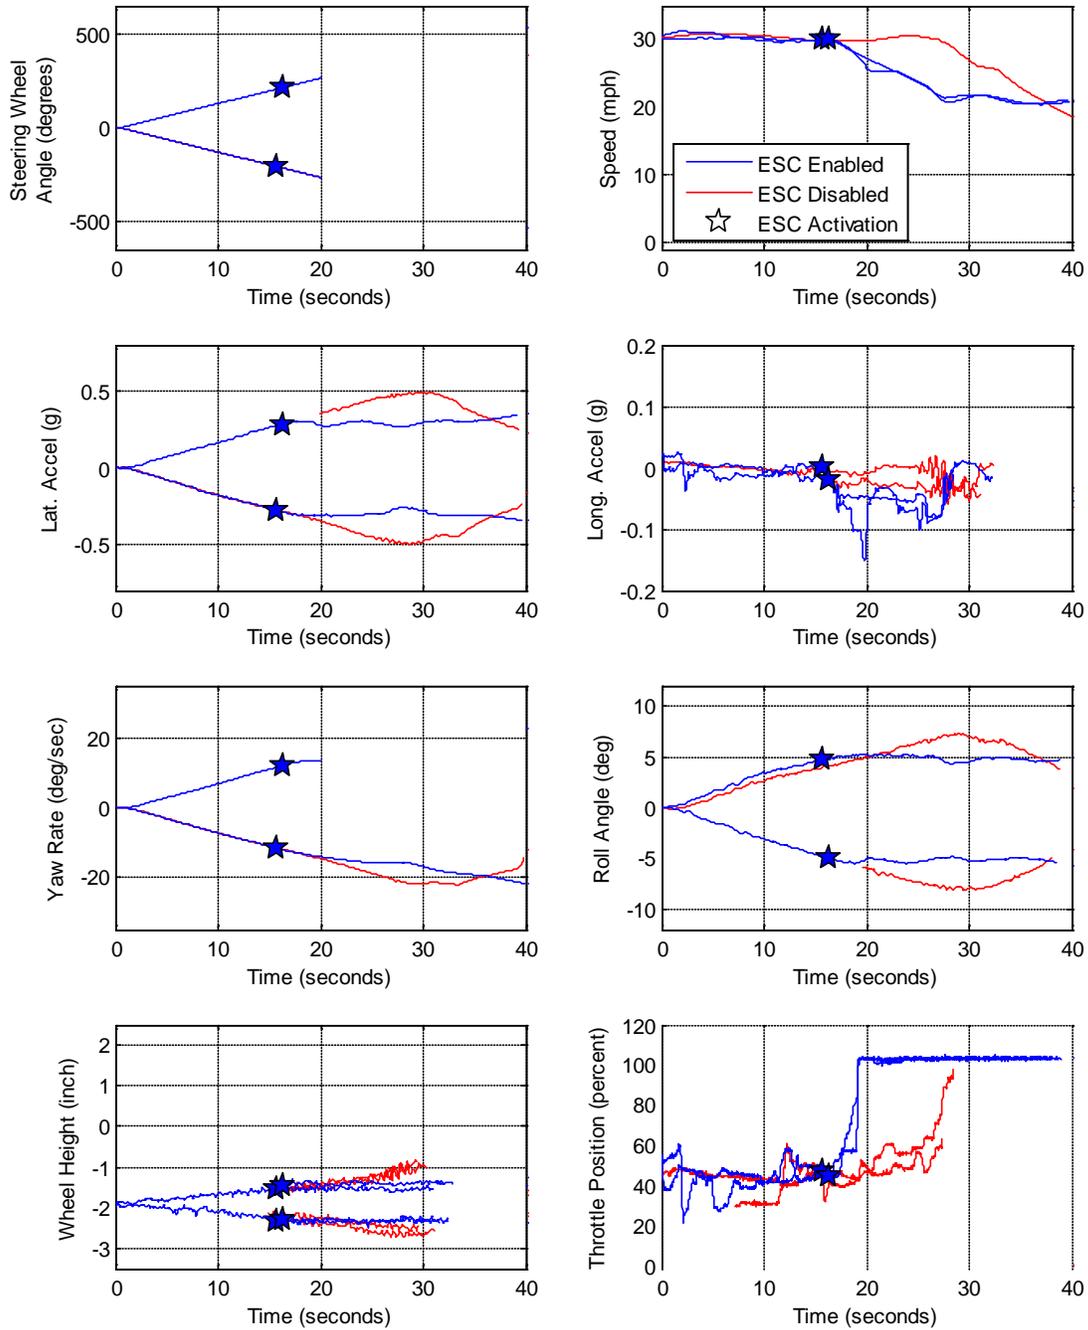
Figure 3.15. Graph shows an example of test data from the PrevoSt SIS maneuver one (one left and one right) in the GPOW load condition, with ESC enabled and disabled.

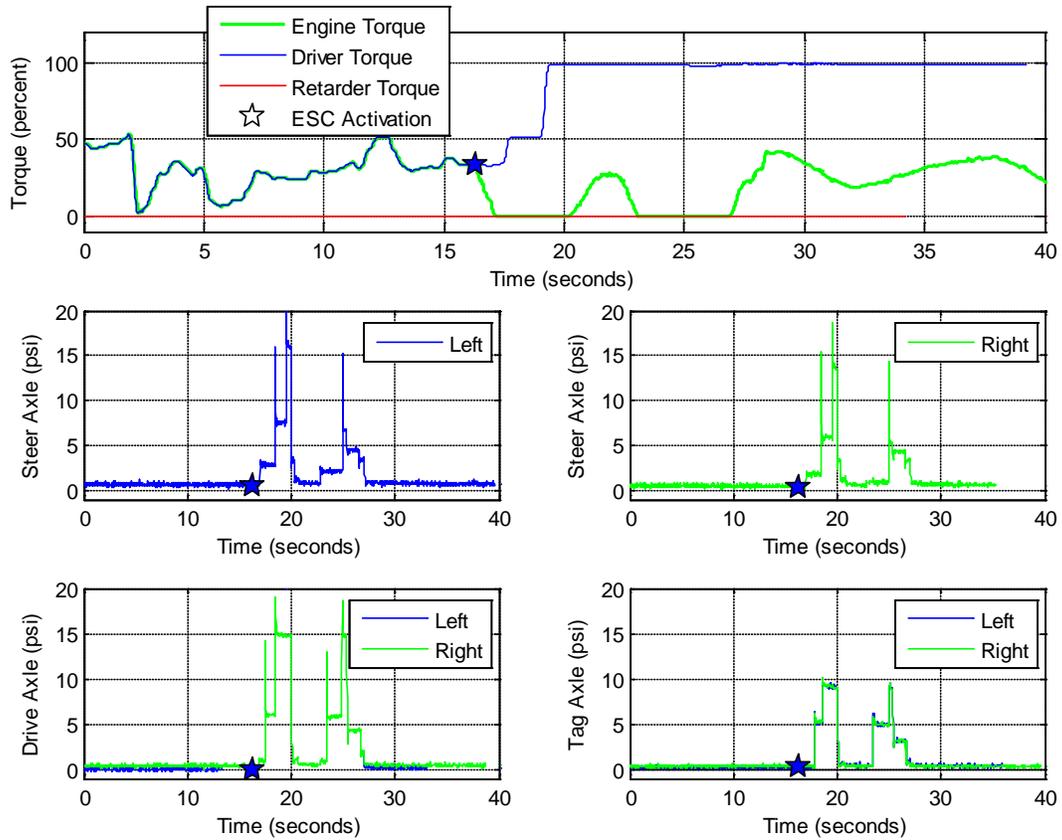
Figure 3.16. Graphs show brake pressures at each wheel and torque outputs for the Prevost during a SIS maneuver to the right, with ESC enabled in the GPOW load condition.

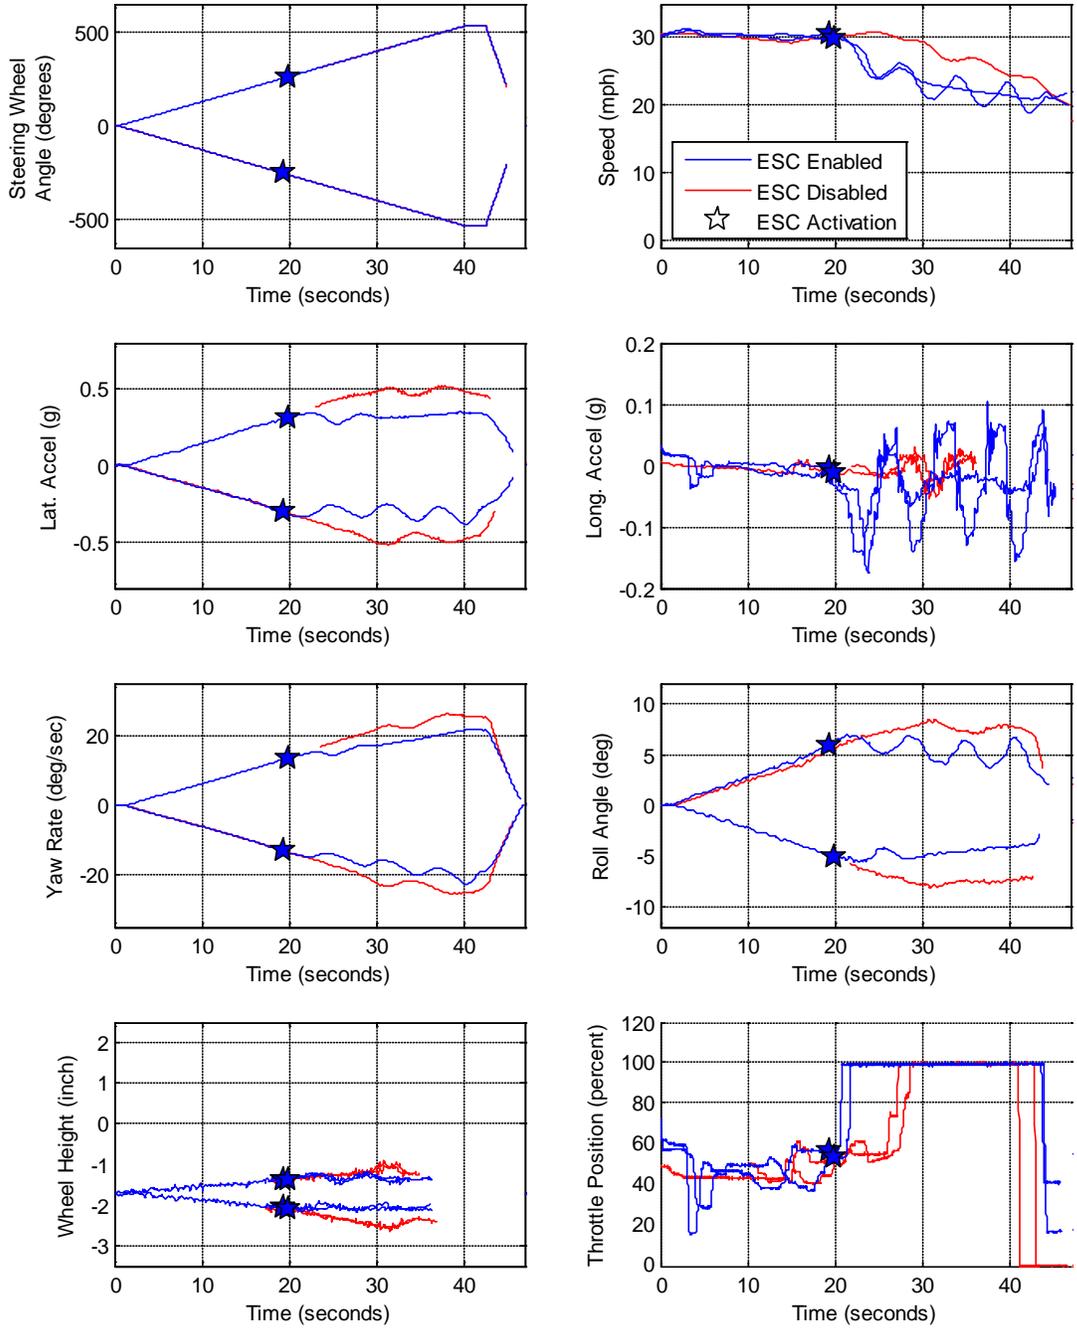
Figure 3.17. Graphs show an example of test data from the MCI #2 SIS maneuver one (one left and one right) in the GPOW load condition, with ESC enabled and disabled.

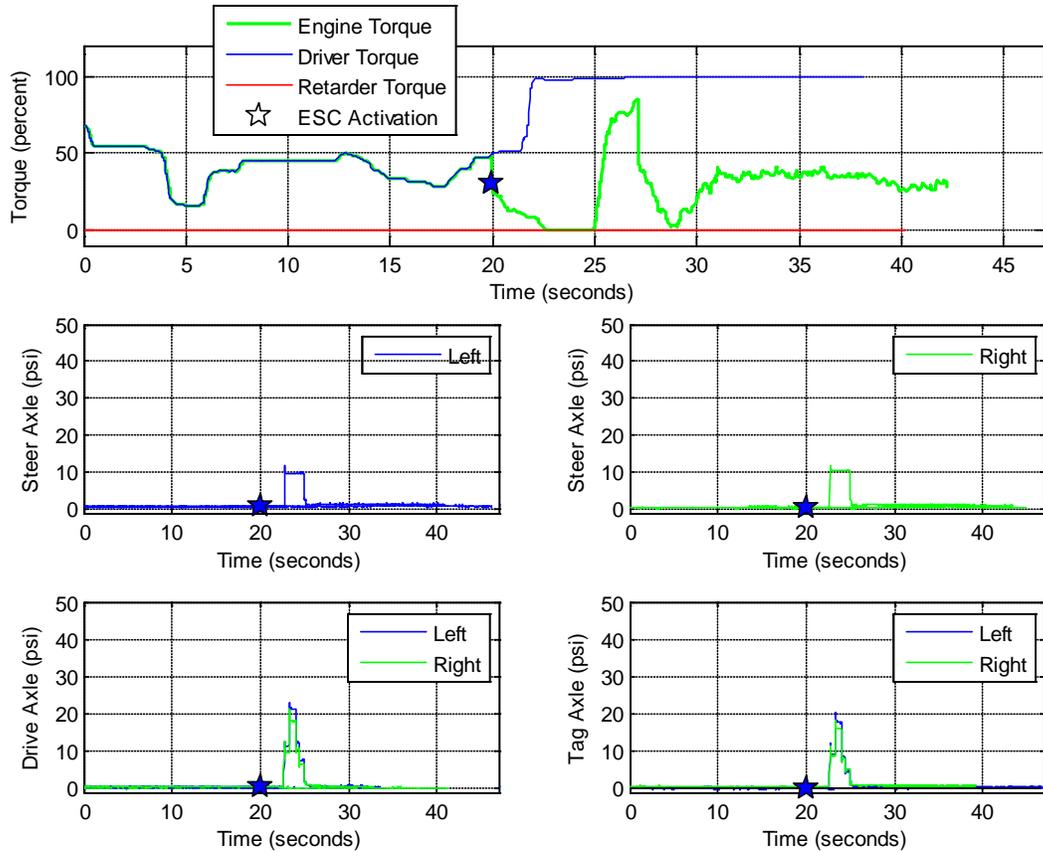
Figure 3.18. Graphs show brake pressures at each wheel and torque outputs for the MCI #2 during a SIS maneuver to the right, with ESC enabled in the GPOW load condition.
