U.S. Department
of Transportation
**National Highway
Traffic Safety
Administration**

DOT HS 811 633

Test Track Lateral Stability Performance of Motorcoaches Equipped With Electronic Stability Control Systems

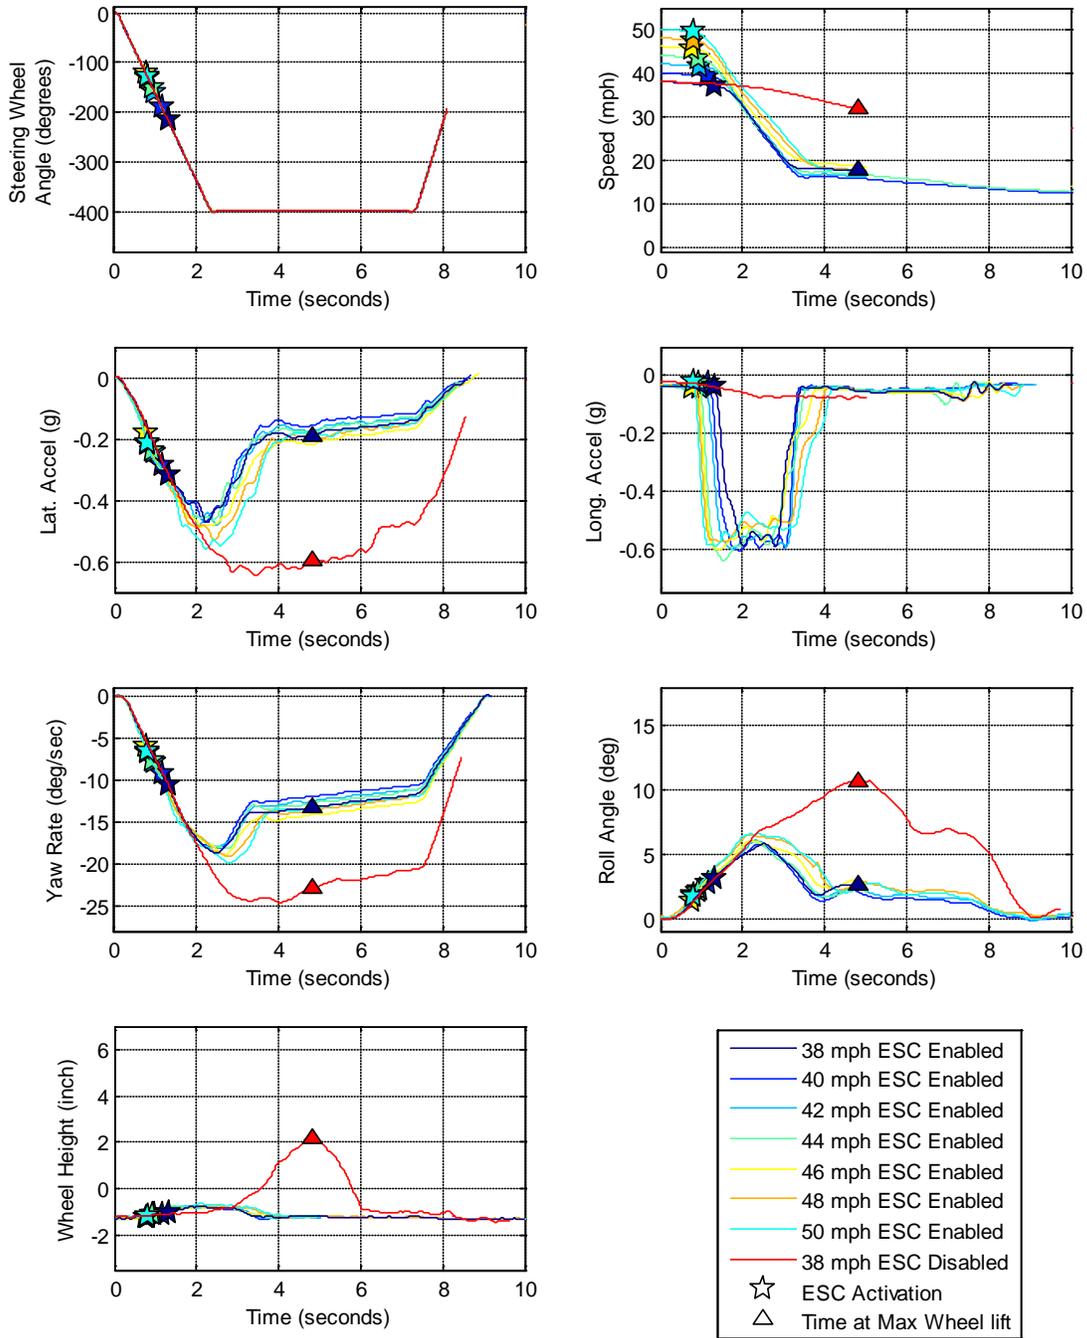
Figure 3.19. Graphs show RSM test data from the MCI #1 in the LLVW load condition with ESC enabled and disabled. Tests shown in this figure were performed at an approximate MES of 38 to 50 mph for ESC enabled and a MES of 38 mph ESC disabled. For the ESC disabled test shown in red, wheel lift of two inches was observed in the data.

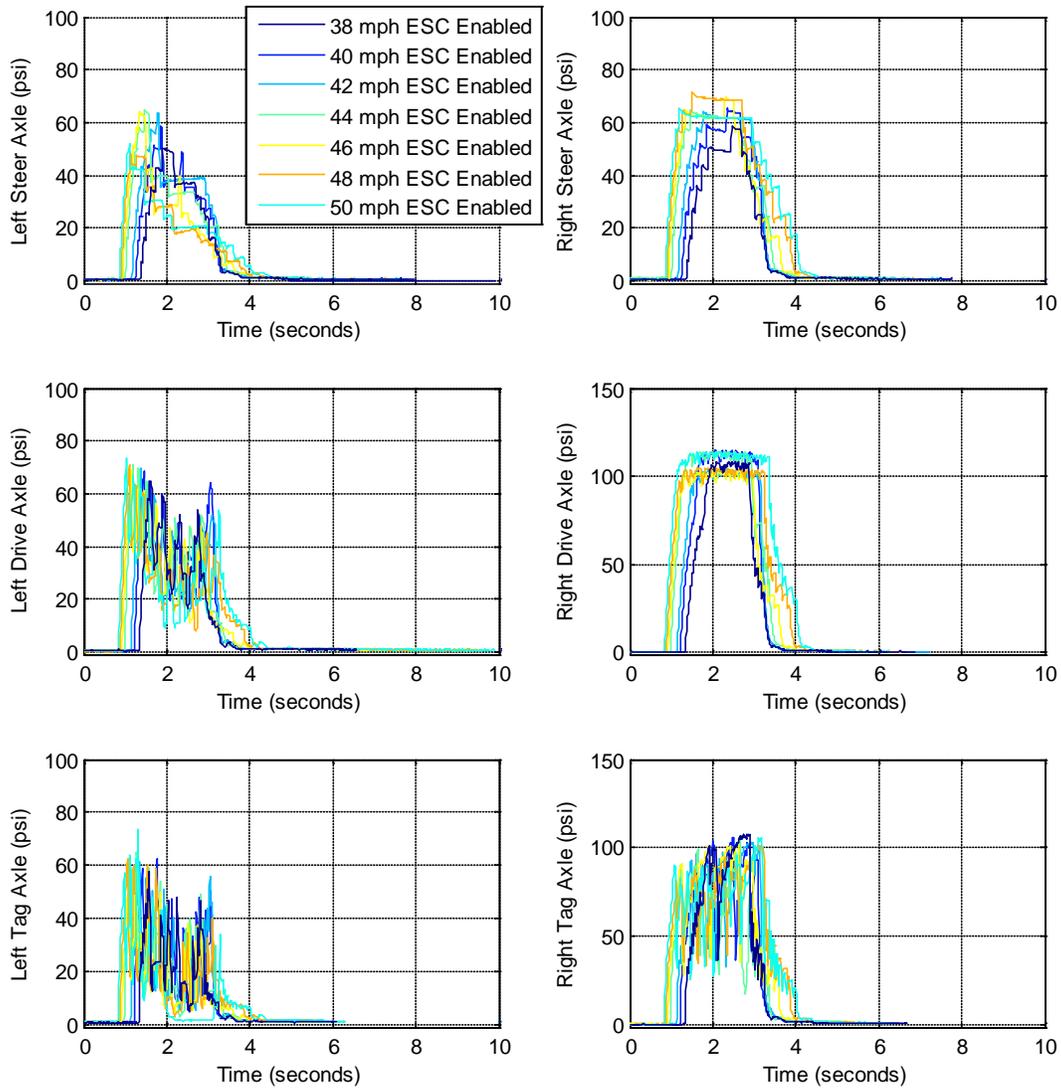
Figure 3.20. Graph shows brake pressures observed for RSM test data from the MCI #1 in the LLVW load condition ESC enabled and disabled. Tests shown in this figure were performed at an approximate MES of 40 to 50 mph ESC enabled.

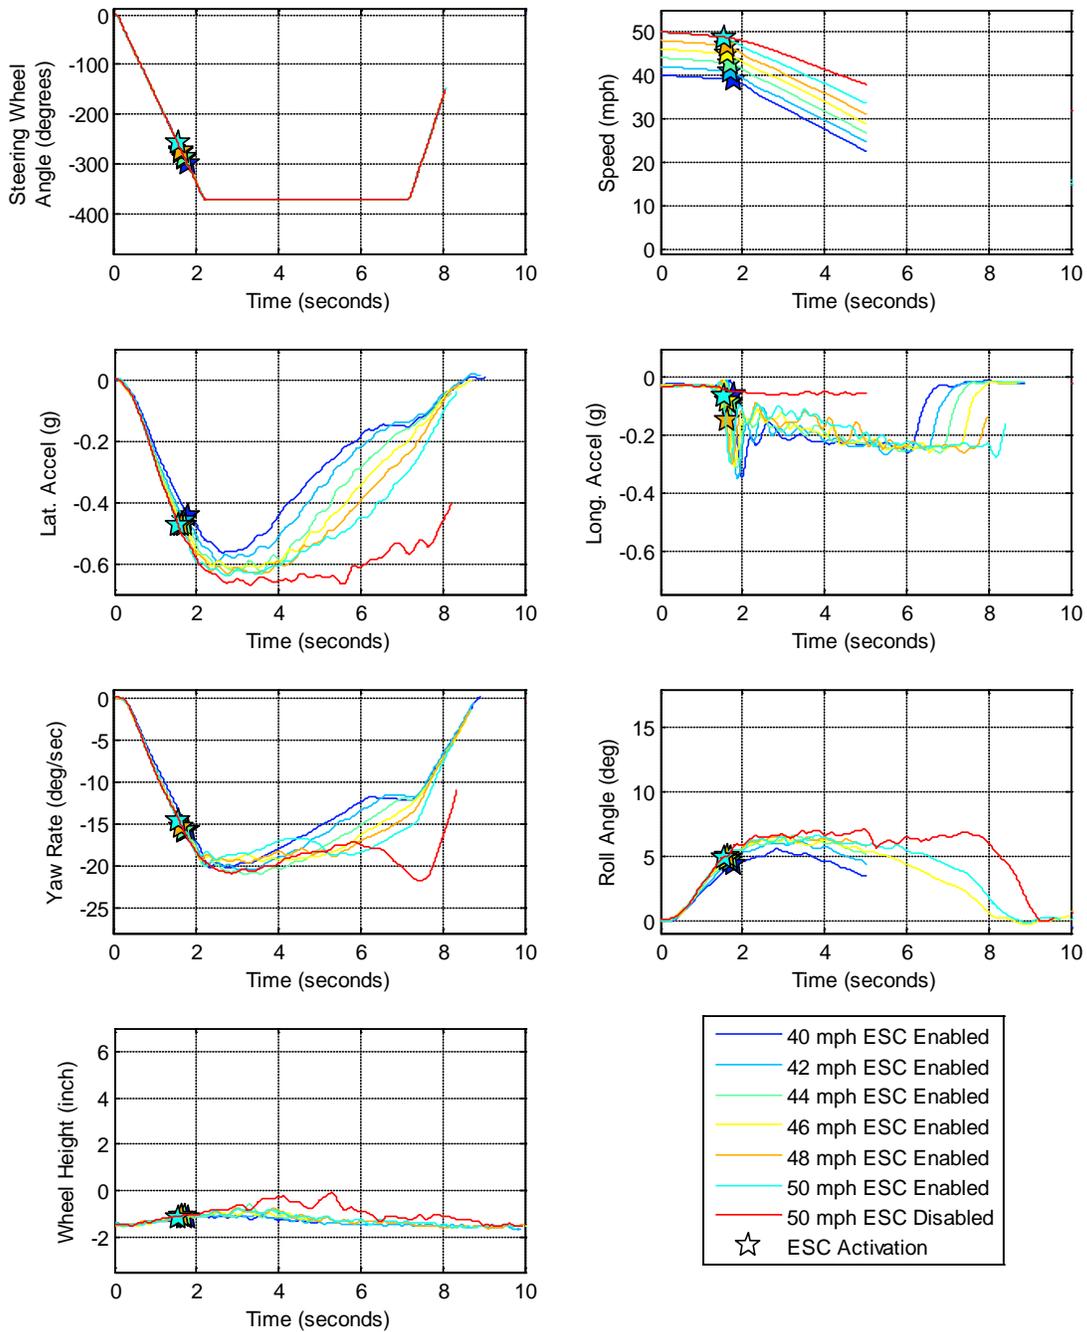
Figure 3.21. Graphs show RSM test data from the Prevost in the LLVW load condition with ESC enabled and disabled. Tests shown in this figure were performed at an approximate MES of 40 to 50 mph with ESC enabled, and at a MES of 50 mph with ESC disabled. The ESC disabled test is shown in red. No wheel lift was observed for the ESC off test at 50 mph.

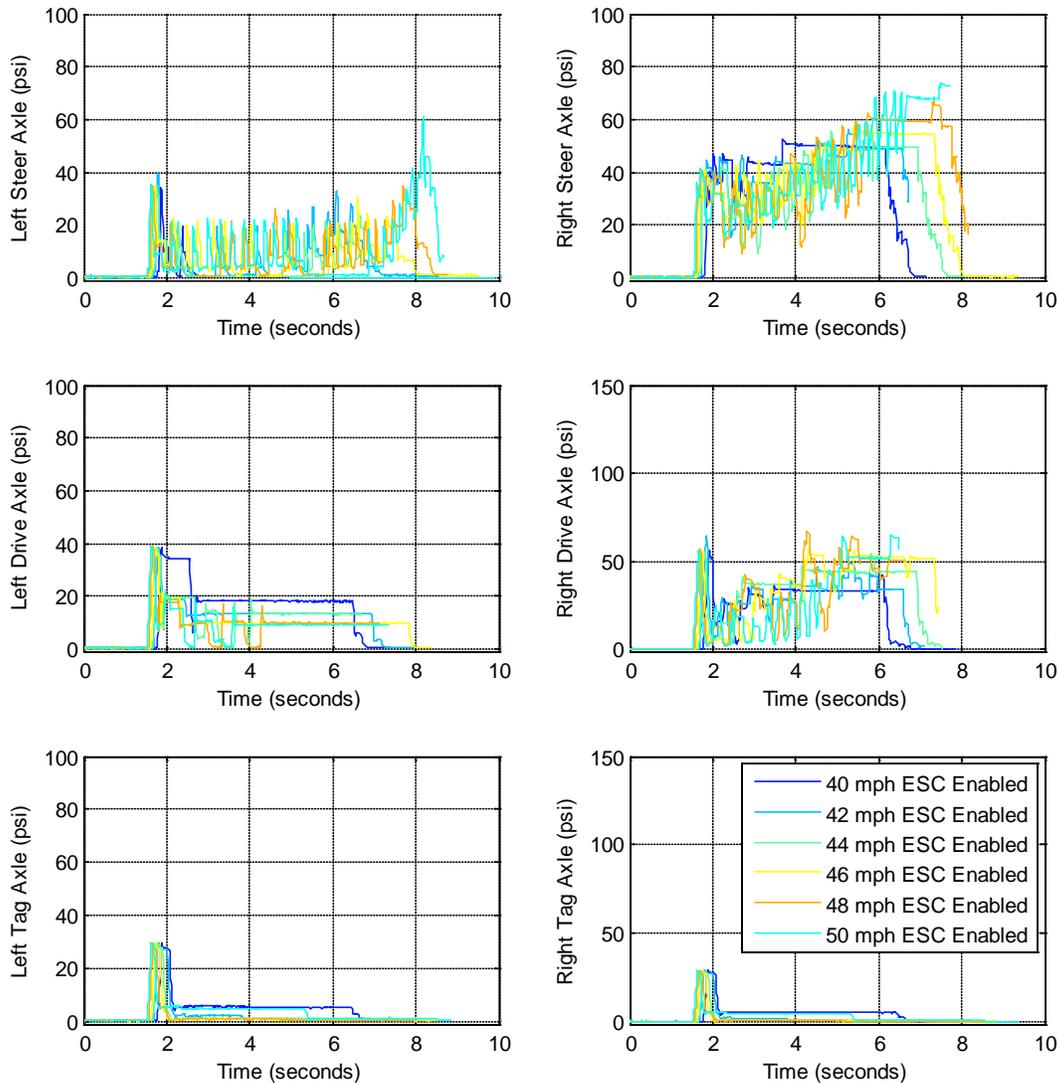
Figure 3.22. Graphs show brake pressures observed for the RSM test data from the Prevost in the LLVW load condition with ESC enabled. Tests shown in this figure were performed at an approximate MES of 40 to 50 mph.

Figure 3.22 shows the Prevost brake pressures at each wheel for the range of MESs with ESC enabled in the RSM tests.

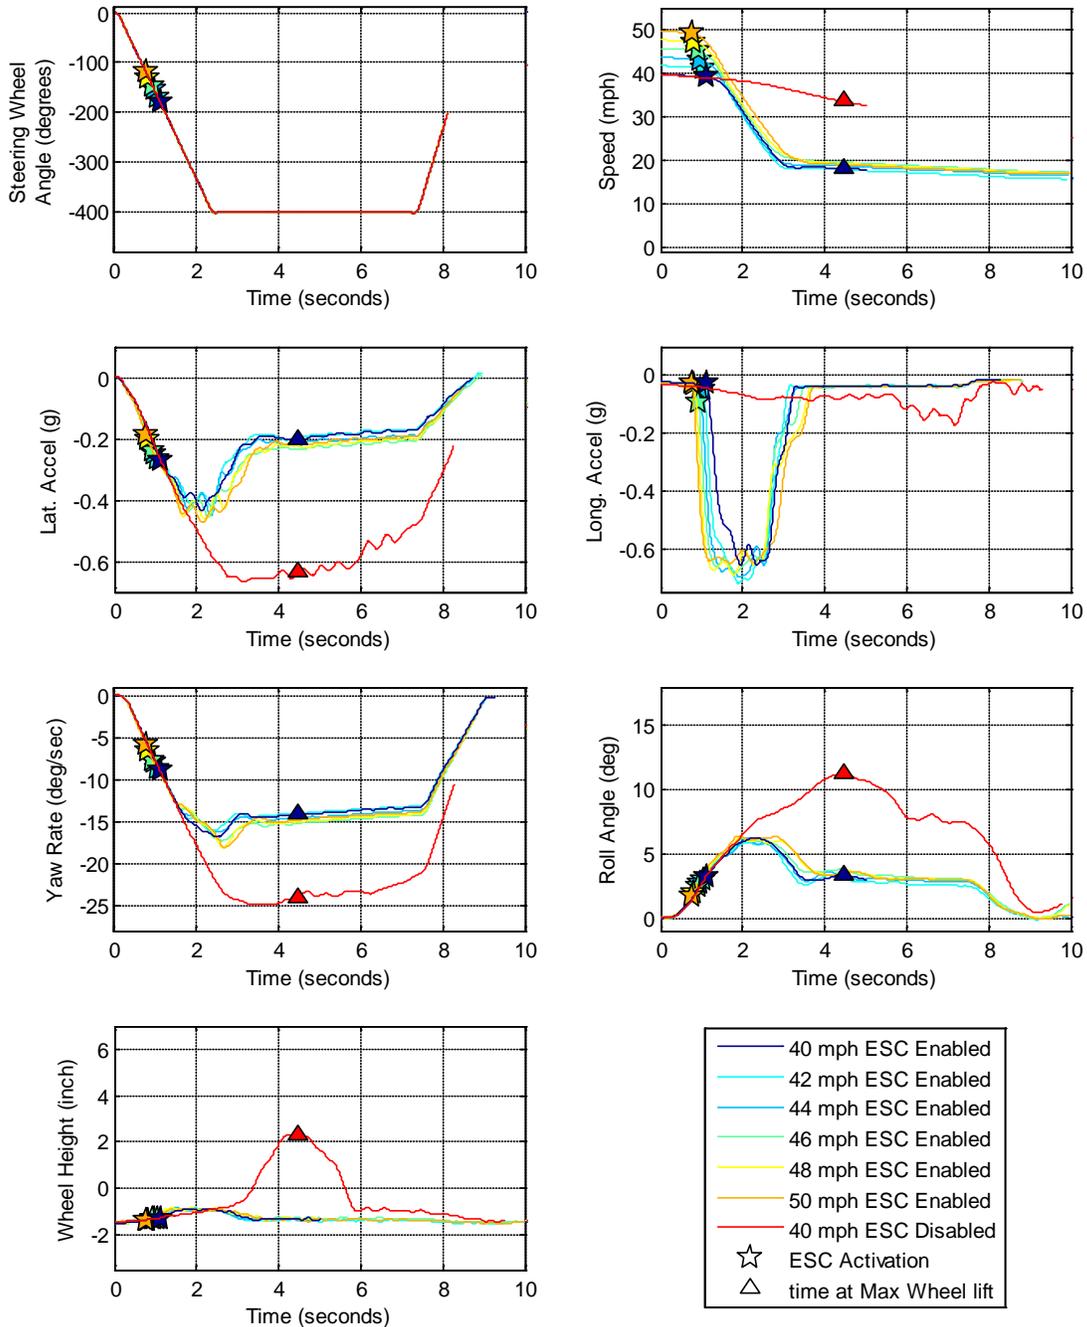
Figure 3.23. Graphs show RSM test data from the MCI #2 in the LLVW load condition with ESC enabled and disabled. Tests shown in this figure were performed at an approximate MES of 40 to 50 mph with ESC enabled, and a MES of 40 mph with ESC disabled. For the ESC disabled test shown in red, wheel lift of two inches was observed in the data.

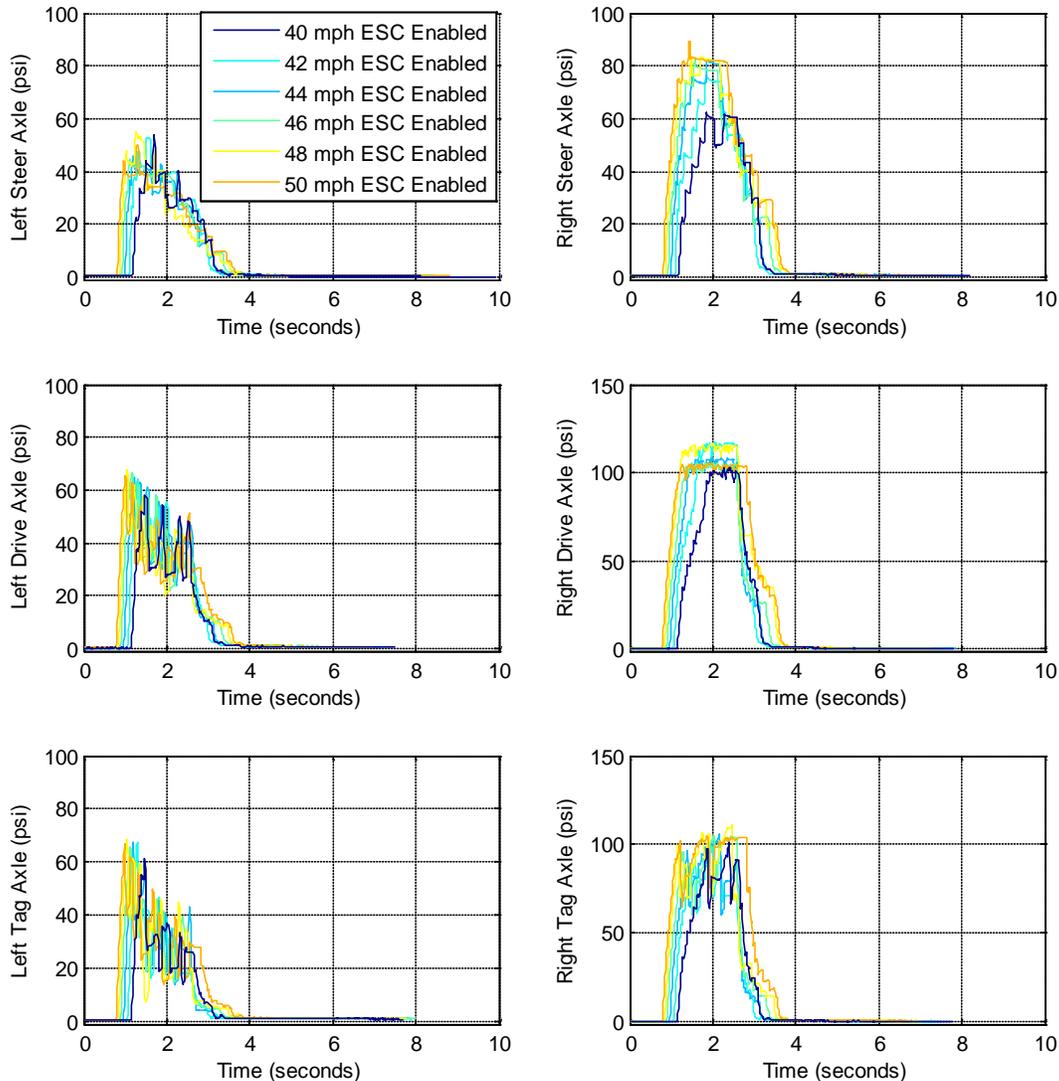
Figure 3.24. Graphs show brake pressures observed for RSM test data from the MCI #2 in the LLVW load condition with ESC enabled and disabled. Tests shown in this figure were performed at an approximate MES of 40 to 50 mph ESC enabled.

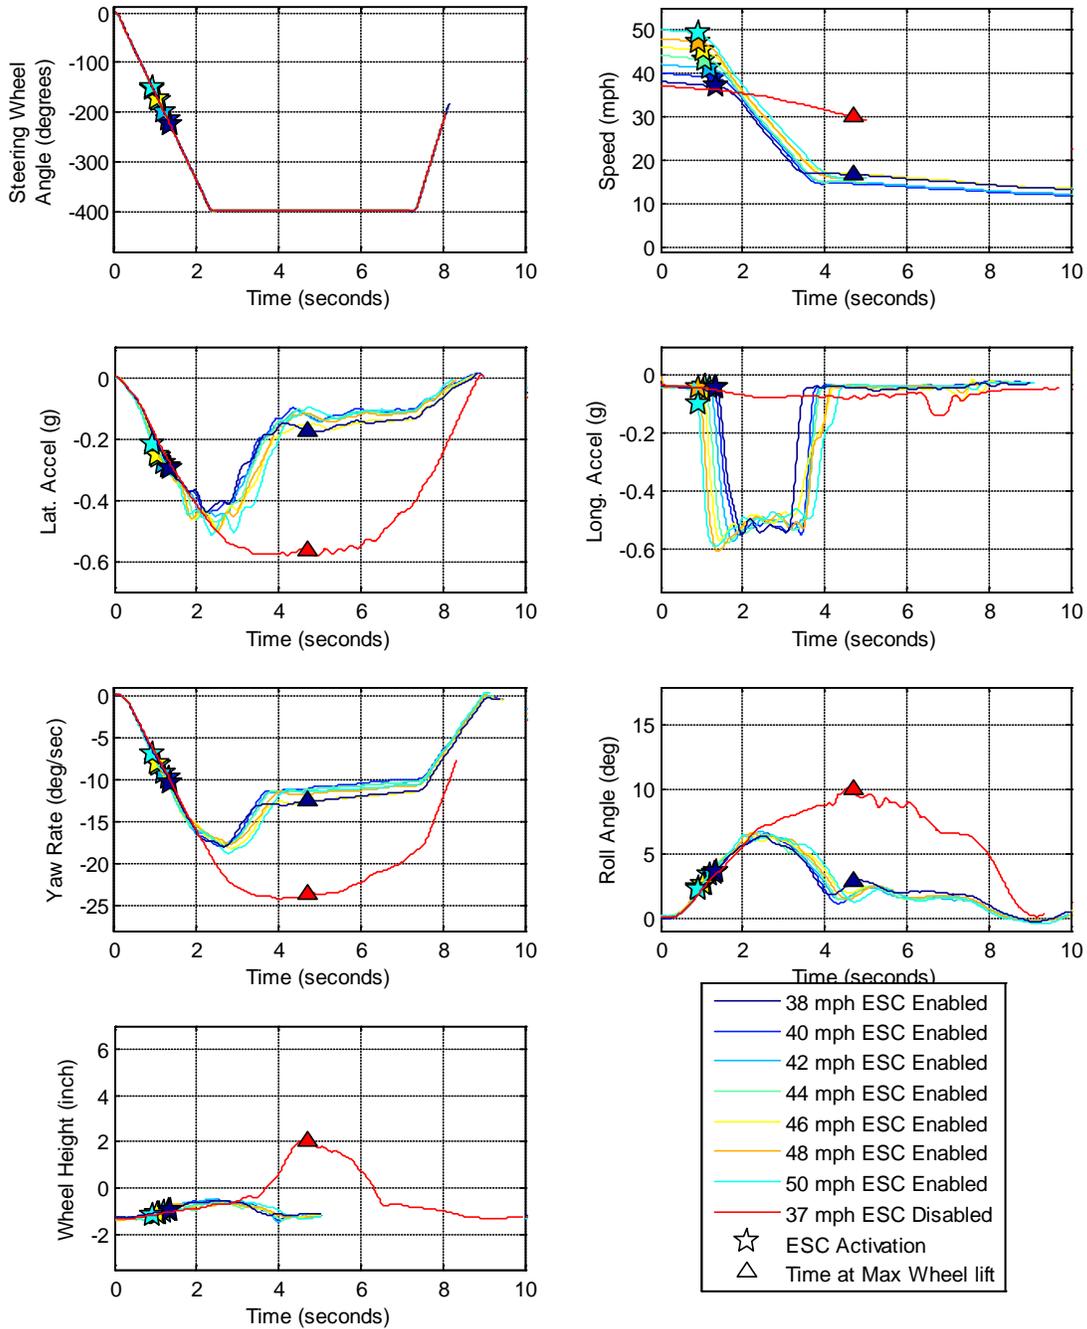
Figure 3.25. Graphs show RSM test data from the MCI #1 in the GPOW load condition with ESC enabled and disabled. Tests shown in this figure were performed at MESs of 38 to 50 mph with ESC enabled and at 37 mph with ESC disabled. For the ESC disabled test shown in red, wheel lift of two inches was observed for the ESC disabled test.

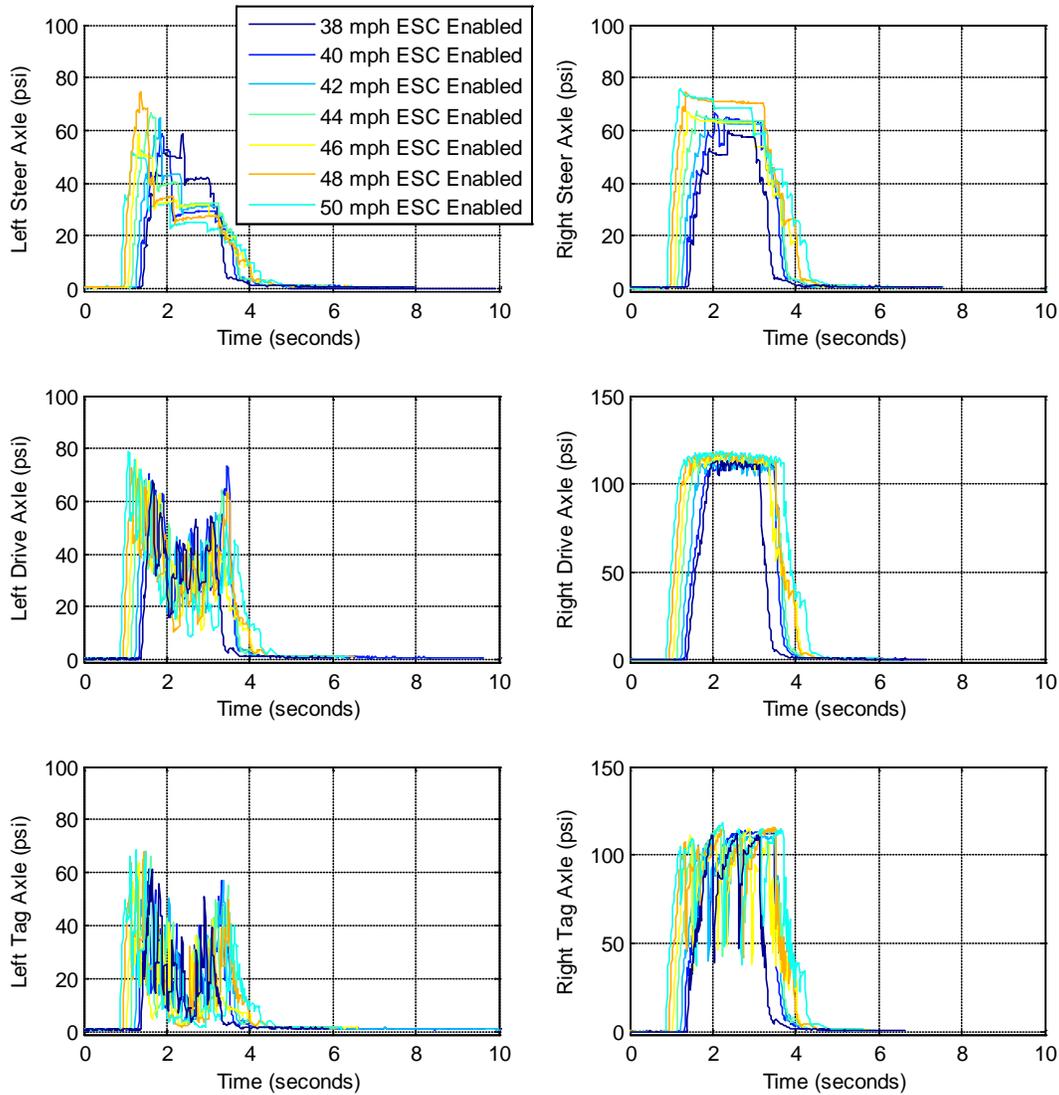
Figure 3.26. Graphs show brake pressures observed for RSM test data from the MCI #1 in the GPOW load condition ESC enabled. Tests shown in this figure were performed at MESs of 38 to 50 mph.

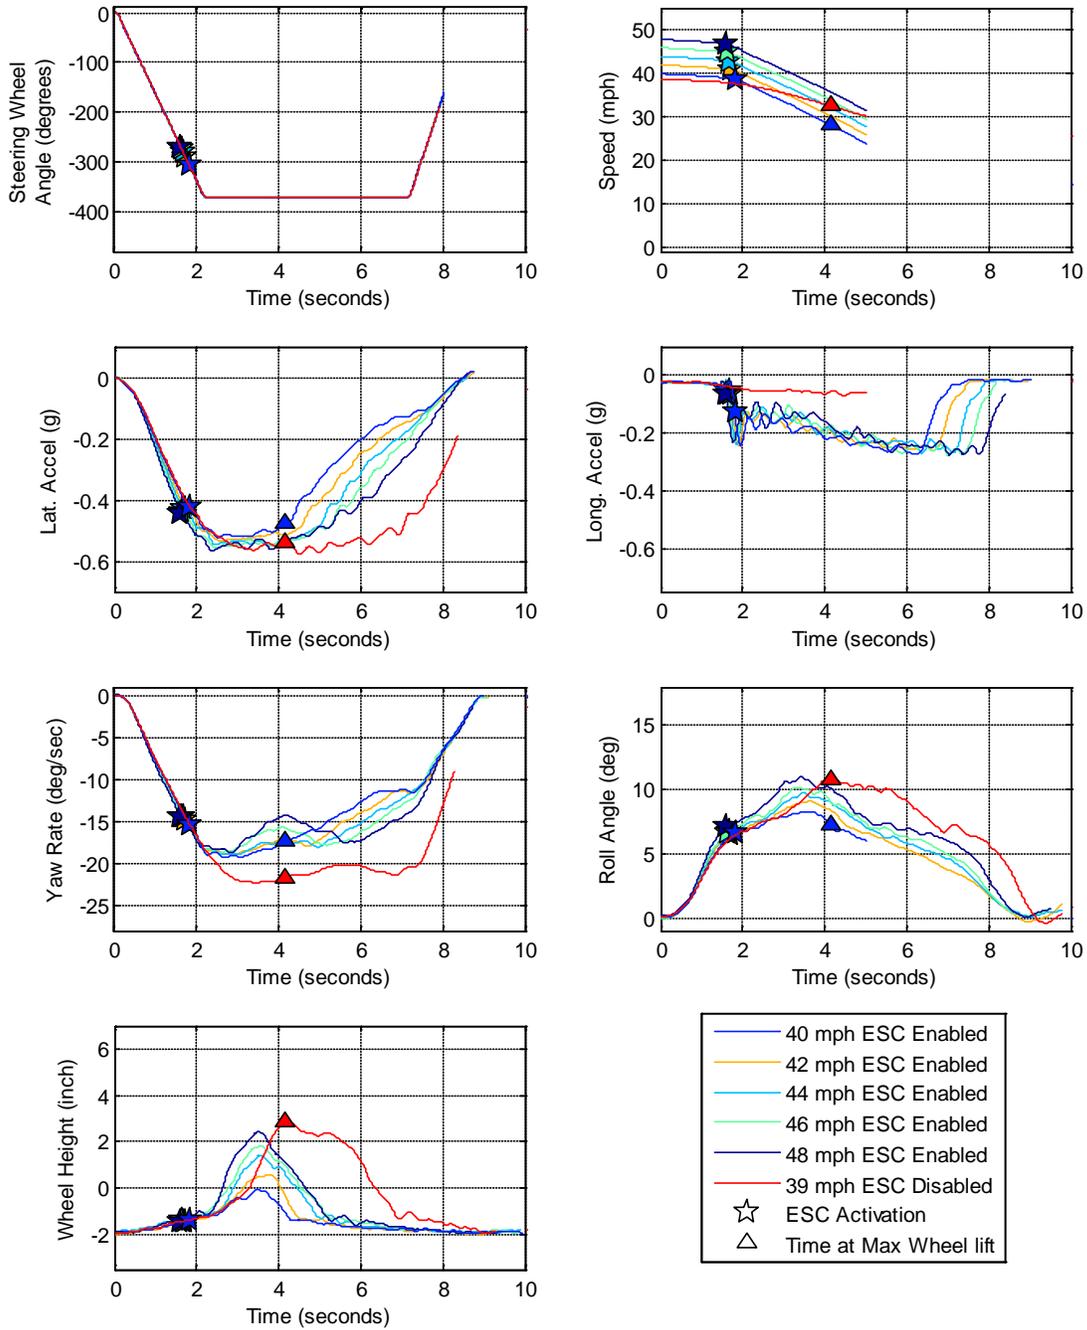
Figure 3.27. Graphs show RSM test data from the Prevost in the GPOW load condition with ESC enabled and disabled. Tests shown in this figure were performed at MESs of 40 to 48 mph with ESC enabled and at 39 mph with ESC disabled. The disabled test is shown in red. Wheel lift of two inches was observed for the ESC enabled tests at 48 mph and for the ESC disabled test at 39 mph.

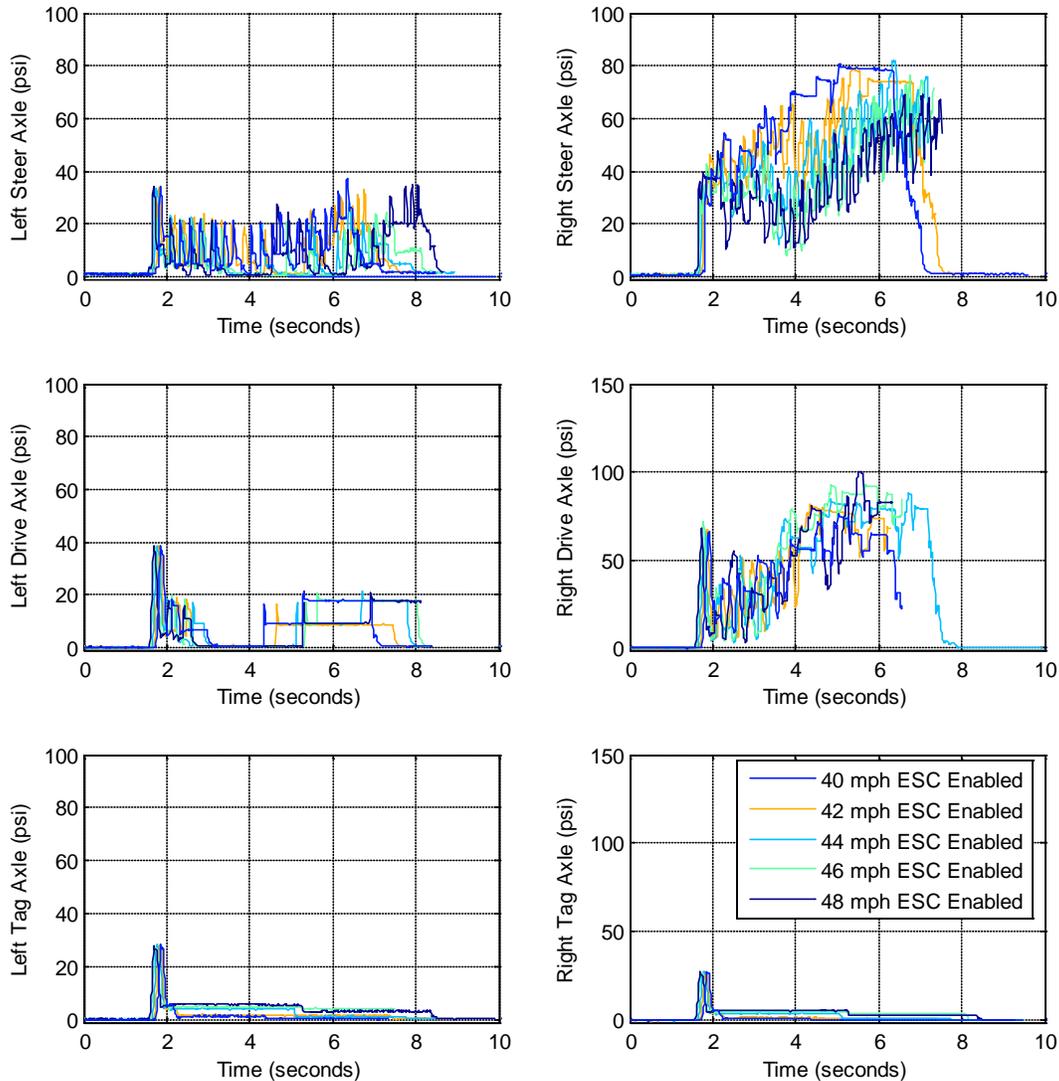
Figure 3.28. Graphs show brake pressures observed for RSM test data from the Prevost in the GPOW load condition ESC enabled. Tests shown in this figure were performed at MESs of 40 to 50.

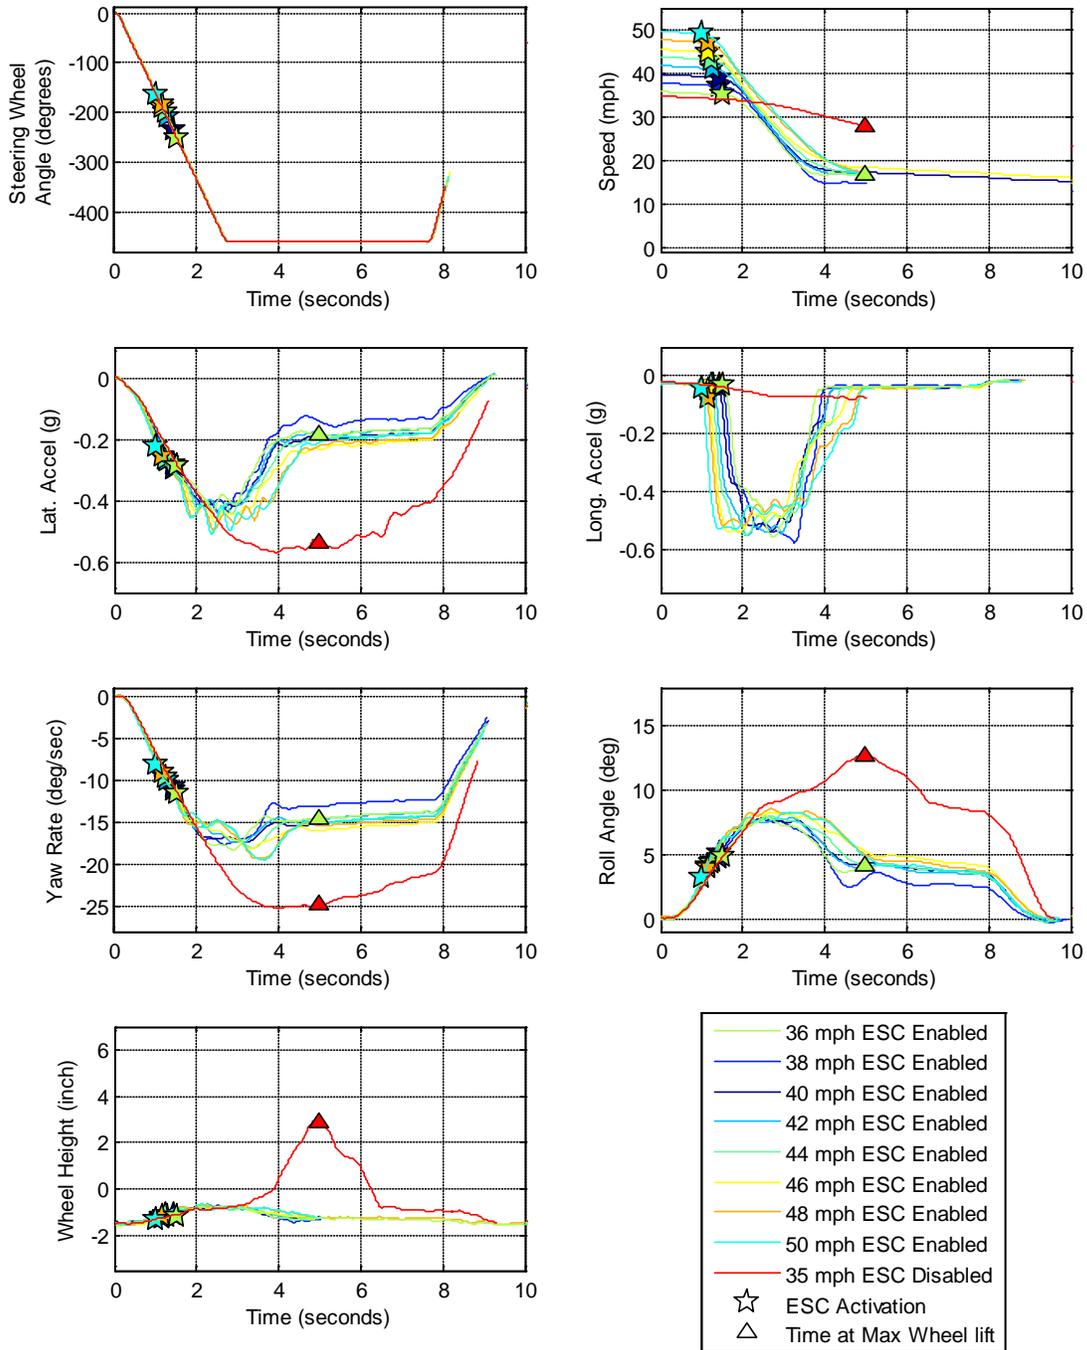
Figure 3.29. Graphs show RSM test data from the MCI #2 in the GPOW load condition ESC enabled and disabled. Tests shown in this figure were performed at MESs of 36 to 50 mph with ESC enabled and at 36 mph with ESC disabled. For the ESC disabled test is shown in red, wheel lift of over two inches was observed.

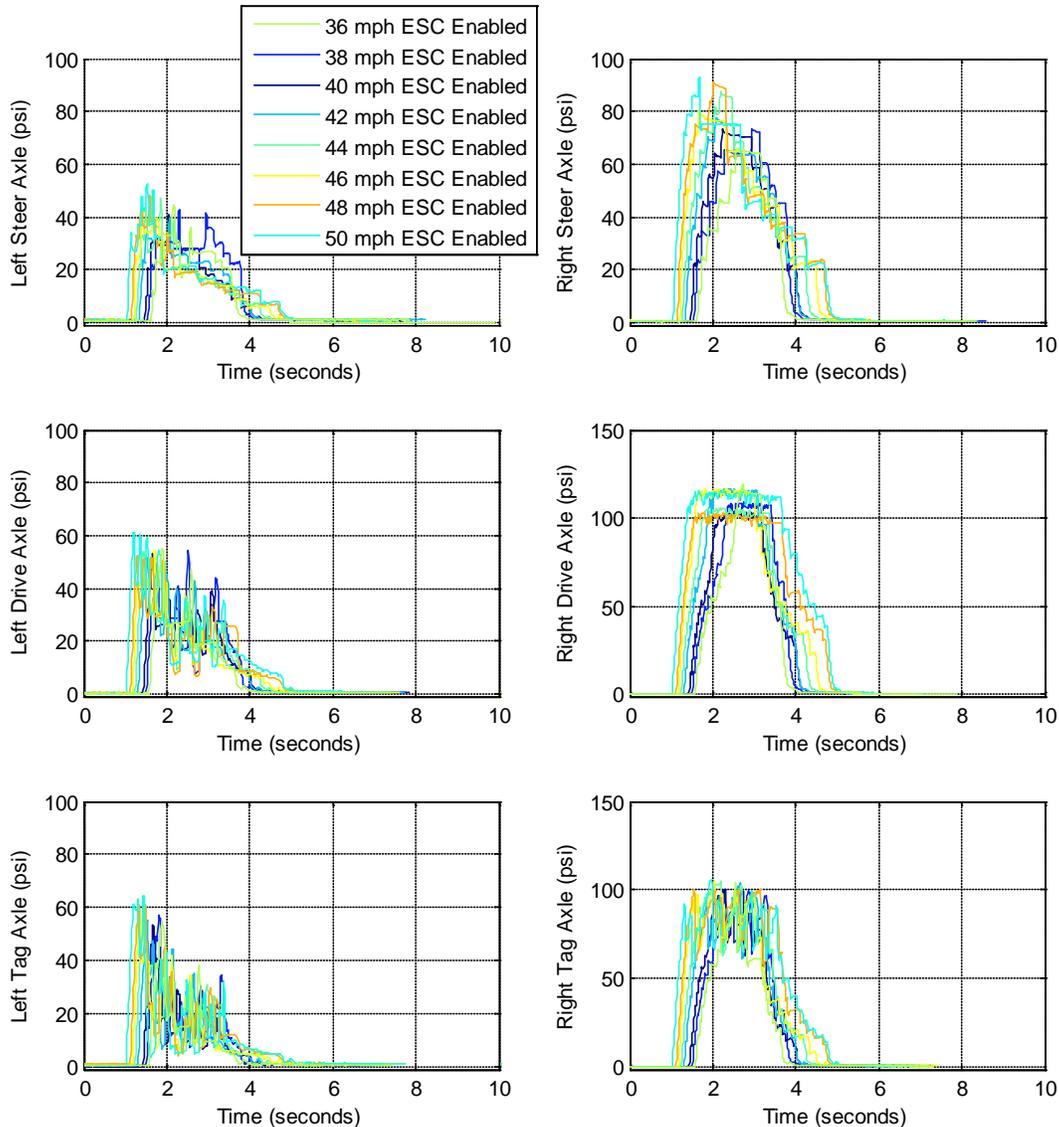
Figure 3.30. Graphs show brake pressures observed for RSM test data from the MCI #2 in the GPOW load condition with ESC enabled. Tests shown in this figure were performed at MESs of 36 to 50 mph.

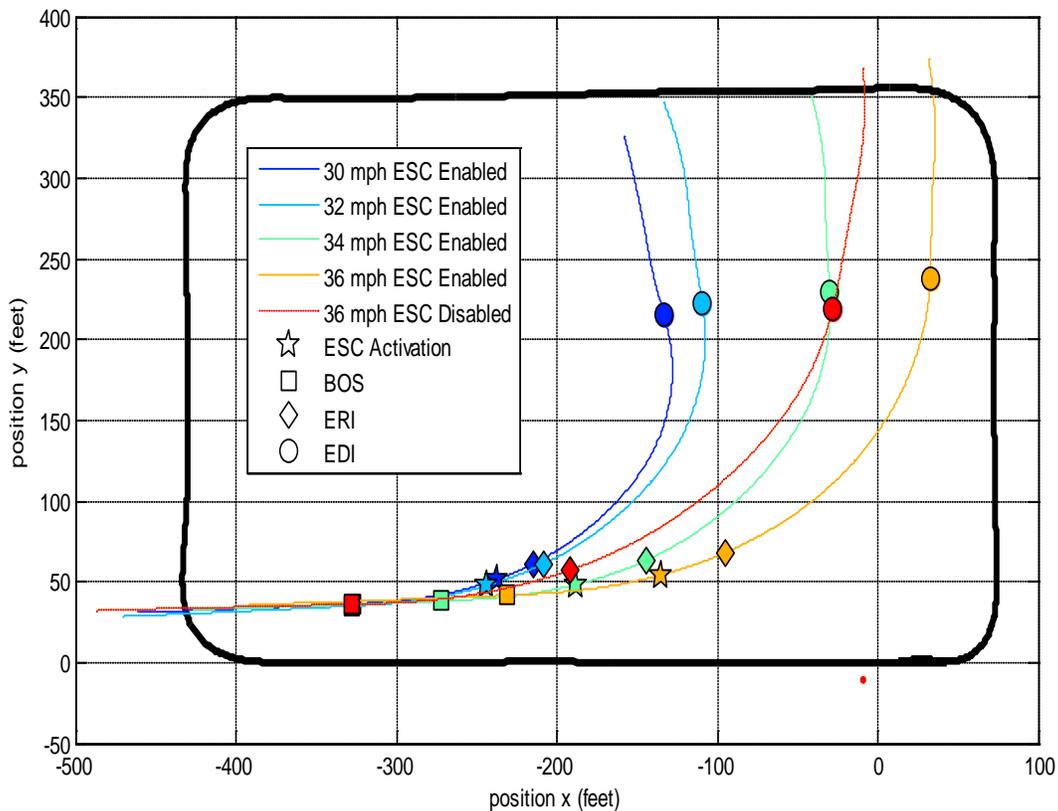
Figure 3.31. Jennite survey example of space needed to conduct RSM.

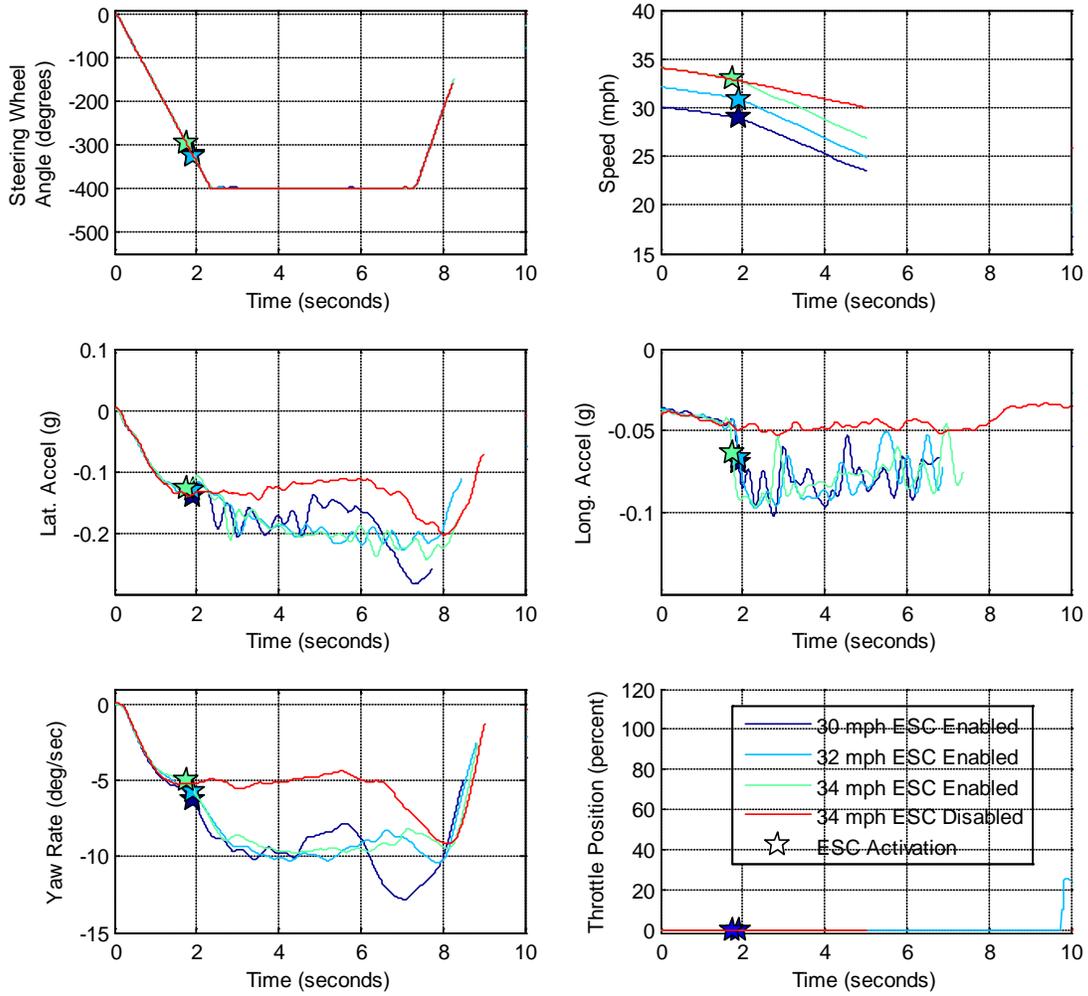
Figure 3.32. MCI #1 RSM time history data from series performed on the Jennite with the GPOW load condition.

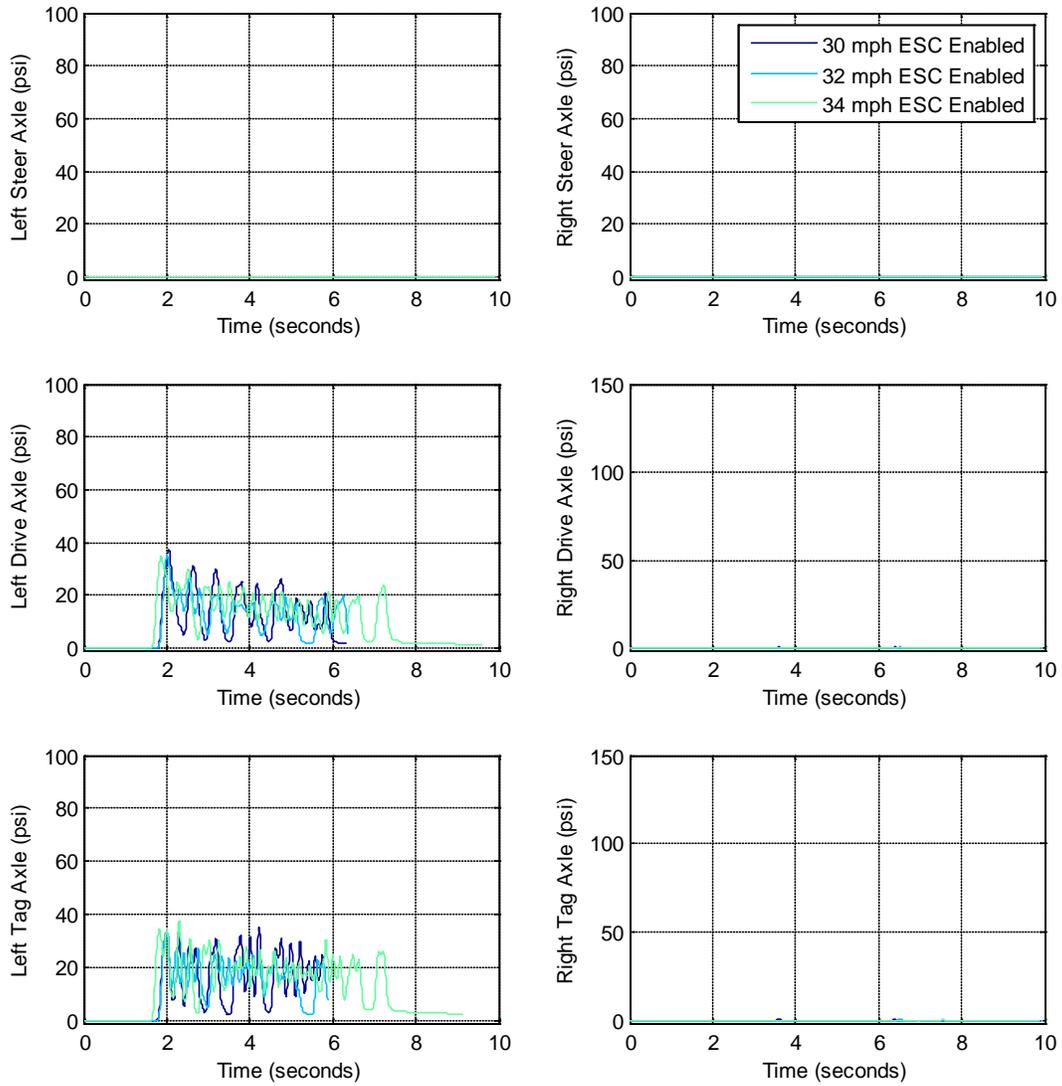
Figure 3.33. MCI #1 brake pressure data from RSM tests conducted on the Jennite (same tests as shown in Figure 3.32)

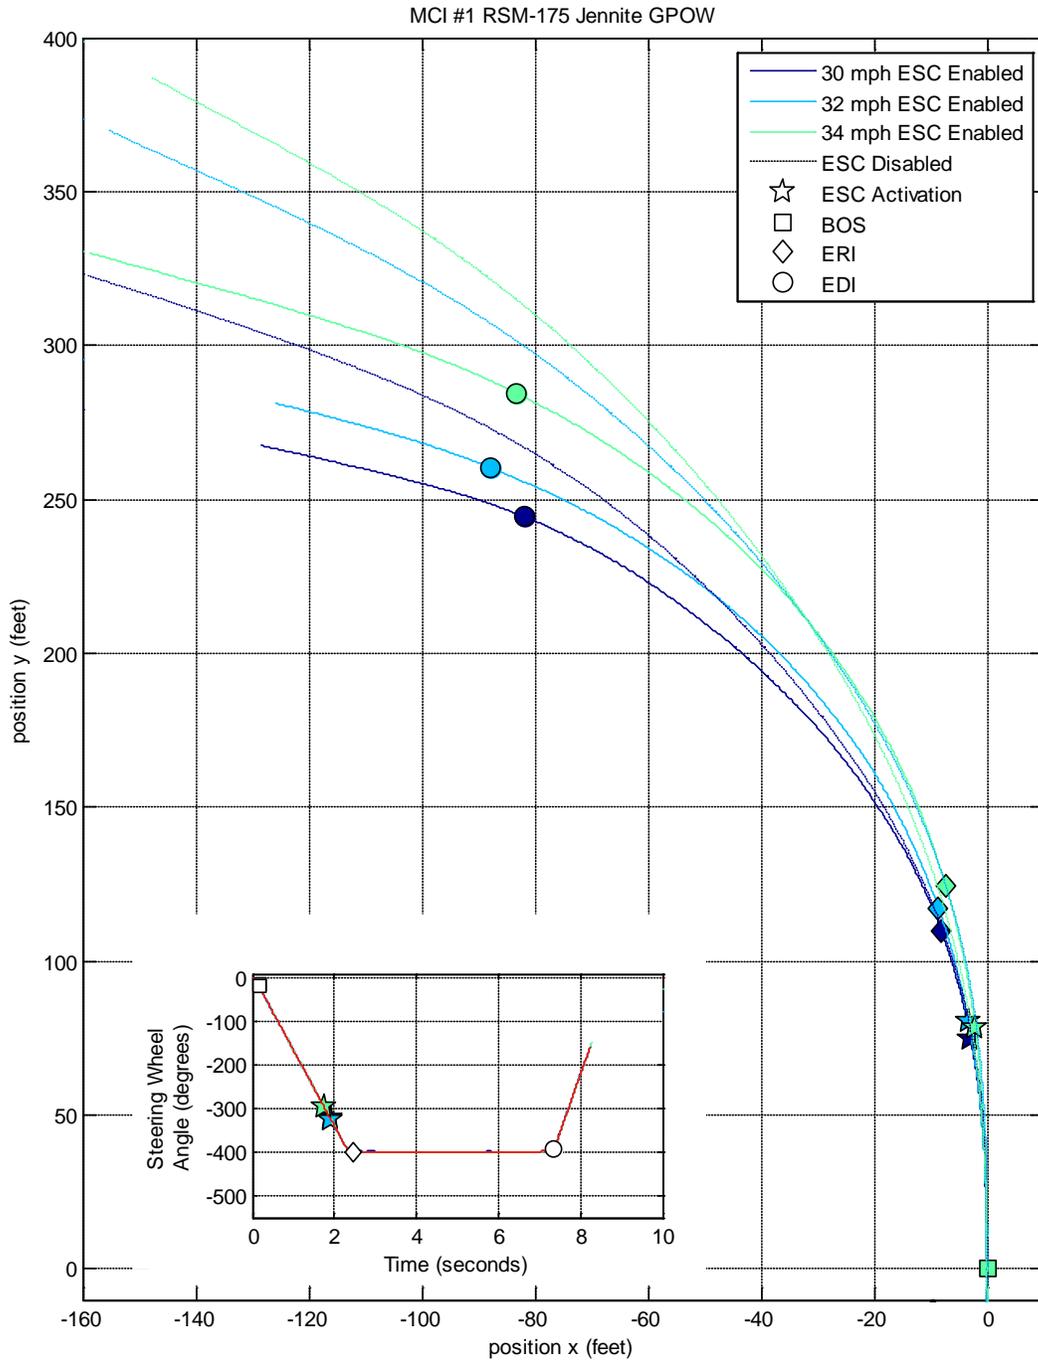
Figure 3.34. MCI #1 path data from RSM test performed on the Jennite.

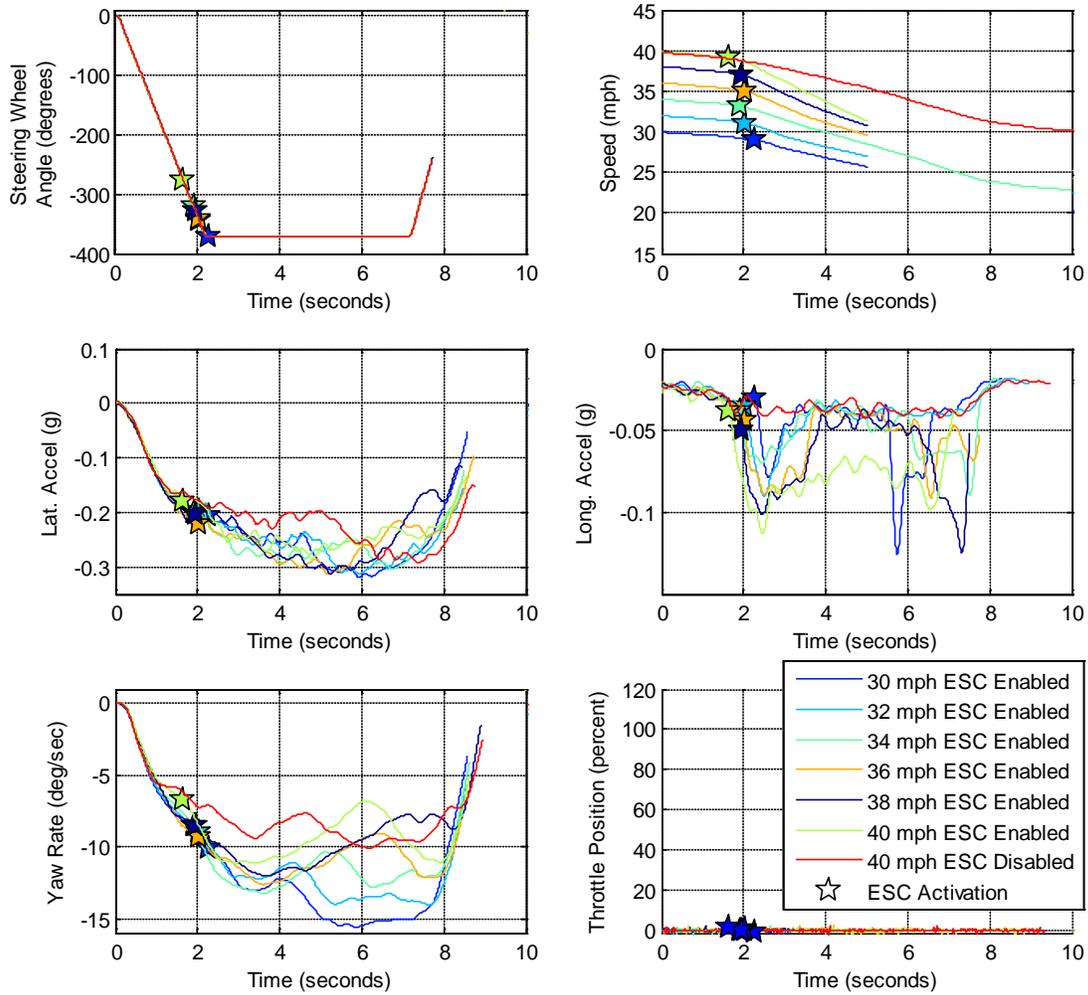
Figure 3.35. Prevost RSM time history data from tests conducted on the Jennite surface.
