U.S. Department
of Transportation
**National Highway
Traffic Safety
Administration**

DOT HS 811 633

Test Track Lateral Stability Performance of Motorcoaches Equipped With Electronic Stability Control Systems

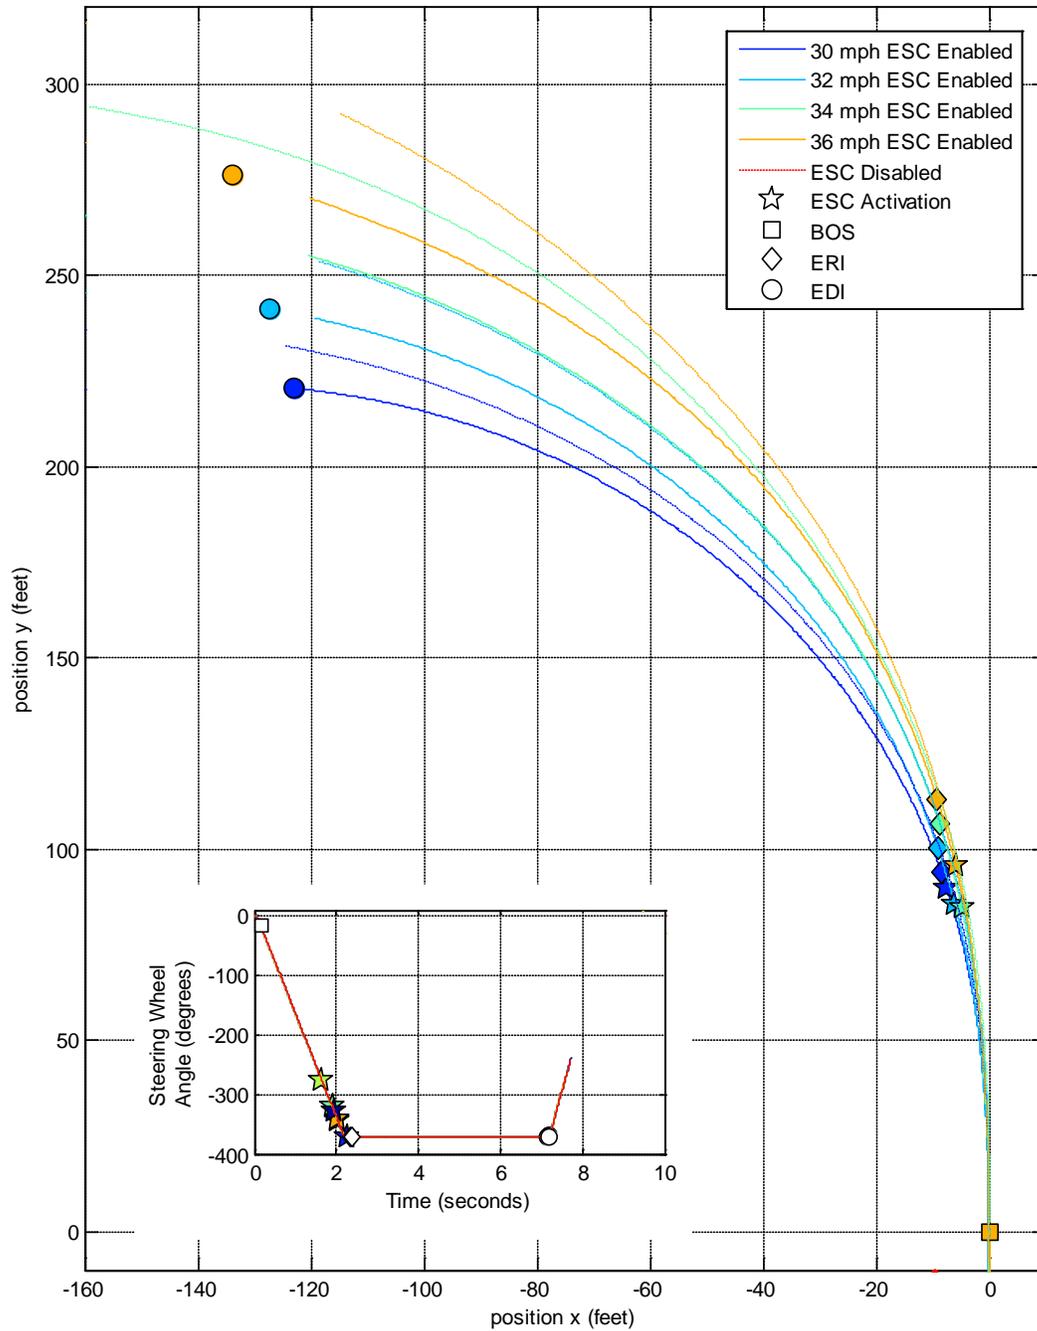
Figure 3.37. Prevost path data from RSMs performed on the Jennite.

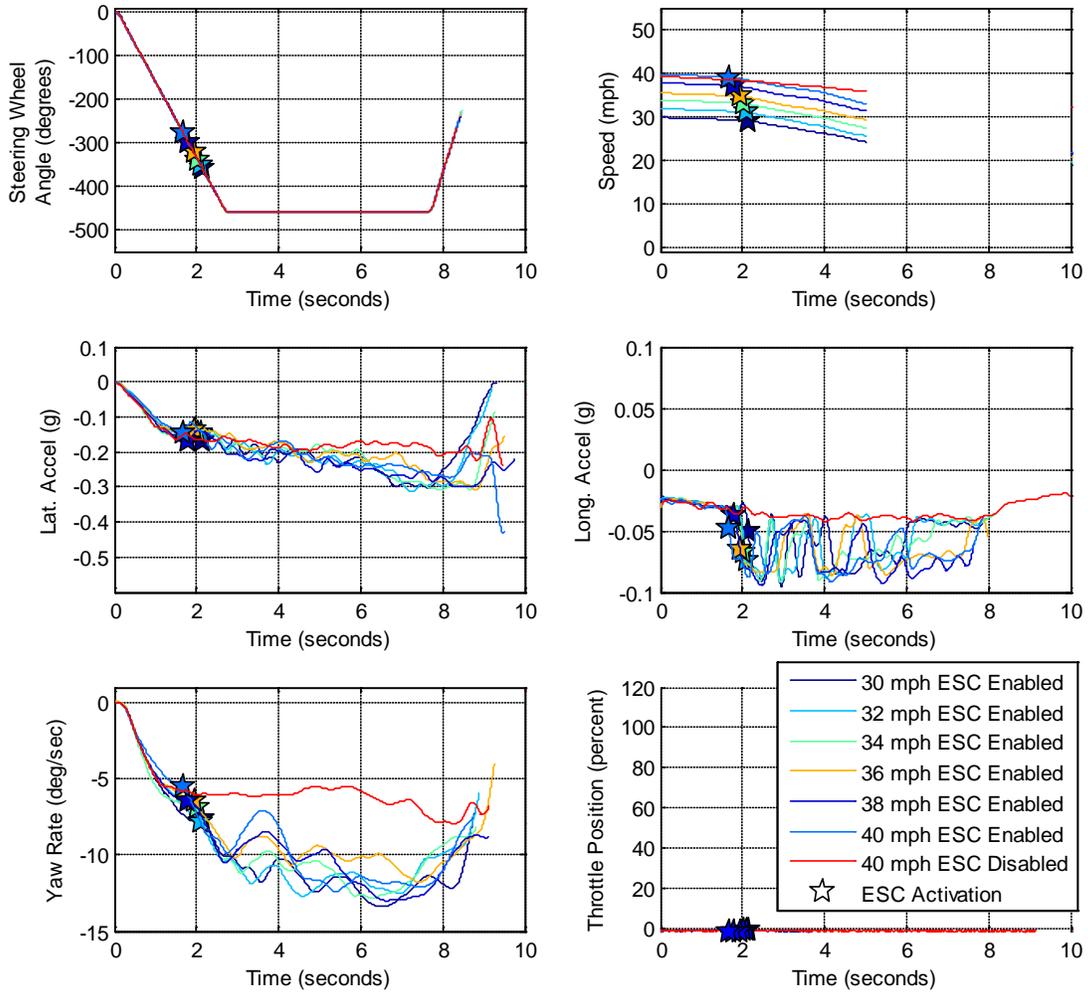
Figure 3.38. MCI #2 RSM time history data from the test series conducted on the wet Jennite.

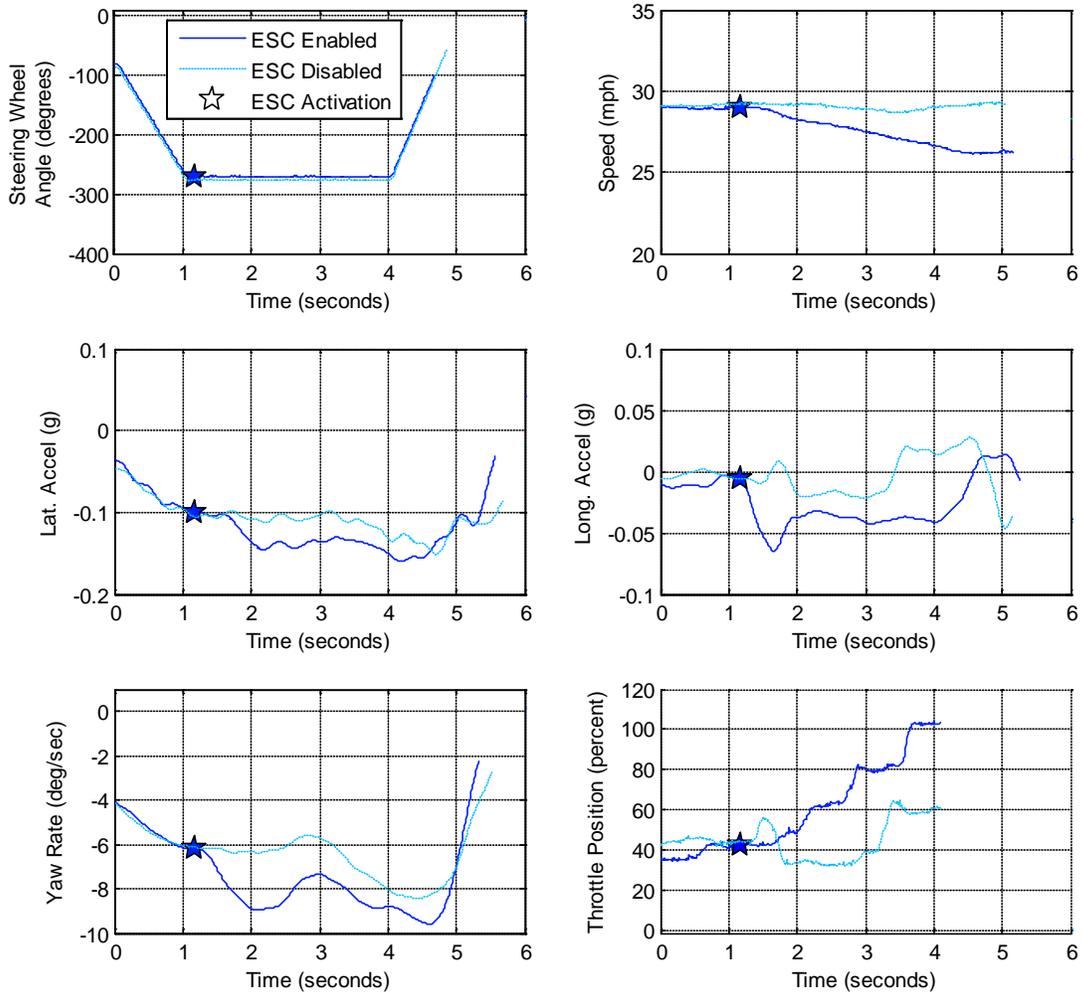
Figure 3.42. Prevost time history data from the RWD maneuver and GPOW load condition. Example shows the RWD test with the lowest steering angle input that resulted in ESC activation.

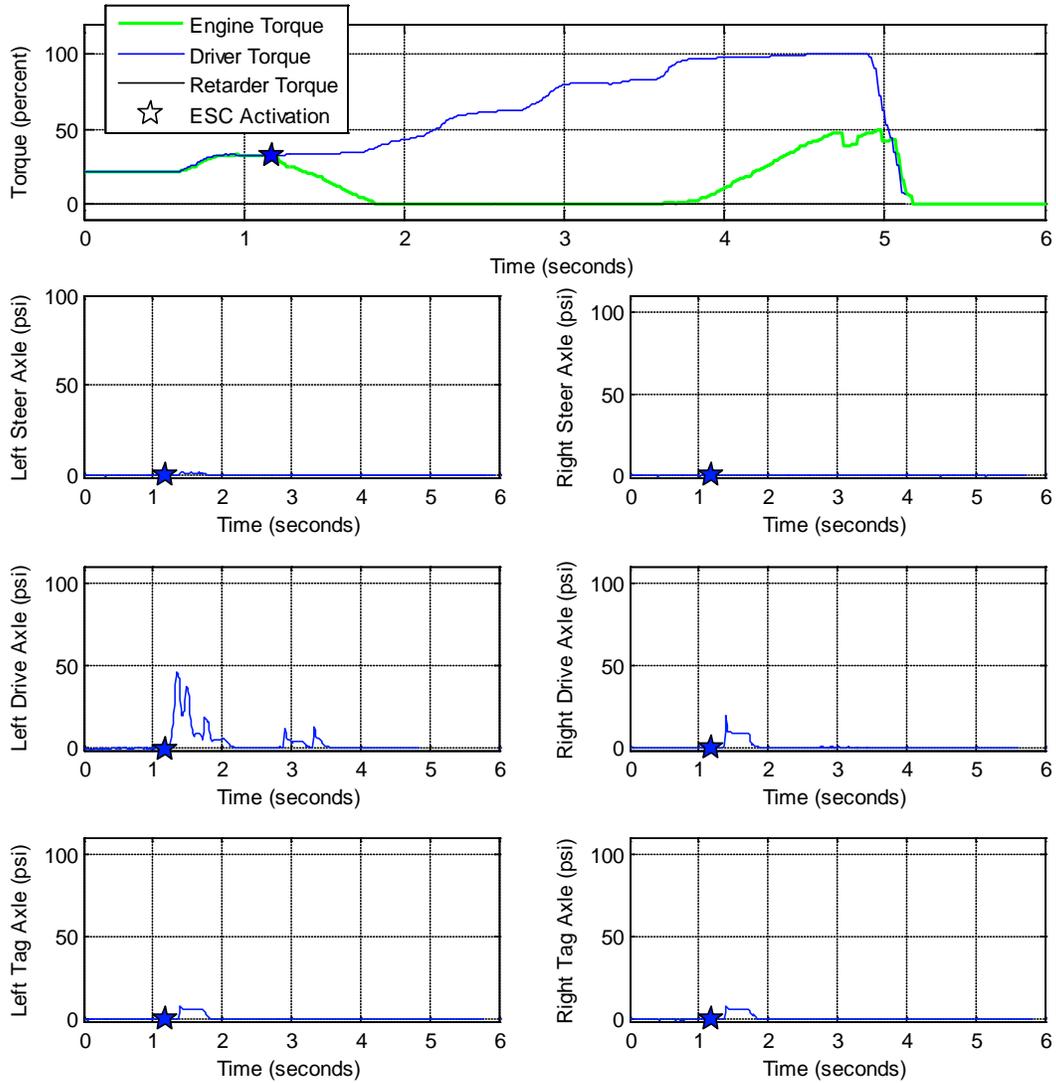
Figure 3.43. Prevost brake pressure data form RWD tests conducted on the Jennite test surface with the GPOW load condition (same enabled tests as shown in Figure 3.42).

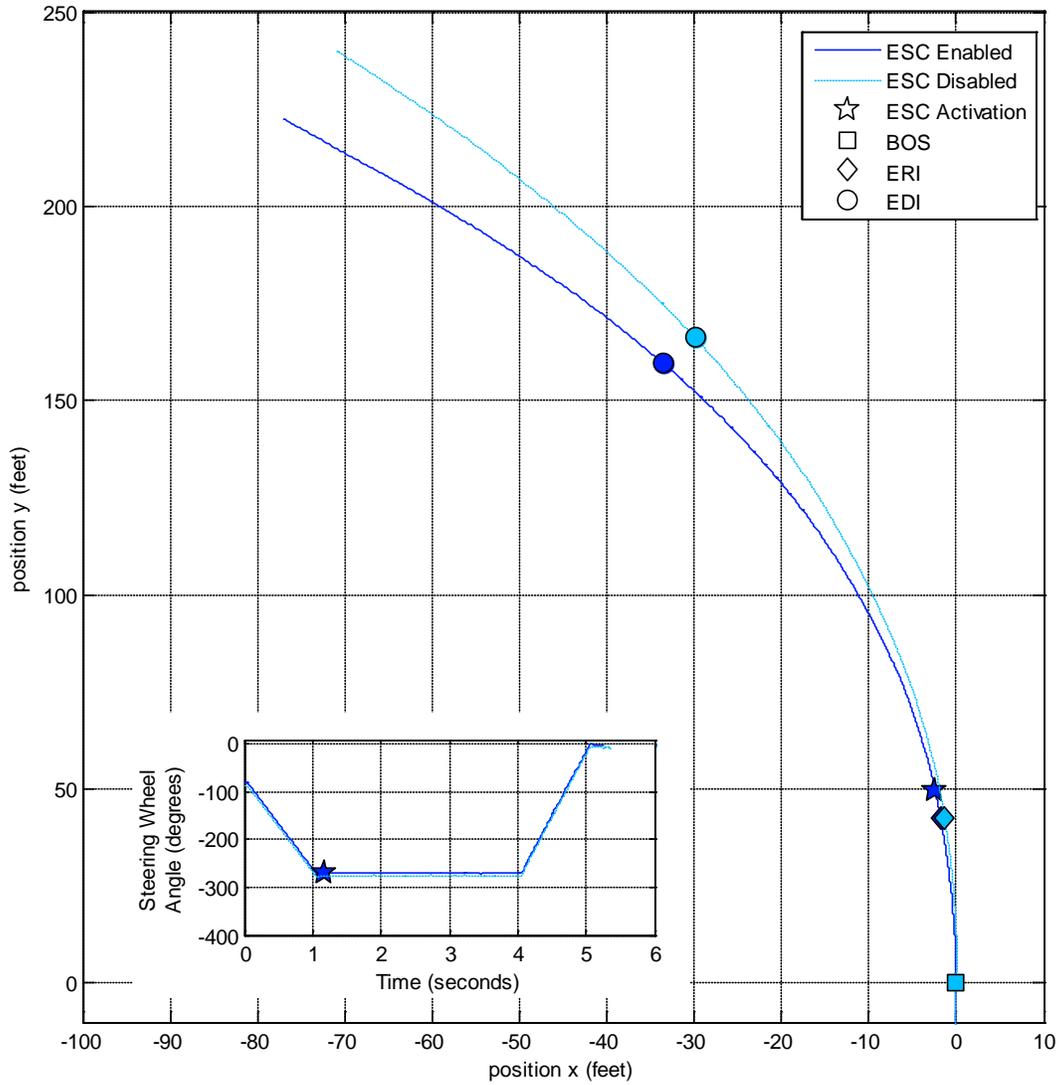
Figure 3.44. Prevost path data from the RWD and the GPOW load condition.

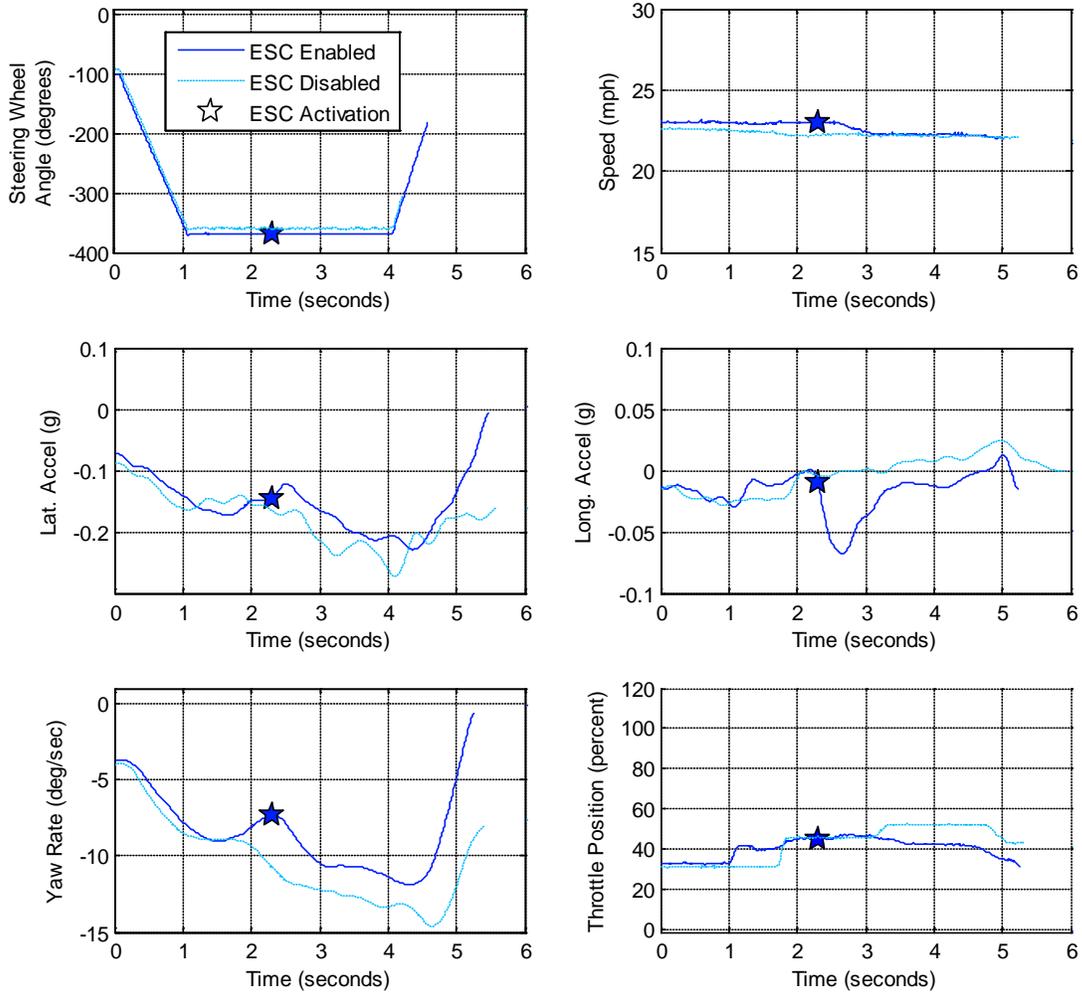
Figure 3.45. MCI #2 time history data from the RWD maneuver and GPOW load condition. Example shows the RWD test with the lowest steering angle input that resulted in ESC activation.

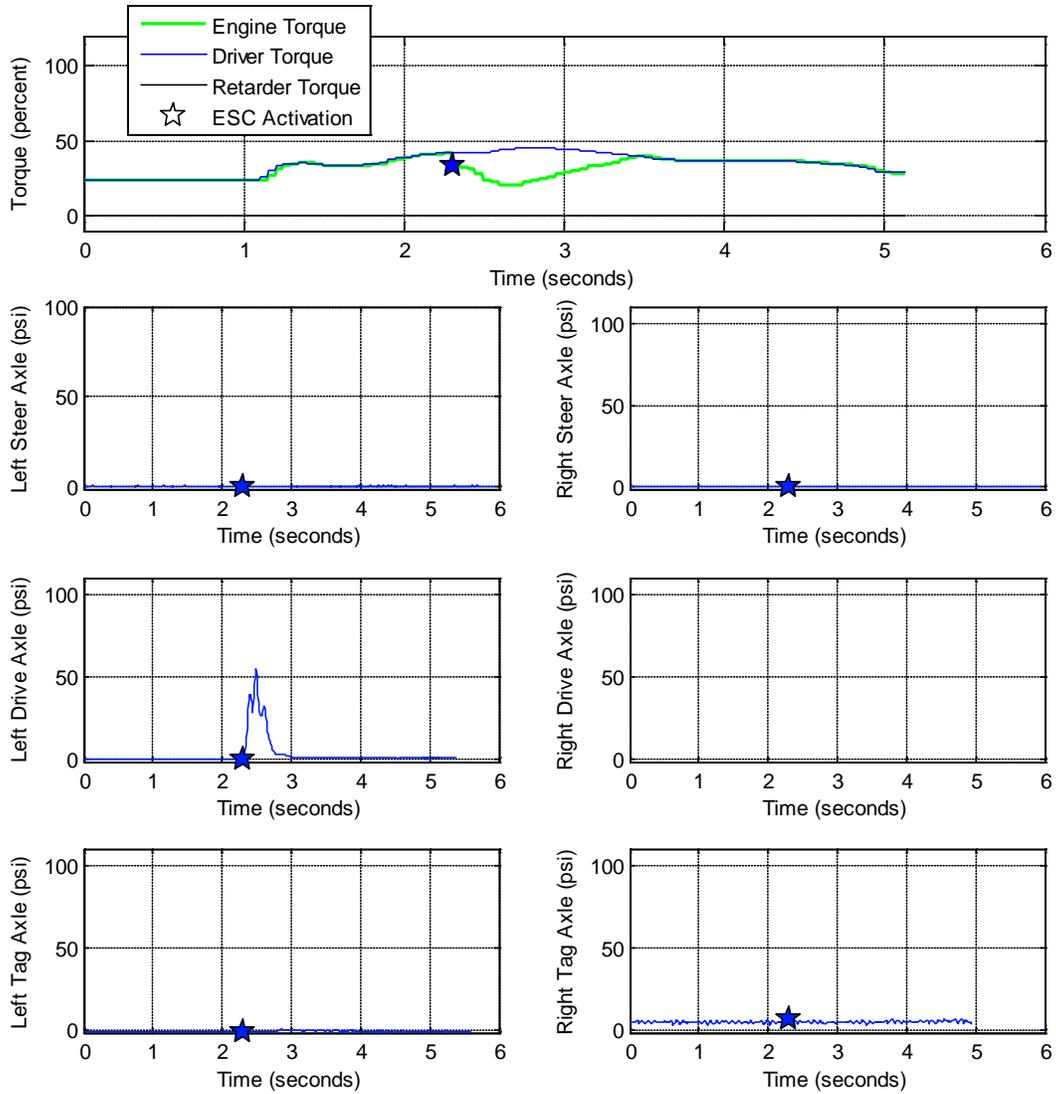
Figure 3.46. MCI #2 brake pressure data from RWD maneuvers with the GPOW load condition and ESC enabled.

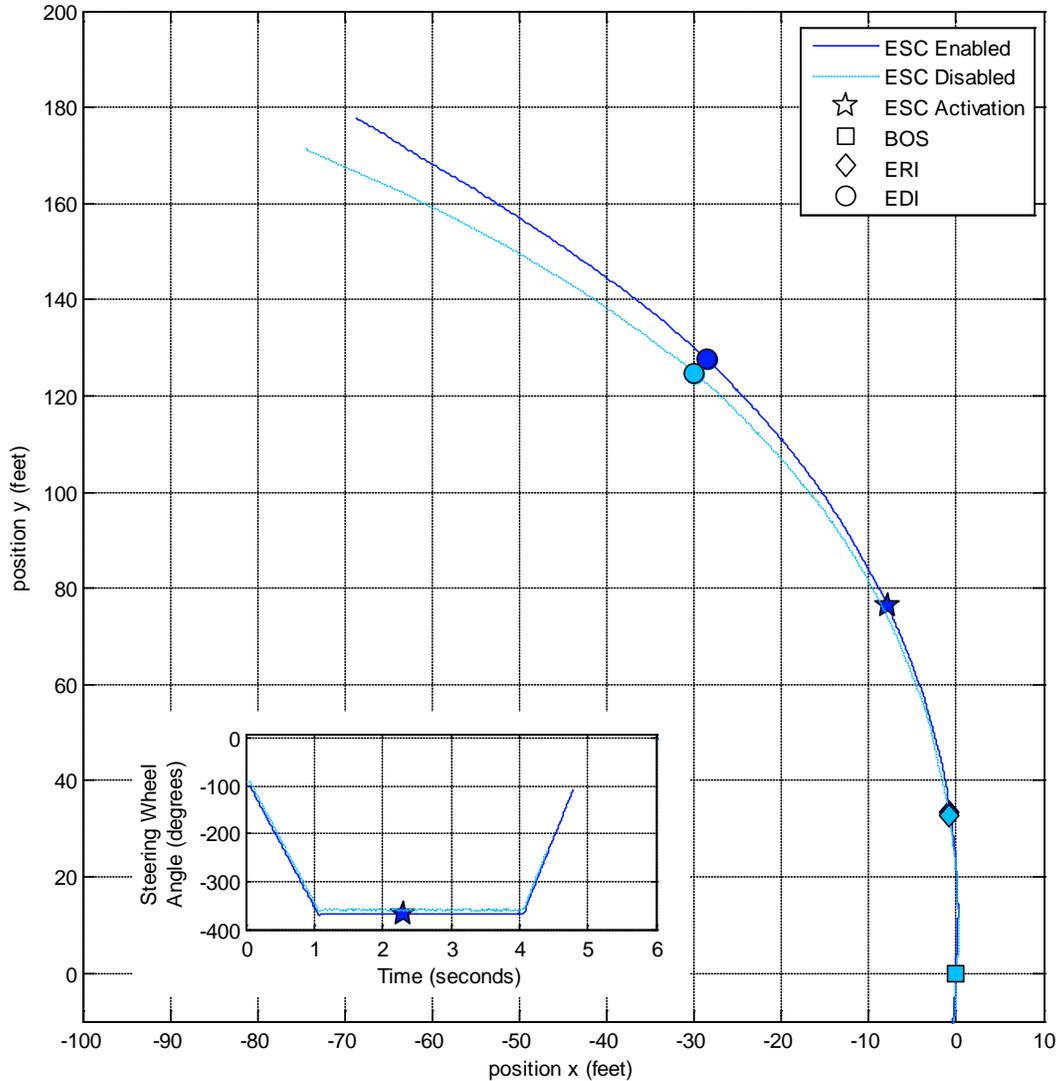
Figure 3.47. MCI #2 path data from RWD maneuvers conducted on the Jennite and the GPOW load condition.

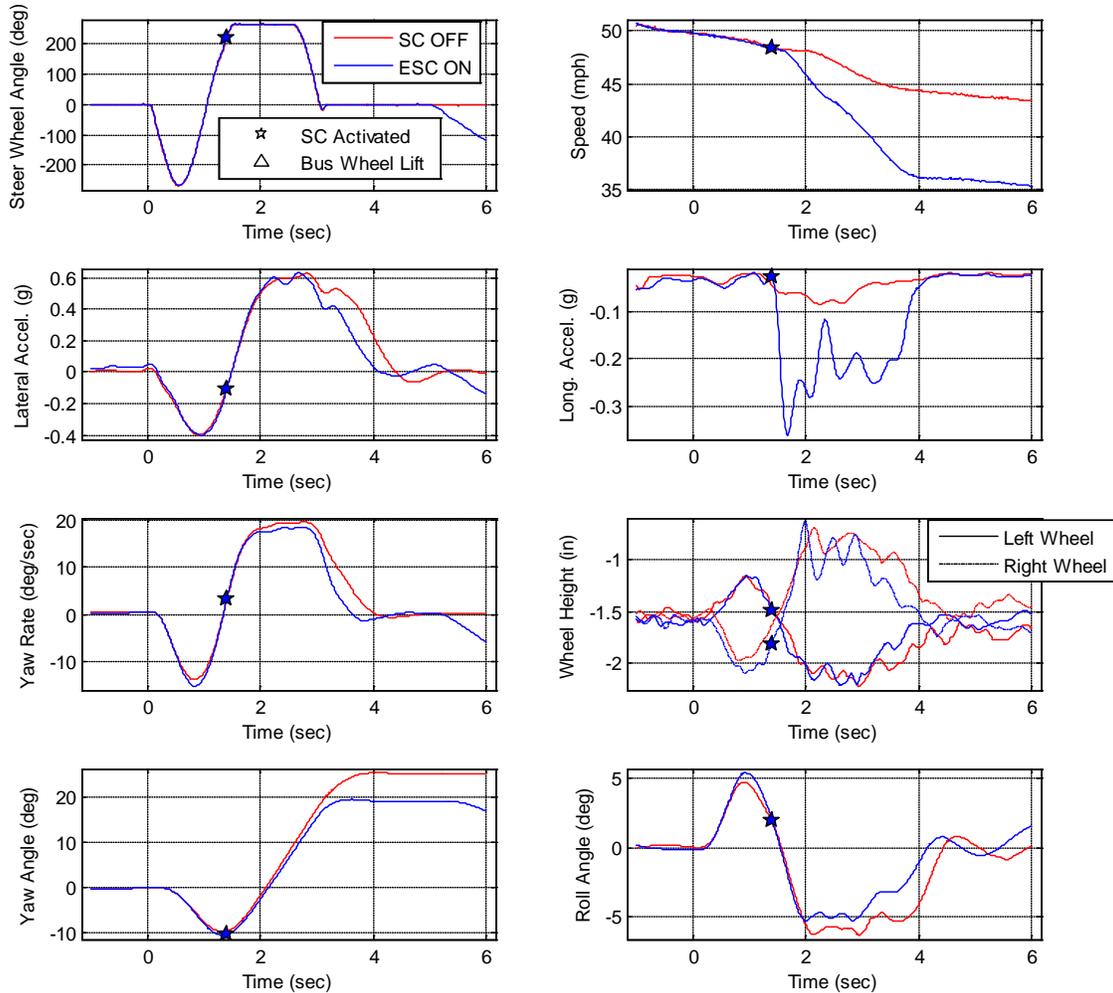
Figure 3.48 Prevost LLVW time history data from SWDs conducted with the 0.5 Hz frequency, 1.0 second dwell time, and 70% steering scalar at 50mph.

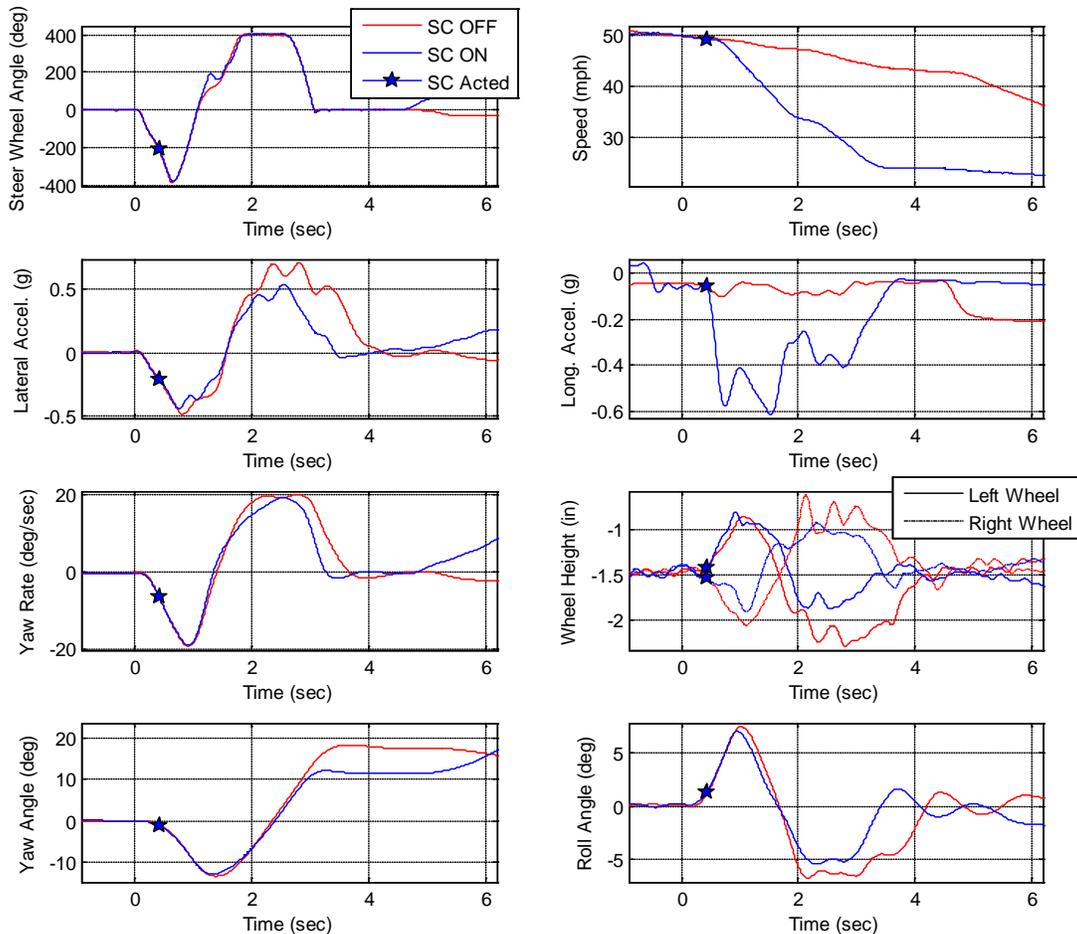
Figure 3.49. MCI #2 time history data from LLVW SWD test series conducted at the 0.5 Hz frequency, with the 1.0 second dwell time, and 100% steering scalar at 50 mph.

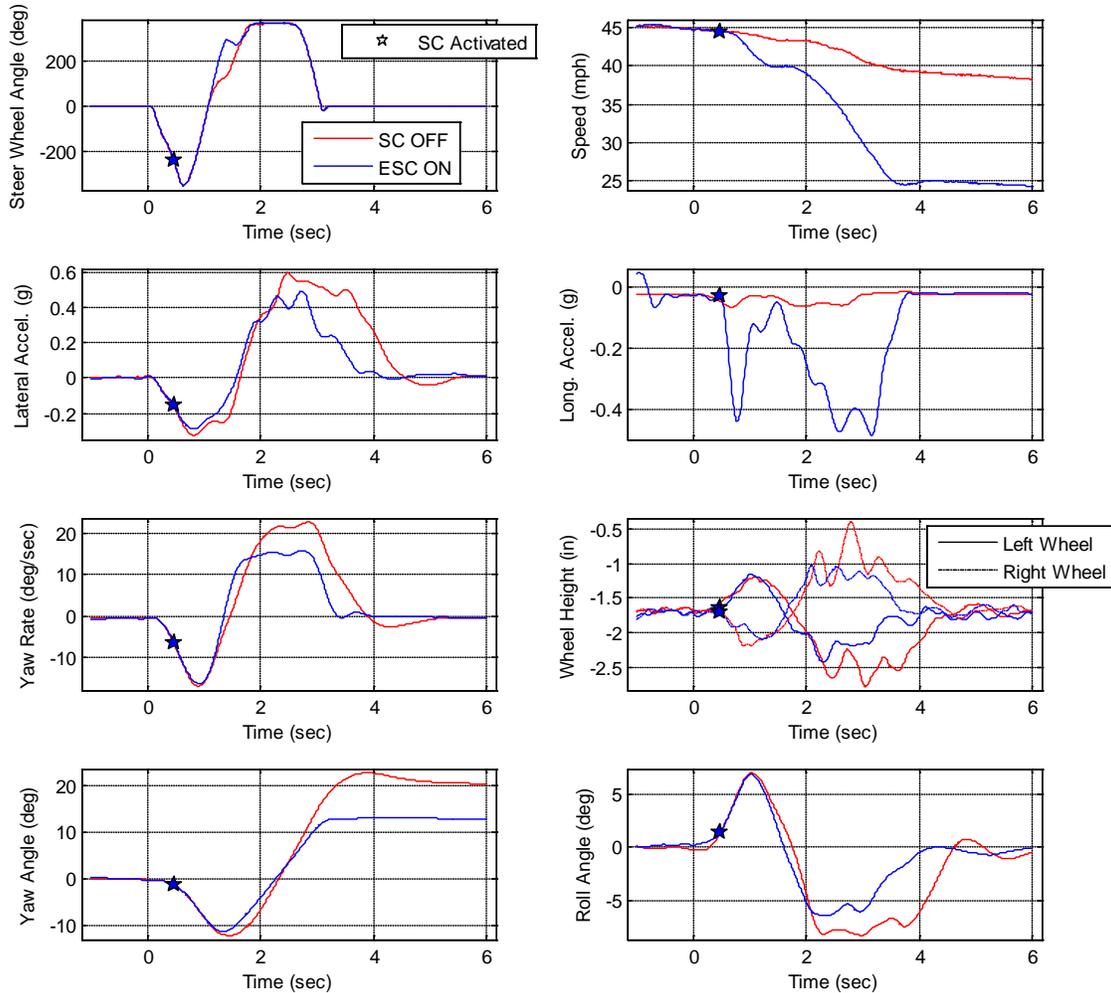
Figure 3.50. MCI #2 time history data from Gross Occupancy SWD test series conducted on dry high friction asphalt with the 0.5 Hz frequency, 1.0 second dwell time and 80% steering scalar at 45 mph.

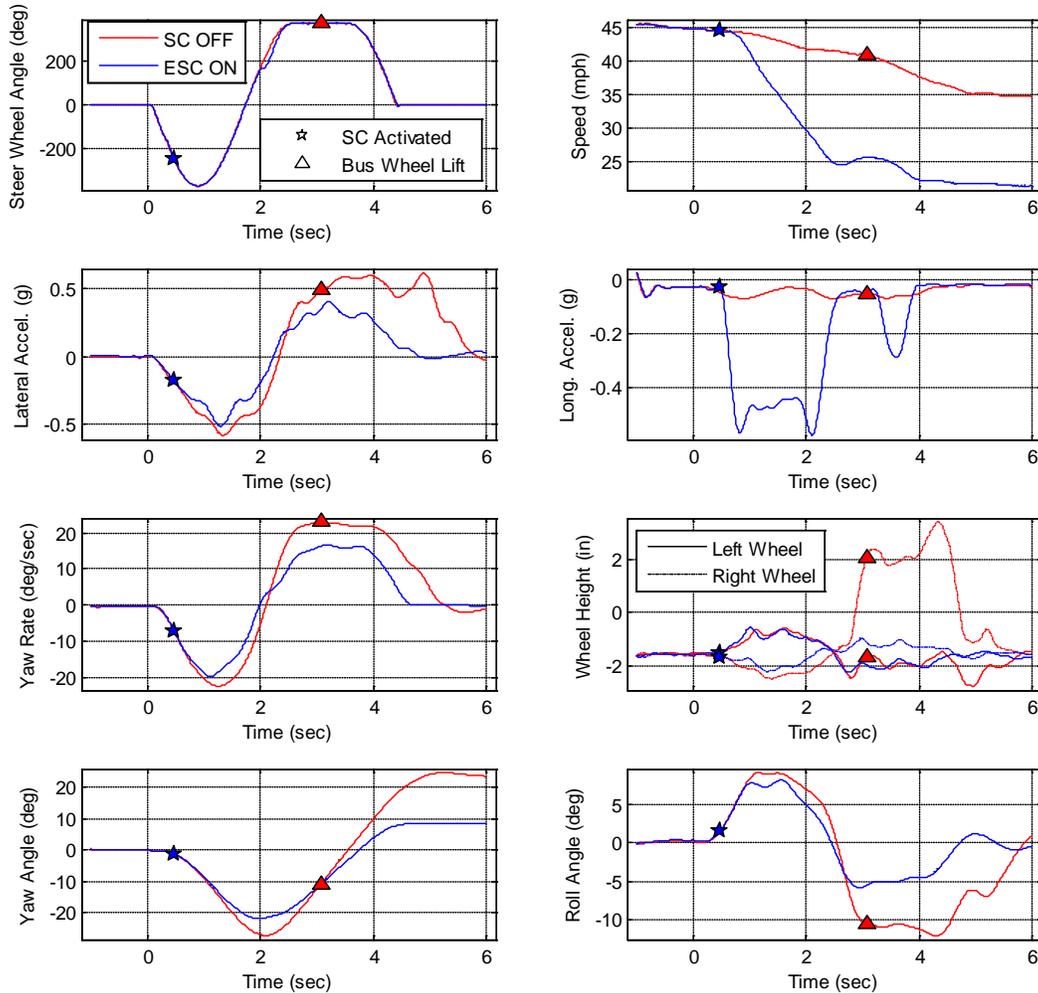
Figure 3.51. MCI #2 time history data from Gross Occupancy SWD test series conducted on dry high friction asphalt at the 0.3 Hz frequency, 1.0 second dwell time, and 80% steering scalar at 45 mph.

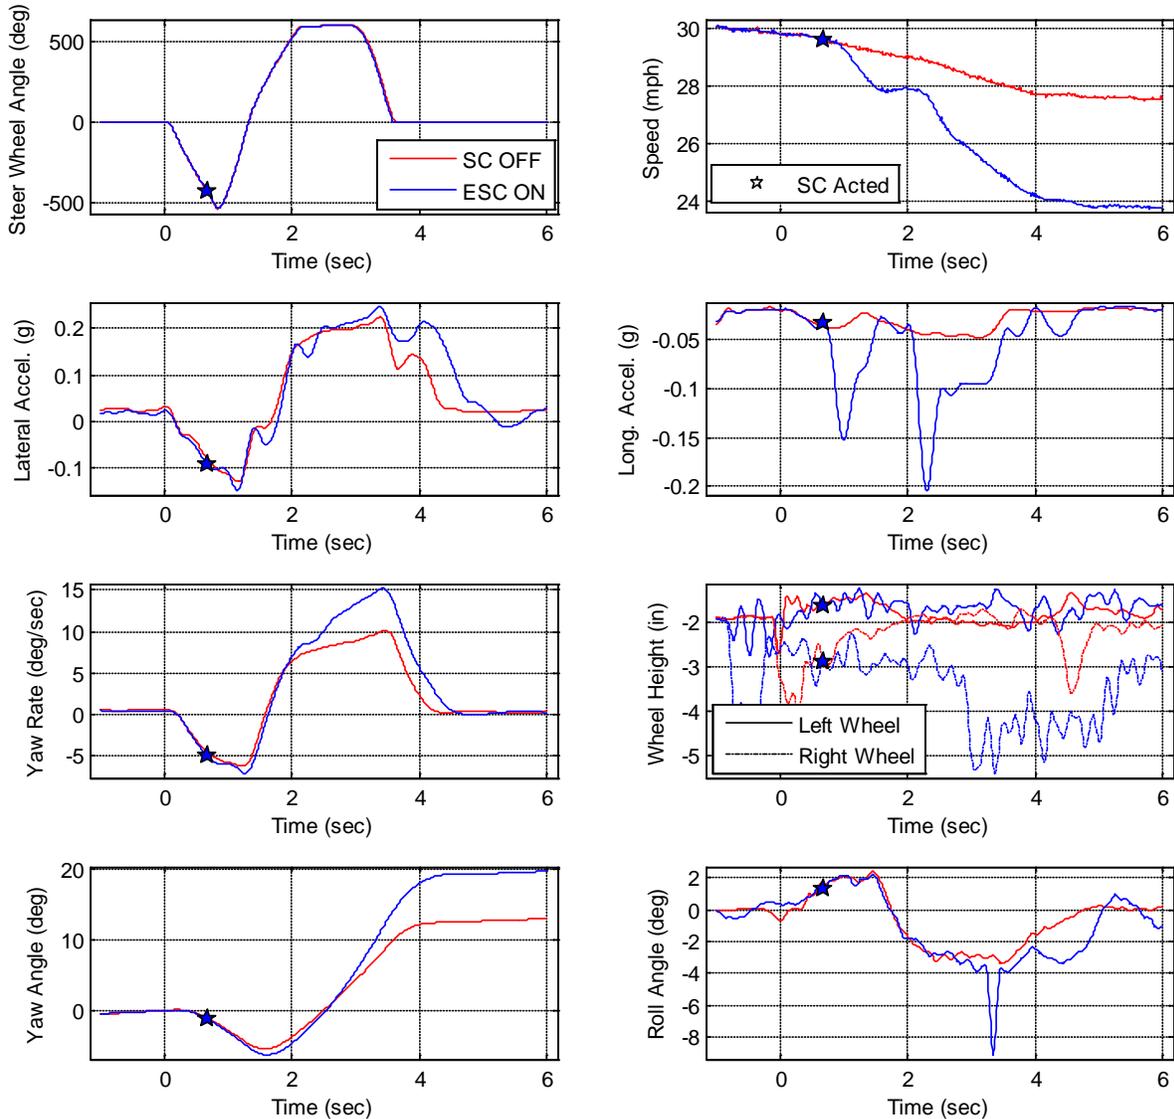
Figure 3.52. MCI #2 time history data from the GPOW SWD test series conducted on wet Jennite surface with the 0.4 Hz frequency, 1.0 second dwell time, and 130% steering scalar at 30 mph.

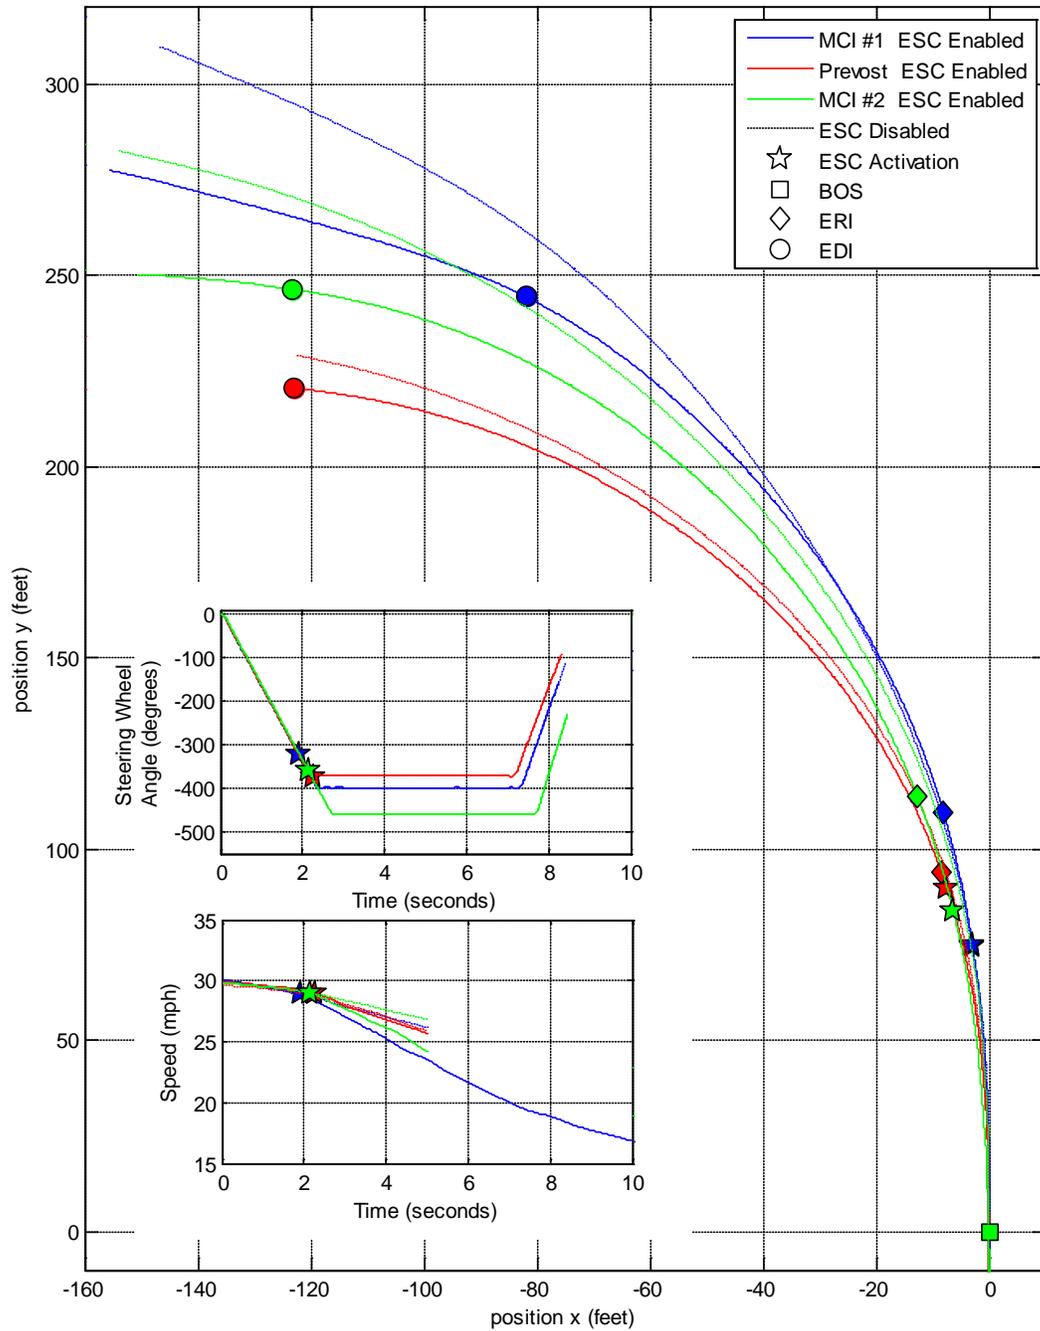
Figure 3.53. Position data of the motorcoaches performing the RSM on the reduced friction surface. Lines approximate the path of the center of the front axle.

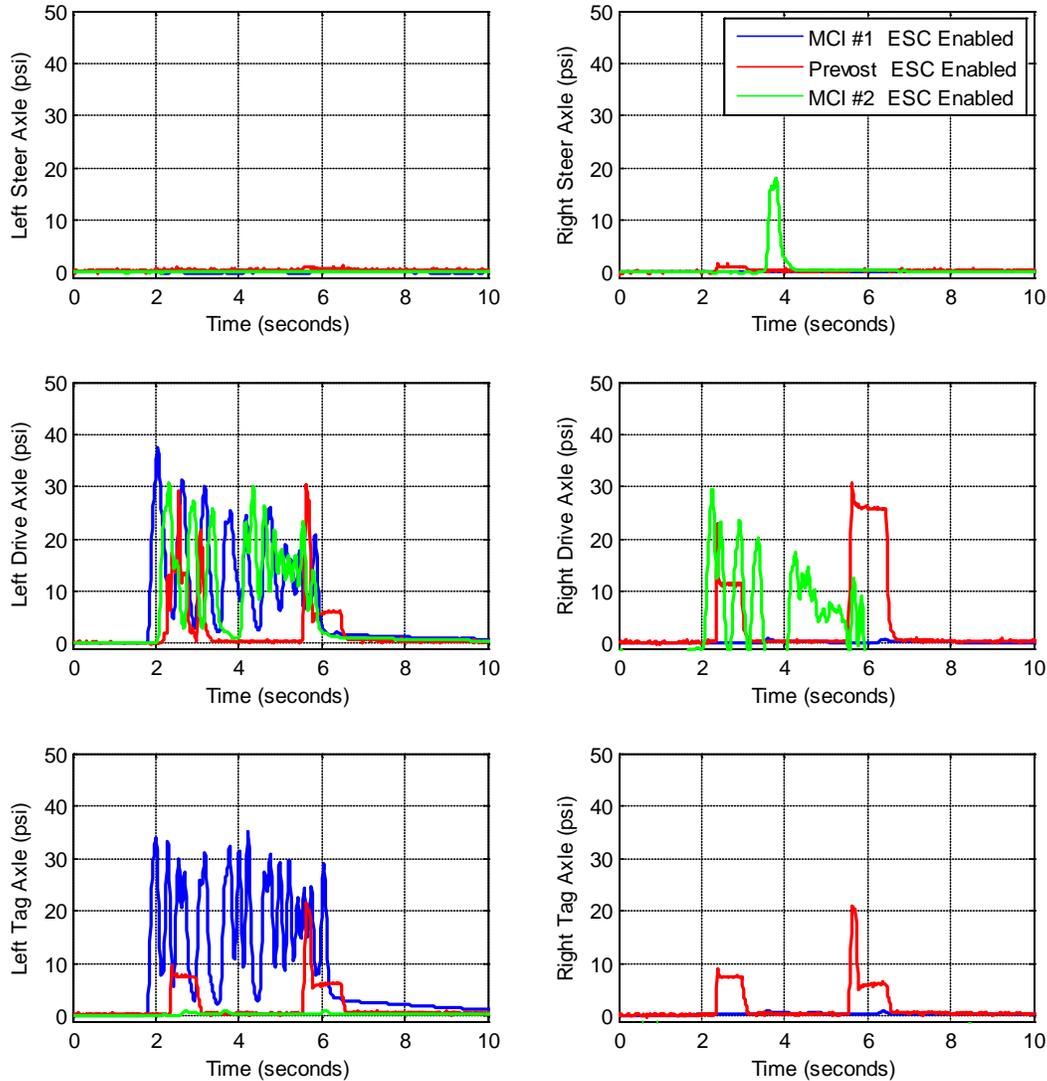
Figure 3.55. Time history data of brake pressures from test shown in Figure 3.53.

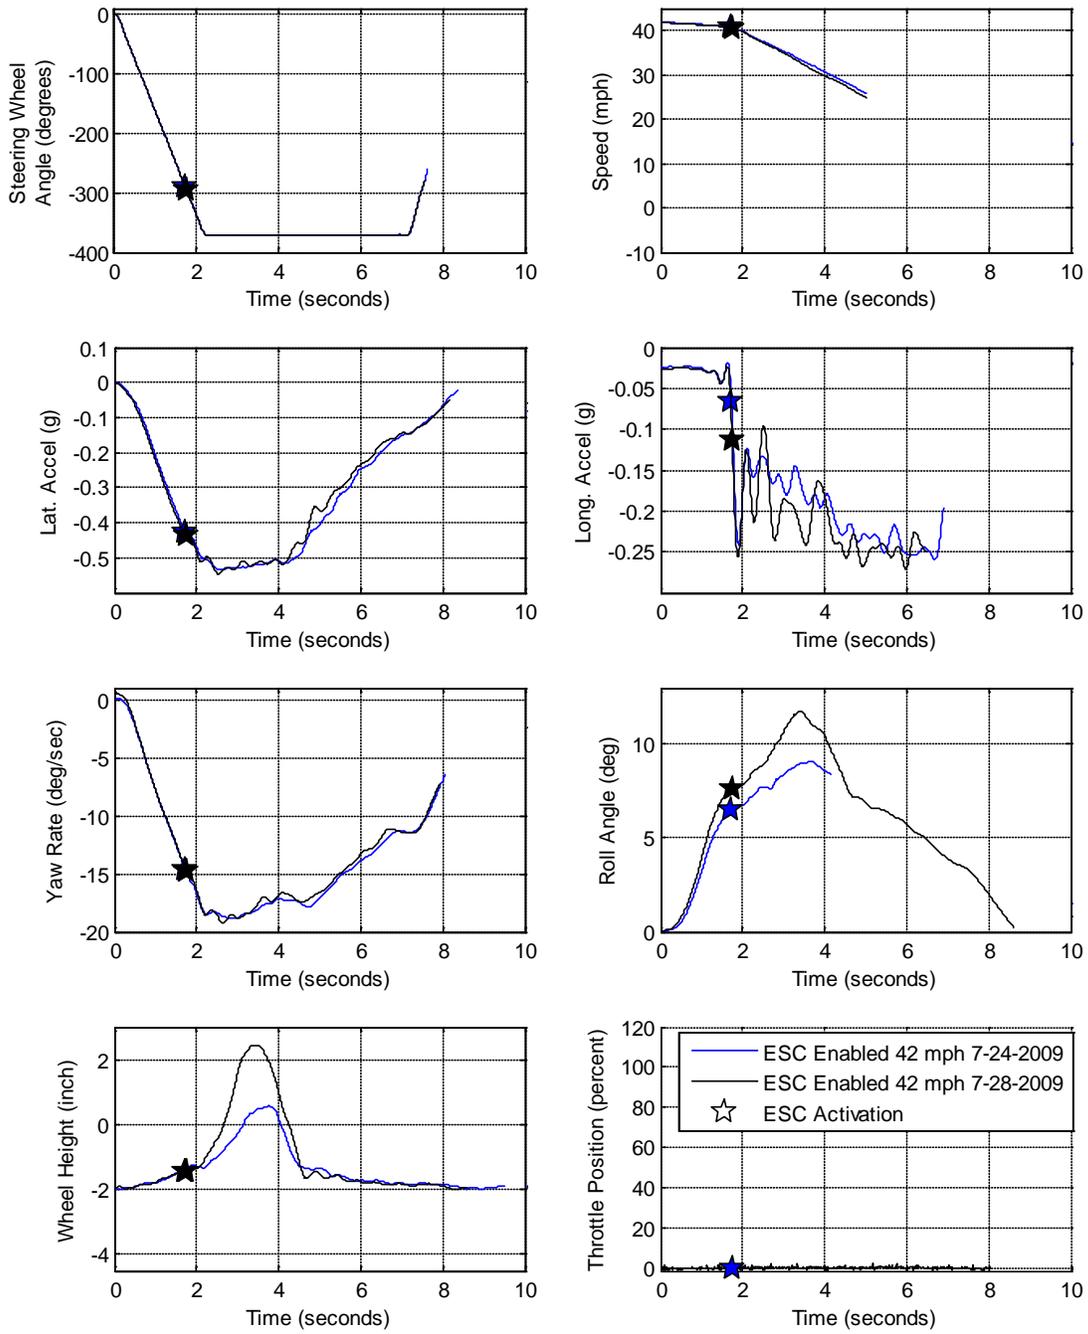
Figure 3.56. Graph shows test data from the Prevost RSM in the GPOW load condition with ESC enabled for two tests with a MES of 42 mph but conducted on different days.

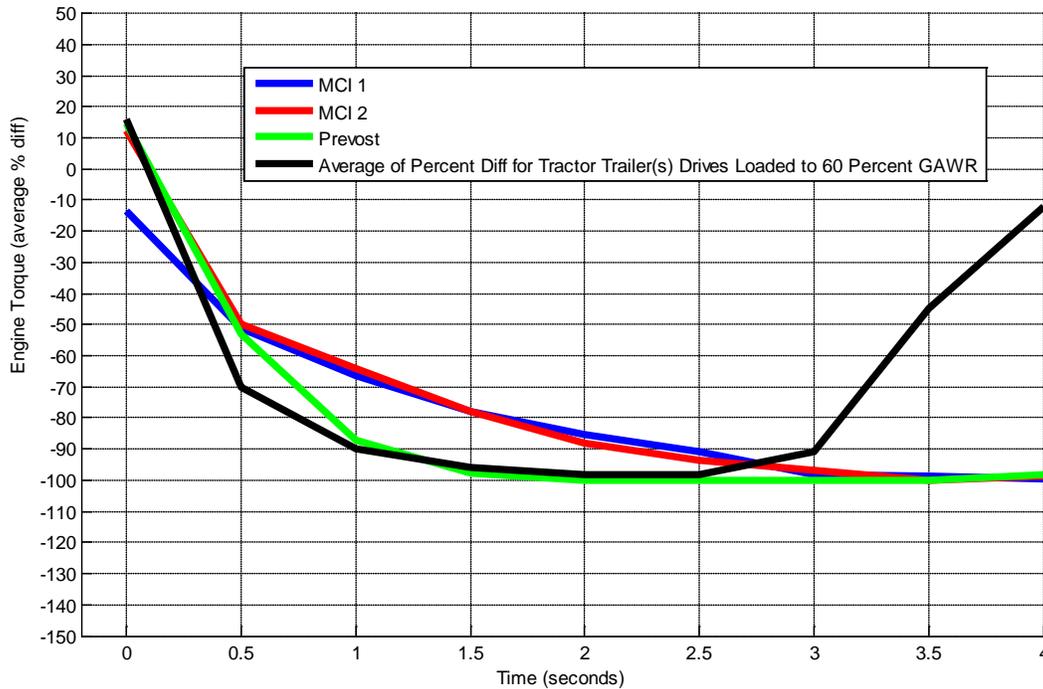
Figure 4.1. Average engine torque reduction for each motorcoach tested in the GPOW load condition. Also included was the average difference (percent change) for all tractors equipped with stability control tested in combination with four different trailers.

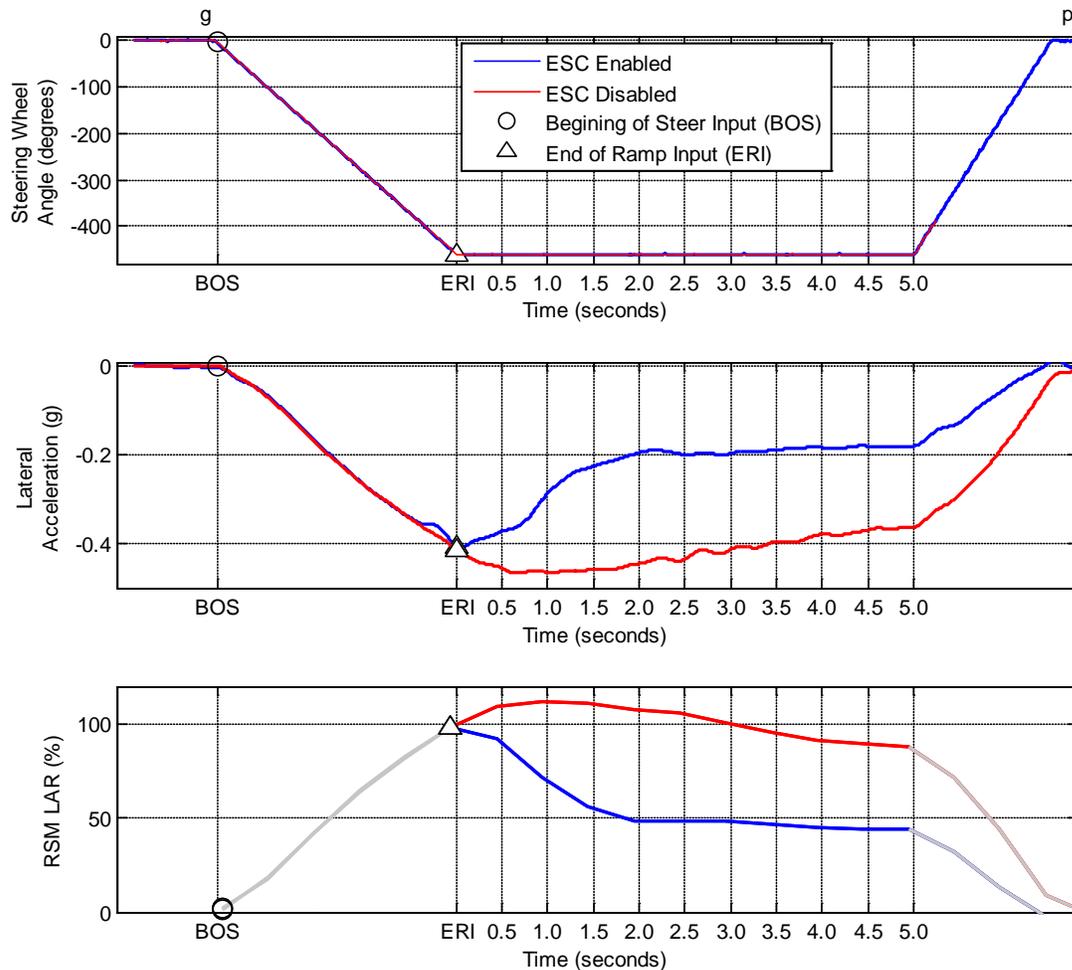
Figure 4.2. Time history data of steering wheel angle, lateral acceleration and the calculated LAR measure. This figure, key points of interest: BOS and ERI.

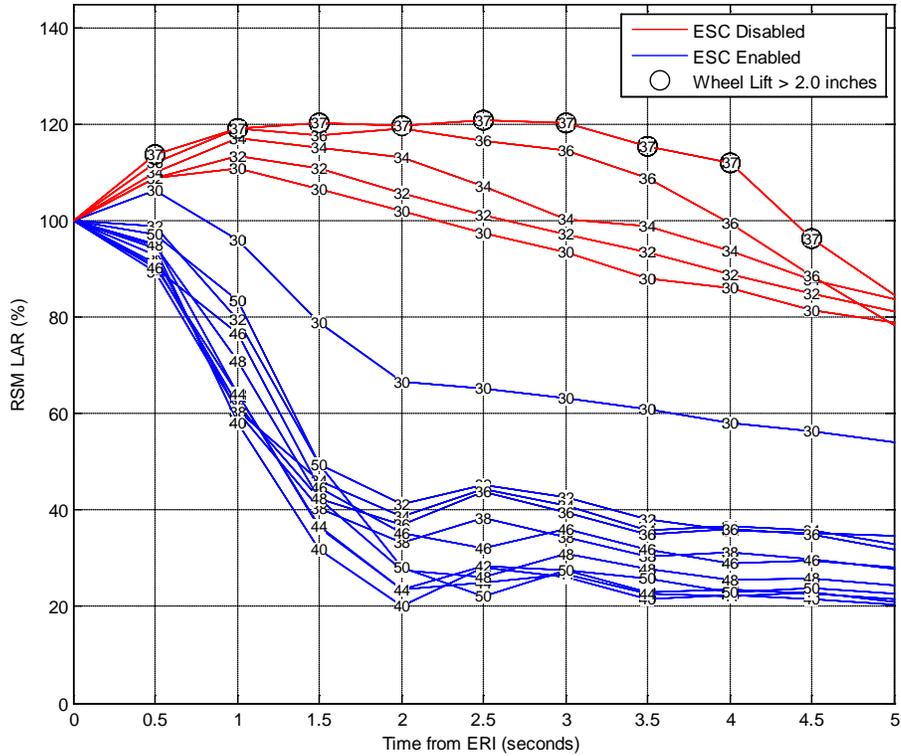
Figure 4.3. LAR versus time after ERI for MCI #1 RSM tests (GPOW load condition) conducted with a MES of 30–37 mph with ESC disabled and 30–50 mph with ESC enabled.

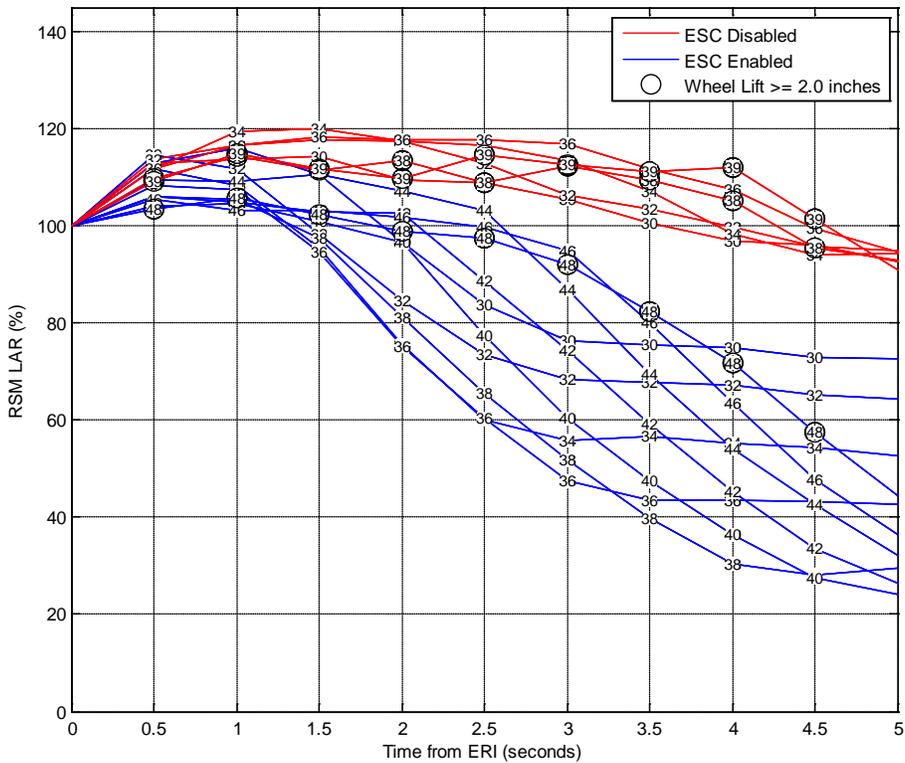
Figure 4.4. LAR versus time after ERI for Prevost RSM tests (GPOW load condition) conducted with a MES of 30–39 mph with ESC disabled and 30–48 mph with ESC enabled.
