U.S. Department
of Transportation
**National Highway
Traffic Safety
Administration**

DOT HS 811 633

Test Track Lateral Stability Performance of Motorcoaches Equipped With Electronic Stability Control Systems

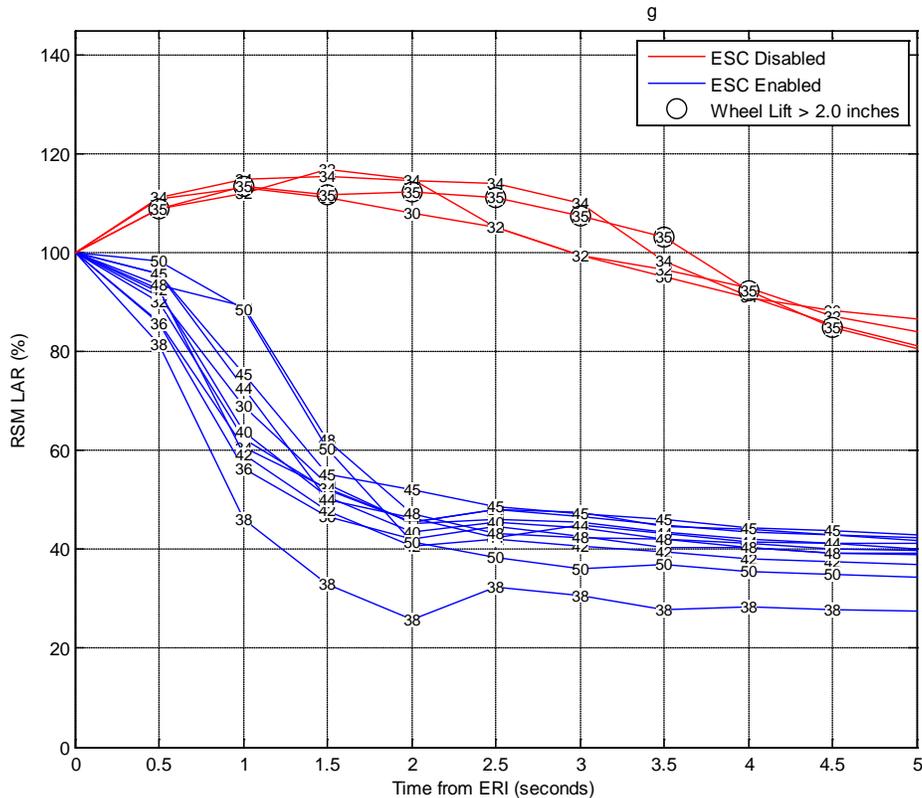
Figure 4.5. LAR versus time after ERI for MCI #2 RSM tests (GPOW load condition) conducted with a MES of 30–35 mph with ESC disabled and 30–50 mph with ESC enabled.

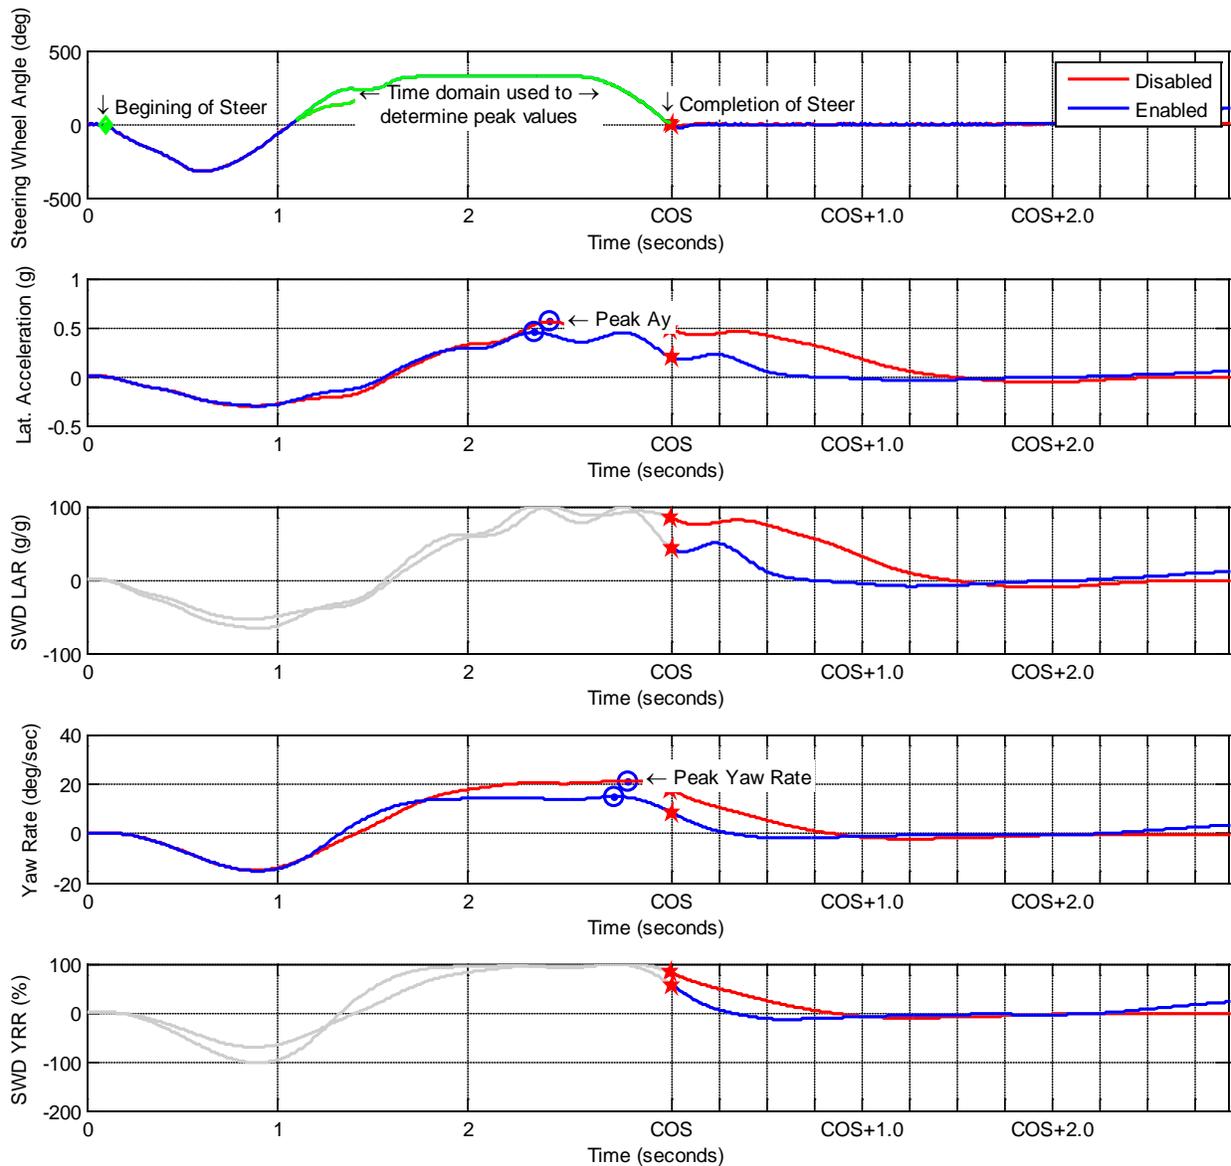
Figure 4.6. Key events in the SWD maneuver's steering input and measured lateral acceleration and yaw rate signals that were used calculate the LAR and YRR measures.

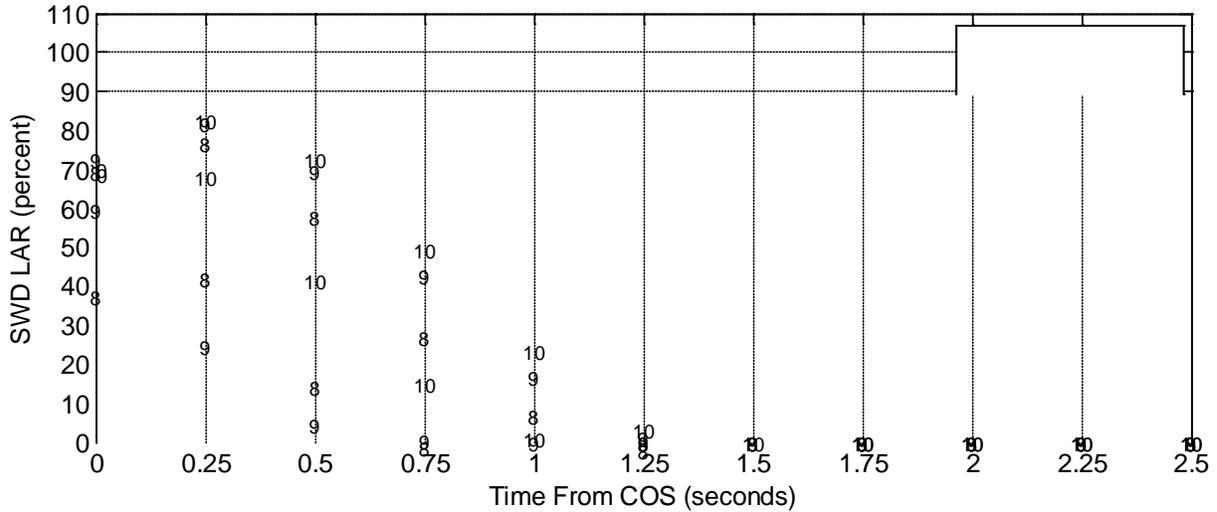
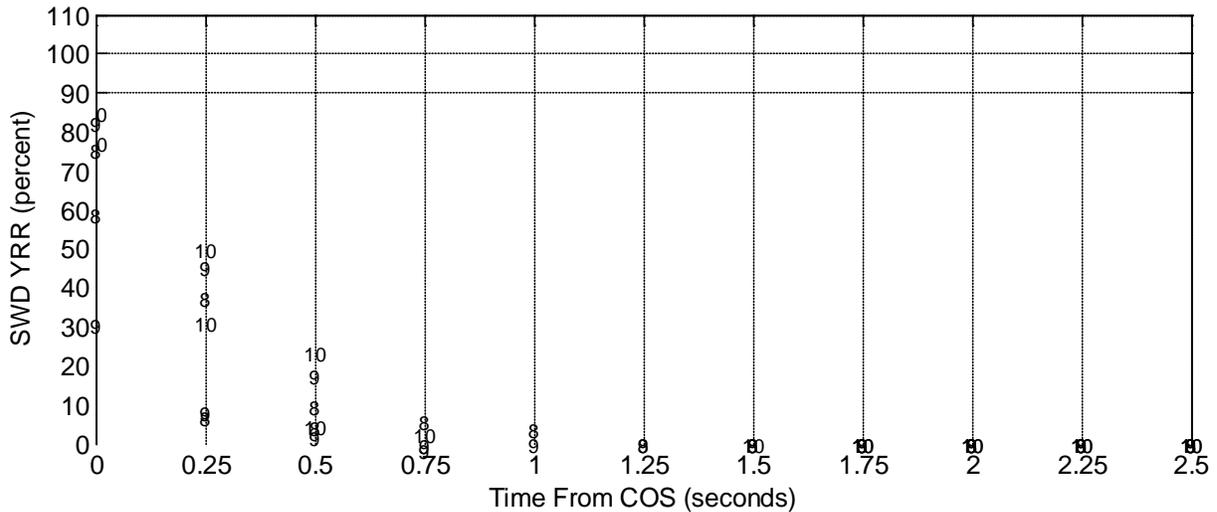
Figure 4.7. SWD LAR and YRR observations produced by the MCI #1 motorcoach with the GPOW load condition. Steering Scalars from 80–100 percent are shown for ESC enabled and disabled test series.

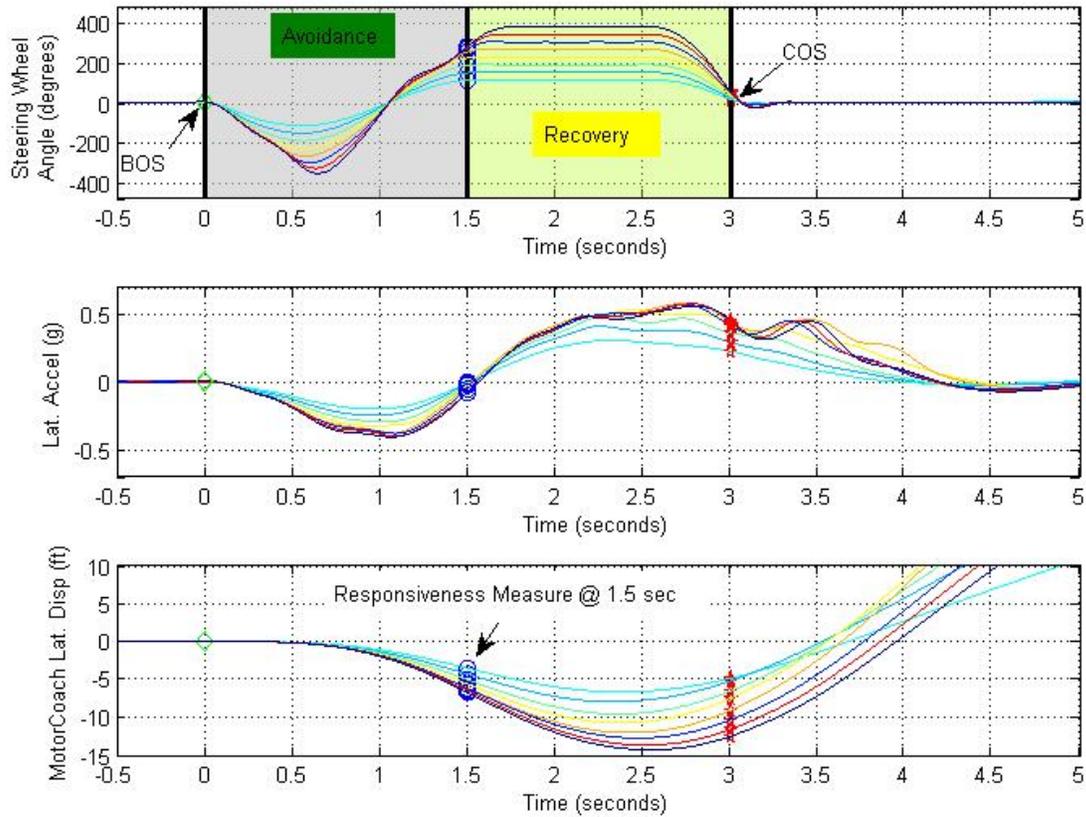
Figure 4.10. Time history data from the SWD denotes BOS, responsiveness measure, COS and the maneuver avoidance and recovery regions.

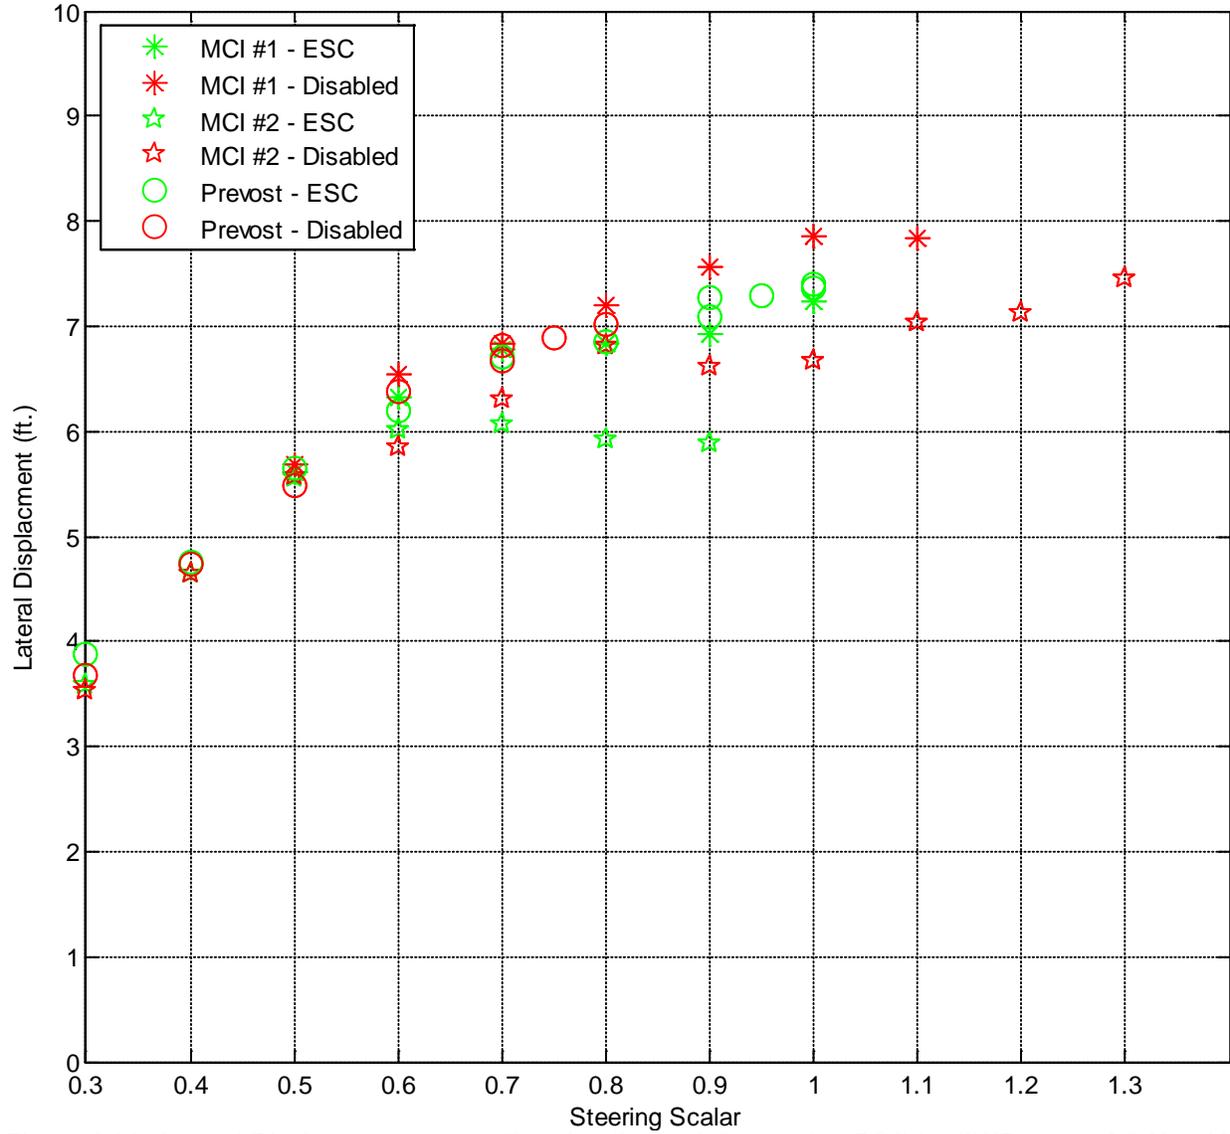
Figure 4.11. Lateral Displacement versus Steering Scalar 1.5 sec. after BOS for SWD test at 0.5 Hz with 1.0 sec. dwell.

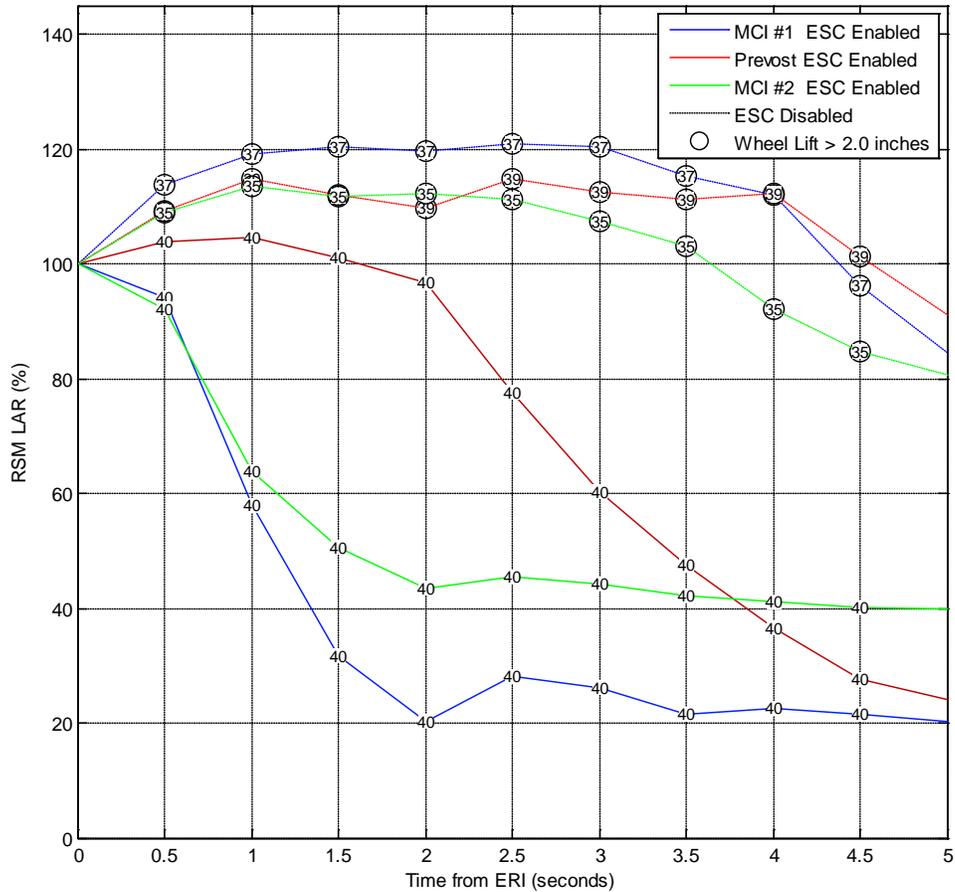
Figure 5.1. RSM LAR after ERI event for all three motorcoaches with ESC enabled at 40 mph (solid lines) and disabled (dotted lines) at 35 – 39 mph with the GPOW load condition

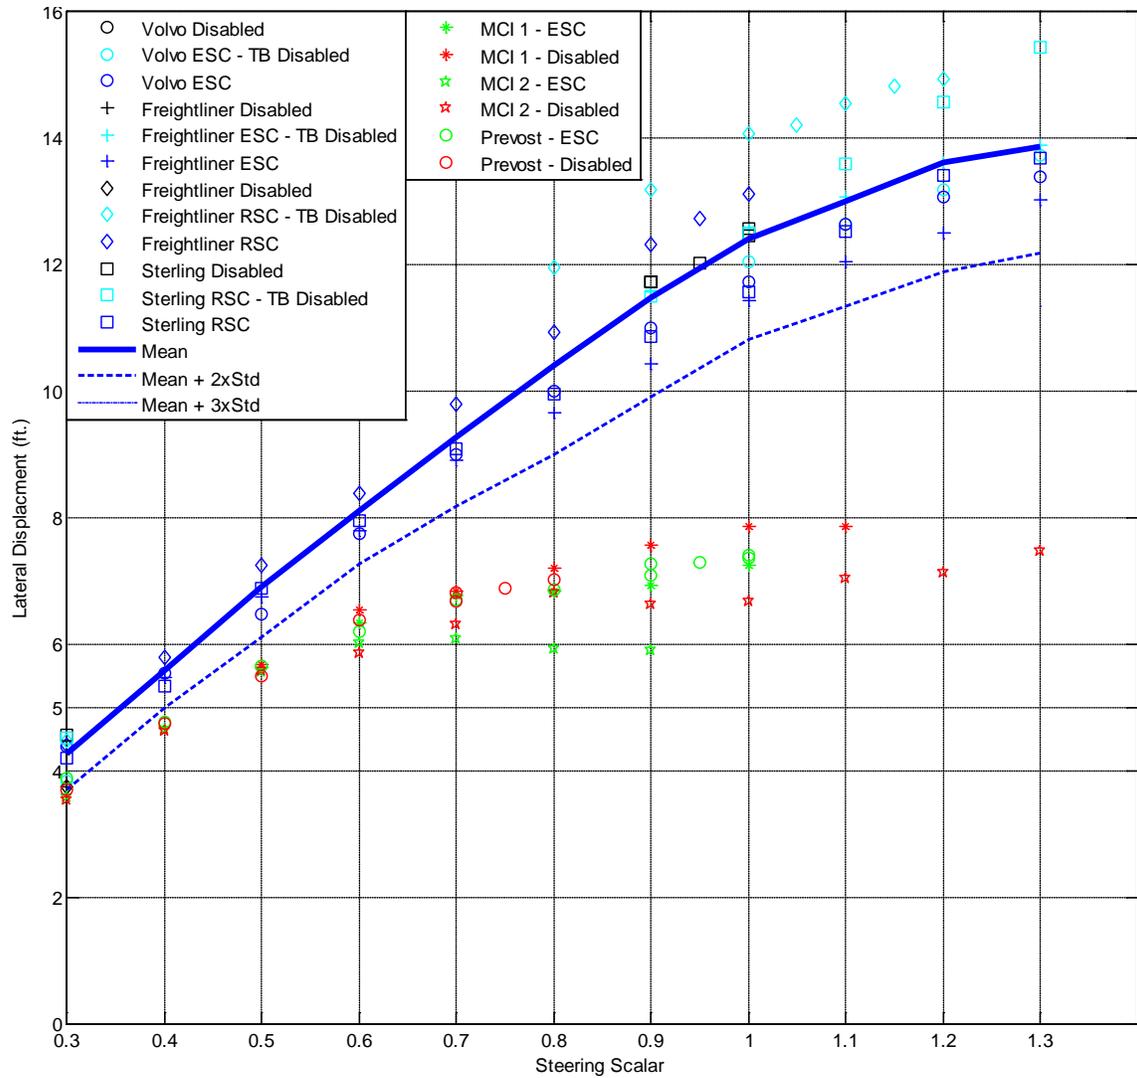
Figure 5.3. 0.5Hz SWD (1.0 second dwell) lateral displacement of truck-tractors and motorcoaches with and without stability control.

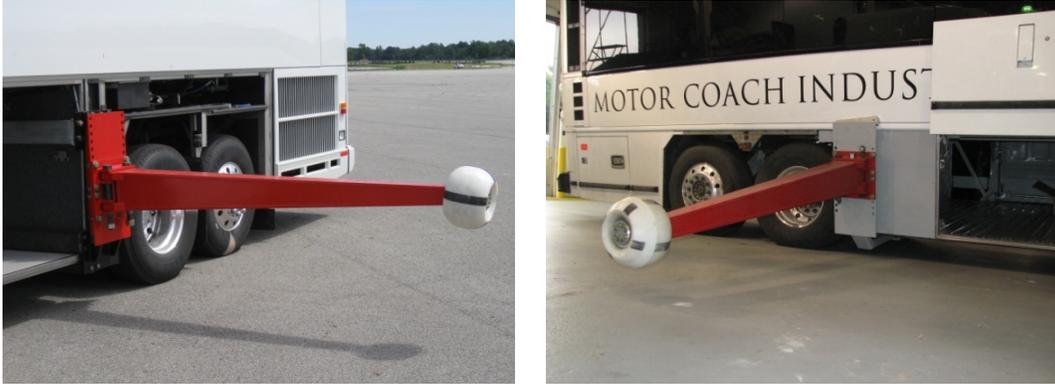
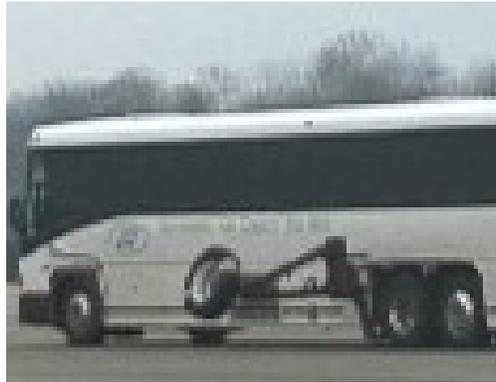
Safety Outriggers: Low inertia outriggers were developed for this testing. The outrigger system adds approximately 1500 lbs to the vehicle but was designed to minimize roll and yaw inertias. When deployed, the outriggers span 315 inches across from wheel to wheel. Further information and detailed specifications of the outriggers can be obtained in, DOT HS 811 289 and in Appendix 0.

AP Figure 1. Outriggers.

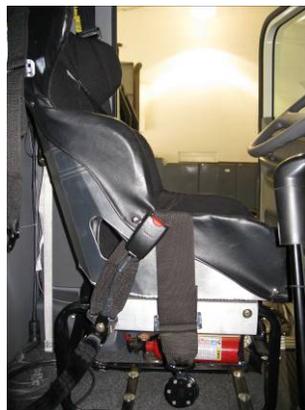
Driver Restraint System: The driver restraint system consists of a racing seat and a 5 point restraint harness. The racing seat allowed the harness to be properly installed in the cab without the risk of compressing the driver in the event of a rollover. Additionally, the racing seat provided stability for the driver when conducting maneuvers that generated high lateral forces.

AP Figure 2. Driver restraint system.

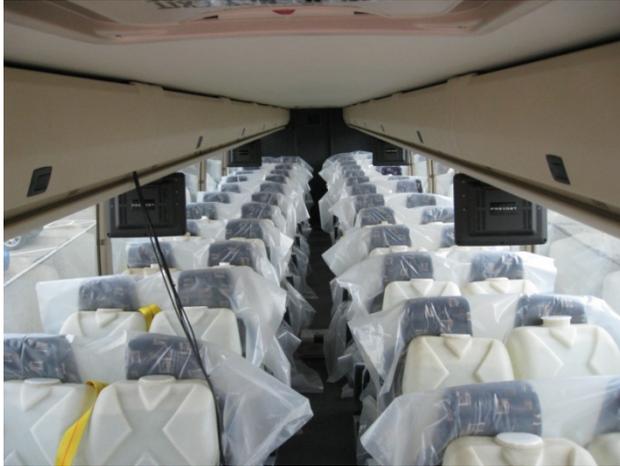
GPOW load condition includes all equipment and instrumentation from LLVW condition plus 175 lb water dummies to simulate passengers. Simulated passengers were added until the measured weight was at the placarded GVWR. AP Figure 3 shows a photograph of the water dummies placed in the passenger seats of a motorcoach.

AP Figure 3. 175 lb. water Dummies were used to ballast the motorcoaches to the GPOW load condition.

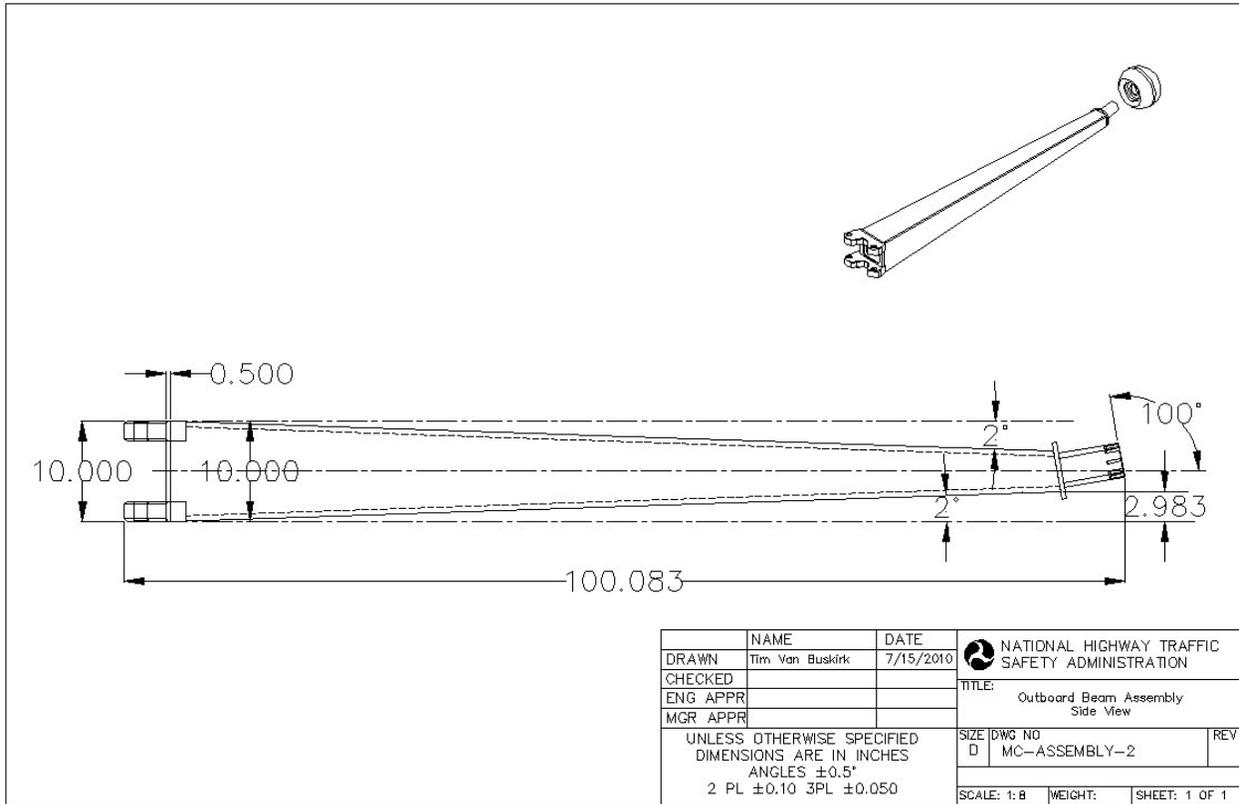
AP Figure 5. Dimensional Outrigger Assembly Drawing - Side-view.

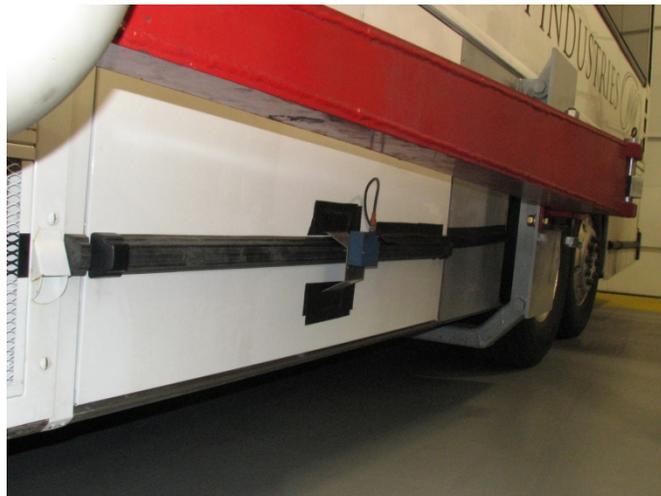
Engineering drawings and pictures from fabrication of the outboard beam can be found in DOT HS 811 289. AP Figure 6 shows the completed outboard outrigger beam assembly in a photograph viewed from the driver's side front towards the rear of the motorcoach. The outrigger was in the folded position installed on a motorcoach test vehicle.

AP Figure 6. Completed outrigger assembly installed on a motorcoach.

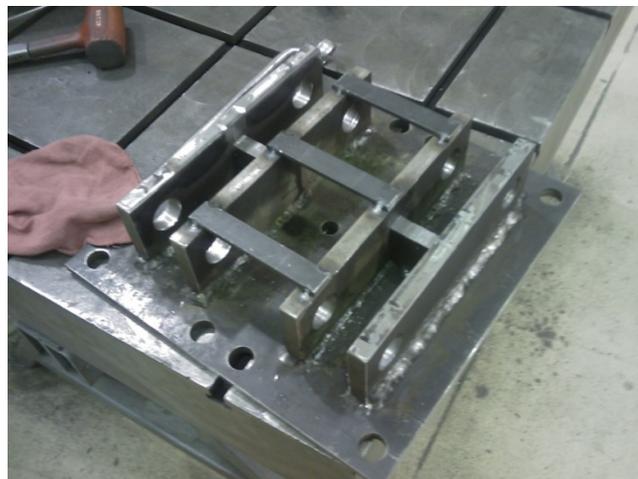
The outrigger beam mounting plate was fabricated from A514 steel plate. Four 0.75 inch thick plates were welded to a 16 inch square plate, 0.50 inch in thickness to form the mounting plate half of the outrigger hinge-set. Two 1.50 inch holes were drilled in these plates to align with the 1.50 inch holes on the outrigger beam hinge brackets. Two 0.75 inch thick steel gussets and three 0.25 inch thick steel stiffeners were added to help keep the plates in alignment. Two outrigger beam mounting plates were needed for each vehicle set of outriggers. AP Figure 8 contains a dimensional drawing of this component. The photograph in AP Figure 9 shows the outrigger mounting plate during fabrication. A total of two outrigger mounting plates were required for each outrigger set.

AP Figure 9. Photograph of the outrigger mounting plate during fabrication.

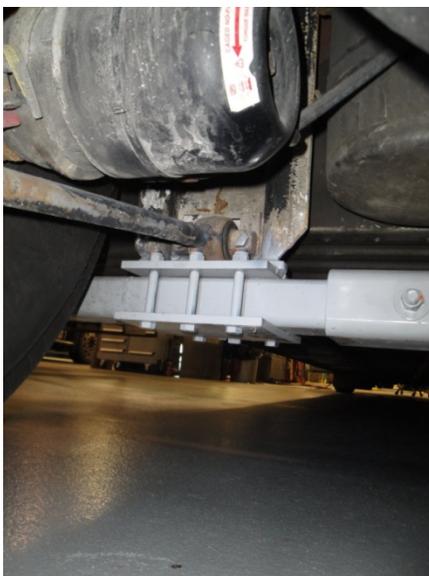
To mount the NHTSA outriggers to the MCI motorcoach, MCI supplied a mounting framework that was integrated and welded into the main chassis of the leased motorcoach. The integrated framework consisted of three main components: a lower under-slung frame assembly, and an upper left side and an upper right side mounting framework. The under-slung frame assembly was fabricated and secured between clamping plates that were welded to the end of the motorcoach's jacking points on vertical suspension struts. Two bottom plates were attached with SAE grade 8 bolts, thus securing the tubing frame in position under the vehicle as shown in the photograph in AP Figure 11.

AP Figure 11. Photograph of the under-slung (lower) mounting frame installed on the MCI motorcoach.

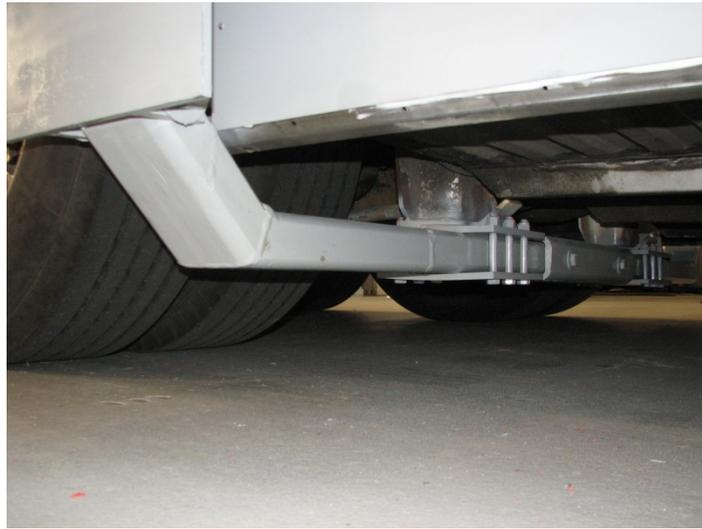
The tube center joiner was fabricated from A500 steel tube, 4 x 8 inch cross-section, and wall thickness of 0.50 inch. The lower mounting frame tubes were inserted into the tube center joiner and secured with 0.750 inch SAE grade 8 bolts. The photograph in AP Figure 13 shows how the two mounting frame tubes are joined with the tube center joiner in a view from the curbside of the motorcoach. The tube center joiner is located

in the right center of the photo flanked by the right and left side clamping plates. The right (curbside) adjustment plate can be seen in the upper left of the photograph.

AP Figure 13. Photograph of the tube center joiner

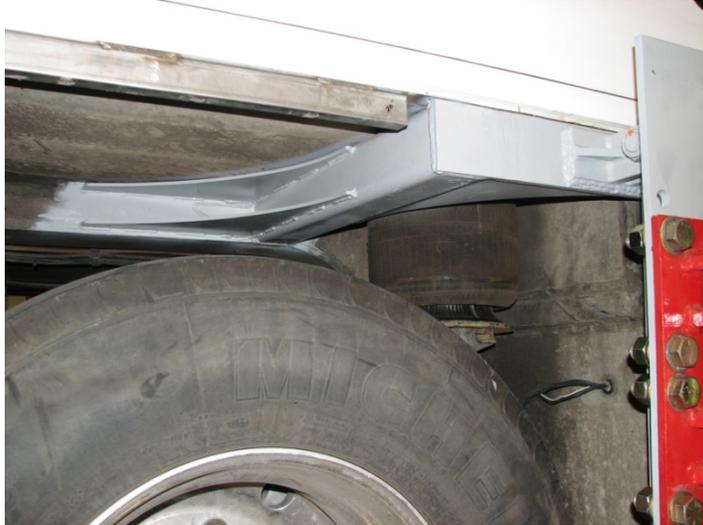
A framework assembly welded to the motorcoach frame supported the top of the outrigger beam adjustment plate with 1-1/4 – 7 UNC SAE grade 8 bolts. This weldment consisted of a horizontal member fabricated from 4 inch square tubing welded perpendicular to a longitudinal vehicle frame member and extending out to the motorcoach's side. A steel plate bracket assembly was welded to the end of the 4 inch square tubing. The bracket assembly had two steel tabs welded to the steel plate on which to mount the upper end of the MCI adjustment plate. 0.25 inch thick steel gussets were welded both fore and aft of the 4 inch square steel tubing. These features are represented in AP Figure 14, a plan view sketch of the MCI upper mounting framework and in AP Figure 15, a side view drawing of the complete MCI mounting framework shown with the outboard outrigger beam assembly. AP Figure 16 contains a photograph of the right (curb-side) upper mounting assembly fabricated by MCI.

AP Figure 16. Photograph of MCI upper mounting framework.

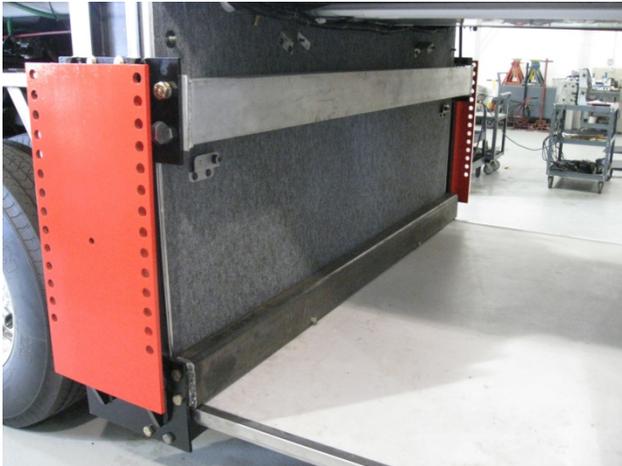
18 for an engineering drawing of this part. This upper frame member bolted to the upper mounting plates (brackets) in the same manner as the steel frame member described above. AP Figure 19 is a photograph of these components viewed from the right (curbside) of the motorcoach from just in front of the drive axle wheels to slightly rearward through the luggage compartment.

AP Figure 19. Photograph of PrevoSt lower 6 inch x 3 inch steel tube and the 6 inch x 4 inch aluminum rectangular tube.

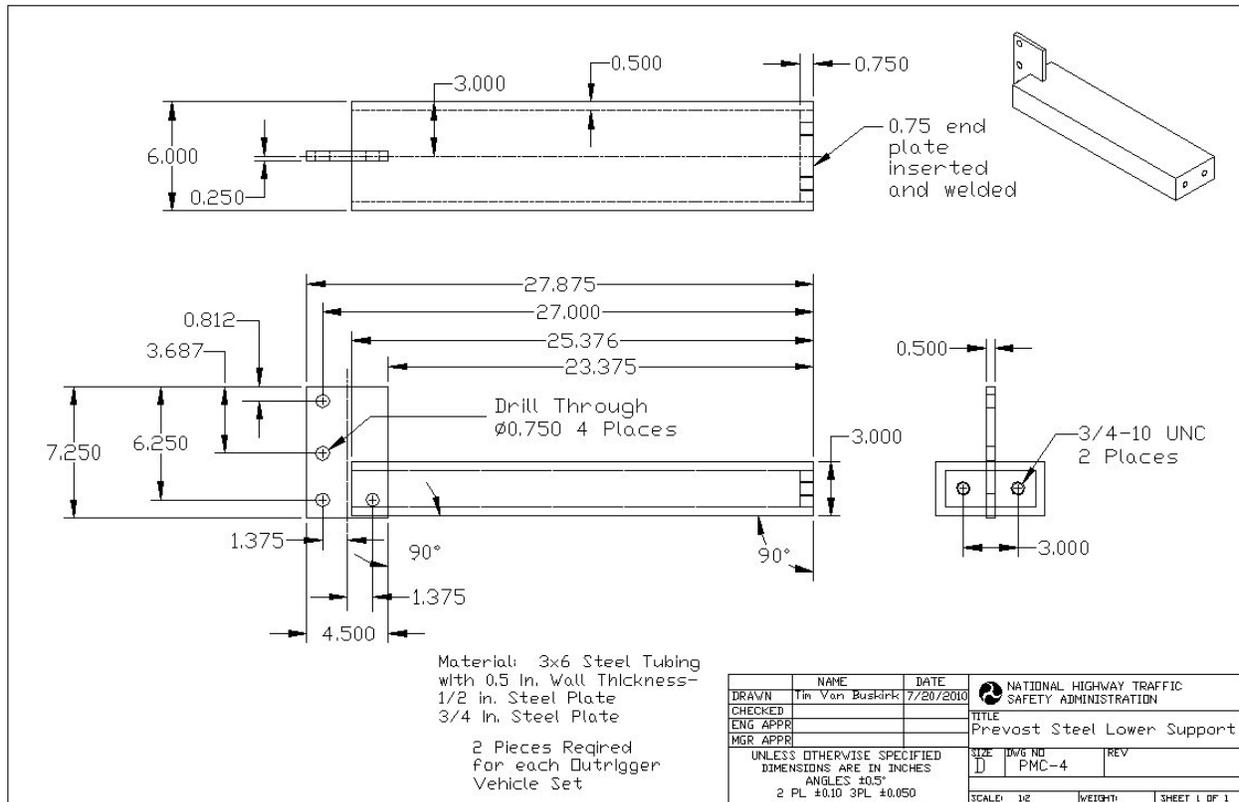
AP Figure 20. Engineering drawing of the Prevost lower steel support.

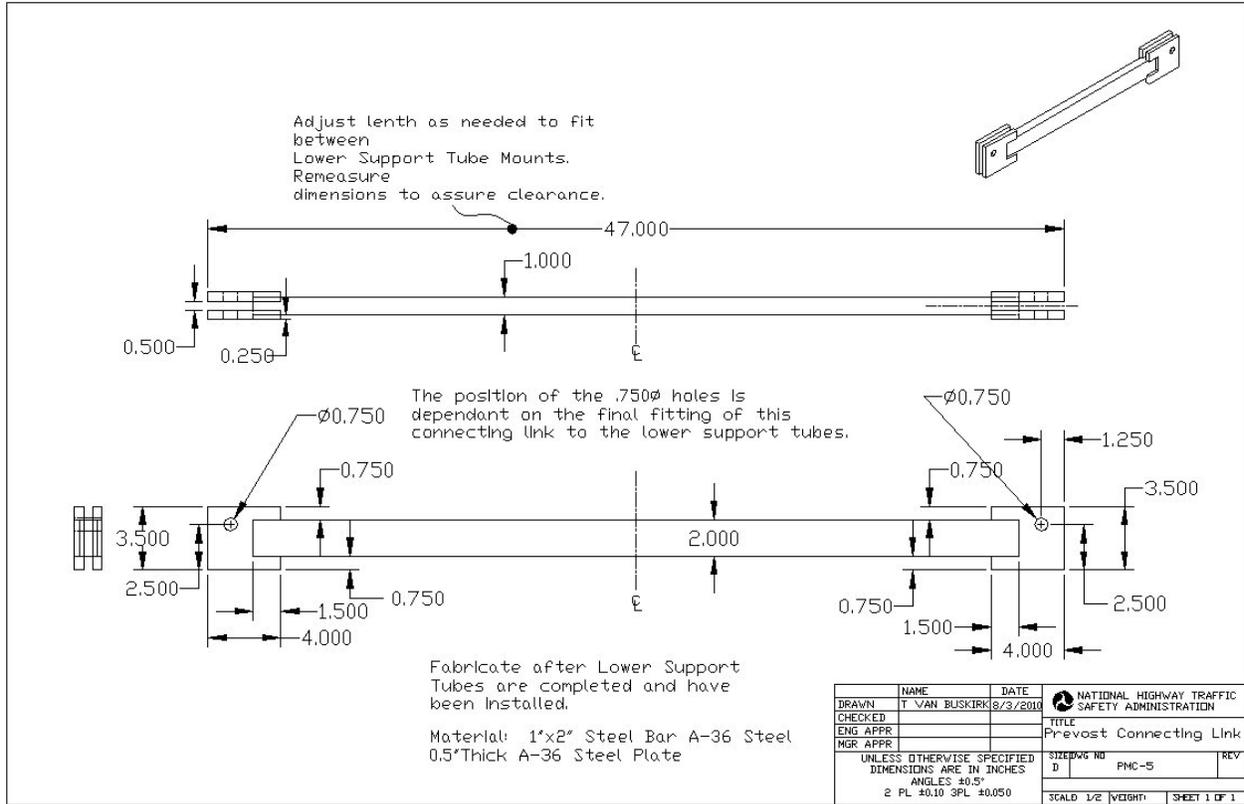
AP Figure 21. Engineering drawing of the Prevost connecting link.

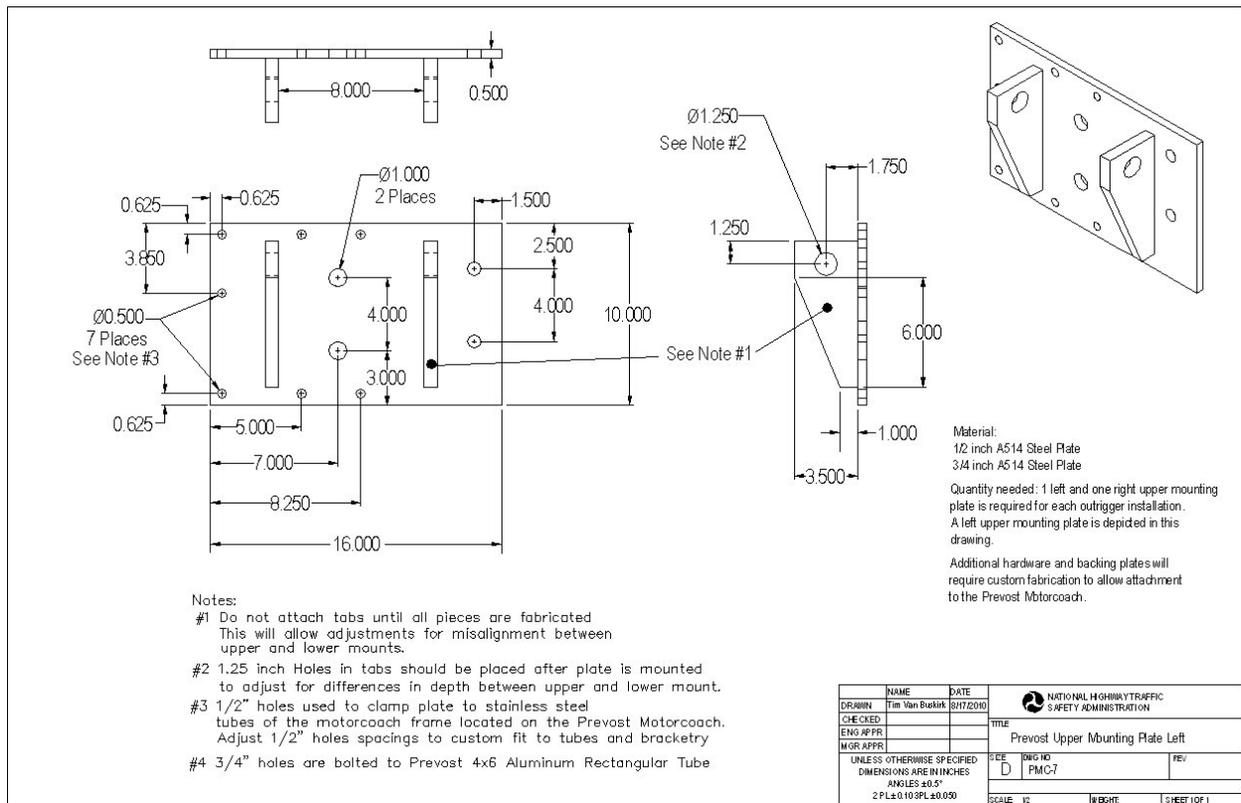
AP Figure 23. Dimensioned drawing of the Prevost upper mounting plate, left side.

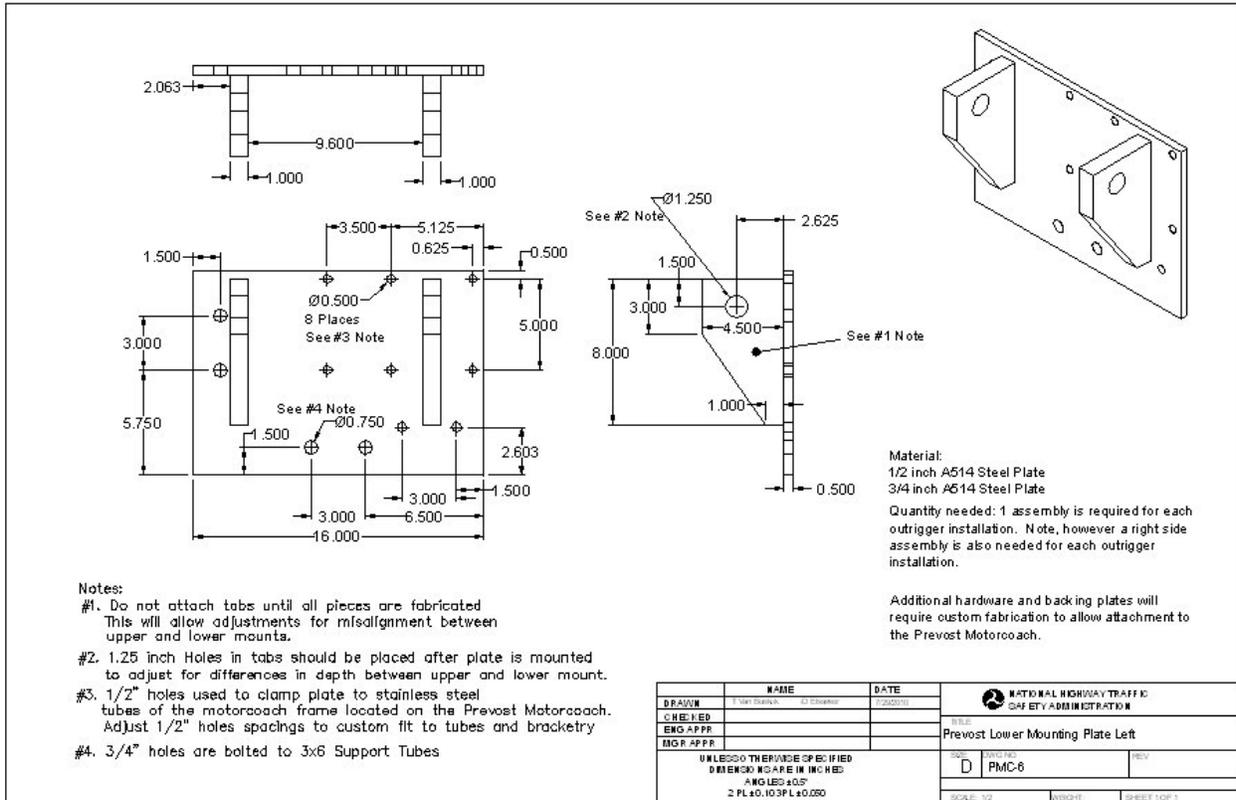
AP Figure 25. Dimensioned drawing of the Prevost lower mounting plate for the left side.

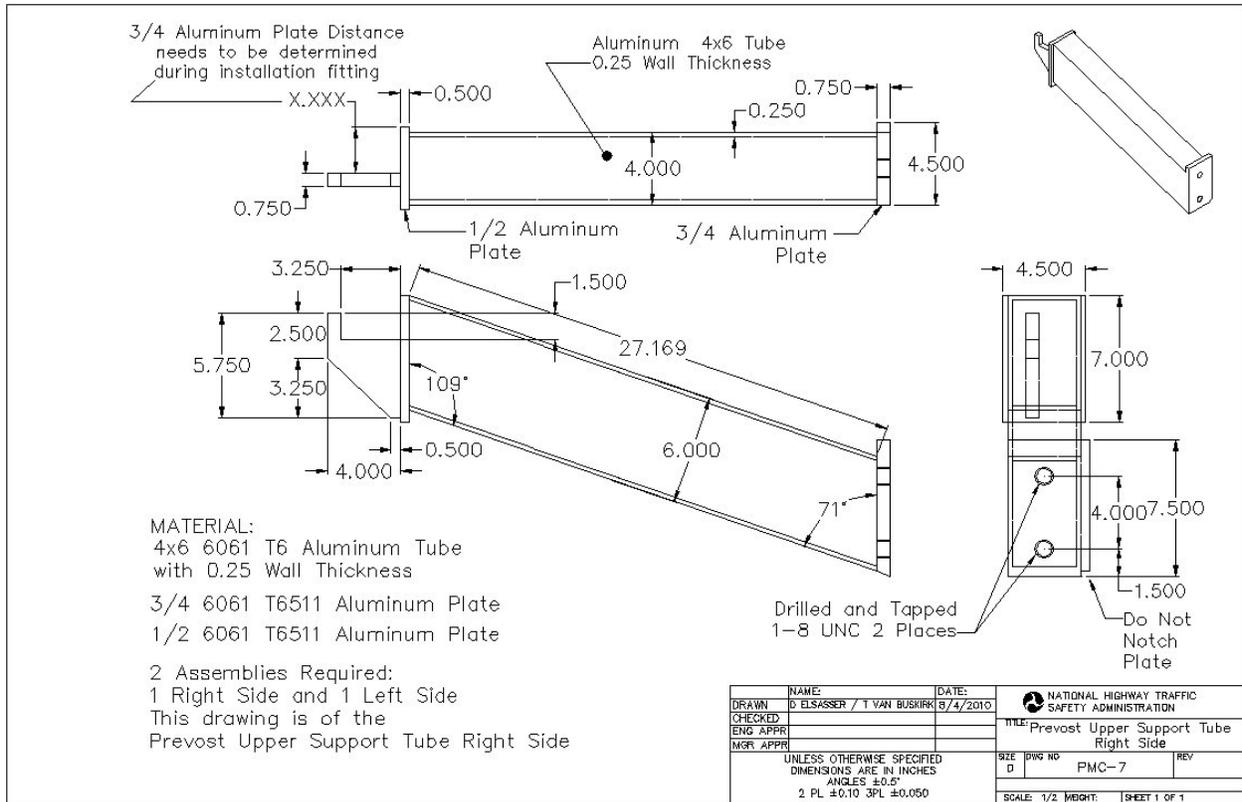
AP Figure 27. Engineering drawing of the Prevost upper support tube for the right side.

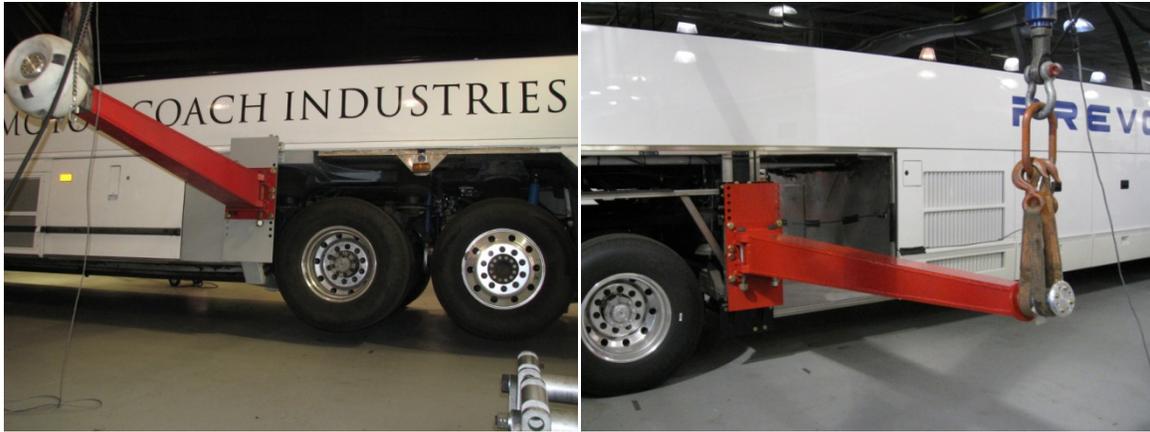
Static loads were applied to the outriggers after they were installed on a test vehicle prior to performing any dynamic maneuvers. This allowed researchers to evaluate the mounts and newly fabricated outrigger in a controlled manner. The setup used for the static testing is shown in the photographs in AP Figure 30. From the figure, an overhead crane and tensile load cell are used to incrementally apply vertical loads to the axle shaft of one of the outriggers. The opposite outrigger is blocked to prevent the motorcoach from rolling and to allow the opposite outrigger to provide the reaction forces against those created by lifting with the crane. The crane was then used to apply force in 1,000 lb increments (up to 7,700 lbs at the HDPE plastic wheel in the case of the MCI motorcoach). All welds, bolts and joints were then inspected for any problems at the maximum load. This methodology was then used to evaluate the mounting brackets by removing the blocks under the outrigger on the opposite side. Loads applied to the outrigger to evaluate the mounts were varied with test vehicles.

AP Figure 30. Photographs of the motorcoach outrigger and mount static load testing. Left: MCI motorcoach. Right: Prevost motorcoach.
