DOT HS 811 885

February 2014

NHTSA Tire Aging Test Development Project Phase 2 – Evaluation of Laboratory Tire Aging Methods

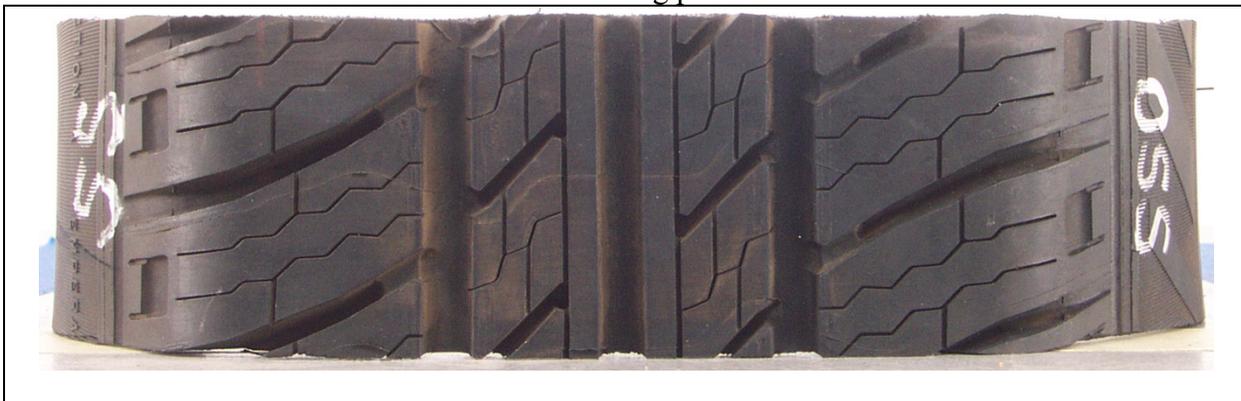
- For each of the two chosen tire regions, cut one 63.5 mm ($2\frac{1}{2}$ ") wide radial section bead to bead. The section should resemble the following photo:

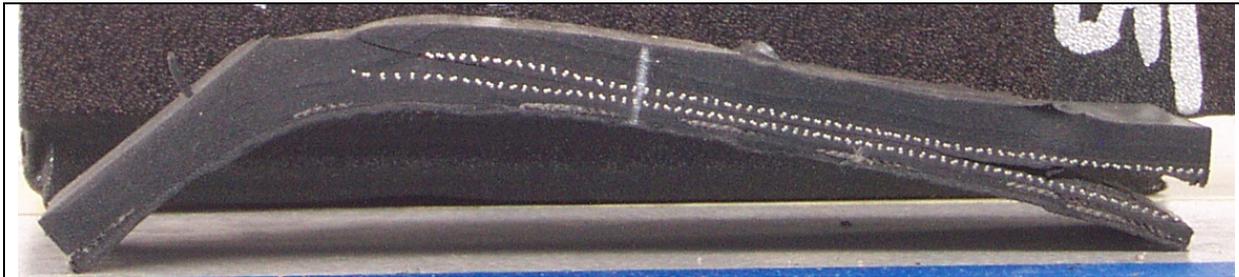
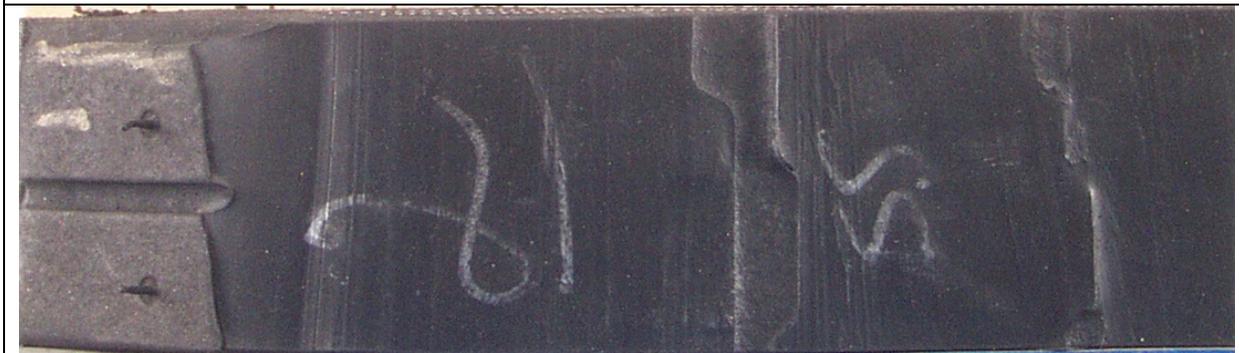
- Score the sides of each specimen at a point midway between the belts to a depth of 3.175 mm (1/8"). The scoring will extend from the end of the gripping surface to the end of belt #2 in the shoulder area, providing a final 25.4 mm (1") wide peel section. The final section should look like this:

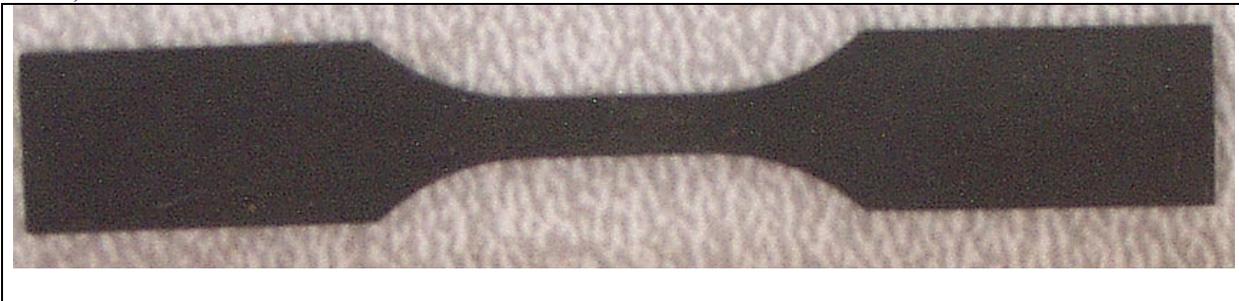
- Samples of at least 100 mm (4 in) in length and 25 mm (1 in) in width shall be removed from the skim and wedge rubber (see **Total Crosslink Density** for sample region details) for each test. Samples shall be buffed to uniform thickness of 0.5 to 1.0 mm (0.02 to 0.04"). Care must be taken to minimize heat generation during buffing.
- Since the test specimen sizes available in D 412 are too large for tire sample purposes, specimens shall be die-cut using an ASTM D 638-02a Type V dumbbell die (see following photo):
