DOT HS 812 130

March 2015

Van Hool 2014 CX45 Motorcoach Lane Departure Warning System Evaluation

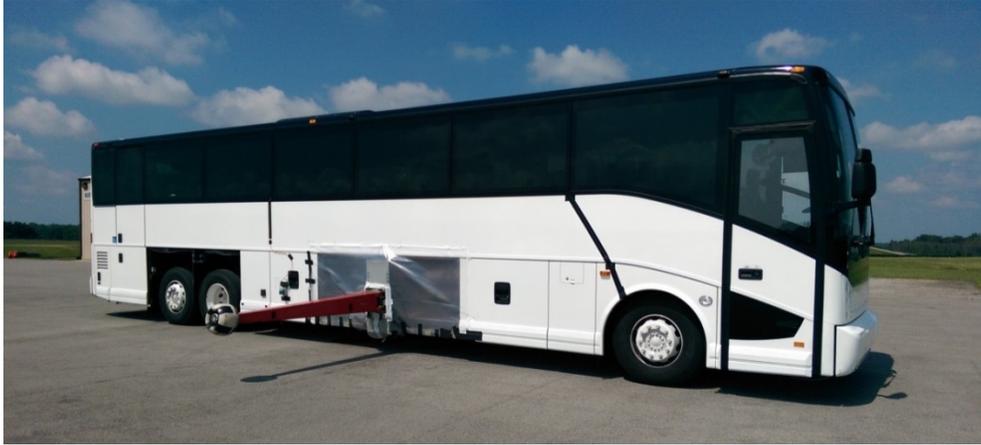
Figure 2.4 Van Hool CX45 56-passenger Motorcoach

The test vehicle used in this research was a class 8 2014 Van Hool CX45 56-passenger motorcoach, shown in Figure 2.4. The Motorcoach is equipped from the manufacturer with a air disc brake system, a 6S/6M Meritor WABCO ABS/ESC system, a Tire Pressure Monitoring System, and a Bendix Commercial Vehicle Systems AutoVue Lane Departure Warning System (referred to as “Van Hool LDW system”). Figure 2.5 shows the windshield mounted camera of the LDW system as well as the haptic feedback equipped driver’s seat. The camera is mounted close to the center of the windshield. The seat is equipped with electric motors that vibrate the appropriate side to provide a silent warning to the driver. Table 2.3 presents some basic information about the motorcoach. Table 2.4 presents the test vehicles “as received” measured axle weights, and total vehicle weight. Table 2.5 presents the test vehicles Gross Axle Weight Ratings (GAWR) and Gross Vehicle Weight Ratings (GVWR).
