Engineering Analysis Report and Initial Decision

EA00-023: Firestone Wilderness AT Tires

U.S. Department of Transportation
National Highway Traffic Safety Administration
Safety Assurance
Office of Defects Investigation

October 2001

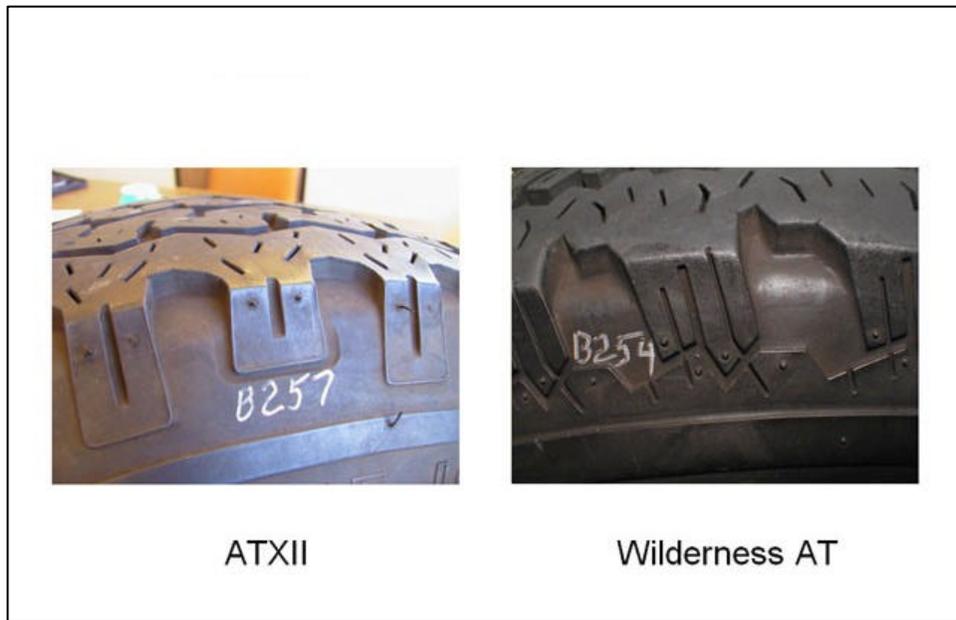
Figure 8 – Shoulder pockets in ATX and Wilderness AT P235/75R15 Tires manufactured for Ford.

Another relevant feature is the design of the shoulder pocket of the focus tires, which can cause higher stresses at the belt edge and lead to a narrowing, or “pinching,” of the wedge gauge at the pocket. The focus tires exhibit a series of weak spots around the tire’s circumference, leading to the initiation and growth of cracks earlier than in competitor tires and in other Firestone tires produced for light trucks and SUVs. In addition, many of the focus tires exhibited shoulder pocket cracking similar to that which Firestone identified as a significant contributor to the risk of tread detachment in the recalled ATX tires.

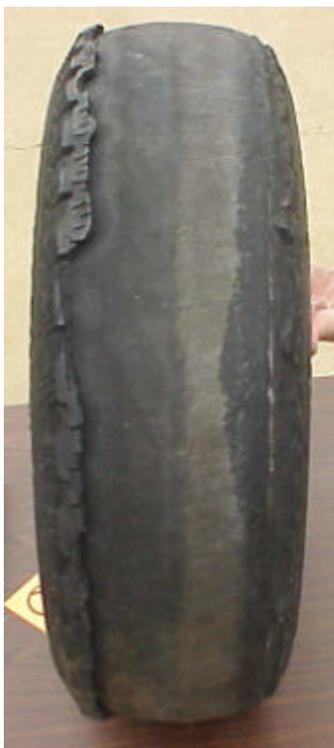
Figure 10 – Separation pattern on the tire carcass of a failed Wilson P235/75R15 Wilderness AT tire, manufactured in Sep 96 (W2 396).

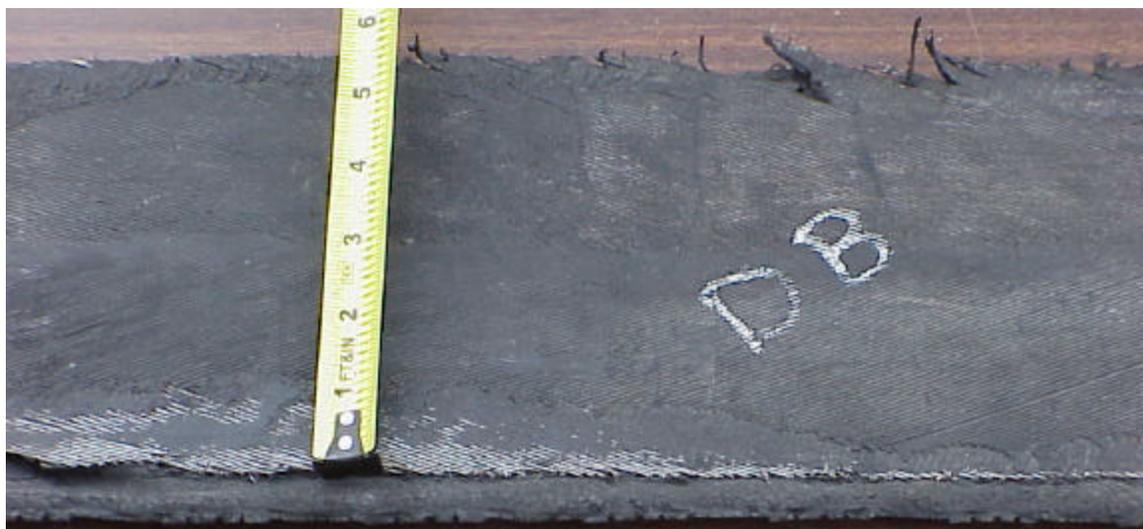
Figure 11 – Separation pattern on the tread of the same failed Wilderness AT tire.

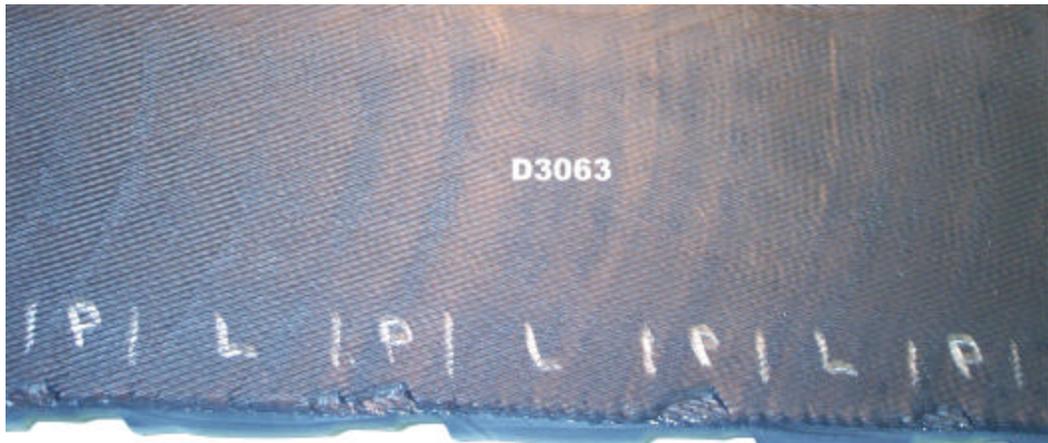
Figure 31 – Localized separation pattern on tread pull of the same tire; “P” = pocket area, “L” = lug area.

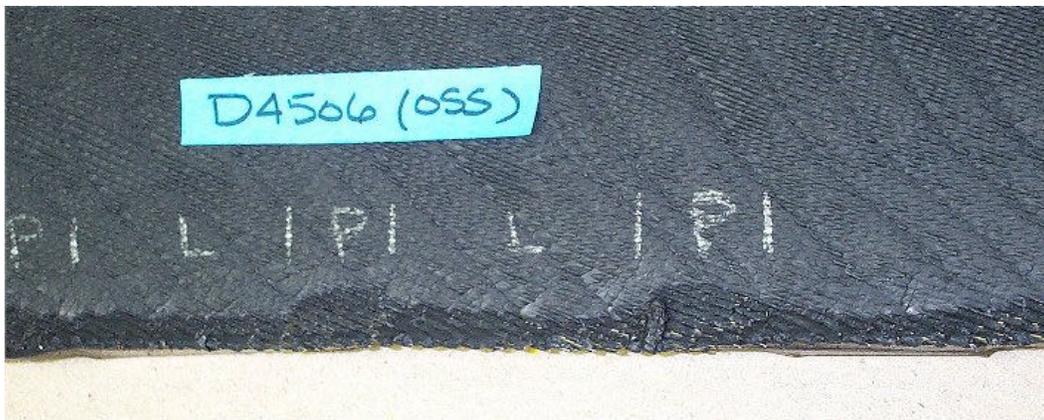
Figure 33 – Belt-edge separation pattern showing growth in pocket areas of the same tire; “P” = pocket area, “L” = lug area.

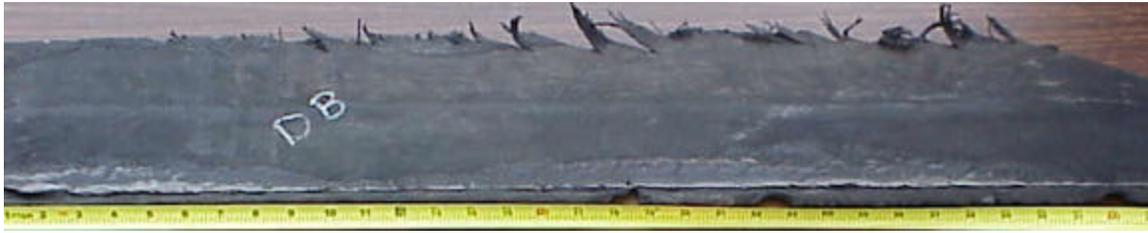
**Figure 37 – Separation patterns on failed Wilderness AT tread
Wilson P235/75R15 Wilderness AT tire, manufactured in Sep 96 (W2 396).**

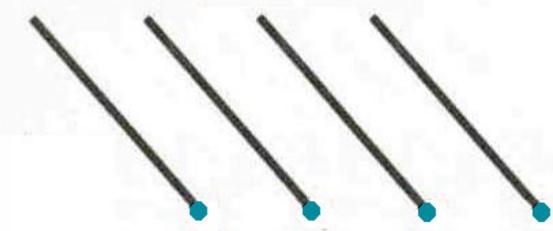
Single Cord End – Level 1

Tire	V113	Looseness develops at the ends of cords where steel is exposed to rubber. Focus tires exhibit pattern of preferential initiation in pocket areas.

Tire Model	Wilderness AT		
Tire Size	P235/75R15		
Tire DOT	W2 338		
Tire Plant	Wilson, NC		
Tread Wear (%)	44		
State	AZ		
Shearography Rating	NR1		
Crack Length (mm)	5.5		
Wedge Gauge (mm)	1.36		
Avg. Peel Strength (lb/in)	24

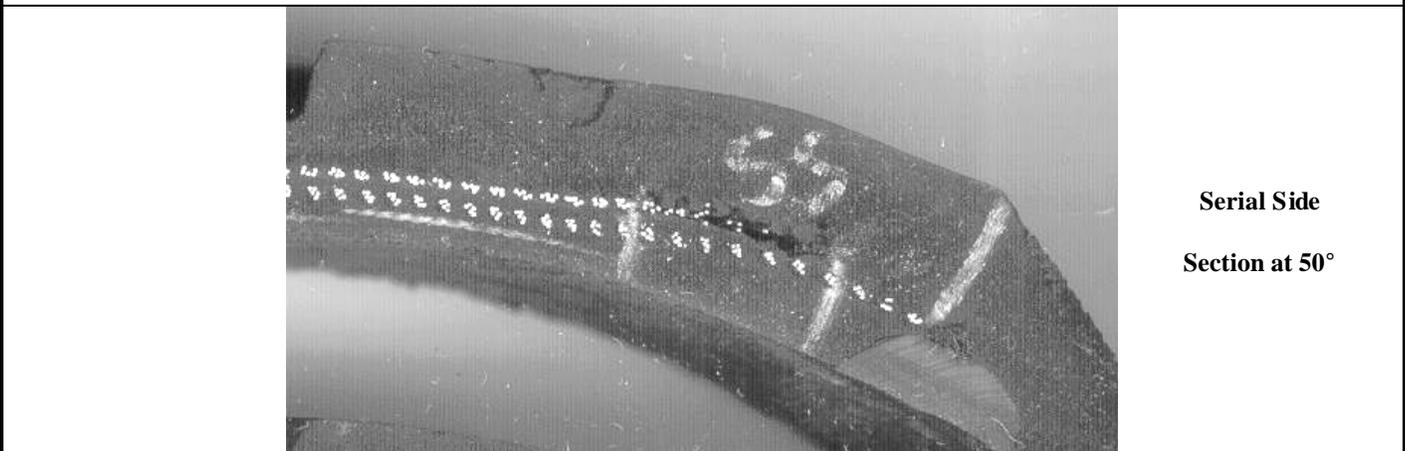
Incipient Separation (“Socketing”) – Level 3

Tire	D4131	Socketing spreads along cords and edge separations continue to grow circumferentially from pockets into neighboring lug areas.

Tire Model	Wilderness AT		
Tire Size	P235/75R15		
Tire DOT	W2 417		
Tire Plant	Wilson, NC		
Tread Wear (%)	56		
State	TX		
Shearography Rating	160LHMR5		
Crack Length (mm)	9.2		
Wedge Gauge (mm)	1.14		
Avg. Peel Strength (lb/in)	29
