UMTRI-2016-8

Wheelchair Occupant Studies

Final Report

The Biosciences Group
University of Michigan
Transportation Research Institute

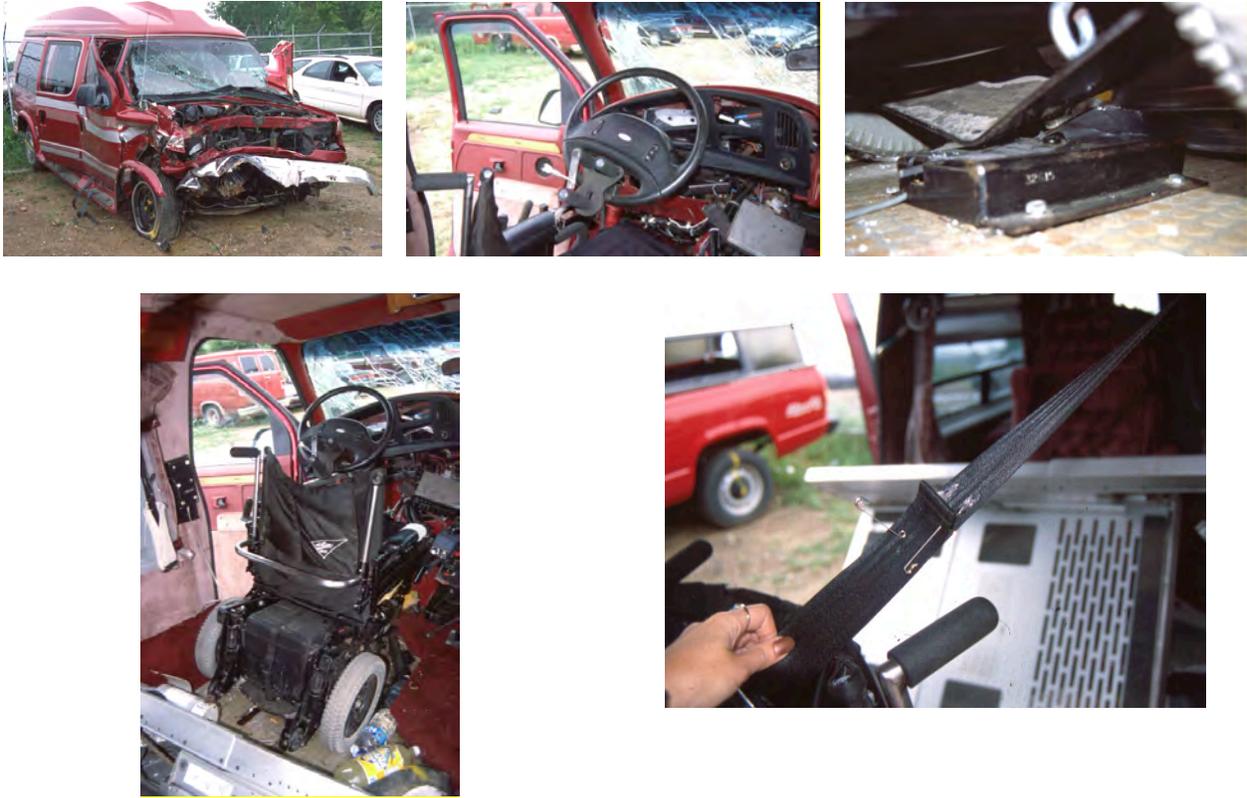
Figure 1.2 - Exterior and interior photos of a full-size van operated by a driver seated in a power wheelchair who sustained fatal chest and abdomen injuries in a severe frontal crash

Although this was a severe frontal crash, there was no evidence of driver contact with the steering wheel or assistive steering device. It is therefore believed that the fatal chest and abdominal injuries, including lung lacerations and contusions plus liver lacerations, were caused primarily by chest and abdomen loading by the loosely worn two-point shoulder belt. Injury to the spleen may also have been caused by contact with the tri-pin steering assist device even though there was no evidence of contact with the tri-pin. The lack of a frontal-impact air bag, significant deformation of the docking-securement device, and use of only a user-modified loosely worn shoulder belt rather than a properly fitted lap/shoulder belt, are likely contributors to the fatal chest and abdominal injuries to this driver.

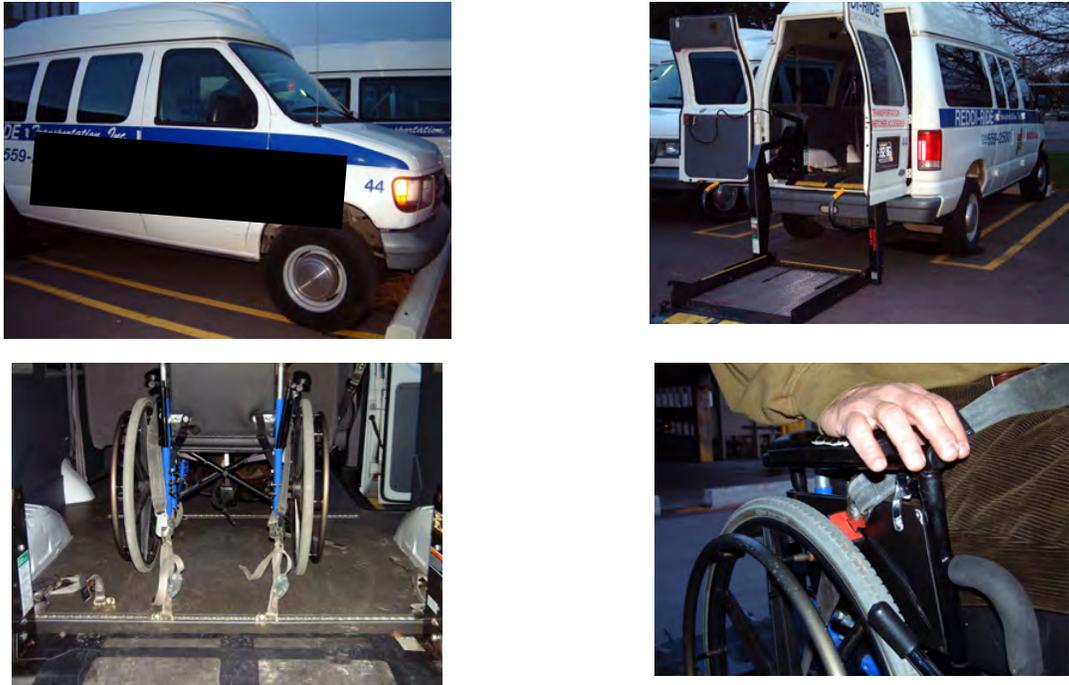
Figure 1.3 - Paratransit van similar to a van from which a lap/shoulder-belt restraint male passenger seated in a properly secured manual wheelchair was ejected during a four quarter-turn rollover due to contact of the buckle release button by the rim of the wheelchair wheel.

The second case involves a paratransit van that was traveling on a four-lane roadway. The sole passenger of the van was an adult male seated in a manual wheelchair at the very back of the van. Figure 1.3 shows exterior and interior photos of an exemplar paratransit van, including reconstruction of the wheelchair securement and positioning of the lap/shoulder belt restraint on an individual of the same gender and similar size as the male passenger. The manual wheelchair was secured by a four-point, strap-type tiedown attached to the frame of the wheelchair and the female driver reported that she positioned the available aftermarket lap/shoulder belt on the passenger.

Upon reconstructing securement of the wheelchair and restraint of an adult male seated in the wheelchair in an exemplar van using the same tiedown/restraint equipment that was used in the vehicle rollover, it was determined that there was no mechanism for adjusting the length of the

lap belt and thus the position of the buckle, and that the end-release button on the seat-belt buckle would have been located just below the metal rim of the large right wheel of the wheelchair. It was therefore concluded that ejection of the wheelchair passenger was the result of the buckle release button being contacted and depressed by the inside metal wheel rim of the large right wheel as the wheelchair shifted from side to side during the rollover. The key lesson from this case is the importance of providing adjustability in the length of vehicle-anchored lap belts so that seat-belt buckles can be positioned against the wheelchair occupant's body and away from hard structures on the wheelchair that can contact and depress the buckle release button during a crash or non-crash event.

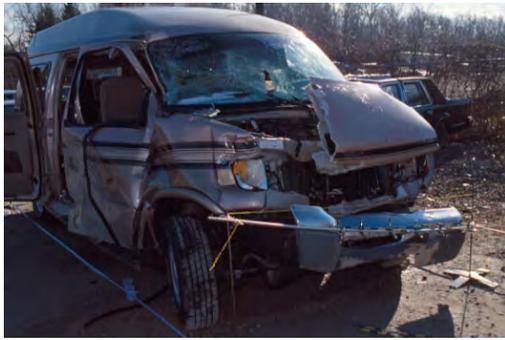
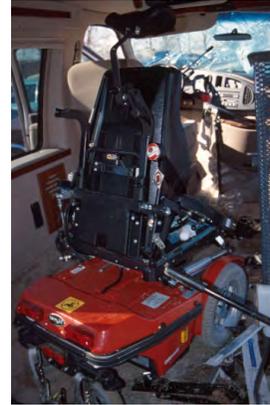
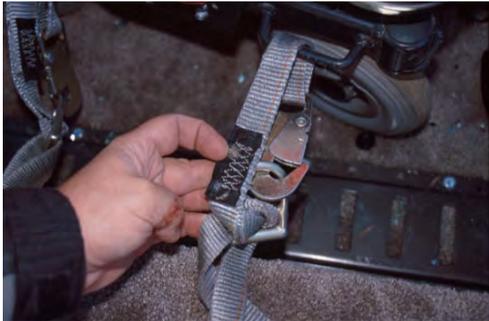
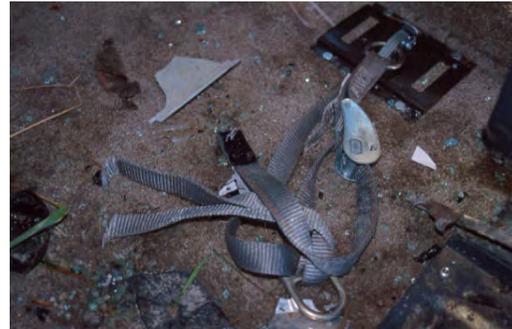
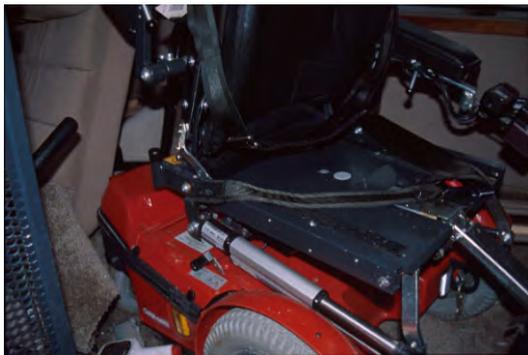
Figure 1.4 - Exterior and interior photos of a van driven by a male driver seated in a power wheelchair that was involved in a frontal crash into the side of the cab and box of a dump truck at a four-leg intersection

During the frontal collision, one side of the postural lap belt and one side of the postural chest belt tore free from the wheelchair (grommets tore through webbing), which allowed the passenger to come out of the wheelchair near the end of the frontal-crash deceleration. He sustained a laceration to the back of his head, a contusion to the spleen, a fracture to the second finger on his right hand, and lost consciousness for less than an hour.

After the crash, an aftermarket lap/shoulder belt restraint system was found hanging on the side of the vehicle. The driver and the wheelchair passenger reported that they thought that the postural belts provided a sufficient vehicle restraint system and therefore they did not think it was necessary to use the available vehicle-anchored seat belt. Although this passenger in a wheelchair was not seriously injured, in part because he was using a crash-tested power wheelchair that was properly and effectively secured during this moderate frontal collision, it is likely that he would have been much more seriously injured had the crash been more severe.

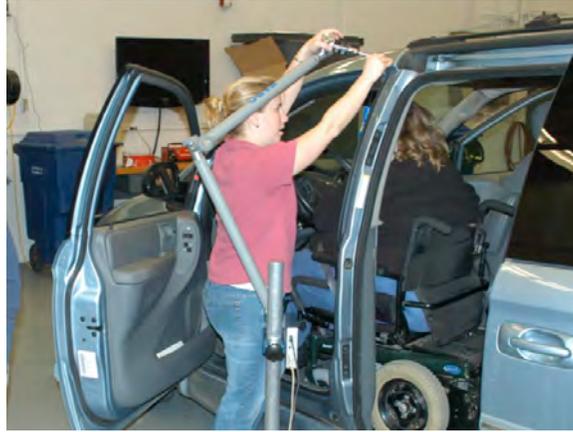
Figure 2.3 - UMTRI investigator taking measurements of a vehicle using the FARO Arm

the position of the wheelchair securement system and occupant restraints relative to the occupant and vehicle interior, respectively. Measurements were taken using both manual and digital techniques, with the latter taken using a Faro Arm as shown in Figure 2.3. The photo in Figure 2.4 shows the horizontal and vertical distances of a driver’s chin and abdomen relative to different locations on the steering wheel and the photo in Figure 2.5 shows the location of a driver’s left knee relative to the knee bolster and hand-control linkages.

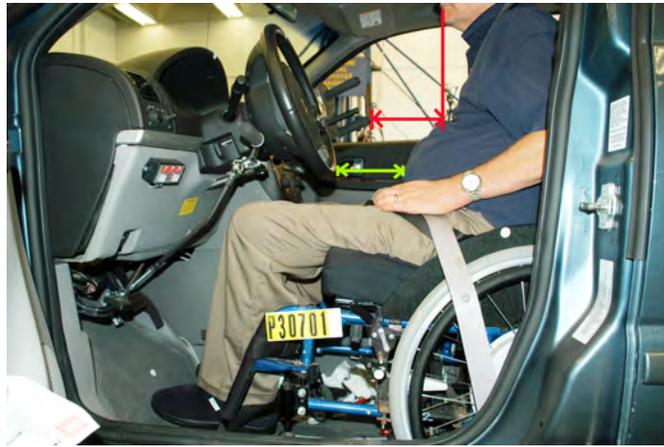
Figure 2.4 – Photo showing horizontal and vertical distances measured between the driver and the steering wheel and the steering assist device

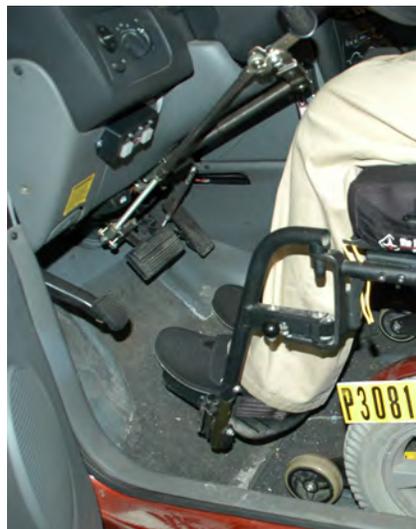
Figure 2.5 – Photo showing driver's knee position relative to the knee restraint and hand-control linkages

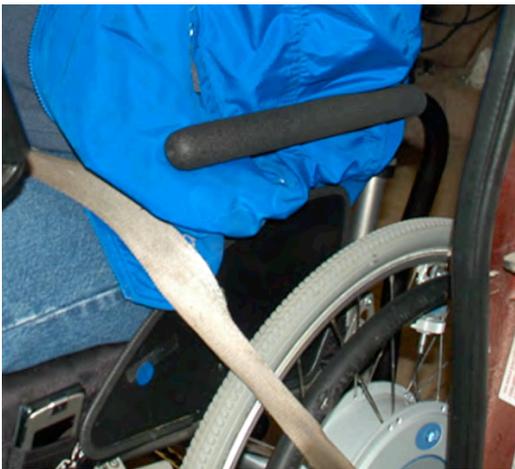
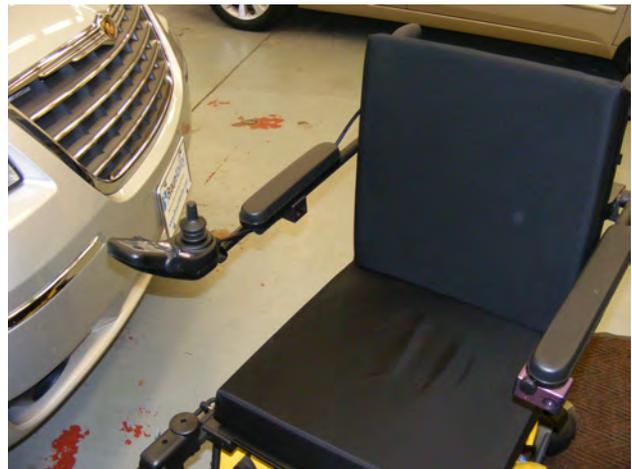
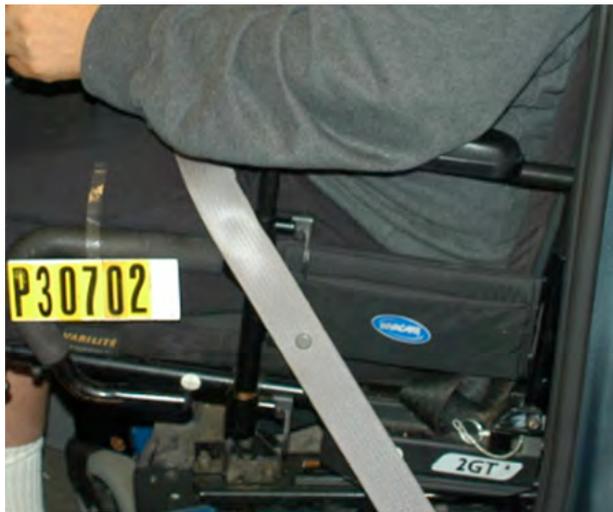
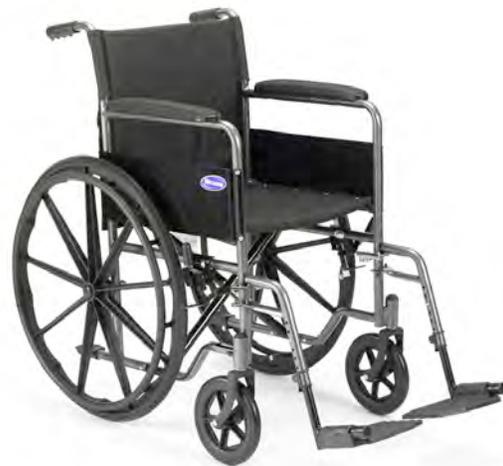
wheelchair with open-front arms supports

wheelchair with open-front arm supports

power wheelchair with closed desk-type arm supports

manual wheelchair with closed-front arm supports

Figure 2.7 -Different types of wheelchair arm supports – top row: open front arm supports cantilevered from the wheelchair back support; bottom row: closed desk-type arm support on the left and closed-front standard arm supports on the right

Of the 21 drivers in the study, three did not use any seat-belt restraint and two did not secure their wheelchair. Of the 18 drivers who used some type of belt restraint, three used manual wheelchairs with power assist and 15 used power wheelchairs. One manual wheelchair did not have arm supports, 4 wheelchairs (2 manual and 2 powered) had arm supports that were characterized as “open-front,” and 13 wheelchairs (all power) had arm supports that were “closed-front.” Of the thirteen wheelchairs with a closed-front arm supports, 12 had a desk-type (or L-shaped) arm support and one had arm supports that connected to the wheelchair in the front and back by arc-shaped components. Figure 2.7 shows several different types of wheelchair arms supports.

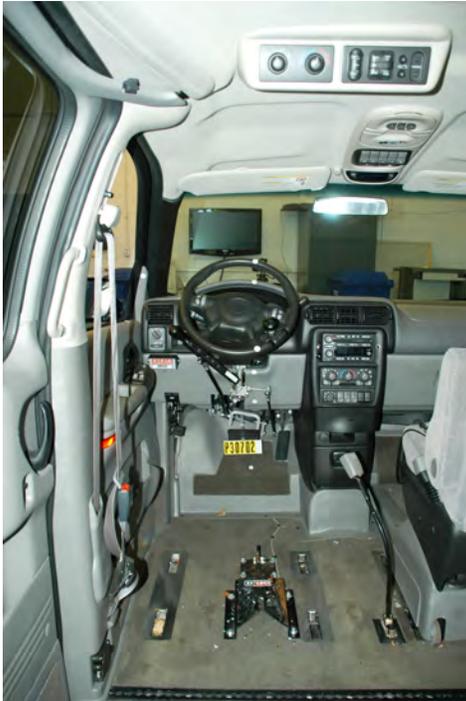
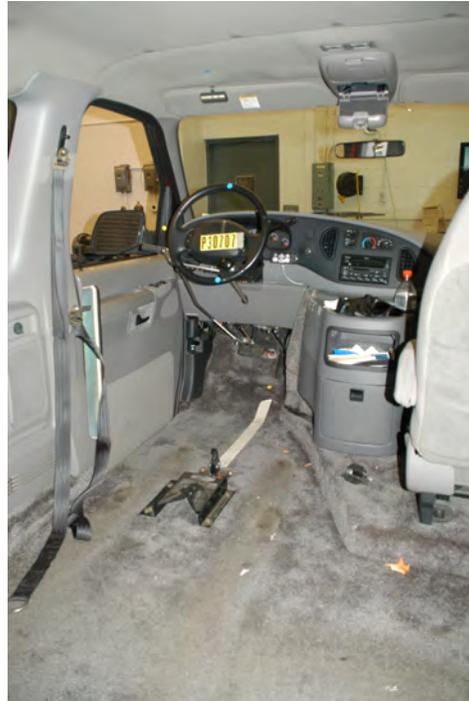
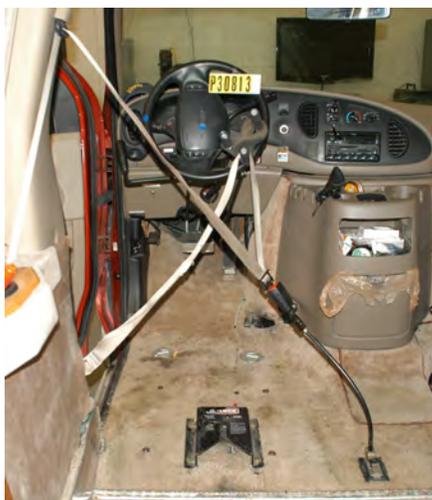
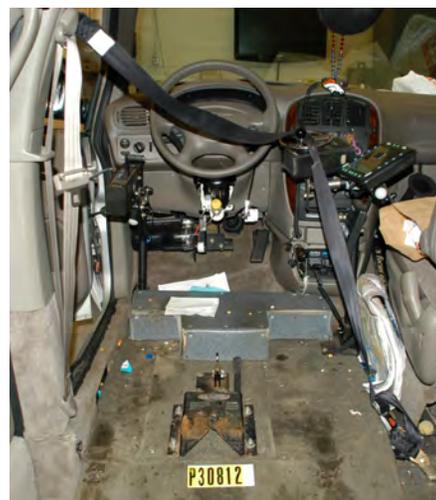
OEM seat belt being used in the active mode

After-market seat belt being used in the active mode

OEM seat belt used in the passive mode

After-market seat belt used in the passive mode

Figure 2.8 - Different types of driver seat belts used by subjects in the study

Figure 2.8 shows different types of seat belts and seat-belt configurations used by drivers in the study. Of the eighteen drivers using some type of belt restraint, 13 used the original equipment manufacturer (OEM) lap/shoulder belt system with an after-market inboard buckle receptacle attached to a cable stalk or a length of webbing anchored to the vehicle floor. Two drivers used a complete after-market lap/shoulder-belt restraint system, and one used a wheelchair-anchored lap belt. This lap belt was used in conjunction with a separate vehicle-anchored shoulder belt used in the passive mode. Two of the drivers used only a passive shoulder-belt restraint and no lap belt.

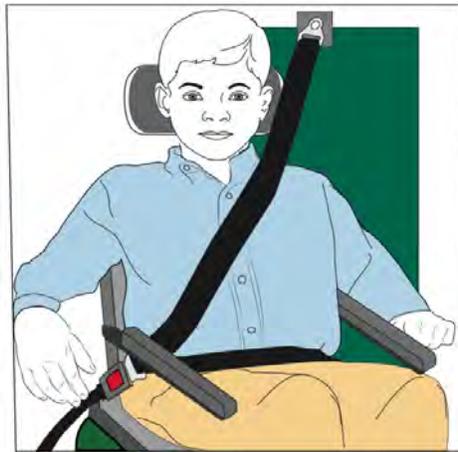
Figure 2.9 - Illustration of proper positioning of the lap/pelvic belt of a three-point seat belt

Routing of any portion of the lap belt over the top of the arm supports resulted in the lap belt being positioned high on the driver's abdomen and not in contact with the pelvis near the thigh-pelvic junctions, unlike the proper seat-belt positioning illustrated in Figure 2.9. Figure 2.10 shows examples of common positioning of lap belts on drivers due to interference by wheelchair arm supports. The average height of the center of the lap belt above the driver's thigh-pelvic junction was 41.8 mm (± 47.5 mm) and, on average, the lap belt was 15.9 mm (± 47.2 mm) forward of the thigh abdominal junction.

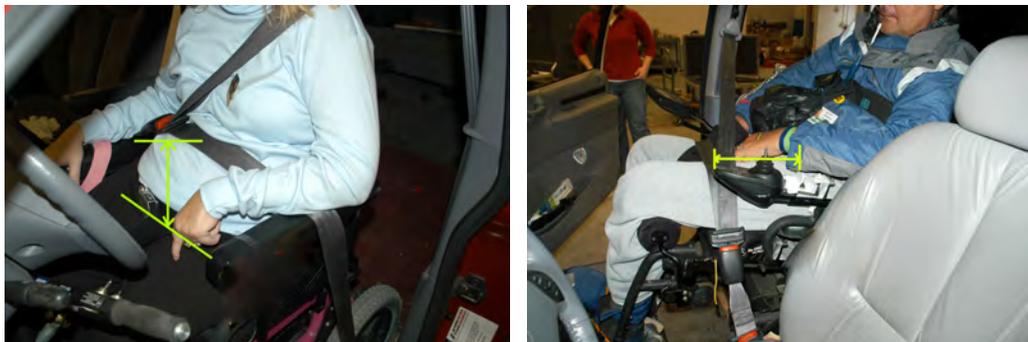
Figure 2.10 - Photos showing lap-belt locations over the arm supports and on the abdomen (left) and forward of the thigh-pelvis junctions (right)

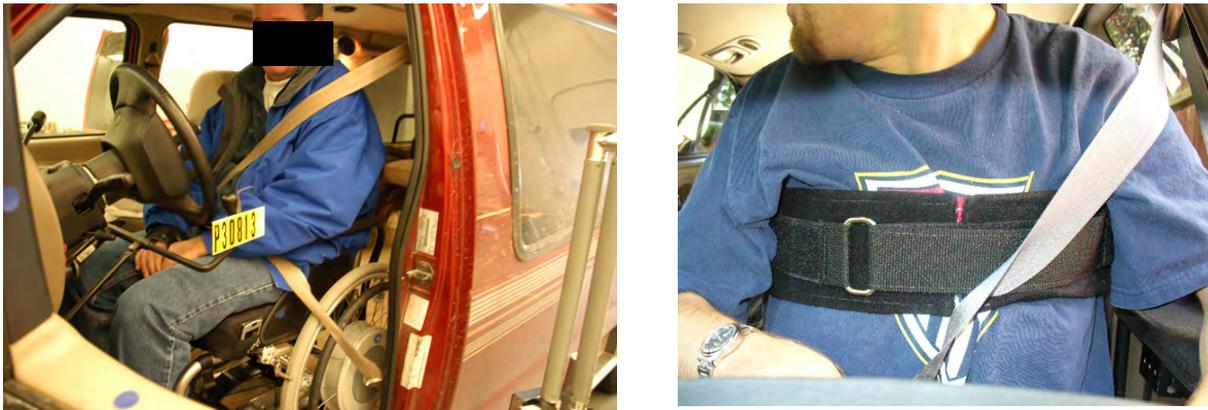
Figure 2.13 - Photos showing typical positioning of the shoulder belt nearly off (left) or completely off (right) the driver’s outboard shoulder

Poor positioning of the shoulder belt was often the result of the wheelchair’s width, which caused the driver to be shifted more inboard than a driver using the OEM vehicle seat. The average lateral distance from the center of the driver’s shoulder belt (measured at the height of the top of the shoulder) to the center of the subject’s shoulder (measured at the acromion) was 95.0 mm (\pm 85.9 mm).

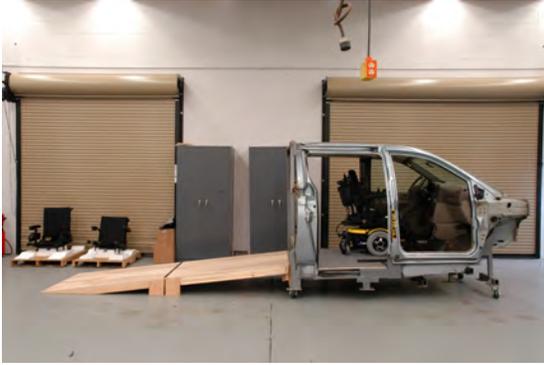
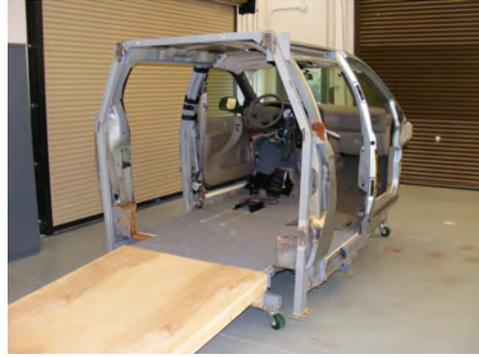
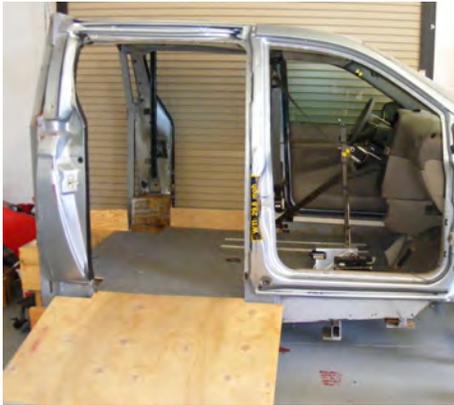
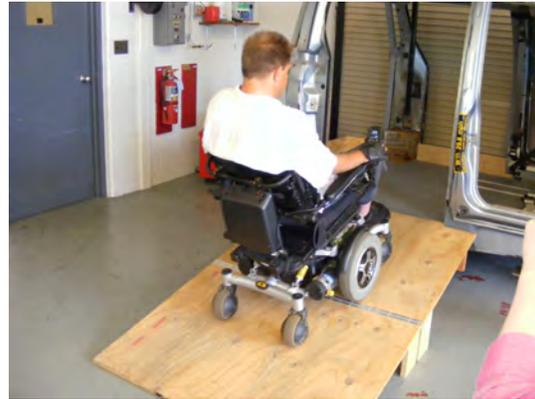
Figure 2.14 -Minivan buck in UMTRI high-bay laboratory with rear-entry and side-entry ramps used for wheelchair driver ingress and egress to evaluate prototype restraint-system designs

Evaluation of prototype designs involved two approaches. One was to install a prototype of the design in a laboratory minivan buck obtained from the Transportation Research Center (TRC) in Ohio, and that had been reinforced for use in their wheelchair-driver sled-test program described in Section 2.4.3.1 (Sword, 2007). When the buck was brought to UMTRI, it was set up in the high-bay laboratory and modified to include side-entry and rear-entry ramps so that wheelchair users could access the driver space and provide comments regarding prototype restraint-system designs. Figure 2.14 shows the minivan buck in one of UMTRI's high-bay laboratories for this purpose, while Figure 2.15 shows the driver space inside the minivan buck.

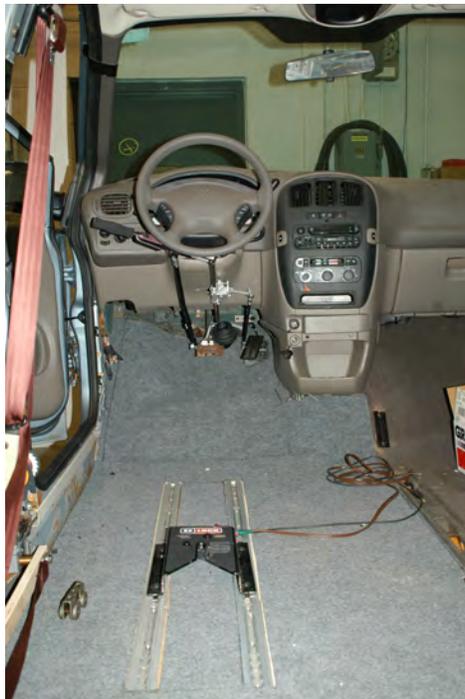
Figure 2.15 – Forward view of driver area inside the minivan laboratory buck

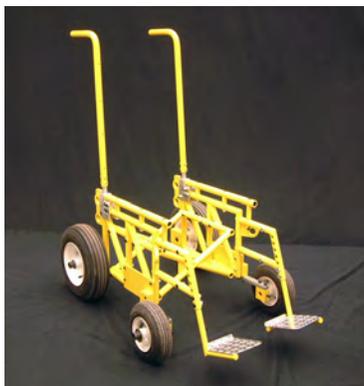
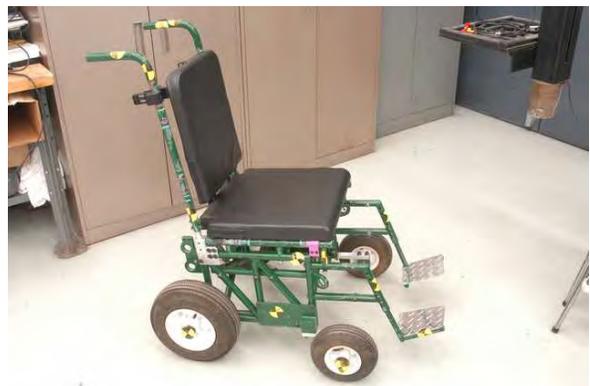
Figure 2.17 - Surrogate wheelchair frame (SWCF) used in tests to evaluate front- and rear-impact restraint systems to evaluate restraint systems in both front and rear impacts

All tests were conducted using the Hybrid III midsize male anthropomorphic test device (ATD), or crash-test dummy, seated in a new or refurbished commercial power wheelchair or seated in the surrogate wheelchair frame (SWCF) shown in Figure 2.17. The latter was designed to evaluate the crashworthiness of commercial wheelchair seating systems independent of the different commercial wheelchair frames on which they may be installed. It includes back-support posts connected to the base frame by means of replaceable deformable rods and front caster wheels mounted to the frame by means of deformable aluminum bars. In this way, the SWCF provides a surrogate wheelchair that mimics the kinematics and key deformability features of typical commercial wheelchairs.

In addition to evaluating a prototype of the pivoting-bar restraint system in the minivan buck, prototypes of the restraint system were fabricated for frontal-impact sled testing. The initial runs were conducted with the surrogate wheelchair frame (SWCF) previously described and shown in Figure 2.17. For these tests, the SWCF was fitted with an aluminum seat and fabric back support, loaded with a midsize-male Hybrid III ATD, and secured by a commercial docking-securement device. In the initial test, the inboard buckle of the restraint system failed due to contact with the aluminum seat of the SWCF caused by inward movement of the pivoting bars during frontal-impact loading. In a subsequent test, the shoulder belt webbing failed due to interaction with the D-ring.

For these sled tests, the surrogate wheelchair frame (SWCF) described in 2.4.2 and shown in Figure 2.17 was fitted with a generic planar wheelchair seat and used to represent a typical driver wheelchair. As previously noted, the deformable bars and rods are used to connect the front casters and back-support posts to the base frame to replicate nominal wheelchair frame deformations during a 48-kph, 20-g frontal crash, and these deformable components are replaced after each test. The SWCF also allows for easy set up of open-front and closed-front arm-support conditions that were shown in the driver measurement study to have a significant influence on position of the lap belt on the driver's lower pelvis near the junctions with the upper thighs. For this test series, the SWCF was secured to the sled platform using the UMTRI-designed surrogate-docking device described in Section 2.4.3.6.

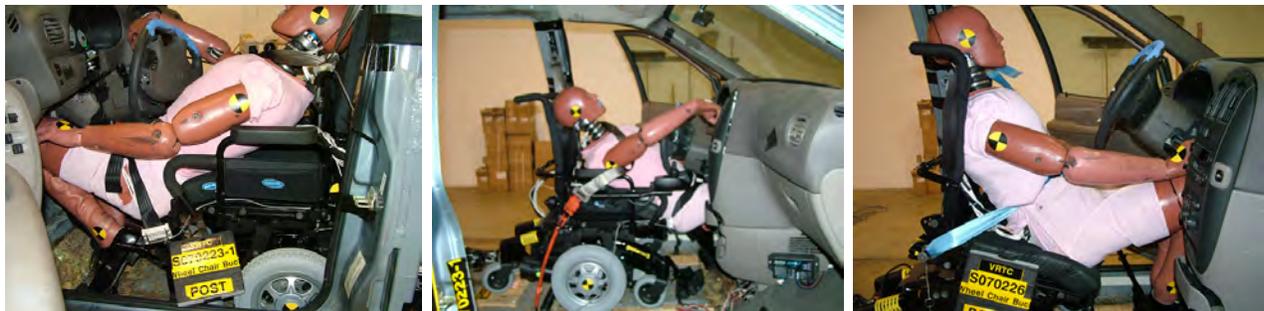
Figure 2.19 - Typical post-test positions of the ATD following TRC wheelchair-driver sled tests

In this regard, one observation from these sled tests was that locating the single securement bolt more rearward under the wheelchair reduces forward pitching of the wheelchair and therefore helps to reduce ATD submarining. This is especially the case when the lap belt is anchored to the back of the wheelchair rather than to the vehicle floor. However, while locating the securement bolt more rearward may be beneficial in frontal crashes, it has a potentially negative effect in rear impacts where the wheelchair will tend to rotate rearward such that the front of the wheelchair rises up off the floor.

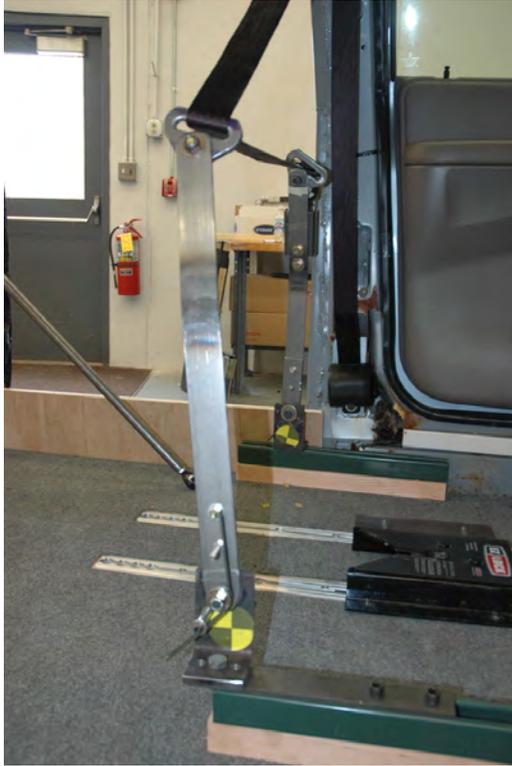
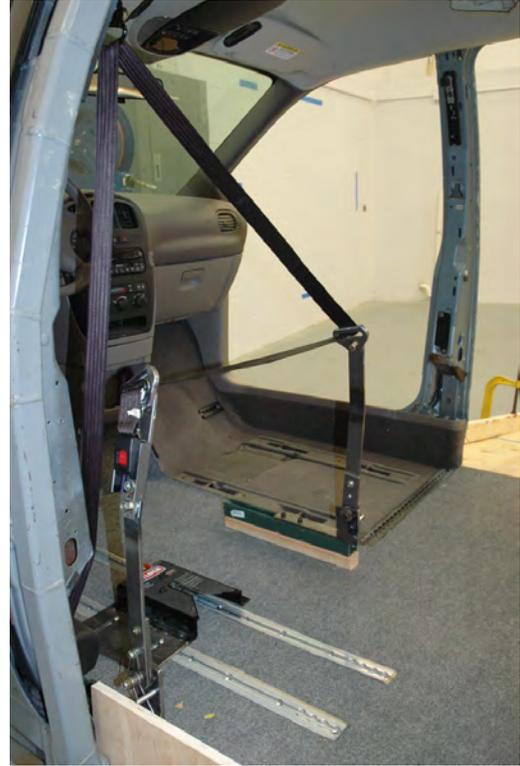
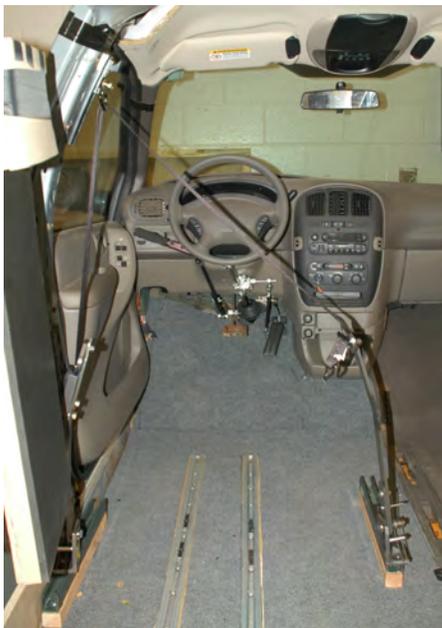
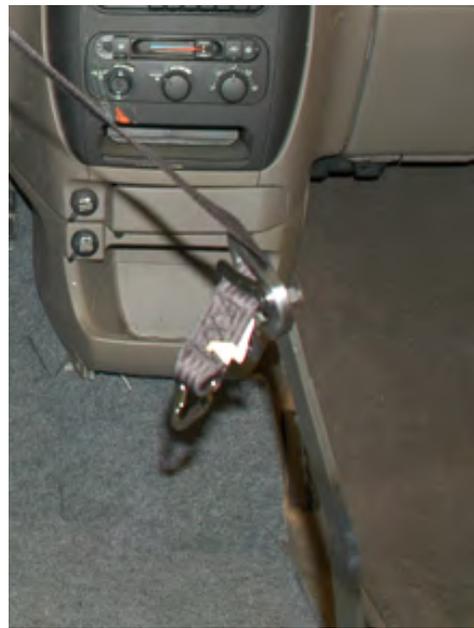
Figure 2.24 – Additional photos of a prototype of the pivoting-bar lap/shoulder belt restraint system installed in the static minivan buck

The photos in Figure 2.23 and Figure 2.24 show photos of a prototype of the pivoting-bar lap/shoulder belt restraint system mocked up in the minivan buck, and the photos in Figure 2.25 show the system being evaluated by two students seated in power wheelchairs. In this prototype,

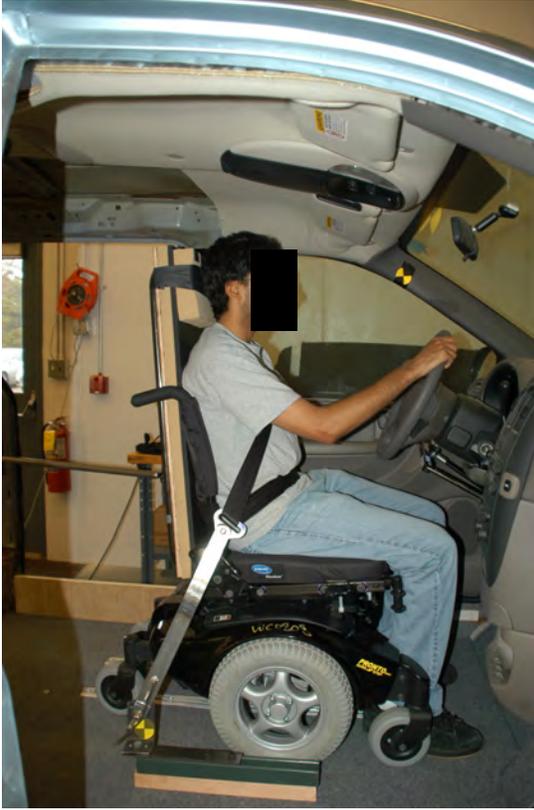
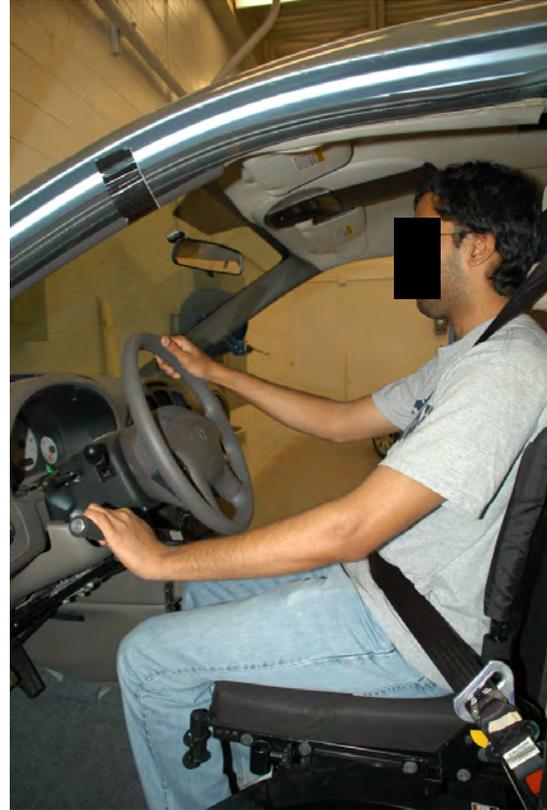
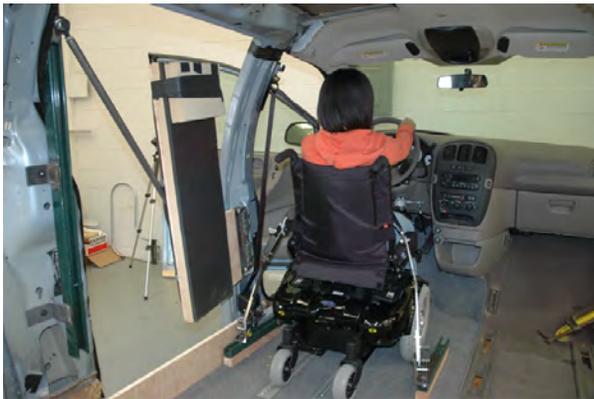
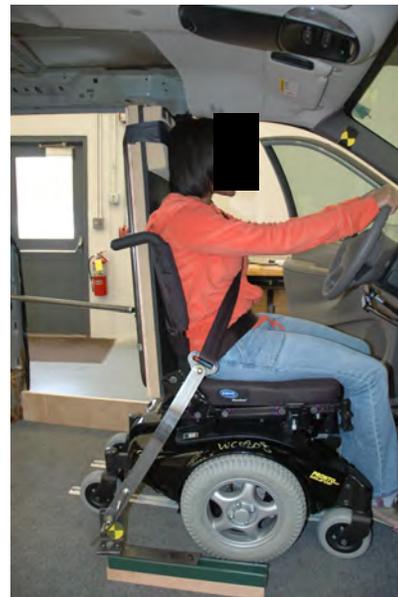
Figure 2.25 - Photos of BME students in power wheelchairs without arm supports evaluating the pivoting-bar lap/shoulder-belt restraint system used in the passive mode in the static minivan buck

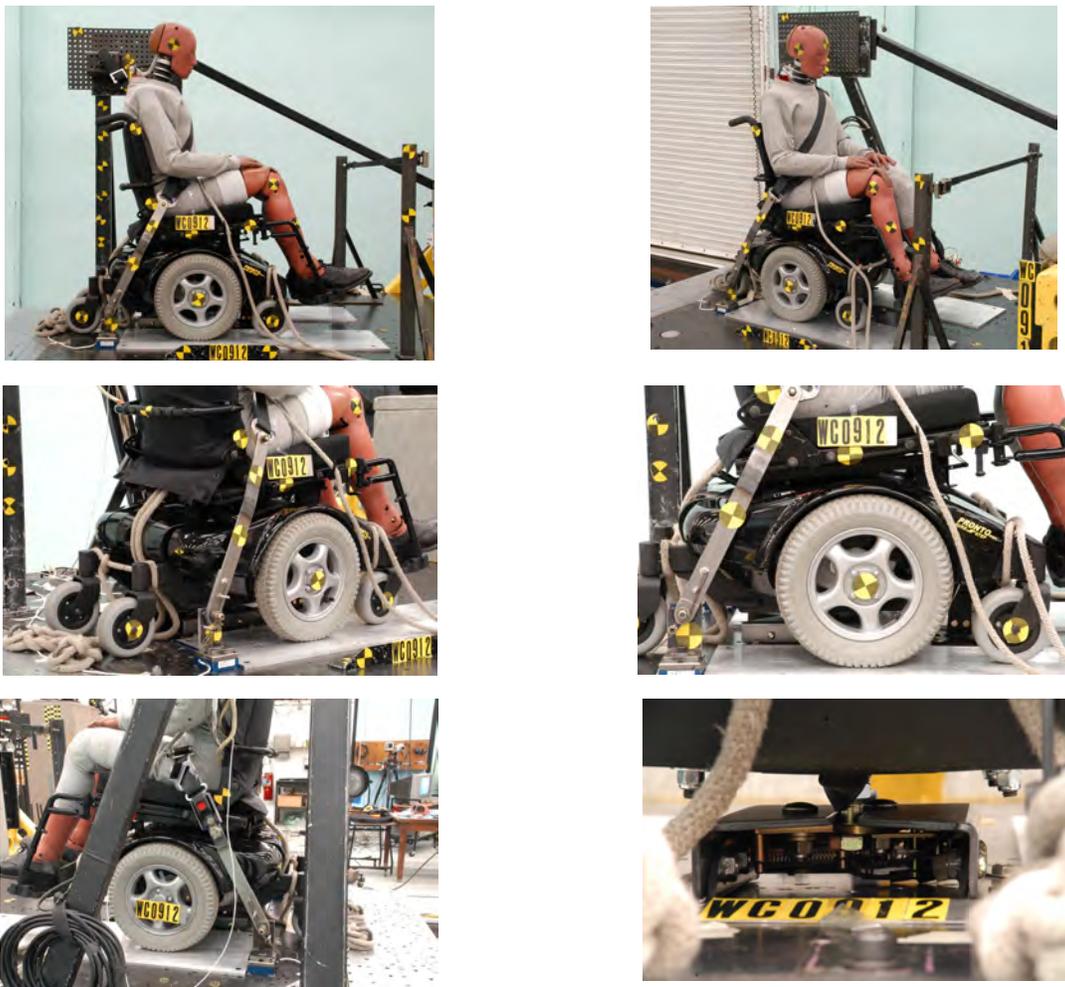
Figure 2.26 -Photos of the prototype pivoting-bar lap/shoulder belt restraint system prior to conducting the third and final 48-kph, 20-g frontal sled-impact test

Figure 2.26 shows pre-test photos of the third and final frontal-impact sled test of the modified pivoting-bar belt-restraint system with the midsize-male Hybrid III test dummy. In this design, the upper shoulder belt anchor point was fixed on the simulated B-pillar structure mounted to the sled platform. Figure 2.27 shows time-sequence frames from the side-view high-speed video and Figure 2.28 shows post-test photos from this test. No failures of any components were noted during or after the test and the lap/shoulder belt restrained the ATD within the forward-excursion criteria in Section 18 of ANSI/RESNA Volume 4 (ANSI/RESNA, 2012). Table 2.6 lists the maximum ATD response values, also known as injury assessment reference values or IARVs, allowed by FMVSS 208 “Occupant Crash Protection” for front outboard seating positions (49 CFR Part 571.208). Table 2.7 summarizes peak values for the ATD response measures for the third and final sled test (WC0912) of the pivoting-bar restraint system from which it can be seen that all values are below the IARVs in Table 2.6.

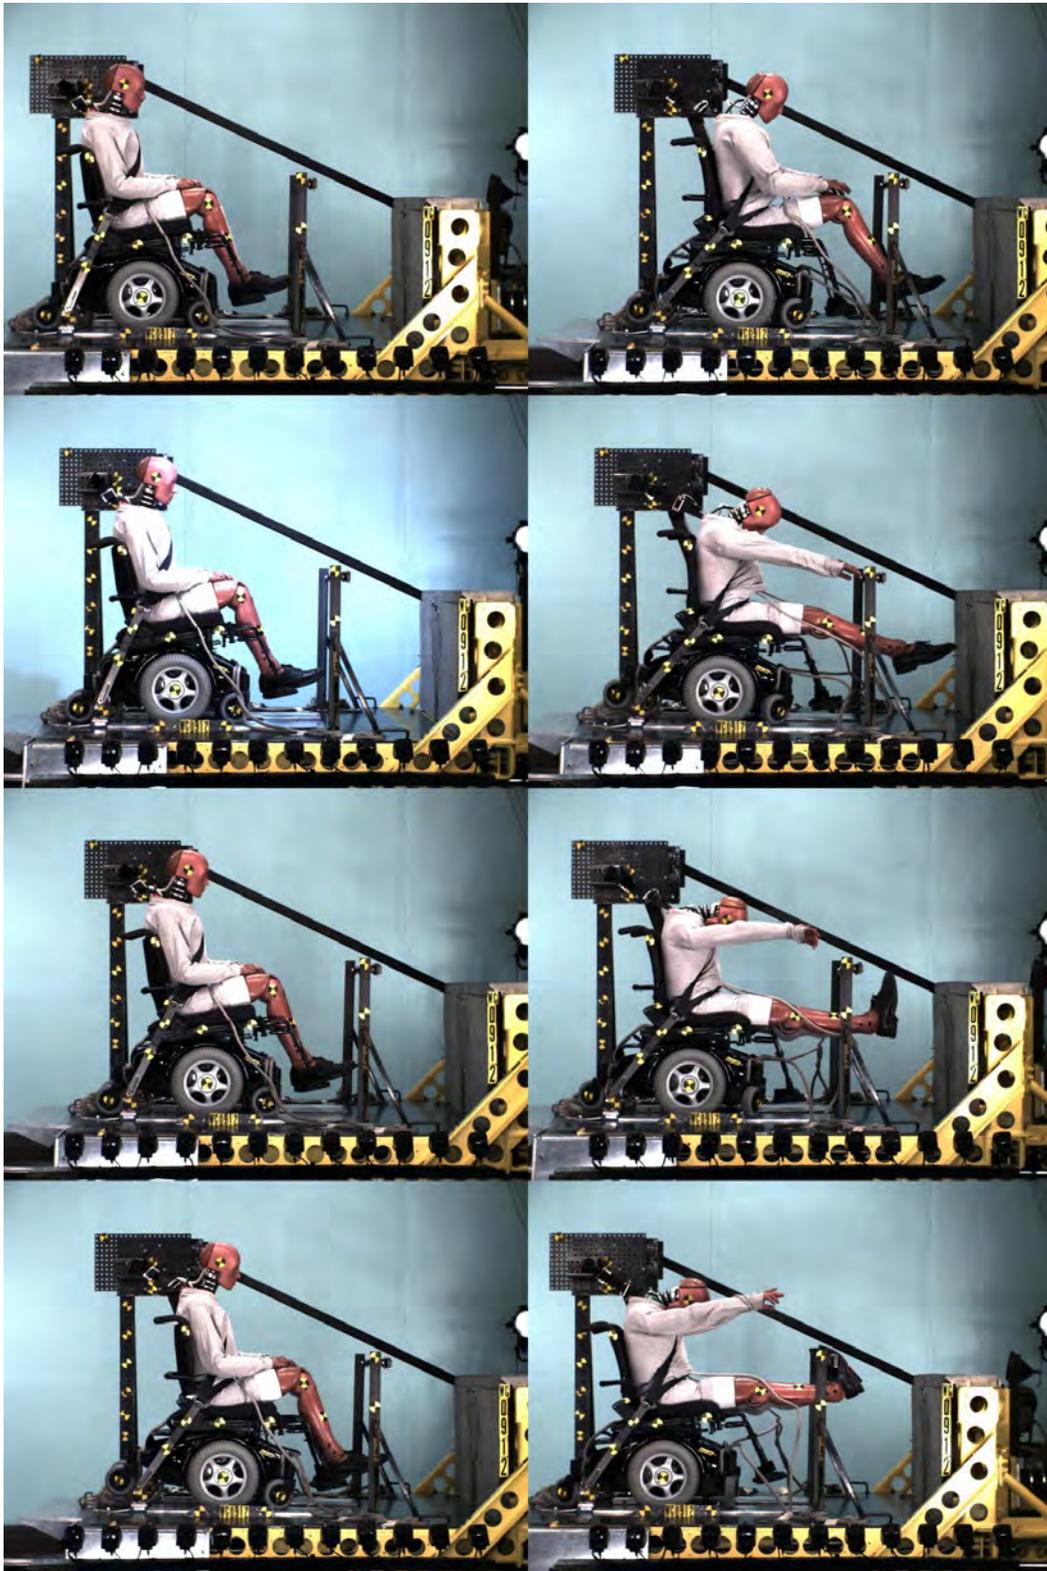
Figure 2.27 – Time-sequence frames from the side-view high-speed digital video for the third 48-kph, 20-g sled test of the pivoting-bar lap/shoulder belt restraint system

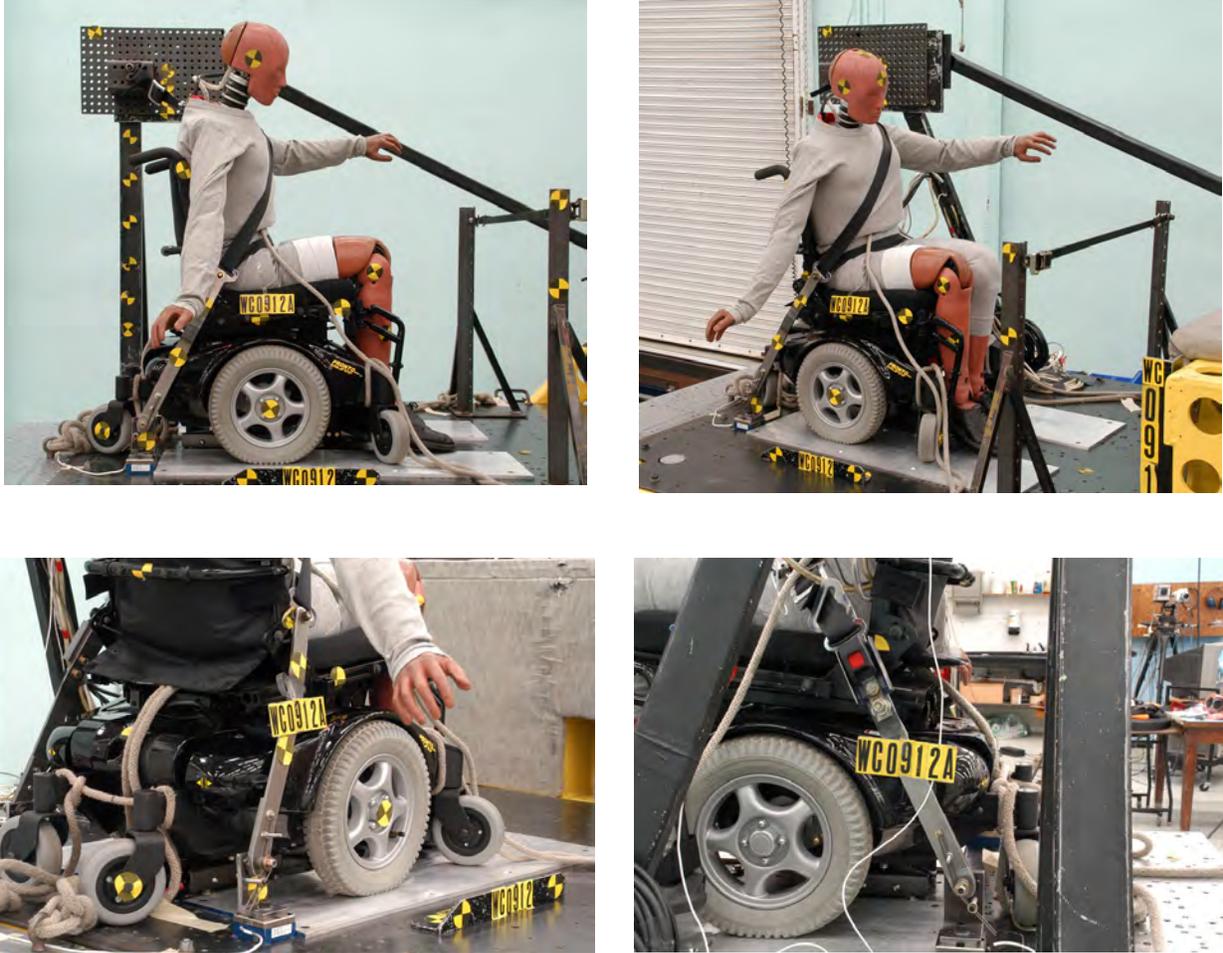
Figure 2.28 - Photos of the wheelchair and ATD following the third 48-kph, 20-g frontal-impact test of the prototype pivoting-bar lap/shoulder belt restraint system

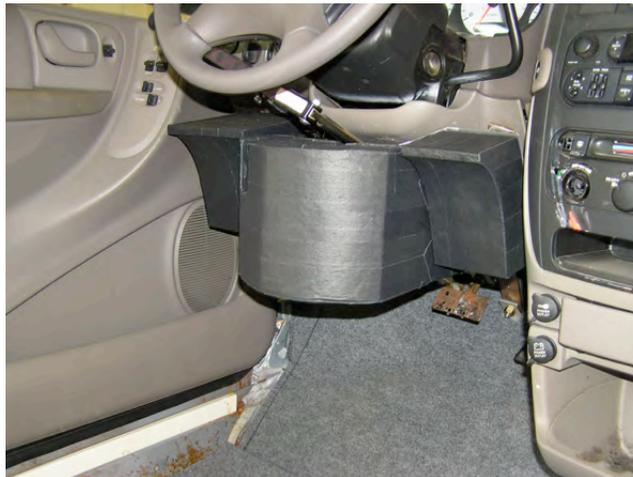
Figure 2.30 – Photo of a prototype close-proximity knee restraint installed in the static minivan buck

Figure 2.30 shows a mockup of a close-proximity knee restraint attached to the OEM knee bolster in the static minivan buck and Figure 2.31 and Figure 2.32 shows a person in a wheelchair positioned in the driver space with his knees in very close proximity to the add-on knee restraint. This add-on knee restraint was custom designed to provide a close and contoured fit to the knees of a member of the project design team when he was seated in a power wheelchair. Commercial hardware for a set of vehicle hand controls was implemented in the minivan prior to installing the add-on knee restraint so that a realistic idea of the additional constraints and problems imposed by this hardware could be addressed during knee-bolster installation.

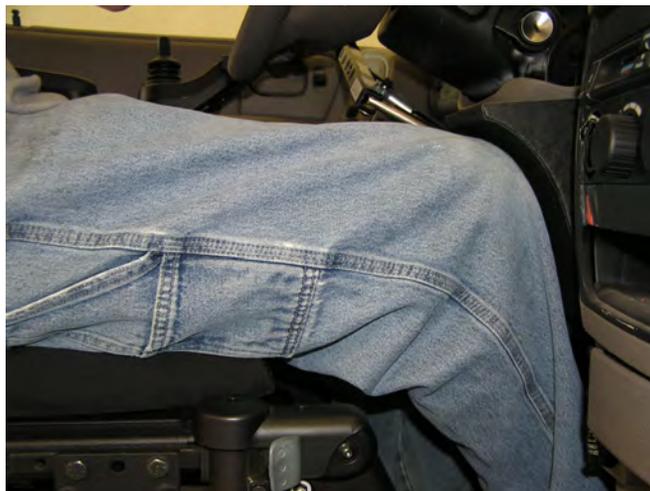
Figure 2.31 - Position of the right knee relative to a prototype contoured close-proximity knee restraint in the static minivan buck

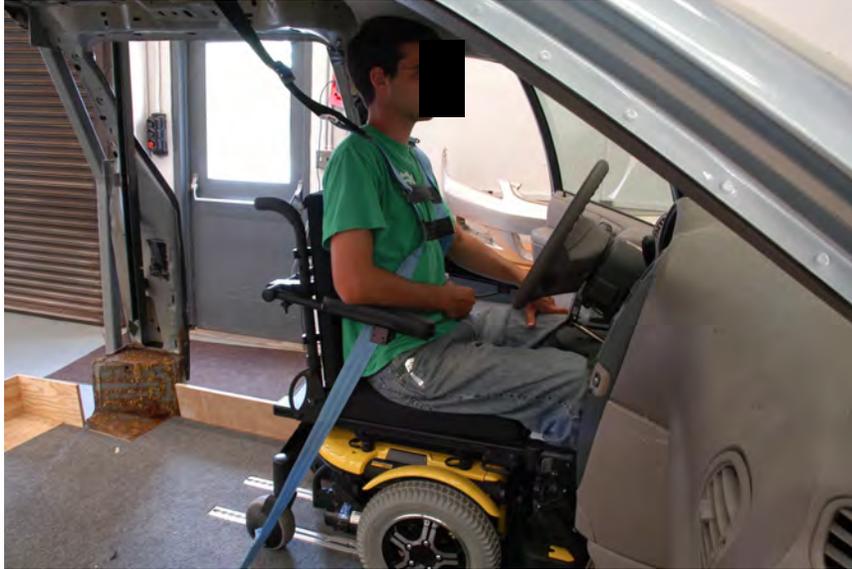
Figure 2.32 - A member of the UMTRI design team evaluating a prototype close-proximity knee restraint in the static minivan buck with a passive shoulder harness to provide upper-torso restraint

In this particular mockup, a prototype four-point upper-torso harness restraint was developed and installed in the minivan-buck. The restraint harness consists of two lengths of webbing that are anchored to the vehicle roof and floor and are connected together by two straps across the chest. The design allows the wheelchair driver to maneuver into the driver space and use the harness in a passive mode without the need to buckle the webbing.

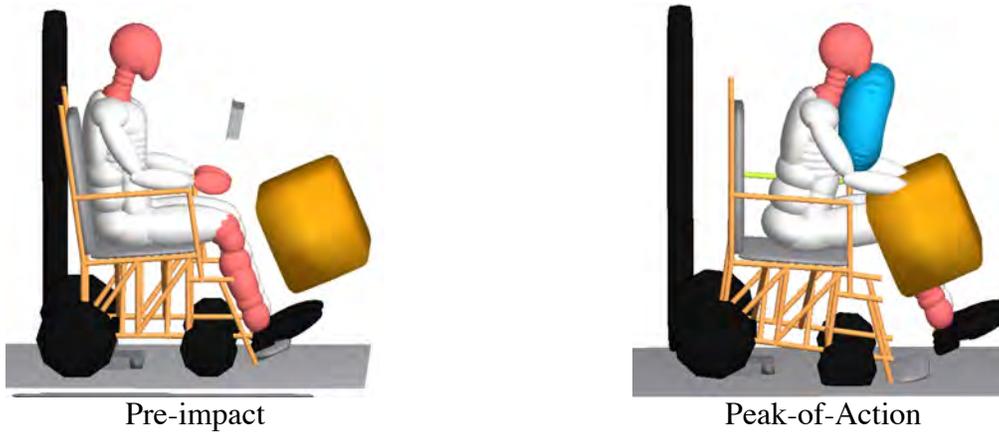
Figure 2.33 - Baseline MADYMO simulations of a 48-kph, 20-g frontal impact for an unbelted midsize-male ATD seated in a simulated wheelchair and restrained by a steering-wheel air bag and a typical production knee-bolster with a stiffness of 100 N/mm

Figure 2.33 shows pre-impact and a peak-of-action frames for the baseline model configured to simulate a 48-kph, 20-g frontal crash with a typical production knee bolster located 100 mm from the anterior aspects of the ATD's flexed knees and with the driver restraint system consisting only of a steering-wheel air bag (i.e., no belt restraints). Based on data collected in a study of human cadaveric knee-thigh-hip impact tests performed by Rupp et al. (2008), the OEM knee bolster was modeled with a constant stiffness of a 100 N/mm and maximum deflection of 100 mm before bottoming out. The peak femur forces from the simulation were approximately 6,450 N.

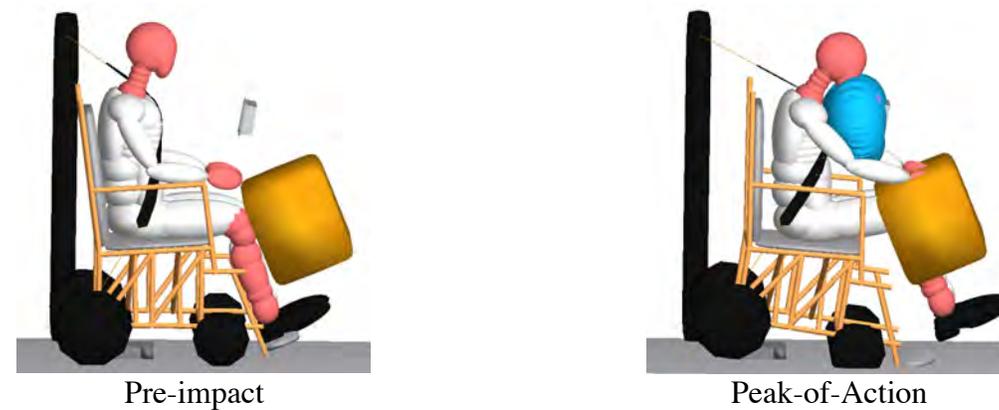
Figure 2.35 - MADYMO simulation for an unbelted midsize-male ATD restrained by a two-point shoulder belt, a steering-wheel air bag, and a 100-mm deep, 50 N/mm close-proximity knee restraint added to the production knee restraint

Figure 2.34 and

Figure 2.35 show pre-impact and peak-of-action frames from simulations in which a 100-mm deep close-proximity knee restraint was added between the production knee bolster and the ATD's knees for the ATD restrained only by a steering-wheel air bag and for the ATD restrained by a steering-wheel air bag plus a passive shoulder-belt restraint. For both of these simulations, when the stiffness of the add-on close-proximity knee restraint was set to 50 N/mm (half that of the production knee bolster), the peak femur force was approximately 3,336 N, which is about half the peak force generated in the simulation using a production knee bolster with a knee-to-knee-bolster pre-crash distance of 100 mm.

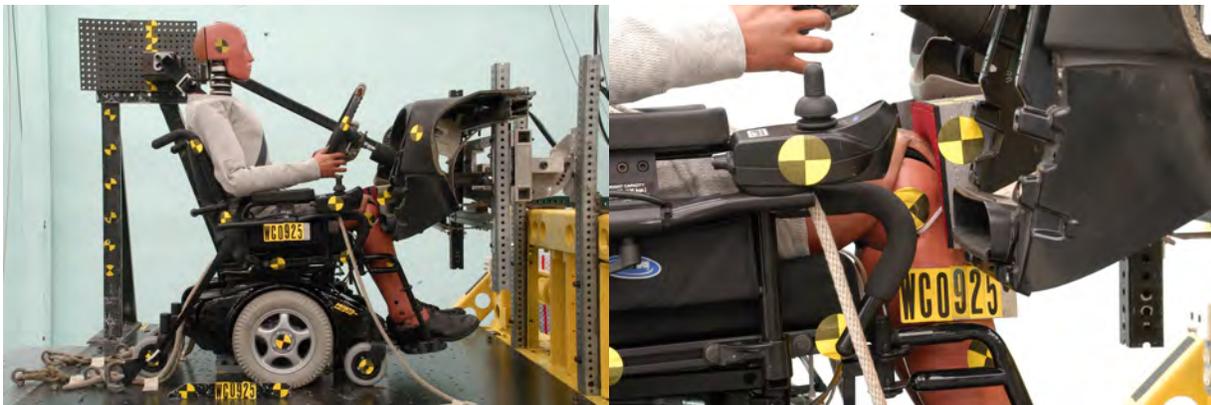
Figure 2.36 - Photos of the setup for frontal-impact sled test of the close-proximity knee restraint with no airbag and a two-point vehicle-anchored shoulder belt
