UMTRI-2016-8

Wheelchair Occupant Studies

Final Report

The Biosciences Group
University of Michigan
Transportation Research Institute

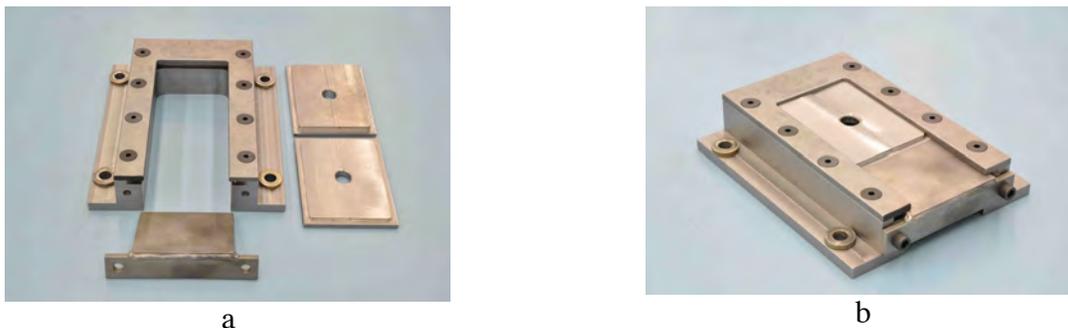
Figure 2.43 - Photos of the final design of the surrogate docking-securement device: a) disassembled with two thicknesses of deformable/replaceable plates; b) assembled

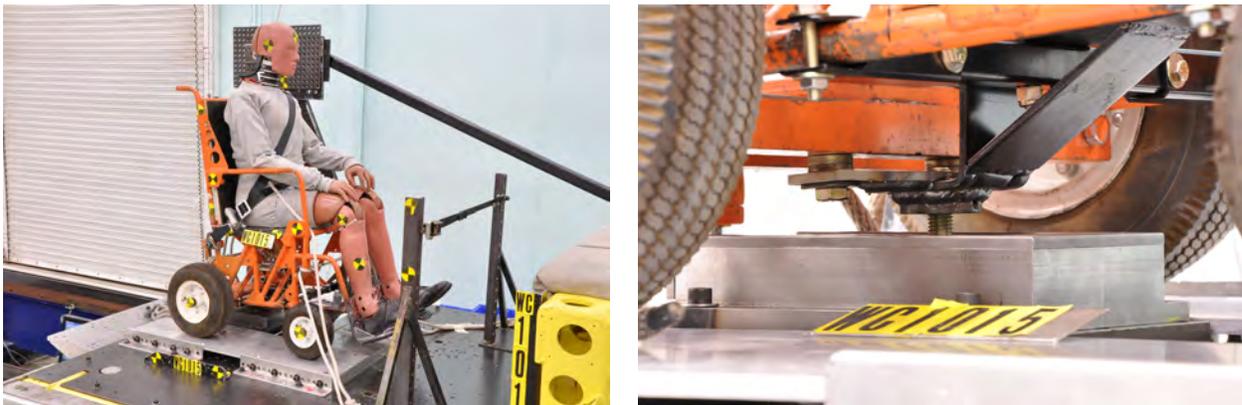
Figure 2.44 - Setup photos for a test of the surrogate docking-securement device (SDSD) with a 7.94-mm (5/16") thick hot-rolled steel plate used to secure the surrogate wheelchair (SWC) loaded with the midsize-male Hybrid III ATD restrained by a surrogate lap/shoulder belt and SWC-anchored lap belt

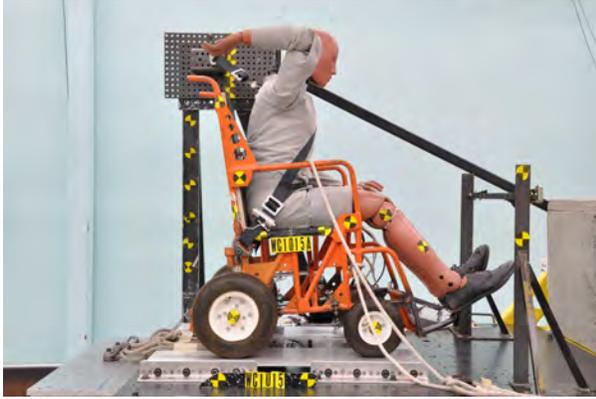
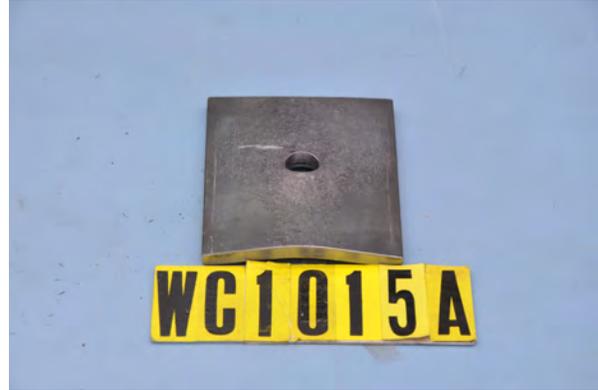
Figure 2.45 - Post-test photos for the sled test of Figure 2.44 showing the degree of plastic deformation of the 7.94-mm (5/16") thick hot-rolled steel plate on the right

Figure 2.44 shows photos of a typical test setup and Figure 2.45 shows post-test photos for this tests and the 7.94-mm (5/16") thick hot-rolled steel plate of the SDSD after removal from the SDSD. By comparison, Figure 2.46 shows post-test photos of a test in which a 6.35-mm (1/4") thick hot-rolled steel plate was used. While the replaceable retaining plates deformed in both cases, the plastic deformation of the 6.35-mm (1/4") thick hot-rolled plate is substantially greater than for the 7.94-mm (5/16") thick hot-rolled plate. Although the 6.35-mm (1/4") thick plate resulted in greater peak excursions of the SWC and ATD that were closer to those of the excursions with the commercial docking-securement devices, this extensive deformation made removal of the plate extremely difficult upon completion of a test.

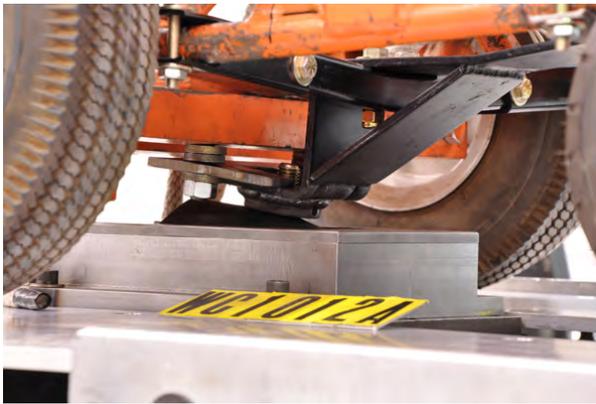
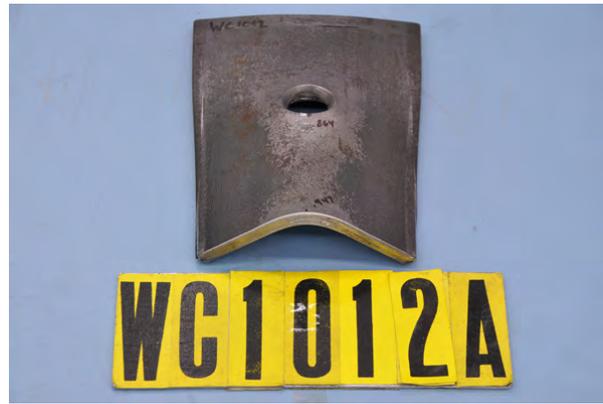
Figure 2.46 - Post-test photos showing plastic deformation of a 6.35-mm (1/4") thick hot-rolled steel plate still installed in the SDSD (left) and after removal from the SDSD (right)

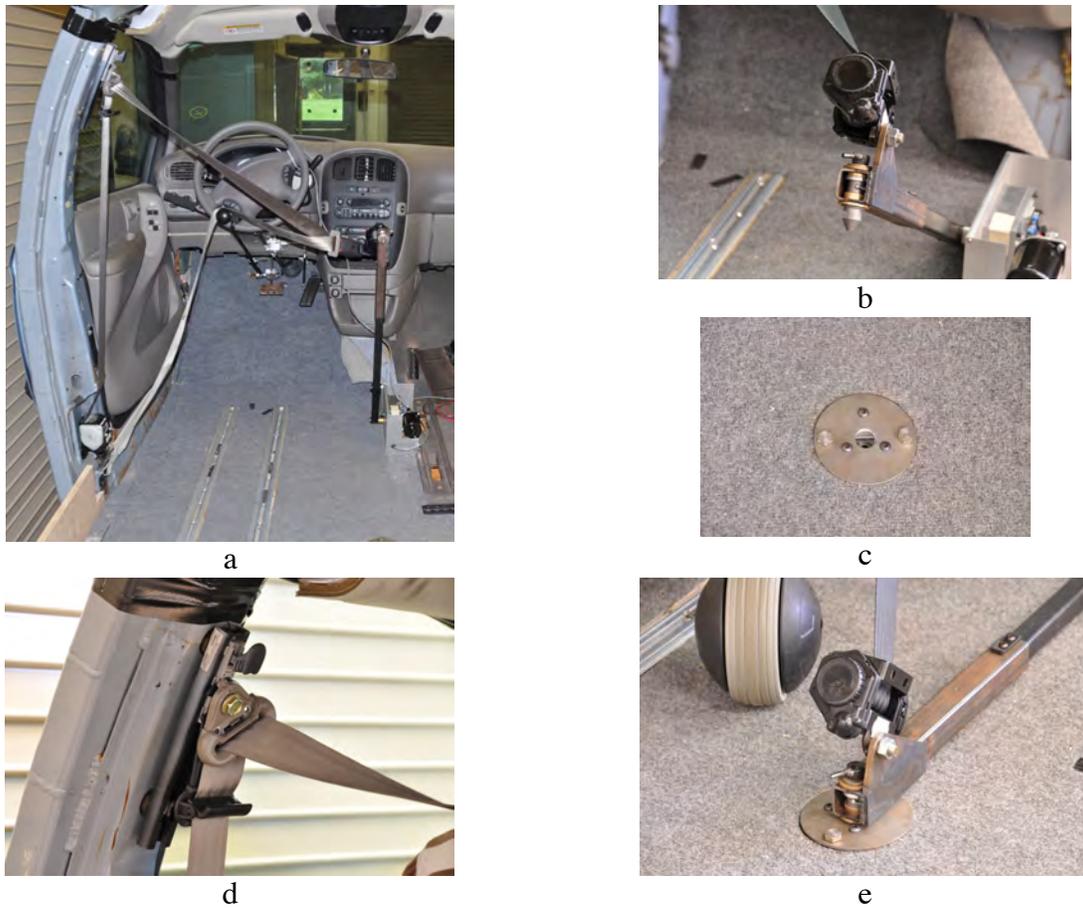
Figure 2.47 - Early version of the seat-belt deployment system (SBDS) installed in the minivan buck

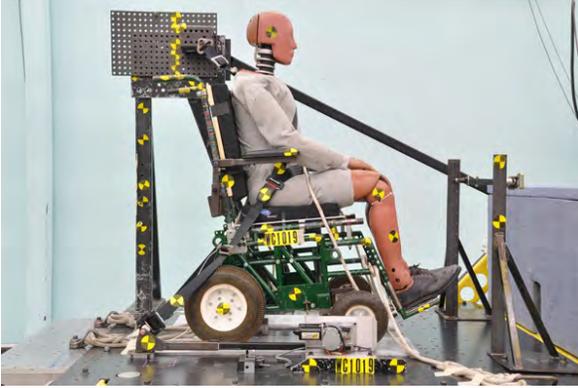
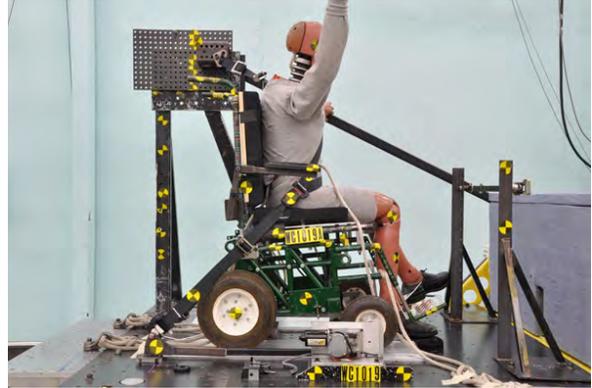
Figure 2.50 - Pre-test and post-test side-view photos for the 48-kph, 20-g frontal sled test of the SBDS used with a surrogate lap/shoulder belt with fixed upper-shoulder-belt anchor point

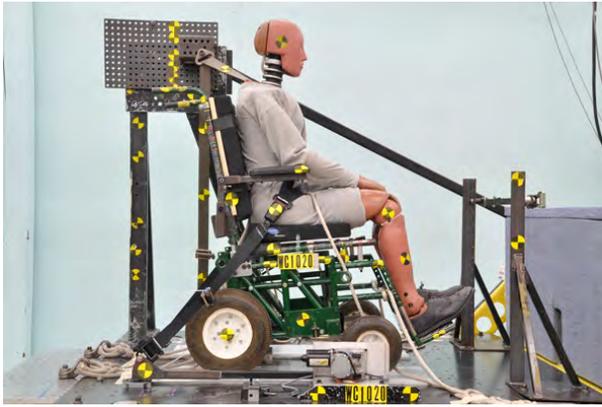
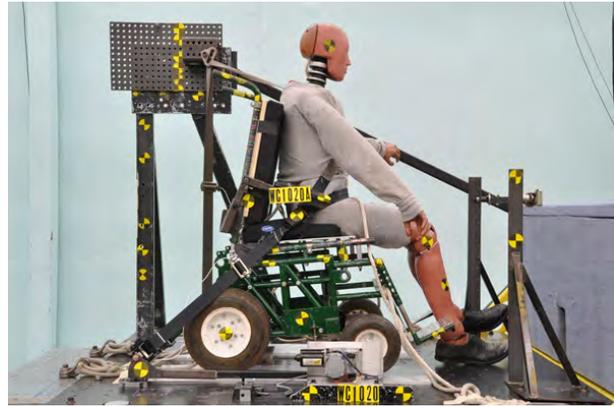
Figure 2.51 - Pre-test and post-test side-view photos for the 48-kph, 20-g frontal sled test of the SBDS used with an OEM minivan lap/shoulder belt with ELR shoulder-belt retractor

The SBDS performed well in all tests and none of the components failed. However, with the OEM lap/shoulder belts obtained from TRC, there was considerable spool out of the shoulder-belt retractor, which allowed higher forward movements of the ATD. As noted in Section 2.4.3.1, this high degree of retractor spool-out occurred in most, if not all, of the tests conducted at TRC (Sword, 2007). However, the reasons for this excessive spool-out remain unknown.

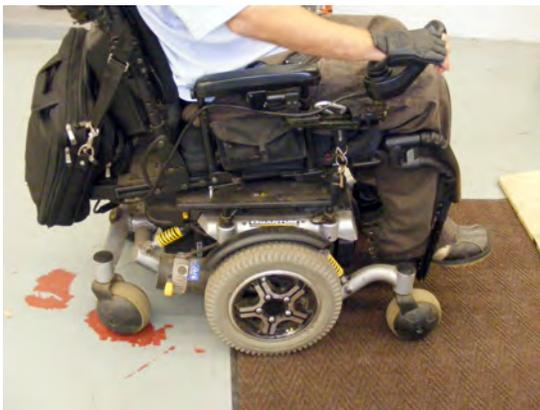
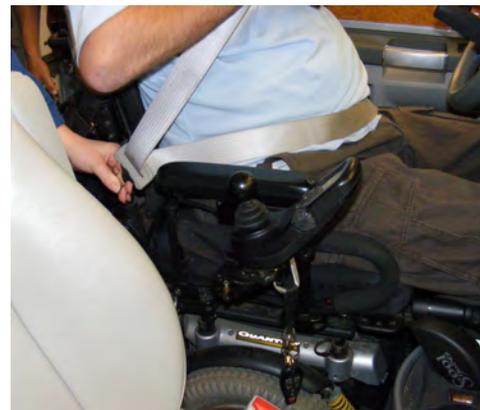
Figure 2.54 – Closed-front arm supports on power wheelchair (a) and poor positioning of passive lap belt over closed-front arm supports and on the abdomen (b) with the driver ready for travel in his personal vehicle

The opportunity came when one of the participants in the wheelchair-driver measurement study obtained a previously owned power wheelchair that was equipped with closed-front arm supports. Figure 2.54 shows the individual in their power wheelchair equipped with these arm supports and the resulting poor positioning of the lap belt over their abdomen when ready to drive in their personal vehicle. Figure 2.55 shows the same wheelchair retrofitted with open-front cantilevered arm supports and the improved fit of the lap belt in the minivan buck when using a vehicle lap/shoulder belt and the seat belt deployment system.

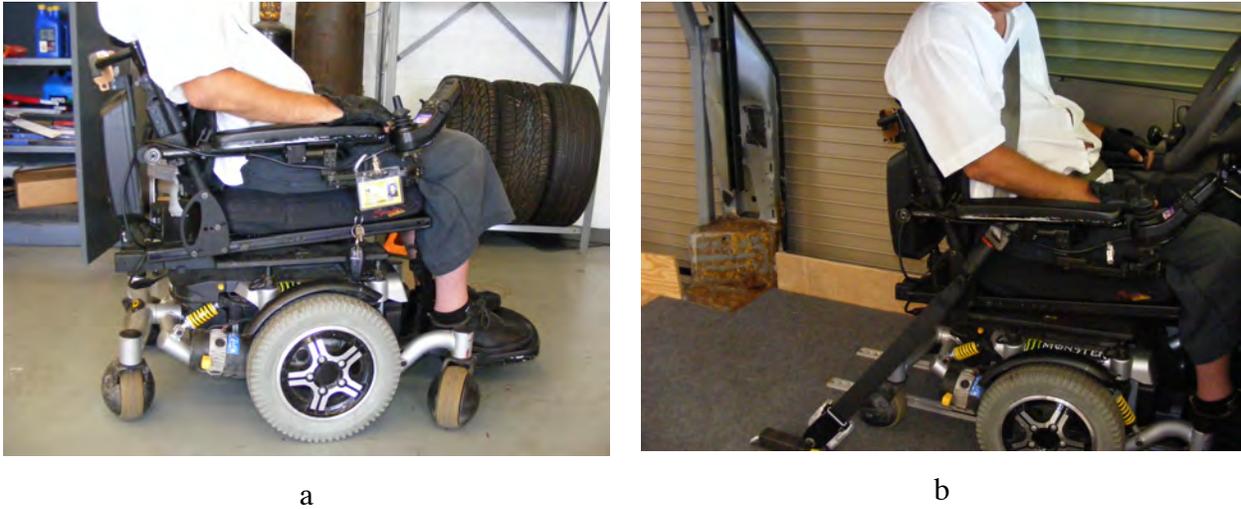
Figure 2.55 - Power wheelchair retrofitted with open-front cantilevered arm supports (a) and driver using a passive lap/shoulder belt with the seat-belt deployment system showing good fit of the lap belt low and in contact with the pelvis (b)

Retrofitting the arm supports on this wheelchair was performed by National Seating, Inc. and was reportedly a relatively simple matter of disconnecting the closed-front arm supports from the wheelchair and replacing them with a used pair of cantilevered arm supports that attached to the back-support posts. The joystick controller and related components were removed from the right-side closed-front arm support and attached to the right-side cantilevered arm support. According to an engineering technician at National Seating, such retrofits can be performed relatively easily on about 75% of all power wheelchairs.

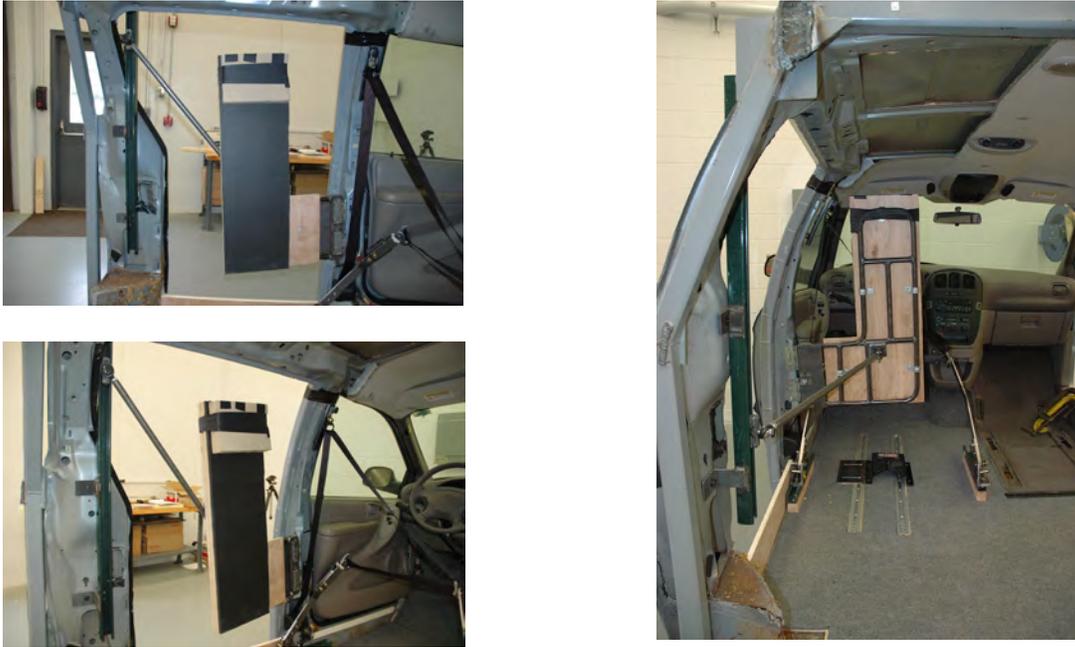
Figure 2.57 - Photos of a BME student-designed deployable vehicle-mounted head-and-back restraint system installed in the static minivan buck – the photos on the left show the head-and-back restraint in the stored position while the photo on the right shows the head-and-back restraint in the deployed position

Figure 2.57 shows photos of an early prototype of the deployable vehicle-mounted head-and-back restraint system installed in the minivan buck, and Figure 2.58 shows the head-and-back restraint deployed behind a student sitting in a wheelchair. The design uses a back-restraint frame constructed of welded steel tubing that is attached to, and pivots on, two hinges anchored to the driver-side B-pillar. A steel bar connected to the lower portion of the back-restraint frame by means of a rod-end bearing and clevis joint connects at the other end by means of another rod-end bearing to a block that slides on linear bearings in a Unistrut channel mounted to the vehicle's C-pillar on the driver side of the vehicle. In the stored position against the side interior of the vehicle, the end of the steel-bar linkage in the channel on the C-pillar is in the raised position. When the driver depresses an accessible button after his/her wheelchair is secured in

the driver space, a linear actuator (not implemented in the prototype) would move the C-pillar end of the linkage downward, causing the back-and-head restraint to rotate into position behind the driver and their wheelchair. When the driver is ready to exit the vehicle, another accessible button would be depressed and the linear actuator would move the end of the bar linkage on the C-pillar upward, causing the back-and-head restraint to rotate back into the stored position against the side of the vehicle.

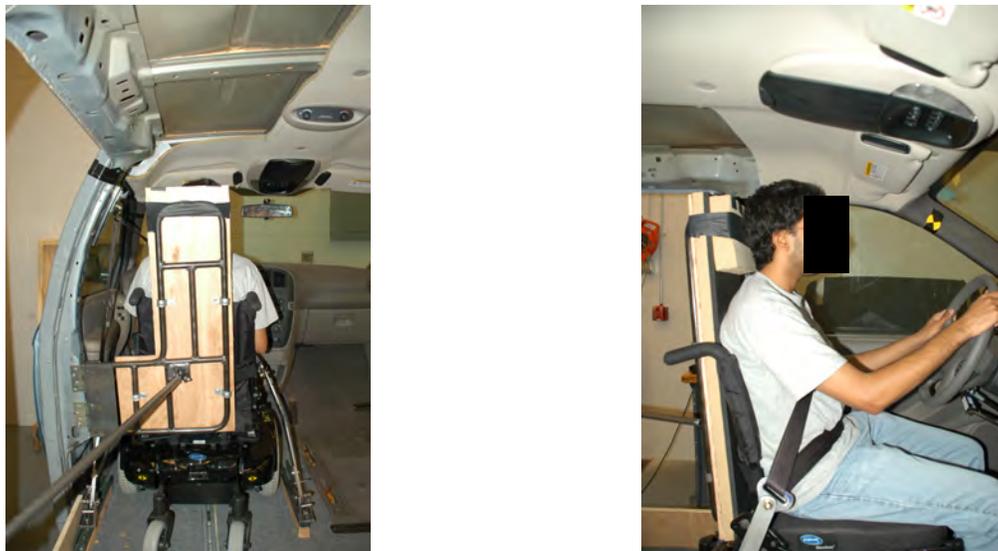
Figure 2.58 – Early prototype of the BME student-designed deployable vehicle-mounted head-and-back restraint in the deployed position behind a student seated in a wheelchair

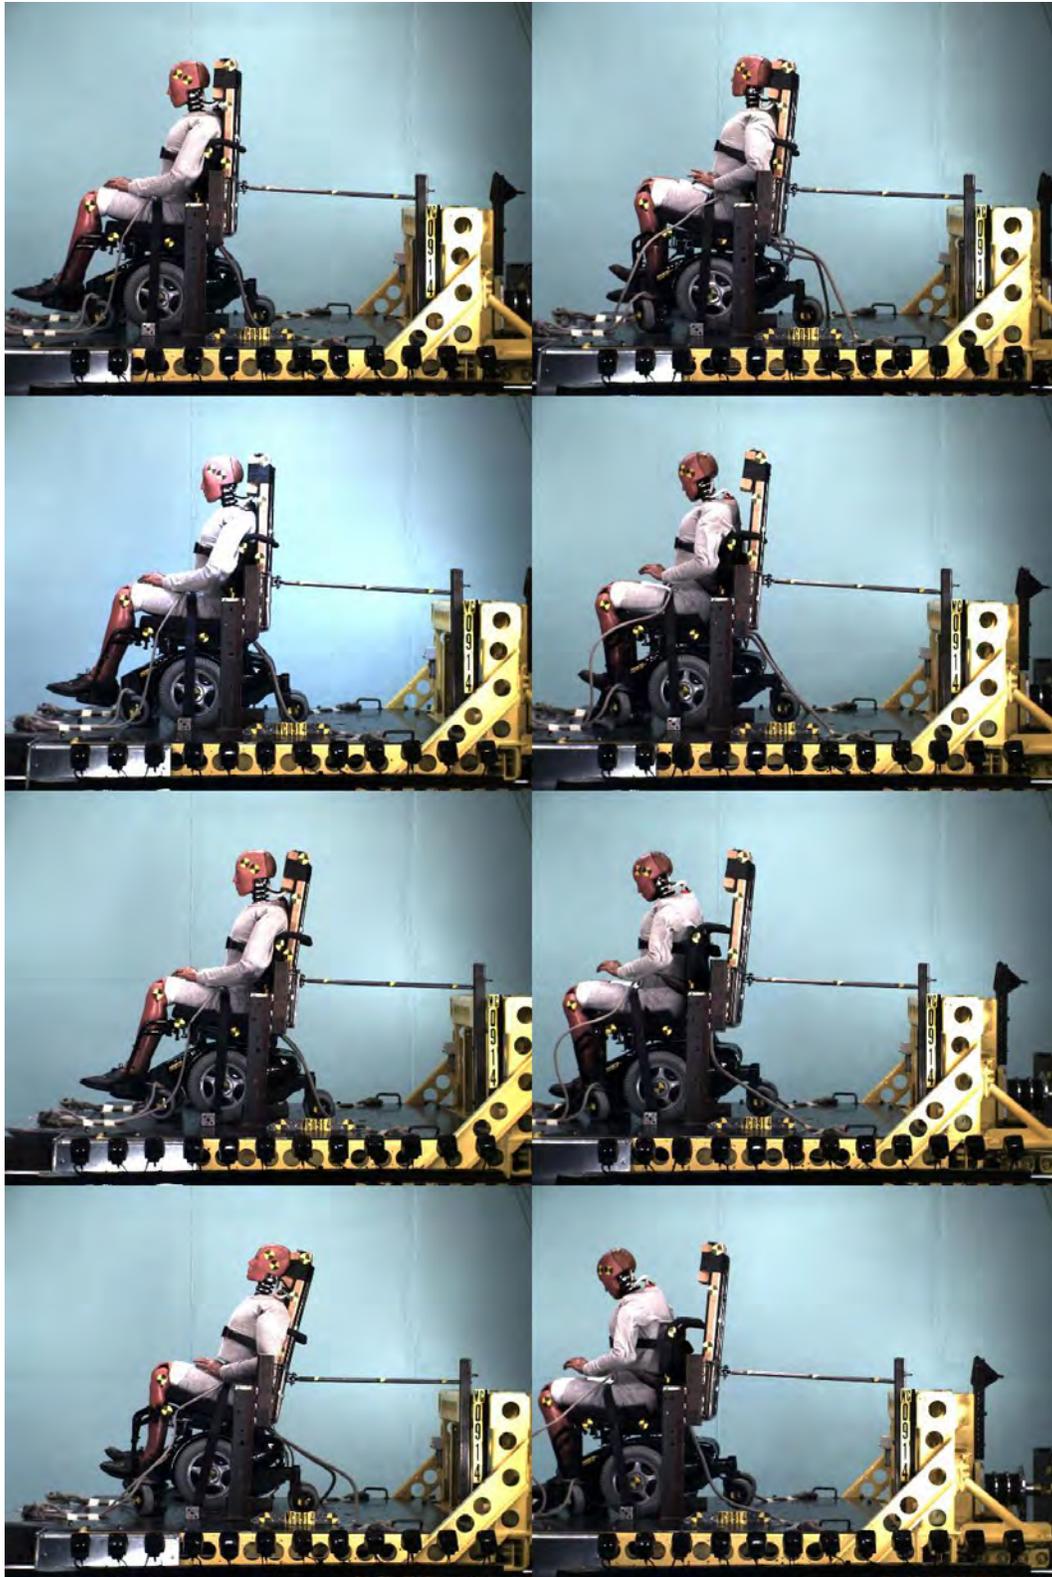
Figure 2.62 – Time-sequence frames from the side-view high-speed digital video of the second rear-impact sled test of the BME student-designed vehicle-mounted head-and-back restraint

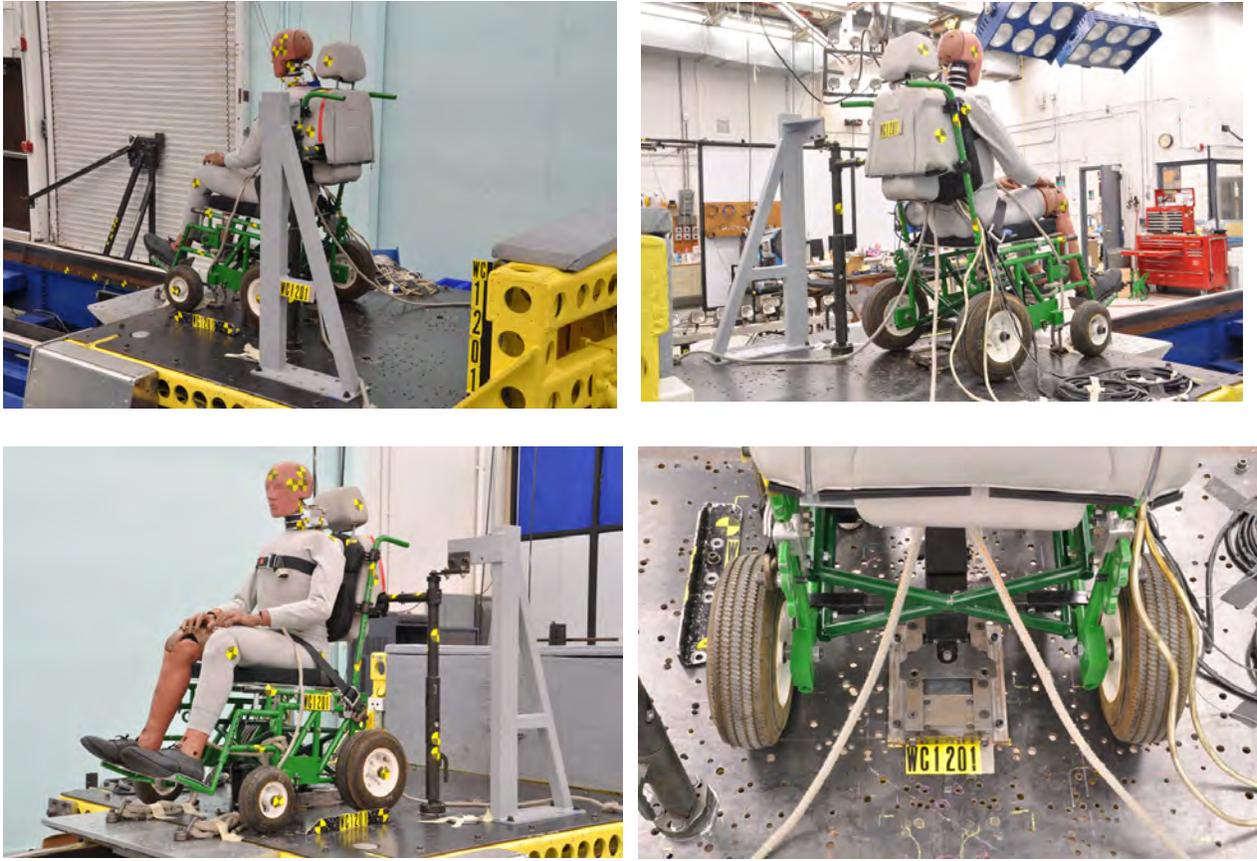
Figure 2.64 - Photos showing the setup of SWCF and midsize-male ATD for the first rear-impact sled test of the deployable Swedish head-and-back restraint system

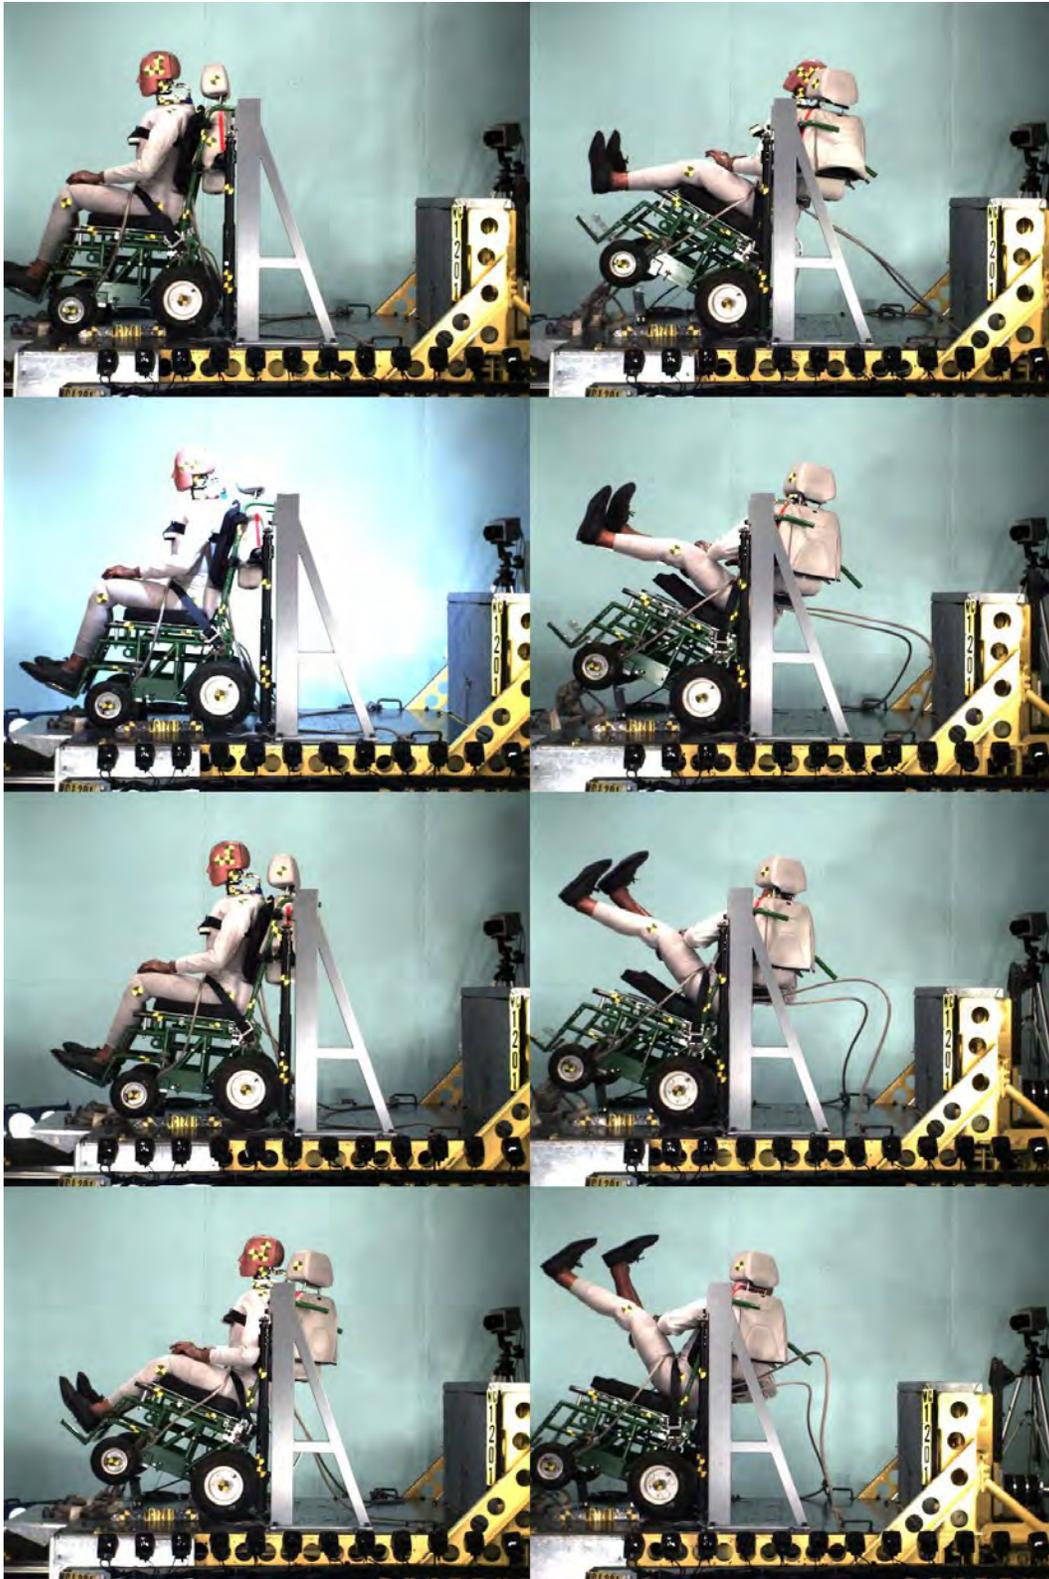
Figure 2.66 – Time-sequence photos from the side-view high-speed digital video of the first rear-impact sled test of the deployable Swedish vehicle-anchored head-and-back restraint system – note the rearward rotation of the SWCF

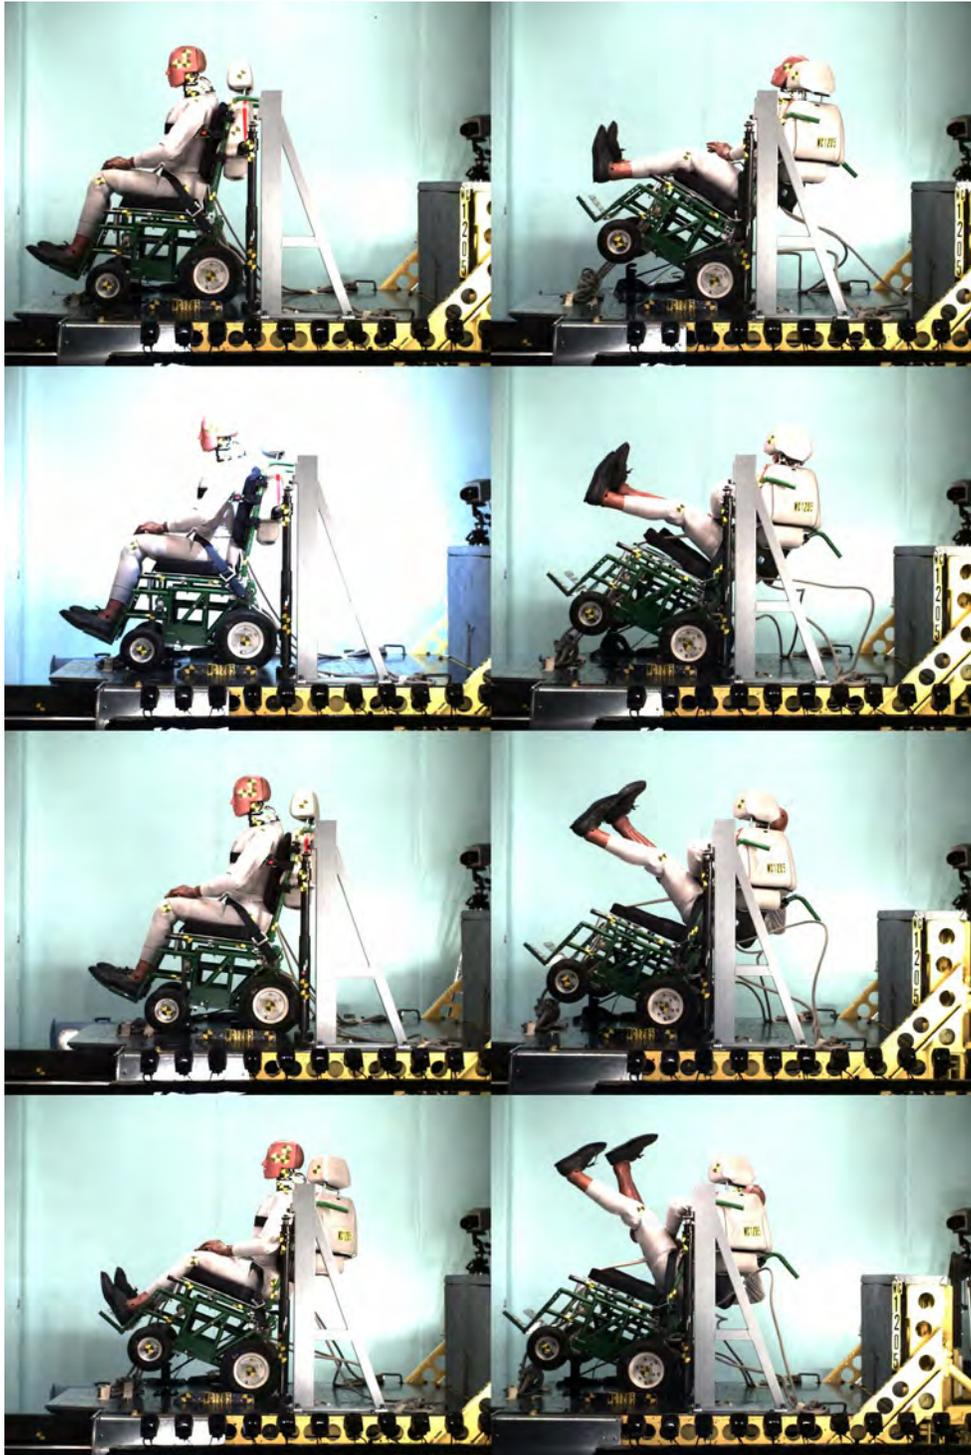
Figure 2.68 – Time-sequence frames from the side-view high-speed digital video of the second rear-impact sled test of the Swedish deployable vehicle-anchored head-and-back restraint system – note the rearward rotation of the SWCF

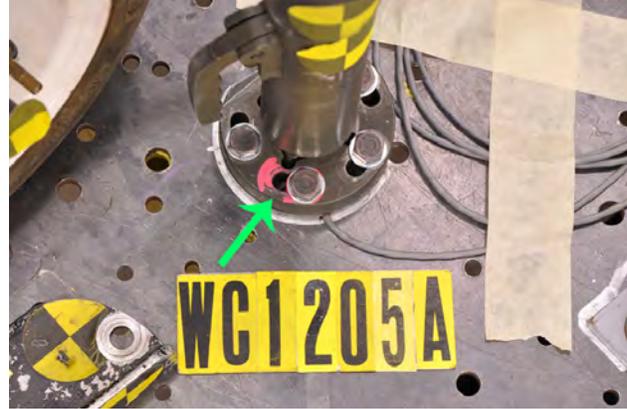
Figure 2.70 - Broken plastic drive nut (upper part of photo on left) on screw-motor actuator and slippage in curved slots at the base of the Swedish head-and-back restraint post (right) that were significant contributors to the poor performance of the Swedish deployable vehicle-anchored head-and-back restraint system in the second sled test

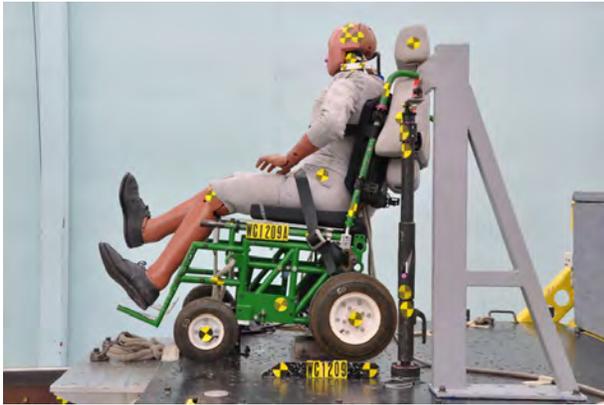
Figure 2.71 - Post-test photos from the third rear-impact test of the modified Swedish deployable vehicle-anchored head-and-back restraint system

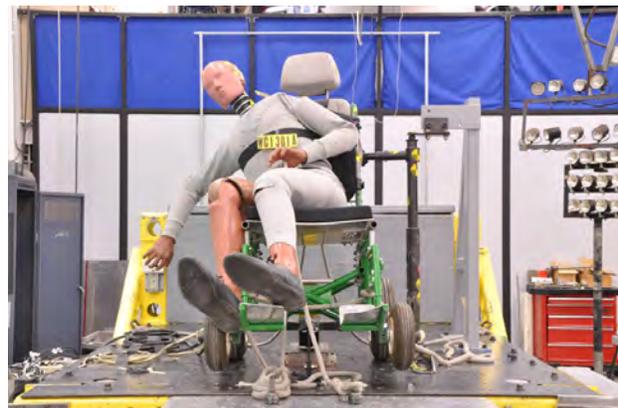
Figure 2.72 - Post-test photos from the fourth rear-impact test of the modified Swedish deployable vehicle-anchored head-and-back restraint system

As shown in the post-test photo of Figure 2.71 and Figure 2.72, and in the time-sequence frames in Figure 2.73 through Figure 2.76, there was considerable improvement in performance during the last two tests, although the peak rearward head excursions of the test dummy were 452 and 470 mm, respectively, which are just slightly greater than the proposed excursion limit of 450 mm. Note also, that there is no rearward rotation of the SWCF in these last two tests due to improvements made in locking the forked bar to the front stabilizing bracket.

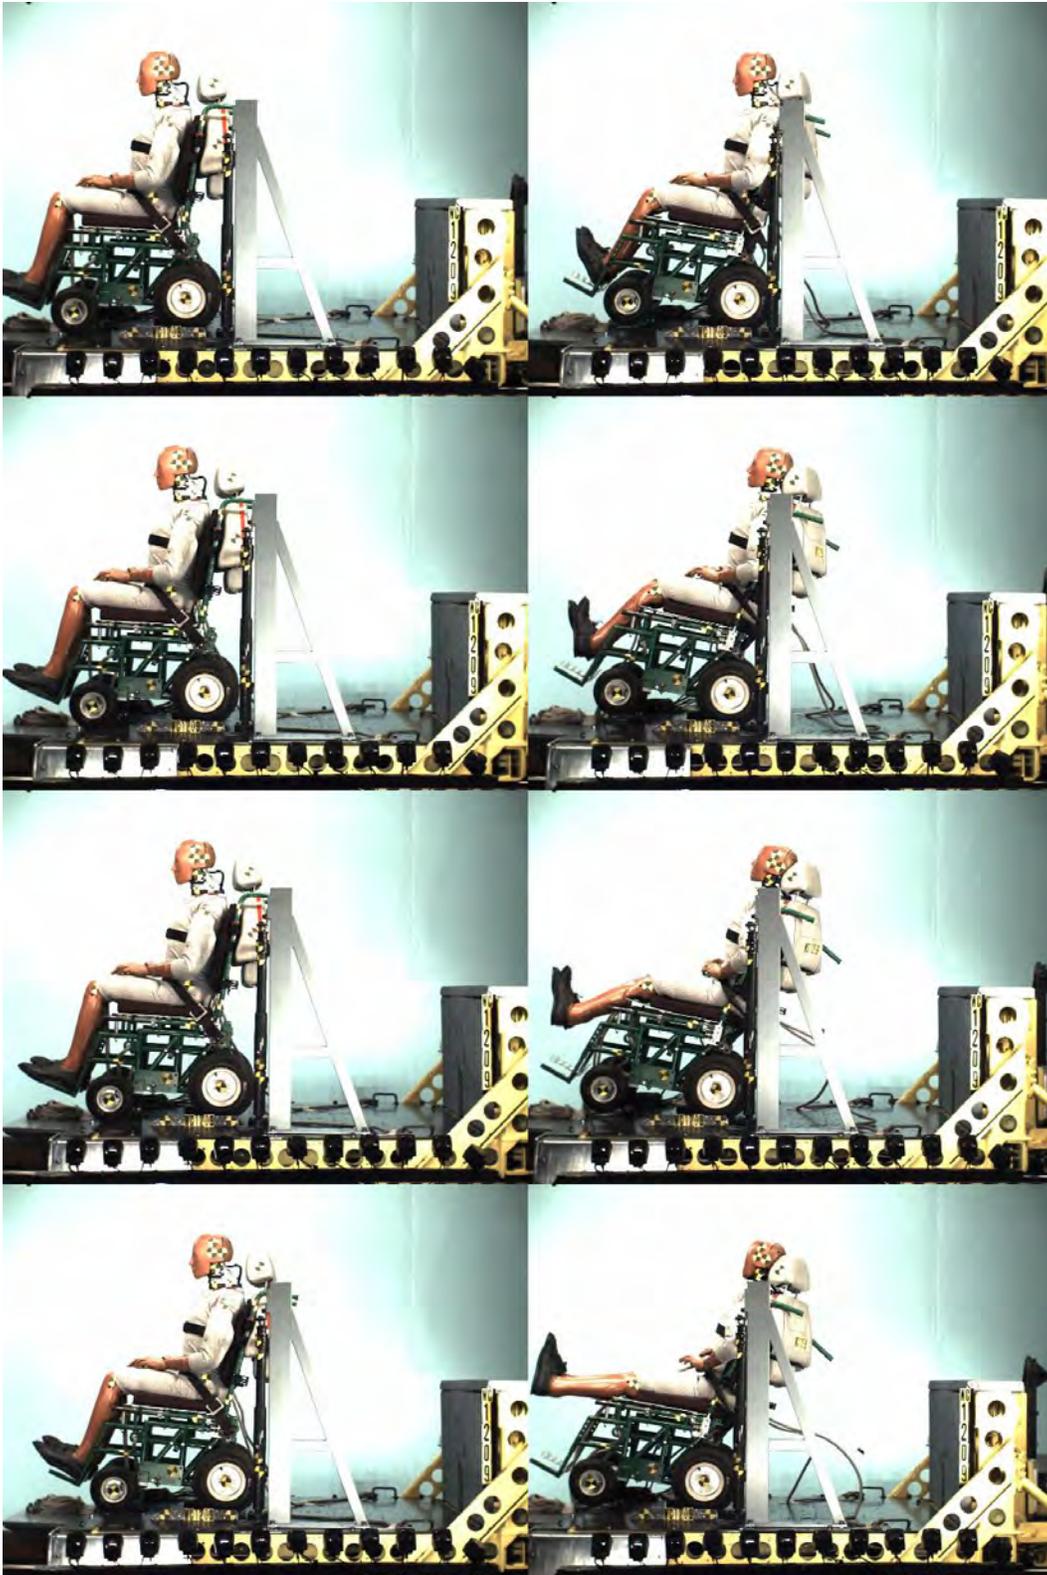
Figure 2.73 – Time-sequence frames from the side-view high-speed digital video of the third rear-impact sled test of the Swedish deployable vehicle-anchored head-and-back restraint system – note that there is no rearward rotation of the SWCF

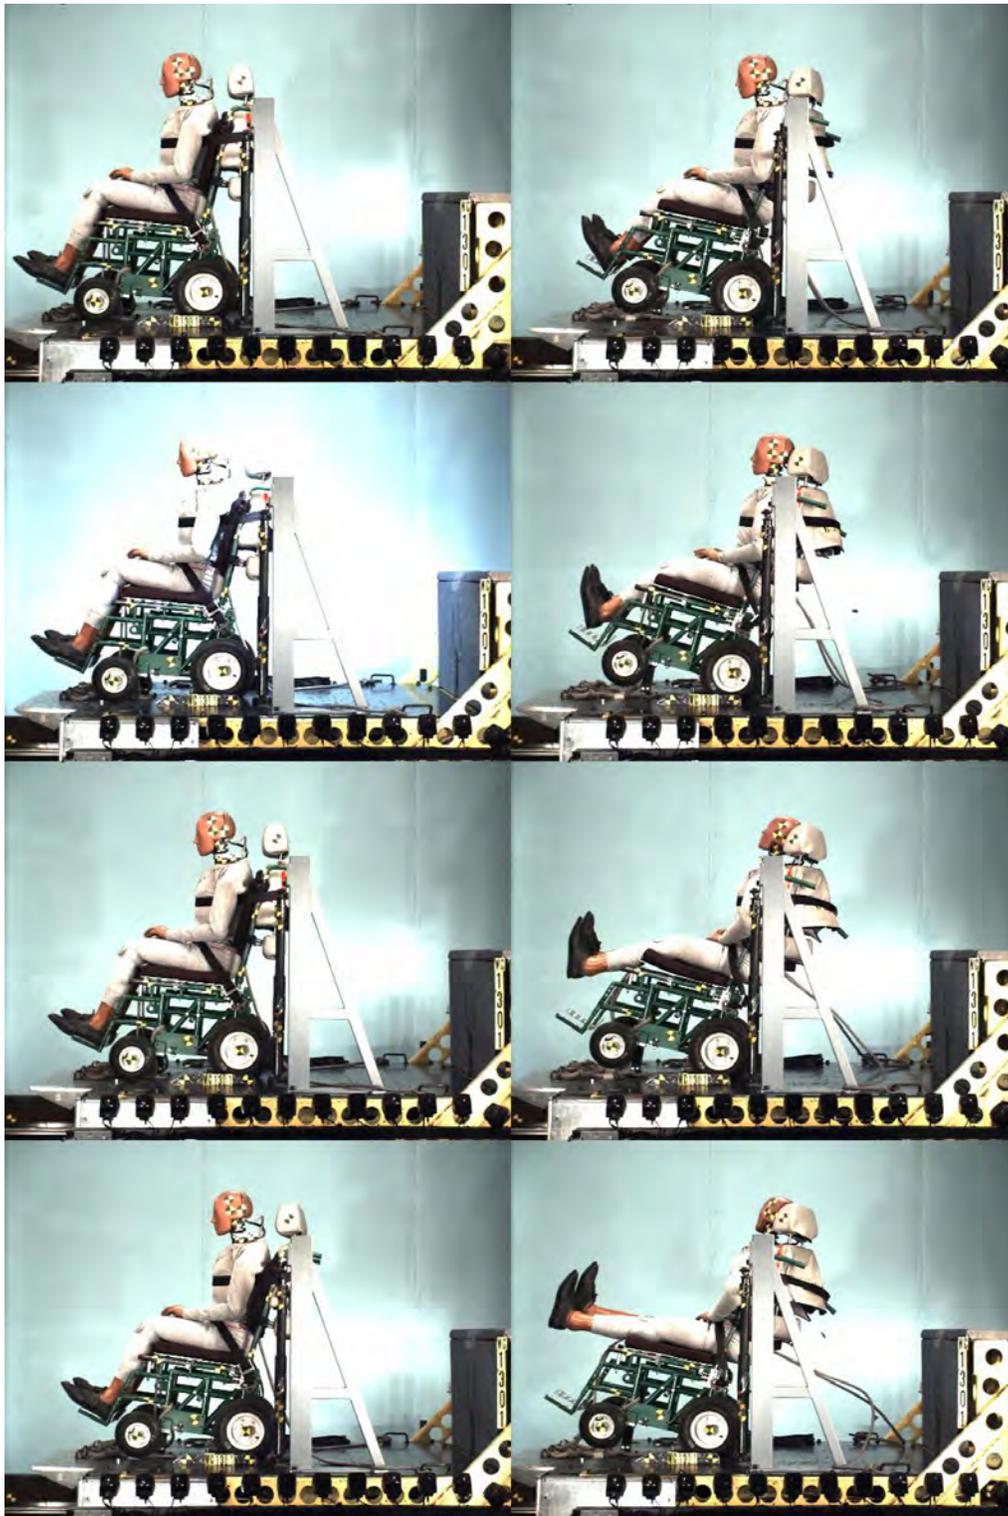
Figure 2.75 – Time-sequence frames from the side-view high-speed digital video of the fourth rear-impact sled test of the Swedish deployable vehicle-anchored head-and-back restraint system – note that there is no rearward rotation of the SWCF

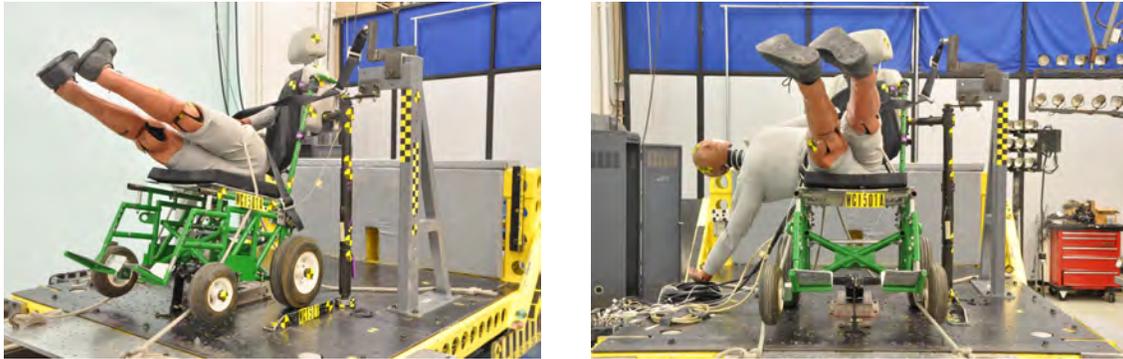
Figure 2.78 - Post-test photos of the Swedish manufacturer's modified design of the deployable vehicle-anchored head-and-back restraint system

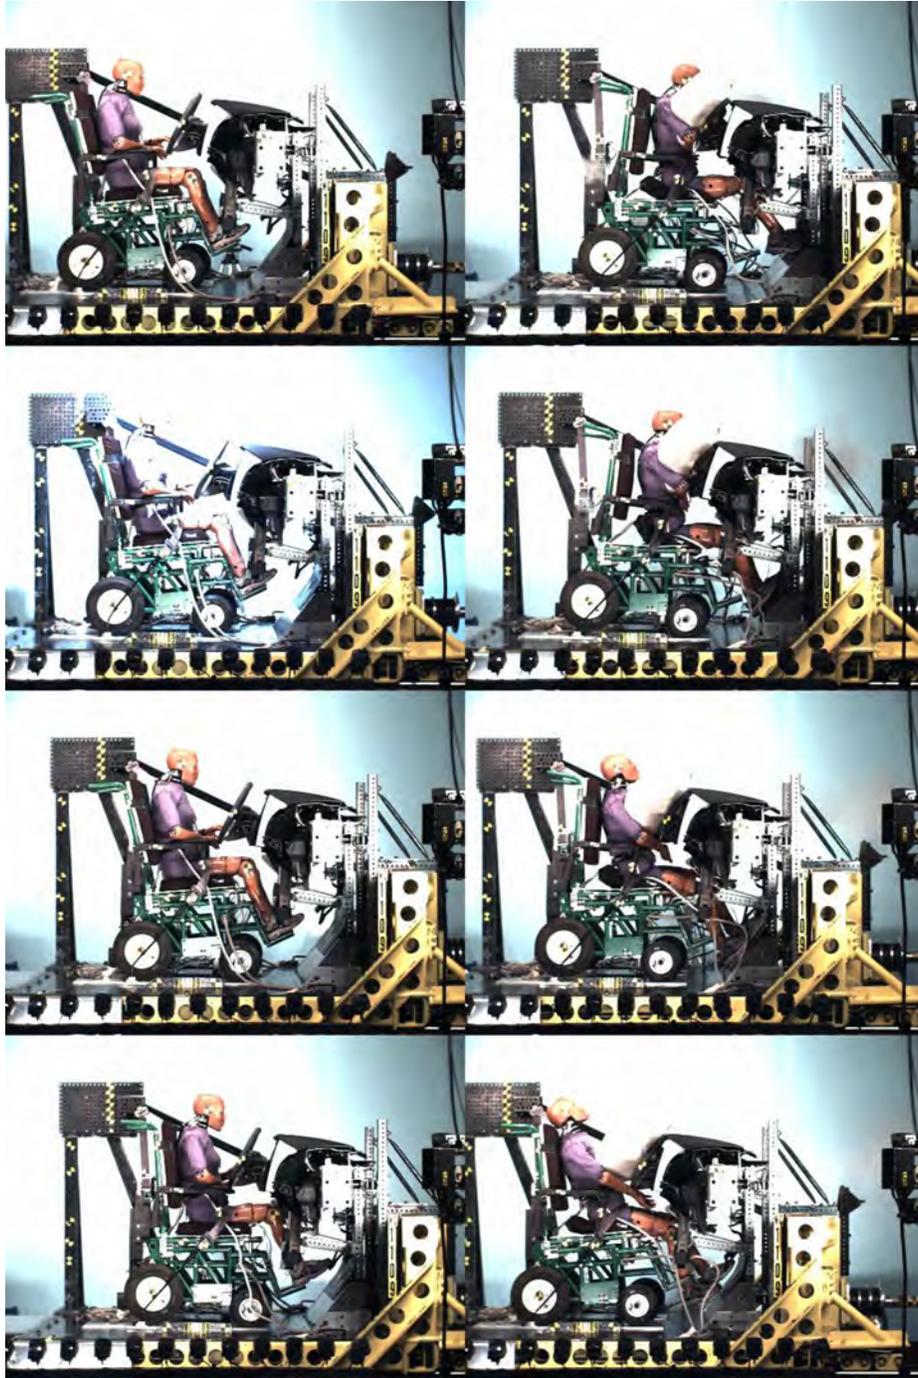
Figure 3.5 - Time-sequence frames from the side-view high-speed video of Test No. WC1109 with poor (loose) belt fit and 42-ms airbag deployment time, showing small-female ATD kinematics and interaction air bag

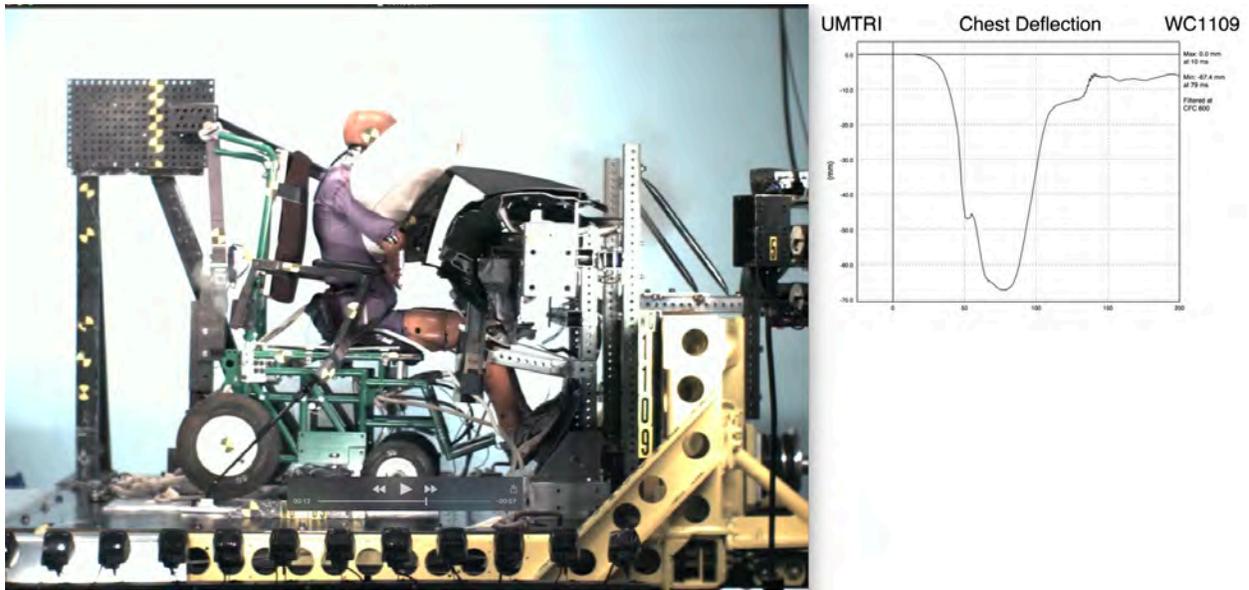
Figure 3.7 - Side-view photo at PEAK CHEST DEFLECTION from high-speed video for Test No. WC1109 with the small-female ATD restrained by loosely fitting lap/shoulder belt and an air-bag deployment time of 42 ms

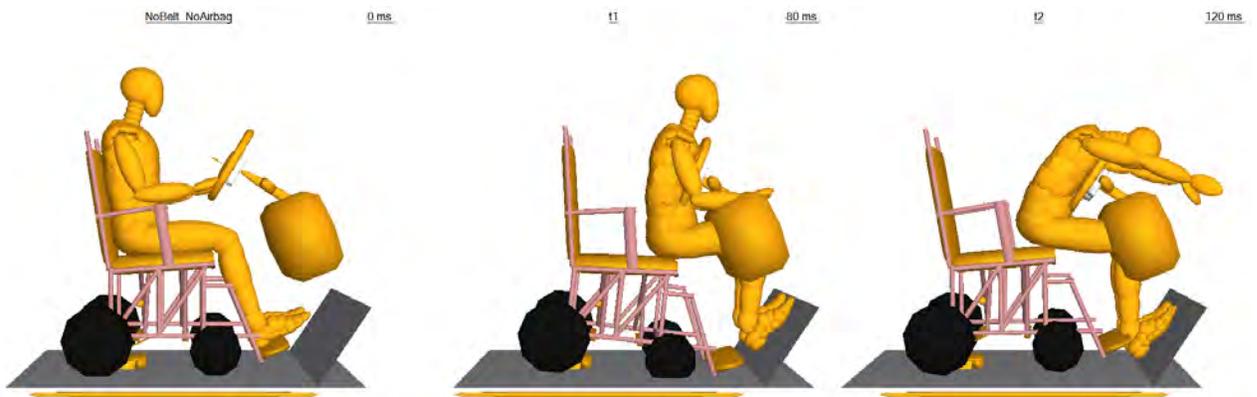
b – midsize-male ATD with no seat belt and no air bag

For the midsize-male ATD, all HIC and all N_{ij} values are lower with deployment of the air bag than for the comparable simulation without deployment of the air bag. High chest deflections exceeding the IARV of 63 mm occurred for the unbelted midsize male with and without deployment of the steering-wheel air bag. As indicated by the first two rows of simulation frames in Figure 3.9 (a and b), it is believed that these high chest deflections are due to loading of the ATD's chest by the steering wheel. For the simulation with air-bag deployment, the high chest compression appears to be due to the ATD overloading the air bag and thus contacting the steering wheel through the airbag. However, it is also noted that the peak chest deflection for this scenario is significantly less than for the scenario without air-bag deployment, in which case the ATDs chest is directly loaded by the steering wheel.

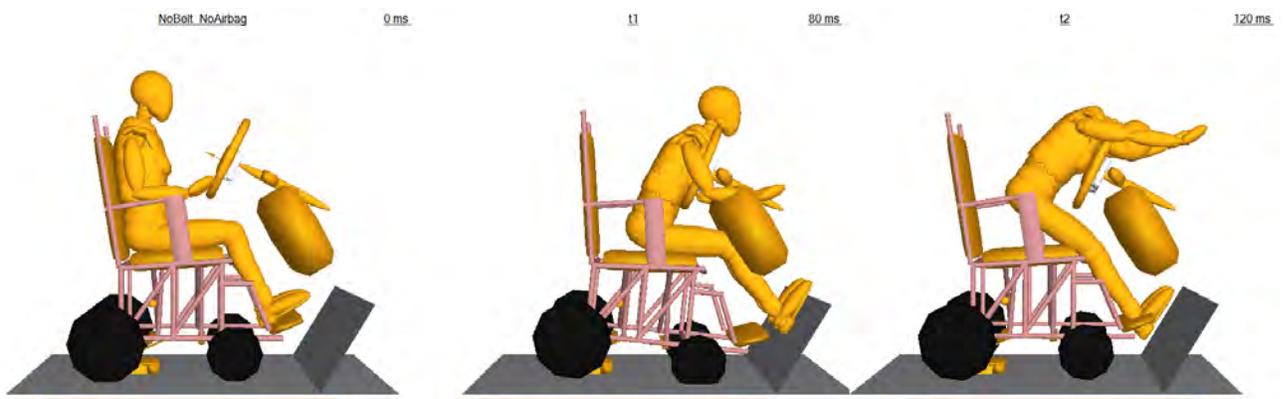
c – small-female ATD with no seat belt and no air bag

Figure 3.9 -Images from the simulation with an unbelted small-female ATD for which neck and chest response measures exceed IARVs

For the small female ATD, simulations with air-bag deployment again have lower HIC values than the comparable simulations without air-bag deployment. The only injury responses of the small-female ATD that are above the IARVs are for N_{ij} and chest deflection and occur for the simulation of the unbelted ATD without air-bag deployment (i.e., for no restraints). Figure 3.9c shows the kinematics of the small-female ATD for this no-restraint condition, and shows the
