UMTRI-2016-8

Wheelchair Occupant Studies

Final Report

The Biosciences Group
University of Michigan
Transportation Research Institute

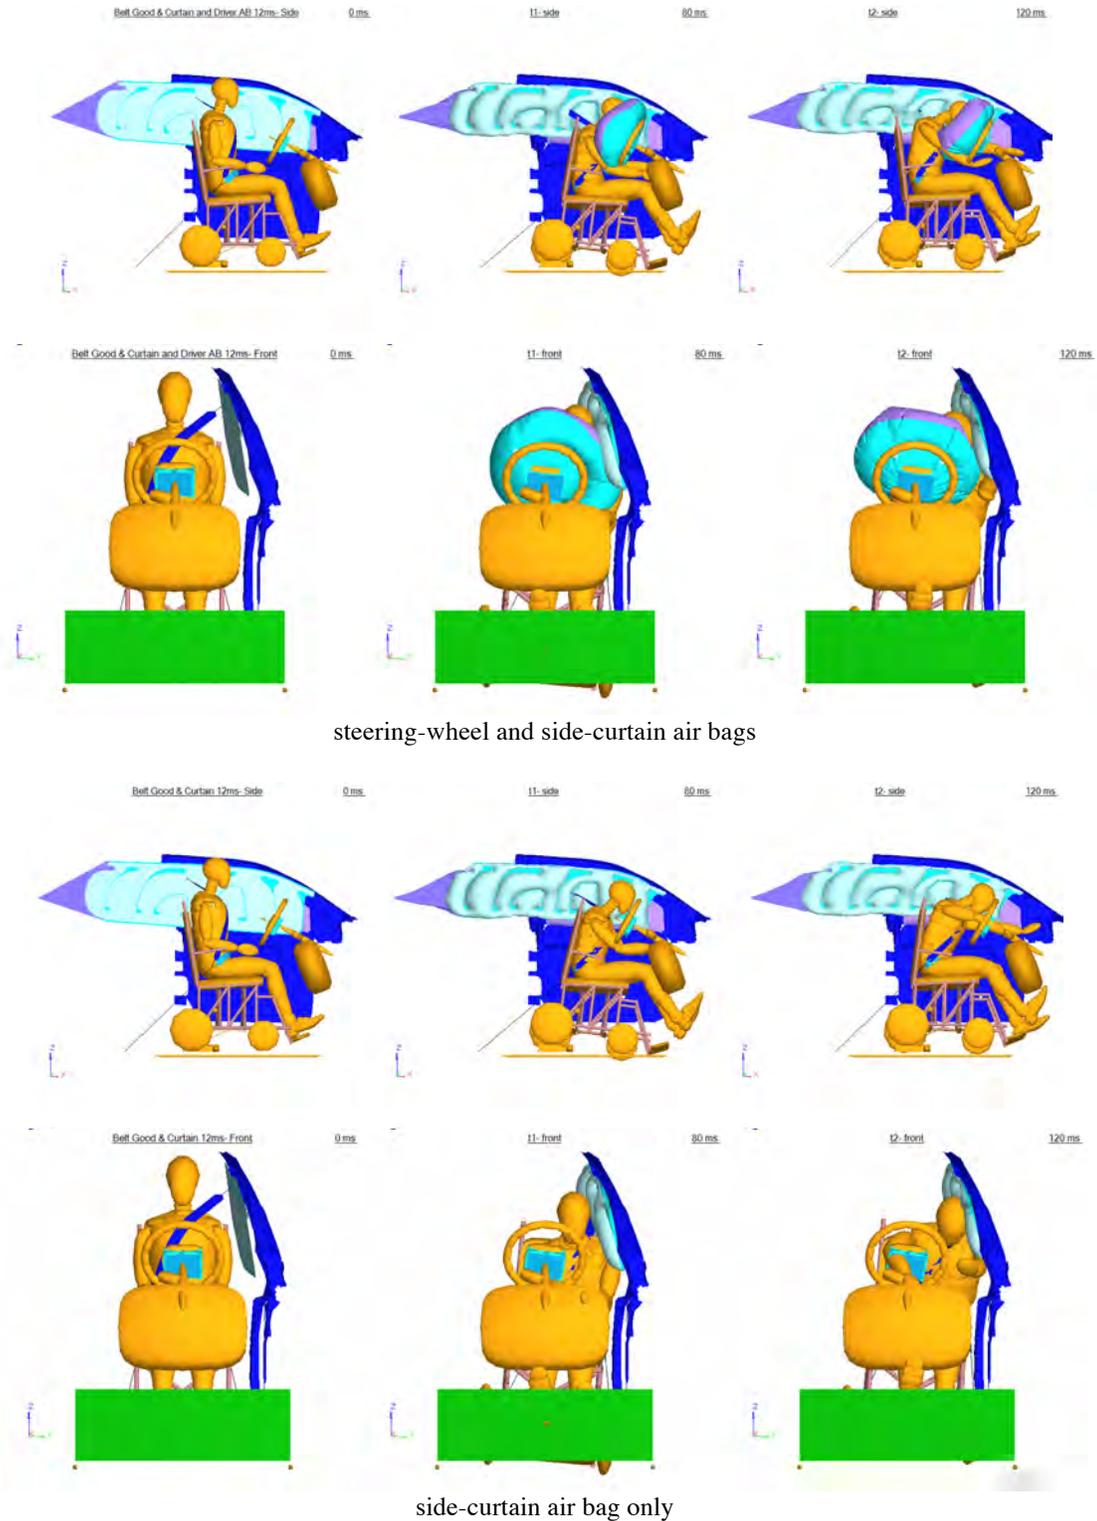
Figure 3.19 - Still frames at 0, 80, and 120 ms for 15-DEGREE angled frontal-impact computer simulations of the MIDSIZE-MALE ATD with GOOD BELT FIT, with deployment of BOTH STEERING-WHEEL AND SIDE-CURTAIN AIRBAGS (upper) and with deployment of ONLY THE SIDE-CURTAIN AIRBAG (lower)

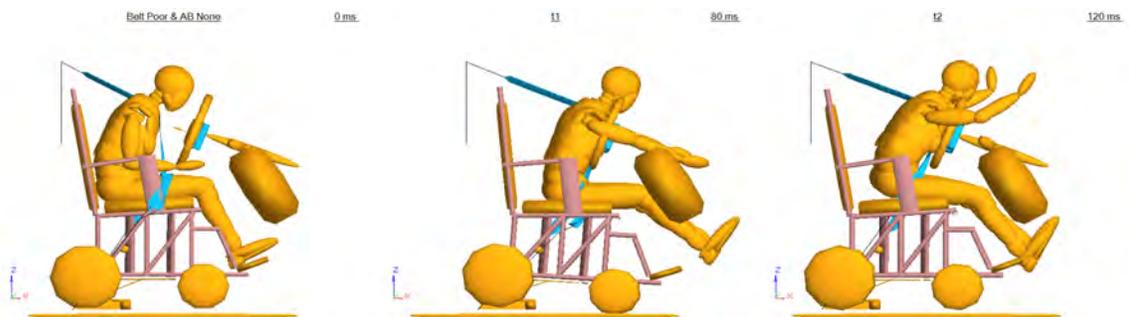
(d) - poor belt fit without deployment of the steering-wheel air bag

Figure 3.23 - Still frames at 0, 80, and 120 ms from computer simulations with the small-female ATD positioned 25-mm (1-inch) from the steering wheel prior to the onset of impact deceleration

Table 3.7 shows the ATD response values for the sixteen conditions simulated. Shaded rows indicate simulations without air bag deployment. The bolded N_{ij} entries in the table highlight the conditions for which the IARVs of Table 2.6 were exceeded. Figure 3.23 to Figure 3.26 show still frames from the simulation output videos at 0 ms, 80 ms, and 120 ms for all sixteen simulations and indicate ATD and wheelchair kinematics and interaction of the ATD with the belt restraints, air bag, and/or steering wheel.

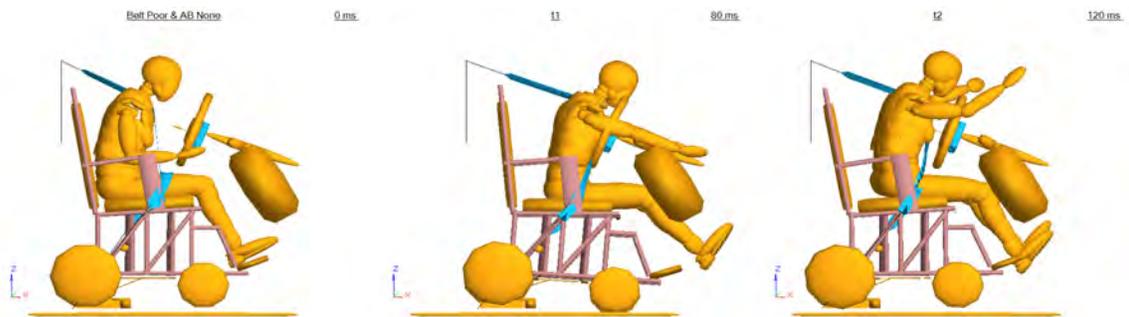
(d) - poor belt fit with no steering-wheel air bag

Figure 3.24 - Still frames at 0, 80, and 120 ms from computer simulations with the small-female ATD positioned 125-mm (5-inches) from the steering wheel prior to the onset of impact deceleration

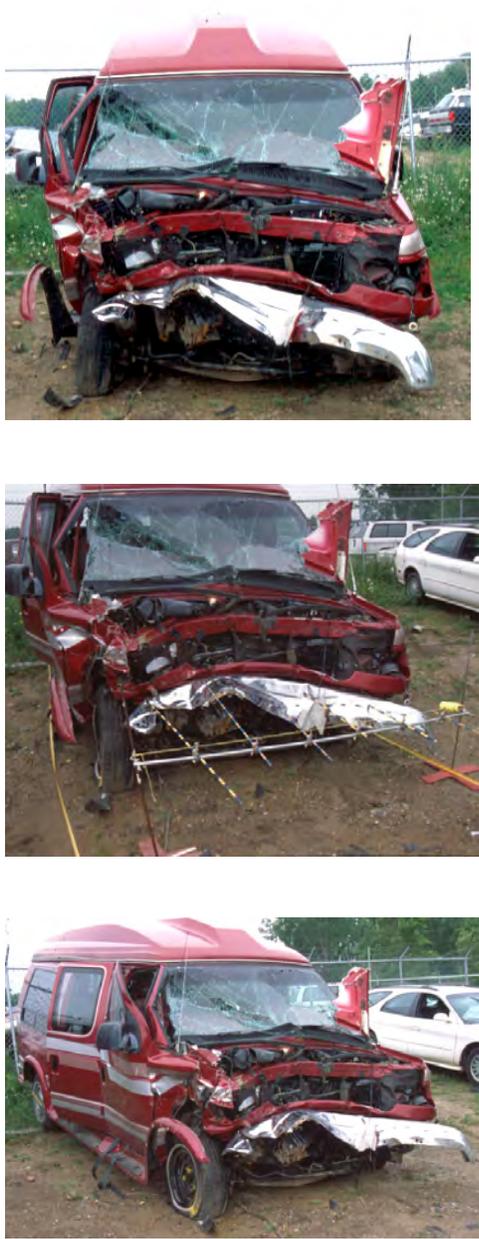
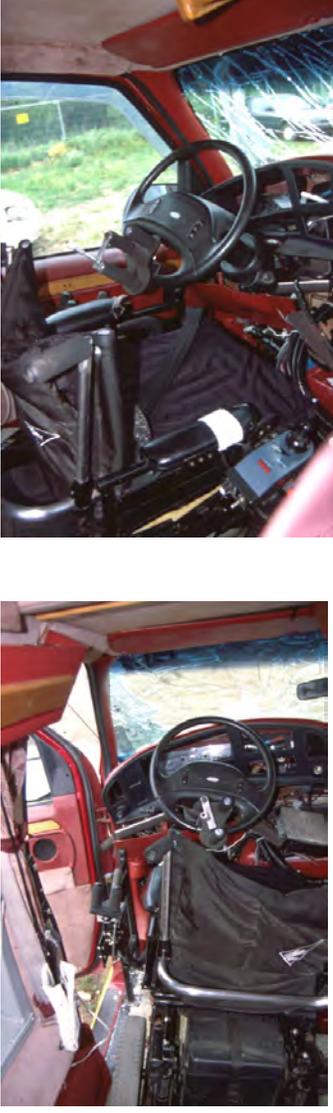
| <p><u>Case Vehicle Information:</u></p> <p>Direct damage length: 158</p> <p>Maximum crush: 69</p> <p>PDOF: 5</p> <p>CDC: 12-FDEW-4</p> | <p><u>Relevant intrusions:</u></p> <p>Instrument panel – 5 cm to rear</p> <p>Steering wheel – 20 cm to rear</p> |

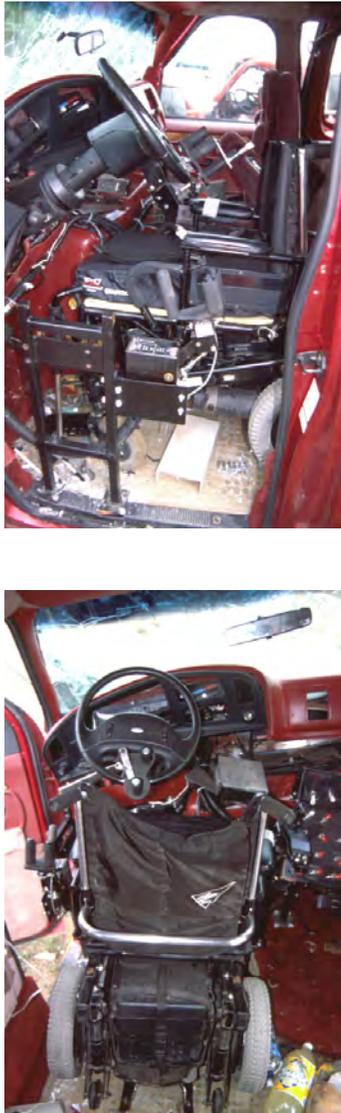
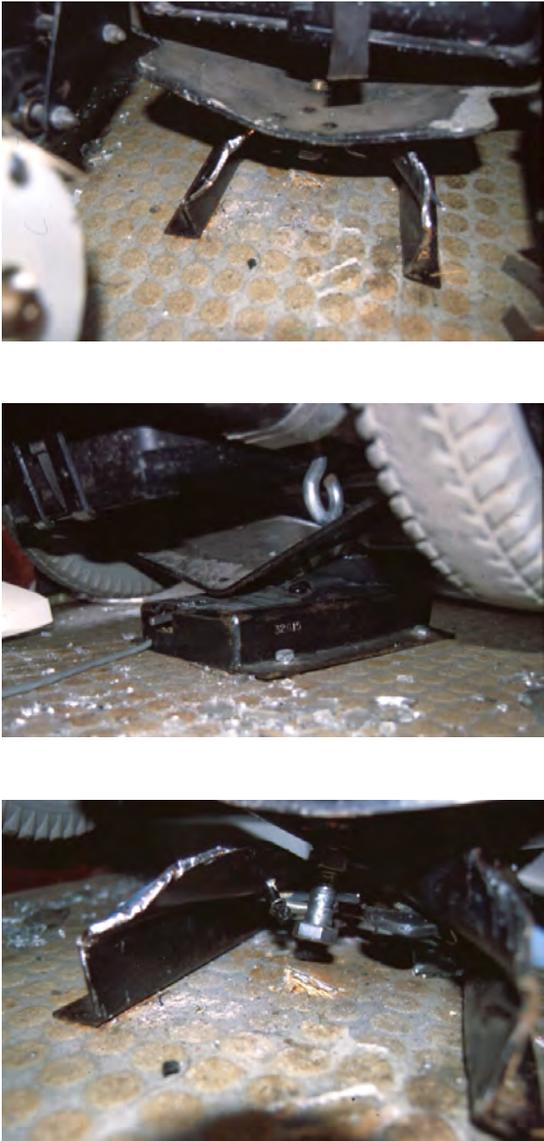
| <p>Description:</p> <p>Wheelchair: AVS WC Ranger X CRM Series, motorized with rigid seat</p> <p>Orientation: forward facing</p> <p>Postural supports: lap belt</p> <p>Head restraint: none</p> <p>Tiedown/use: auto-engage docking; used correctly</p> | <p>Damage:</p> <p>Wheelchair: moderate</p> <p>Seating system: back support broken</p> <p>Postural supports: no damage</p> <p>Tiedown system: partial failure and significant deformation, but did not release wheelchair</p> |

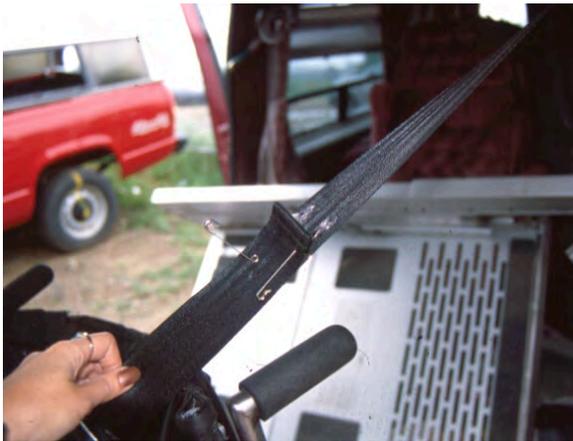
Shoulder belt modified by safety pins

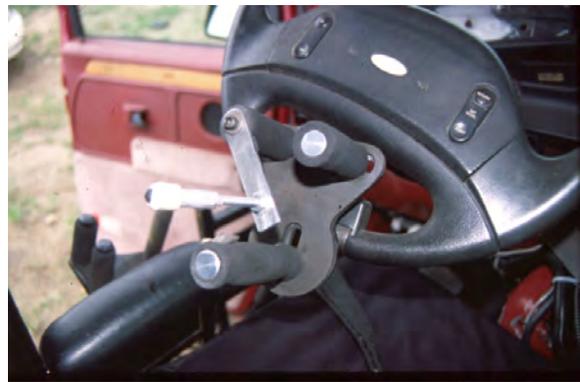
Tri-pin attached to lower steering-wheel rim

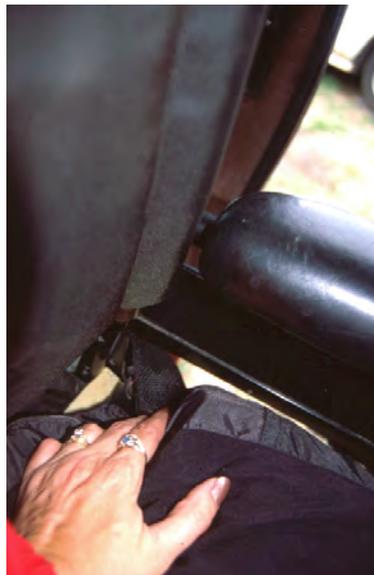
Postural lap belt

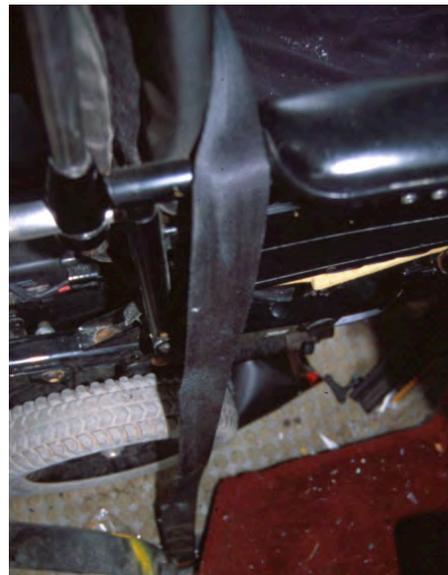
Routing of 2-pt shoulder belt over WC arm support

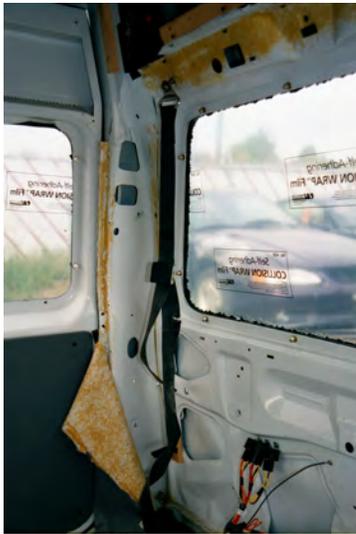
Shoulder belt at back of van

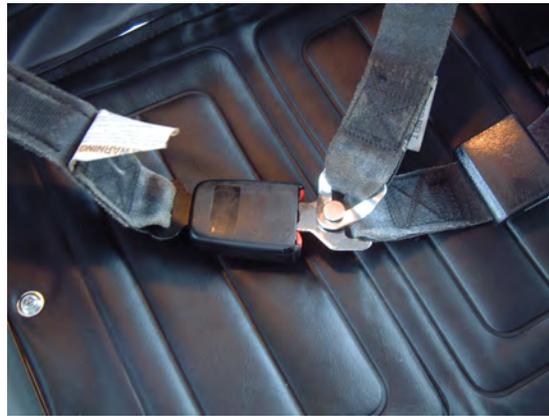
Lap-belt buckle with lower end of shoulder belt attached

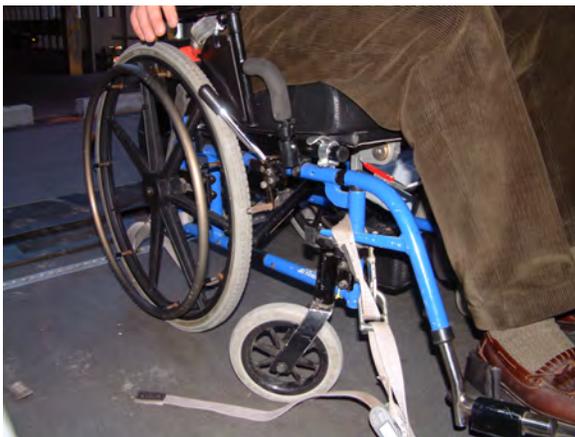
Lap-belt buckle with end-release button located close to rim of left wheelchair wheel

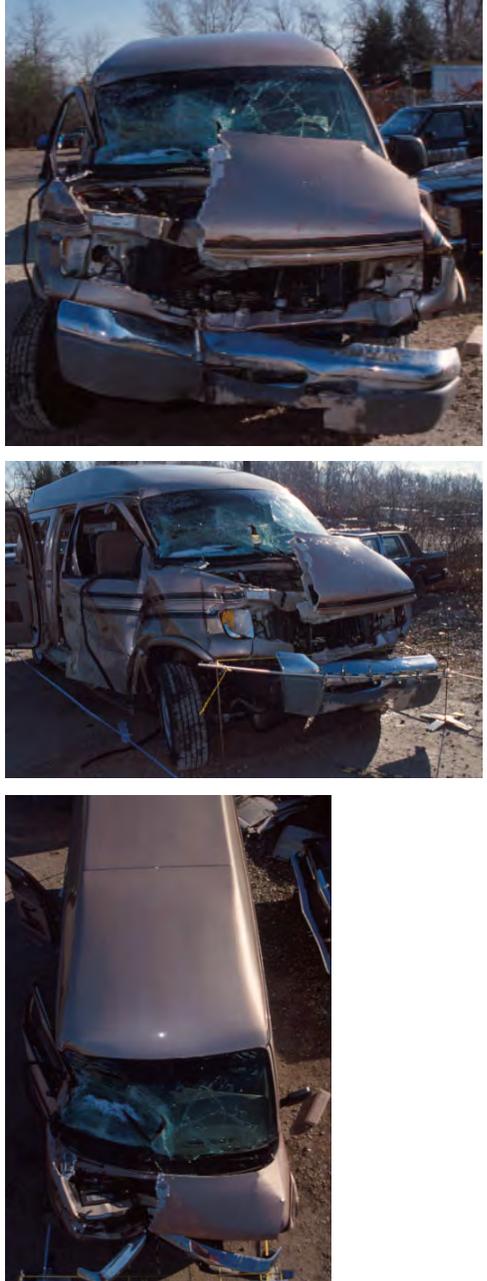
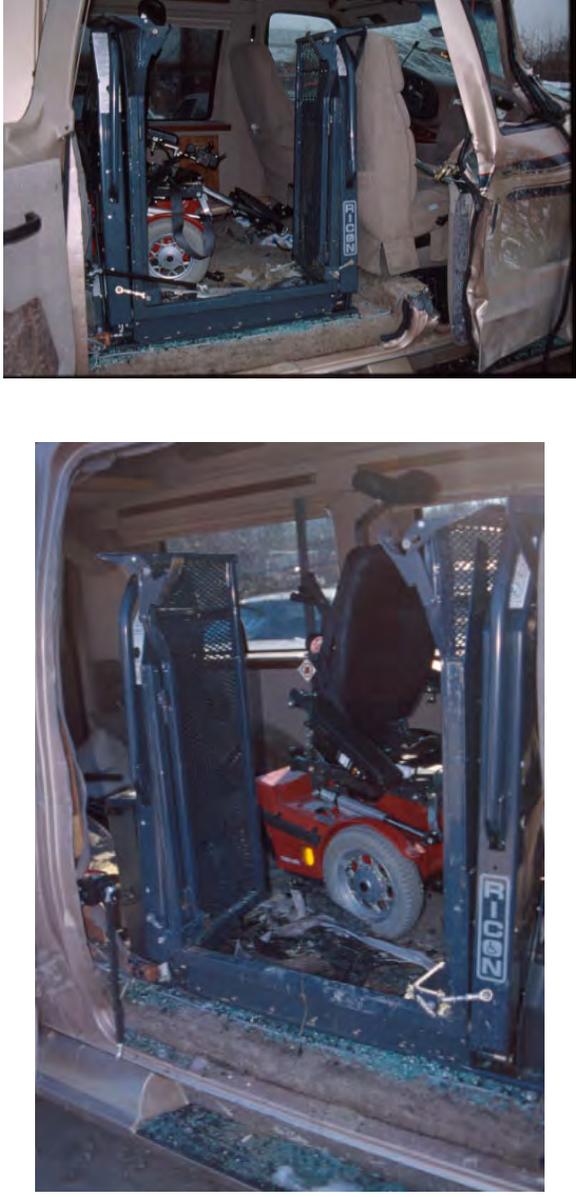
| <p><u>Case Vehicle Information:</u></p> <p>Direct damage length: 172 cm</p> <p>Maximum crush: 47 cm</p> <p>PDOF: 0 degrees</p> <p>CDC: 12-FDAA-7</p> | <p><u>Relevant intrusions:</u></p> <p>none</p> |

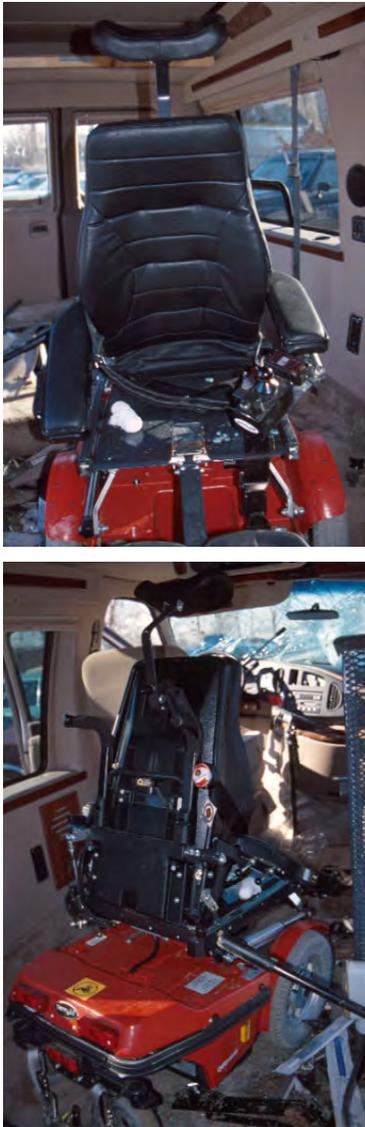
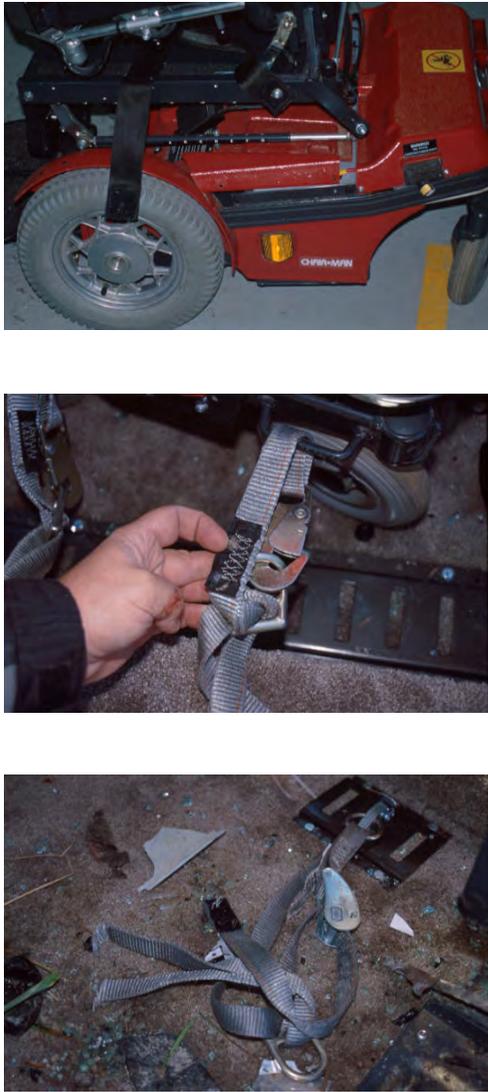
| <p>Description:</p> <p>Wheelchair: Crash-tested powered Permobil Chairman Corpus with four securement points</p> <p>Orientation: forward facing</p> <p>Postural supports: chest and lap belts attached to wheelchair using screws through metal grommets on wheelchair</p> <p>Head support: upper part of back support</p> <p>Tiedown/use: 4-point strap tiedown used correctly</p> | <p>Damage:</p> <p>Wheelchair: a linkage in the adjustable back support was broken</p> <p>Seating system: backrest adjustment linkage failed</p> <p>Postural supports: failed at grommet attachment</p> <p>Tiedown system: no damage</p> |

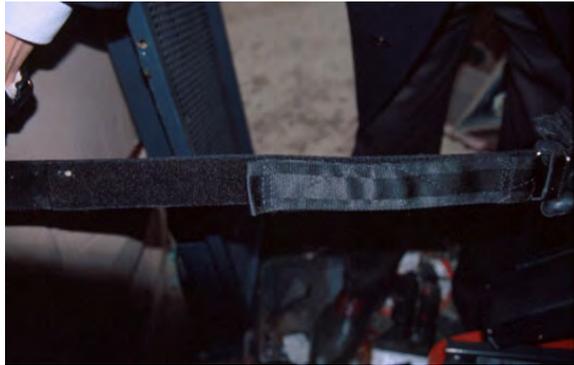
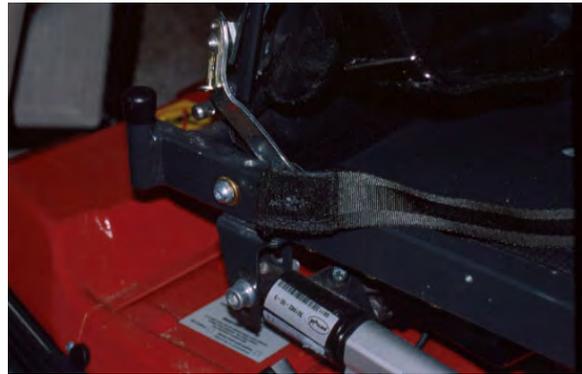
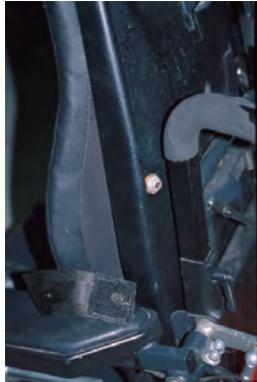
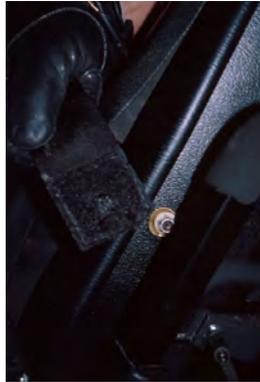
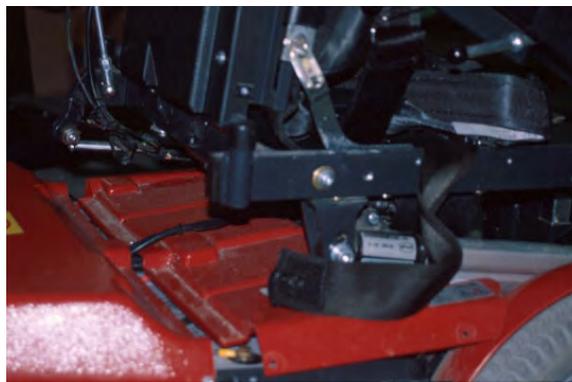
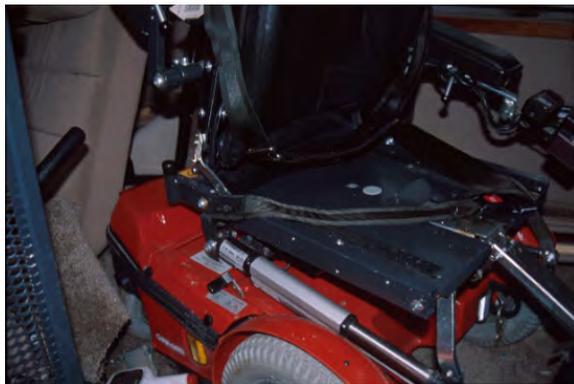
Restraint system:

| <p><u>Occupant Kinematics:</u></p> <p>During the frontal impact, the wheelchair-seated male passenger moved forward into the postural straps, causing them to fail at the grommet attachment. When the postural straps on the wheelchair failed, the passenger slid out of the wheelchair and his head contacted the wheelchair. He lost consciousness for less than one hour and sustained a laceration to the posterior aspect of his head, probably from head contact with the wheelchair. He sustained a contusion to the spleen due to loading by the postural straps, and a fracture to the right second finger, probably from hand contact with the right-front passenger seat.</p> | <p><u>Occupant Contacts:</u></p> <p>Occupant’s head contacted wheelchair.</p> <p>Right finger contacted back of right-front passenger seat.</p> |

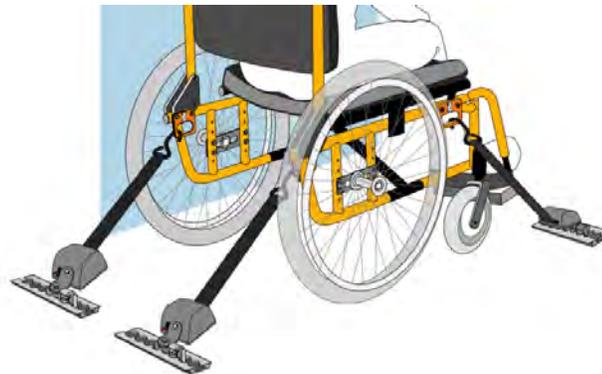
Illustration of a wheelchair secured by a four-point, strap-type tiedown

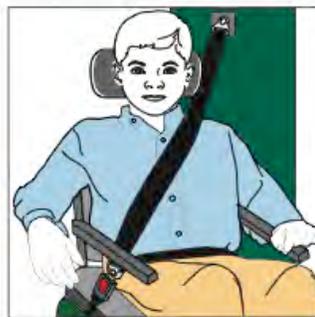
Good shoulder belt positioning over the center of the shoulder and chest

- the angle of the lap belt is no less than 30 degrees and preferable greater than 45 degrees to the horizontal,
 - the shoulder belt crosses over the middle of the shoulder closest to the side of the vehicle to an upper anchor point or D-ring on the vehicle that is behind and above the top of the passenger's shoulder, and

- the junction of the lap and shoulder belt is near the hip of the passenger.

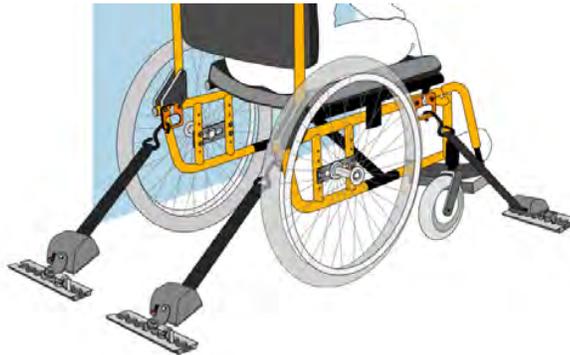
Illustration of a WC19 wheelchair secured by a four-point, strap-type tiedown

- 1) If the client doesn't have a wheelchair that complies with the industry wheelchair transportation safety (WTS) safety standard, known as a WC19-wheelchair, tell them about these crashworthy wheelchairs that are designed for use as seats in motor vehicles with four easily accessible places for attaching hooks of tiedown straps, and encourage the client to purchase a WC19-wheelchair the next time they are in the market for a new wheelchair.

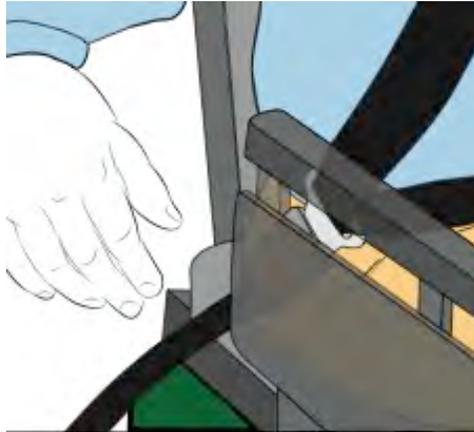
Lap belt placed in gap between arm support and back to achieve proper positioning of the belt low on the pelvis

- If the client has a wheelchair with arm supports that are not open at the front but there are sufficiently large gaps between the arm supports and the wheelchair

back support, show the client how the lap belt can be inserted into these gaps to achieve proper lap-belt positioning in good contact with the lower part of the pelvis.

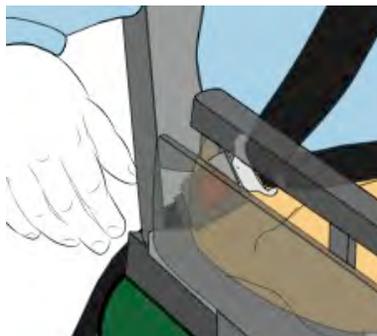
Lap belt threaded into opening between the seat and back support to achieve proper positioning low on the pelvis

NOTE: Seat belts provided by tiedown manufacturers often provide stiffened lap-belt webbing with small anchorage hardware that make it easier to thread the anchorage ends of the lap belt through openings between the wheelchair back and seat on both sides of the passenger. The anchorages are then manually connected to anchorage fittings on the vehicle floor behind the wheelchair.

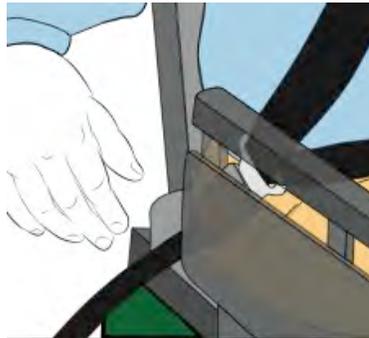
Lap belt placed in gaps between arm supports and the back support to achieve proper positioning low on the pelvis

- For wheelchairs with arm supports that are connected to the wheelchair frame at the front so that it is not possible to slide the lap belt under the front of the arm supports, proper positioning of a vehicle-anchored lap belt can often be achieved by inserting the two halves of the lap belt into sufficiently large gaps between the arm supports and the back support.

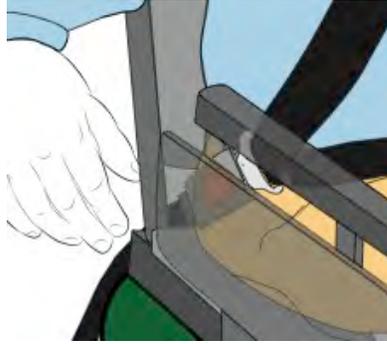
Lap belt threaded into opening between the wheelchair seat and back support to achieve proper positioning low on the pelvis

- For wheelchairs with arm supports that are not open underneath at the front but that can be rotated upward or sideways, this feature can be used to help achieve proper positioning of a vehicle-anchored lap belt in contact with the lower part of the pelvis.
- For some wheelchairs, achieving proper positioning of the lap belt low on the pelvis may require “threading” the stiffened anchorage ends of the lap belt through openings between the wheelchair back support and the seat on each side of the passenger.
