Memorandum

**National Highway
Traffic Safety
Administration**

Subject: Consumer Interview and Vehicle Inspection Date: 8/30/2007
Vehicle Owner Questionnaire (VOQ) ODI 10189655

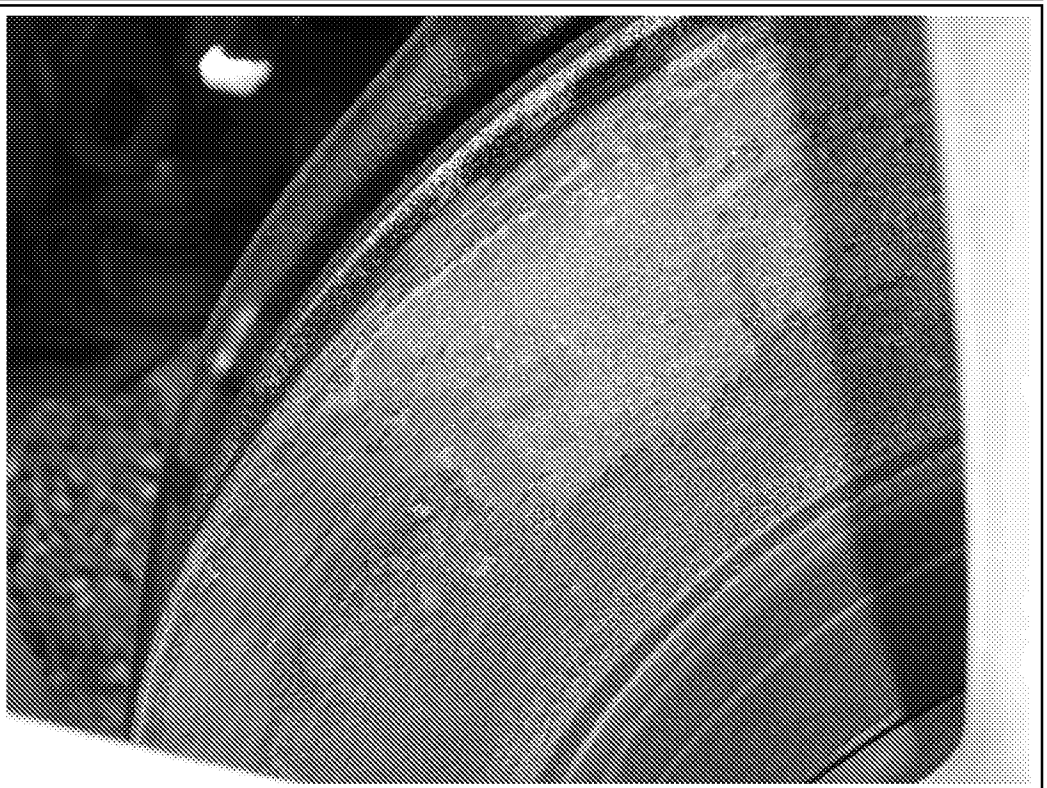
With the exception of the damage related to the collision, fire, and the subsequent storage and protection, the vehicle's condition is consistent with the estimated vehicle mileage indicated on the VOQ. The fire origination appears to be in the engine compartment; causation was not evident however portions of the fuel system were damaged. The fire consumed most of the

engine compartment combustibles and damaged the windshield, driver glass, and other interior and exterior components. See photos 2 to 5.

Photo 5: Fire damage to front windshield and dash panel

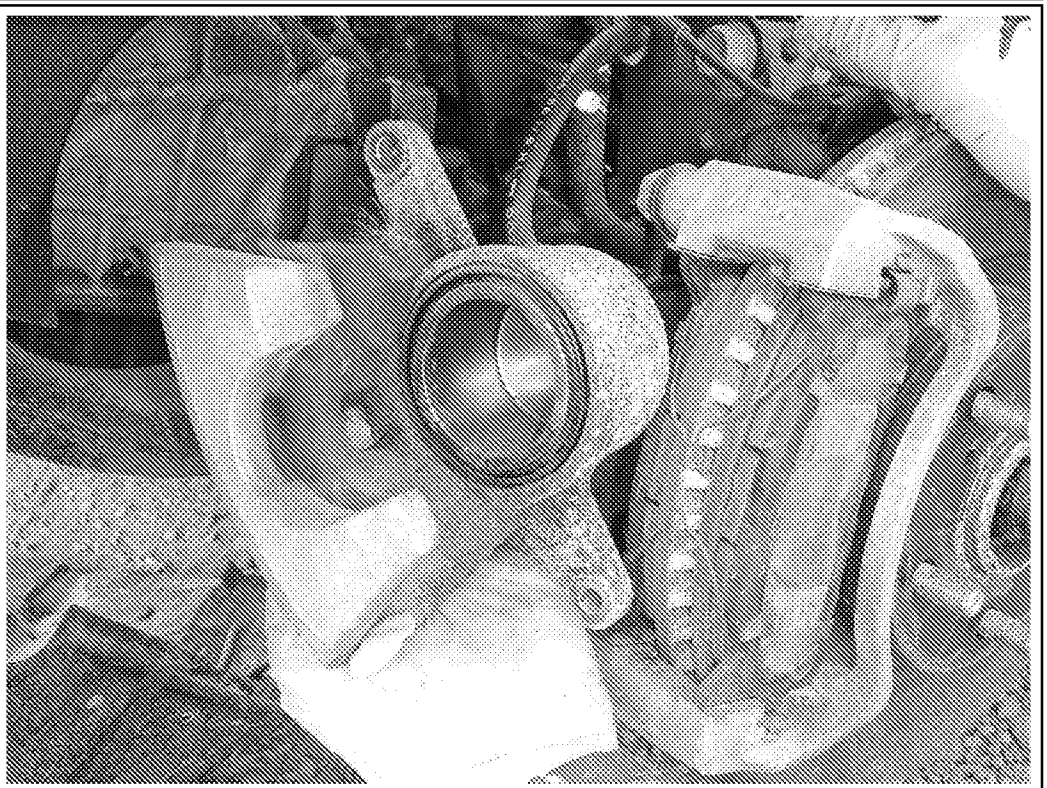
Discoloration, rust and surface damage to the brake rotors is visible through all four wheel apertures. The LHF and LHR brake calipers were removed and the brake components inspected. The components displayed significant damage due to overheating. The damage is consistent with the driver's statement that she was attempting to stop the vehicle while it was moving at high speed for a significant distance. See photos 6 to 10.

Photo 7: LHF brake assembly, wheel removed

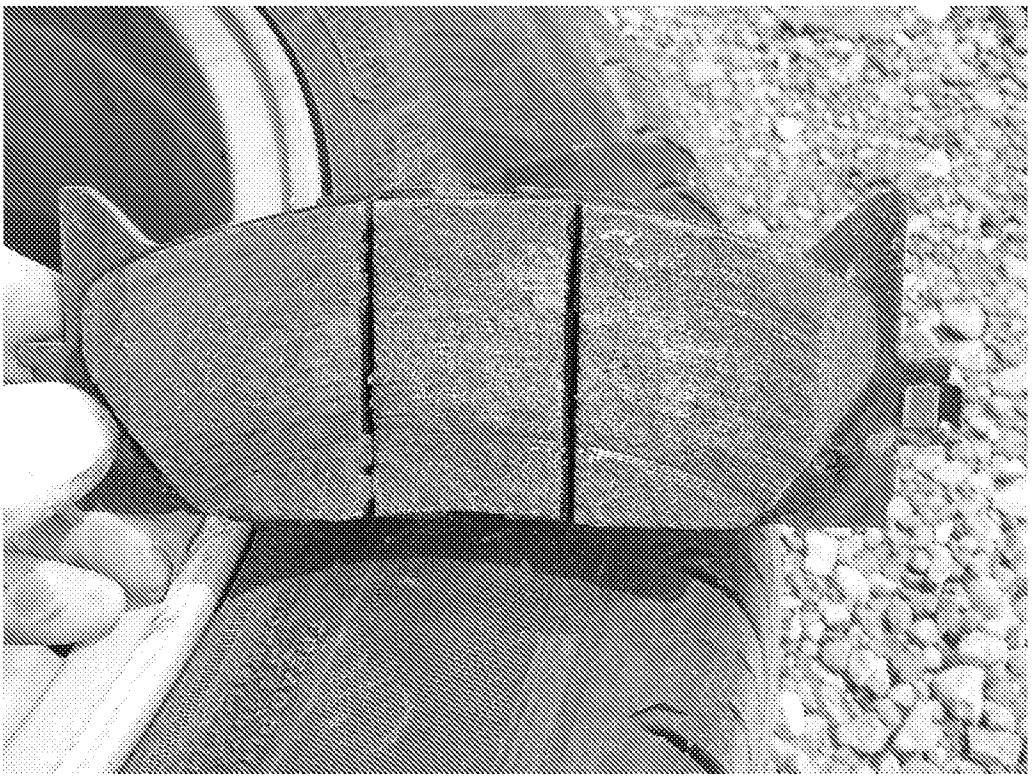
Photo 9: LHF disc brake pad, friction surface/rotor side

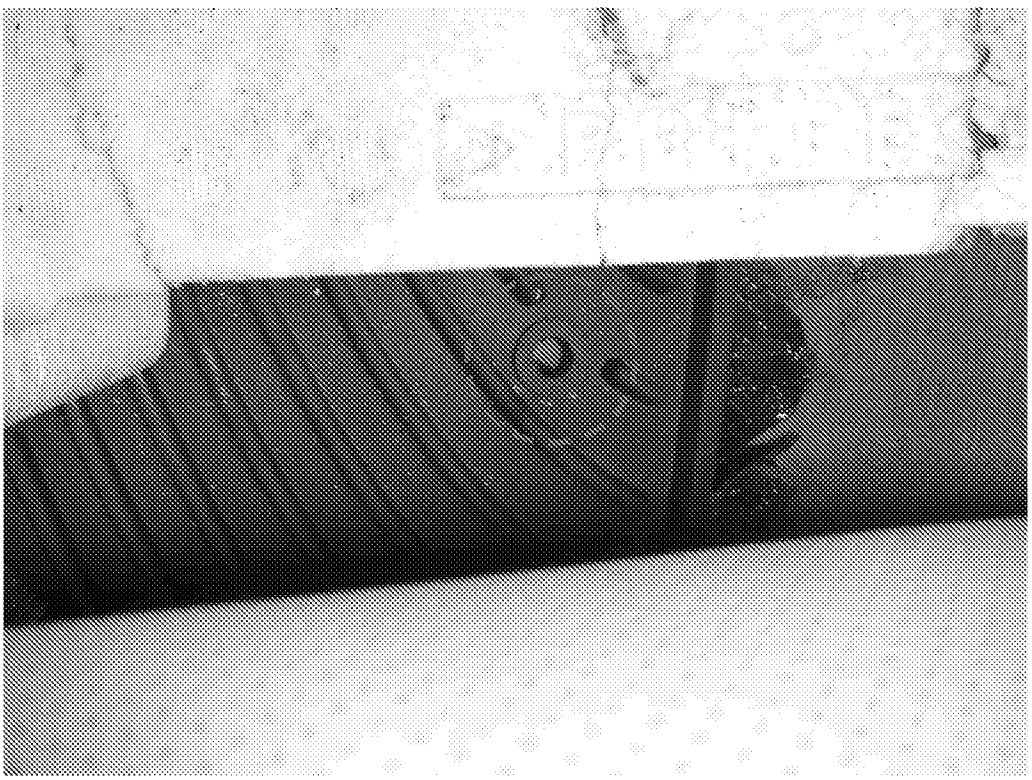
The vehicle interior condition is consistent with the estimated vehicle mileage. All weather mats are installed at all four seating positions. The driver side all weather mat was found to be installed by itself; it was not on top of another floor mat. The installed mat was found to be unsecured by the retention hooks; the mat did not interfere with the accelerator pedal in the position it was originally inspected. The mat was removed from the vehicle. The two retention hooks were found engaged in the flooring material after the mat was removed[5]. The hooks were intact and did not appear to be damaged from the collision. See photos 11 to 16.

Photo 13: Driver inboard mat retention hole without retaining hook engaged
