# Investigation Report for Tacoma vehicle

Oct 25, 2007

North America CQE-LA center

## 1. Vehicle Outline

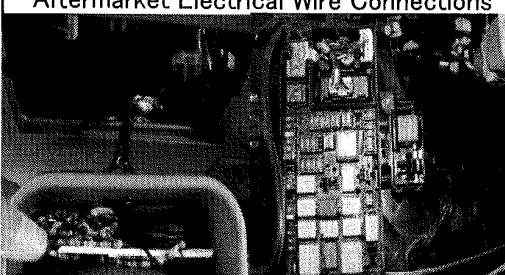
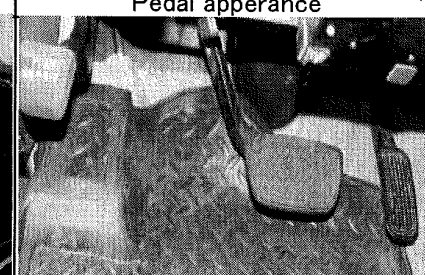
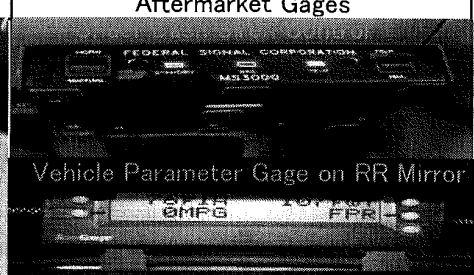
### (3) Notes

Abnormal position. Deformation (fully opened) : None	
		Contact of movement range : Bottom of Husky mat	
		Abnormal pedal force, Contact with other component : Bottom/top of mat	
		Return spring : Good	
Throttle Body	Foreign body adhesion from air cleaner to surge tank : None

Aftermarket Electrical Wire Connections	Pedal appearance	Aftermarket Gages
